1. Hydraulic Generation Refurbishment and Modernization (2019-2020)

Hydraulic Generation Refurbishment and Modernization

July 2018

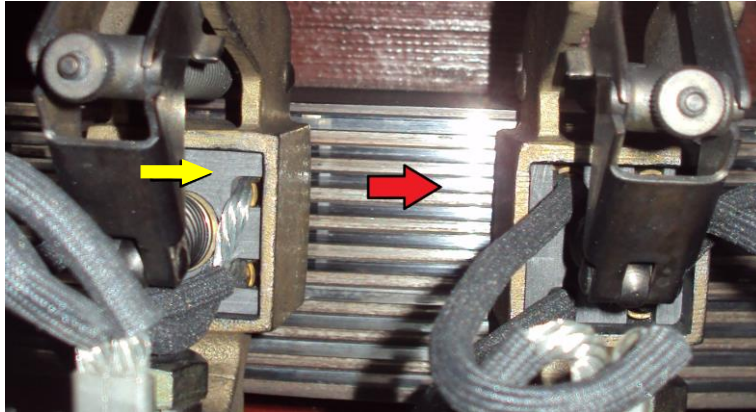
Figure 3: Slip ring (red arrow); Brushes (yellow arrow). There are 26 brushes and two rings

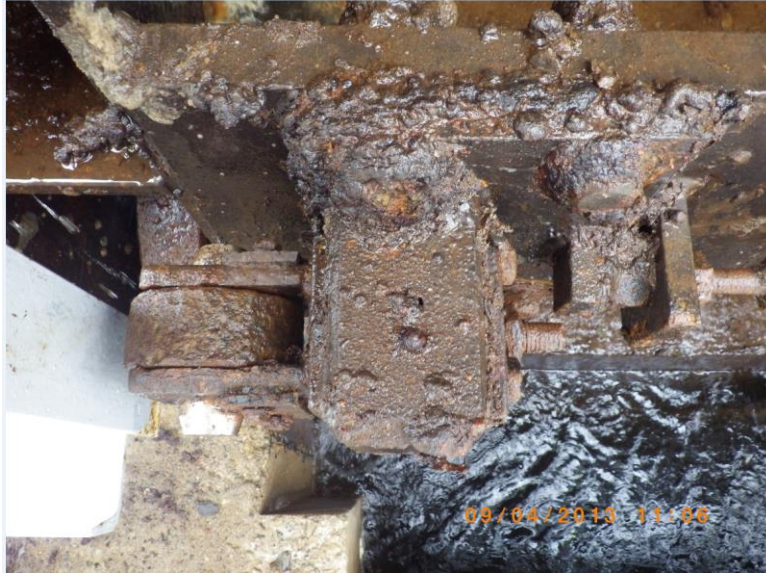
2 A detailed assessment of Bay d'Espoir Intake 1 was completed in 2016 and it was determined
3 that there were varying levels of deterioration, particularly in the submerged/embedded
4 components. Deterioration consists of concrete erosion and corrosion on embedded parts/
5 gate components. Critical components that have shown deterioration include main rollers, roll
6 paths, side-rollers and seals. It was also noted that the deterioration of these components is
7 creating extra stress on the hoist system. As these intakes are the same vintage, with similar
8 operating conditions and in the same environment, Hydro expects that the state of Intakes 2
9 and 3 are similar to the state of Intake 1 identified in 2016. Also, in 2013 Intake gate 2 failed to
10 close due to issues related to those identified for the Intake 1. Figure 5 and Figure 6 are images
11 of the side and main rollers on Intakes 2 and 1.

Figure 5: Bay d'Espoir Intake 2 Side Rollers - 2013

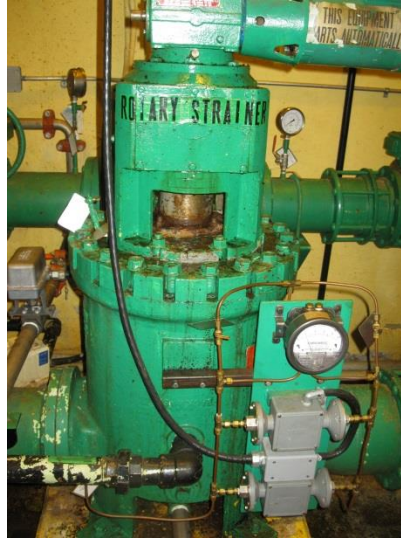
Figure 16: Rotary Strainer

- 1 **Existing State**
- 2 The cooling water pump, rotary strainer, and emergency Y strainer⁷ are original equipment and
- 3 have been operating throughout the life of the plant since commissioning in 1980.

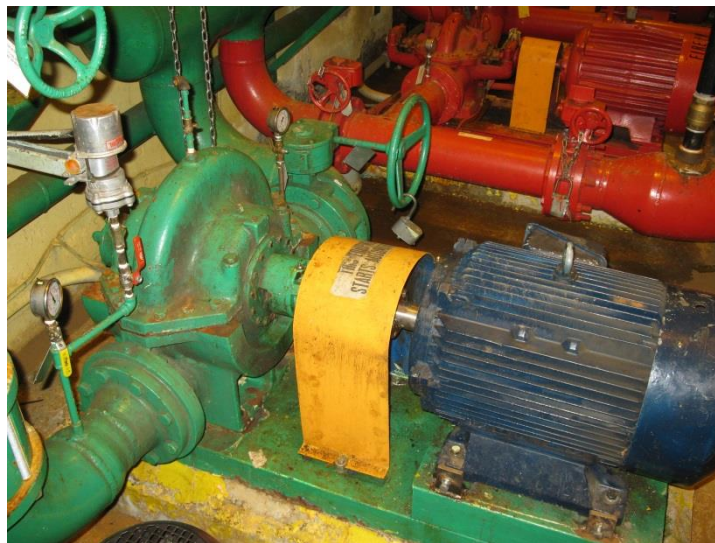
Figure 17: Cooling Water Pumps
