1   **Re: D-85, Replace Radio Tower, Ebbegunbaeg, \$179,000**

## STRUCTURAL ASSESSMENT

### EXISTING 30m KNOCK-DOWN SELF-SUPPORT TOWER

Ebbegunbaeg, NL

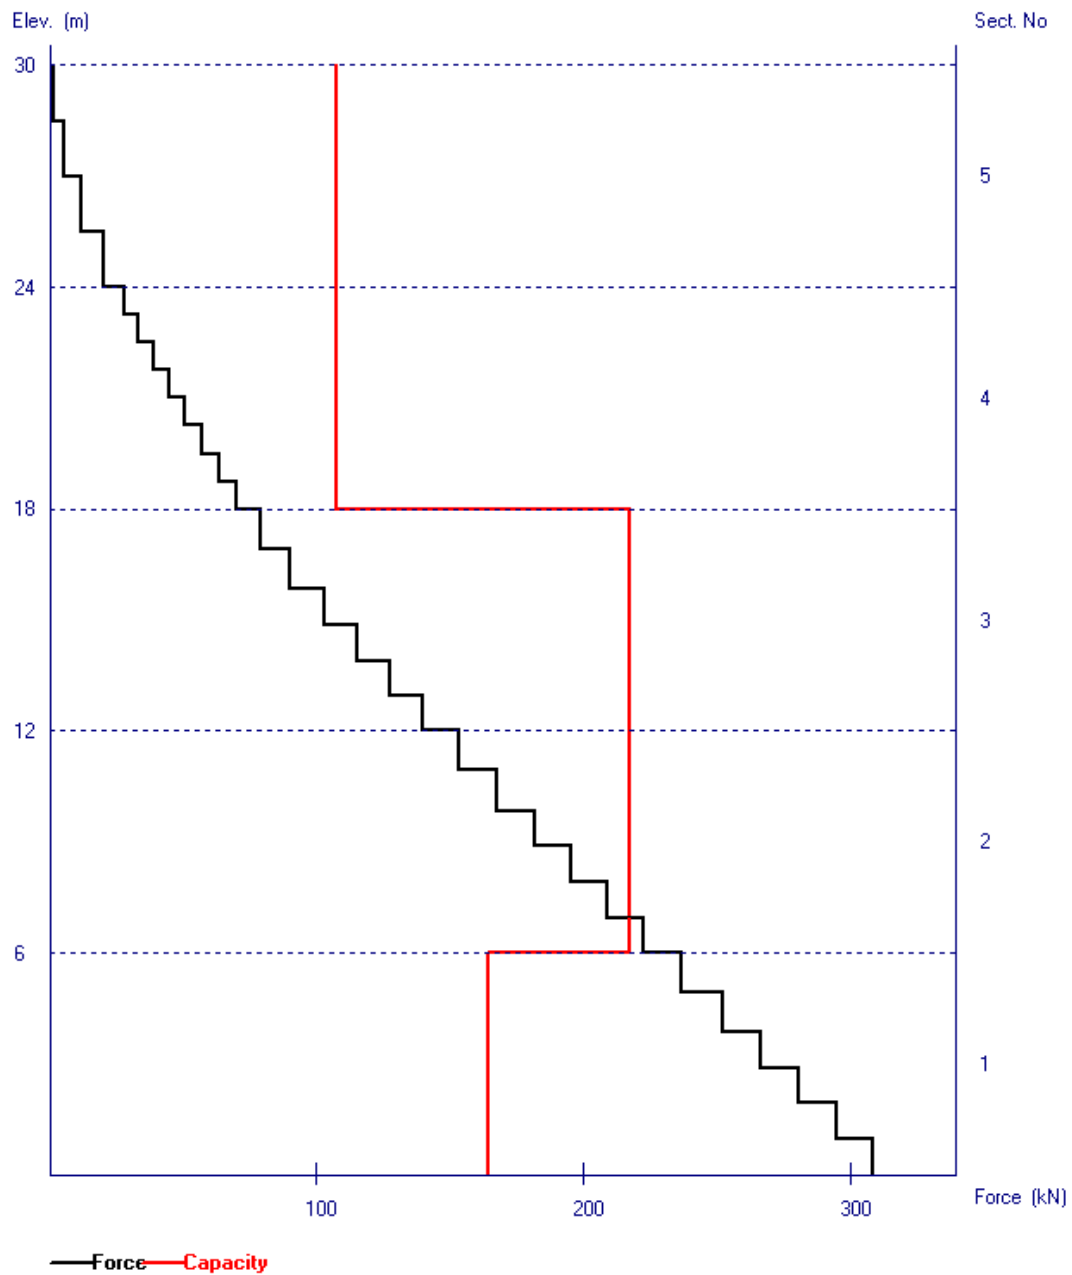
**Leg Load Tension Diagram**  
**Max. Envelope (All Loading Cases)**

The analysis considered all existing loading for the Ebbegunbaeg tower. The EBB tower exhibits tower leg overloads over 300% and minor diagonal overloads. In addition to leg overloads the existing condition of the tower foundation is deteriorated and requires structural repairs (See Appendix C, Photos #3 & #4). As a result of the extensive leg overloads and deteriorated tower foundations we recommend a full replacement of this tower. As a temporary cautionary measure we recommend installing signage indicating that the tower does not meet CSA-S37-01 requirement and should not be climbed during icing or high wind conditions.
