**Undertaking 78**

**Re: Investigation and Hearing into Supply Issues and Power Outages on the Island Interconnected System**

**DESIGN STUDY AND FAILURE INVESTIGATION FOR AUTO  
TRANSFORMER**

**SERIAL # 289147**

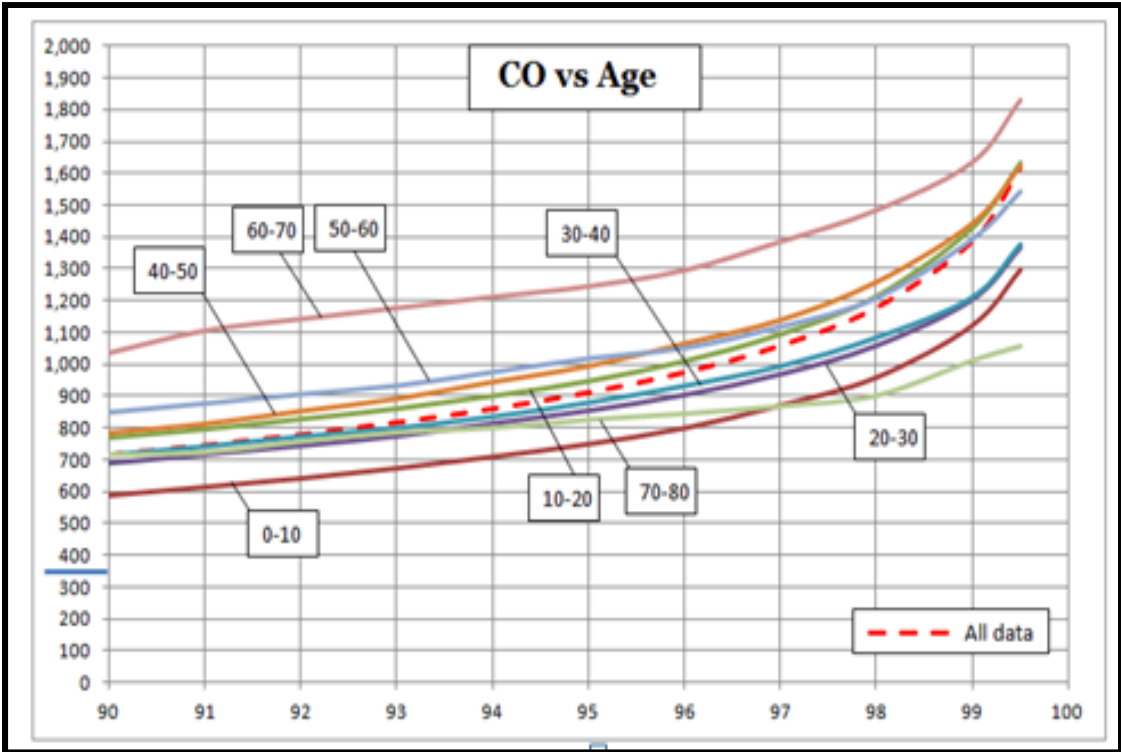
Figure 5 – IEEE Transformer Committee Carbon Oxide Survey Results

- Shown below in Figure 5 is a distribution plot of carbon oxide gas levels taken from a survey by the IEEE Transformer Committee using > 520,000 data records of units in service. This very large quantity of data is being used to revise the gas level limits in C57.104 (the famous Table 1 with condition 1 – 4 levels) – note that the levels will be increased. As can be seen, the 90<sup>th</sup> percentile levels are 700 ppm and 7500 for CO and CO<sub>2</sub> respectively. Figure 6 shows the CO distribution by age categories and for 30 – 40 years category, the 90<sup>th</sup> percentile is about 700 ppm. The history gassing on this transformer was around 500 ppm and 3600 ppm for CO and CO<sub>2</sub> respectively. Thus these levels are well below the 90<sup>th</sup> percentile of the IEEE data for the age of this unit.

- As can be seen from Figure 5 & 6, the 90<sup>th</sup> percentile levels are 700 ppm and 7500 for CO and CO<sub>2</sub> respectively. The 90<sup>th</sup> percentile is about 700 ppm for the CO distribution by age categories and for 30 – 40 years category. The history gassing on this transformer was around 450 ppm and 3000 ppm for CO and CO<sub>2</sub> respectively. Thus these levels are below the 90<sup>th</sup> percentile of the IEEE data for the age of this unit.

- As can be seen from **Figure 5 & 6**, the 90<sup>th</sup> percentile levels are 700 ppm and 7500 for CO and CO<sub>2</sub> respectively. The 90<sup>th</sup> percentile is about 700 ppm for the CO distribution by age categories and for 30 – 40 years category. The history gassing on this transformer was around 590 ppm and 4400 ppm for CO and CO<sub>2</sub> respectively. Thus these levels are below the 90<sup>th</sup> percentile of the IEEE data for the age of this unit.

- As can be seen from **Figure 5 & 6**, the 90<sup>th</sup> percentile levels are 700 ppm and 7500 for CO and CO<sub>2</sub> respectively. The 90<sup>th</sup> percentile is about 700 ppm for the CO distribution by age categories and for 30 – 40 years category. The history gassing on this transformer was around 560 ppm and 5500 ppm for CO and CO<sub>2</sub> respectively. Thus these levels are below the 90<sup>th</sup> percentile of the IEEE data for the age of this unit.

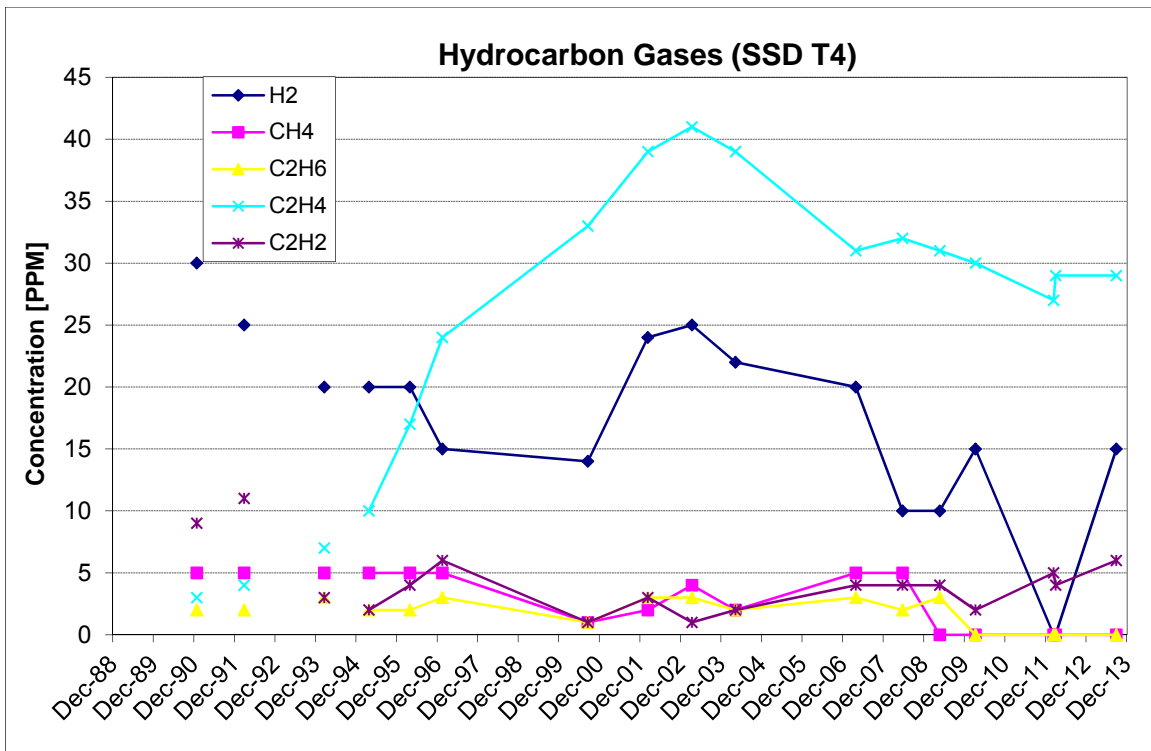
Figure 7 - Hydrocarbon Gas Concentrations

- The concentration of Hydrogen (H<sub>2</sub>) has been well below IEEE C57.104-2008 guide condition level 1 since 1991, the highest level is 30 ppm.
- The concentration of Methane (CH<sub>4</sub>) and Ethane (C<sub>2</sub>H<sub>6</sub>) have been steadily low for the period of the data provided. The Ethylene (C<sub>2</sub>H<sub>4</sub>) level is slightly above condition level one of the IEEE C57.104-2008 guide since 1991.

- The concentration of Acetylene (C<sub>2</sub>H<sub>2</sub>) has been above IEEE C57.104-2008 guide condition level 1 since 1991. The level went up and down since then but was almost stable around the 5ppm. This could be oil leaking from LTC diverter compartment.

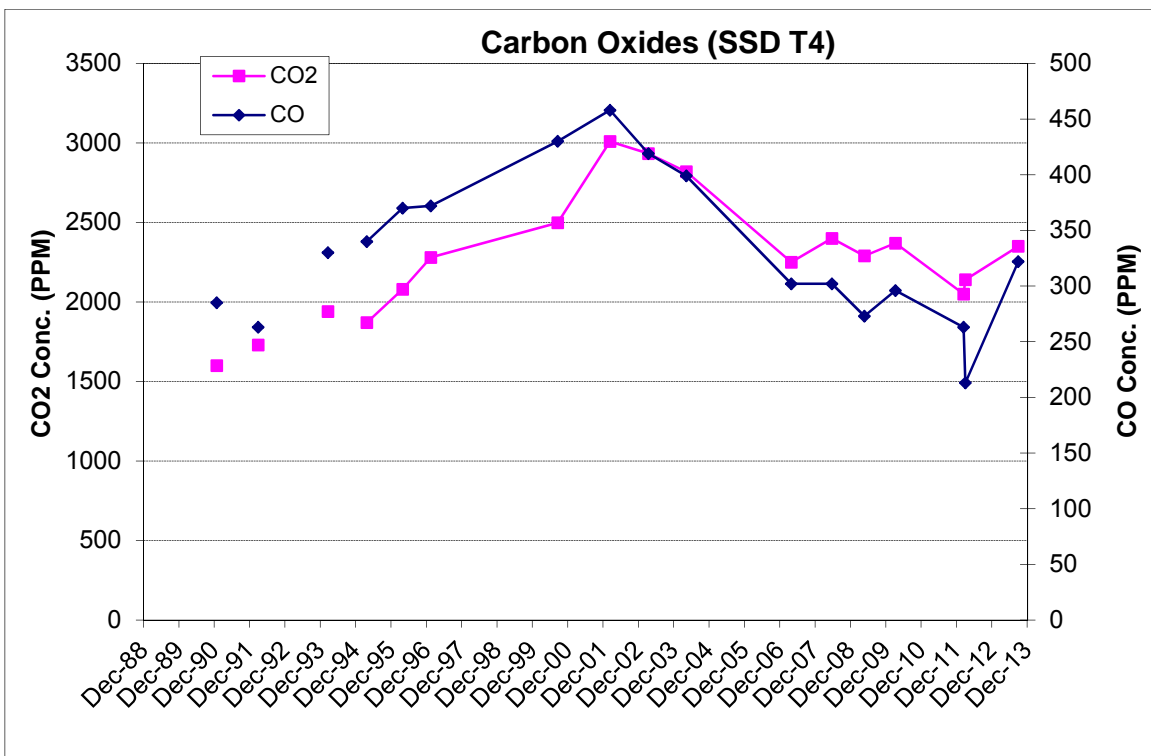
Figure 8 - Carbon Oxides Gas Concentrations

- The carbon dioxide level has been below the IEEE C57.104-2008 guide condition level 1 for the time period provided. The carbon monoxide level is slightly above the IEEE C57.104-2008 guide condition level 1 between 1996 and 2004, however the level became normal after 2004. The ratio of CO<sub>2</sub>/CO is between 5 and 10. The normal CO<sub>2</sub>/CO ratios are typically in the range of 5-9. The ratio of the carbon oxides suggests that the concentrations are due to the normal aging process of the transformer.

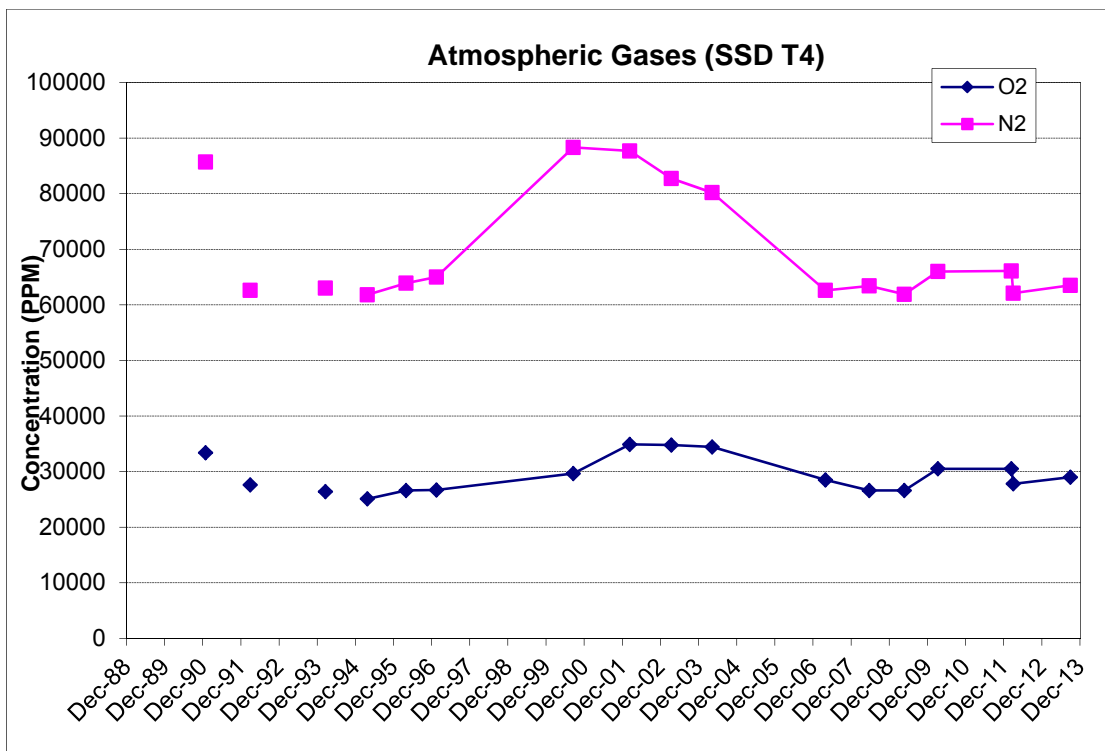
Figure 9 – Atmospheric Gases Concentrations

- The presence of large concentrations of oxygen in the oil can promote the formation of acids in the oil and cellulose and accelerate the aging rate of the cellulose insulation. It is recommended that the concentration of oxygen in the transformer be less than 2000 ppm (Refer to CIGRE report 323 – Aging of Cellulose in Mineral-Oil Insulated Transformers). The transformer maintenance record (09/06/2012) provided by the customer does not mention if the oil had ever been vacuum processed since 1991. The oil samples from this transformer have consistently shown very high oxygen concentrations (>20,000 ppm) of oxygen. The source of this high oxygen is the free-breathing oil conservator. To reduce the oxygen in the transformer oil and eliminate the uncertainty concerning the gas generation, it is recommended to add a conservator diaphragm. The diaphragm prevents oil from coming in contact with the air. This will prevent moisture, excessive atmospheric gases from dissolving into the oil and it also helps to keep all gases generated by the transformer in oil for more accurate diagnostics.

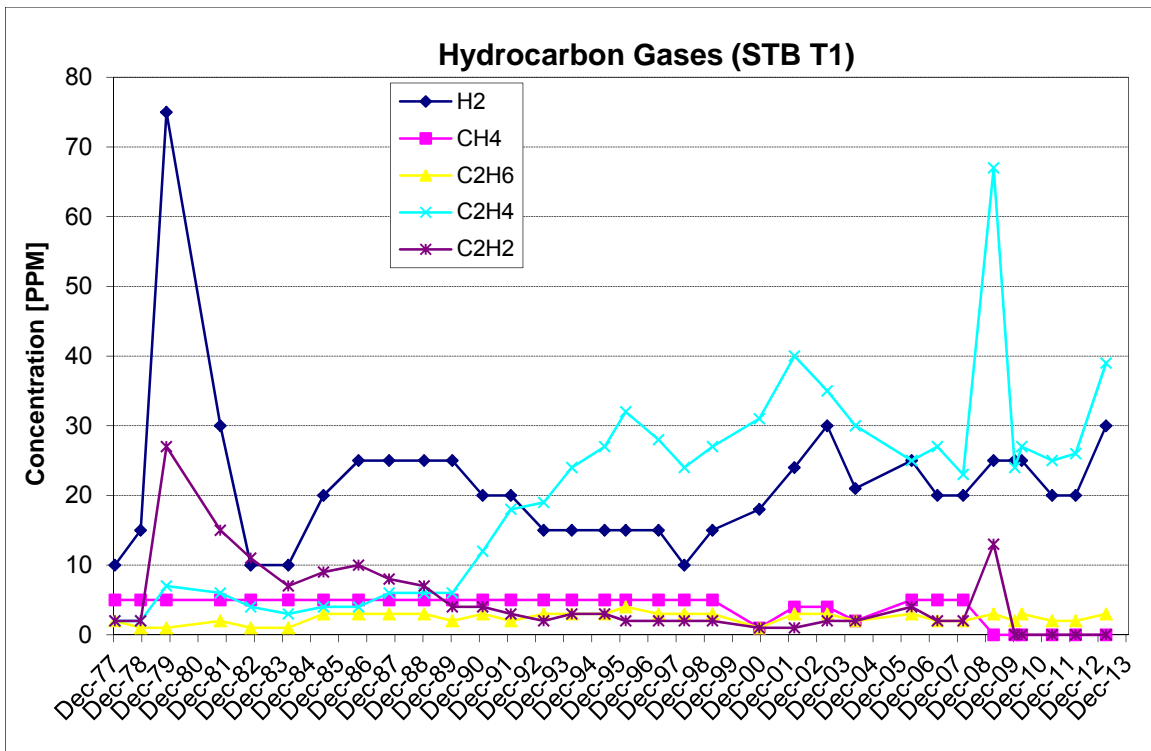
Figure 10 - Hydrocarbon Gas Concentrations

- The concentration of Hydrogen (H<sub>2</sub>) has been well below IEEE C57.104-2008 guide condition level 1 since 1977, the highest level is 75 ppm in 1979.

- The concentration of Methane (CH<sub>4</sub>) and Ethane (C<sub>2</sub>H<sub>6</sub>) have been steadily low for the period of the data provided. The Ethylene (C<sub>2</sub>H<sub>4</sub>) level has been below condition level 1 of the IEEE C57.104-2008 guide since 1977, except one sample (67 ppm) in 2009.

- The concentration of Acetylene (C<sub>2</sub>H<sub>2</sub>) has been below IEEE C57.104-2008 guide condition level 1 since 2009. However the DGA sample for the year 1979 shows high level of C<sub>2</sub>H<sub>2</sub>. This could be a bad oil sample.

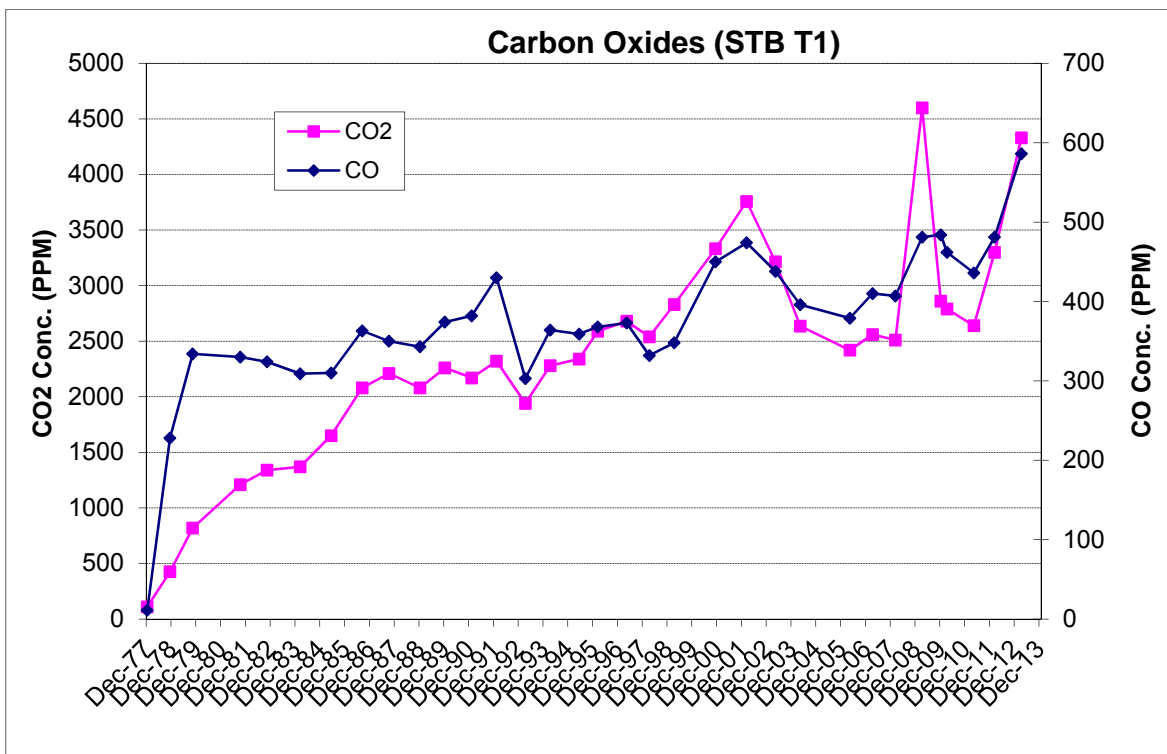
Figure 11 - Carbon Oxides Gas Concentrations

- The carbon dioxide level has been above the IEEE C57.104-2008 guide condition level 1 for the most of time period provided. The carbon monoxide level is above the IEEE C57.104-2008 guide condition level 1 for most of time as well. However the ratio of CO<sub>2</sub>/CO is between 4 and 9. The normal CO<sub>2</sub>/CO ratios are typically in the range of 5-9. The ratio of the carbon oxides suggests that the concentrations are due to the normal aging process of the transformer.

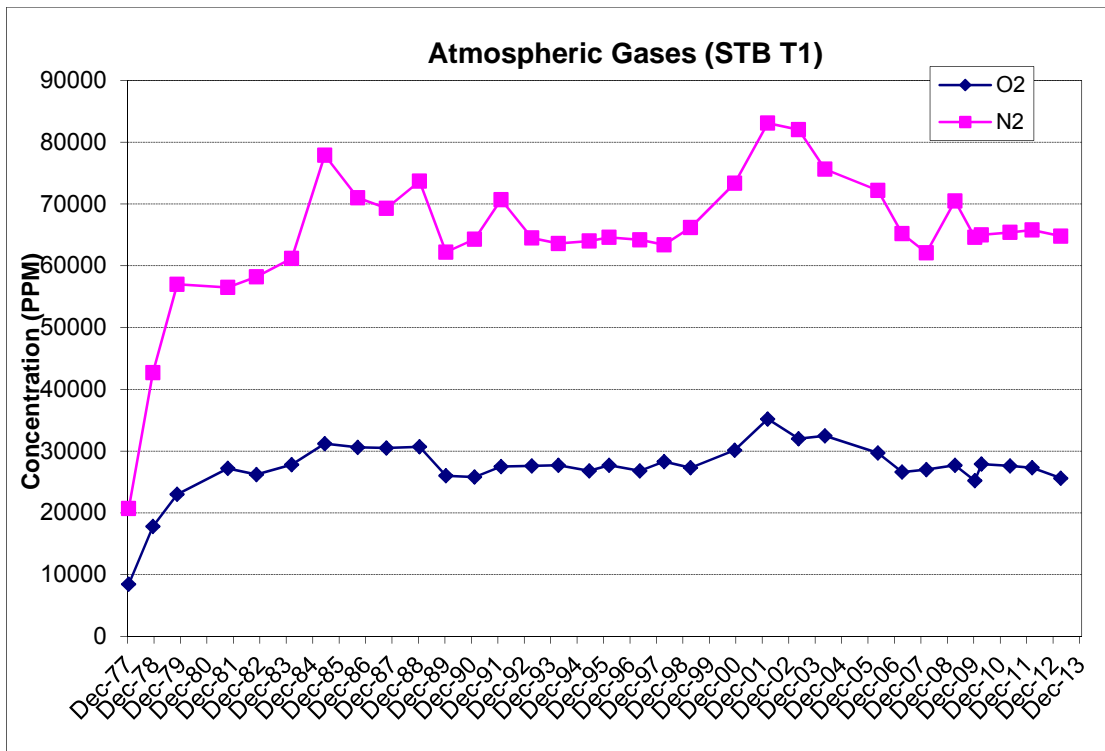
Figure 12 – Atmospheric Gases Concentrations

- The presence of large concentrations of oxygen in the oil can promote the formation of acids in the oil and cellulose and accelerate the aging rate of the cellulose insulation. It is recommended that the concentration of oxygen in the transformer be less than 2000 ppm (Refer to CIGRE report 323 – Aging of Cellulose in Mineral-Oil Insulated Transformers). The transformer maintenance record (09/22/2011) provided by the customer does not mention if the oil had ever been vacuum processed since 1991. The oil samples from this transformer have consistently shown very high oxygen concentrations (>20,000 ppm) of oxygen. The source of this high oxygen is the free-breathing oil conservator. To reduce the oxygen in the transformer oil and eliminate the uncertainty concerning the gas generation, it is recommended to add a conservator diaphragm. The diaphragm prevents oil from coming in contact with the air. This will prevent moisture, excessive atmospheric gases from dissolving into the oil and it also helps to keep all gases generated by the transformer in oil for more accurate diagnostics

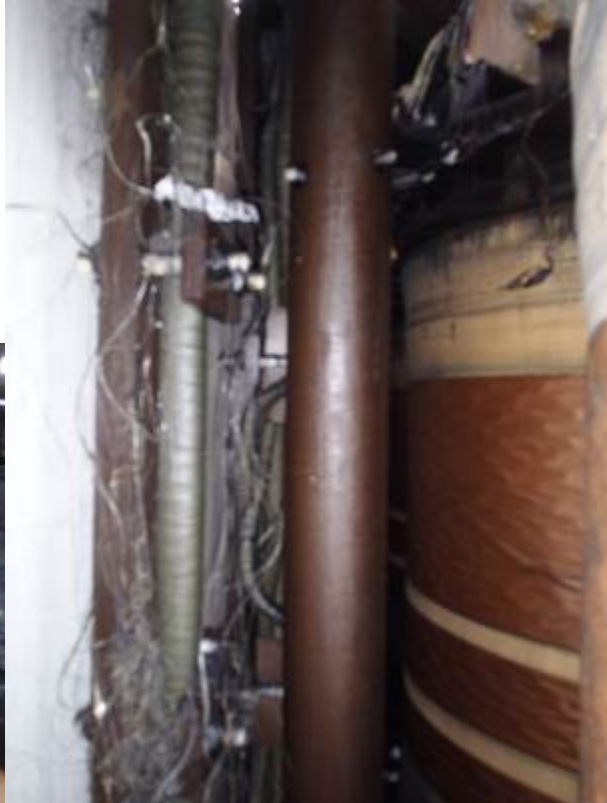
- The fire left indications of burning on the tank wall to a level about a foot above the windings. **See Photo 13**
- No signs of flash over were seen in the cleats and leads including tap leads.

**Photo 13** – Fire Line on Tank Wall & Core Clamp

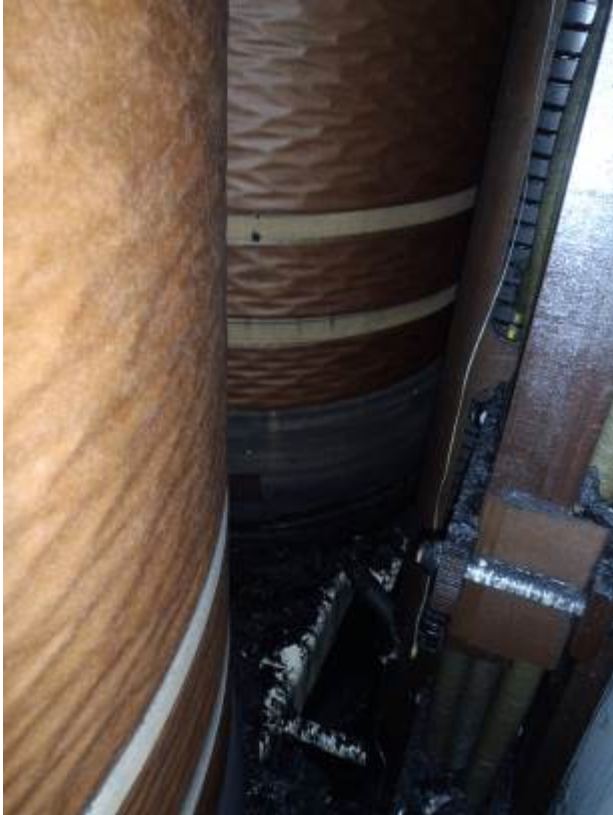
- All windings looked good with no signs of failure within the windings. **See Photos 14&15**
- The L1 & L3 bushing's porcelain inside the transformer were shattered. Also marks of flashover were seen on core clamp just opposite to Phase 1 LV bushing. **See Photos 16&17&18**

**Photo 14** – Windings

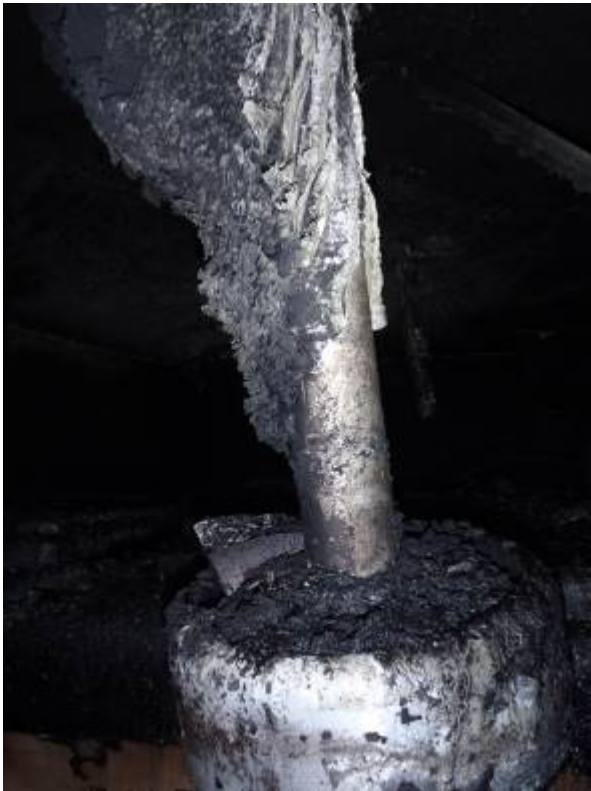
**Photo 16 – LV1 Bushing & Flashover marks**

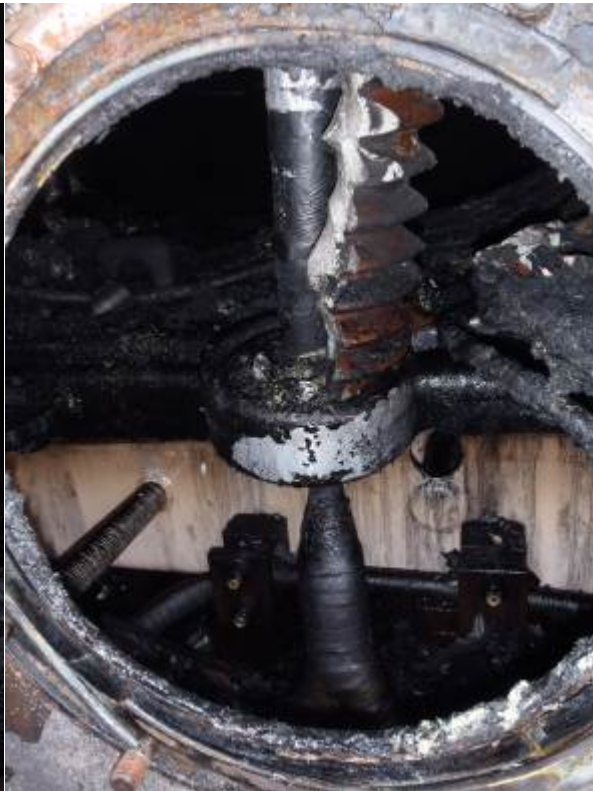
**Photo 17 – LV1 Bushing**

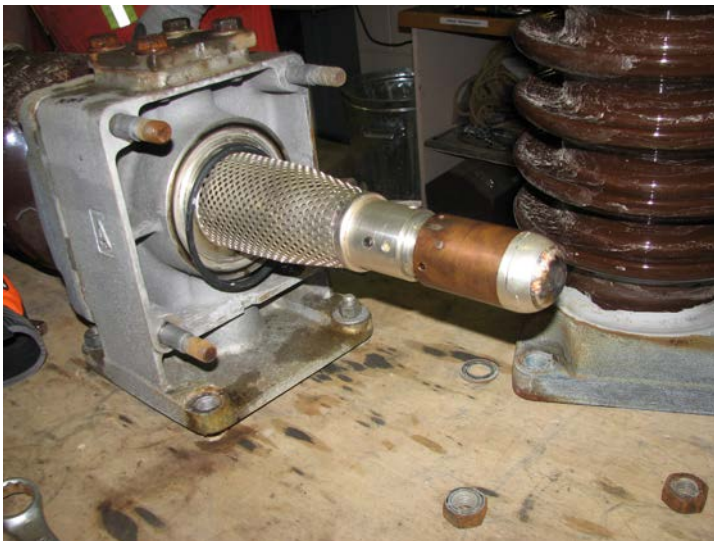
Stationary Contact

1. Interrupter contacts showing no abnormal wear
2. Moving interrupter contacts were moving freely.
3. Micro-ohm readings acceptable.
4. The O-rings and seals showing no abnormal wear.
5. It was noted that some consumable parts and lubricants were not OEM.
6. The main and stationary contacts were lubricated with a thin film of graphite.
7. Renolit HLT2 lubricant was used on dissimilar metals.
8. Dow Corning 55 lubricant was used on static O-rings.

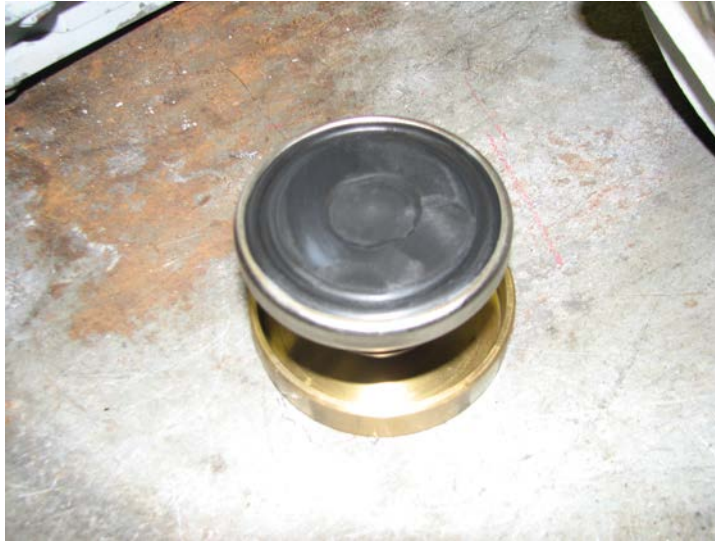
Servo Gasket

1. None of the three servos indicated any problems.
2. The parts were showing normal wear and nothing was binding.
3. Non OEM parts were found on the servos.

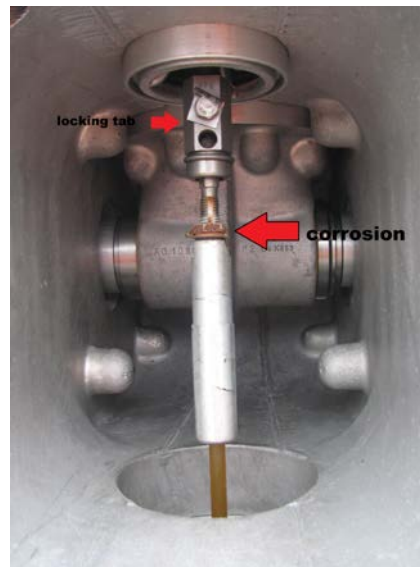
- 09:30 site meeting to discuss breaker failure, sequence of events, general discussion and next steps
- The cover was removed on the “A” phase interrupter to inspect the top of the breaker control rod. The control rod was not under tension as I should be. The control rod adjustment locking tab was in place and one side was bent over the flat on the bolt. The other side of the locking tab was not bent over the hex flat of the control rod. The preferred method is to have both ends of the locking tab secured. Observed that the top nut of the control rod was corroded as shown in the picture below. It is not normal to see corrosion on an air blast breaker using dry air. At this point it was assumed the control rod was broken.

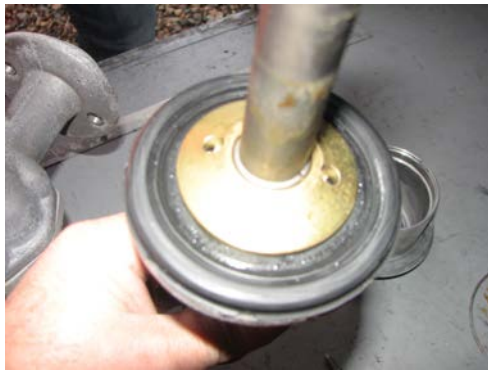
- The B2B12 breaker air receivers and the “C” phase control rod drive inspected. There were no signs of moisture in the air receivers and the “C” phase control rod drive showed no signs of corrosion.
- A closer inspection of the “A” phase interrupters and control valve was done.
- The control valve of “A” phase interrupter had signs of water and moisture was present. The percussion gasket showed normal signs of wear and was in good condition. The valve was overhauled about one year ago. In my opinion the control valve would operate properly if properly initiated to do so. A picture is below.

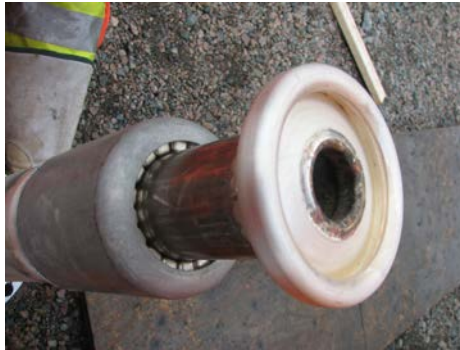
- The blast valve from the “A” phase interrupter was not inspected.
- The two moving interrupter contacts from the “A” phase were removed for inspection.
- Both the main and stationary contacts for both interrupters showed what would be considered to be normal wear. The breaker has 1885 operations. A picture of a moving contact is below.
