1 Q. Provide copies of all opinions, reviews, reports, studies and assessments  
2 commissioned or obtained by Hydro internally, or commissioned or obtained by  
3 Hydro from external sources, which address or discuss, in any respect, Hydro's  
4 capabilities for black starting the Holyrood generating units.  
5  
6

## POWER SYSTEM OUTAGE REPORT

**DEC. 8 TO DEC. 11 1994**

**NEWFOUNDLAND AND LABRADOR HYDRO**

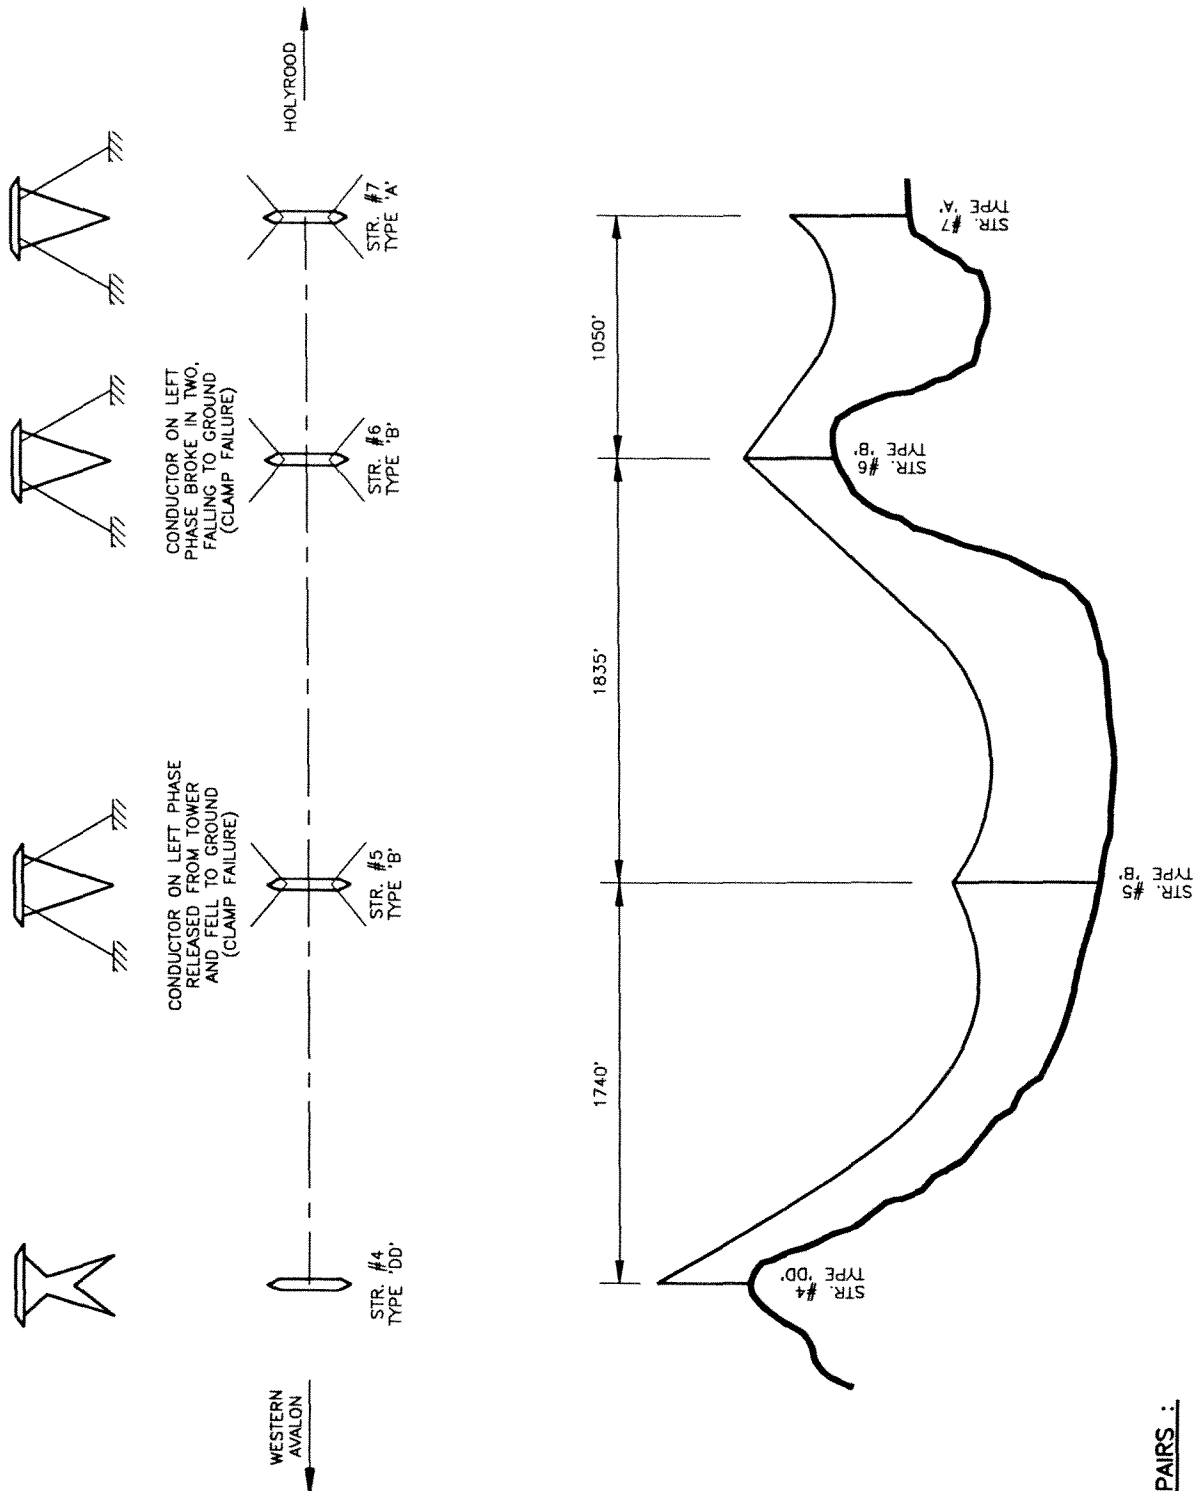
TL.201 LINE FAILURE  
STRUCTURE No.2 TO No.9

Near Western Avalon Terminal Station, seven (7) wooden structures (structures # 2 to # 9) failed (see photographs #5 to #9, Appendix A). In addition, at structure # 134, near Brigus Junction, an eyebolt supporting the line conductor failed.

It is concluded that the excessive ice accumulation, in excess of design, (2 inch radial) on transmission line conductors combined with high winds (126km/hr or higher) was the major cause of structure and hardware failure during the storm. These lines were originally designed for a load of one (1) inch radial ice on the conductor and a wind speed of 176 km/hr.

Repairs to structure # 2 to # 9 commenced immediately and were completed in fourteen (14) days. The damaged eyebolt at structure # 134 was also replaced.

During the repairs to the damaged sections, the design of these sections of line was upgraded to withstand the climatic loading conditions which were actually experienced.

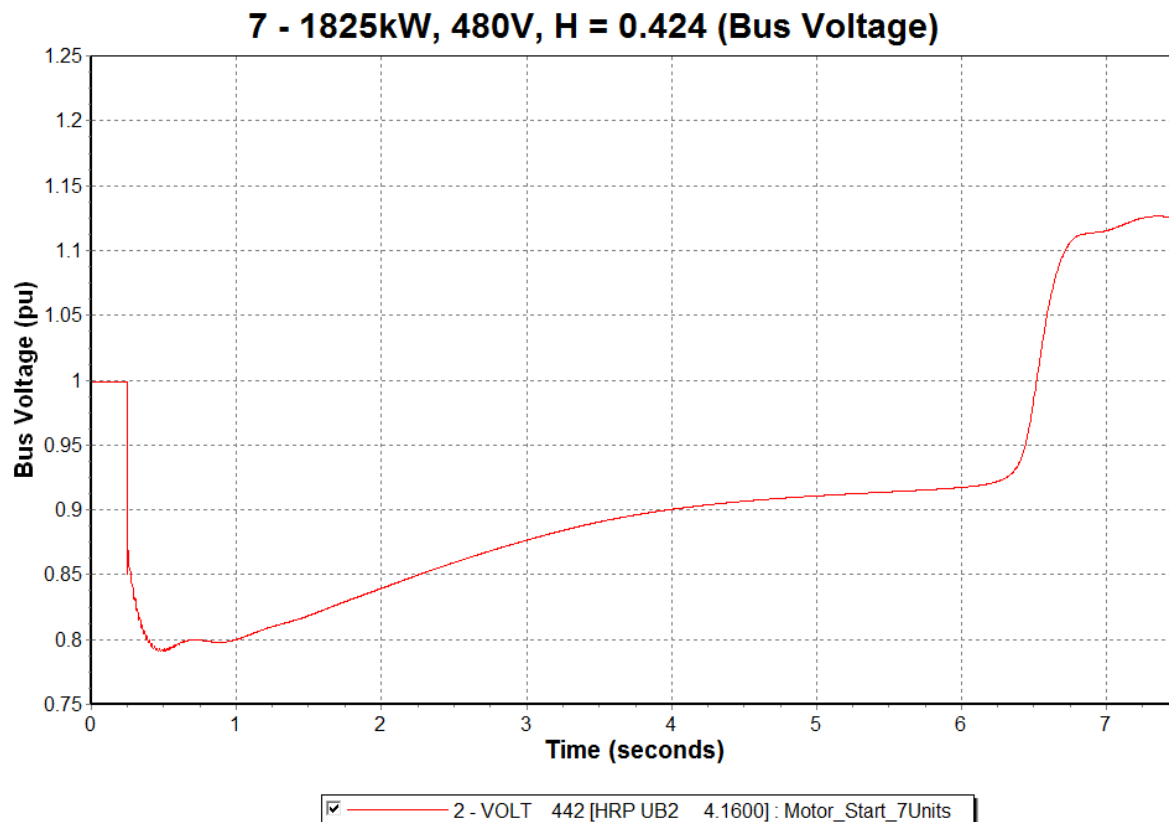
Figure 2. System Voltage Response of 7 - 1825kw Diesel Generators

Hydro analyzed the generator solution to determine if it meets the technical requirements as indicated in Section 3. The analysis shown in Figure 2 indicates that the system voltage will fall below the 0.81pu (81% of nominal) voltage threshold requirement. Figure 3 indicates that the generator can supply the motor current, and it does not exceed the motor thermal limit shown in Appendix A.

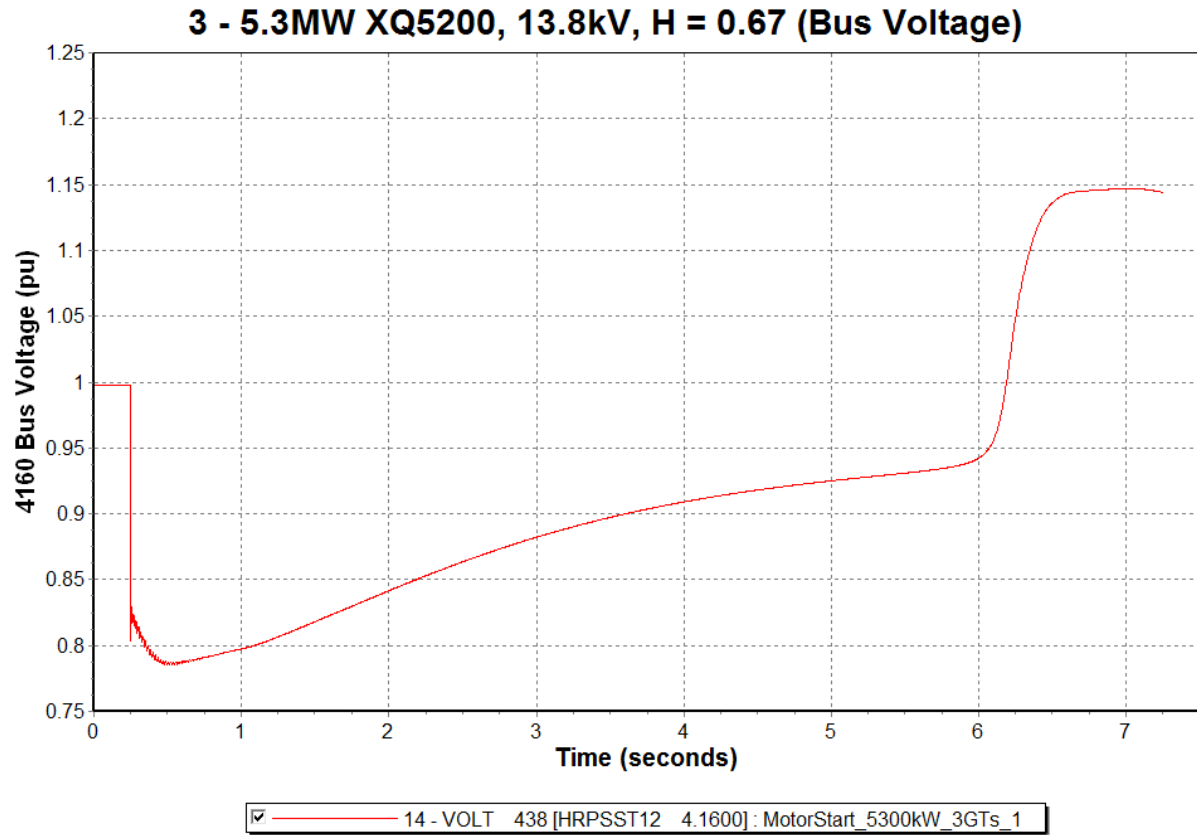
Figure 6. System Voltage Response of 3 - 5.3MW CT's during Blackstart

Hydro has analyzed the generator solution to determine if it meets the technical requirements as indicated in section 3. The analysis shown in Figure 6 indicates that the system voltage does fall below the 0.81pu voltage threshold requirement. Figure 7 indicates that the generator can supply the motor current, and it does not exceed the thermal limit shown in Appendix A.

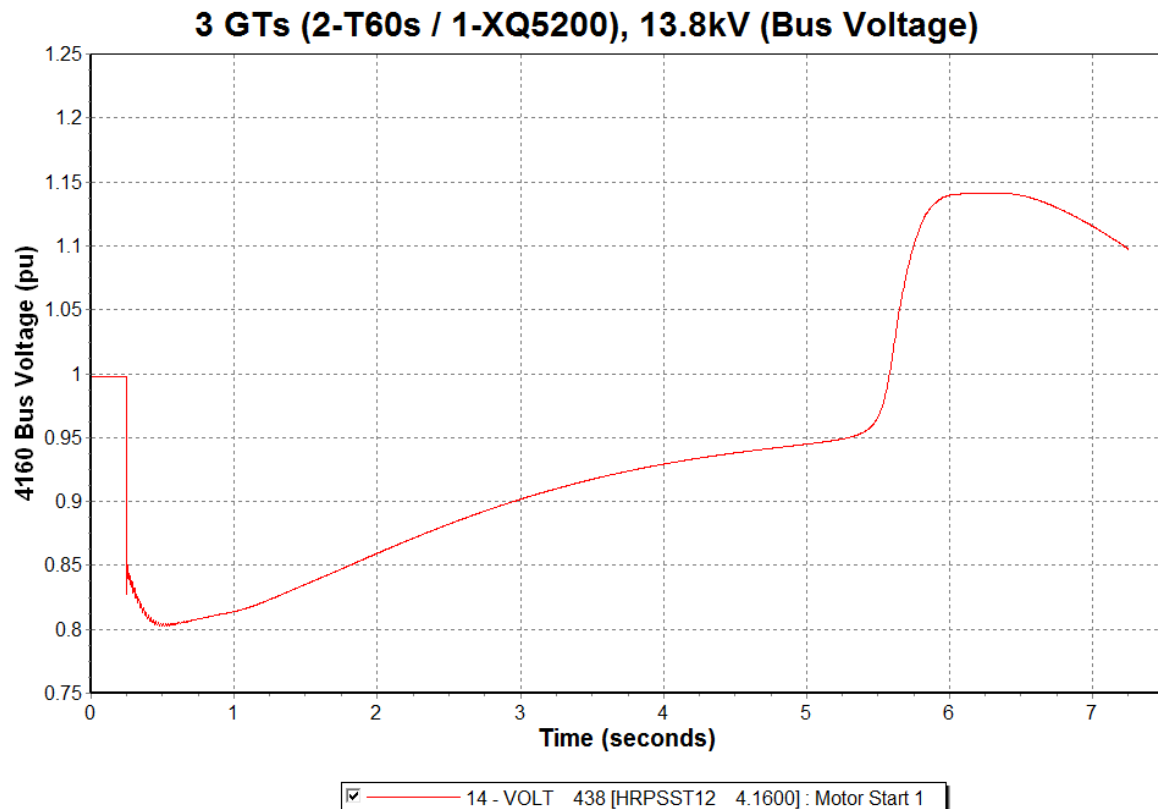
Figure 8. System Voltage Response of a 16.7MW CT plant on Blackstart

Hydro has analyzed the generator solution to determine if it meets the technical requirements as indicated in Section 3. The analysis shown in Figure 8 indicates that the system voltage does not fall below the 0.81pu voltage threshold requirement. However, because the system voltage comes quite close to the threshold, verification of the Hydro model would be required from the manufacturer during the tendering process.
