Inspection Report To

Borescope inspection of Avon 37029 1533 70L

Date: June 10 2008

IC-NLH-012, Attachment 1 Page 2 of 14, Holyrood Blackstart

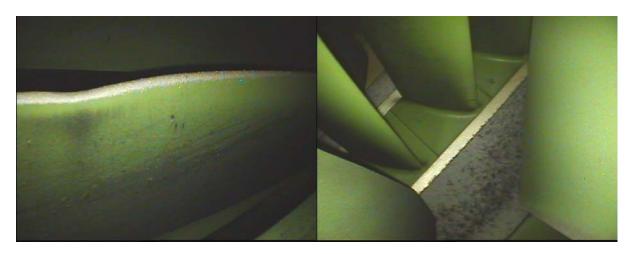
It was noted that the Front bearing housing, Inlet Guide Vanes and Compressor have significant corrosion and coating loss. This has now increased greatly from last year's inspection with the addition of salt ingress and the Front Bearing housing pitting (As shown in above section)

Coating loss and pitting stage 1
