1 Q. Black Start: Please confirm that Hydro lacked black start capability at the Holyrood
2 Plant in the winters 2011-2012, 2012-2013 and 2013-2014.

POWER SYSTEM OUTAGE REPORT

DEC. 8 TO DEC. 11 1994

NEWFOUNDLAND AND LABRADOR HYDRO

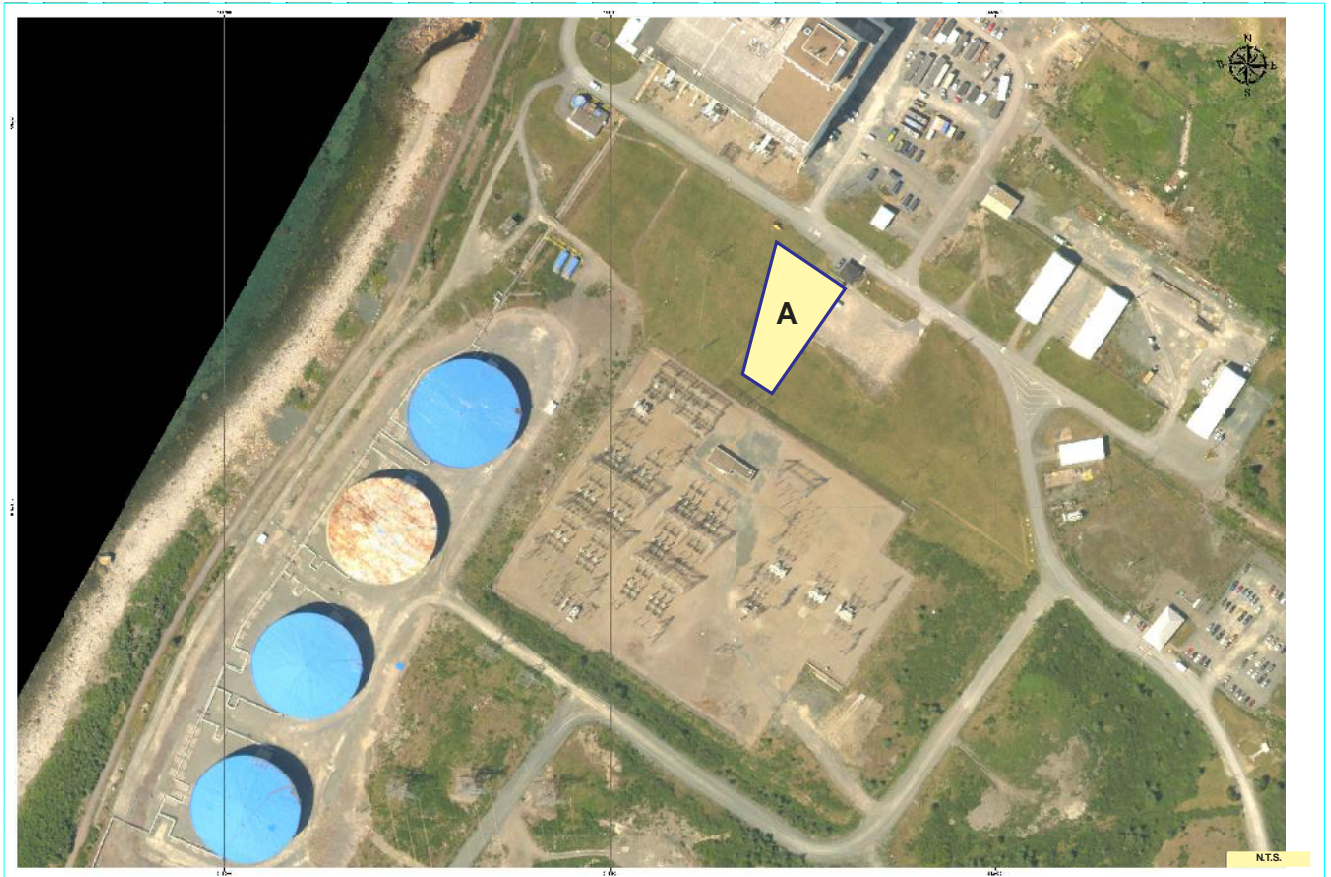
Figure 1. Location of Generator Solution

As shown in Figure 1, there is one area which is suitable for a temporary black start generator solution. It consists of flat land across from the thermal plant. This area will be adjacent to the proposed 60MW combustion turbine for Holyrood, hence it is prudent to situate this project so as to allow for the construction of a 60MW plant at that location. In order to maximize the space available, and allow for future projects, this location will require some civil work.

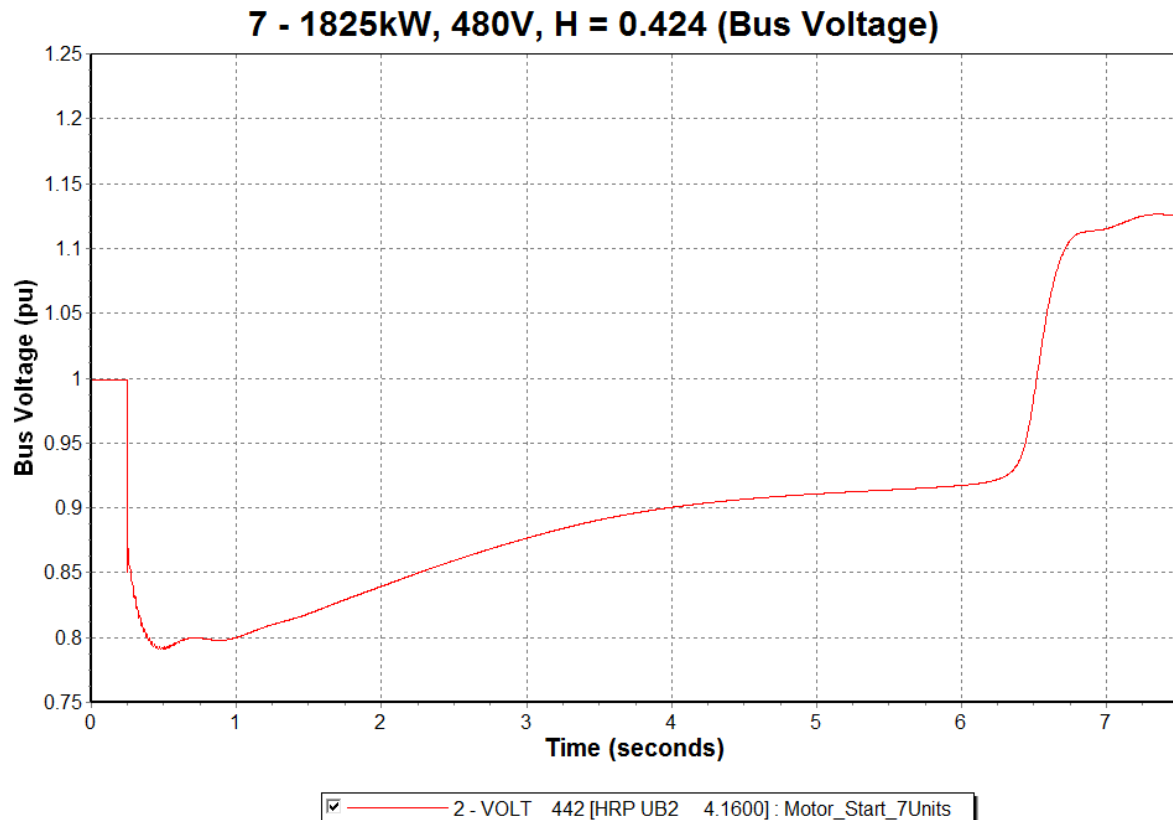
Figure 2. System Voltage Response of 7 - 1825kw Diesel Generators

Hydro analyzed the generator solution to determine if it meets the technical requirements as indicated in Section 3. The analysis shown in Figure 2 indicates that the system voltage will fall below the 0.81pu (81% of nominal) voltage threshold requirement. Figure 3 indicates that the generator can supply the motor current, and it does not exceed the motor thermal limit shown in Appendix A.

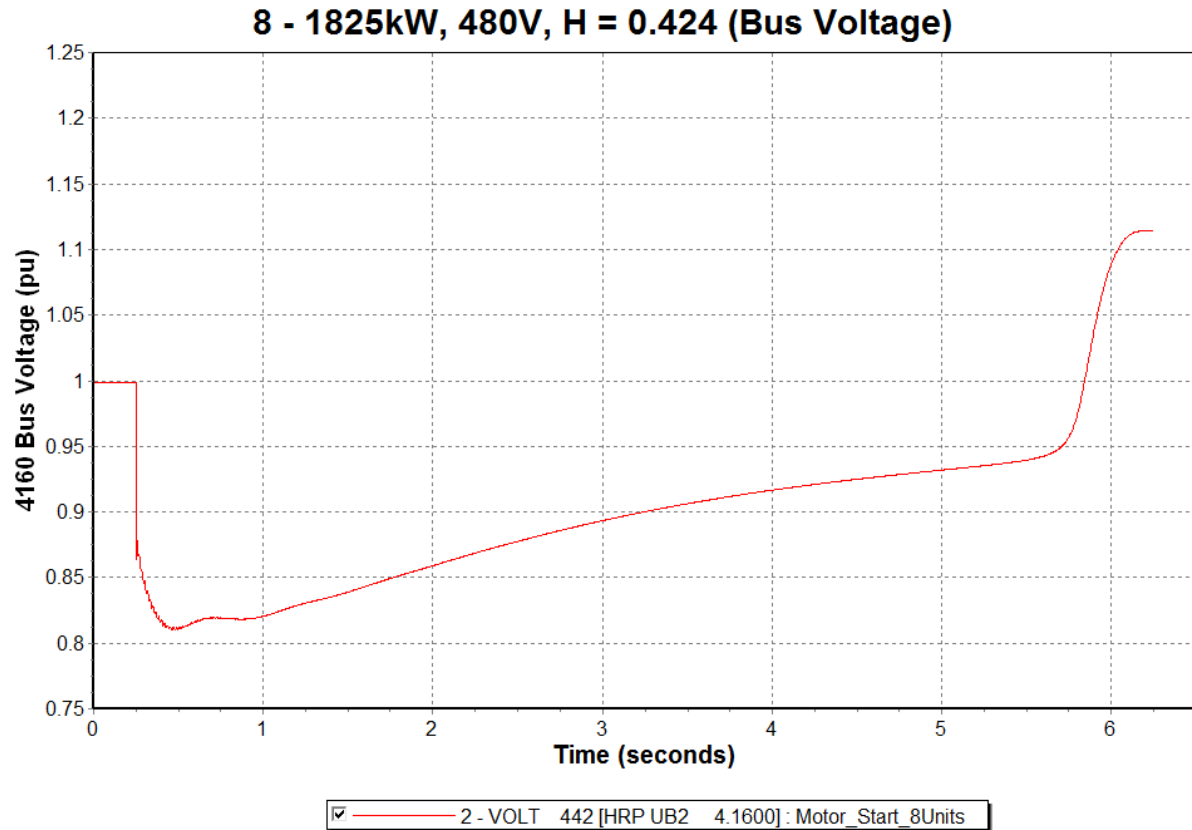
Figure 4. System Voltage Response of 8 - 1825kW Diesel Generators

Hydro has analyzed the generator solution to determine if it meets the technical requirements as indicated in section 3. The analysis shown in Figure 4 indicates that the system voltage does not fall below the 0.81pu voltage threshold requirement. Figure 5 indicates that the generator can supply the motor current, and it does not exceed the motor thermal limit shown in Appendix A.

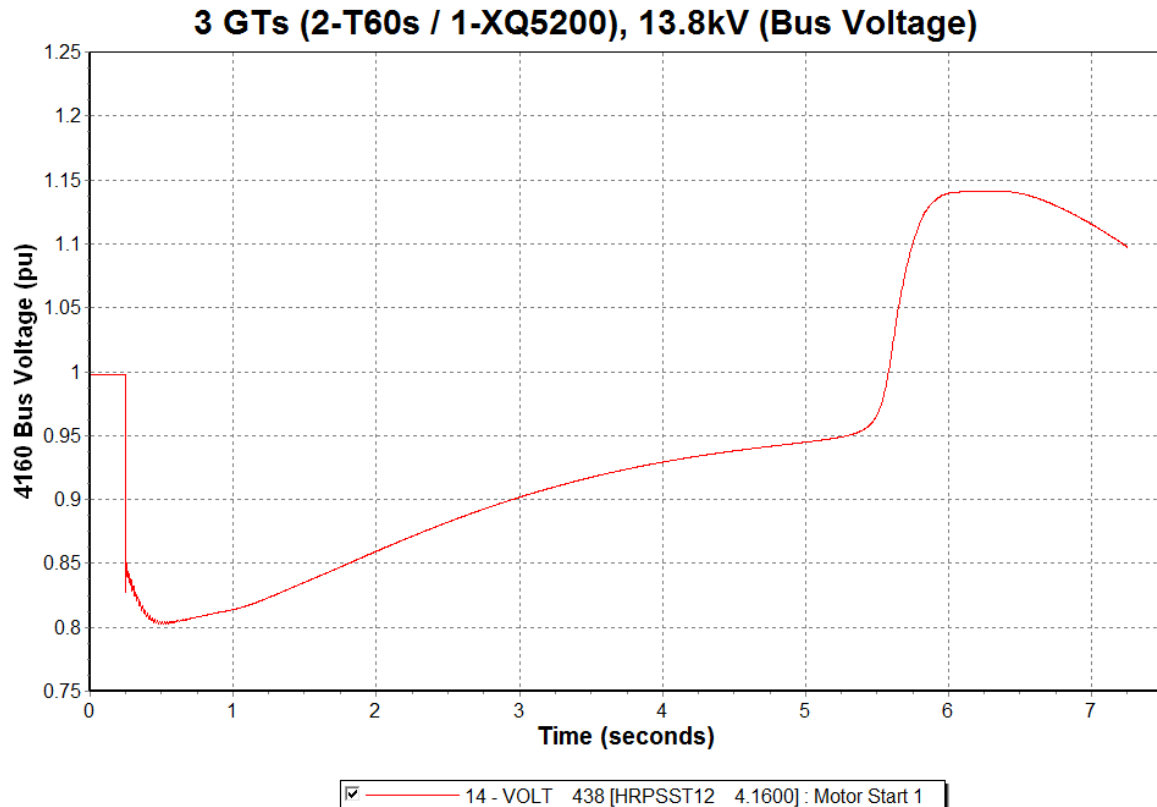
Figure 8. System Voltage Response of a 16.7MW CT plant on Blackstart

Hydro has analyzed the generator solution to determine if it meets the technical requirements as indicated in Section 3. The analysis shown in Figure 8 indicates that the system voltage does not fall below the 0.81pu voltage threshold requirement. However, because the system voltage comes quite close to the threshold, verification of the Hydro model would be required from the manufacturer during the tendering process.

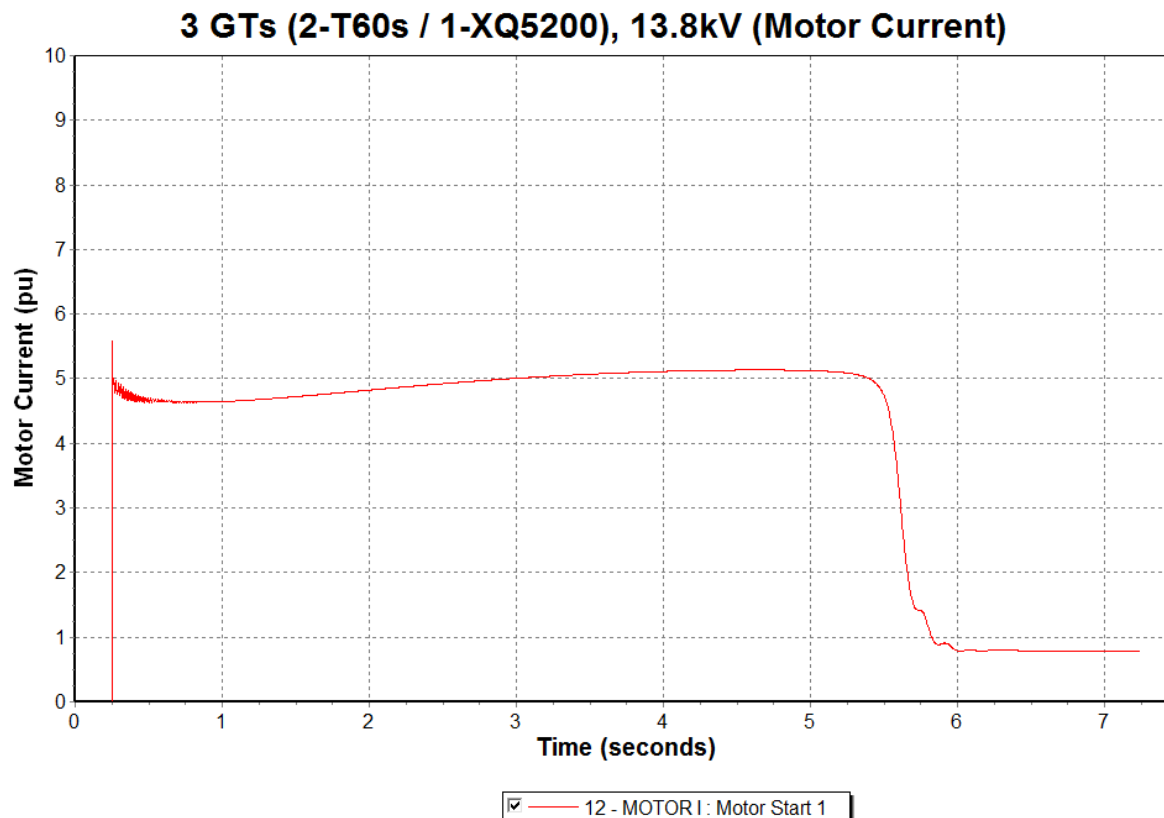
Figure 9. System Current Response of a 16.7MW CT Plant during Blackstart

Figure 9 indicates that the generator can supply the motor current, and it does not exceed the motor thermal limit shown in Appendix A.

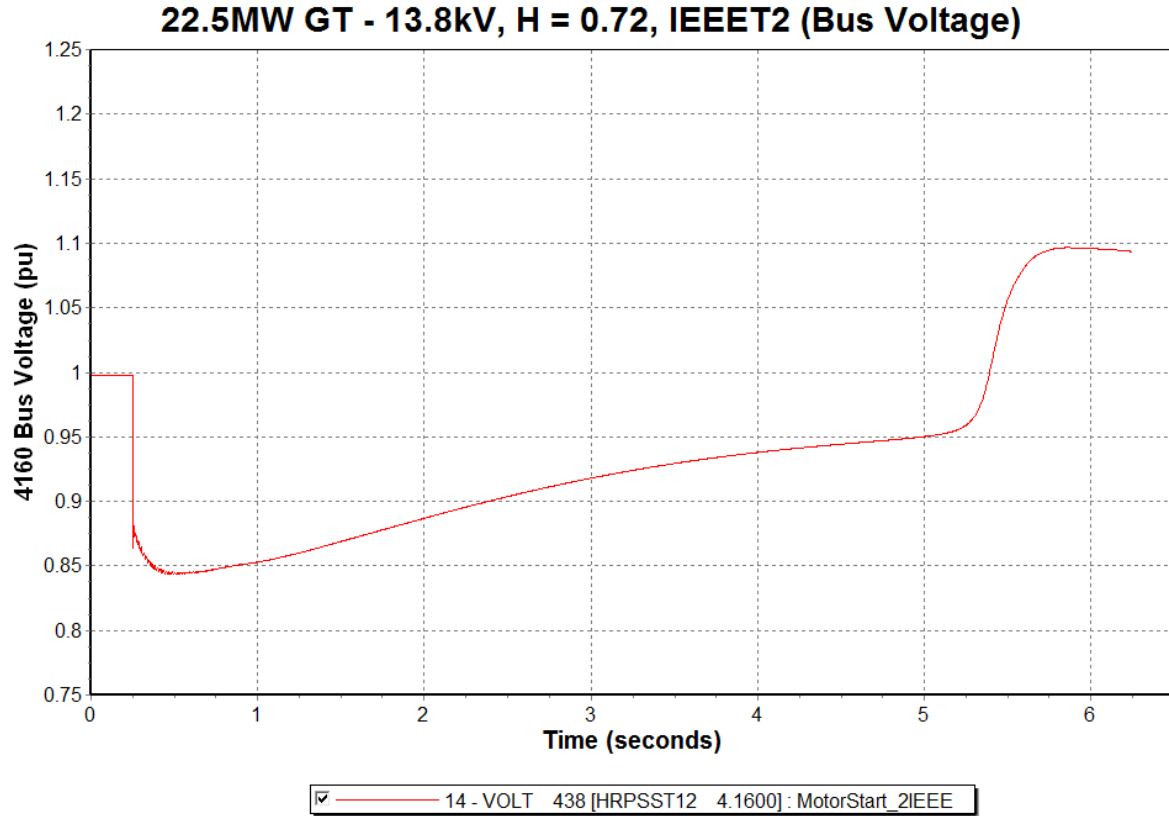
Figure 10. System Voltage Response of a 22.5MW CT during Blackstart

Hydro has analyzed the generator solution to determine if it meets the technical requirements as indicated in section 3. The analysis shown in Figure 10 indicates that the system voltage does not fall below the 0.81pu voltage threshold requirement. Figure 11 indicates that the generator can supply the motor current, and it does not exceed the thermal limit shown in Appendix A.
