1 Q. Further to PR-PUB-NLH-172, despite the conclusion of the technical analysis  
2 referred to, the Newfoundland Power option was found to be inadequate on May  
3 10, 2013. Please describe what actions Hydro took between the time it learned the  
4 Newfoundland Power option was inadequate and November 29, 2013 when the  
5 Board approved new action to be taken to provide black start capability.

14  
15 This report summarizes the sequence of events that occurred on the power system, the  
16 problems experienced, the damage incurred, and identifies remedial actions being taken as a  
17 result of follow up investigations.

**Unit 1 Failure – Holyrood  
Life Safety Review  
SWOP # 2013000599  
January 11, 2013**

# **Nalcor Holyrood Unit 1 Turbine and Generator Inspection Report January 15, 2013**

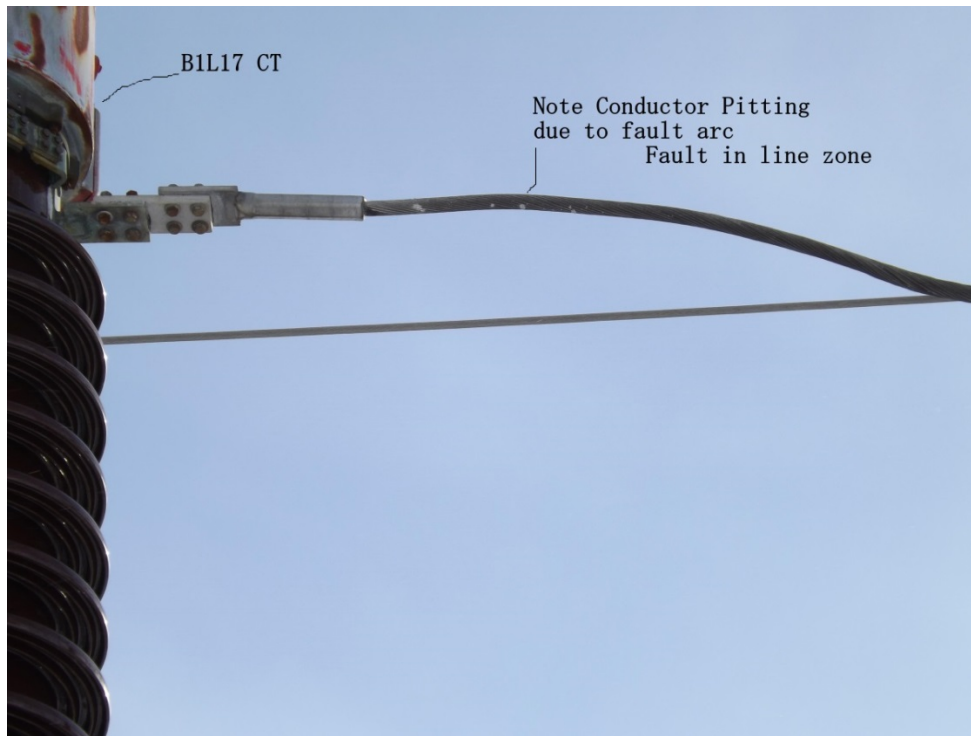
Figure 2-5c: Conductor Between Breaker B1L17 to B1L17 CT

At 06:42, while Holyrood plant personnel were in the process of restoring Unit 3, there were trips of Units 1 and 2 and transmission line TL 217 at the Western Avalon end. Both units were loaded to 110 MW. Newfoundland Power's 138 kV line, 39L, also tripped at this time. This resulted in a significant customer impact with nearly 250 MW of Newfoundland Power load loss, primarily on the Avalon Peninsula. This was caused by a fault on Unit 1 230 kV breaker B1L17, which was a result of salt contamination.

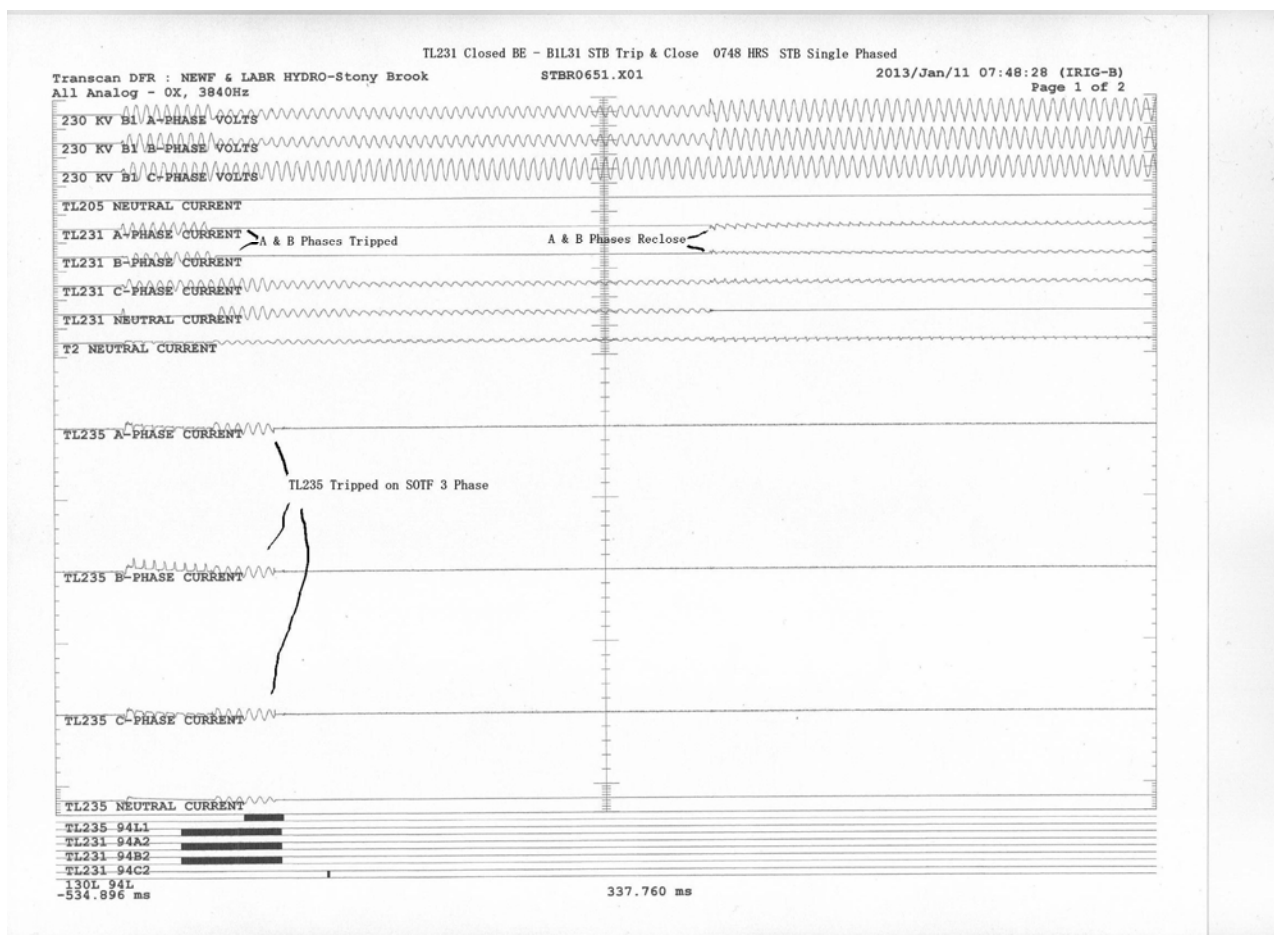
Figure 3-1: Stony Brook DFR Trace at 0748 Hours Showing STB B1L31 Trip/Close

- At 0748 hours, when TL231 was closed at BDE to re-energize STB, the P2 protection (Schweitzer distance) operated on TL231 at STB sending a three phase trip signal to the breaker B1L31 (L05L31 was already tripped from the incident at 0742 hours). With reference to previous Figure 3-1, B1L31 tripped only on two phases - A and B. The 230 KV bus at STB remained energized via C phase only for approximately 47 cycles until the A and B phases reclosed. C phase failed to open due to problems with the C phase breaker circuit. During later testing, the C phase trip coil circuit was showing open (no continuity) initially, but after several breaker operations it was shown to be closed or continuous. The non-continuity issue is believed to have cleared during the 'wiping' of the C phase auxiliary contact during the operational testing. This contact is in series with the trip coil of the breaker. Also revealed during testing was that C phase failed to open via the trip relay signals and instead tripped on phase disagreement protection.

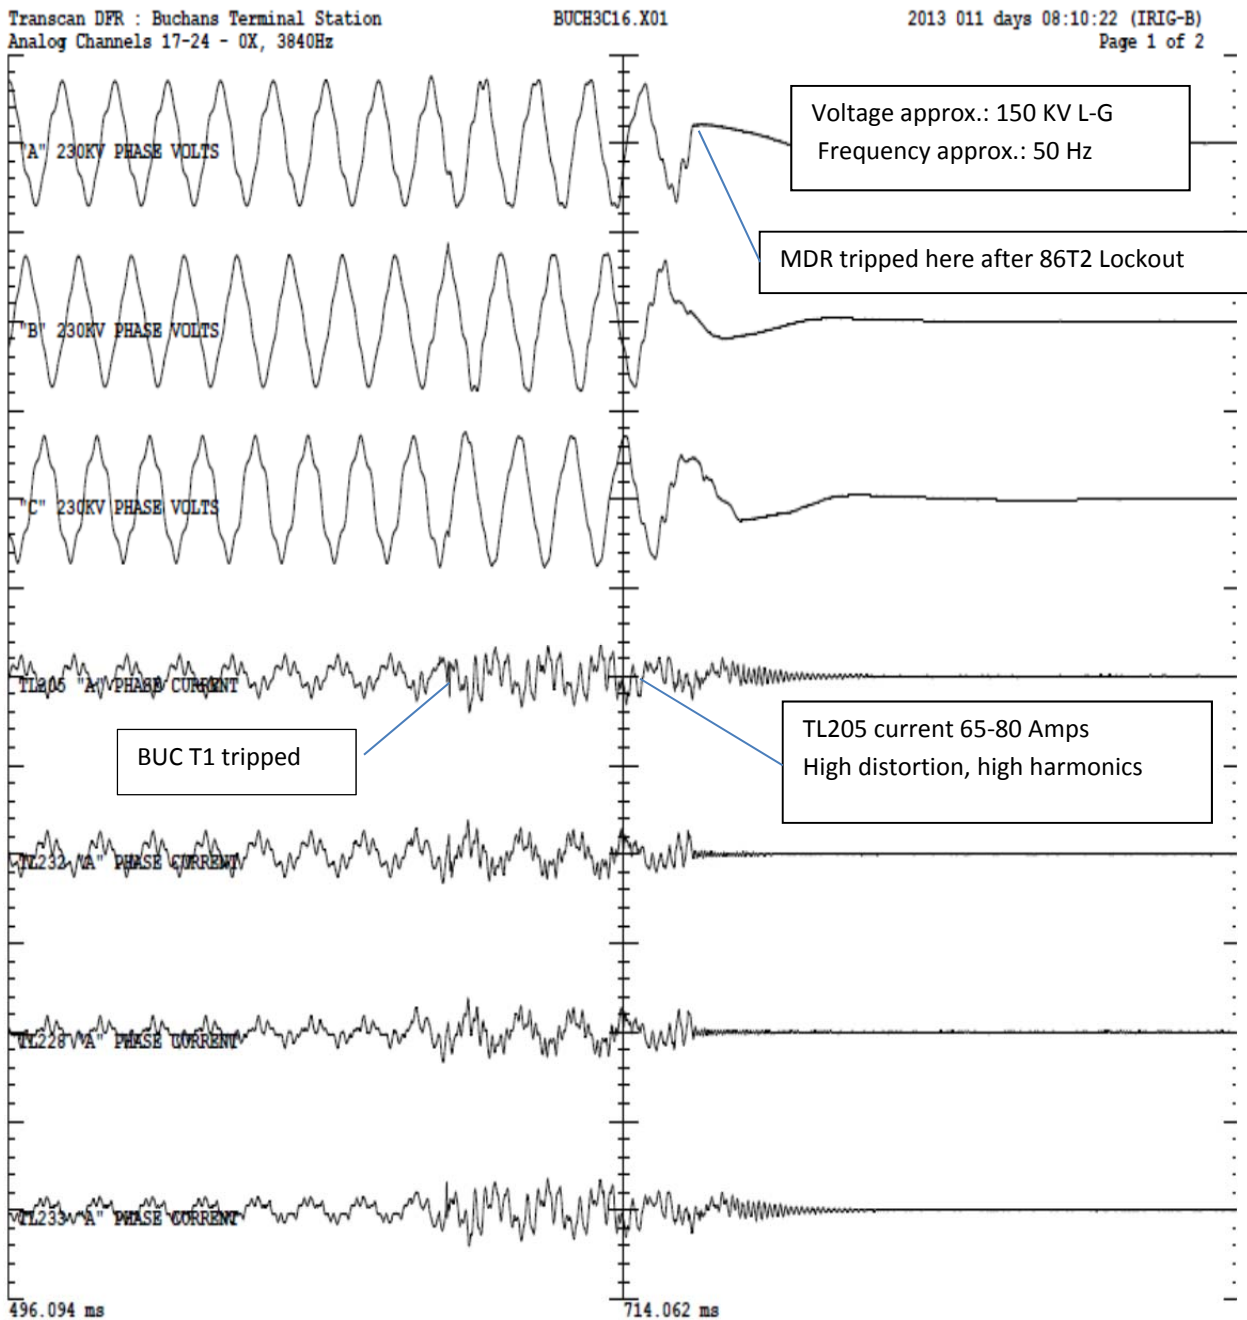
Figure 3-4: Buchans DFR Traces at 0810 hours Indicating Overexcitation Prior to BUC and MDR Lockouts

The operation of the Buchans and the Massey Drive transformer differential protection occurred around 0810 hours. Prior to this, between 0802 and 0804 hours, additional lines (TL233 and TL232) were energized. At 0810 hours the Massey Drive load was tripped by the ECC operator, to offload the Hinds Lake unit. This resulted in an immediate increase in the 230 KV voltage and caused the frequency at the Hinds Lake unit to increase. As the frequency increased so did the voltage which was being controlled by the exciter volts per hertz monitor. This caused an increase in the overexcitation on the system at this time resulting in the transformer differentials to operate, first at Buchans, followed in about three cycles at Massey Drive. The trip of Buchans T1 caused breaker openings but no line trips. The 87 relays on Buchans T1 and Massey Drive T2 are Alstom MBCH12 which do not use harmonic restraint and are more prone to overexcitation operation than the harmonic restraint differential types. During overexcitation, as is evident from the sine wave distortion prevalent in the DFR traces, there is significant harmonic content on the higher than normal line charging currents which is reflective of the excitation currents in the transformers. With the high level of overexcitation of the transformers, the threshold pickups of the MBCHs were exceeded and the relays operated at around 0810 hours. Although the differentials (87T1 at BUC and 87T2 at MDR) are misoperations, they misoperated during system conditions beyond what would be expected in most contingencies and their operation to trip the

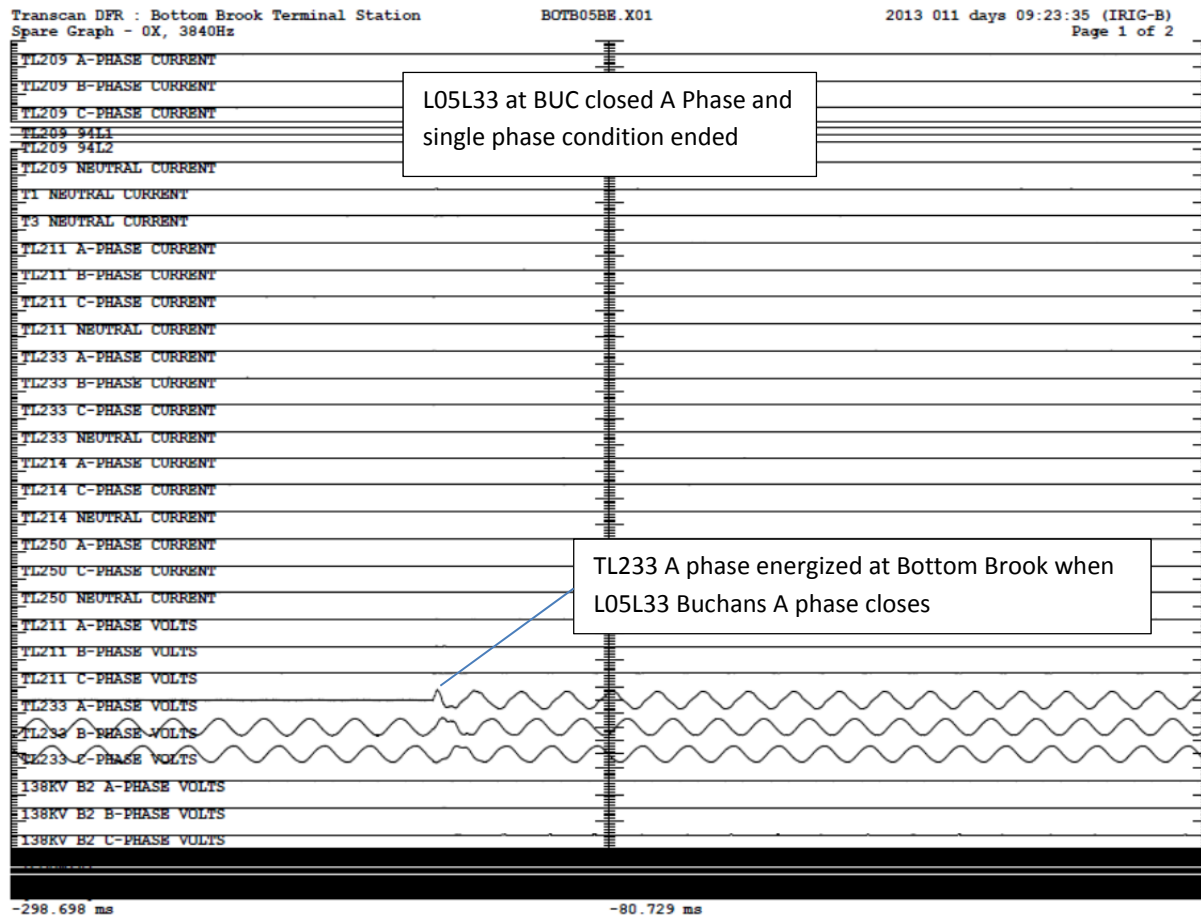
At 09:22:58 C phase of Buchans breaker L05L33 closed and 09:23:34 there was a closure of A phase (see Figure 3-15), most likely due to loss of air, ending the single phasing condition and energizing TL233 on all three phases. This closing now permitted the ECC to begin a more normal restoration of the West Coast system.

Figure 3-15: Bottom Brook DFR Trace at 0923 Hours Showing BUC L05L33 Closed Three Phase

- Buchans breaker L05L33 was removed from service. A damaged C phase head and auxiliary switches were replaced. A pressure switch, which was found to be installed incorrectly, was correctly positioned. The six year planned preventative maintenance routine was completed followed by tests and checks on the breaker.
- Also associated with the Buchans breaker L05L33, the defective trip relay 94L2 associated with line TL205 was replaced.
- A line patrol of transmission line TL242 was conducted which did not reveal any issues of a permanent nature on the line.
- Buchans transformer T1 was inspected and tested prior to putting it back in-service following the transformer differential and lockout operation.

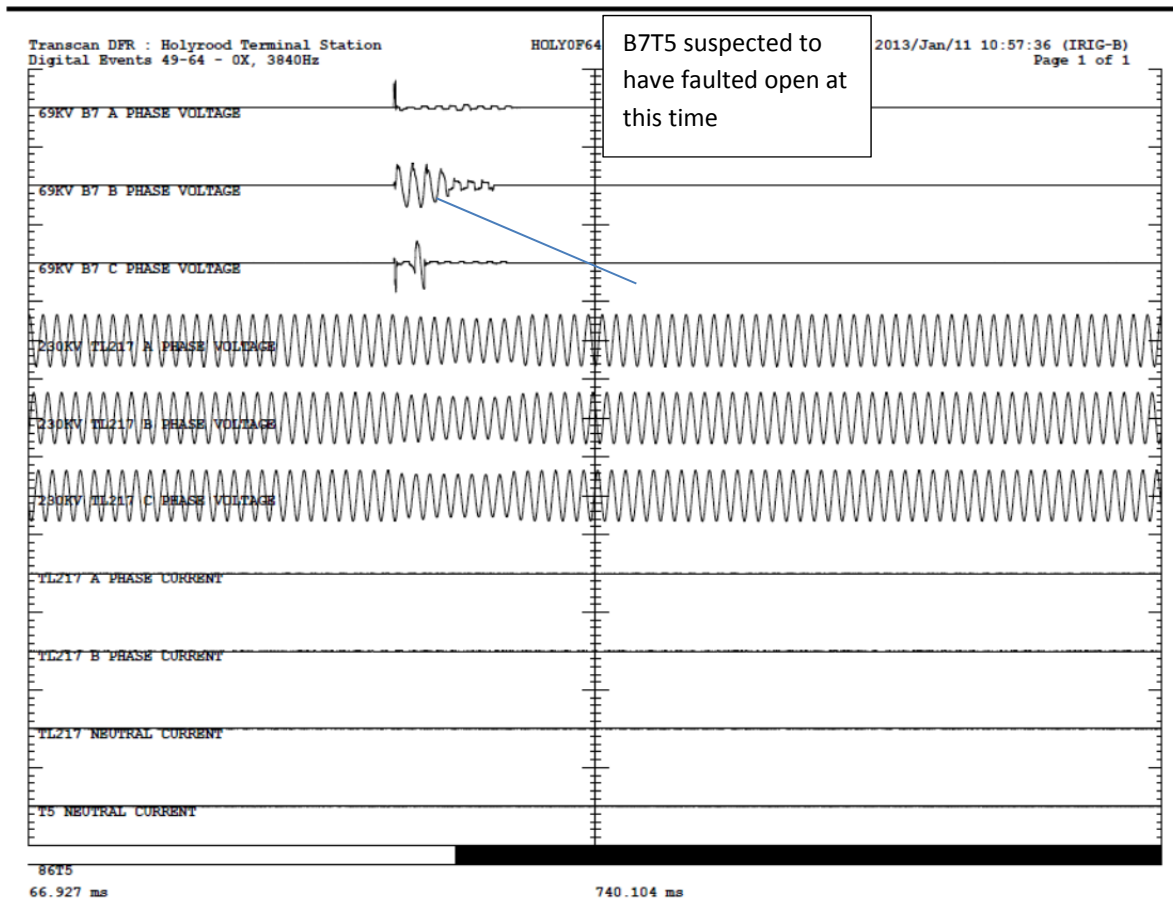
- At 1057 hours NP breaker 38L-B closed and tripped at Seal Cove. The Holyrood breaker, B7T5, faulted (it was open at the time) when energized from 38L, see Figure 3-18. The lockouts associated with T5 (86T5) and the 66 KV bus (86B6B7) both operated via instantaneous differential protection, transformer and bus respectively. The fault was cleared by breaker B7L38 at Holyrood and by NP 38L-B at Seal Cove.

Figure 3-18: Holyrood DFR Trace at 1057 Hours Showing Suspected Fault to Breaker B7T5

- At 1057 hours the Holyrood lockouts 86B6B7 and 86T5 operated when an attempt was made to energize the 66 KV bus B6B7 from NP's line 38L. As breaker B7T5 was open at the time and, given there was a fault as recorded in the DFR trace (see previous Figure 3-18), the fault location is, in all likelihood, on or in the breaker. This was also indicated by the protection operations (in both zones). A and B phases were involved, most likely related to the severe salt contamination. The fault was cleared by 38L protection at NP's Seal Cove station.

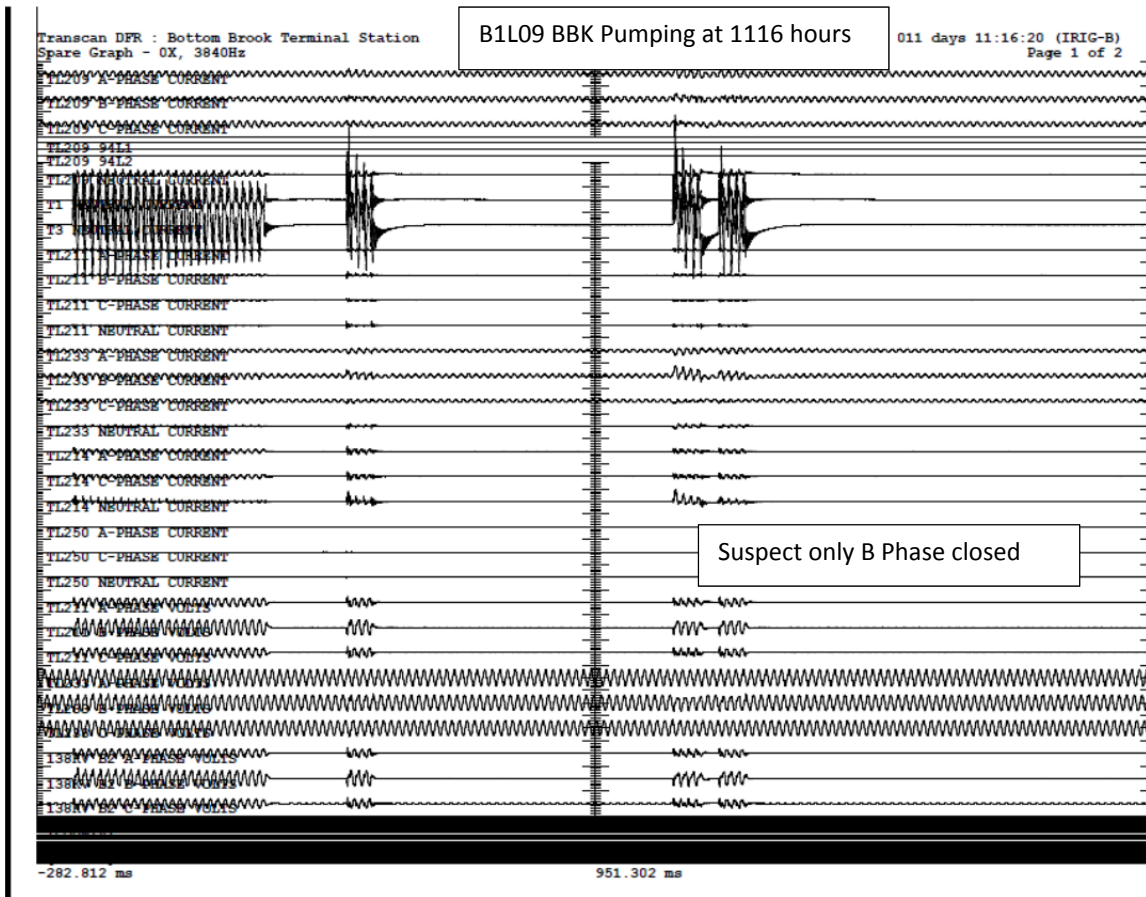
- At 1116 hours the Bottom Brook breaker B1L09 was closed by the ECC but opened and closed multiple times due to suspected breaker air problems. TL214 and the Doyles station were connected at the time. The breaker ended up open, see Figure 3-19.

Figure 3-19: Bottom Brook DFR Trace at 1116 Hours Showing BBK Breaker B1L09 Pumping

- At 1116 hours there was an issue with breaker B1L09 at Bottom Brook when it was closed to energize the station. It 'pumped' multiple times before ending up tripped. This can be seen in the Bottom Brook DFR trace, previous Figure 3-19. It is suspected that it only closed B phase. TL214 and the Doyles station were energized during the pumping operations.

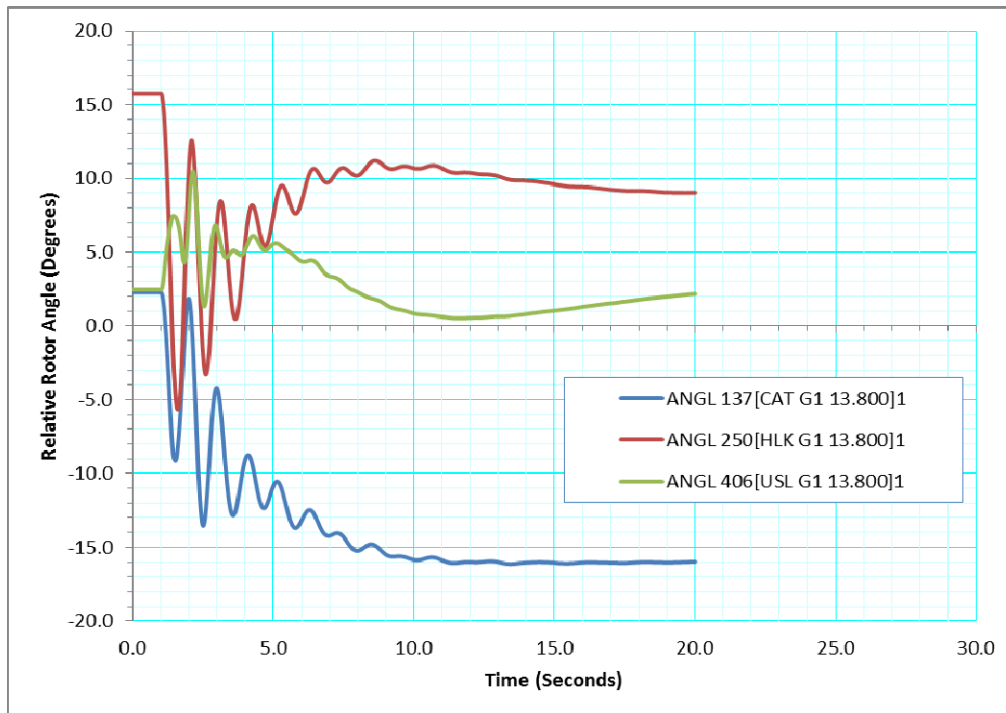
4. Despite the loss of load, the simulation indicates that angular stability is maintained for the units across the system. This is illustrated in Figure 4.

**Figure 4 – Machine Angular Stability Following SLG Fault on TL201**

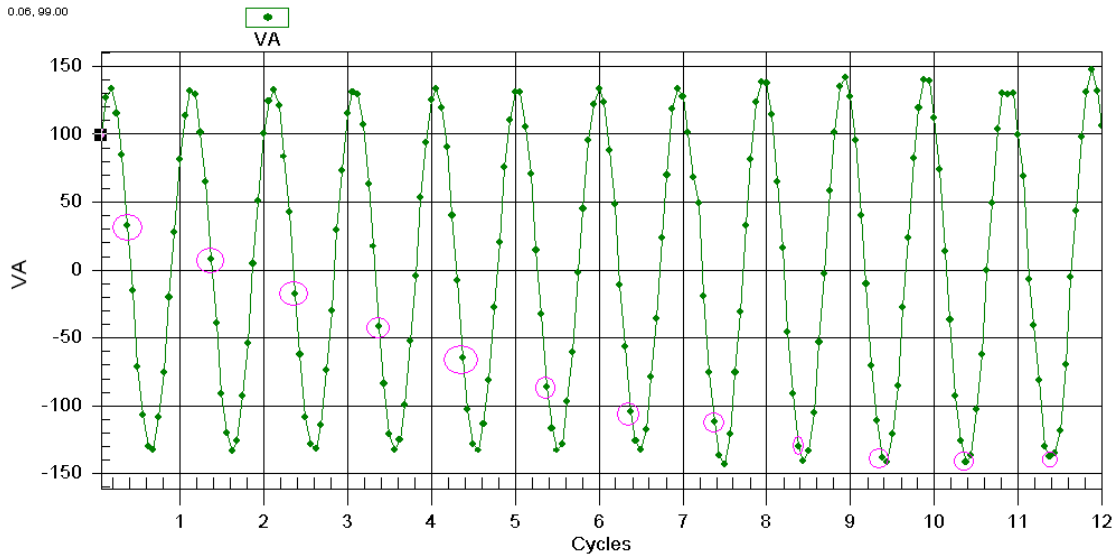
At the time of the relay operation the relay's tracking frequency was out of synchronism with that of the power system frequency. What this means is that the relay is designed to sample the primary power system quantities (voltage and current) at 16 samples per cycle (spc), however at the time of the relay operation the relay was not sampling the primary system at this rate, this can be seen when examining the A-phase voltage, as shown in Fig.2.

Fig.2. Is an oscillographic plot of the “A-phase” voltage, the oscillography indicates when the wave form was sampled by the relay.

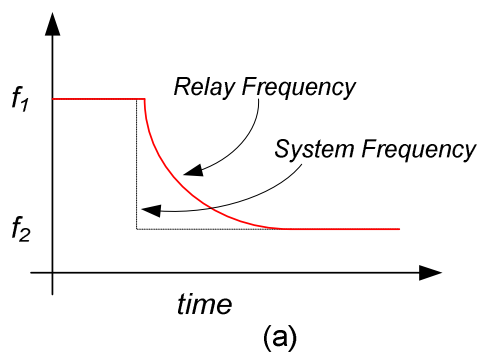
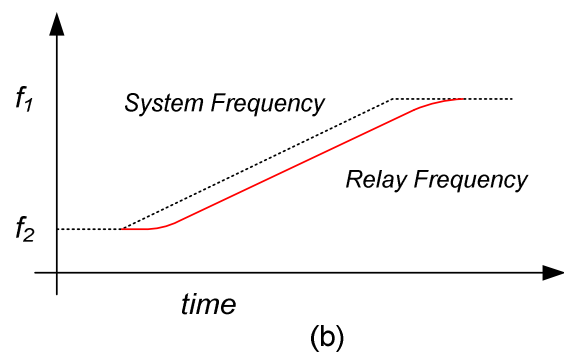
- One could be that prior to the relay operation the power system experienced a sudden loss of a significant load or generation source. The result of which is rapid change in the system frequency. For the loss of a significant load, the system frequency will rapidly increase to a newer higher frequency or in the case of losing generation, results in a rapid decrease to a lower frequency. The relay frequency tracking algorithm is designed such that a sudden jump in the power system frequency does not result in the relay jumping to the new frequency but slewing to the new frequency as show in Fig. 3 (a) and (b). The relay frequency slews to the new rate using the following algorithm:

Fig.3. show the response of the relay frequency tracking algorithm for a (a) step in the power system frequency (b) for a ramp in the system frequency.

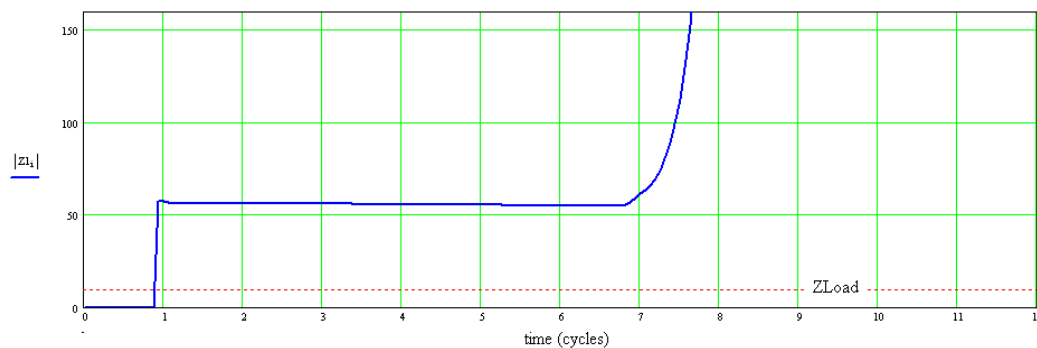
Fig.8 Plot of the positive sequence impedance magnitude.

Fig.8 shows that even if the relay is not tracking the system frequency correctly, the positive sequence impedance retains its correct value (within reason) because the positive sequence voltage and current will have the same error and by dividing these two quantities with each other that have the same relative errors, the errors basically cancel each other and the positive sequence impedance is preserved.

As stated previously the reason for the distance elements operating is that the operating and polarizing quantities were not at the same frequency and this resulted in the operating quantity rotating with respect to the restrain quantity. Also recall that one of the conditions to allow the phase-to-phase distance elements to operate is that the load encroachment element must not be asserted. Load encroachment calculates the positive sequence impedance of the load using the instantaneous positive sequence voltage and current (this means that the voltage and currents are at the same frequency with respect to each other). A plot of the positive sequence impedance is shown in Fig.8

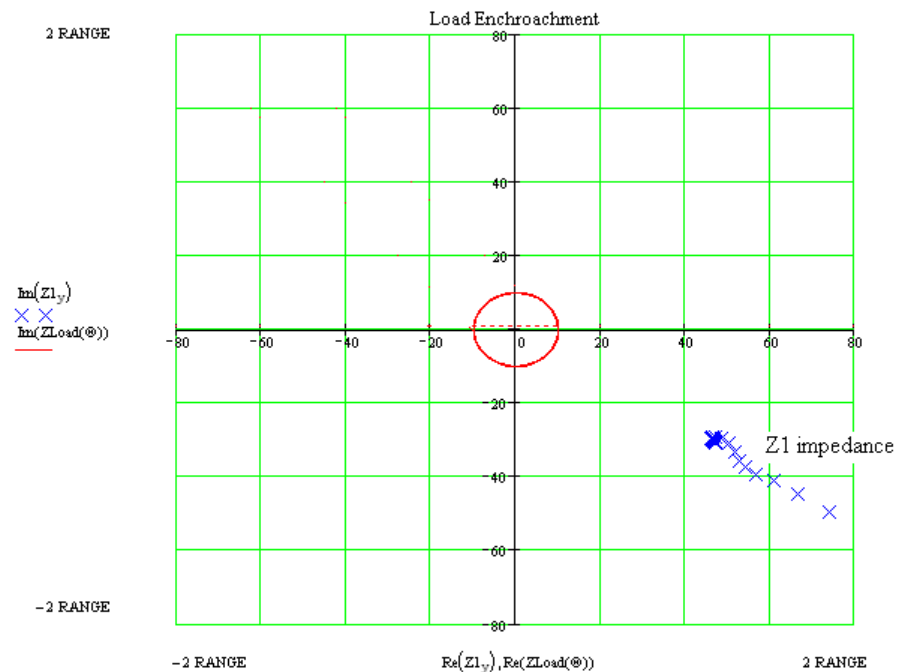
Fig.9 Plot of the load encroachment element characteristic, and the positive sequence impedance, note that the phase-to-phase distance elements fall within the load encroachment element.

With these settings the relay would have prevented the distance elements from asserting, however it must be pointed out that with these settings the load encroachment element will not block the relay for operating for any genuine phase-to-phase fault and the reason for this is that the phase-to-phase distance elements are a subset of the load encroachment element as shown in Fig. 9.

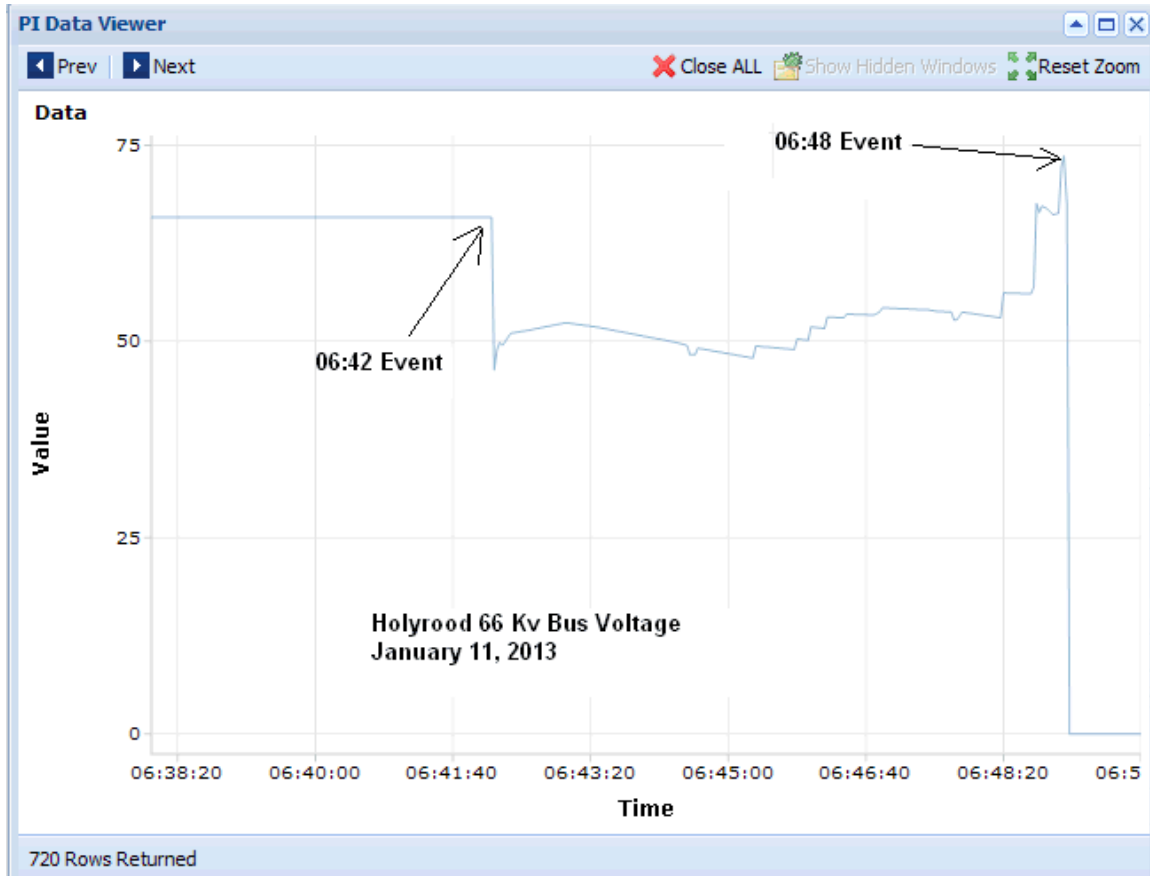
The removal of the generating units and other transmission system voltage support equipment resulted in a severe depression in system voltage to approximately 80% of normal voltage levels (See Figure 1).

**Figure 1: Voltage depression experienced in the Holyrood Terminal Station during January 11, 2013 06:42 fault event**

When Unit 1 was removed from operation in response to the terminal station electrical fault, the North AC Pump consequentially shut down. The South AC Pump tripped offline due to the voltage depression that was experienced during the terminal station electrical fault (See Figure 1). It did not restart with the loss of the North AC Pump, as is expected when the station service supply is available. The DC Pump started in response to the loss of the AC pumps and the resultant drop in lubricating oil pressure. However, it did not deliver sufficient lubricating oil to the generator bearings. The lack of sufficient lubricating oil continued for a period of approximately three minutes and fourteen seconds. With the plant completely shut down, many alarms and process upsets were being reviewed and assessed. Plant personnel manually started the 600 V emergency diesel generator D1, which removed the station service supply from the grid and established supply from the diesel generator. This resulted in the South AC Pump starting, recovering sufficient lubricating oil pressure. (See Figure 2 below for plant Distributed Control System {DCS} trends which illustrate this sequence of events.)

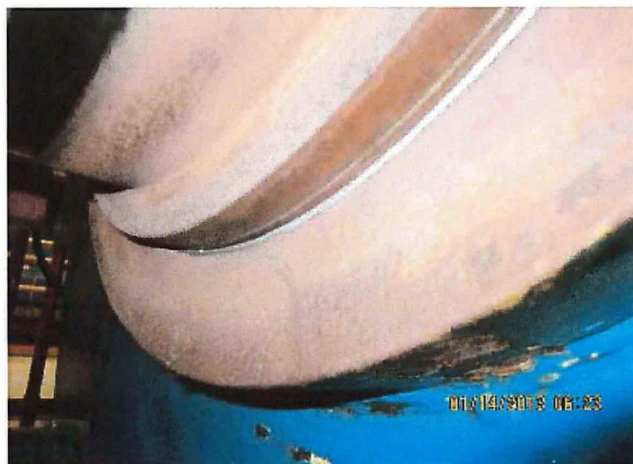
Figure 4 Bearing #4 – lower oil deflector clearance

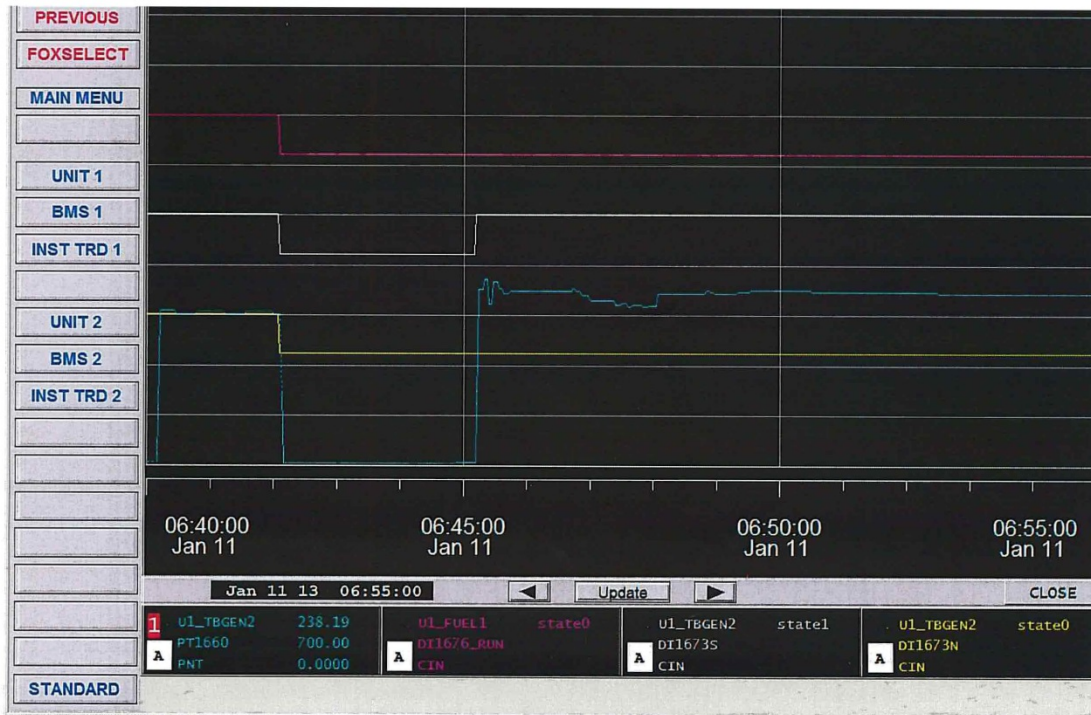
- DCS trends confirm loss of both AC lubricating pumps and crash of lube oil pressure following unit trip (see Figure 1 below); and
  - Lubricating oil pressure is re-established three minutes and 14 seconds after unit trip, when manual start of emergency diesel D1 re-establishes power to MCC-E1 (see Casual Factor # 2 in main report).

**Figure 1: Status of Unit 1 Lube Oil Pumps and Lubricating Pressure during January 11, 2013 event. PT1660 (blue) is lubricating oil pressure at the front standard of the unit. DI1676\_RUN (magenta) is the run/stop status of the DC lube oil pump (Note: DC pump's run status is triggered by a normally closed contact that opens to indicate run/start. Its running indication is opposite of both AC pumps North and South {i.e. run is indicated after the state change, the portion of the trend that is lower vertically}). DI1673s (white) is the run/stop status of the AC lube oil pump South. DI1673N is the run/stop status of the AC Lube Oil pump North. Upon loss of AC pumps the lube oil pressure crashes, despite DC lube oil pump starting. Pressure is restored 3 minutes, 14 seconds later after manual start of emergency diesel restores power to AC lube oil pump South.**

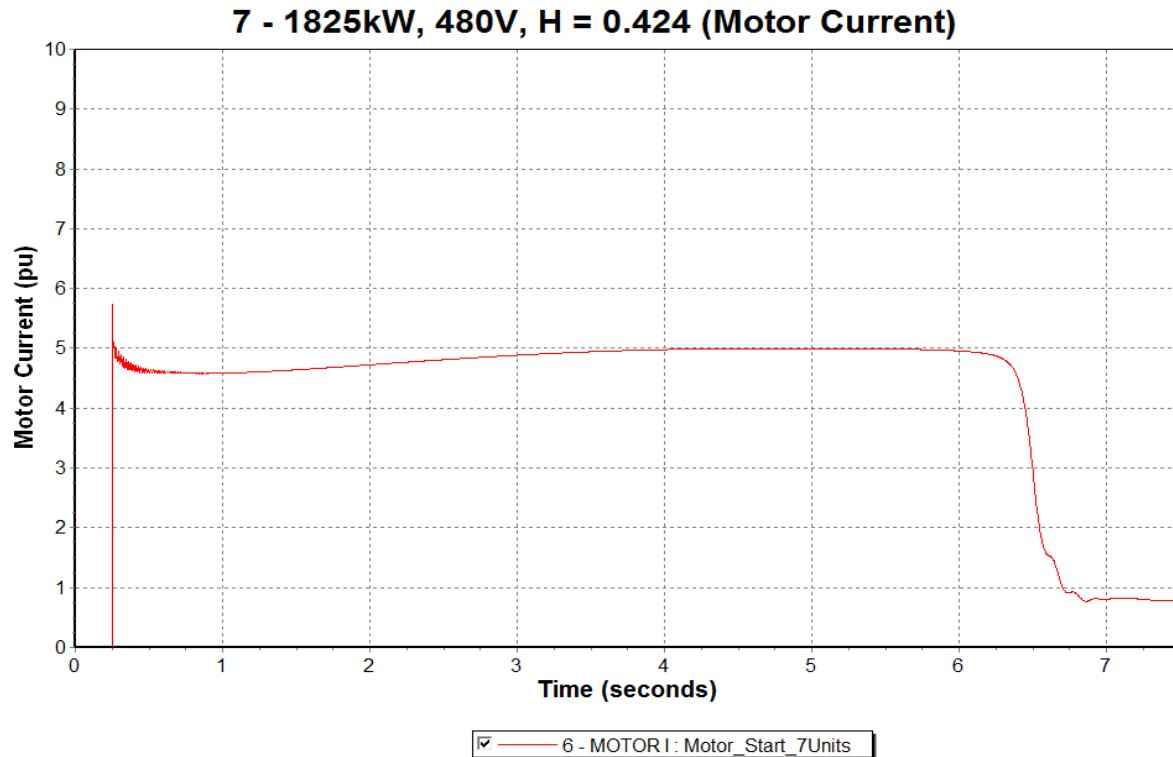
Hydro analyzed the generator solution to determine if it meets the technical requirements as indicated in Section 3. The analysis shown in Figure 2 indicates that the system voltage will fall below the 0.81pu (81% of nominal) voltage threshold requirement. Figure 3 indicates that the generator can supply the motor current, and it does not exceed the motor thermal limit shown in Appendix A.

Figure 3. System Current Response on Motor Start

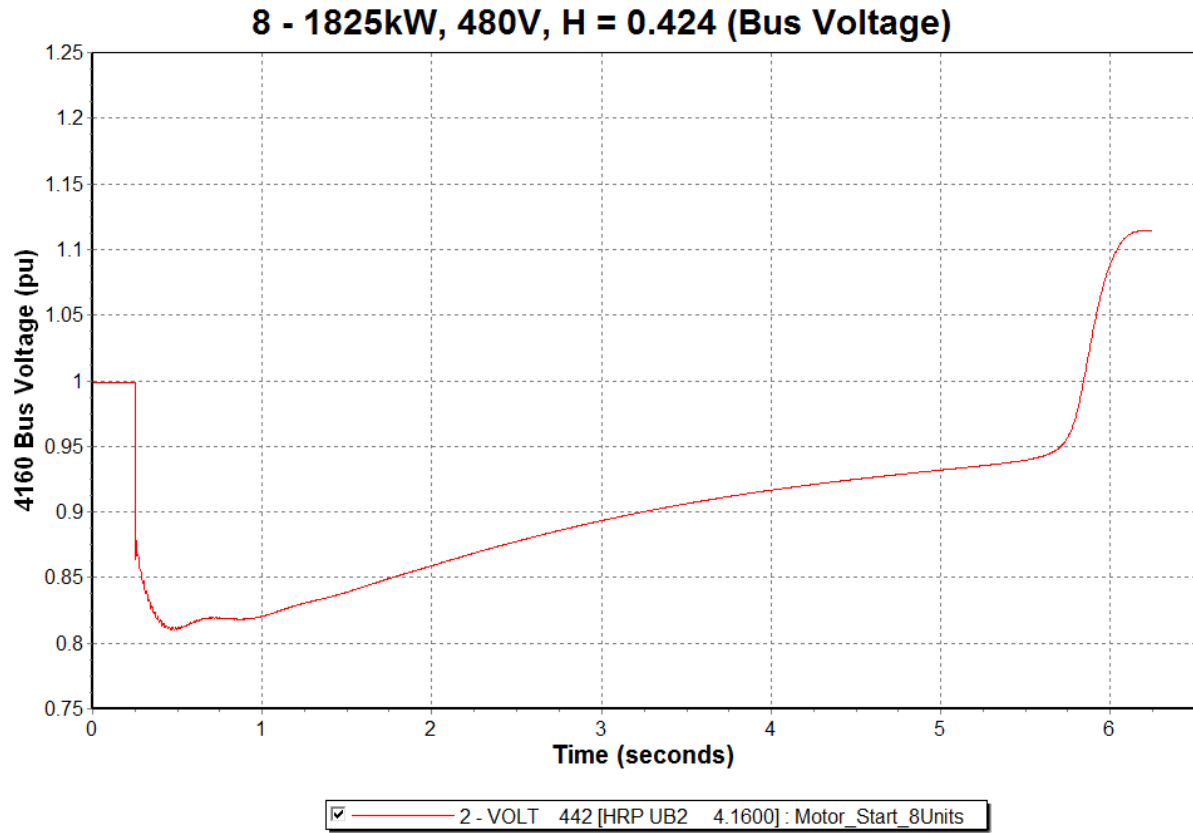
Hydro has analyzed the generator solution to determine if it meets the technical requirements as indicated in section 3. The analysis shown in Figure 4 indicates that the system voltage does not fall below the 0.81pu voltage threshold requirement. Figure 5 indicates that the generator can supply the motor current, and it does not exceed the motor thermal limit shown in Appendix A.

Figure 4. System Voltage Response of 8 - 1825kW Diesel Generators

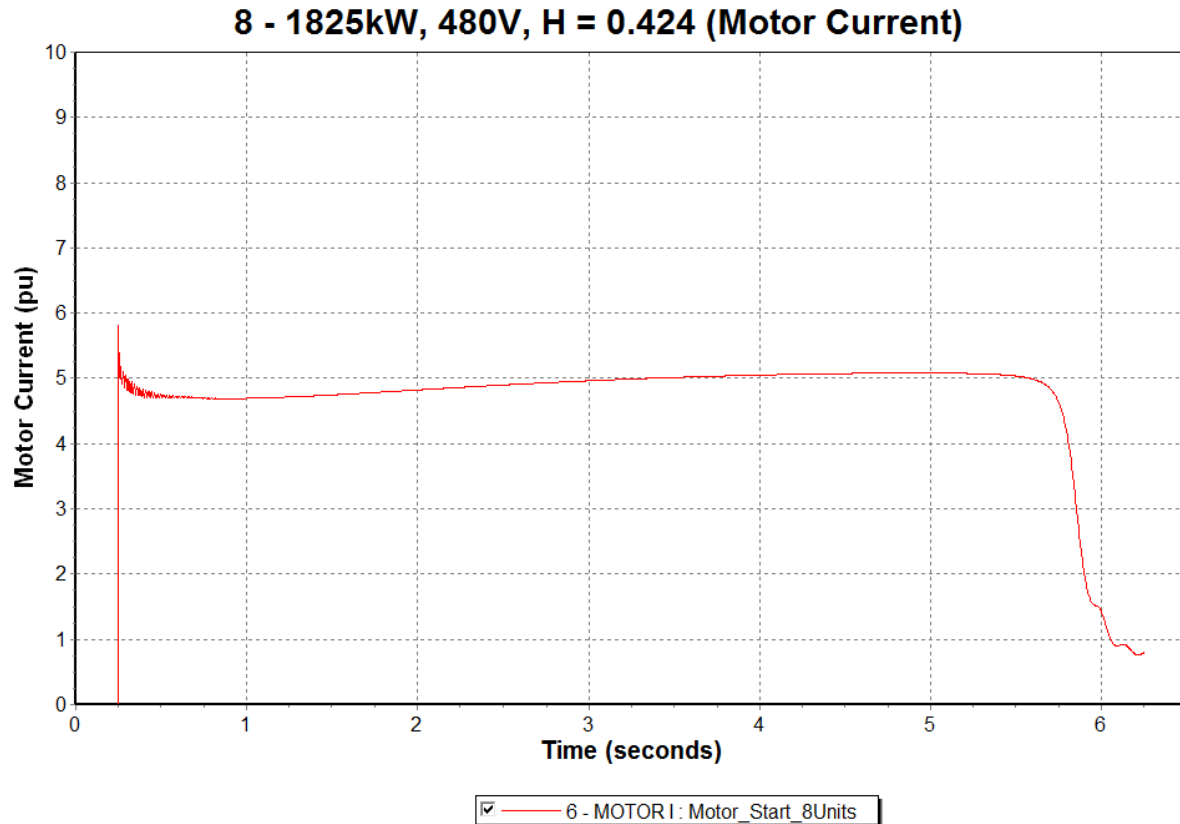
Figure 5. System Current Response on Motor Start

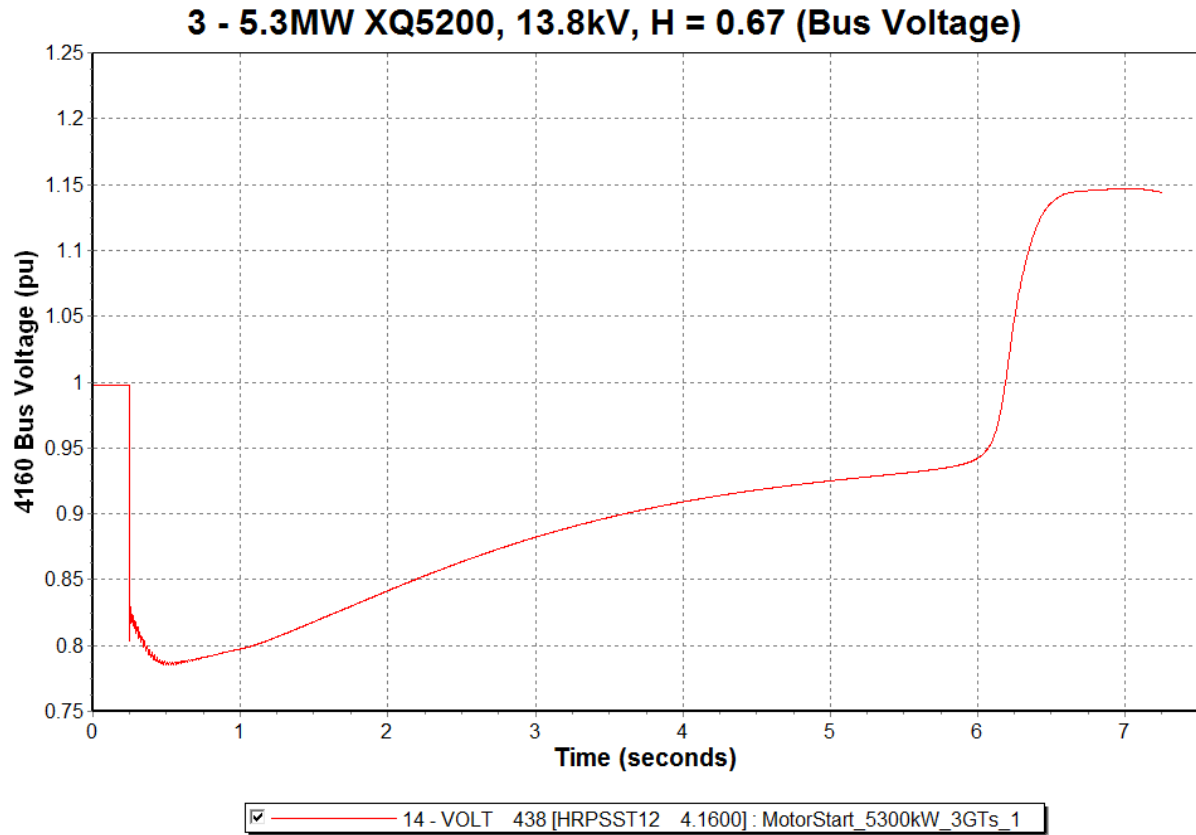
Hydro has analyzed the generator solution to determine if it meets the technical requirements as indicated in section 3. The analysis shown in Figure 6 indicates that the system voltage does fall below the 0.81pu voltage threshold requirement. Figure 7 indicates that the generator can supply the motor current, and it does not exceed the thermal limit shown in Appendix A.

Figure 6. System Voltage Response of 3 - 5.3MW CT's during Blackstart

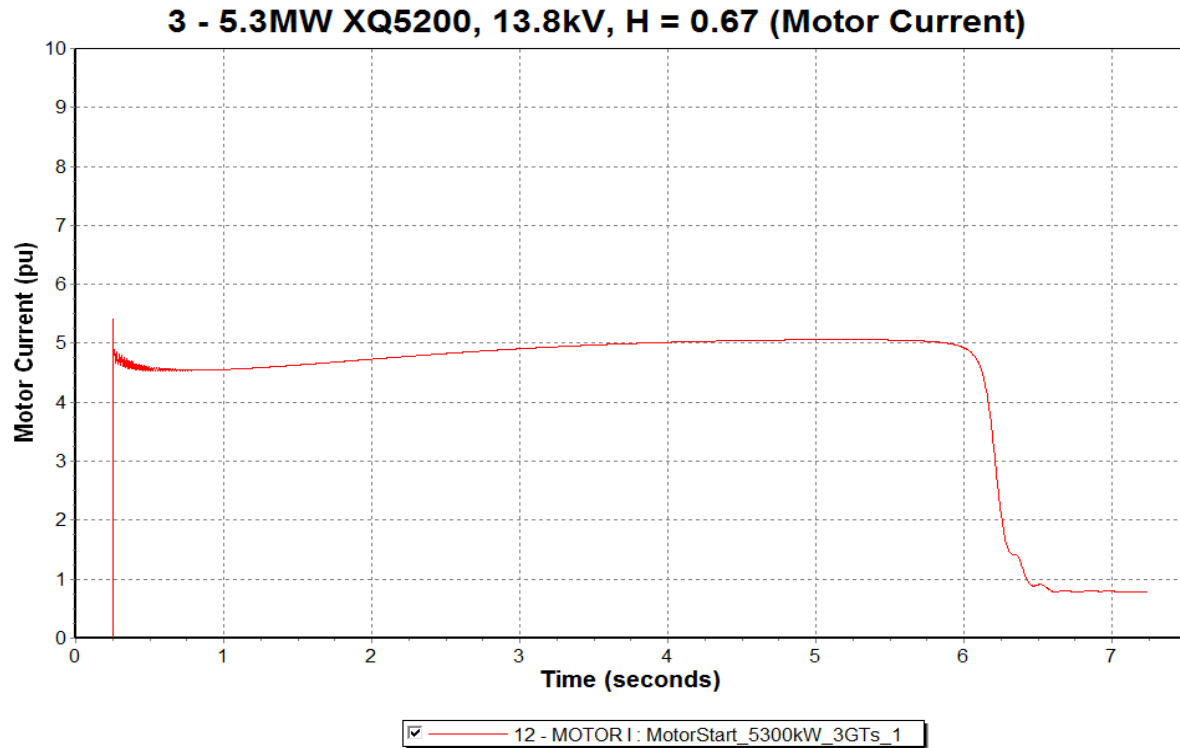
Figure 7. System Current Response during Blackstart

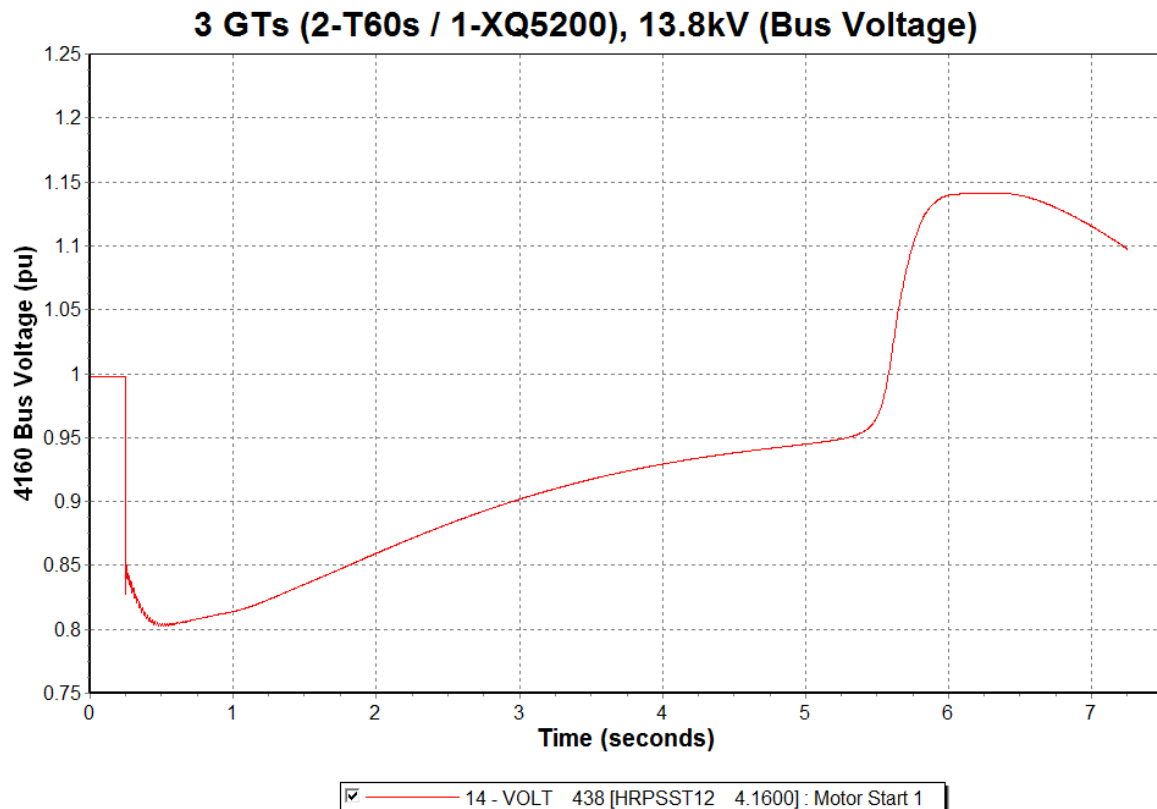
Hydro has analyzed the generator solution to determine if it meets the technical requirements as indicated in Section 3. The analysis shown in Figure 8 indicates that the system voltage does not fall below the 0.81pu voltage threshold requirement. However, because the system voltage comes quite close to the threshold, verification of the Hydro model would be required from the manufacturer during the tendering process.

Figure 8. System Voltage Response of a 16.7MW CT plant on Blackstart

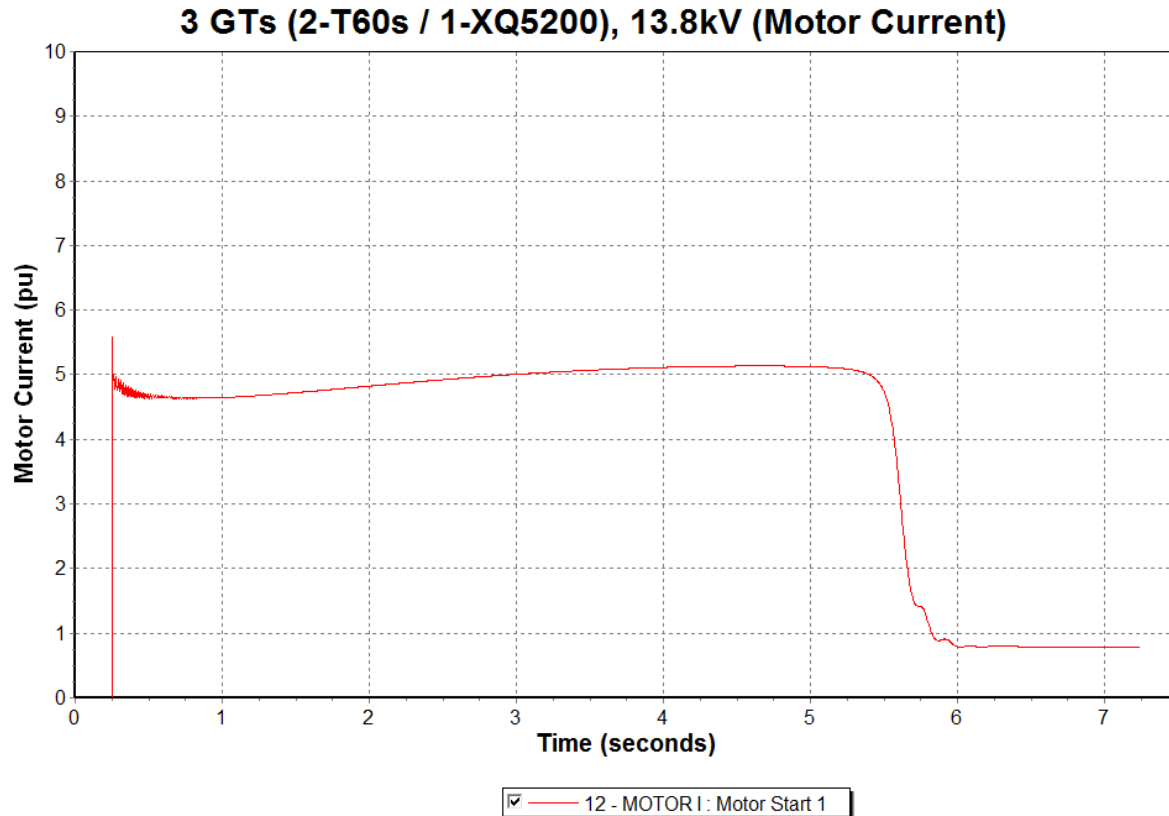
Figure 9 indicates that the generator can supply the motor current, and it does not exceed the motor thermal limit shown in Appendix A.

Figure 9. System Current Response of a 16.7MW CT Plant during Blackstart
