1 Q. Further to PR-PUB-NLH-172, despite the conclusion of the technical analysis  
2 referred to, the Newfoundland Power option was found to be inadequate on May  
3 10, 2013. Please describe what actions Hydro took between the time it learned the  
4 Newfoundland Power option was inadequate and November 29, 2013 when the  
5 Board approved new action to be taken to provide black start capability.

14  
15 This report summarizes the sequence of events that occurred on the power system, the  
16 problems experienced, the damage incurred, and identifies remedial actions being taken as a  
17 result of follow up investigations.

**Unit 1 Failure – Holyrood  
Life Safety Review  
SWOP # 2013000599  
January 11, 2013**

# **Nalcor Holyrood Unit 1 Turbine and Generator Inspection Report January 15, 2013**

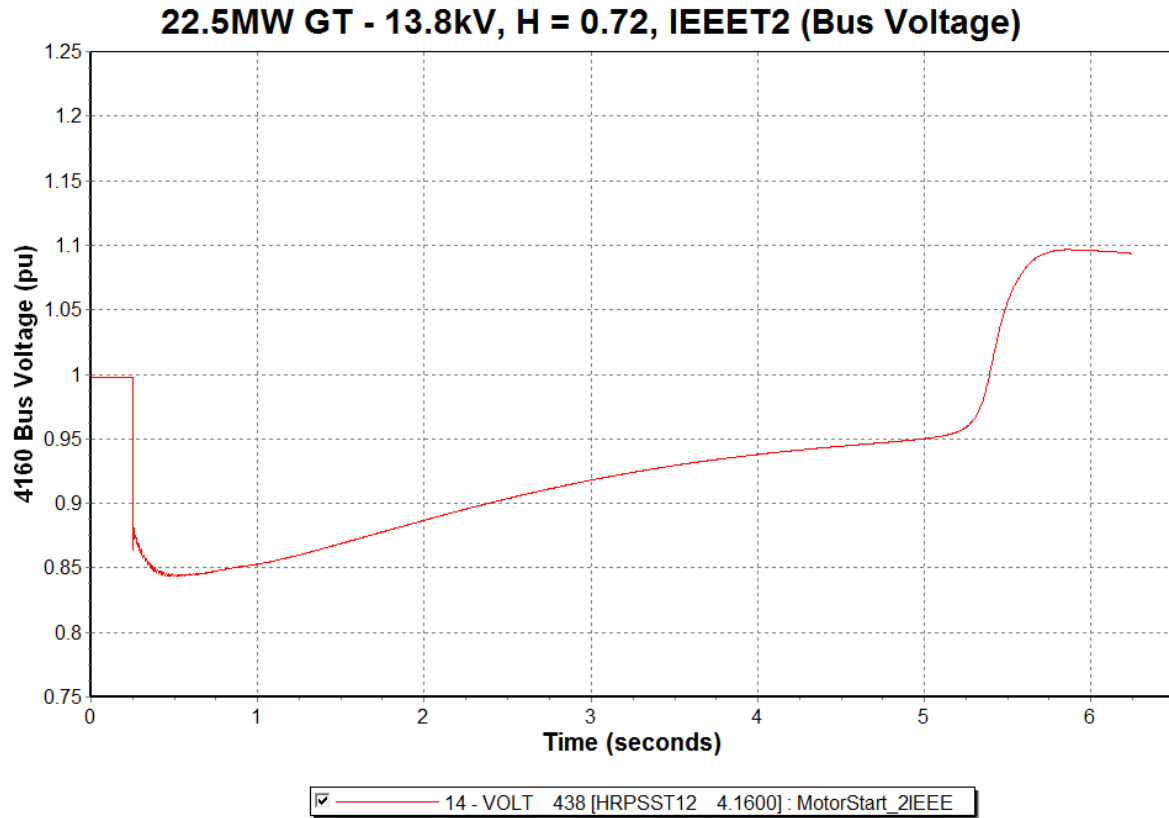
Hydro has analyzed the generator solution to determine if it meets the technical requirements as indicated in section 3. The analysis shown in Figure 10 indicates that the system voltage does not fall below the 0.81pu voltage threshold requirement. Figure 11 indicates that the generator can supply the motor current, and it does not exceed the thermal limit shown in Appendix A.

Figure 10. System Voltage Response of a 22.5MW CT during Blackstart

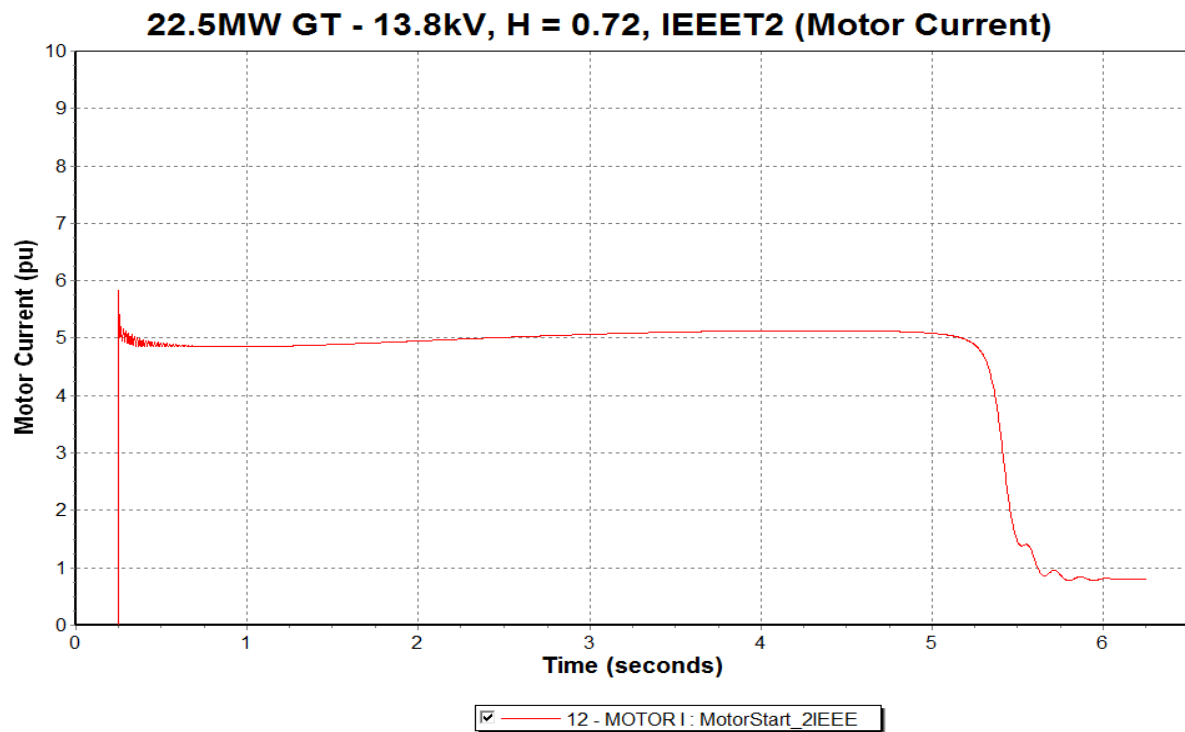
Figure 11. System Current Response of 22.5MW CT during Blackstart
