May 15, 2015

**Re: March 4, 2015 Power Outage Report (*Power Outage/Incident Advisory 2015-H-062*)**

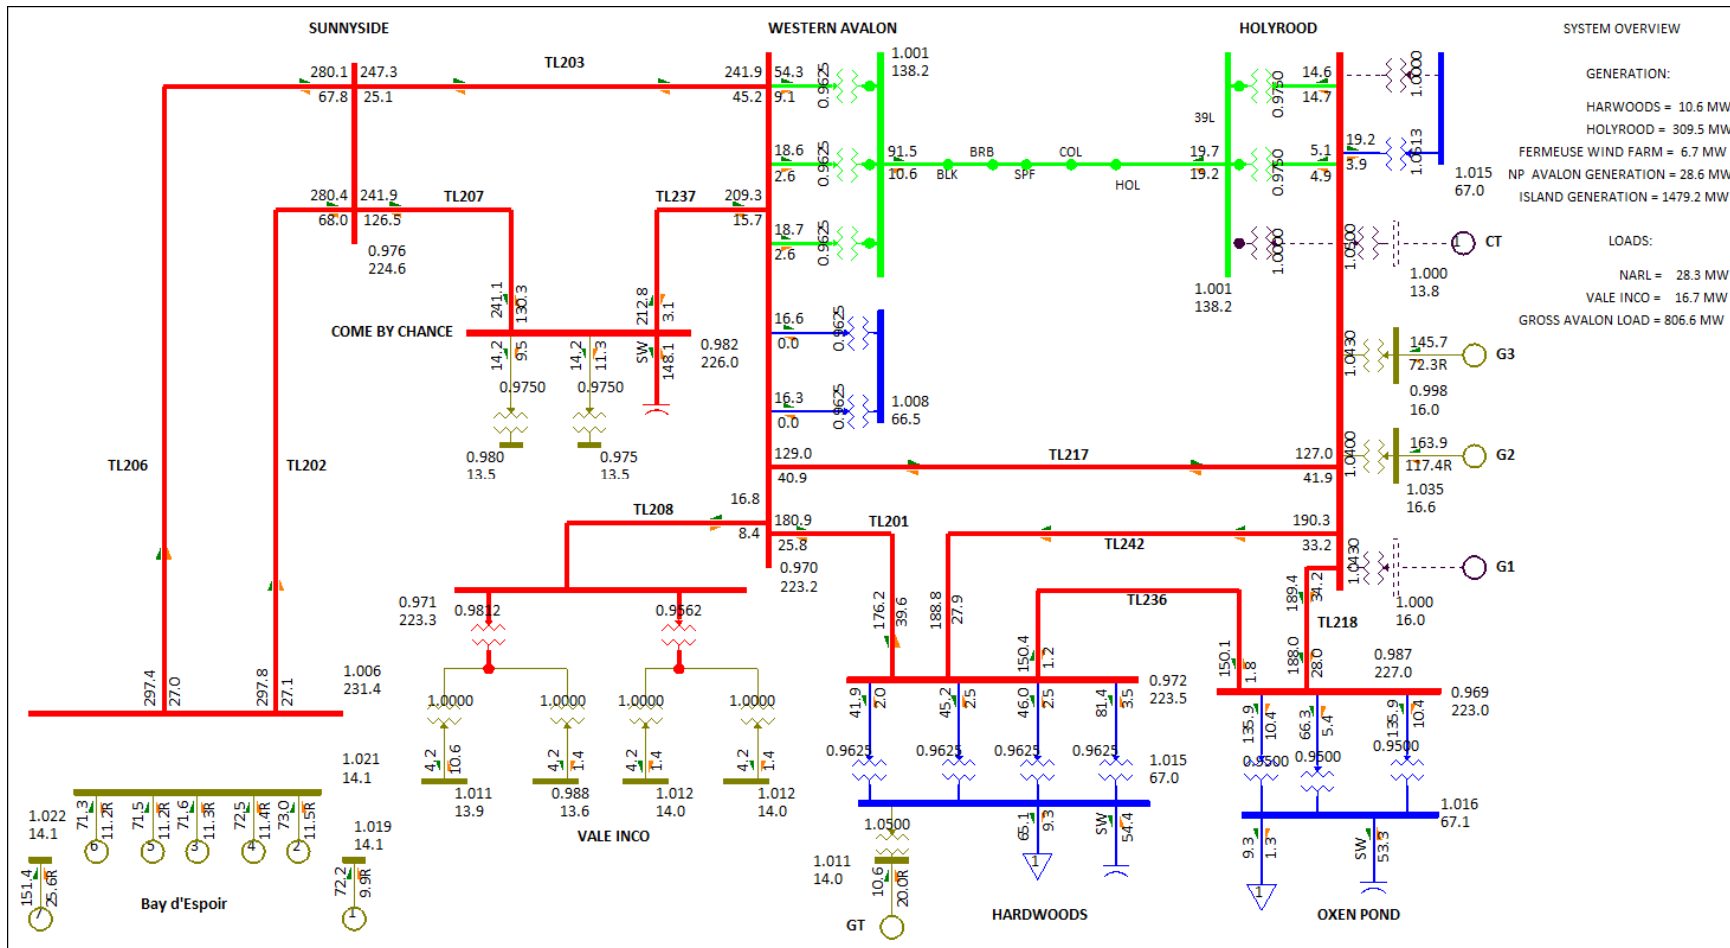
06:30:00 AM

If the voltage of a bus drops below 95% of nominal value, the colour is changed to grey. For example, the Oxen Pond 66 kV bus is coloured blue at 07:00 and grey at 07:14. As per the events described in the Power Outage Report, the plots contained in the appendix detail the system conditions over the specified timeframe. As indicated, system voltages are acceptable

prior to 07:00. At 07:00, low voltage conditions are noted at 230 kV buses at Western Avalon Terminal Station, Voisey's Bay Nickel (Vale Inco) Terminal Station, Hardwoods Terminal Station, and Oxen Pond Terminal Station. Extensive low voltage conditions are noted at 07:14.
