Snook's Arm Wood Stave Penstock

Evaluation, Recommendation and Estimated Cost for Replacement

Newfoundland and Labrador Hydro
Generation Engineering

January 26, 2004

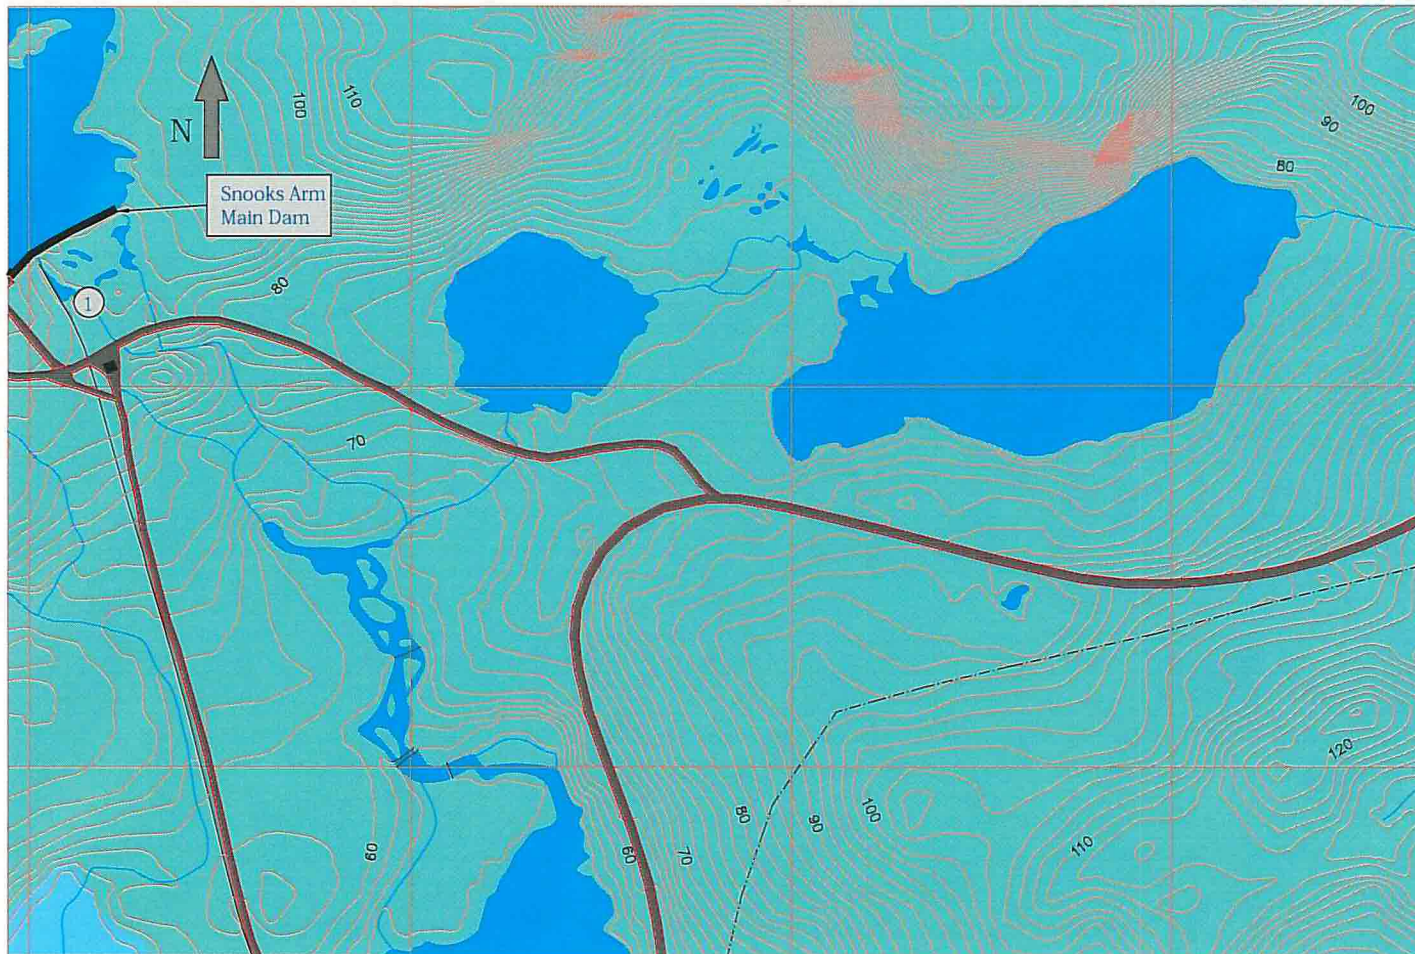
NEWFOUNDLAND AND LABRADOR HYDRO		
SNOOKS ARM PENSTOCK TOPO MAP km 0.0 to km 0.5		
Date : Mar. 2001	Design: J. Phillips	Map No. SA-2
Dwn.: D. Oliver	App.:	Sheet 1 of 2

The penstock passes through the middle of the community and at times, is within a few feet of the adjacent houses; see photos #20 & #21. Also a considerable length of the penstock, approx. 200 ft is buried, refer to location #3 on map SA-2 and see photo #22. In 1998, a section of the buried penstock was excavated and it was observed that the penstock is supported on cradles, similar to the rest of the penstock. Buried penstocks are designed to be fully supported along their length, the discovery of cradles supporting the penstock in the buried section, suggests that the penstock was not designed to be buried. The burial of the penstock subjects it to additional loads from the overburden soil and live loads from vehicles, skidoos, woodpiles, etc. In addition, there is very poor drainage around the penstock causing the penstock to be submerged in water. The risk associated with this section of penstock is high because of additional loading, moist conditions and lack of maintenance; there is a high probability of failure of this section of the penstock.

A section of the penstock (approximately 30 ft) crosses under the main access road through the community, refer to location #4 on map SA-2. There are two key items at this location, the support structure and penstock condition.
