1 Q. Reference: *Gas Generator Engine Refurbishments Hardwoods and Stephenville*,
2 Page 8, line 5 to Page 9, line 10.

Field Service Report For Removal of Serial No: 202205 Installation of Alba Lease Serial No: 202040

Customer: Newfoundland Hydro Hardwoods

Field Service Report For Investigation of High Vibration Olympus Serial No: 202204

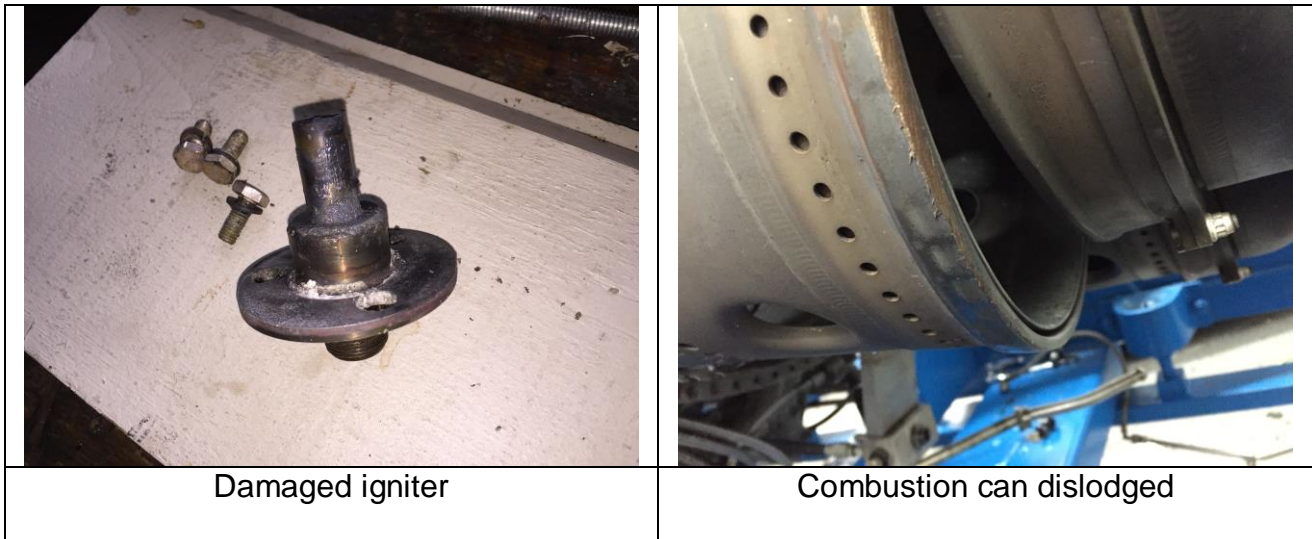
The heat shields, the combustion casings, and the damaged combustion chamber were removed. The gas turbine had sustained extensive damage to the turbine section and could not be repaired on site and would have to be shipped back to Alba Power for investigation and detail strip of the turbine section.

Combustion can failure. Rivets missing

Combustion can in two parts
