1 **Q. Project C-14: Upgrade Work – Cat Arm**

Projet / Project : Servomotor - CAT ARM - PO4501166807Rapport / Report # : RC 3.0Client/Customer: Andritz Hydro Ltée# Contrat/contract: 1262Qtée/Qty: 1Produit/Product: Cylinder #1 (big diameter) (oil side)Index: item: Type rapport / report: Visual at receivingDessin/Dwg: 1262-001Rev.: 0

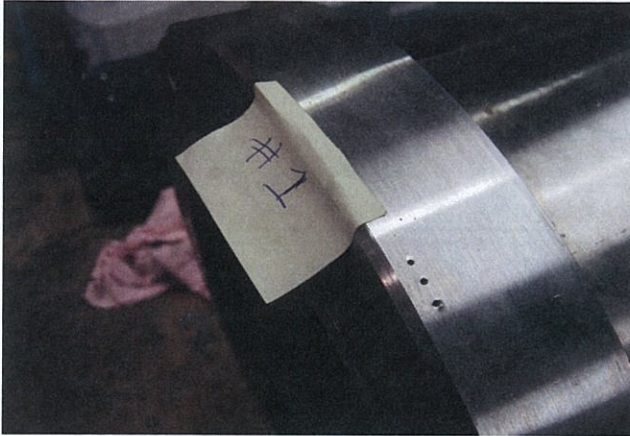
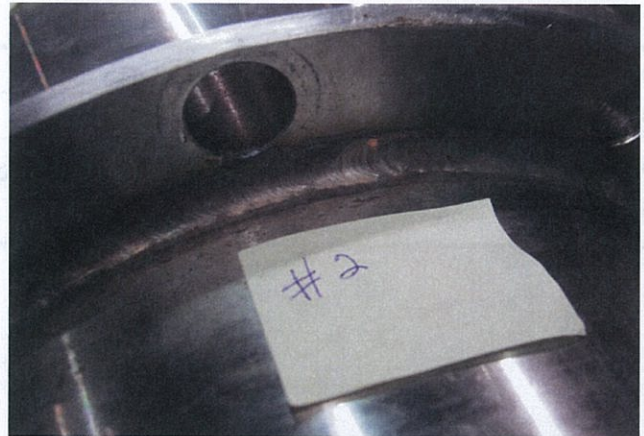
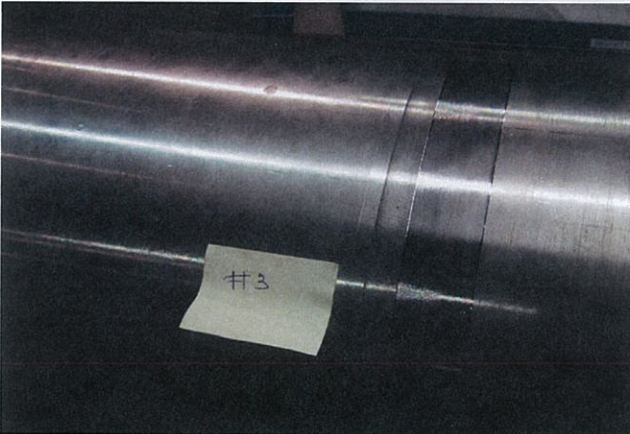
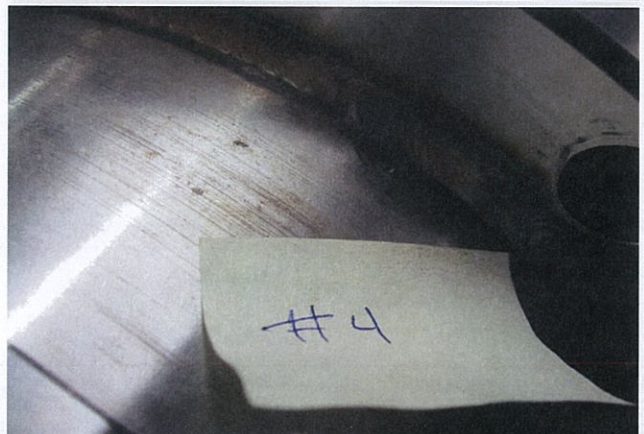
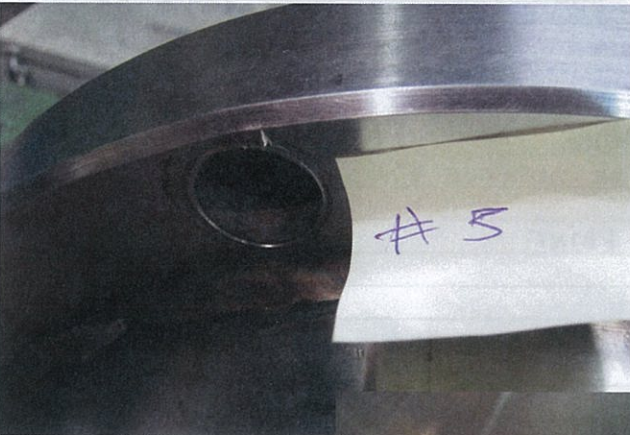
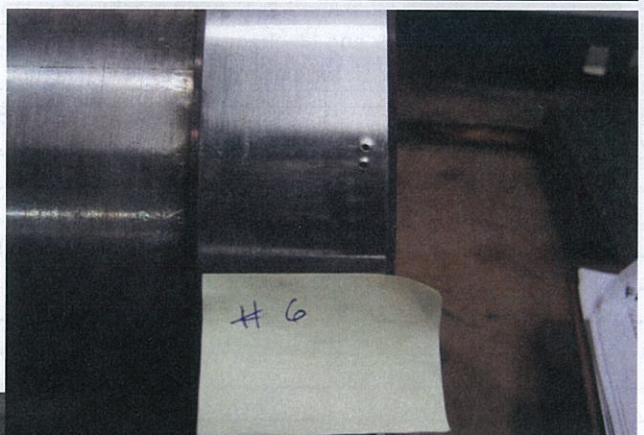
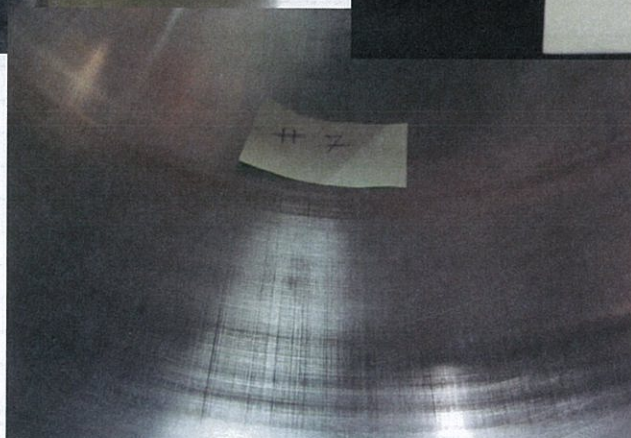
1- 3 punch marks, scratches and dents all around the flange, up to .010" deep.

2- Rust and blackened welded joint all around flange.

3- Scratches and marks all around & 1" wide machined surface by .010" deep for run out purposes.

4- Lightly rusted diameter and blackened welded joint all around.

5- Lightly damaged holes on back of both flanges.

7- Light scratches all around the inside diameter, no depth.

LEAVE AS IS

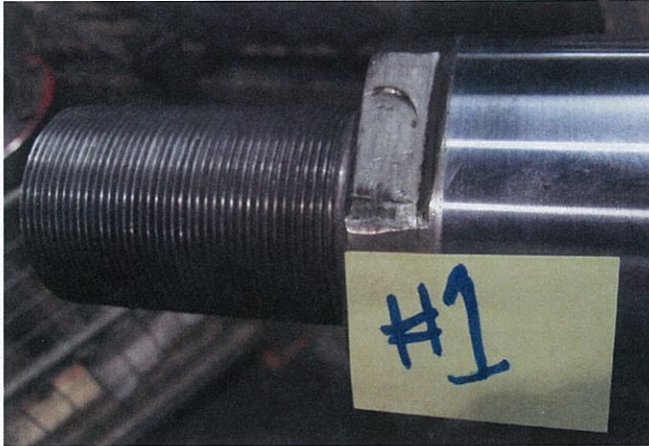
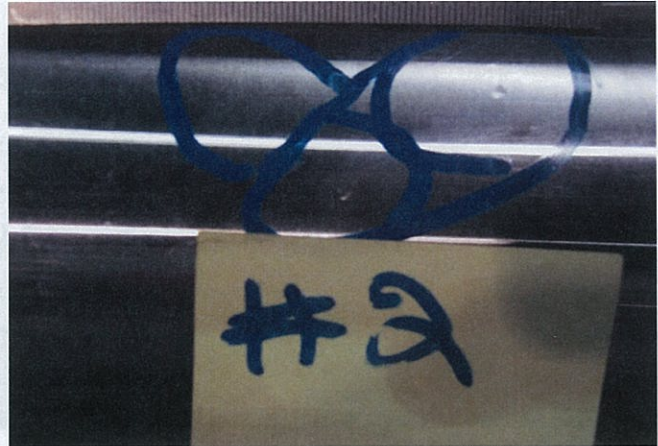
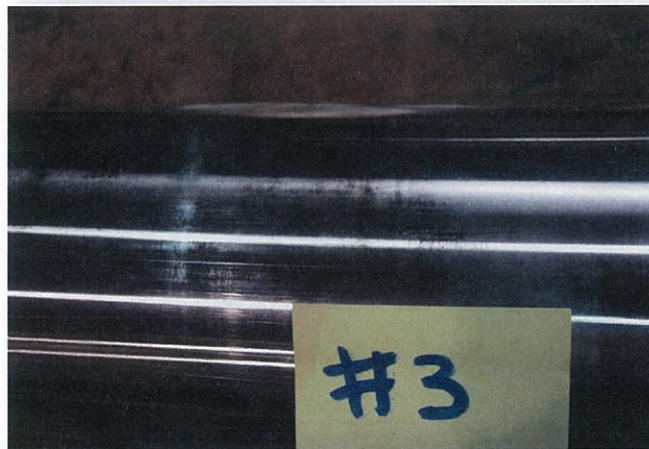
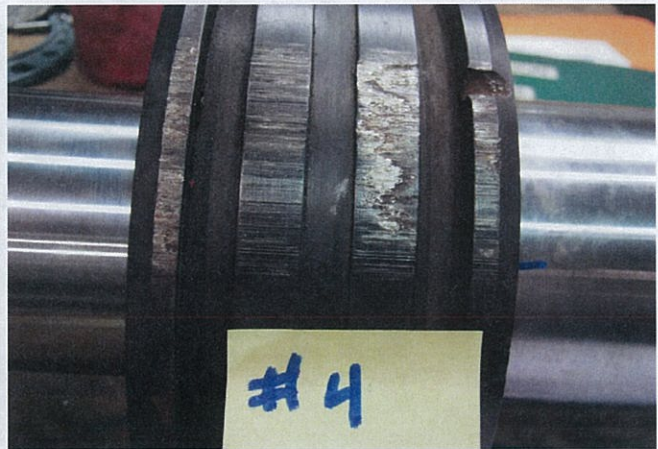
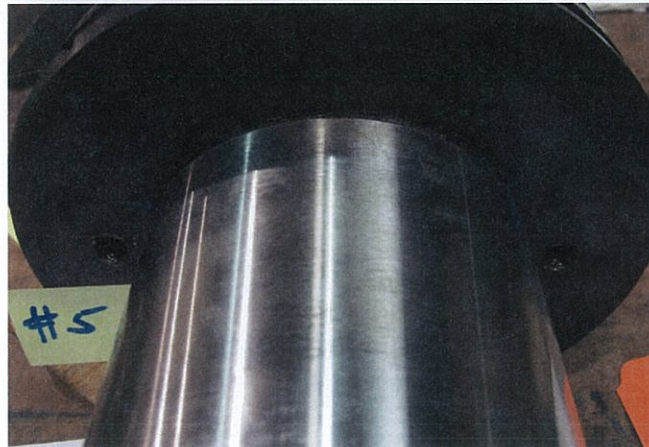
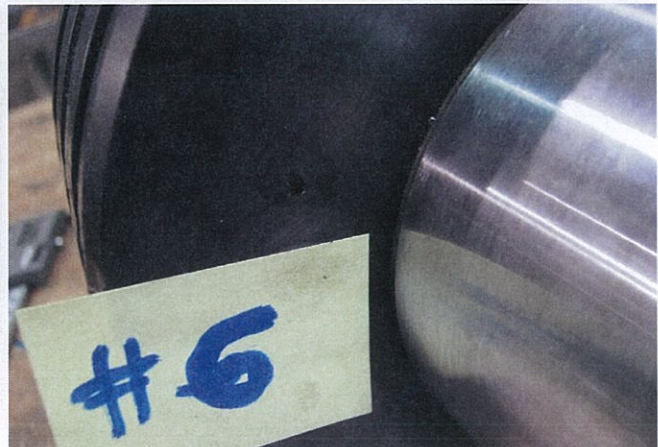
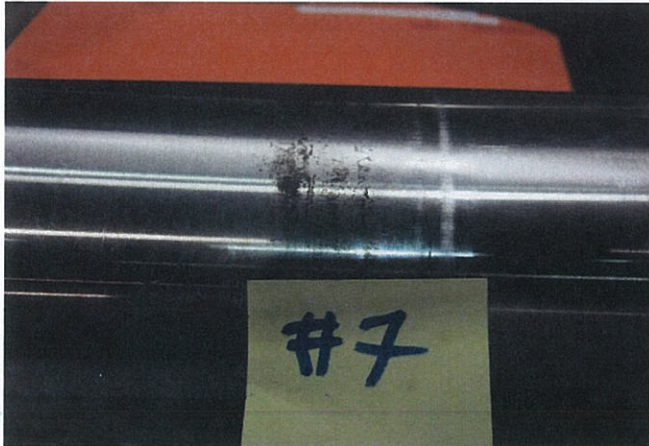
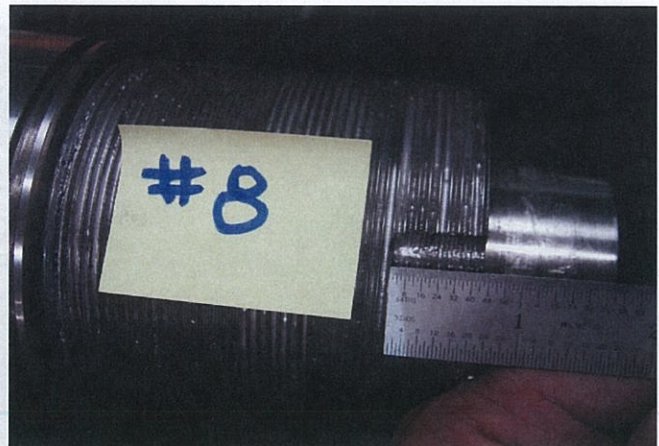
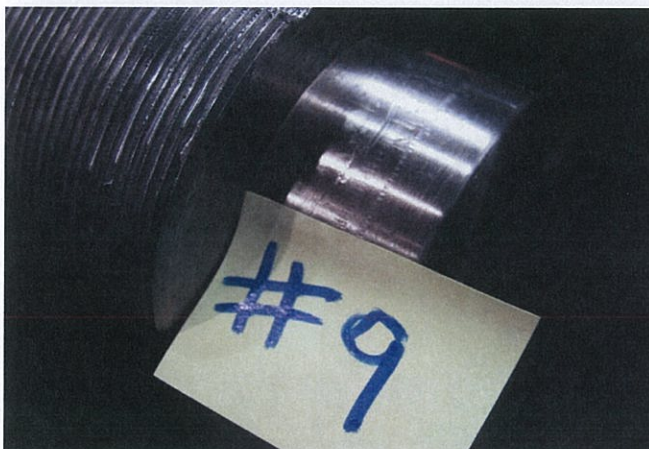
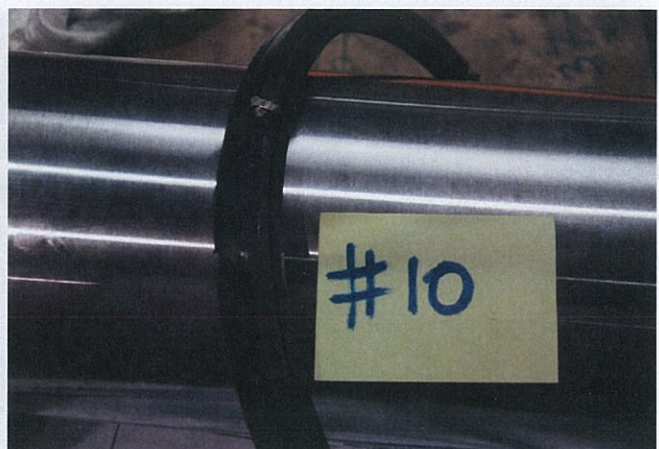
1- Damaged flat 5/8" long x .030" deep. SLIGHTLY GRIND TO REMOVE BURRS.2- 6 hollow spots up to .003" deep x Ø .040". LEAVE AS IS3- Linear scratches all around 17" long up to .001" deep. POLISH TO RESTORE NO SURFACE FINISH

4- Damaged outside diameter on piston up to .180" deep 4 places : 0° - 90° - 180° - 270°.

5- 2 holes Ø 3/8", 180° appart.

6- 1 holes Ø .080" x .040" deepé

7- Black marks and scratches, no depth.

LEAVE AS ISSTEEL.8- 3/4" long threads used to lock piston on rear end. REFRESH USING A DIE9- Scratches and marks all around the diameter, up to .005" deep. LEAVE AS IS10- Damaged seal. REPLACE BY A NEW SEAL

} MAKE NEW PISTON
MADE OF STAINLESS

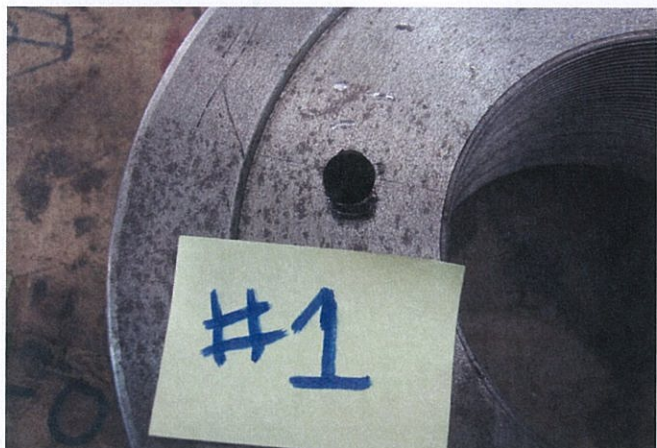
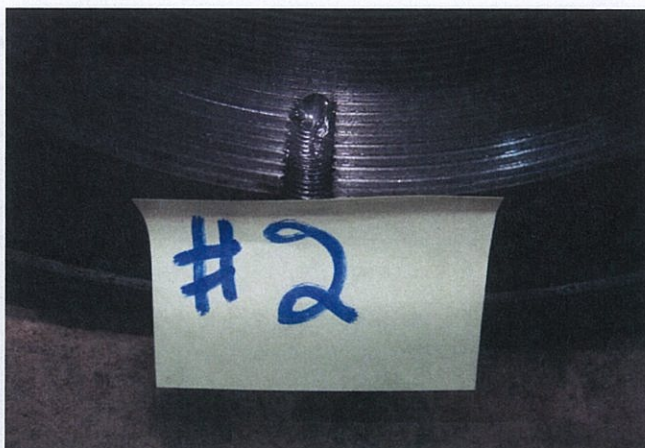
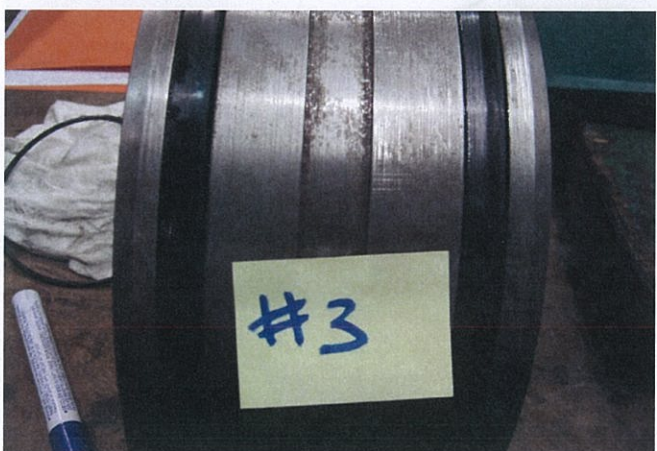
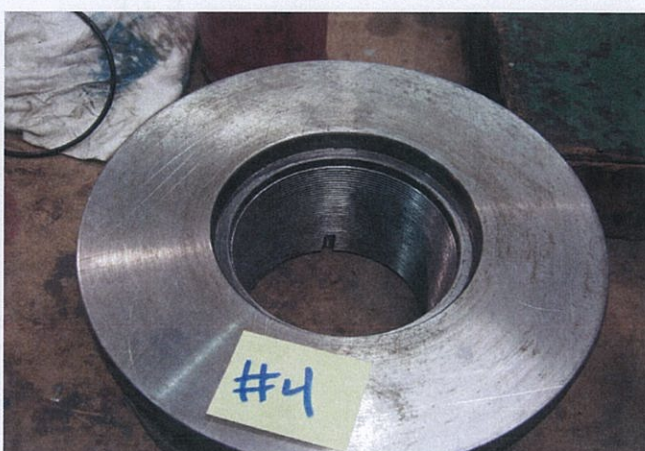
1- One $\varnothing 3/8$ " damaged hole.

3- Rust all around the diameter.

4- Rust and minor scratches all over face. Scratches are up to .002" deep.

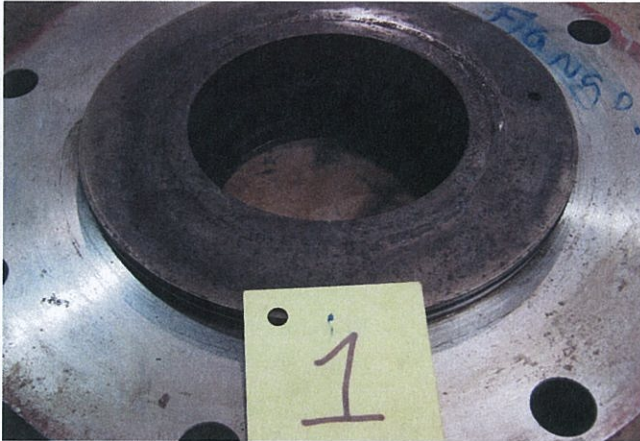
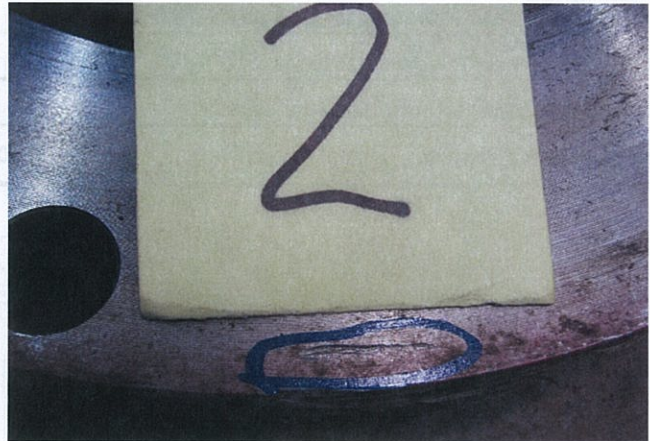
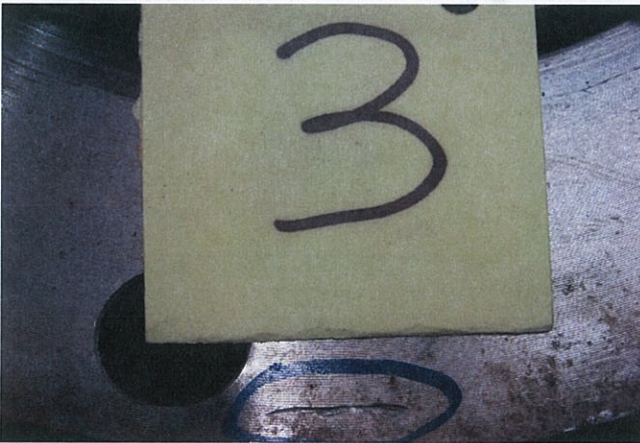
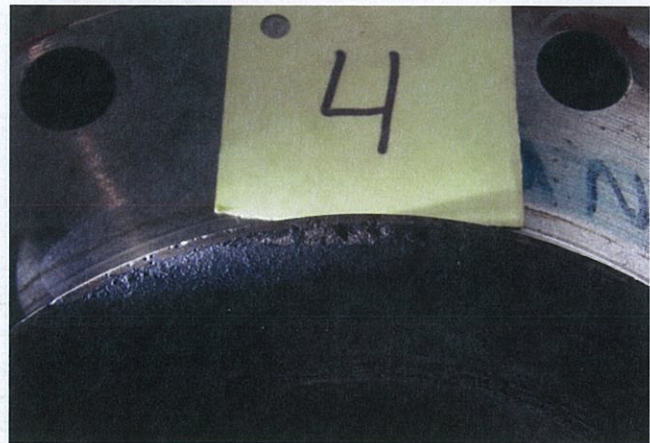
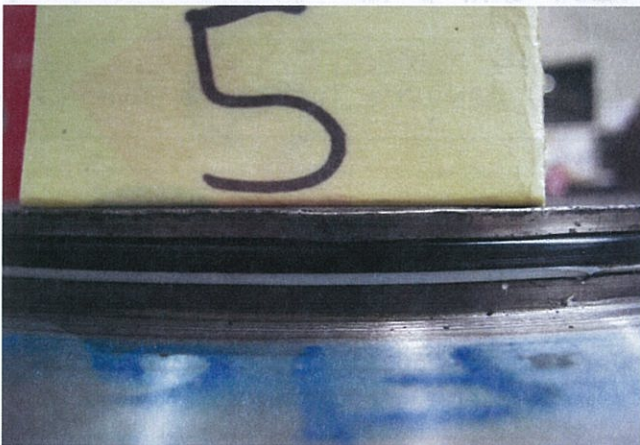
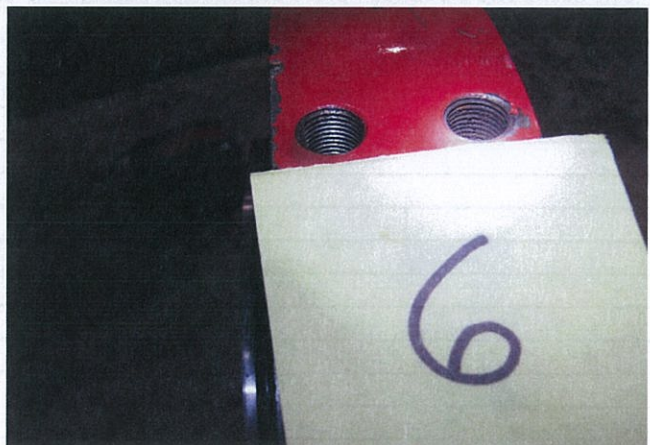
1- Dirt on this side & wear about $\varnothing 5 \frac{1}{2}$ " x $\frac{3}{16}$ " width x .015" deep. **LIGHT SANDING TO REMOVE BURRS ONLY.**2 & 3- Scratches about $\frac{3}{4}$ " x $\frac{1}{16}$ " x .010" deep. **LIGHT SANDING TO REMOVE BURRS ONLY.**4- Pits up to $\frac{1}{4}$ " x $\frac{3}{16}$ " x .020" deep. **REBUILD SPIGOT WITH STAINLESS STEEL WELDING MAT'L**5- Puck on spigot "D" about .020" deep. **AND REMACHINE TO ORIGINAL DIAMETER. DO A NEW 'O' RING GROOVE.**6- One of the two threaded holes have dirt and rust in. **→ REFRESH WITH A TAP**7a & 7b - Good condition of inside diameter. **→ OK**8- Grinder marks up to $\frac{1}{32}$ " deep. **GRIND SMOOTH TO REMOVE BURRS**9 & 10- Many light scratches and tool marks up to .002" deep. **LIGHT SANDING TO REMOVE BURRS ONLY**Good condition of spigot "C". **→ OK**

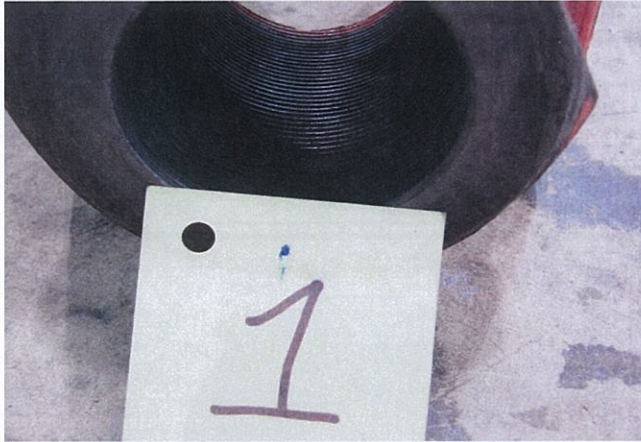
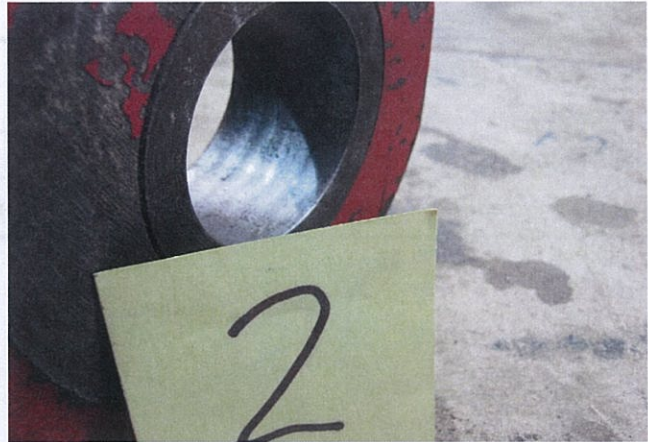
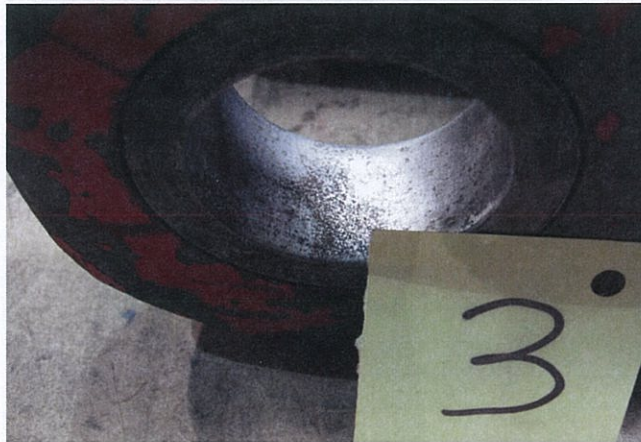
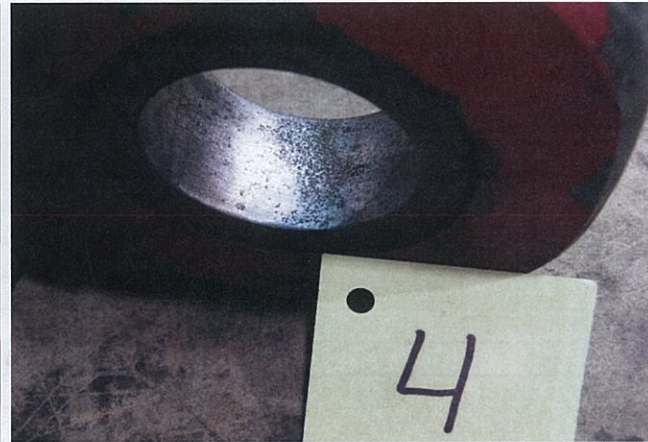
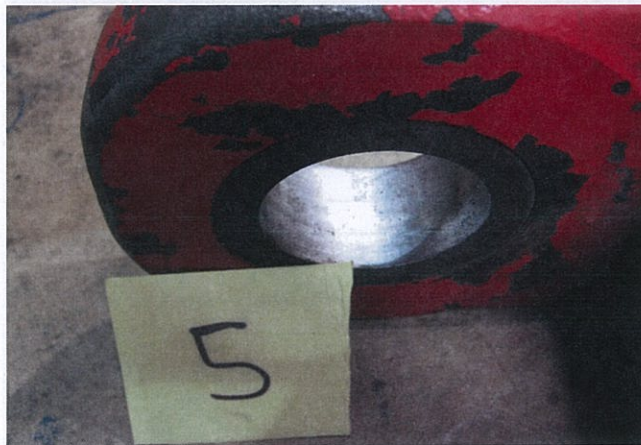
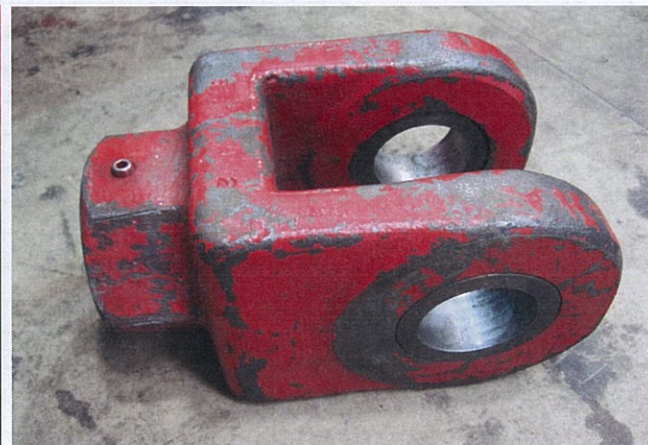
- 1- Good condition of all surface of this side.
- 2- Good condition of o-ring and groove.
- 3- Good condition of all surface of this side.
- 4- Good condition of inside diameter.
- 5- Punch mark.
- 6- Many pits about .002" deep on 2" x 1" area.
- 7- Puck 1/4" x 1/4" x 1/8" deep.
- 8 - 9 - Good condition of face.
- Good condition of all holes and threaded holes.

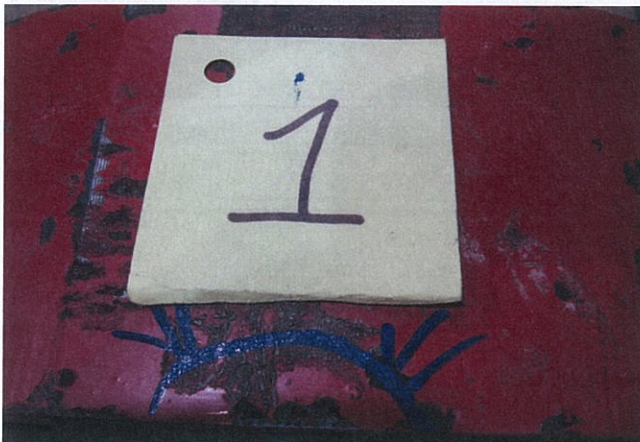
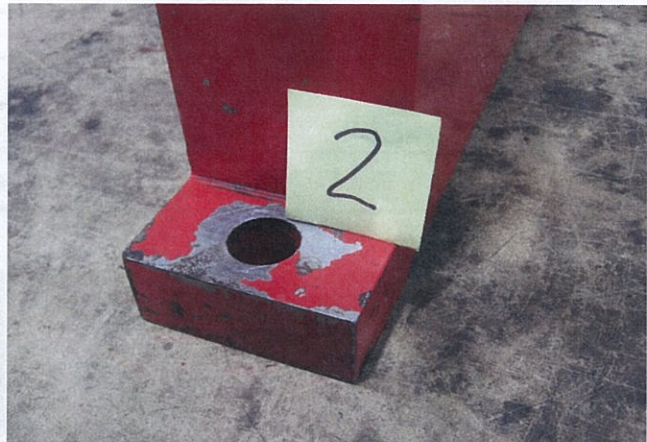
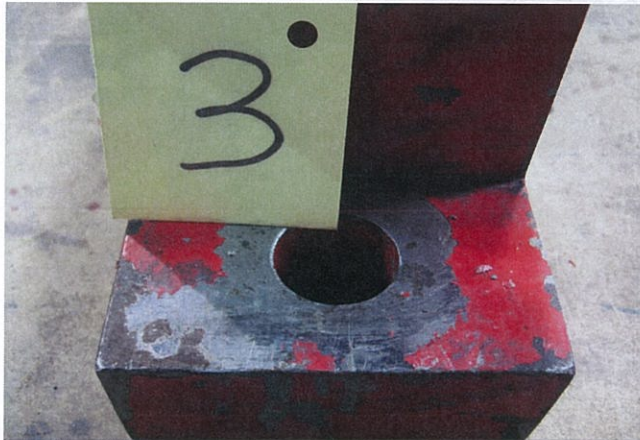
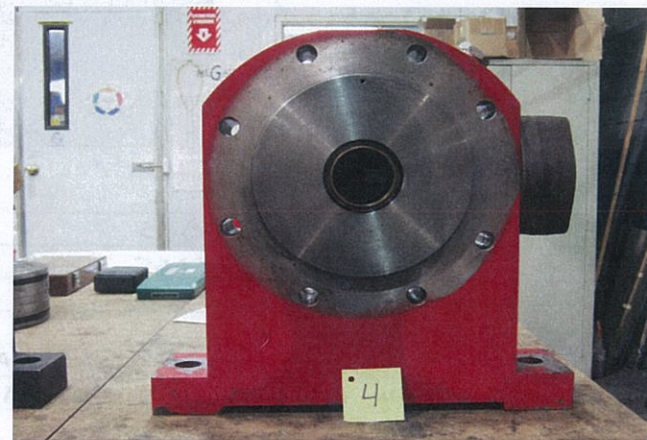
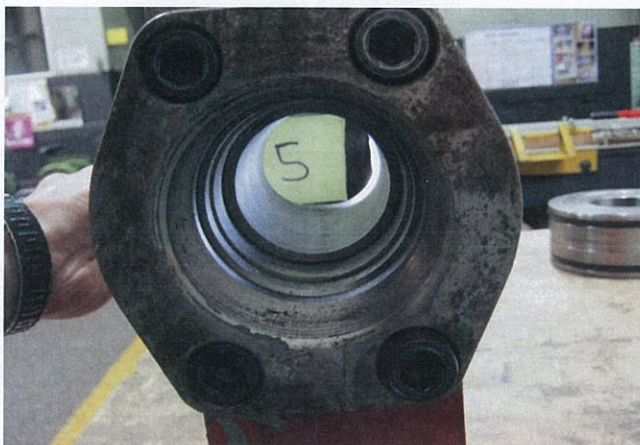
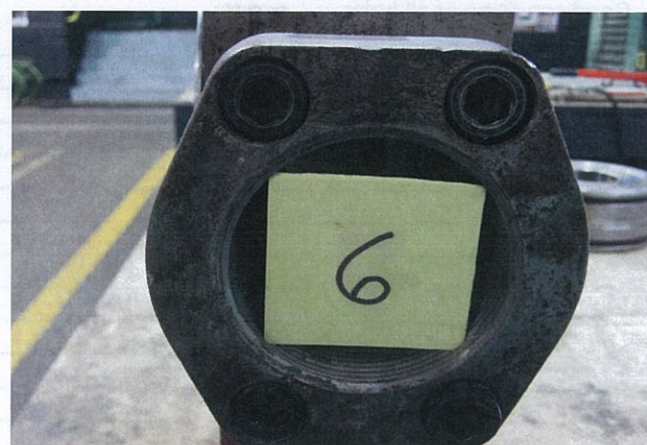
1- Punch mark

2 - 3 - Paint peeling

6- Light rust on face.

7- Dirt in threads.

12- Dirt in NPT threads and on thread of plug.

LEAVE AS IS

SAND BLAST AND PAINT

LIGHT SANDING TO CLEAN SURFACE

→ REFRESH USING A TAP

→ OK. REPLACE "O" RING ONLY

→ REFRESH THREADS USING A TAP
