THE **Lower Churchill** PROJECT

March 2010

**MF1271 - Evaluation of Existing Wells,
Pumps and Related Infrastructure in the
Muskrat Falls Pumpwell System**

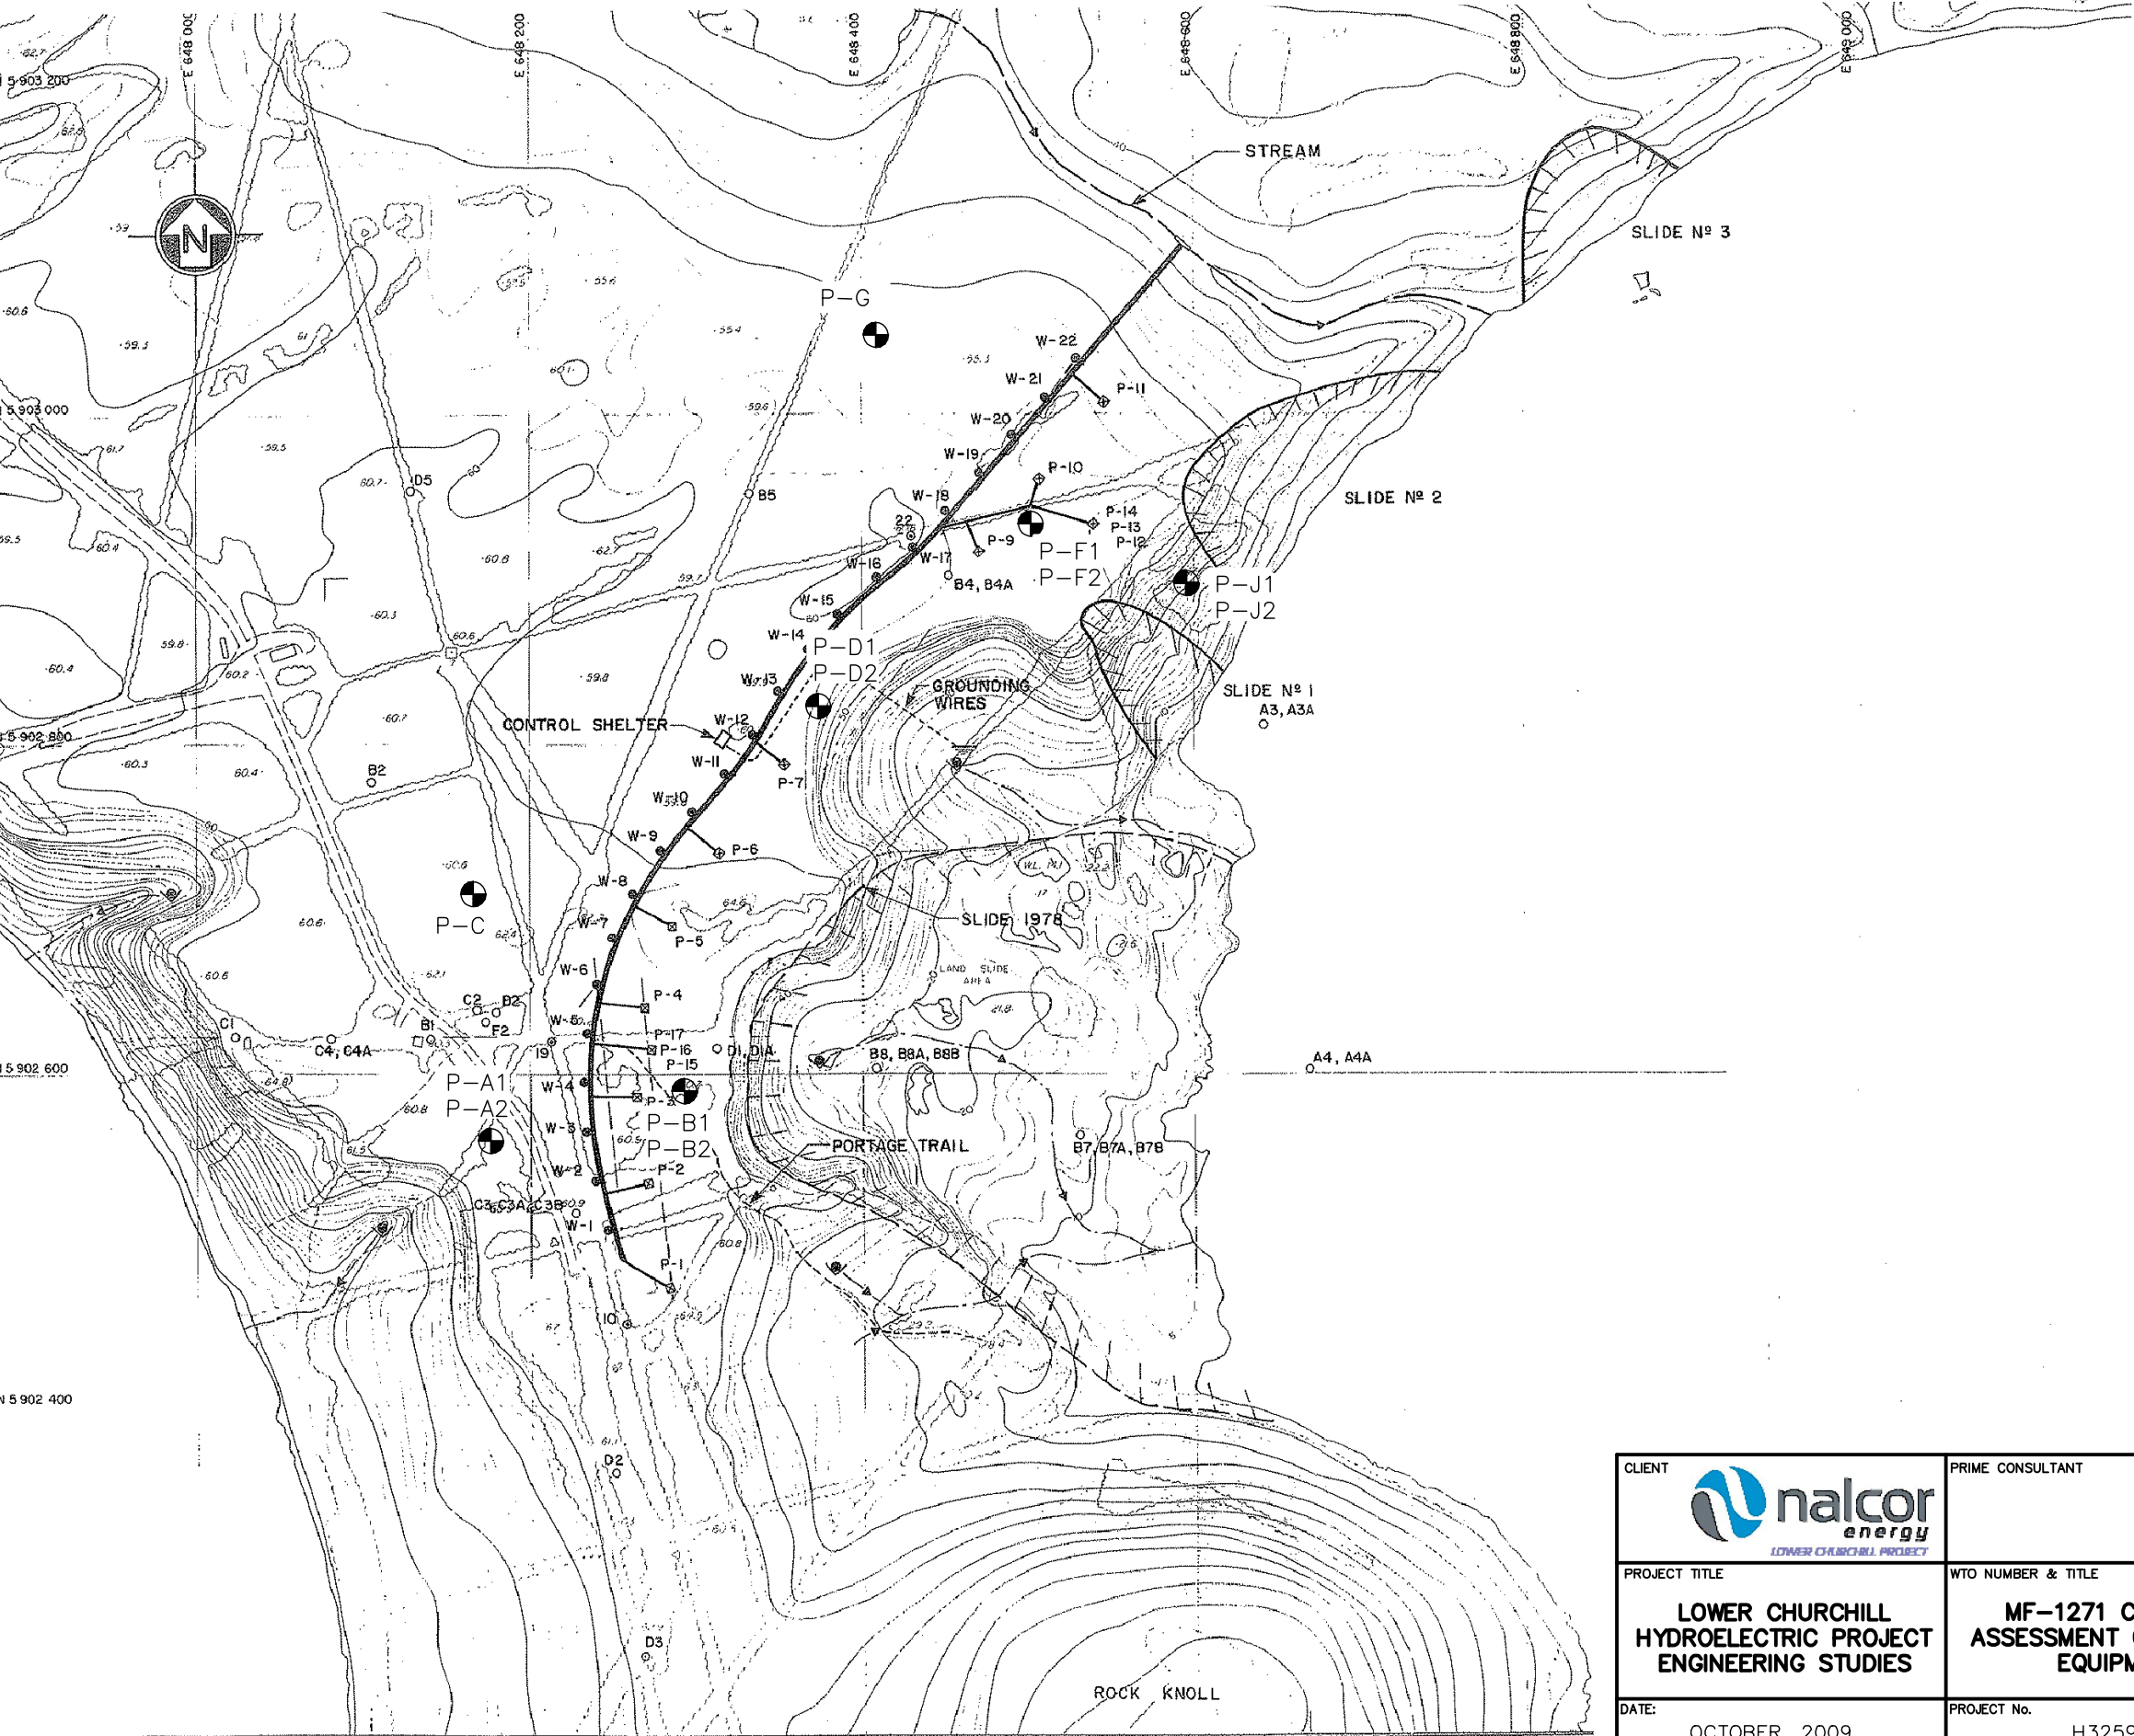
PROJECT TITLE LOWER CHURCHILL HYDROELECTRIC PROJECT ENGINEERING STUDIES		WTO NUMBER & TITLE MF-1271 CONDITION ASSESSMENT OF EXISTING EQUIPMENT	DRAWING TITLE SITE LOCATION PLAN
DATE: OCTOBER, 2009		PROJECT No. H325967	DRAWING No. FIGURE 1

The site of Muskrat Falls (Figure 1, Appendix C) on the Lower Churchill River, located about 30 km upstream from HVGB in Labrador, has been recognized as a potential hydroelectric development for several decades. At this site, the Churchill River has a drop of about 15 m from el 18 m at the upstream side to el 3 m at the downstream side. Past studies contemplated raising the head to about 40 m.

The well inspection program commenced on August 27 and was completed on September 7, 2009. Figure 1 in Appendix C shows the location and configuration of the well system.

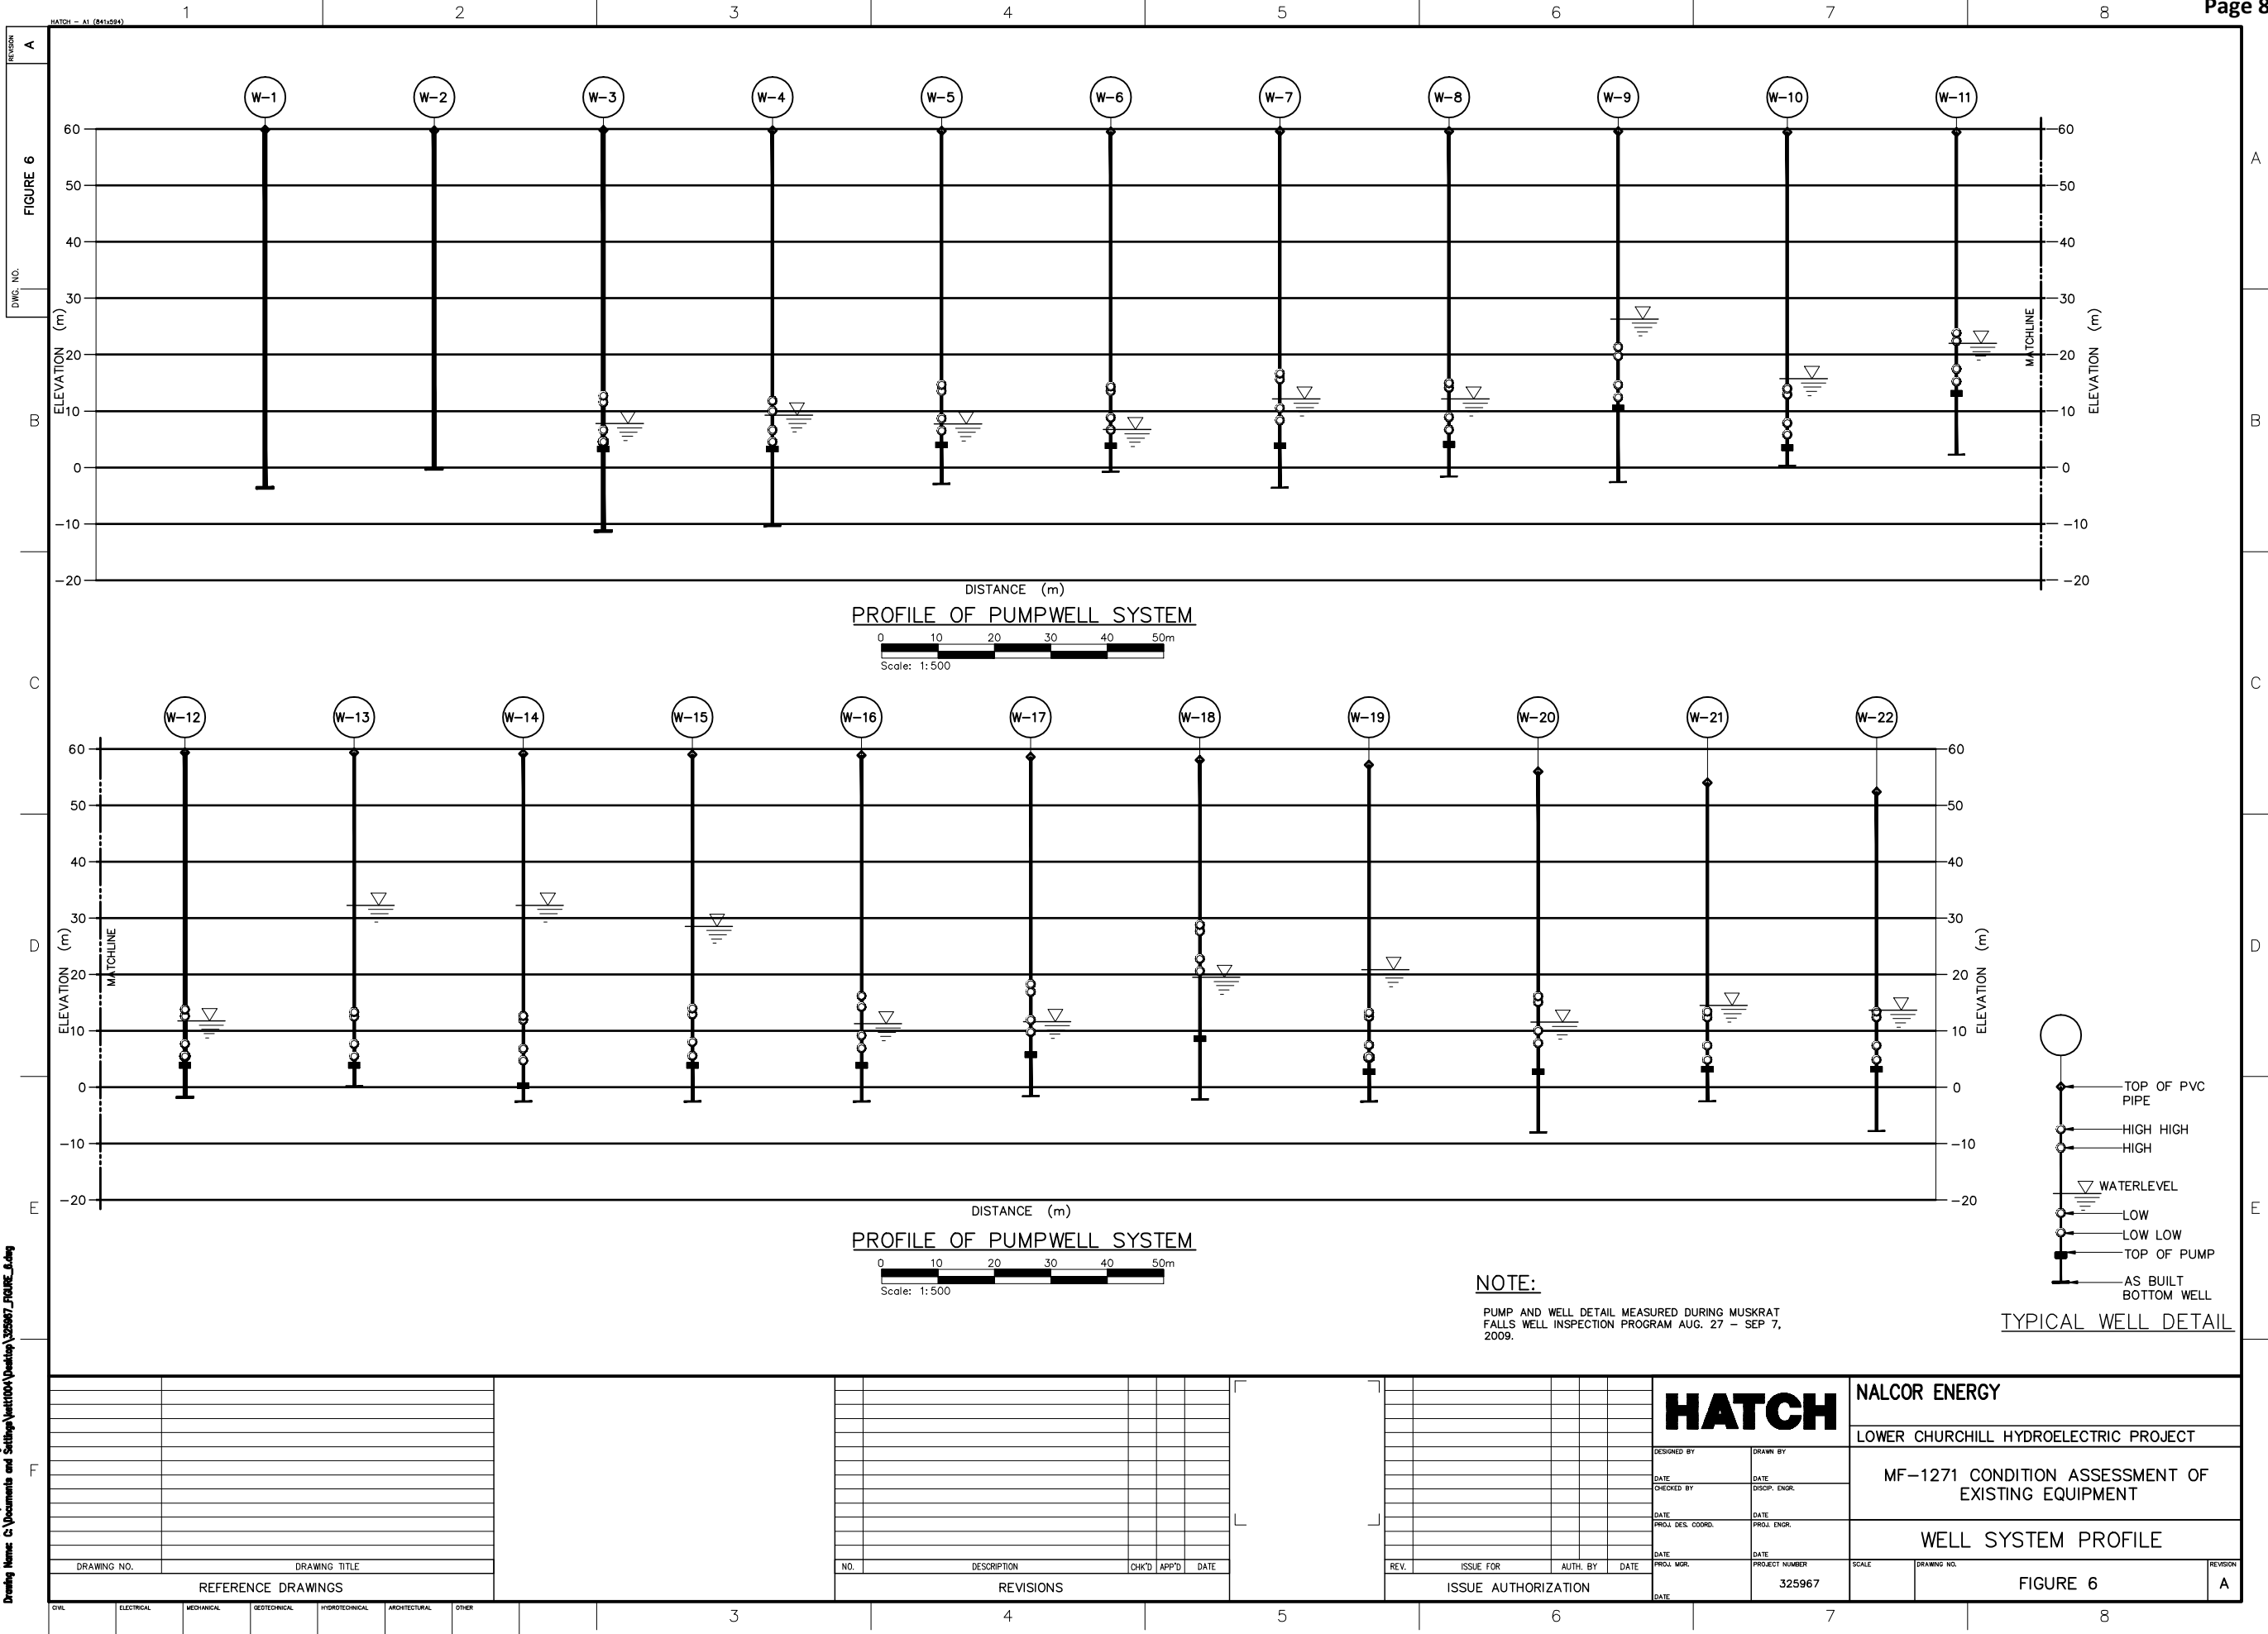
The process was documented and photographs taken of the equipment for each well. Table 3-3, Pump and Sensor Details, records the measurements of each well system (depth, water level, depth to each sensor, model number of pump). Figure 6 is a profile of the well system, based on measurements taken and included in Table 3-3.
