**LOWER CHURCHILL PROJECT**

**MUSKRAT FALLS NORTH SPUR**

**Technical Note**

**Muskrat Falls North Spur - 1999 to 2011**

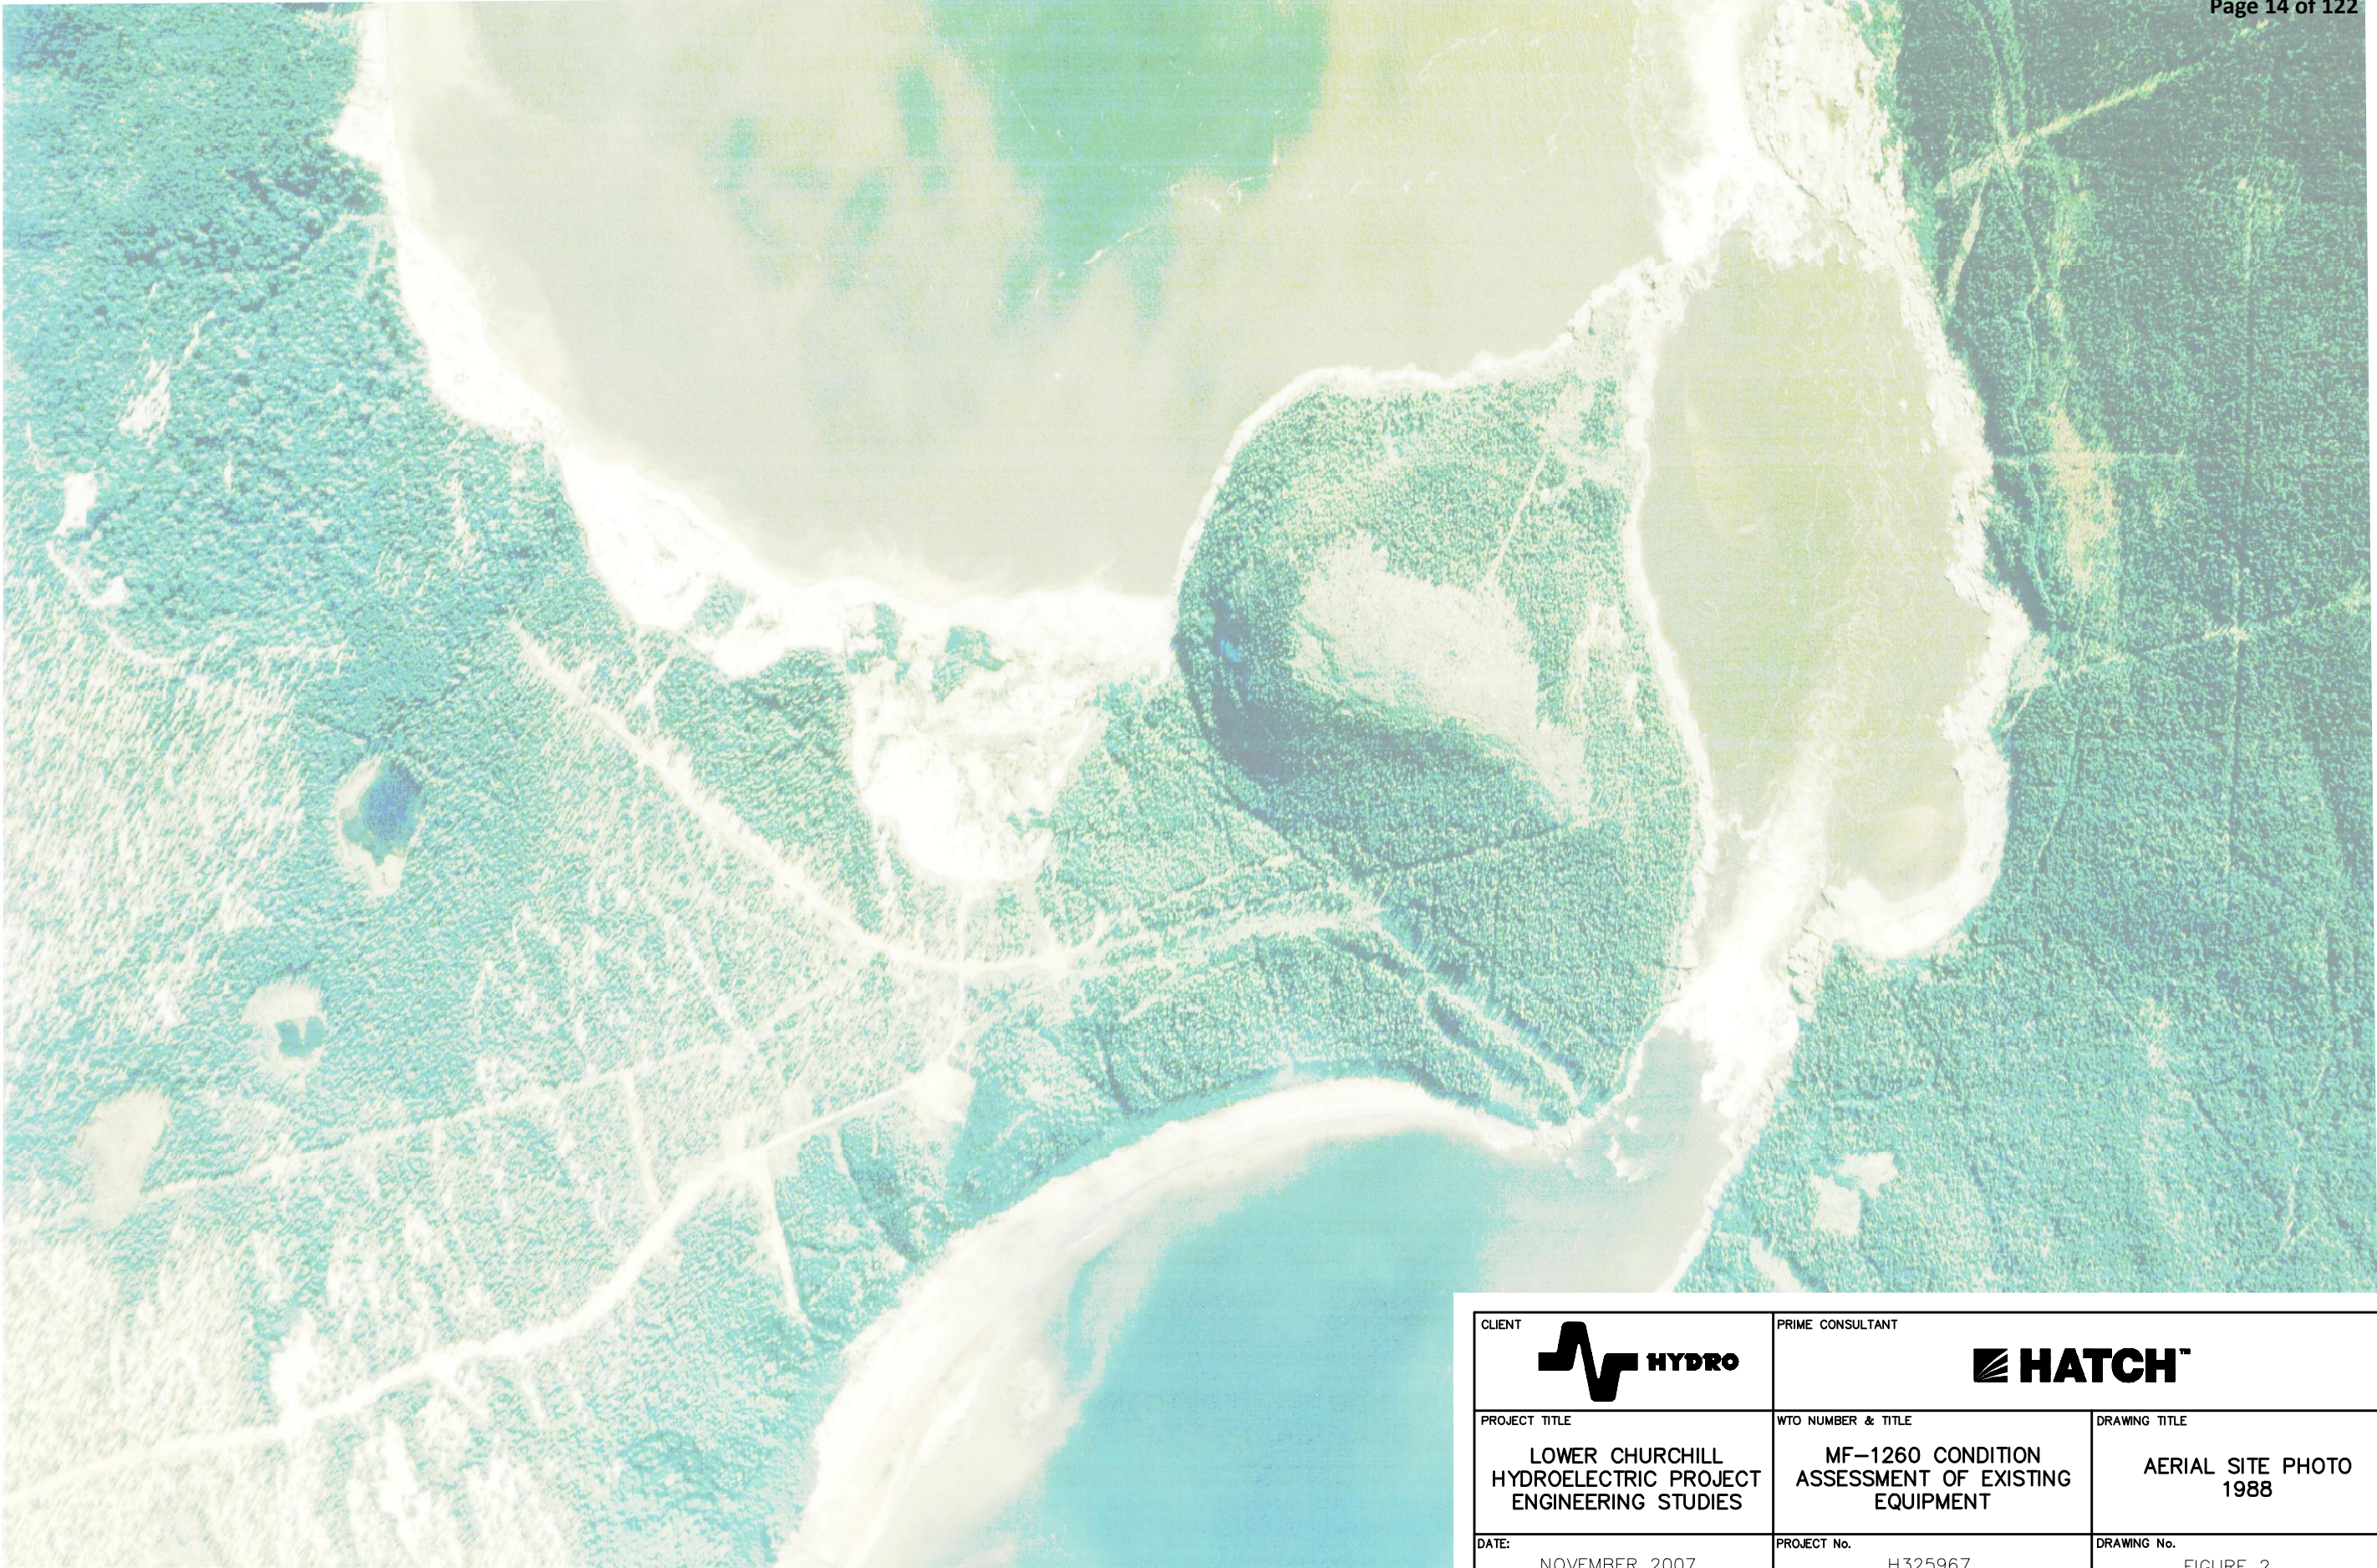
PROJECT TITLE LOWER CHURCHILL HYDROELECTRIC PROJECT ENGINEERING STUDIES		WTO NUMBER & TITLE MF-1260 CONDITION ASSESSMENT OF EXISTING EQUIPMENT	DRAWING TITLE AERIAL SITE PHOTO 1988
DATE: NOVEMBER 2007		PROJECT No. H325967	DRAWING No. FIGURE 2

The banks of the Churchill River between Gull Island and Goose Bay are scarred by numerous landslides, some of which involve large quantities of overburden. Figure 2 shows an aerial site photo taken in 1988. A common characteristic of these slides, including those located inland, is that they are adjacent to a watercourse. In some instances where the failed mass has been transported by the erosive influence of water, as is the case on the downstream face of the spur, the scars left behind are rather steep. The destructive effect of erosion is most evident in the riverbed immediately downstream from the rapids. Erosion here is extensive and is caused by eddy currents emerging below the falls. Soundings indicate the presence of a local depression in the riverbed of the order of 70 m below river level adjacent to the rock knoll.

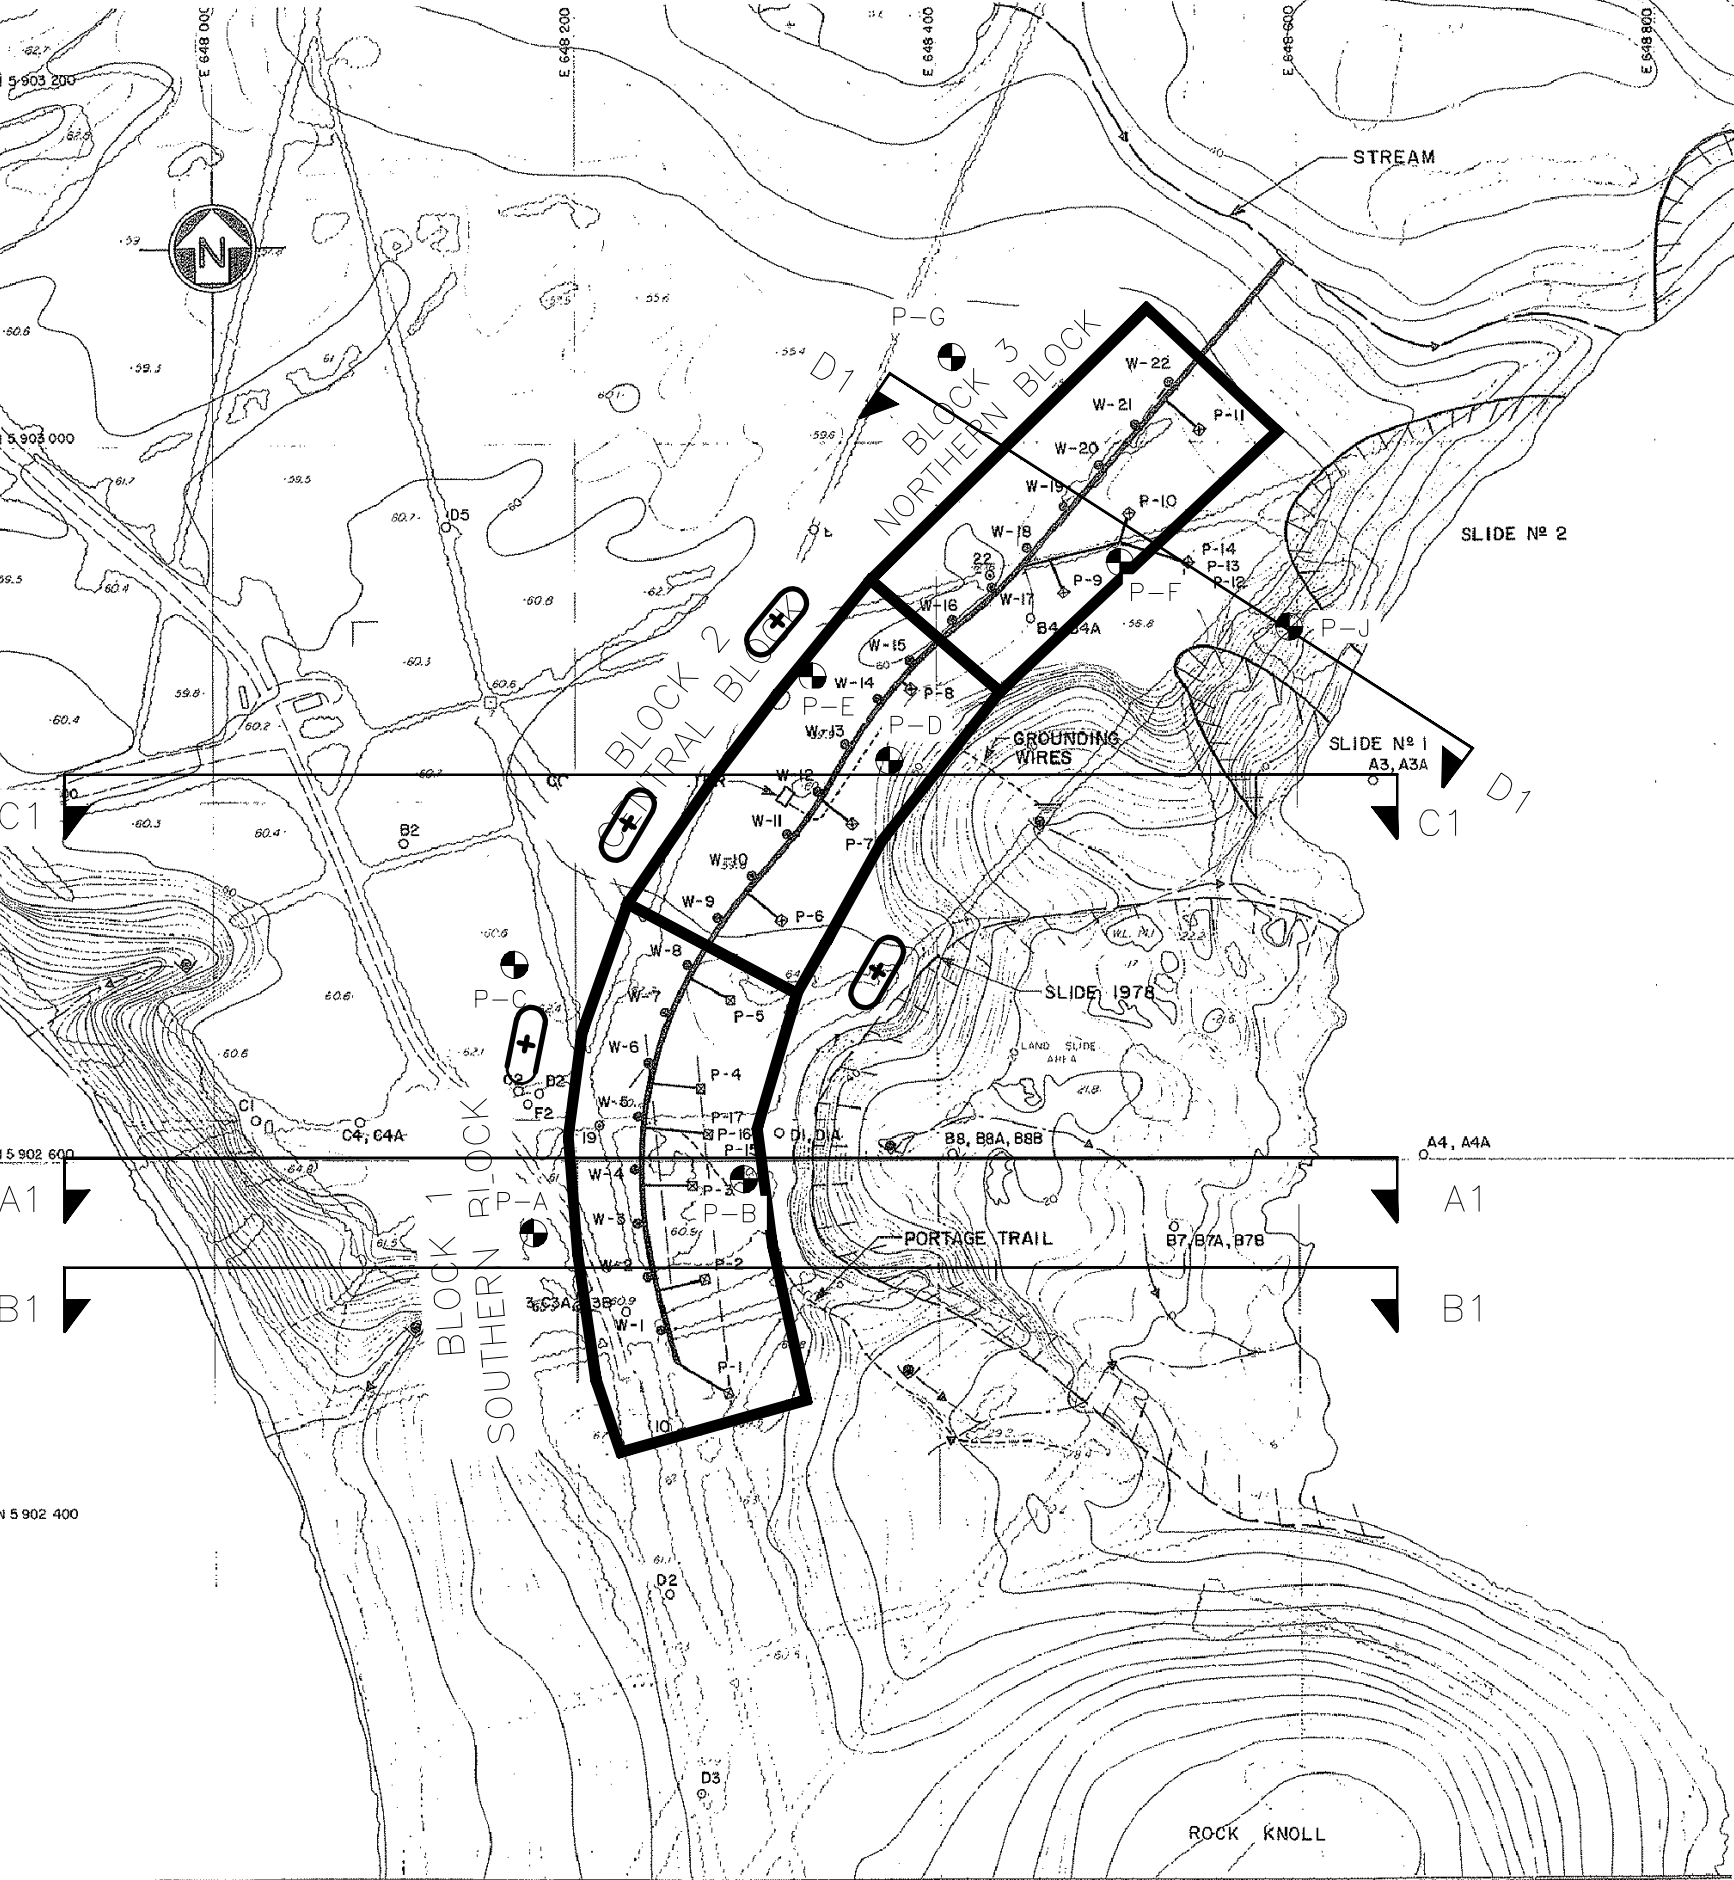
CLIENT 	PRIME CONSULTANT 	
PROJECT TITLE LOWER CHURCHILL HYDROELECTRIC PROJECT ENGINEERING STUDIES	WTO NUMBER & TITLE MF-1260 CONDITION ASSESSMENT OF EXISTING EQUIPMENT	DRAWING TITLE ORIGINAL BLOCK TEST PLAN
DATE: NOVEMBER 2007	PROJECT No. H325967	DRAWING No. FIGURE 4

Initially, it was intended to divide the wells into three main blocks as shown in Figure 4. These test blocks were to consist of the following wells and piezometers:

- In order to develop a more complete understanding of the phreatic surface and to assist in the creation of hydrogeological cross sections, such as those presented in Section 4.4, and in other sections to be developed in the future, it is suggested to install 4 new double standpipe piezometers. It is estimated that this will cost in the order of \$120,000 plus engineering and management fees (Details are provided in Appendix E). The locations of the new piezometers are suggested as follows as shown in Figure 4:

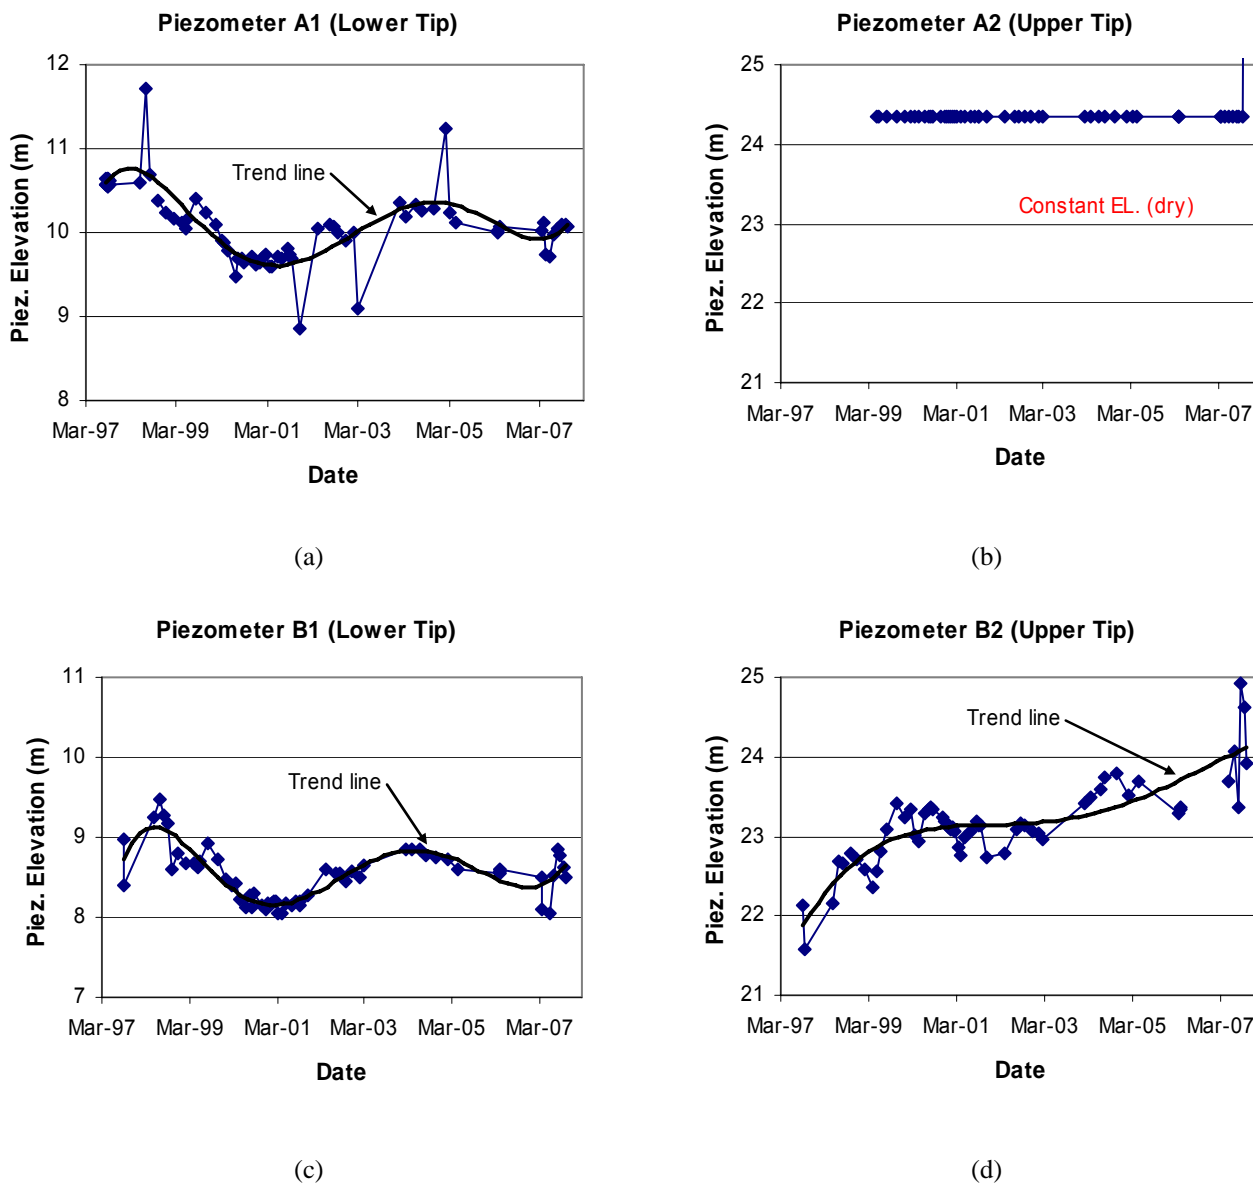
Figures 7 to 10 plot the variation of piezometer water elevation for the last 10 years. Out of 12 observed tips, the readings of four tips are not consistent with the other installations or historic data. These are: P-A2, P-B2, P-C, and P-D2. In the piezometers which have two tips, the suffixes 1 and 2 refer to lower and higher tips, respectively.

Figure 7 - Piezometer water level variations from 1997 to 2007: (a) P-A1 lower tip, (b) P-A2 upper tip, (c) P-B1 lower tip, (d) P-B2 upper tip

Comparing the variation of the upstream water levels (showing highest in 1999 and lowest in 2003) with the variation of piezometers P-A , P-B, and P-D, Figures 7 and 8 (which have their lowest elevation in 2001 and the highest value in 2004/5) , it can be concluded that there is no clear correlation between upstream river water level variation and the piezometric elevations.

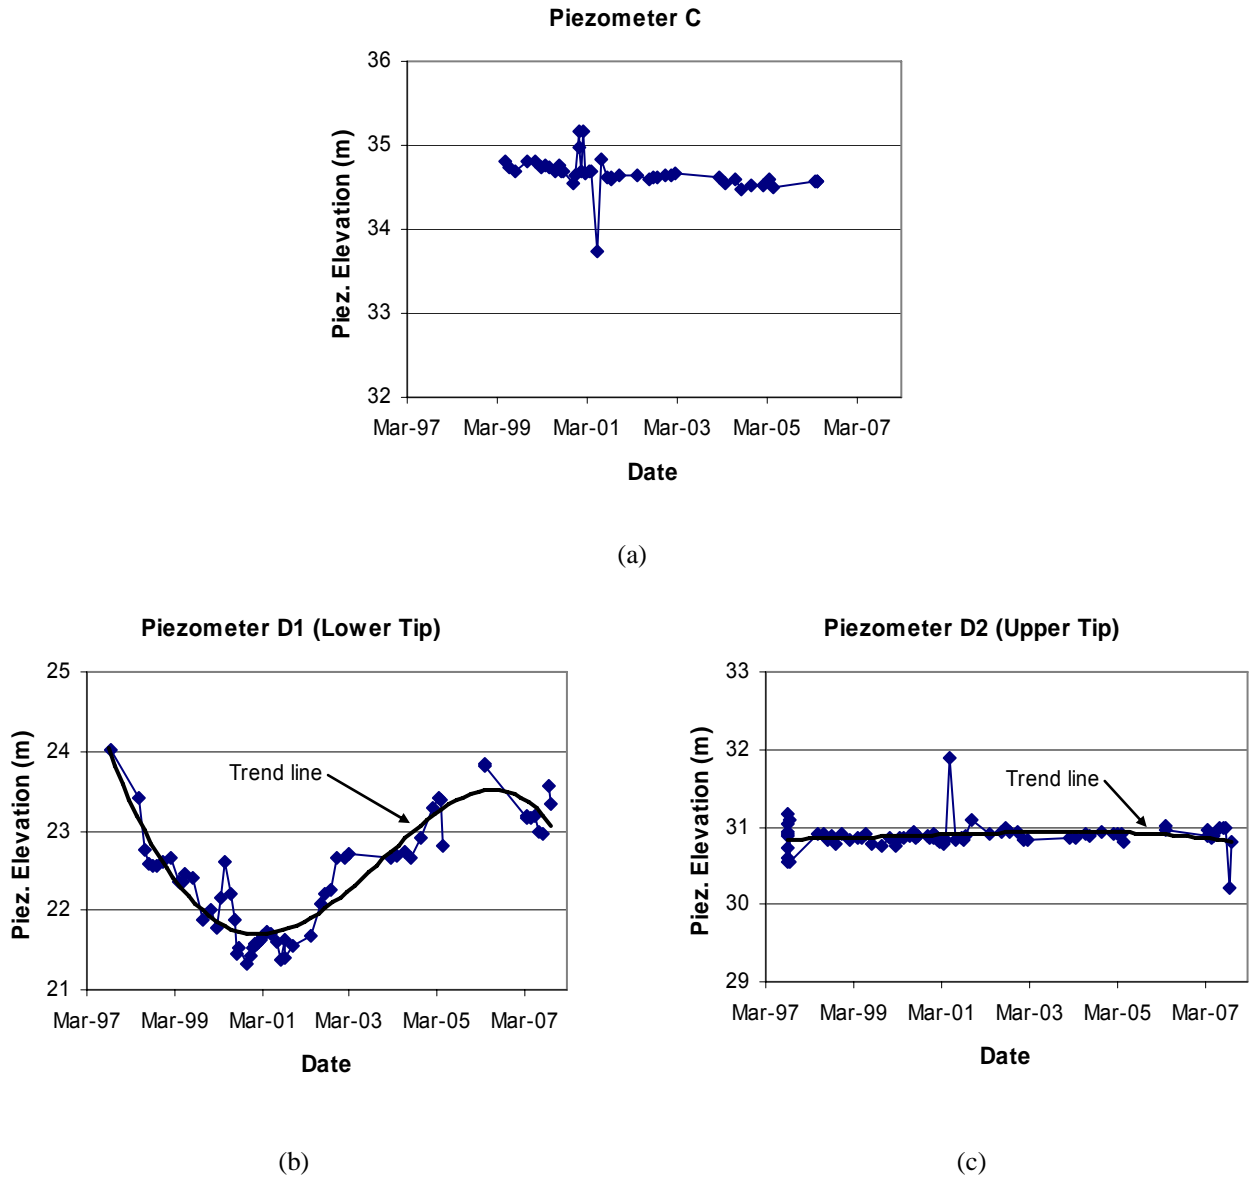
Figure 8 - Piezometer water level variations from 1997 to 2007: (a) P-C, (b) P-D1 upper tip, (c) P-D2 lower tip

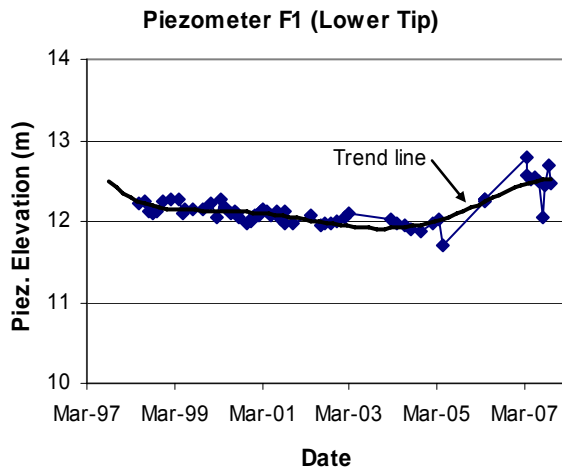
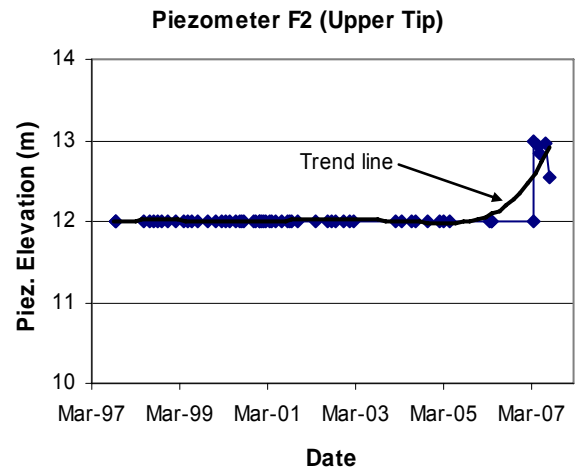
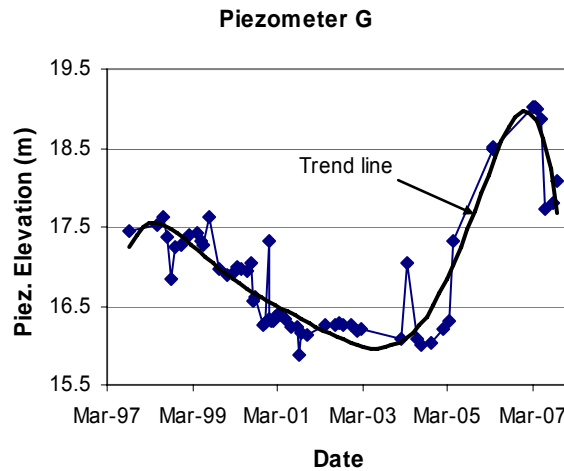
The piezometer readings in P-F, P-G, and P-J indicate that the water levels had already risen as a result of the first day shutdown and had not recovered to the undisturbed situation. The information gathered from these piezometers is plotted and presented in Appendix B; however, little variation was noted on the last day.

Figure 9 - Piezometer water level variations from 1997 to 2007: (a) P-F1 lower tip, (b) P-F2 upper tip, (c) P-G

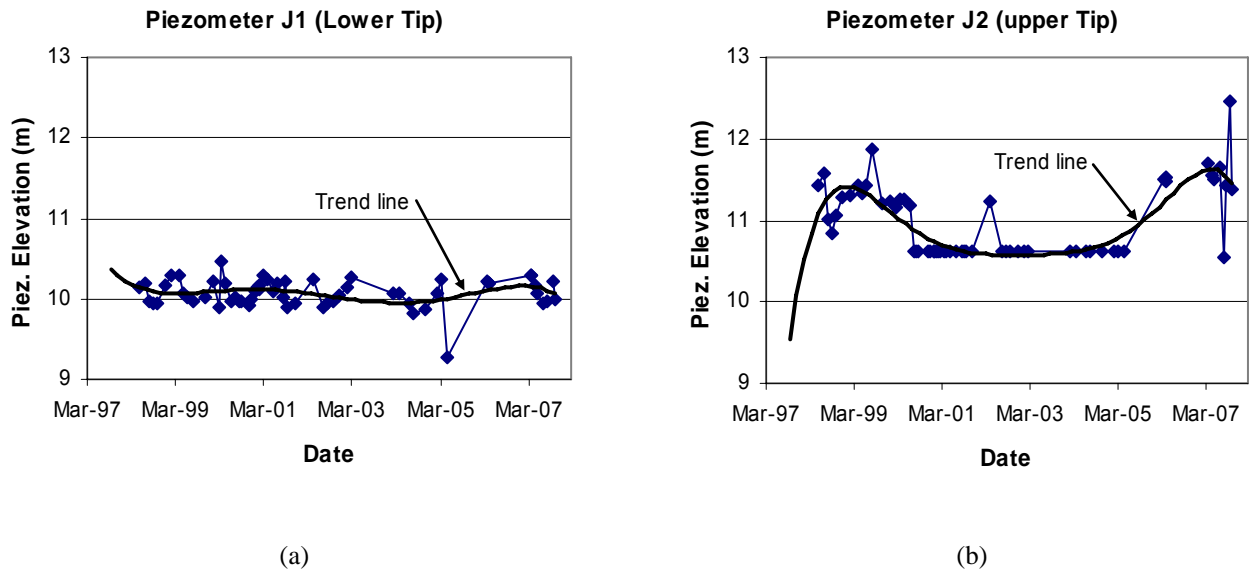
- P-J1 shows an approximately constant level of el 10 m. In March 2007, this tip showed the highest elevation of el 10.3.
- P-J2, which is the higher tip, was dry from 2000 to March 2005. From April 2006, the piezometer showed an increase in water elevation of about 0.9 m. In March 2007, this value was equal to el 11.70 m and in September 2007, it was el 11.54 m. In August 2007, the water level was reported as el 14.95 m, which may not be correct and was eliminated from the figure.

- Similar to the two tips of P-F, the two piezometer tips (P-J1 and P-J2) show approximately the same value or a slightly downward gradient.

Figure 10 - Piezometer water level variation from 1997 to 2007: (a) P-J1 lower tip, (b) P-J2 upper tip

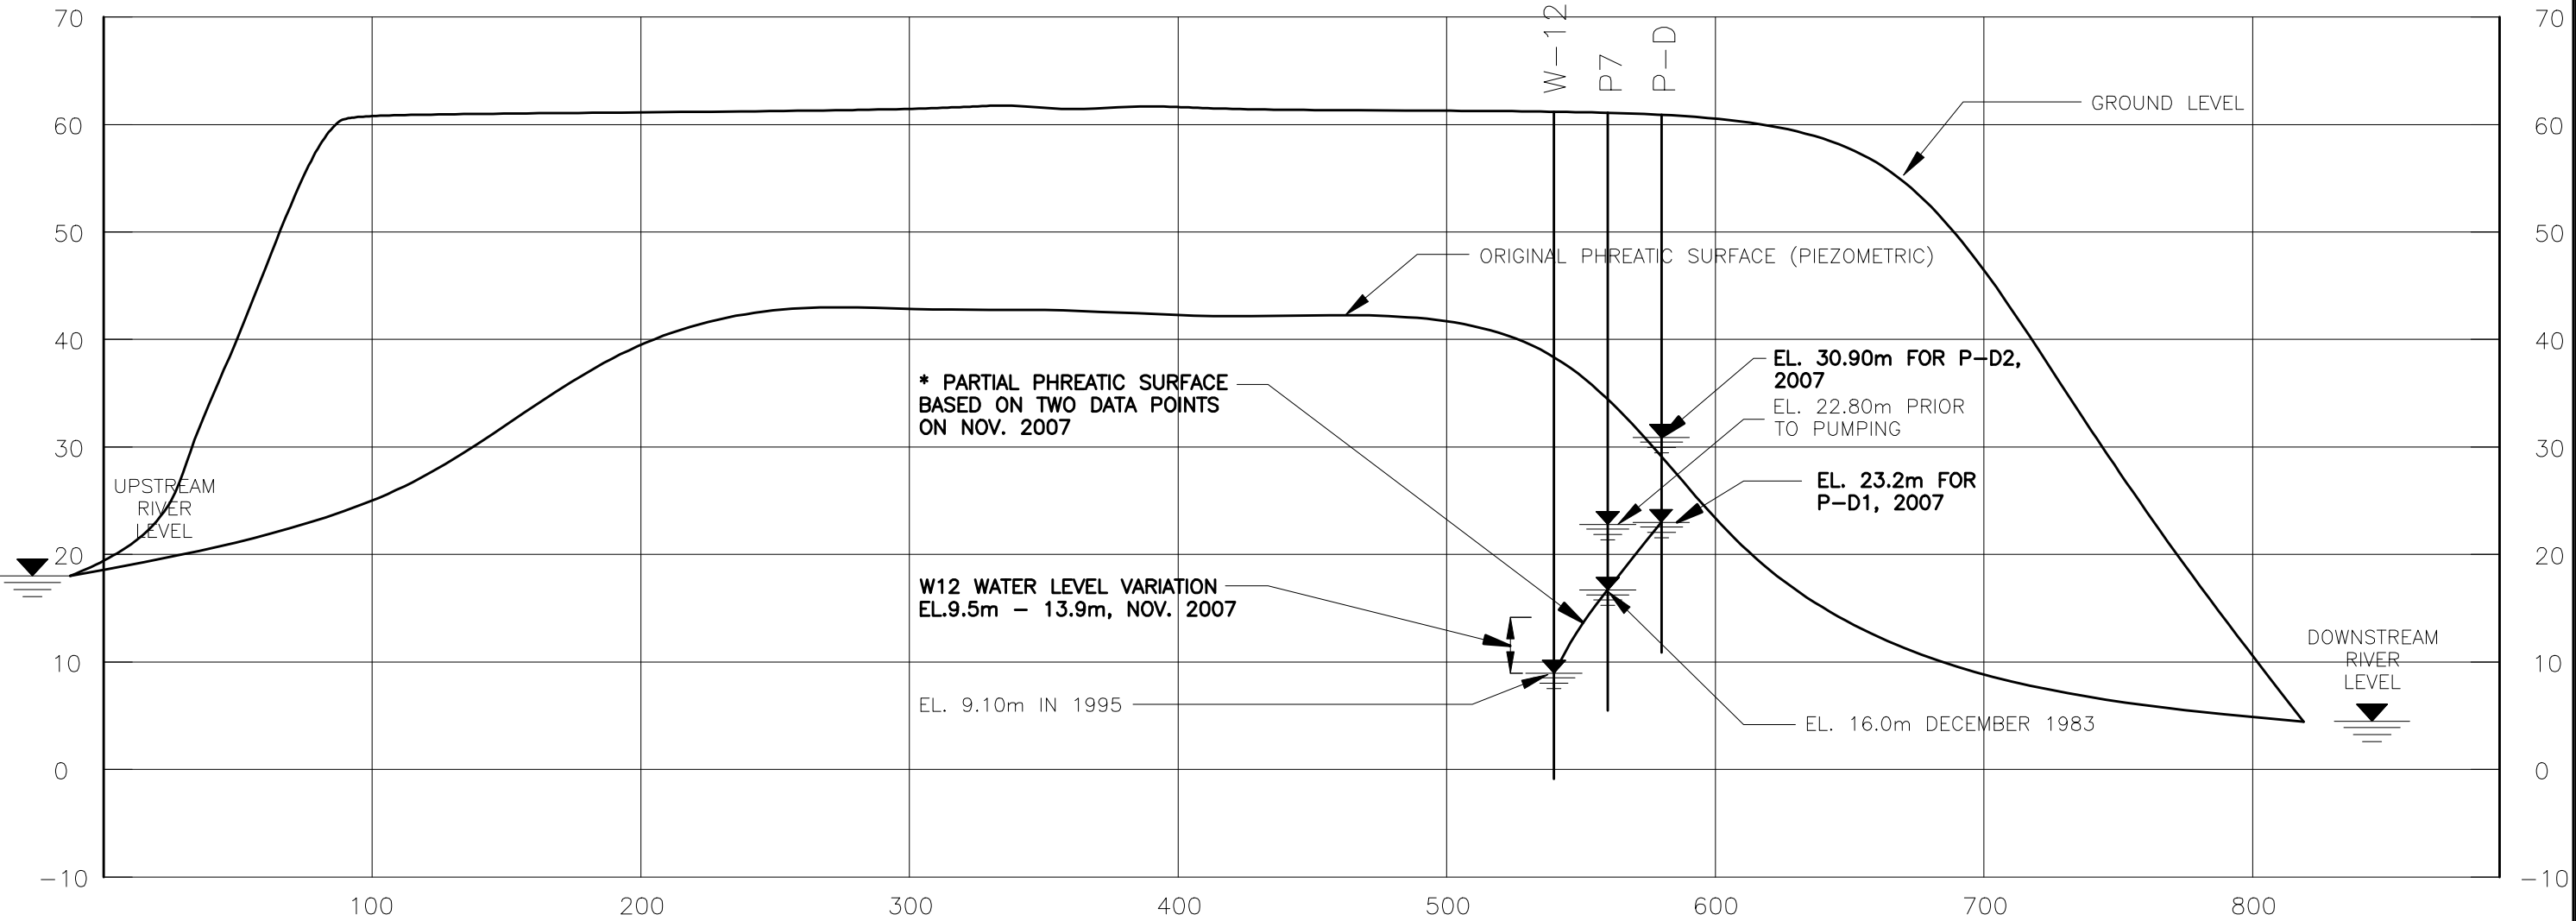
# SECTION C1-C1

This cross section passes through W-12 and P-D and former piezometer, P-7, illustrated in Figure 13. Similar to Section B1-B1, the original water table is plotted on this section based on the SNC-Lavalin report. The reported values for P7 show that the water level decreased from el 22.8 to el 16.7 in Dec 1983. However, the original levels of P7 are not consistent with those derived from the phreatic surface for the intermediate aquifer.

NOTE:  
1. DRAWING THE CURRENT PHREATIC SURFACE IS NOT PRACTICAL WITH ONLY TWO DATA POINTS.  
2. ELEVATION IN P-D IS SIGNIFICANTLY HIGH.

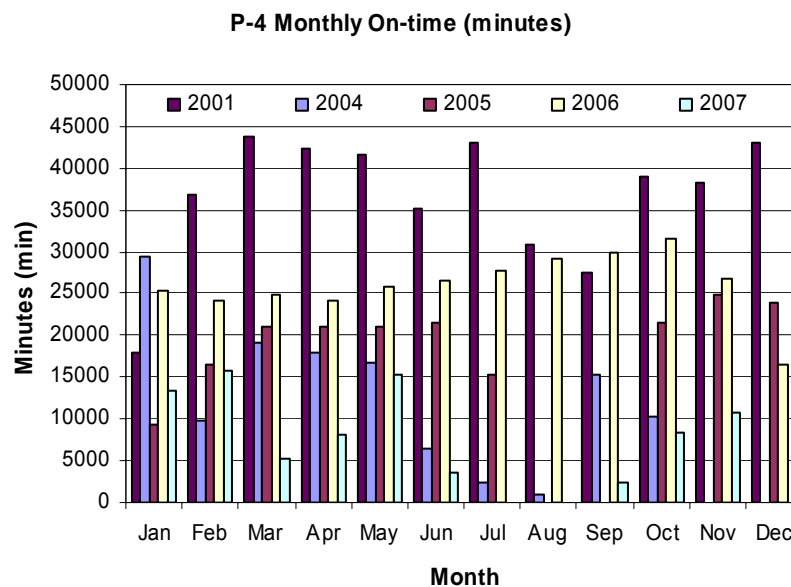
Figure 18 demonstrates the total monthly on-time for pump no.4 for the last four years (2004 to 2007) as well as a randomly chosen year, 2001, for comparison purposes. This figure shows that the data are usually well recorded for the first six months of each year. The pump experienced its most active year of the four in 2006; however, the values are significantly lower than in 2001. The pump P-4 in well W-4 was changed in September 2007, and the recorded values show that there is a significant decrease in the on-time Oct and Nov 2007 when compared with Oct and Nov 2004 to 2006. The relatively high on-time throughout 2006 suggests that the pump was not performing satisfactorily during this year, as the well water inflow to the well could not be evacuated fast enough. As a result, pump on-time data might be a useful tool for the purpose of system maintenance. The decreased on-time values in the recent years in comparison to 2001 suggest that P-4 has become less active which should be considered carefully.

**Figure 18 - Monthly on-time for pump no. 4 (P-4)**

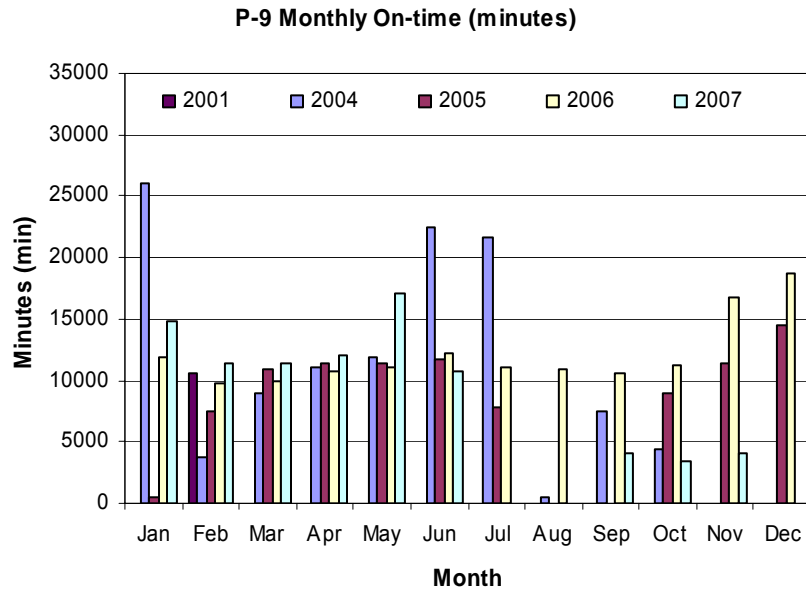
Figure 19 plots the activity of pump no.9 for the years of 2004 to 2007 and also 2001. This shows that the pump on-time is significantly lower than that of pump no.4. The activities in the recent years have not changed meaningfully from 2001.

**Figure 19 - Monthly on-time for pump no. 9 (P-9)**

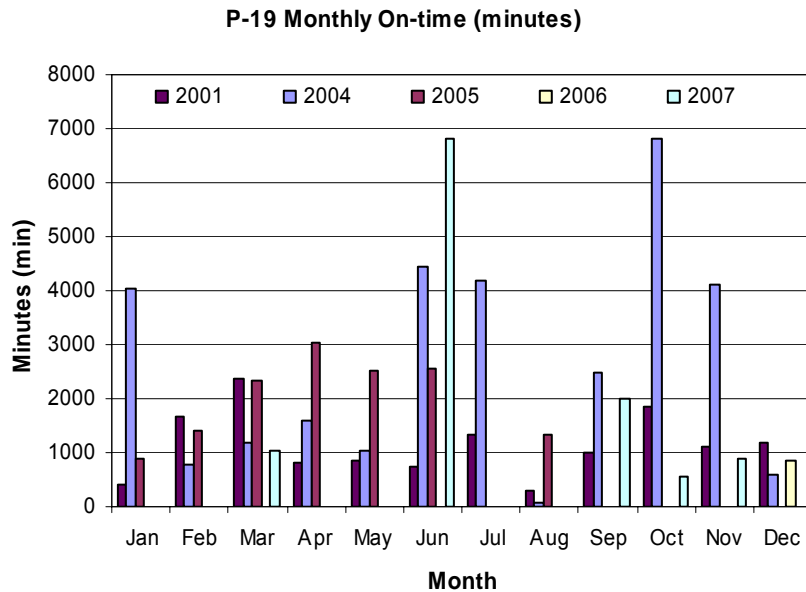
Figure 20 shows the on-time for pump no. 19. This figure suggests that the pump is generally inactive for years after 2005. This pump is located in the northern block where the water table level has significantly increased in the years after 2005.

**Figure 20 - Monthly on-time for pump no. 19 (P-19)**

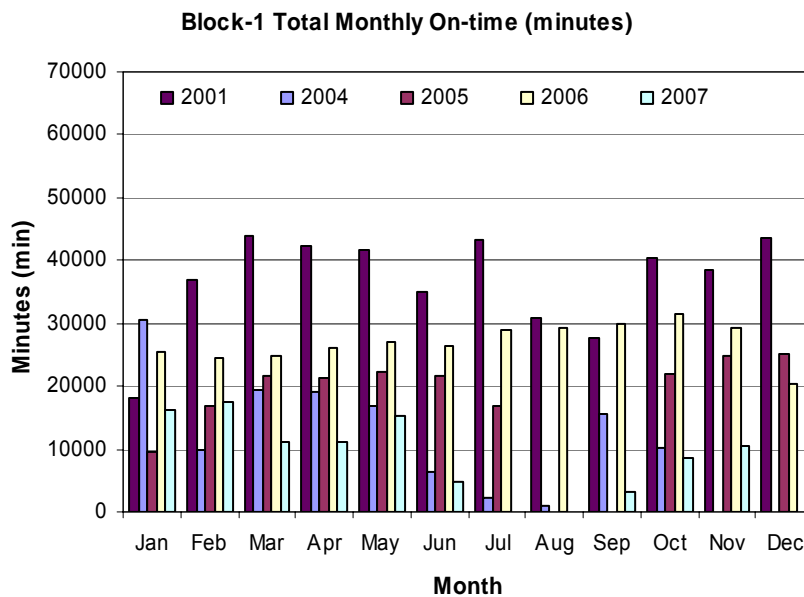
Figure 21 depicts the total monthly on-time for the block 1 (Southern Block). The block experienced its most active time during year 2006, as a result of high pump no.4 activity; however, the on-time values are much less than the year of 2001.

**Figure 21 - Total monthly on-time for Block-1 (Southern Block)**

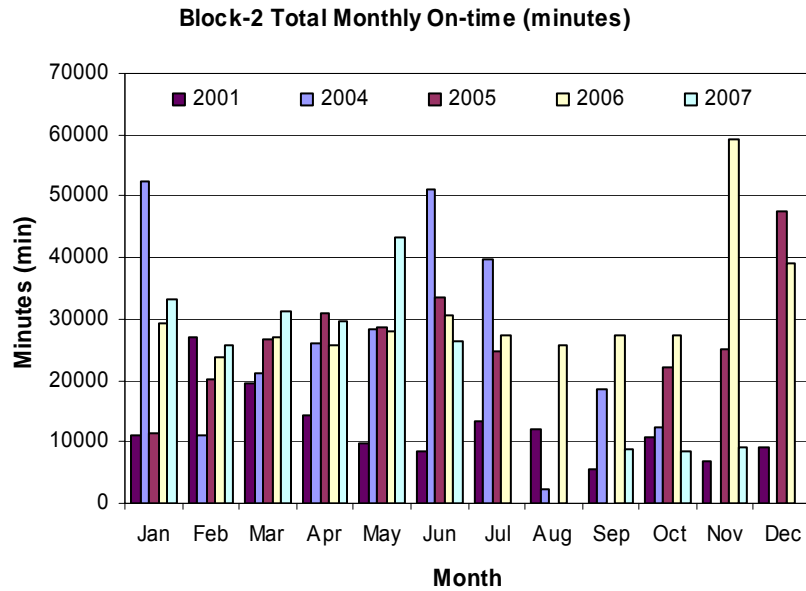
Figure 22 also shows that Block-2 (Central Block) had its most active month in November 2006.

**Figure 22 - Total monthly on-time for Block-2 (Central Block)**

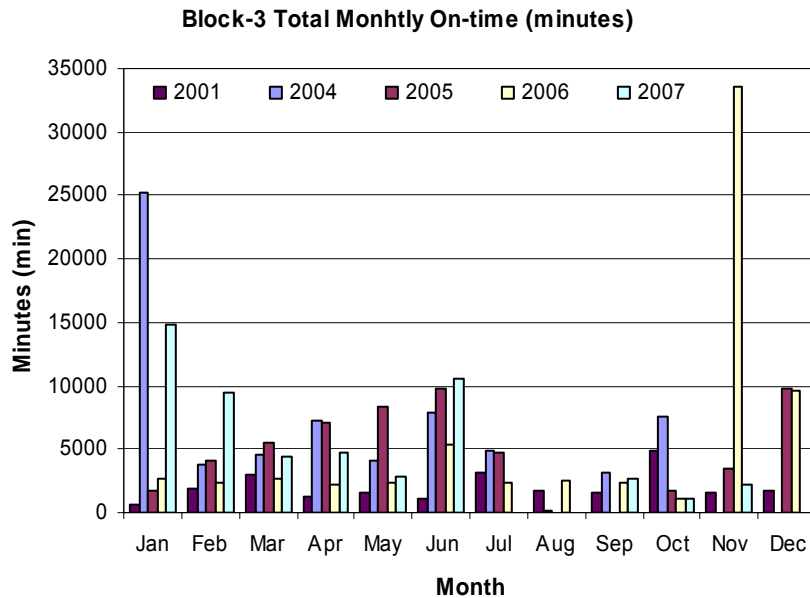
Figure 23 confirms that Block-3 (Northern Block) is generally much less active than the other two blocks. The two monthly on-time values, Jan 2004 and Nov 2006, are significantly higher than the other years. This might be the result of inconsistent recordings of some on-time activities.

**Figure 23 - Total monthly on-time for Block-3 (Northern Block)**

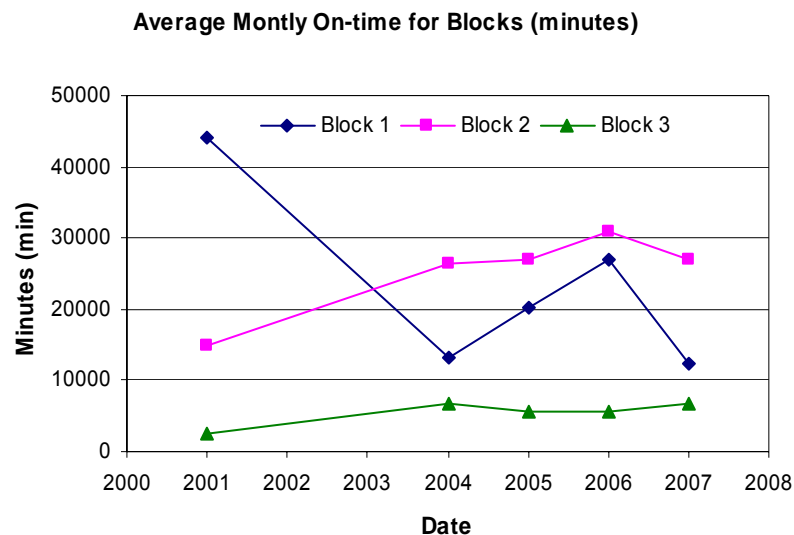
Figure 24 shows the average monthly on-time for different blocks for the last four years. This figure shows that Block-2 (Central Block) is the most active block in the recent years followed by Block-1. While the on-time of Block-3 has been almost constant over the years, the other two blocks experienced the most active years in 2006 (other than 2001).

Figure 24 - Average monthly on-time for different blocks

- Considering all the uncertainties in the dewatering system data recording and transmission as mentioned in Section 4.6, historical pump operation data indicates that the pumps in the northern block are generally inactive (Figure 24). The average monthly on-time of the northern block is significantly lower than the other two blocks. This observation is to be compared within an observed rise in groundwater levels in piezometers within this block. Despite the increase in the on-time hours in recent years in comparison to 2001, it is clear that pumping in the north block is inefficient.

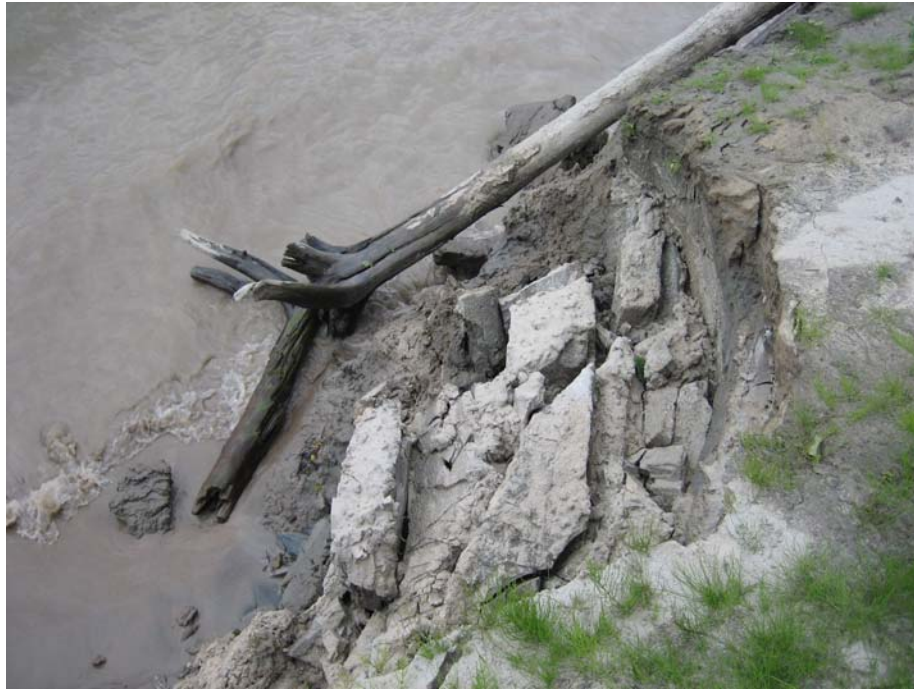
- Ongoing erosion and sloughing and active springs exist at the downstream toe of the spur.
- The upstream toe was also inspected and no significant erosion was observed.
- Access to the discharge point of the well system was difficult as the area was very overgrown.

**Erosion at downstream slope toe (Site Visit -1)**

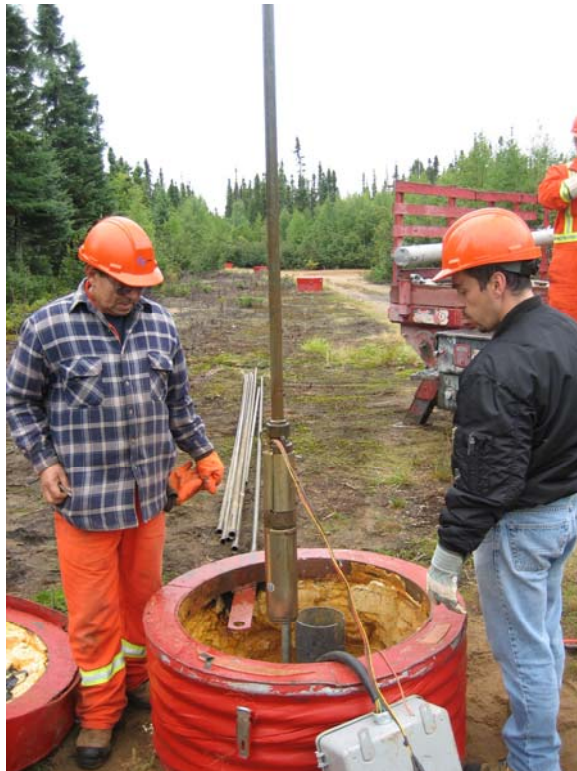
- During the site visit, the existing pump in W-4 was removed and a new pump was installed by Hydro. The replacement started about 10 am (September 11) and the system returned back to operation around 1 pm.
- Silt and fine sand were produced from W4 (observed in discharged water, the pump riser, and the pump) which may have intensified after 4 months of operation with a weaker pump (0.5 hp pump instead of 1.5 hp).
- The discharge from W4 has been reduced significantly as a result of a weaker pump.
- Silt and fine sand were also produced in Wells 9 and 10.

Acres (1994) reported that W-4 is responsible for up to 85% of the total dewatering activity. During the first site visit, it was noted that the pump motor installed in W-4 for several months prior to the visit had a capacity of 0.5 hp. During the site visit, this motor was replaced with a 1.5 hp unit. Shortly after replacement of this pump and system restoration, the pump in W-3 went offline, while on the first day, in addition to the pump in W-4 being in operation, the pump in W-3 was also continuously operational. It is important to mention that after system restoration, W-4 also did not operate continuously. This is taken to mean that W-3, or other wells in the vicinity, can not act as a sufficient substitute for W-4 due to either high transmissivity in W-4 or low transmissivity in other adjacent wells, unless sufficient pump capacity exists in all pumps.

**Pull-out of the pump in W4 (Site Visit -1)**

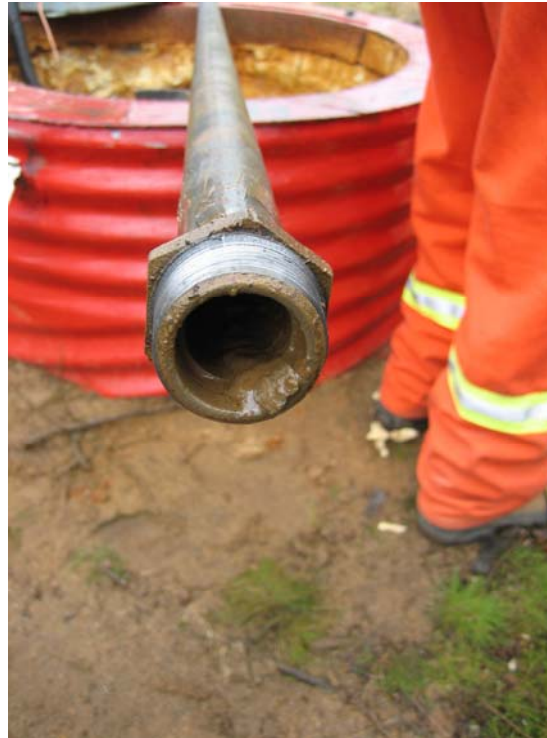
**Silt and fines in W4 riser pipe (Site Visit -1)**

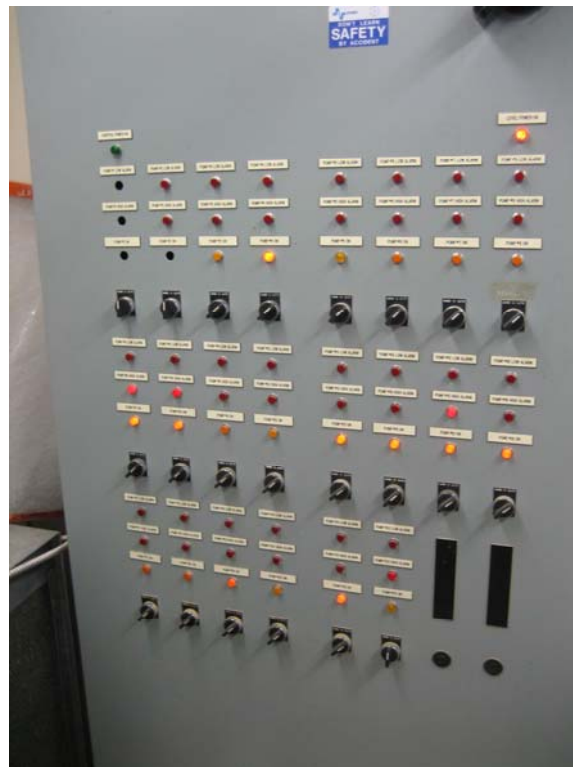
- The telephone operating via the Hawk 2 VHF radio had heavy static and was unable to transmit a call.
- W-10 relay underwent approximately 10 minutes of continuous switching between operating and high level alarms after power returned to the control panel (subsequent to system shutdown during W-4 replacement).

Control panel after system restoration (Site Visit -1)

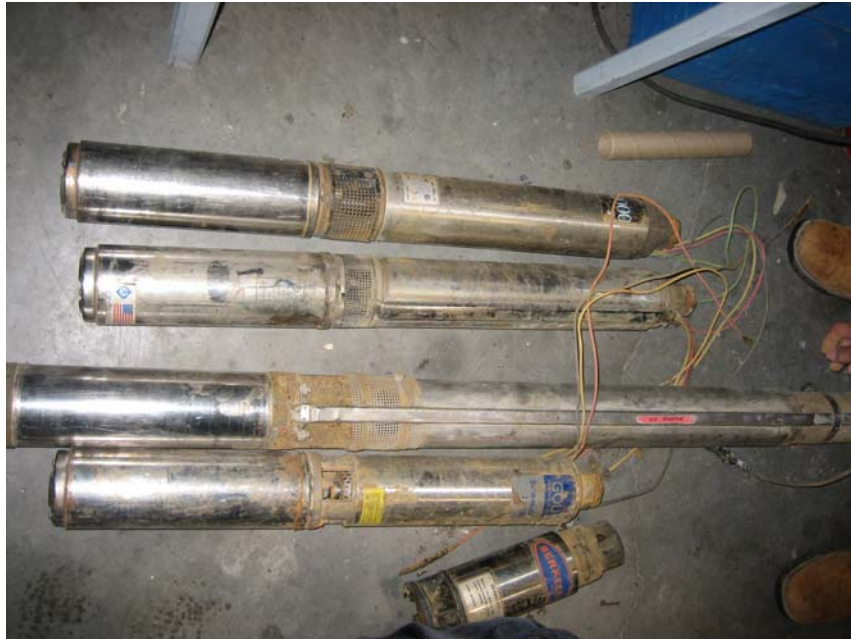
**Decommissioned pumps (Site Visit -1)**
