**LOWER CHURCHILL PROJECT**

**MUSKRAT FALLS NORTH SPUR**

**Technical Note**

**Muskrat Falls North Spur - 1999 to 2011**

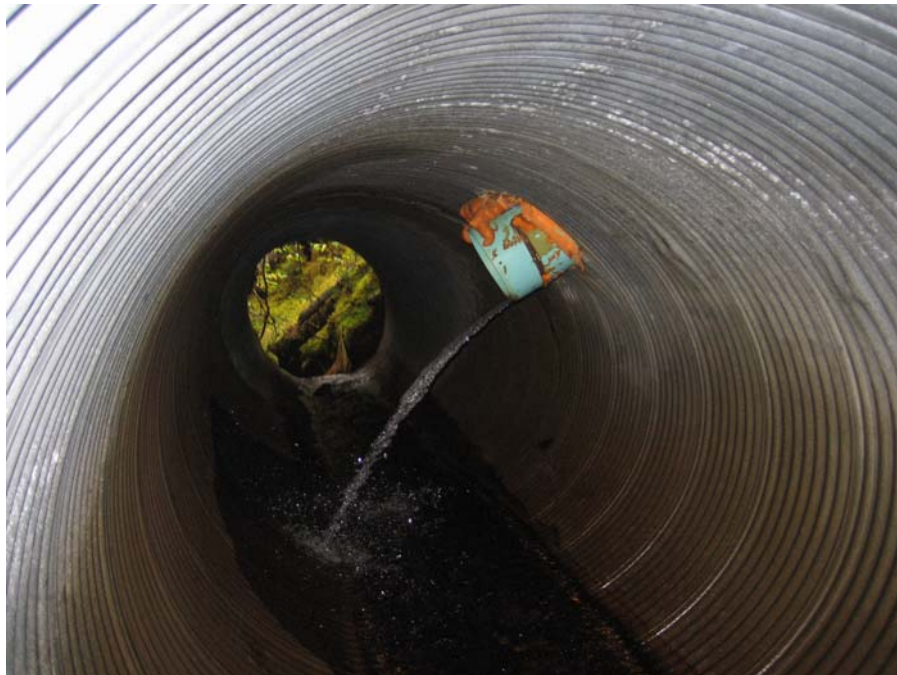
**Discharge water from outfall pipe (Site Visit -1)**

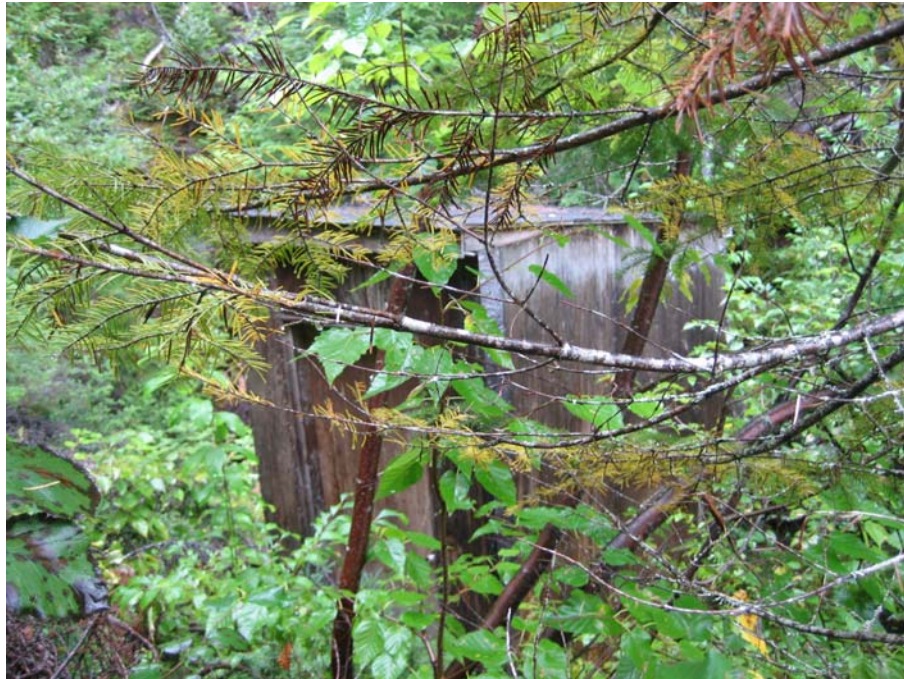
**Shelter room at water outfall (Site Visit -1)**

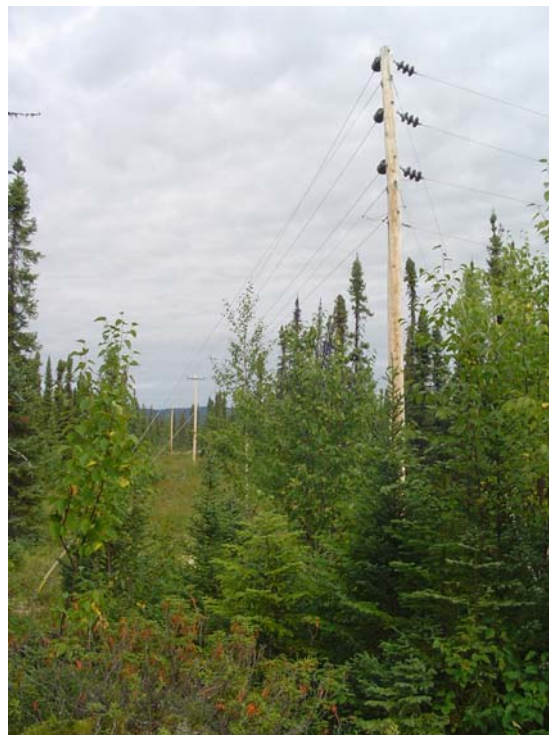
**25kV Power to Control Shelter (Site Visit -1)**

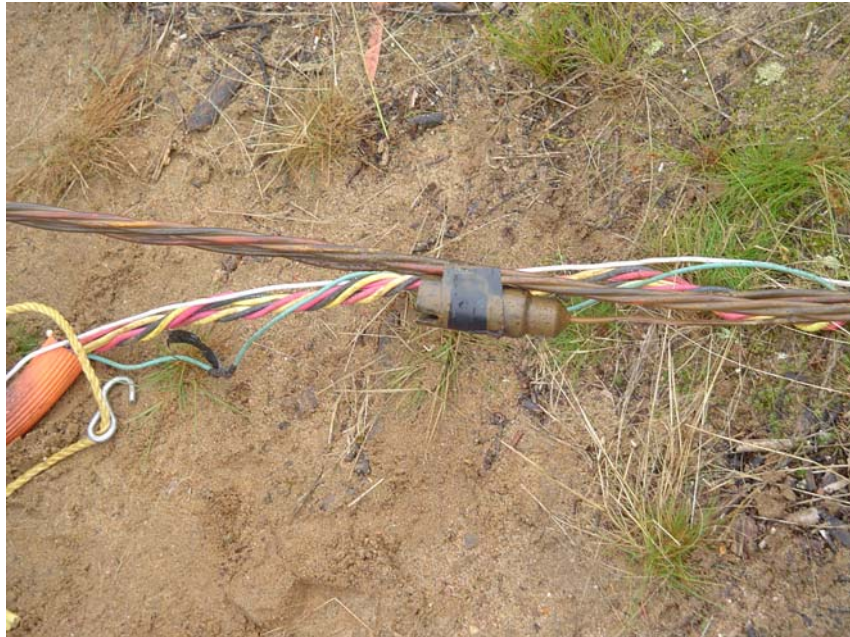
**Level Electrode removed from W4 (Site Visit -1)**

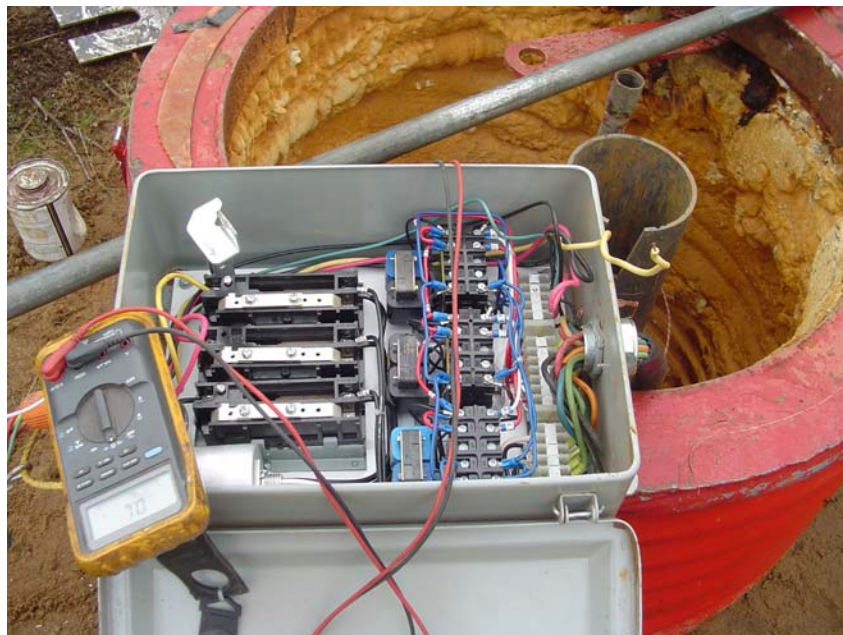
**Electrical Junction Box in W4 (Site Visit -1)**

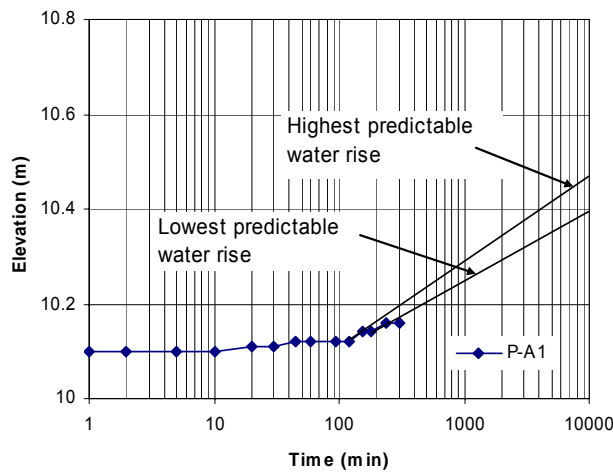
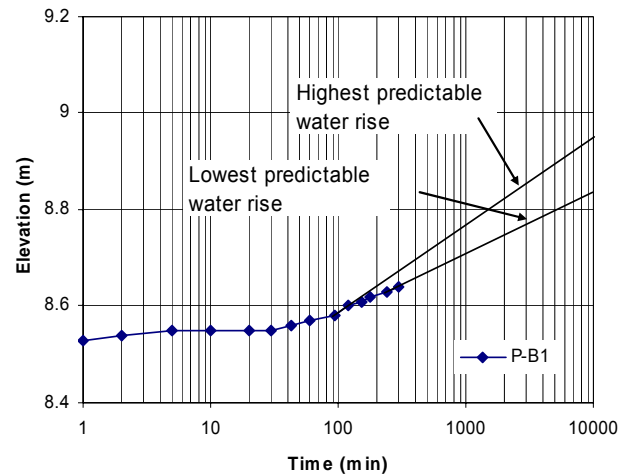
**Figure B1 - Water level rise in piezometers using graphical method (a) P-A1 (lower tip), (b) P-B1 (lower tip)**

It can be noticed that the level rise derived from the graphical method is considerably higher than the calculation method, about 1.6 to 2.4 times the graphical method. This is because in the graphical method, it is assumed that the rate of variation in logarithmic scale stays constant; however, as the water rises, hydraulic gradient decreases accordingly. It is recommended to consider the experimental results as conservative values as the experiments were performed for only 5 hours, which may not be considered long enough for a 7-day prediction.

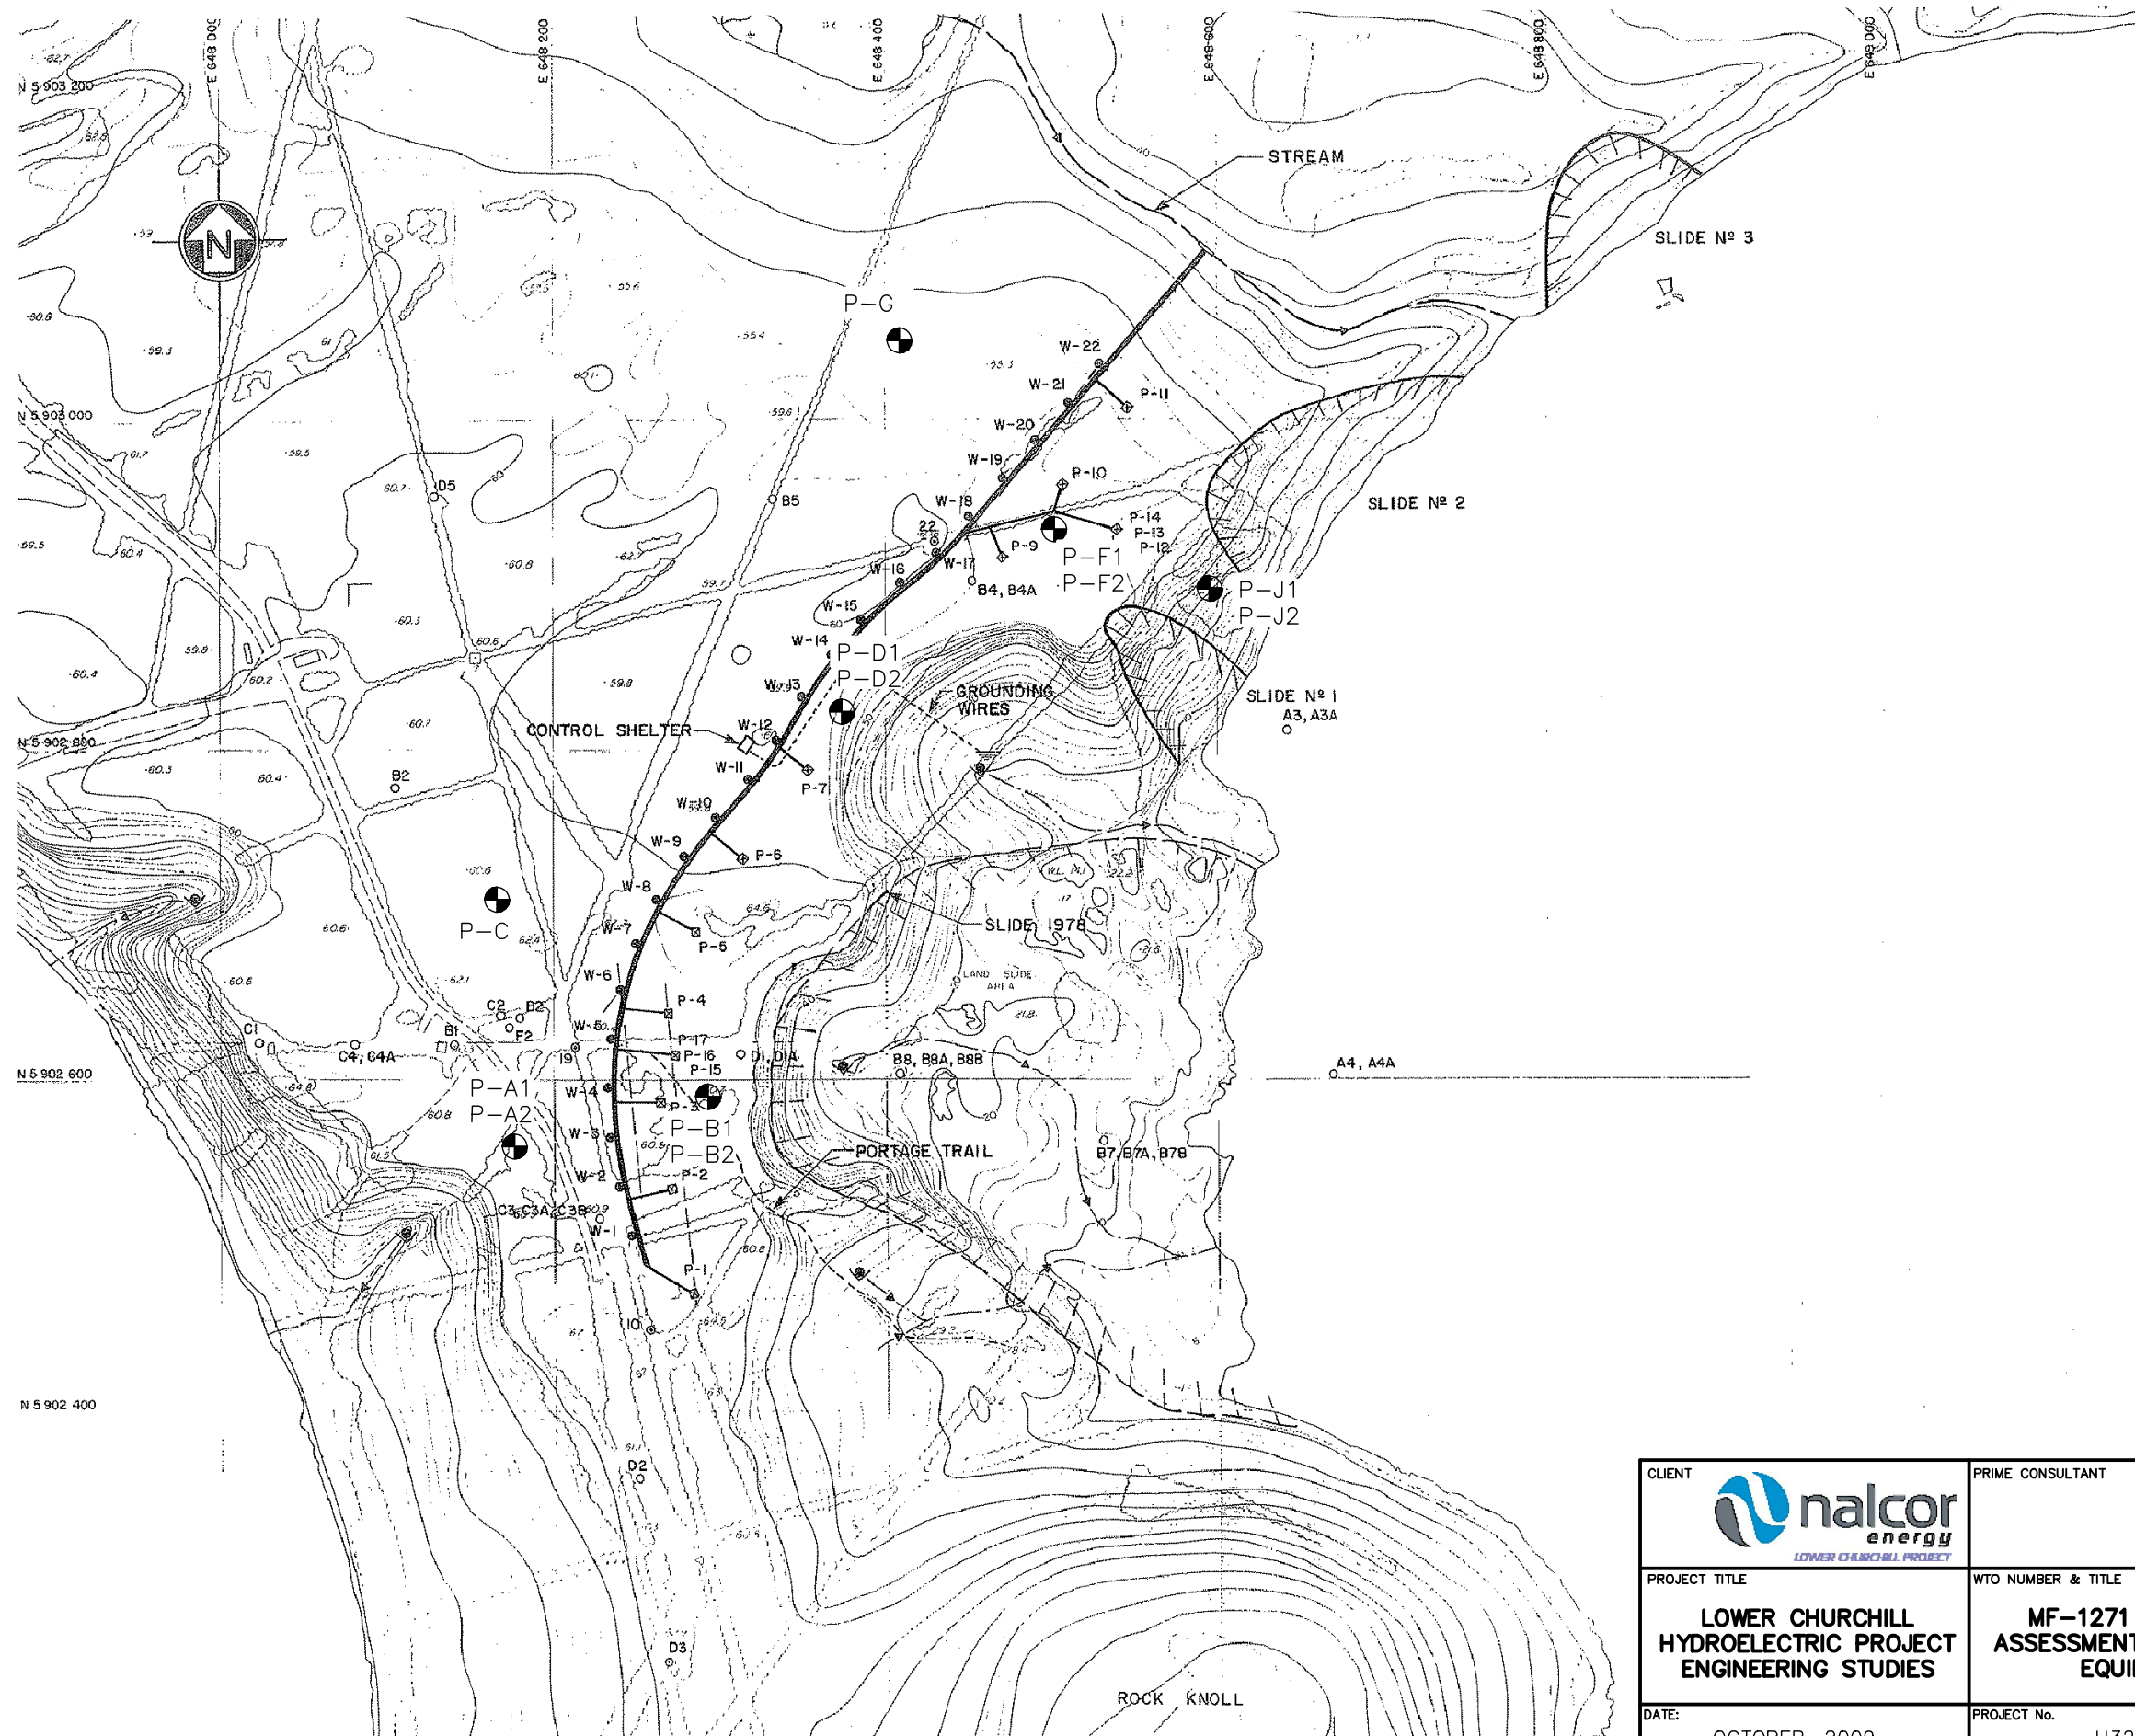
PROJECT TITLE LOWER CHURCHILL HYDROELECTRIC PROJECT ENGINEERING STUDIES		WTO NUMBER & TITLE MF-1271 CONDITION ASSESSMENT OF EXISTING EQUIPMENT	
DATE: OCTOBER, 2009		DRAWING TITLE SITE LOCATION PLAN	
PROJECT No. H325967		DRAWING No. FIGURE 1

The well inspection program commenced on August 27 and was completed on September 7, 2009. Figure 1 in Appendix C shows the location and configuration of the well system.

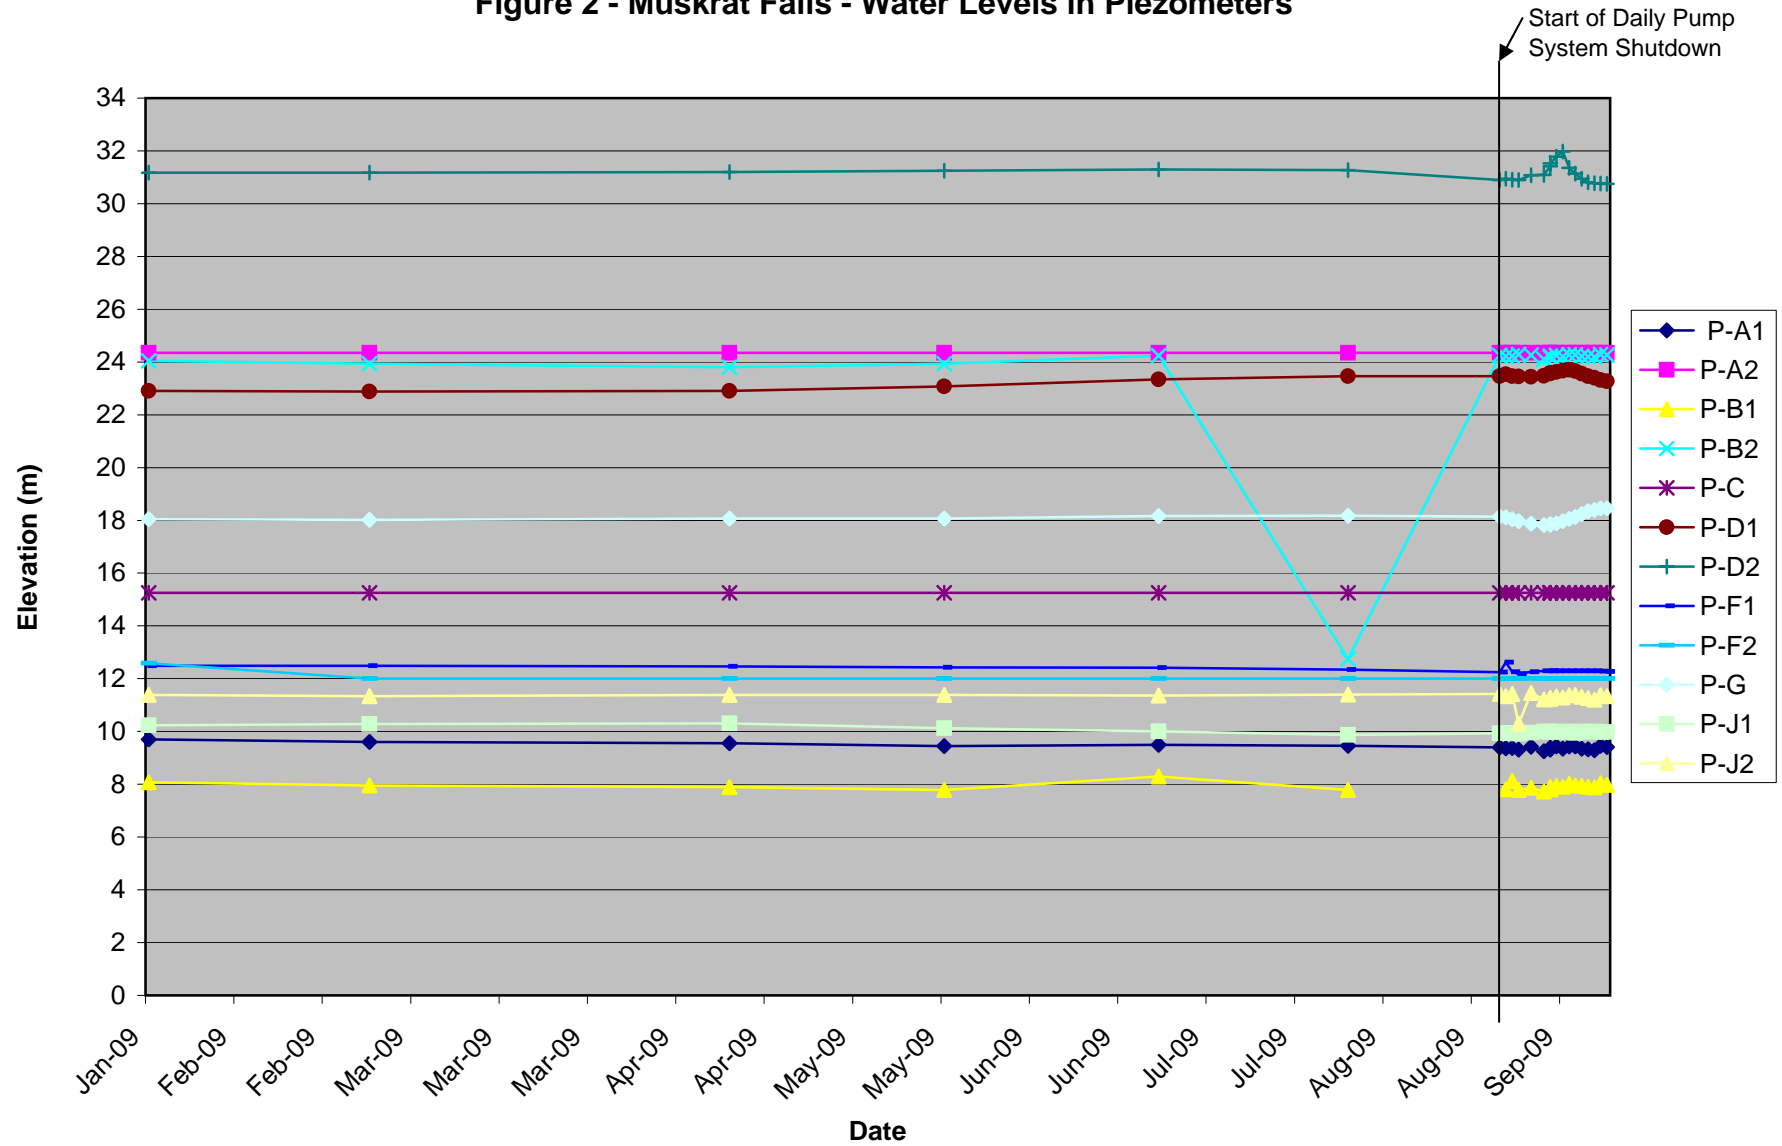
### Figure 2 - Muskrat Falls - Water Levels in Piezometers

Figure 2 in Appendix C shows the water level elevations in the piezometers from January 2009 to September 8, 2009. The readings from August 27 to September 7 were taken during the full shutdown condition. The pumps were shut off completely through the work day for approximately 10 hours and then turned back on for the overnight period.

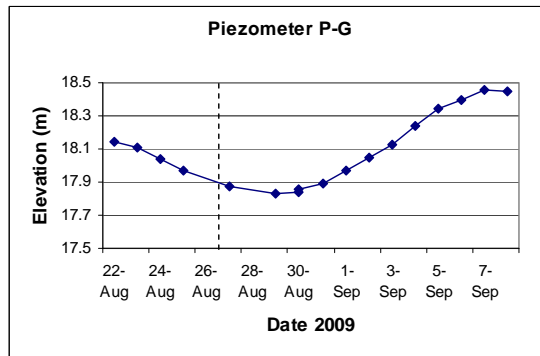
(c)

Figures 3, 4 and 5 show the water levels in each individual piezometer just prior to and during the well inspection program. In general, the water levels recovered by approximately 0.3 m to 0.6 m during the full shutdown with the exception of P-D-2, where the water level rose about 1.0 m (Figure 4 (c)).

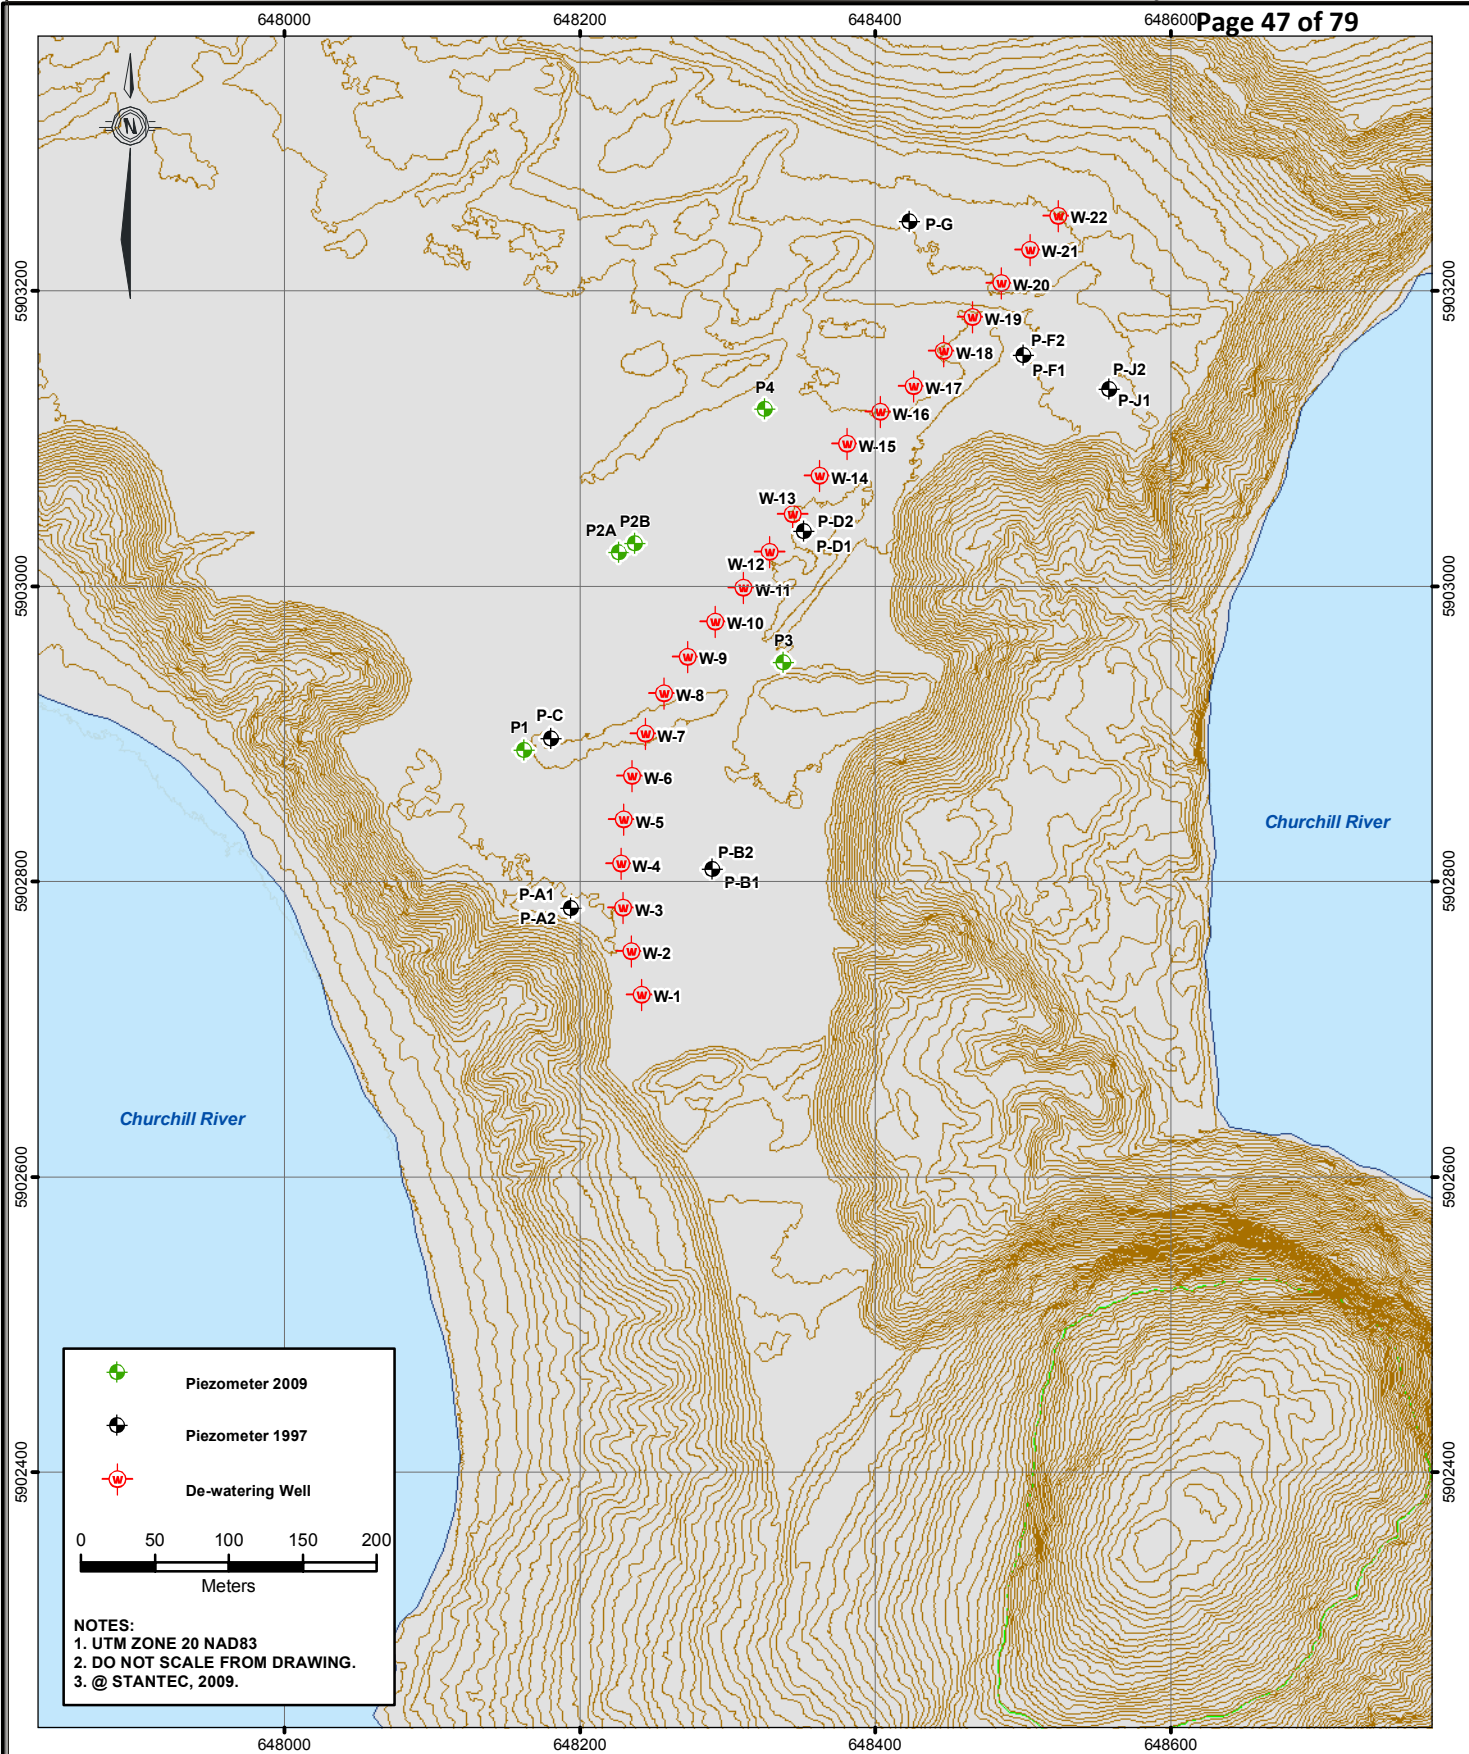
CLIENT:	HATCH LTD.	SCALE:	1:5,000	DATE:	DEC. 11, 2009
		DRAWN BY:	EM	CHECKED BY:	
		EDITED BY:	EM	REV. No.	0
		DRAWING No.: 1054326-GE-01			
PROJECT TITLE:	NEW PIEZOMETER INSTALLATIONS (2009)	MAP FILE: 1054326-GE-SITEPLAN.MXD			
DRAWING TITLE:		NEW PIEZOMETER LOCATION PLAN

The Borehole Drilling Program commenced on August 19 and was completed on September 10, 2009. The locations of the boreholes are shown in Drawing 1054326-GE-01, found in Appendix A, Attachment C. All boreholes were advanced using a CME 75 truck mounted drill rig. A total of 5 boreholes were drilled and 8 piezometers were installed in the 5 boreholes. The specific details of the drilling are described in Section 4 and the piezometer construction details are shown in the borehole logs found in Appendix A, Attachment B. Soil samples were collected from the boreholes and grain size analyzes completed on the samples.
