1 Q. Please provide the inspection report and any other report authorized by
2 Alstom (*sic*) in relation to this matter.

EVALUATION OF A WATERWALL TUBE

**NEWFOUNDLAND & LABRADOR HYDRO
HOLYROOD GENERATING STATION
UNIT NUMBER 2
CONTRACT NO. 04968
PSA -85800/LN-05J656
MTC-05-376**

Technical Services Report
Newfoundland & Labrador Hydro
Holyrood Unit 2
January 2006 - East Waterwall Tube Failures

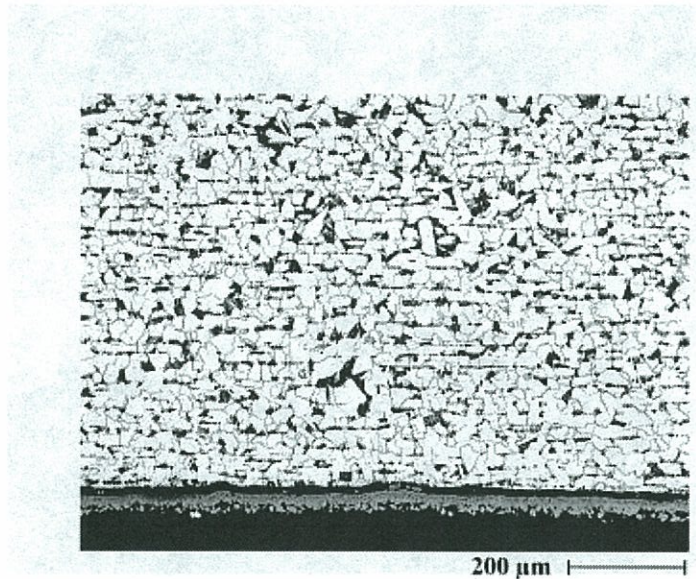
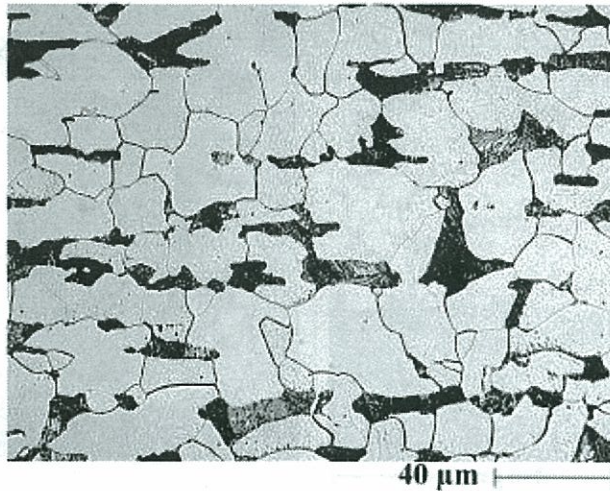
Figure 5. Documenting the Typical Condition of the Microstructure in Areas Away From the Failure on Tube 42.

The condition of the microstructure on the side of the tubing opposite the failures was found to be normal, consisting mainly of pearlite colonies in a ferrite matrix. Typical views of the microstructure in this area of the tubing are presented in Figure 3 and 5.

*Casing Side - 180°
From Failure*

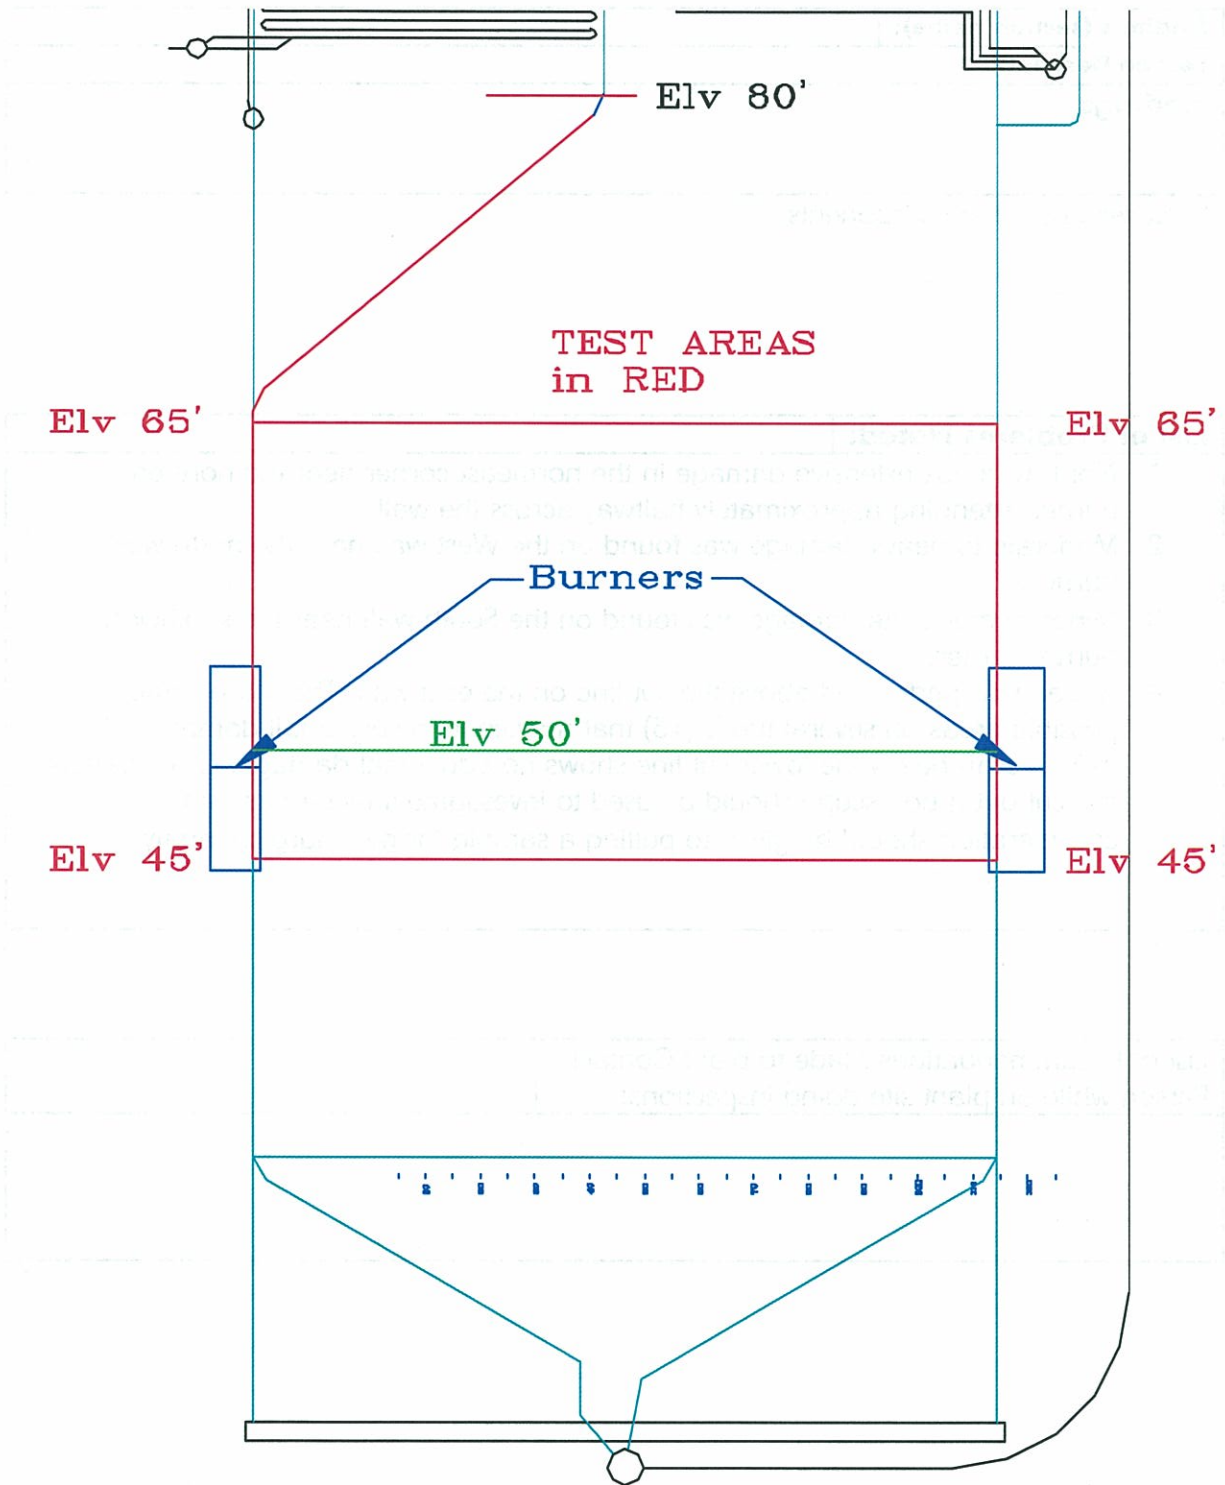
Findings (section name):	Waterwall Inspections
Section Description:	<p>Generally area to be inspected begins at the middle of burners (~45') and extends upward for 20'. LFET used on these wall follows up by UT of certain areas for checking findings.</p> <p>Left Sidewall 133 tubes each 2.5" OD x 0.200" MWT SA-210-A1 elevation 45' to 65'</p> <p>Right Sidewall 133 tubes each 2.5" OD x 0.200" MWT SA-210-A1 elevation 45' to 65'</p> <p>rear wall 127 tubes each 2.5" OD x 0.200" MWT SA-210-A1 elevation 45' to 80' (includes the arch). Probably some checking on the East wall tubes that are being removed and replaced during this outage</p>
Findings:	<ol style="list-style-type: none"> 1. Left Sidewall (West Wall) A few spot indications indicative of Hydrogen damage were found in this wall. Specifically Tube numbers 5,6,8,11,12,13,31,49. Heavy damage was observed on tubes 5 remaining wall of 0.159" 8 remaining wall 0.140" 11 remaining wall 148 and 12 remaining wall of 0.126". All of these locations were near the middle and lower sections of the burner zone. 2. Front wall (South Wall) A few spot indications indicative of hydrogen damage were found in this wall. Specifically tubes 13,15,17,21,23,24,and 25. Tube number 24 shows a remaining wall of 0.140". All locations are in the middle burner zone. 3. Rear Wall (North Wall) Severe damage was found on this wall in the north east corner extending from the burner to approximately midwall. The following tubes show damage indicative of hydrogen damage. Tube numbers 7,8,9,10,11,12,13,14,15,16,18,19,21,22,23,24,25,26,27,28,29,30,31,32,33,34,35,36,40,43,44,48,50,51,52,56,59,72 show varying degrees of damage from a low of tube 12 at 0.107" to minor damage of >.200". All locations are in the lower to upper burner zone with the highest concentration in the middle burner zone. <p style="color: red; text-align: center;">Note all tubing is numbered right to left facing each wall from inside the furnace</p>

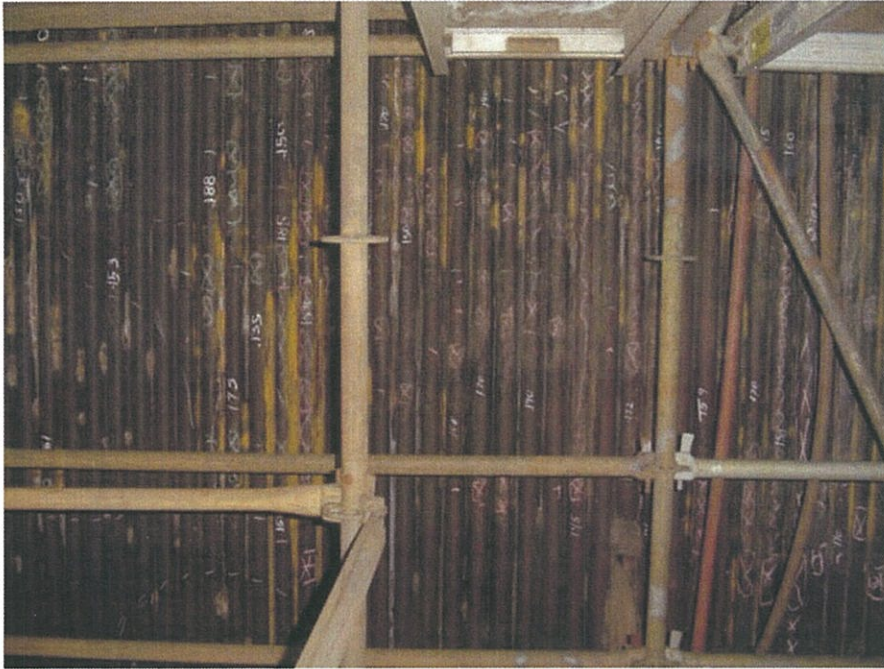
List of Problems Noted:	
<ol style="list-style-type: none"> 1. North wall has extensive damage in the northeast corner near the northeast burner extending approximately halfway across the wall. 2. Moderate to heavy damage was found on the West wall near the north west burner. 3. Minor to moderate damage was found on the South wall near the southwest burner corner. 4. A scan was performed above the cut line on the east wall. There are some possible areas on several tubes (15) that may contain very small damage 10-20 mils. A scan below the lower cut line shows no additional damage. Once panels are cut out a borescope should be used to investigate those areas and consideration should be given to pulling a sample for metallurgical analysis.
