1 **Re: Page B-199, Refurbish Microwave Site, \$202,200**

ORIGINAL 1979 WEST COAST TOWER SITE

DEFICIENCY SUMMARY AND SITE REPORT

Gull Pond Hill Repeater, NL
280 ft (85 m)

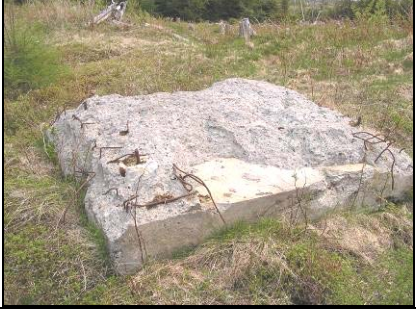
Moderate	\$ 3 k	
5	<p>Install additional support to transmission line 1 at the top of the run.</p>	Moderate	\$ 1 k	
6	<p>Remove debris and old concrete foundations from site.</p>	Low	\$ 5 k

7	Grade access road to remove ruts and washouts.	Low	\$ 5 k	
8	Remove unused conduit hangers between the elevations 240' and 280'.	Low	\$ 1 k
