Re: Page B-25, Upgrade Intake #4 Gate Controls, \$115,500

Q. Please provide documentation outlining the problems encountered during the two major incidents that occurred during penstock filling.

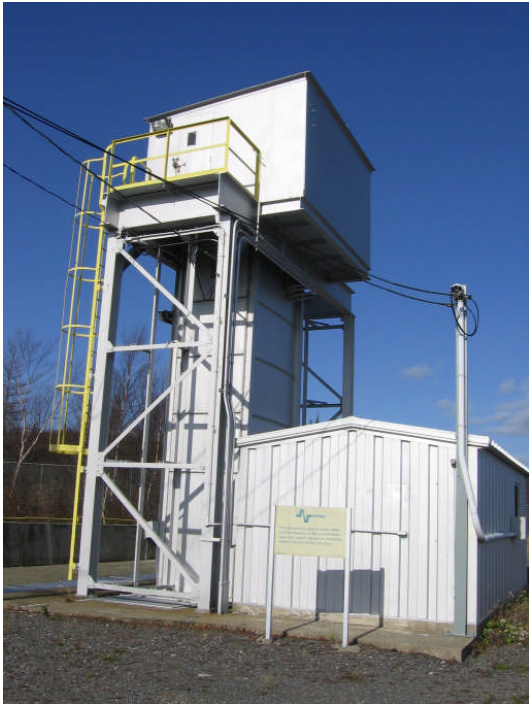
Bay D'Espoir Intake #4. Shown is the vent house down below as well as the hoist house located about 30 feet above the ground.
