**A REPORT TO  
THE BOARD OF COMMISSIONERS OF PUBLIC UTILITIES**

## **UPGRADE UNIT 1 STACK BREECHING**

### **Holyrood Thermal Generating Station**

**Revision 1, October 26, 2010**

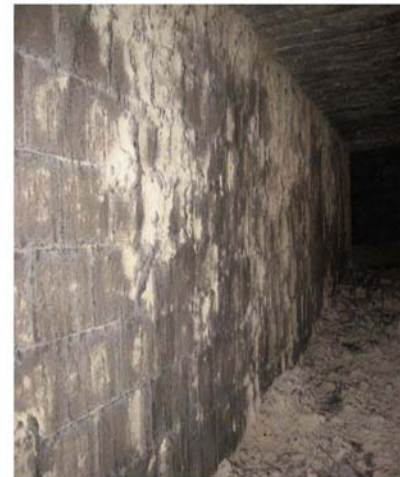
**Fig. 10: Unit 1 – Sloped section as found**
