Newfoundland and Labrador Hydro

Condition Assessment Final Report

Condition Assessment of Ten Diesel Plants

H333005-0000-10-236-0001

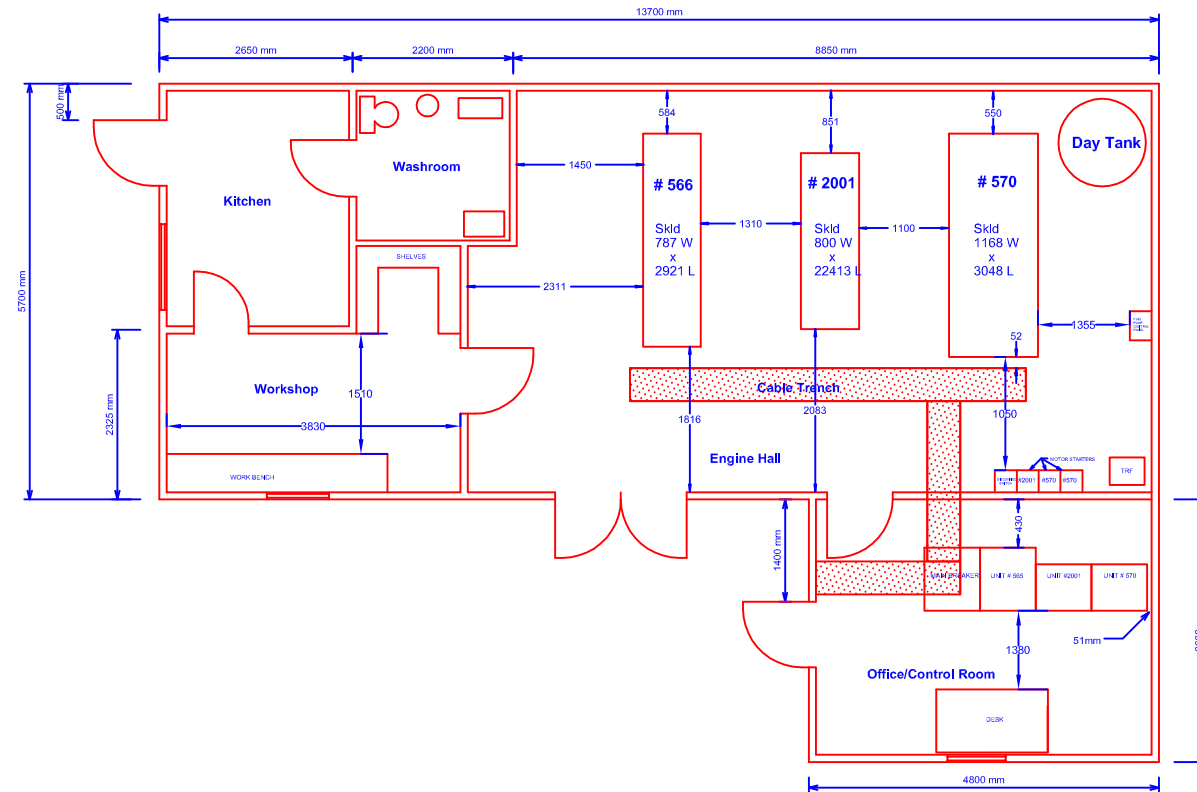
Francois, Newfoundland

1. Main breaker - 762mm width x 864mm depth x 1981mm height.
2. Unit #565 Control Panel - 762mm width x 864mm depth x 1981mm height.
3. Unit #2001 Control Panel - 762mm width x 635mm depth x 1829mm height.
4. Unit #570 Control Panel - 762mm width x 635mm depth x 1829mm height.
5. The new standard size control panel as per St. Brendan's are 1016mm width x 737mm depth x 1829mm height.
6. To Install the standard size control panel in the Francois Plant, would have to shift the main breaker, #565 Panel, & #2001 Panel toward the engine hall door min. 254mm (5 hour outage).
7. The existing control panels are accessed thru the back for maintenance.
8. Maximum width of the new panel without having to move the existing equipment is 813mm.

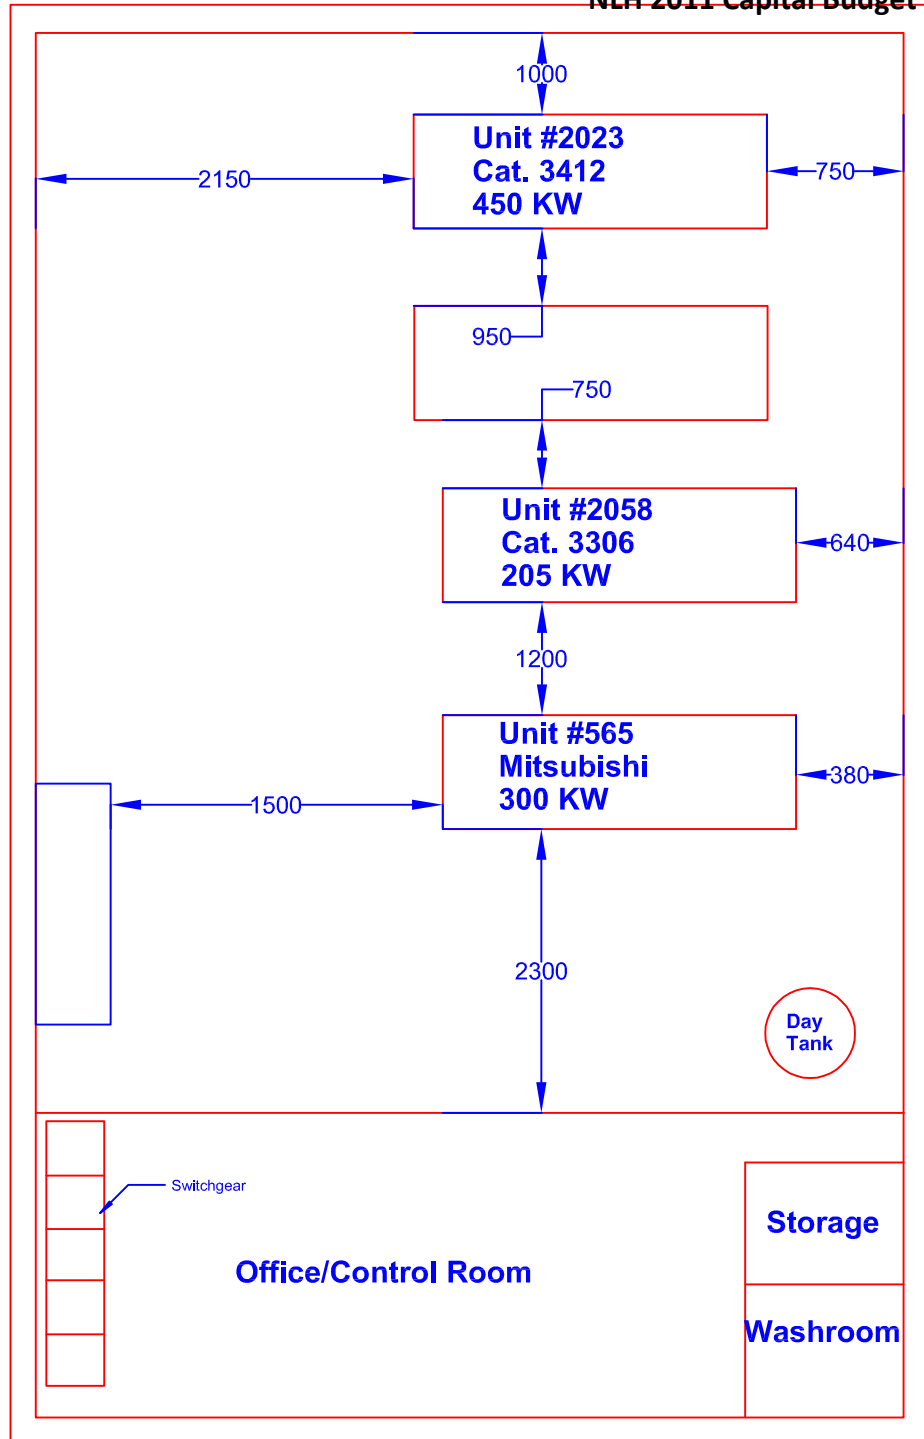
Little Bay Islands, Newfoundland

1. There is a Mobile at this site - Caterpillar 3412, 450 KW
2. This is permanent to replace Unit #297 inside the plant.
