Upgrade Unit 1 Stack Breeching

Holyrood Thermal Generating Station

UNIT #1 AIRHEATER TO STACK DUCTING

ULTRASONIC EXAMINATION REPORT

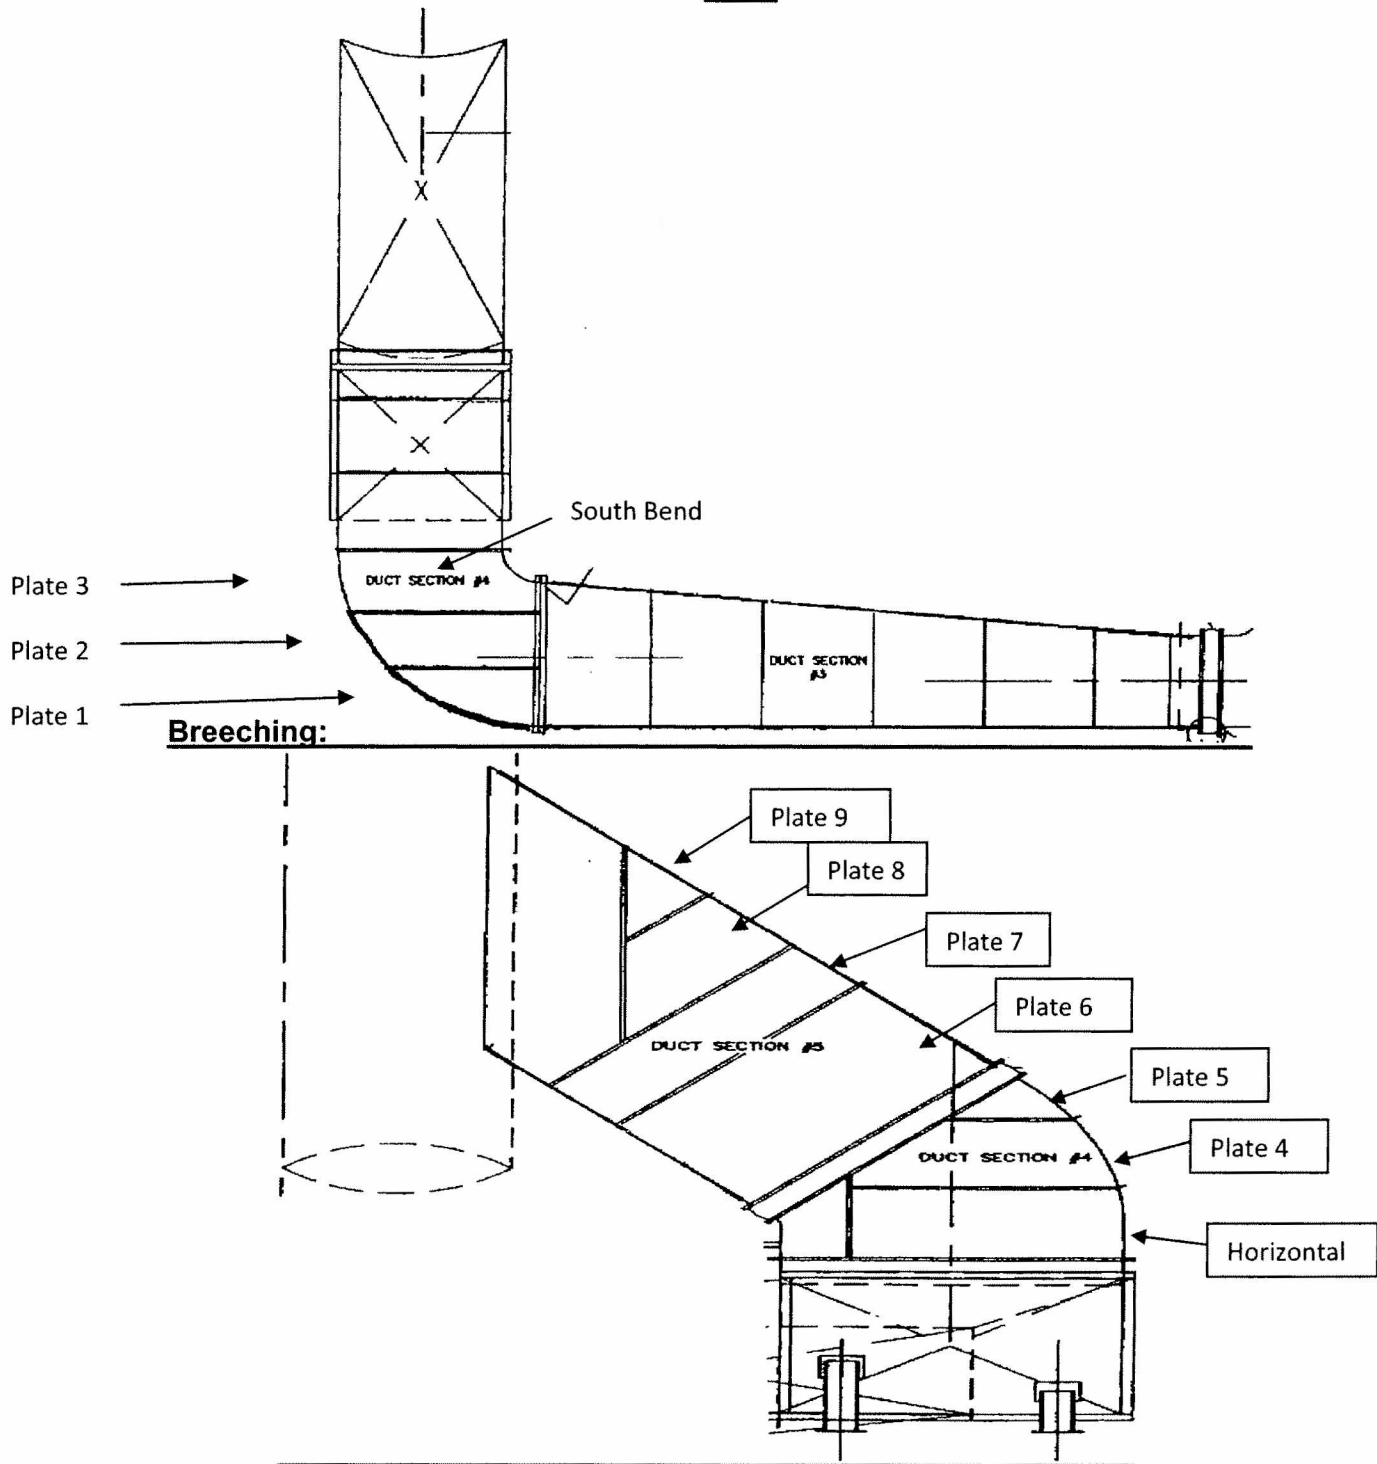
UNIT #1 WEST AIRHEATER TO STACK DUCTING

The ultrasonic thickness survey was completed on all accessible areas of both the east and west breeching. Several thickness measurements were taken at each location with the lowest recorded. There are isolated areas that have wall loss less than .200 inches. It appears that the nominal wall thickness was .250 inches. The overall paint condition is fair to good with deterioration noted around the stiffeners. All observed holes were covered with Devon and painted. There is a lot of deterioration around both expansion joints.
