1    Q.    **Re: Project B-12 Upgrade Unit 2 Stack Breeching**

**Condition Assessment of Stack Breeching**

**Holyrood G.S.**

**Alstom Canada Inc.**

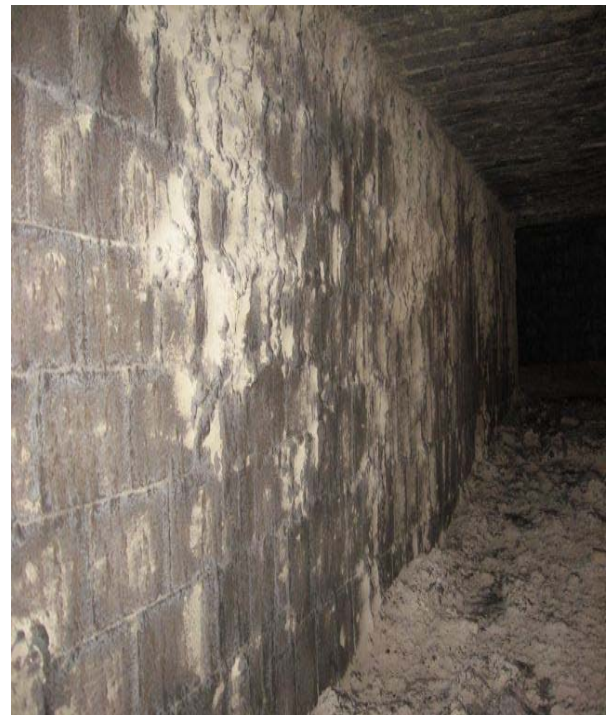
**Fig. 10: Unit 1 – Sloped section as found**
