A REPORT TO  
THE BOARD OF COMMISSIONERS OF PUBLIC UTILITIES

## REFURBISHMENT OF THE FUEL OIL STORAGE FACILITY

Holyrood Thermal Generating Station

July 2011

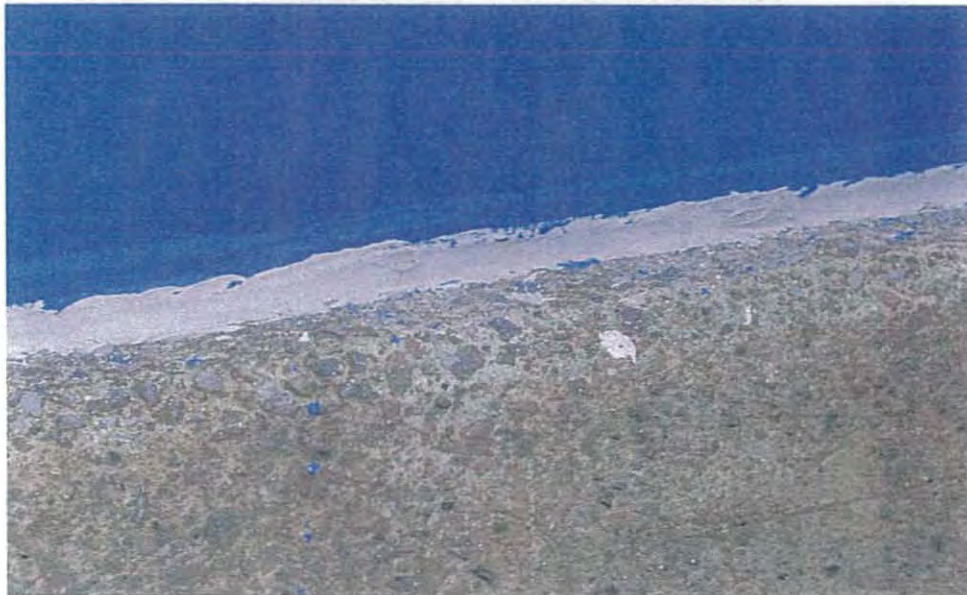
**Figure No.2 Annular ring  
(Sketch plate)**

The sketch plates are in good condition with no topside corrosion noted. The outside edge of the sketch plate where it is sitting on the concrete ring wall is sealed with some type of caulking therefore a view of the bottom edge to check for underside corrosion was not possible. See **Figure 2 in section 6.0**

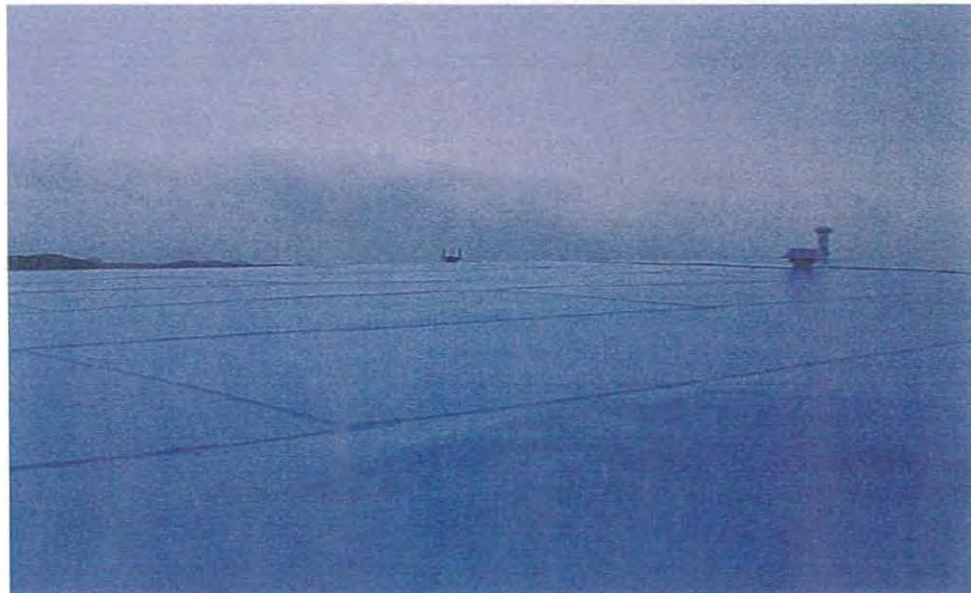
**Figure No.6 Roof Plate Profile**

The roof plates are in fair to good condition, there was a considerable amount of minor bulking and bulging noted in several areas, there were five (5) locations where minor leaks were noted in the lap joint welds. These areas were marked for repair and are located on plate row No. 5, 8, 12, 17, and 20 starting at the north side and proceeding to the south. The paint on the roof is in good condition. All vents are in fair to good condition however there are no screens in place. Ultrasonic thickness readings were taken on the roof plates in the north, south, east and west quadrants with the first reading taken at the rim angle and at approx. four foot intervals proceeding toward the center of the tank, **See Figure 6 in section 6.0 photographs, See 5.0 Non-Destructive Testing** for results.

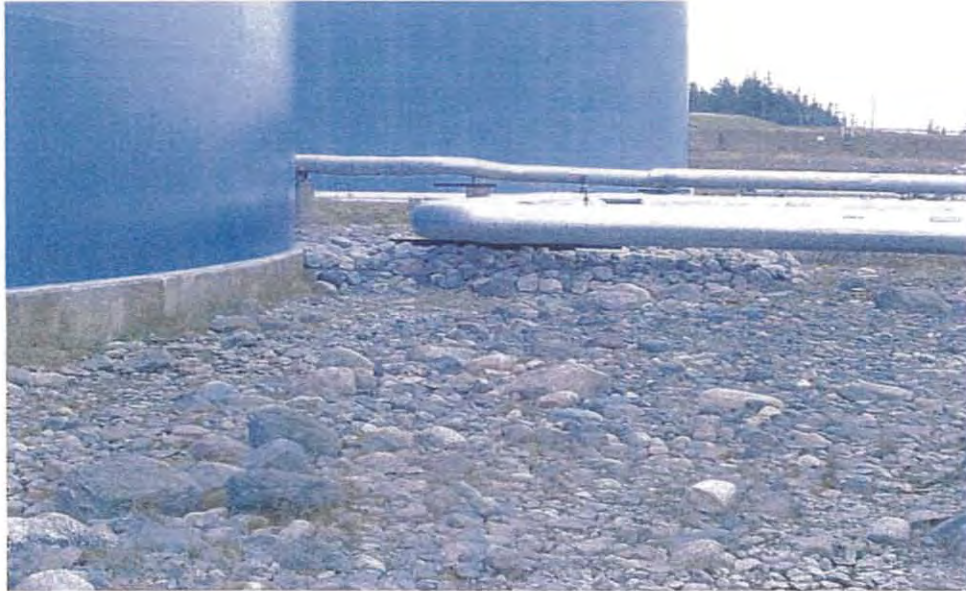
**Figure No. 7 Rocks In  
Compound On West Side**

The compound surrounding this tank is in relatively poor condition with a great amount of large rock on the West Side of the tank, water is holding up in large amounts all around the tank and vegetation is growing in some areas close to the concrete ring wall. **See Figures 7&8 in section 6.0 photographs.**
