# **DESIGN STUDY AND FAILURE INVESTIGATION FOR AUTO TRANSFORMER**

**NALCOR**

**SERIAL # 289147**

**CANADIAN GENERAL ELECTRIC**

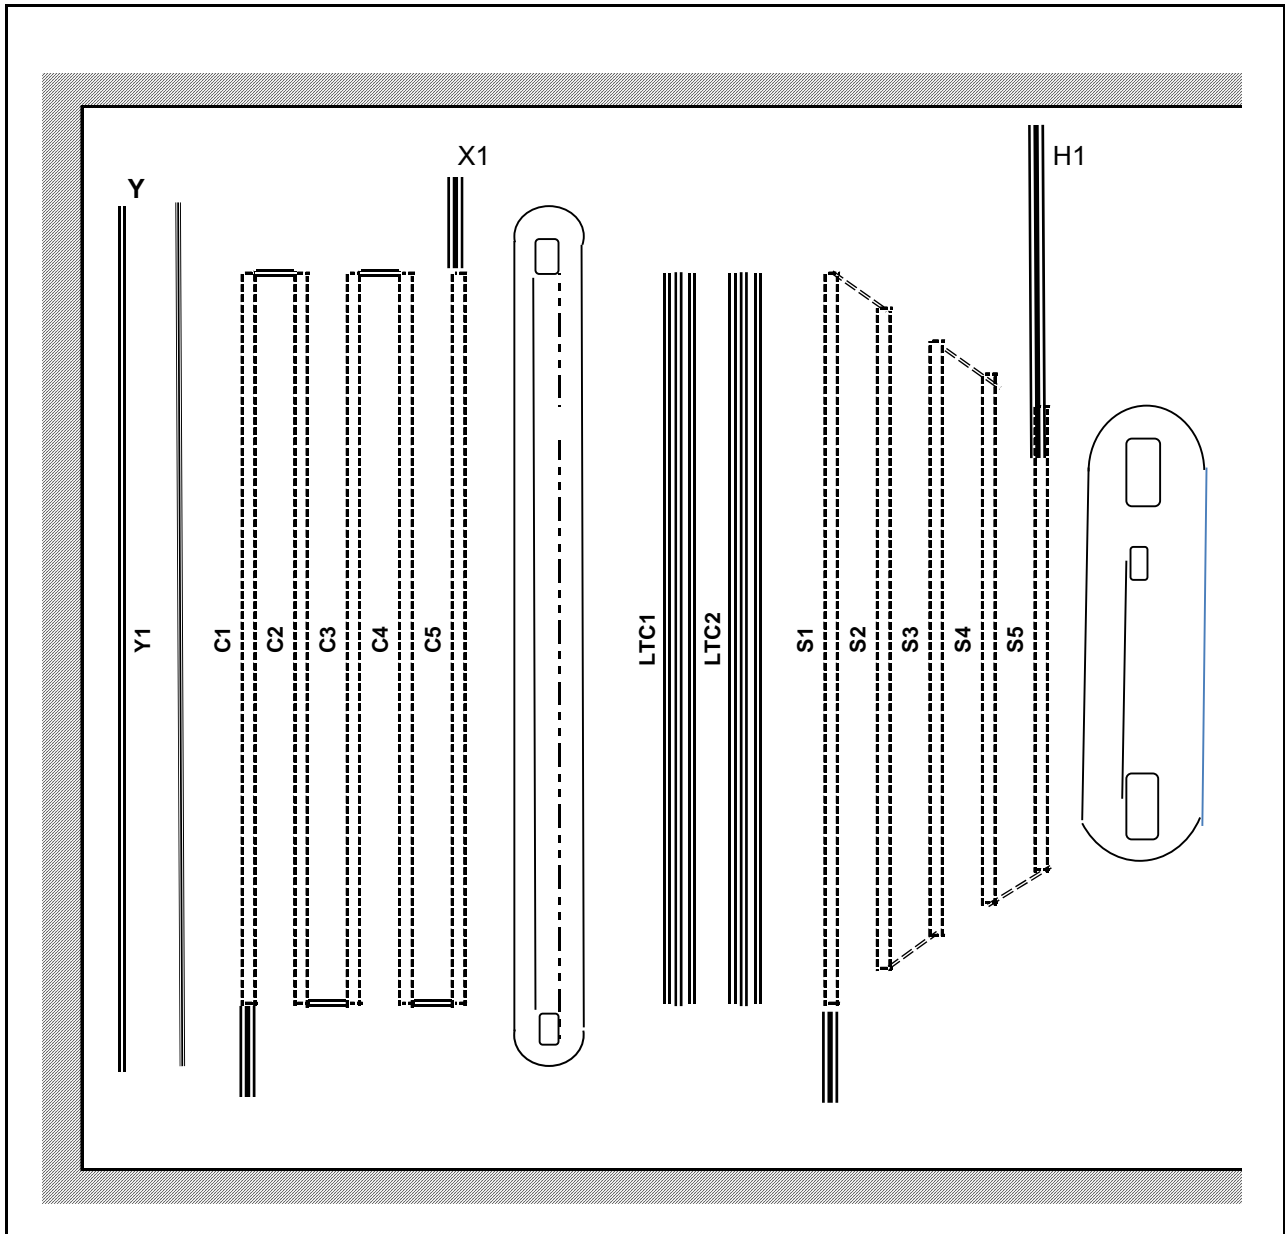
**Figure 1 - Schematic Diagram of the Windings**

This winding is failing on axial forces. The winding pressboard end rings are not strong enough to sustain the axial force. The calculated force is higher than the strength of the end ring material.

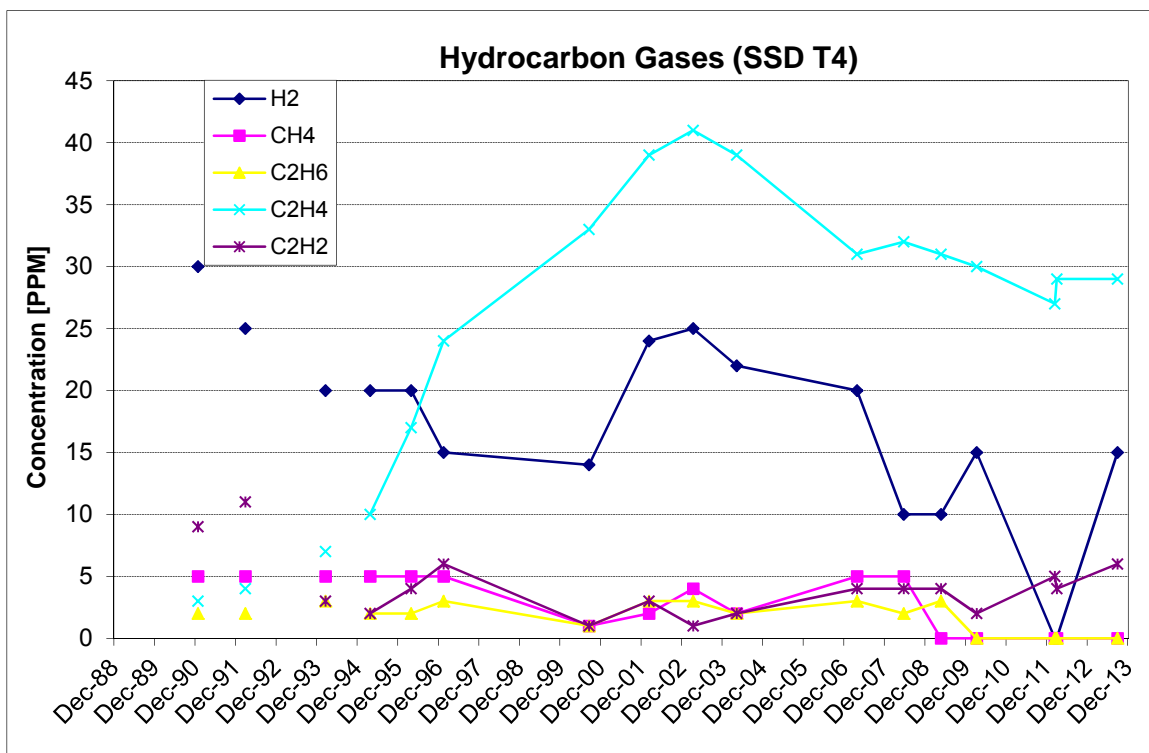
**Figure 7 - Hydrocarbon Gas Concentrations**

- The concentration of Hydrogen (H<sub>2</sub>) has been well below IEEE C57.104-2008 guide condition level 1 since 1991, the highest level is 30 ppm.
- The concentration of Methane (CH<sub>4</sub>) and Ethane (C<sub>2</sub>H<sub>6</sub>) have been steadily low for the period of the data provided. The Ethylene (C<sub>2</sub>H<sub>4</sub>) level is slightly above condition level one of the IEEE C57.104-2008 guide since 1991.

- The presence of large concentrations of oxygen in the oil can promote the formation of acids in the oil and cellulose and accelerate the aging rate of the cellulose insulation. It is recommended that the concentration of oxygen in the transformer be less than 2000 ppm (Refer to CIGRE report 323 – Aging of Cellulose in Mineral-Oil Insulated Transformers). The transformer maintenance record (09/06/2012) provided by the customer does not mention if the oil had ever been vacuum processed since 1991. The oil samples from this transformer have consistently shown very high oxygen concentrations (>20,000 ppm) of oxygen. The source of this high oxygen is the free-breathing oil conservator. To reduce the oxygen in the transformer oil and eliminate the uncertainty concerning the gas generation, it is recommended to add a conservator diaphragm. The diaphragm prevents oil from coming in contact with the air. This will prevent moisture, excessive atmospheric gases from dissolving into the oil and it also helps to keep all gases generated by the transformer in oil for more accurate diagnostics.

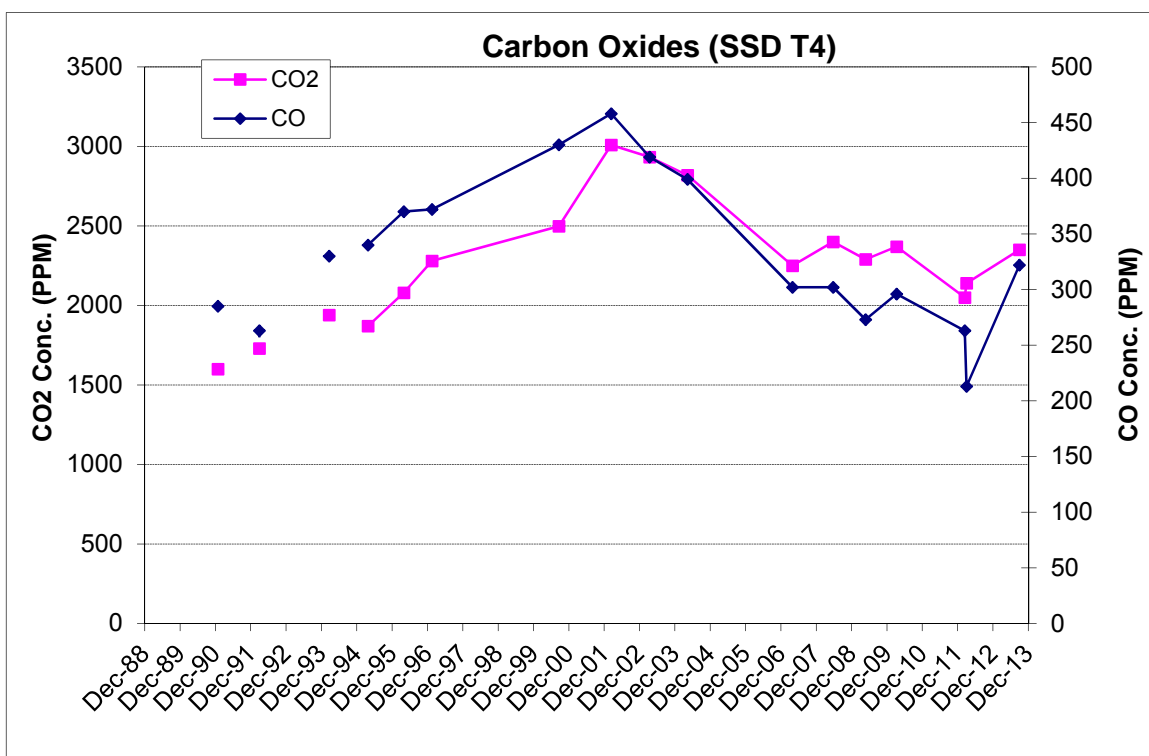
**Figure 8 - Carbon Oxides Gas Concentrations**

- As can be seen from **Figure 5 & 6**, the 90<sup>th</sup> percentile levels are 700 ppm and 7500 for CO and CO<sub>2</sub> respectively. The 90<sup>th</sup> percentile is about 700 ppm for the CO distribution by age categories and for 30 – 40 years category. The history gassing on this transformer was around 450 ppm and 3000 ppm for CO and CO<sub>2</sub> respectively. Thus these levels are below the 90<sup>th</sup> percentile of the IEEE data for the age of this unit.

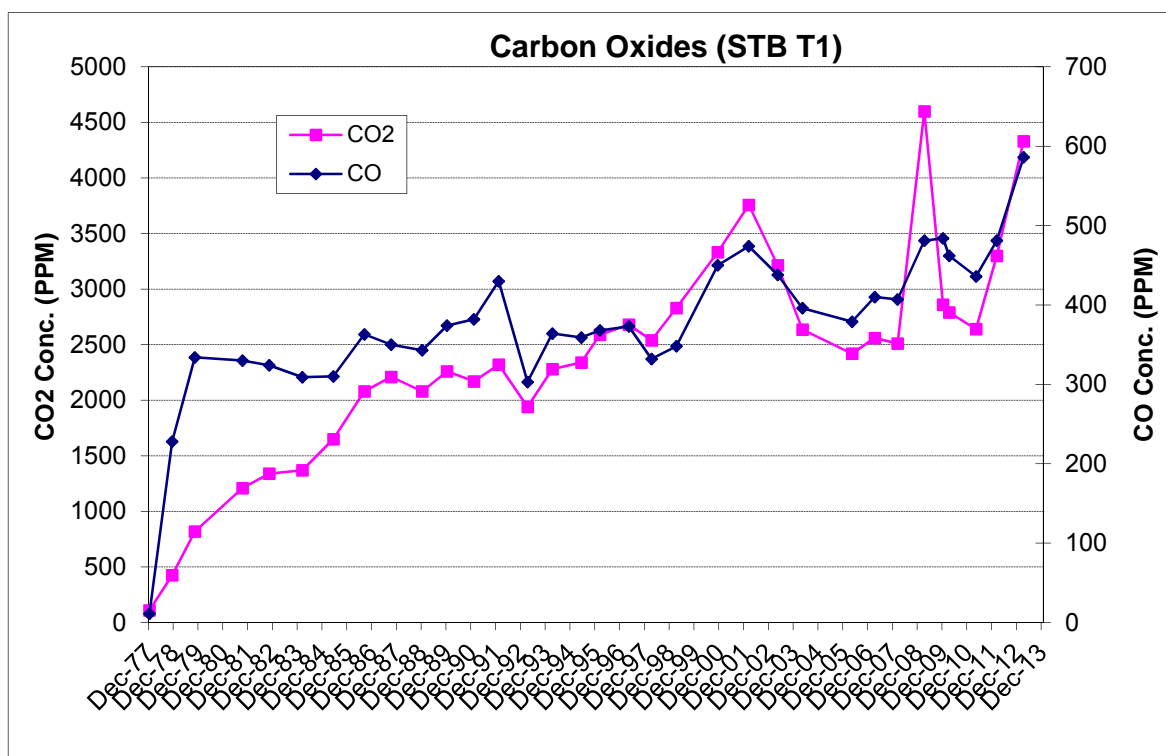
Figure 11 - Carbon Oxides Gas Concentrations

- As can be seen from **Figure 5 & 6**, the 90<sup>th</sup> percentile levels are 700 ppm and 7500 for CO and CO<sub>2</sub> respectively. The 90<sup>th</sup> percentile is about 700 ppm for the CO distribution by age categories and for 30 – 40 years category. The history gassing on this transformer was around 590 ppm and 4400 ppm for CO and CO<sub>2</sub> respectively. Thus these levels are below the 90<sup>th</sup> percentile of the IEEE data for the age of this unit.

- The presence of large concentrations of oxygen in the oil can promote the formation of acids in the oil and cellulose and accelerate the aging rate of the cellulose insulation. It is recommended that the concentration of oxygen in the transformer be less than 2000 ppm (Refer to CIGRE report 323 – Aging of Cellulose in Mineral-Oil Insulated Transformers). The transformer maintenance record (09/22/2011) provided by the customer does not mention if the oil had ever been vacuum processed since 1991. The oil samples from this transformer have consistently shown very high oxygen concentrations (>20,000 ppm) of oxygen. The source of this high oxygen is the free-breathing oil conservator. To reduce the oxygen in the transformer oil and eliminate the uncertainty concerning the gas generation, it is recommended to add a conservator diaphragm. The diaphragm prevents oil from coming in contact with the air. This will prevent moisture, excessive atmospheric gases from dissolving into the oil and it also helps to keep all gases generated by the transformer in oil for more accurate diagnostics

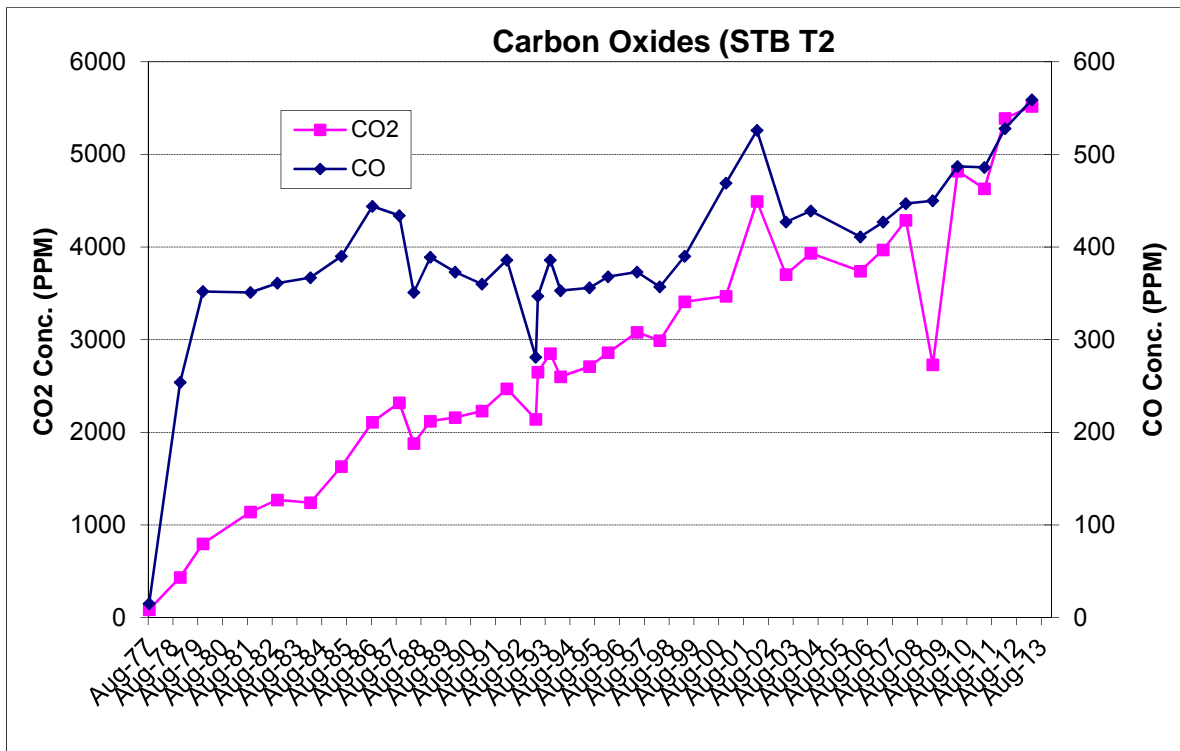
**Figure 14 - Carbon Oxides Gas Concentrations**

- As can be seen from **Figure 5 & 6**, the 90<sup>th</sup> percentile levels are 700 ppm and 7500 for CO and CO<sub>2</sub> respectively. The 90<sup>th</sup> percentile is about 700 ppm for the CO distribution by age categories and for 30 – 40 years category. The history gassing on this transformer was around 560 ppm and 5500 ppm for CO and CO<sub>2</sub> respectively. Thus these levels are below the 90<sup>th</sup> percentile of the IEEE data for the age of this unit.

- The presence of large concentrations of oxygen in the oil can promote the formation of acids in the oil and cellulose and accelerate the aging rate of the cellulose insulation. It is recommended that the concentration of oxygen in the transformer be less than 2000 ppm (Refer to CIGRE report 323 – Aging of Cellulose in Mineral-Oil Insulated Transformers). It is unknown if the oil had ever been vacuum processed since 1977. The oil samples from this transformer have consistently shown very high oxygen concentrations (>20,000 ppm) of oxygen. The source of this high oxygen is the free-breathing oil conservator. To reduce the oxygen in the transformer oil and eliminate the uncertainty concerning the gas generation, it is recommended to add a conservator diaphragm. The diaphragm prevents oil from coming in contact with the air. This will prevent moisture, excessive atmospheric gases from dissolving into the oil and it also helps to keep all gases generated by the transformer in oil for more accurate diagnostics
