**AND IN THE MATTER OF** an Application by Newfoundland and Labrador Hydro pursuant to Subsection 41(3) of the *Act*, for the approval of the replacement of the tap changer on transformer T5 at the Western Avalon Terminal Station.

## Replace T5 Tap Changer Western Avalon Terminal Station

**OEM (CG Power) Recommendation on Transformer T5**

**CONDITION ASSESSMENT OF  
FEDERAL PIONEER TRANSFORMER  
AT WESTERN AVALON STATION  
FOR NALCOR ENERGY**

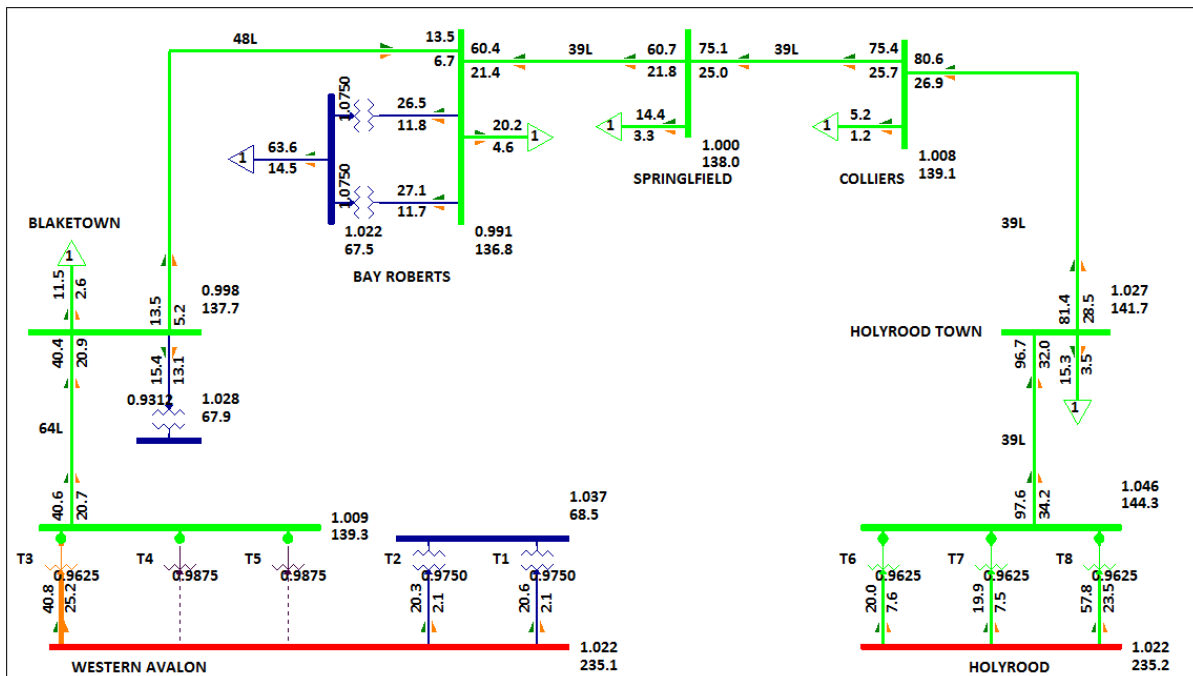
15  
16 If Hydro were to not repair the Western Avalon T5 OLTC then the total installed transformer  
17 capacity in the Western Avalon – Holyrood 138 kV Loop equals 291.8 MVA. Applying the  
18 transmission planning criteria for loss of the largest transformer in the loop, Holyrood T8 is  
19 assumed to be out of service leaving four 41.7 MVA units, or 166.8 MVA in firm transformer  
20 capacity to supply the peak load. By comparison the 2018 peak load for the 138 kV loop is  
21 forecast to equal 122.4 MVA, or 73% of the firm transformer capacity. However, load flow  
22 analysis of the 2018 peak load for the Western Avalon – Holyrood 138 kV Loop reveals that  
23 if Western Avalon T5 is not returned to service and one of the 41.7 MVA units were to fail at  
24 Western Avalon (i.e. T4) the remaining 41.7 MVA unit at Western Avalon (i.e. T3) would be  
25 loaded to 113% of its rating despite there being adequate transformer capacity at Holyrood

26 to supply the loop load. The load flow plot is provided in Figure 4.

1 **Figure 4: Western Avalon – Holyrood 138 kV Loop – 2018 Peak Load WAV T5 Not Repaired**  
 2 **– WAV T4 Out of Service**
