1 Q. On page 9 of Hydro's *Insulator Replacement TL-201 and TL-203* report, Hydro
2 states:
3 "The testing is currently ongoing and a report will be provided from Kinectrics by
4 the second quarter of 2014."

CONDITION ASSESSMENT TESTS OF PORCELAIN INSULATORS REMOVED FROM NALCOR'S CIRCUITS

Kinectrics Inc. Report No.: K-419614-RC-0001-R00

July 18, 2014

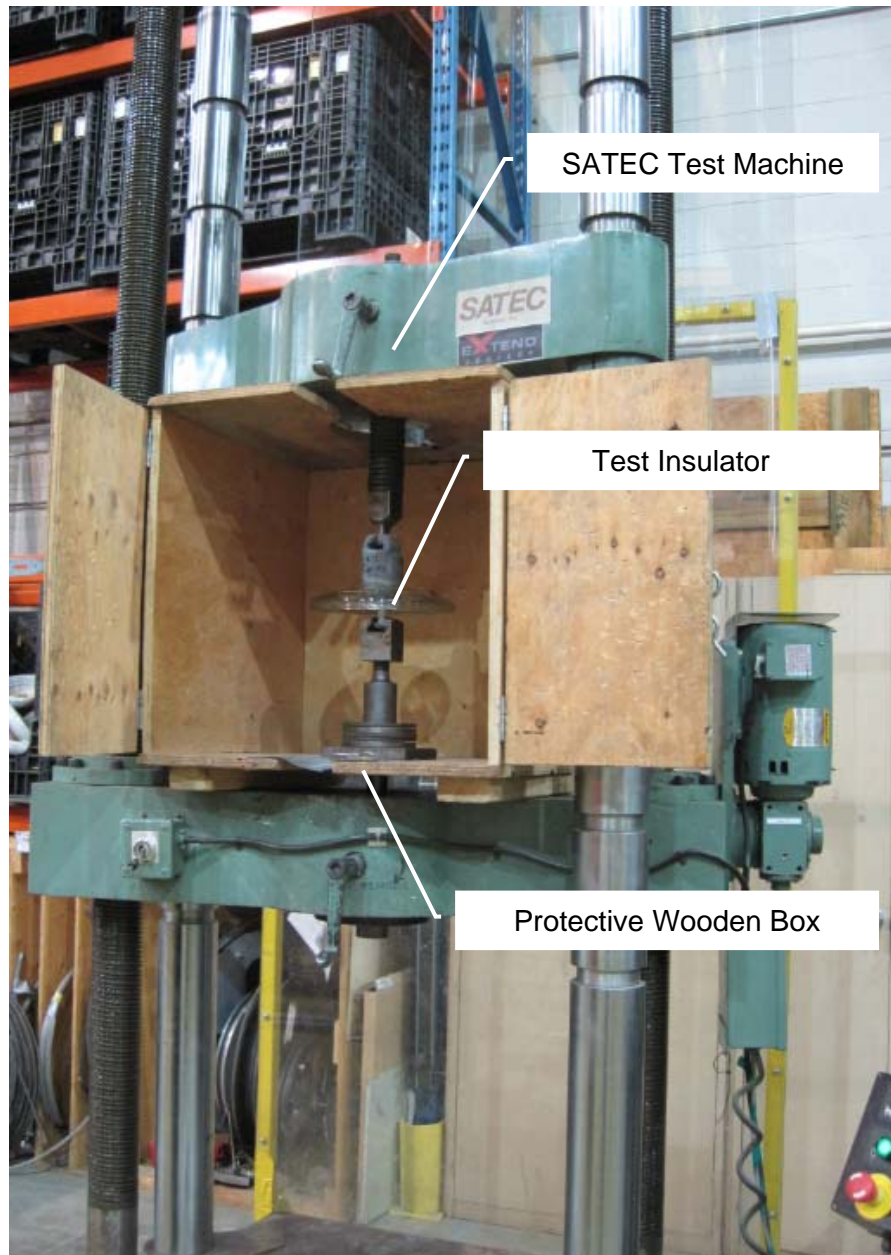
Figures 1 and 2 show photos of the general setup for performing the Mechanical Strength Test. The top (cap) of the insulator under test was connected to the upper plate of a tensile testing machine using an appropriate fixture. The insulator pin was connected directly to the test machine's lower plate. A wooden box completely enclosed the insulator to contain fragments of the insulator during failure.

Figure 1 Typical Test Setup for Mechanical Testing on Glass Insulators

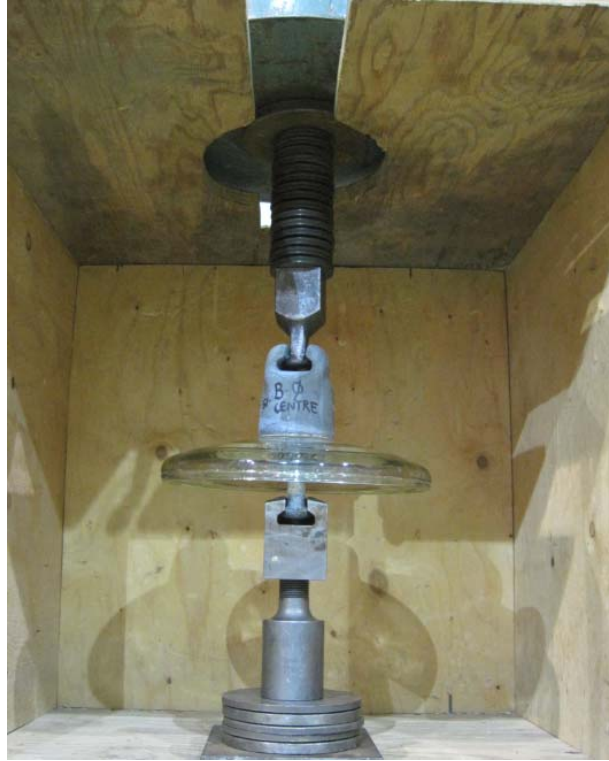
Figure 2 Insulator Sample Prepared for Mechanical Testing
