**Re: Newfoundland and Labrador Hydro – 2014 Capital Budget Application**

**An Application to the  
Board of Commissioners of Public Utilities**

# **2014 CAPITAL BUDGET**

### **VOLUME I**

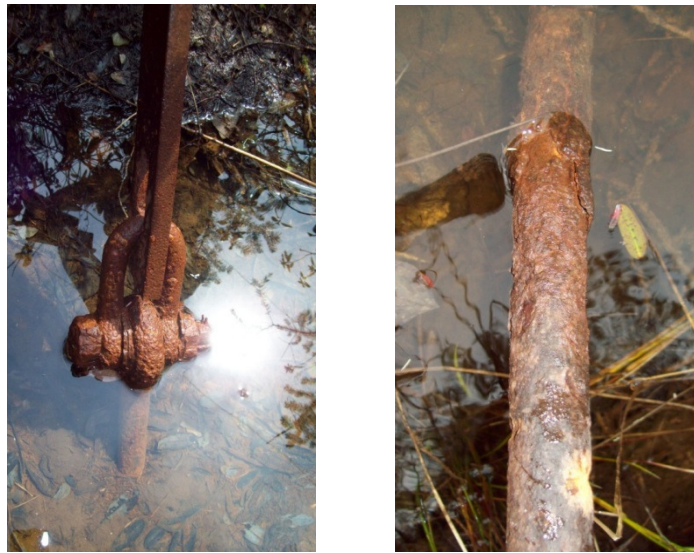
Figures 1 to 3 depict examples of deteriorated anchors, footings and joints on these lines.

**Figure 1: Corroded Anchor Rods on Structures 71 and 73 of TL202**

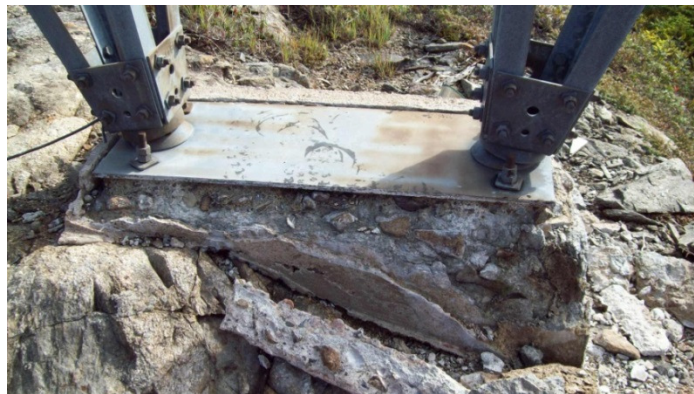
**Figure 2: Deteriorated Concrete Footing on Structure 52 of TL202**

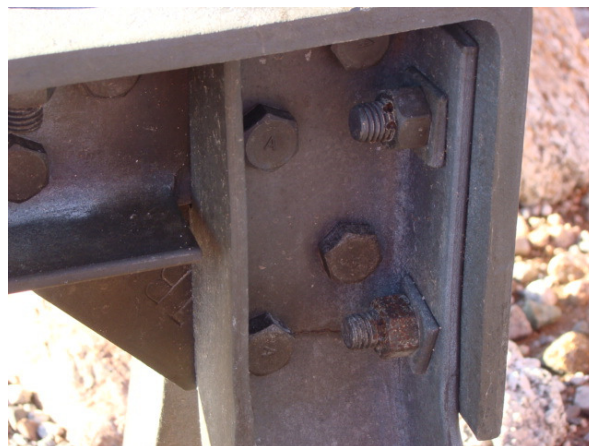
**Figure 6: Failed Bolt Connection on Structure 216 of TL206**

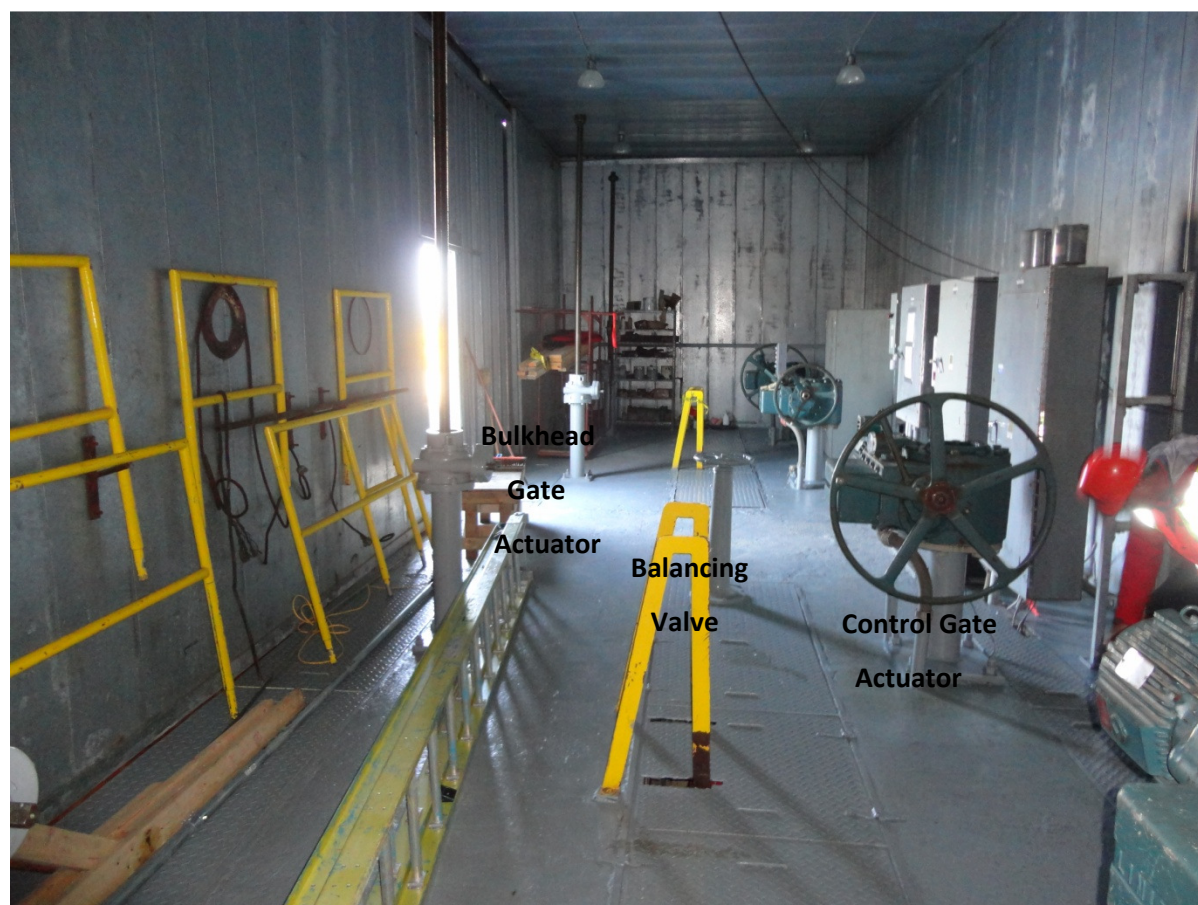
**Figure 4: Victoria Control Structure – Actuators and Balancing Valve**

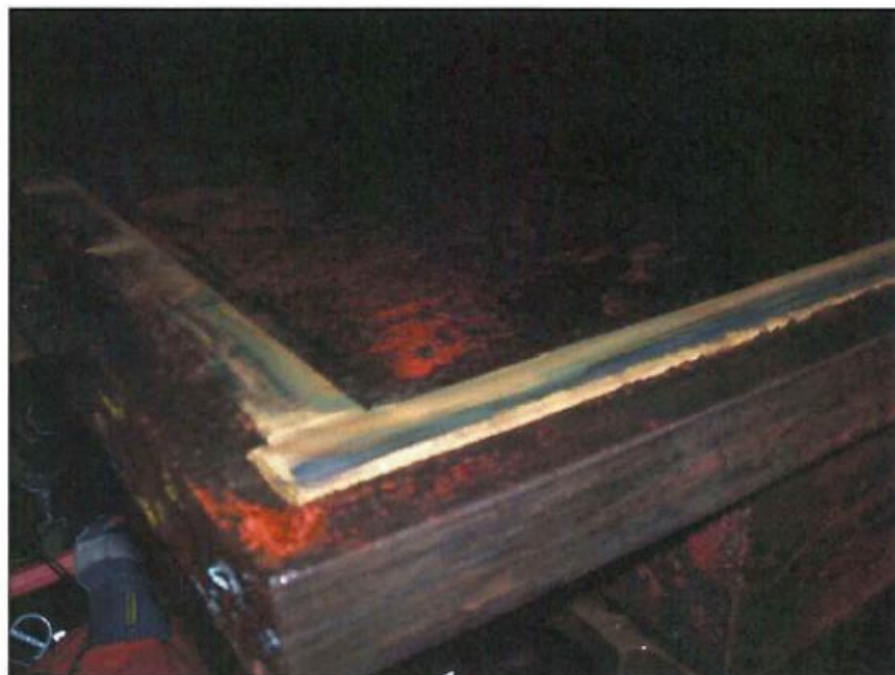
**Photo 100: View of Brass Seals on Victoria Control Gate 2**

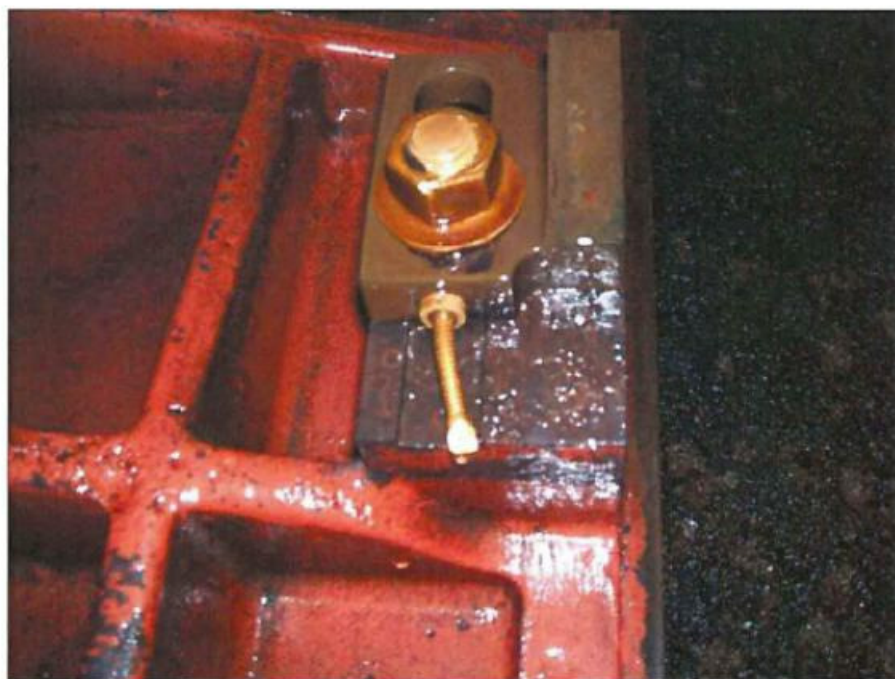
**Photo 101: Bent Wedge Set Screw on Victoria Control Gate 2**

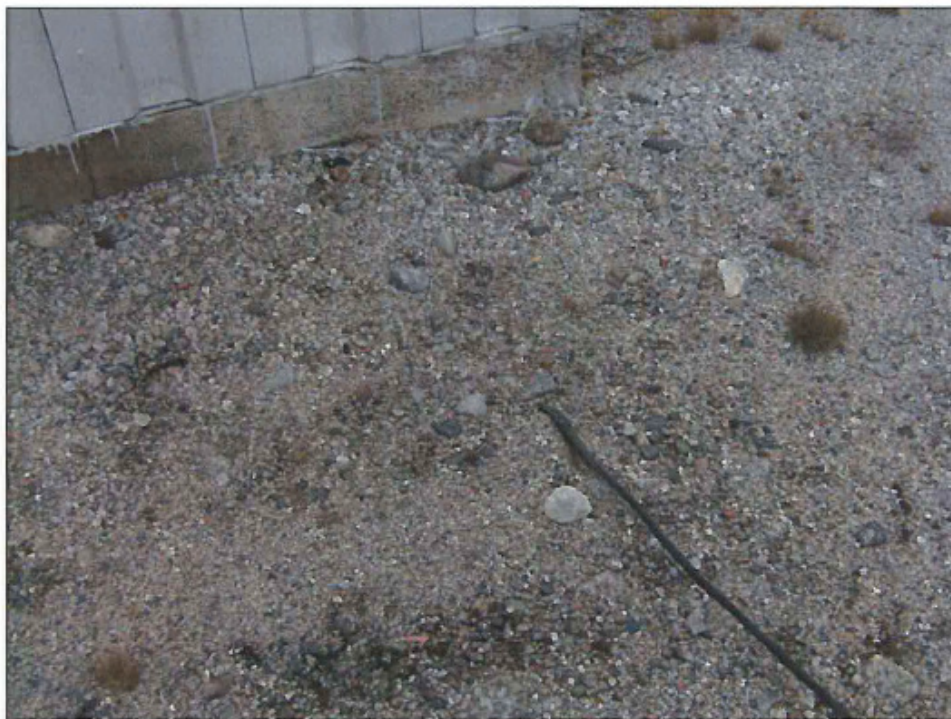
**Photo 108: Victoria Control Structure - Exposed Grounding Conductors**

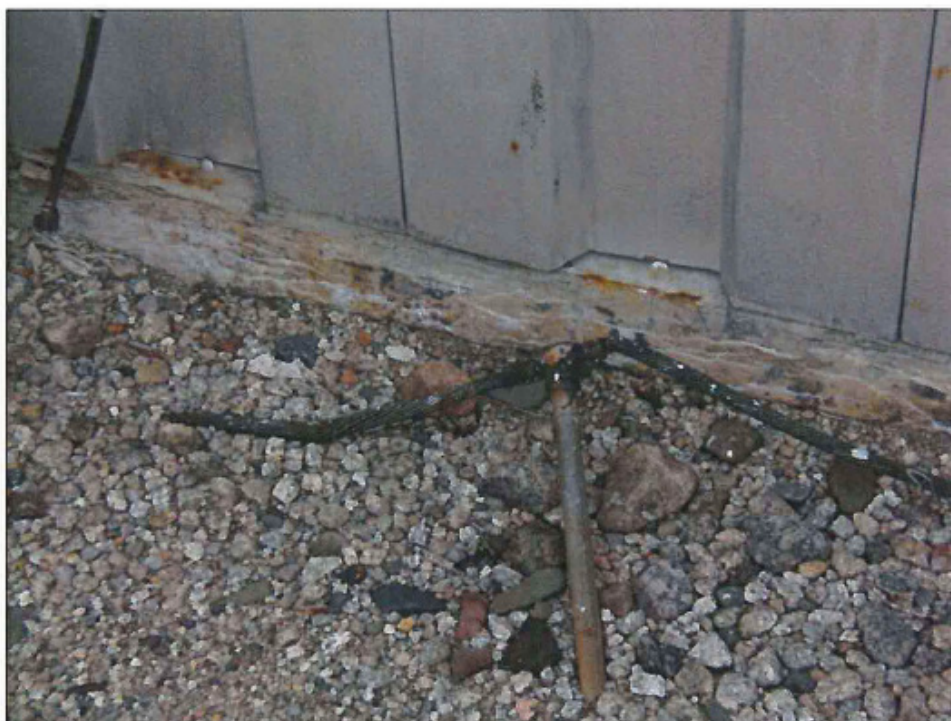
**Photo 109: Victoria Control Structure - Exposed Grounding Conductors**

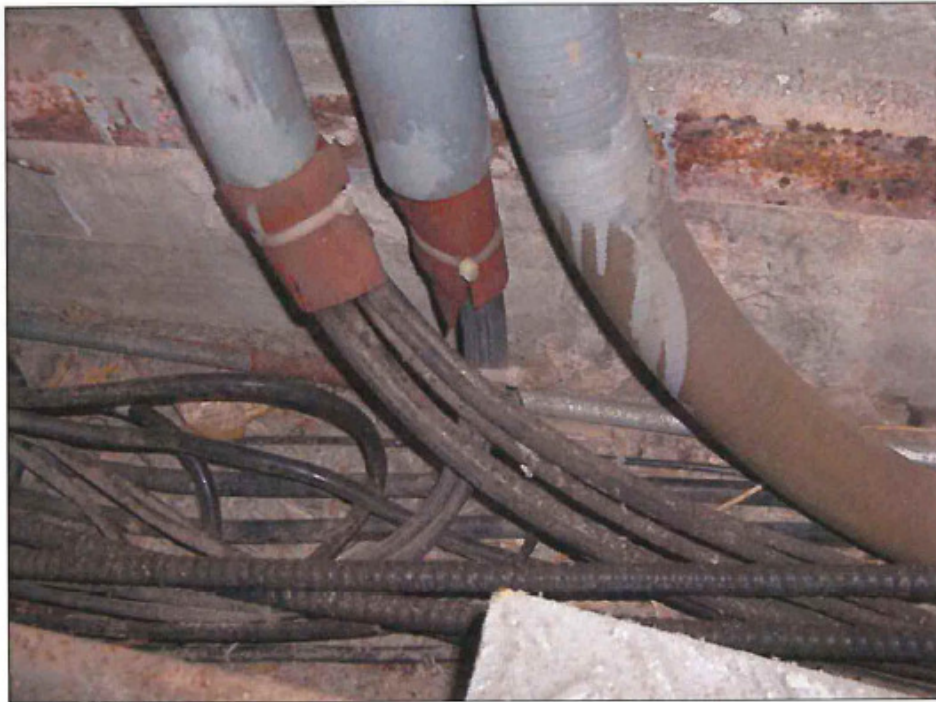
**Photo 110: Victoria Control Structure - Cables Exiting Conduits**

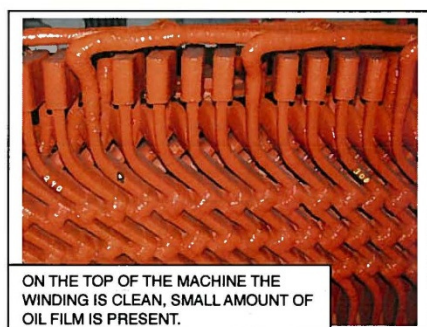
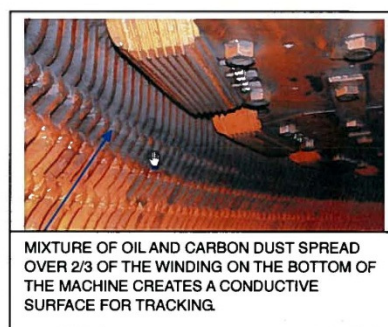
Otherwise build up of the mixture of the oil and carbon dust will clog up the ventilation ducts in stator core over time, increasing the temperature rise of the stator winding.

- repair the oil lines or other source of oil leak
- due the fact that collector rings are above the thrust bearing, installation of a carbon dust collection system would improve performance of the unit and lower the cost of maintenance on stator winding.

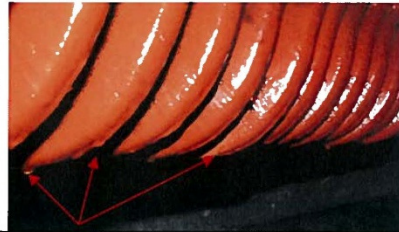
OIL DRIPPING FROM COIL NOSE AT THE BOTTOM OF THE UNIT

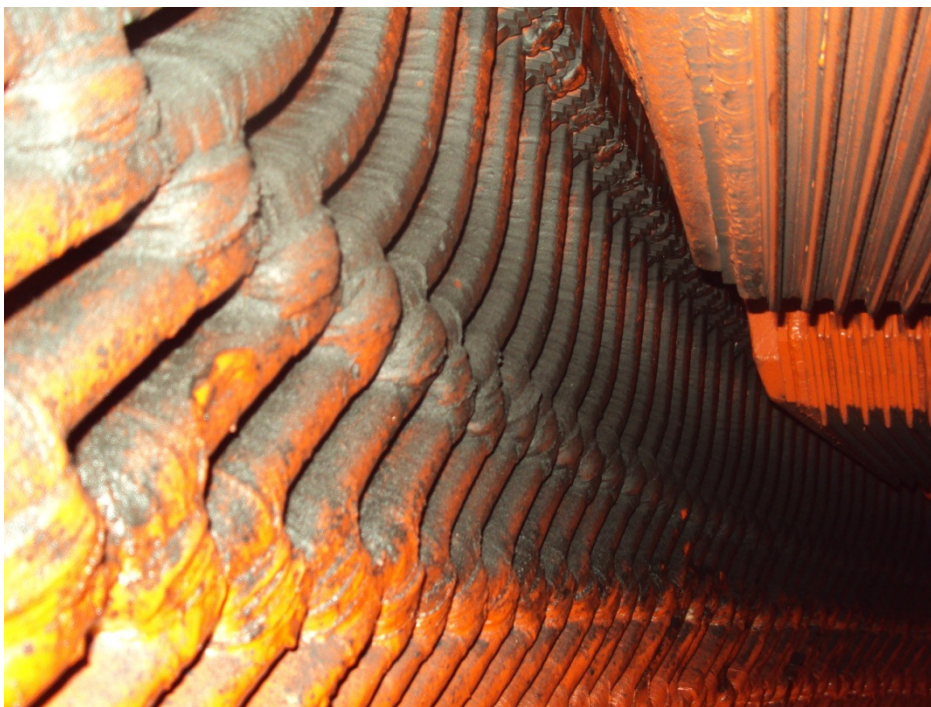
**Contamination of Unit 2 Stator Windings – April 2013**

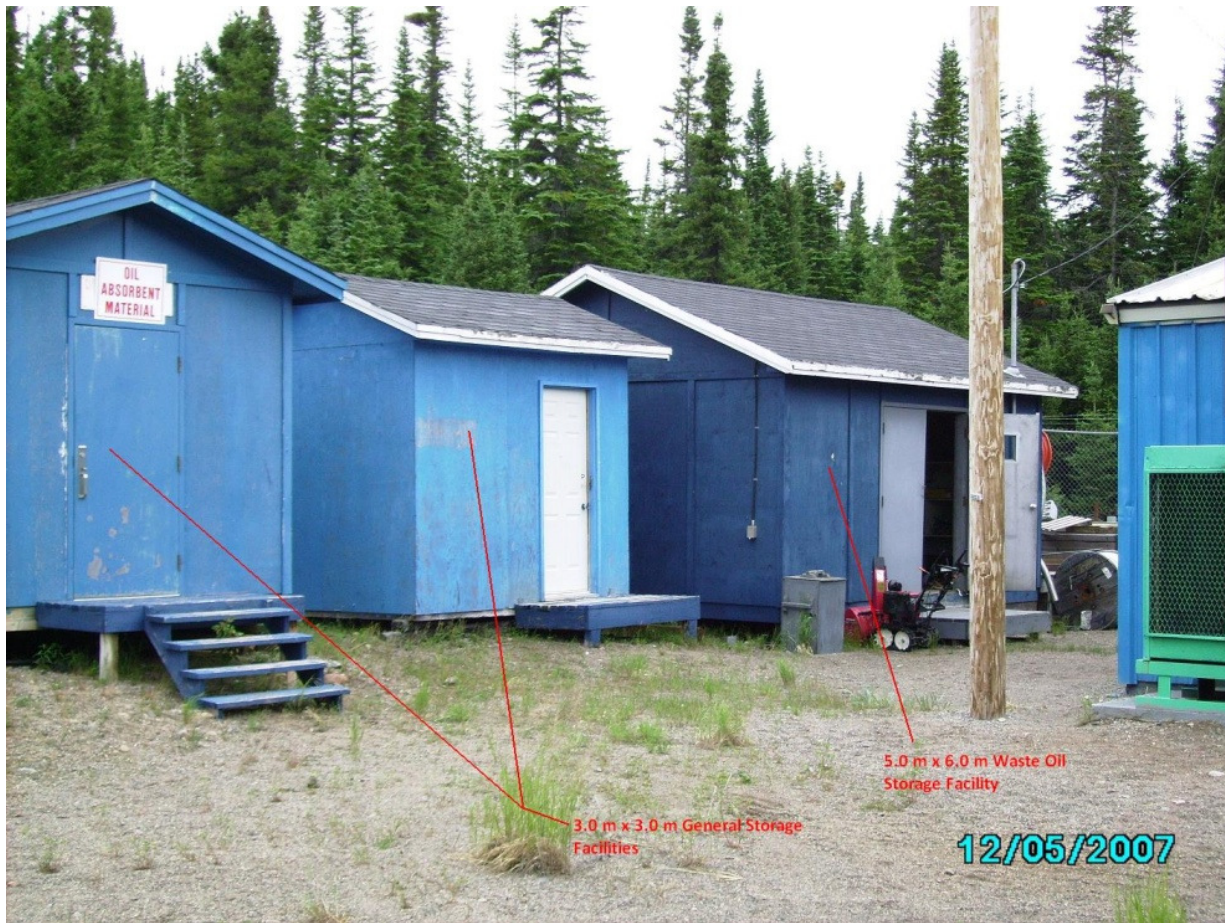
The Postville diesel generation facility was constructed in 1975. Measuring 6.09 m wide by 15.25 m long, the structure consists of a porch, a washroom, a small office area and an engine hall, which houses four diesel generating units. There is presently no work space or dedicated storage areas in the plant. Site storage is restricted to a 5.0 m x 6.0 m waste oil storage facility and two small 3.0 m x 3.0 m general storage sheds, located at the rear of the plant (see Figure 1).

**Figure 3: Postville Diesel Generation Facility General and Waste Oil Storage Buildings**

The absence of a proper workspace impedes the ability of the plant operators to conduct day-to-day maintenance work at the facility. This work is presently confined to a corner of the engine hall which restricts the ability of the employees to maneuver and complete the task at hand.

Presently, there is inadequate space available to meet Hydro's requirements. This creates both maintenance and safety concerns for personnel utilizing the facility. The requirement to store materials and equipment within the engine hall has resulted in inadequate clearances around the perimeter of the generation equipment. This hinders maintenance personnel's ability to follow proper work procedures when working on the equipment and results in a cluttered work space, with an increased potential for injury as a results of trips and falls. The construction of a new, detached structure is required to provide the required space and resolve these concerns.

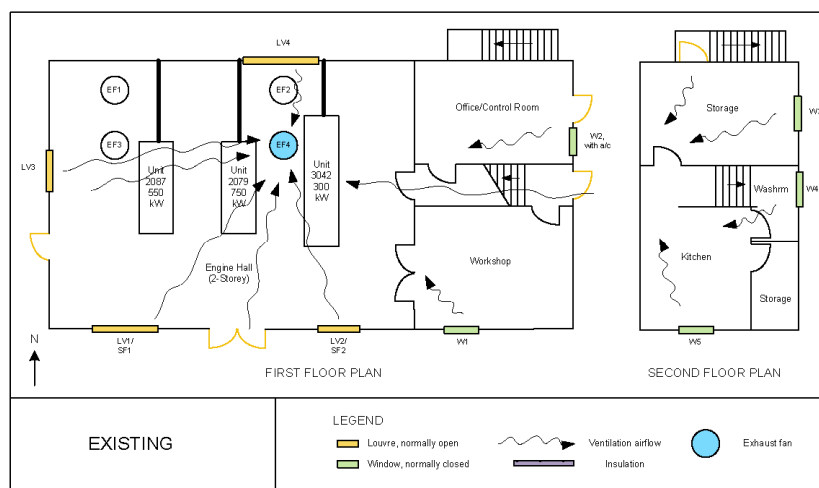
Charlottetown's Phase I site visit was conducted on November 13, 2012. On this day, the ambient temperature was 5°C, while inside the plant, it was 30°C. It was noted that most ventilation equipment was not operable. Only one genset (Unit #2034) was running, only one exhaust fan was operating and all louvres, windows and doors were open.

**Figure 3-1: Charlottetown – Existing Ventilation System (Nov 13, 2012)**

Ventilation systems must be designed to operate with all doors and windows closed in case of bad weather. When plant personnel resort to opening all doors and windows for cooling relief, the system is not functioning properly. At the time of the site visit, ventilation air flow was not adequate. If the one operating exhaust fan was running at its design flow capacity, the temperature rise would theoretically only have been 10°C and inside temperature would have been comfortable. It is likely that the exhaust fan was running below capacity. Additionally, with only this fan running, the path of fresh supply air from the open louvres, windows and doors to the exhaust point was not "sweeping" over the warmest part of the operating generator. Although some air was being exchanged in the building, the warm air was not being removed at an adequate active rate.

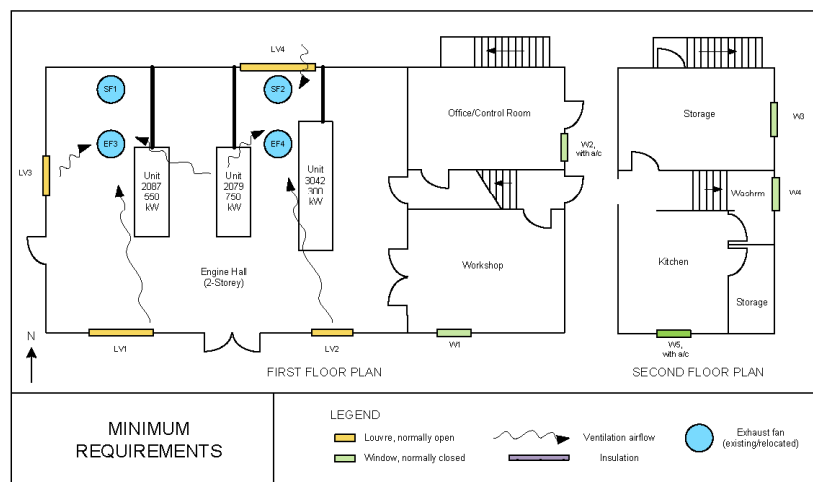
**Figure 3-5: Charlottetown – Minimum Requirements Schematic**

Heat rejection from all three generator sets running on full load is 493 kW without insulating the exhaust piping. This equates to a maximum ventilation requirement of 162,639 Am<sup>3</sup>/h (154,251 Am<sup>3</sup>/h cooling airflow and 8,388 Am<sup>3</sup>/h combustion airflow) to achieve a temperature rise of no more than 10°C.

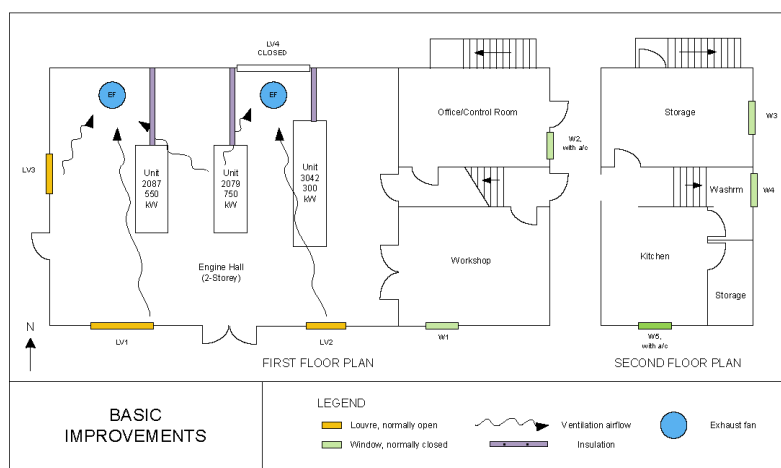
**Figure 3-6: Charlottetown – Basic Improvements Schematic**

In this scenario, heat rejection from all three generator sets running on full load is 329 kW with insulation on exhaust piping, which is a 33% reduction of the heat rejection rate to the building from the existing scenario. This equates to a maximum ventilation requirement of 111,243 Am<sup>3</sup>/h (102,855 Am<sup>3</sup>/h cooling airflow and 8,388 Am<sup>3</sup>/h combustion airflow).

- addition of a window air conditioning unit in the kitchen;
- installation of generator mounted crankcase breather filters to remove oil from the building atmosphere; and
- decommission the existing exhaust and supply fans and seal the existing exhaust fan roof openings.

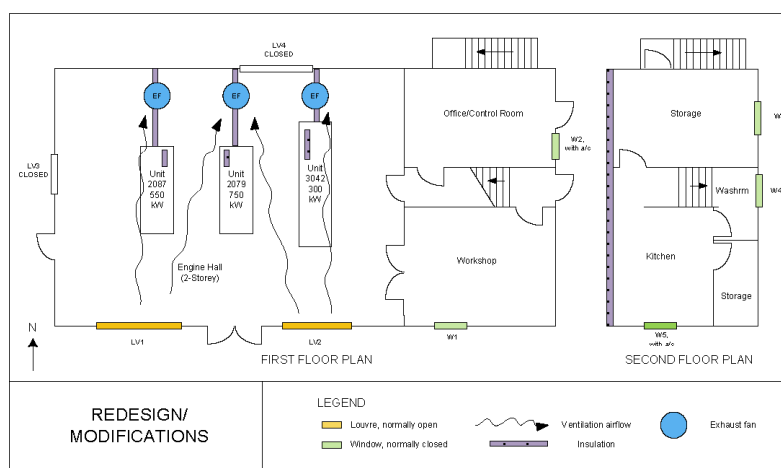
Figure 3-7: Charlottetown – Redesign/Modification Schematic

- Installation of three new 'corrosion resistant', direct-drive roof exhausters in new locations in the engine hall.
- Closure of supply louvres on the back and side walls relative to the generator sets (LV3 and LV4) to improve ventilation airflow routing.
- Replacement of the two existing louvres on the south wall (LV1 and LV2) with larger ones (equivalent to 1.8 m x 1.8 m each).
- Installation of insulation blankets on the exhaust piping and manifolds.
- Installation of insulation on the wall between the engine hall and the second-storey kitchen and storage rooms.
- Addition of a window air conditioning unit in the kitchen.
- Installation of three (1 for each generator) wall-mounted crankcase mist eliminators to remove oil from the building atmosphere.
- Decommission the existing exhaust and supply fans and seal the existing exhaust fan roof openings.

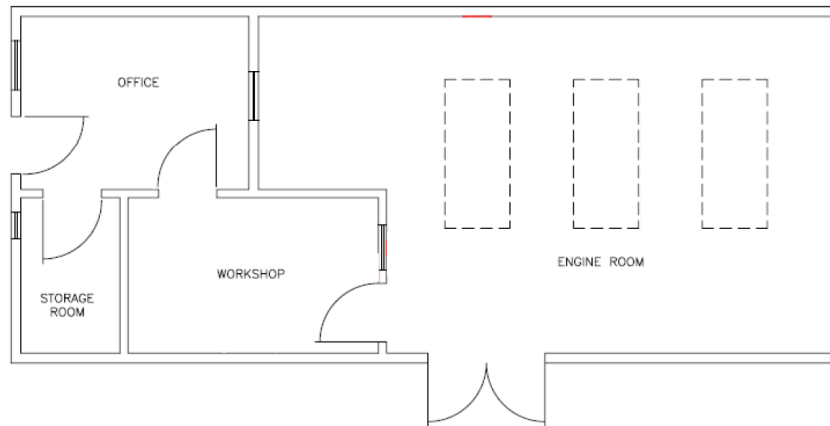
The original building appears to have a shallow concrete foundation supporting the exterior walls with a concrete slab on grade floor. The building extension appears to be constructed with a wooden floor on grade without a foundation wall extending below grade. The building is of wood frame construction with wooden roof trusses. It was reported that the building envelope develops open gaps during winter primarily along the connection between the original building and the extension.

Figure 5-1: Paradise River Original Floor Layout (Extension Not Shown)

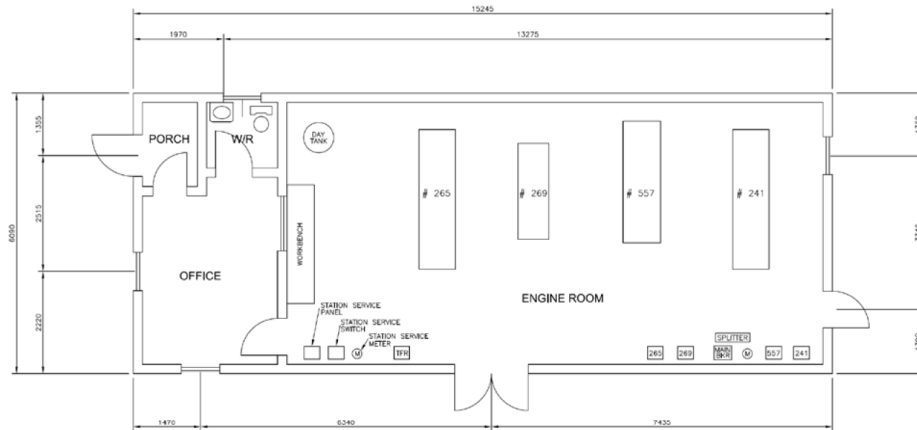
Postville's generator plant is a single storey building which consists of an engine hall, an office and a washroom. The plant currently has no workshop or dedicated storage areas.

Figure 6-1: Postville Floor Layout

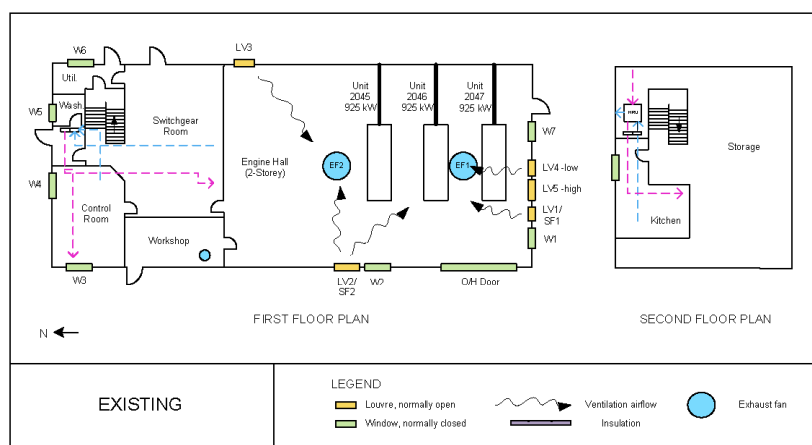
Historical weather data most representative of the Ramea location was obtained from Environment Canada's Port aux Basques station. The mean daily maximum temperature in August is 18°C (considered to be summer maximum) while the mean daily minimum temperature in February is -10°C (considered to be winter minimum). Winds are most frequently from the east at an average speed of 24.4 km/h. Exposure to the harsh climate and high levels of salt in the air has been the main cause of ventilation system equipment failure at this plant.

**Figure 7-1: Ramea – Existing Ventilation System**

Heat rejection from all 3 generator sets running on full load is 718 kW without insulating the exhaust piping/mufflers. This equates to a maximum ventilation requirement of 237,864 Am<sup>3</sup>/h (224,742 Am<sup>3</sup>/h cooling airflow and 13,122 Am<sup>3</sup>/h combustion airflow) to achieve a temperature rise of no more than 10°C.

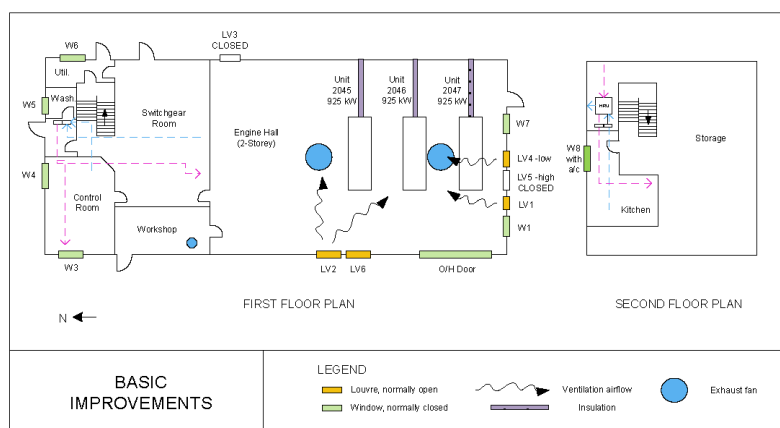
**Figure 7-2: Ramea – Basic Improvements Schematic**

In this scenario, heat rejection from all 3 generator sets running on full load is 355 kW with insulation on exhaust piping and mufflers, which is a 51% reduction of the heat rejection rate to the building from the existing scenario. This equates to a maximum ventilation requirement of 124,255 Am<sup>3</sup>/h (111,133 Am<sup>3</sup>/h cooling airflow and 13,122 Am<sup>3</sup>/h combustion airflow).

- replacement of the window on the west wall of the engine hall (W2) with a supply louvre (LV6);
- installation of insulation blankets on the exhaust piping and mufflers;
- installation of generator mounted crankcase breather filters to remove oil from the building atmosphere;
- addition of a window air conditioning unit in the kitchen; and
- decommission the existing exhaust and supply fans and seal the roof and wall openings.

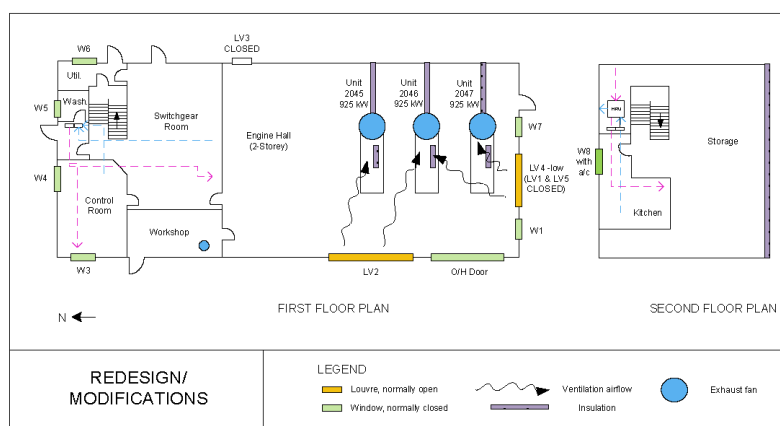
**Figure 7-3: Ramea – Redesign/Modification Schematic**

Heat rejection from all 3 generator sets running on full load, is 341 kW with insulation on exhaust piping/mufflers and manifolds which is a 53% reduction of the heat rejection rate

- sealing of the existing exhaust and supply fan and 2 window roof and wall opening.

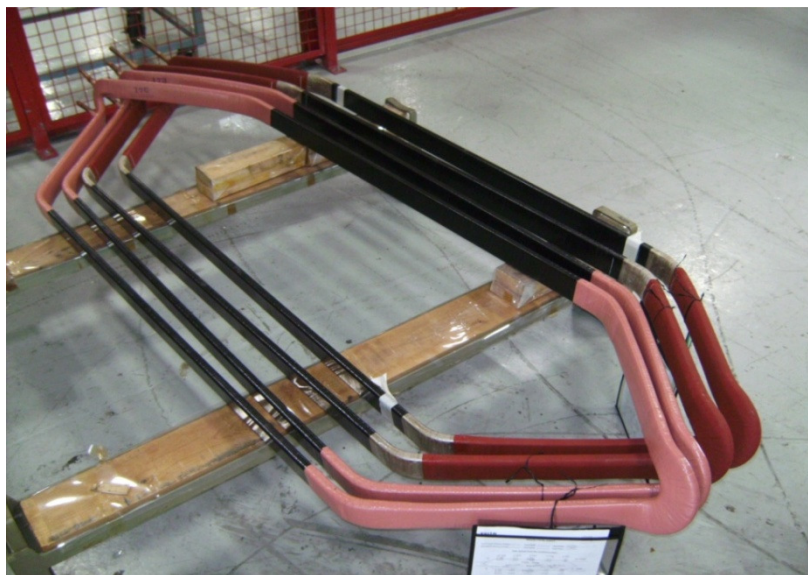
Replacement cost for metal siding are based unit rates from Hanscomb 2012 Yardsticks For Costing - Canadian Construction Cost Data, for St. John's, NL.

series of copper coils that as a complete unit form the stator winding. Physically, the rotor is a series of large magnets that when rotated inside the stator's ring of copper coils will produce electricity. The stator winding on Unit 3 has an asphalt mica tape design to insulate the copper coils. An insulation system is required to prevent the copper coils from coming in contact with each other and the amount of electrical protection from the insulation is known as the dielectric strength. Because of age, the asphalt mica tape insulation on the Unit 3's stator coils have become dry and brittle, reducing the mechanical and dielectric strength of the insulation, making it more susceptible to failure. The repair or replacement of any one stator coil is quite complex and involves the removal of approximately 25 additional coils due to the inter-twining coil design of the stator winding and its coils. Due to aging and the brittle nature of the coils, any attempted stator coil repairs are expected to lead to additional failures in other adjoining stator coils because of the disturbance caused by their removal.

Based on previous stator winding replacements on Units 2, 4 and 1 the operating lifecycle of the stator winding on Unit 3 is known. The physical condition of the stator winding for Unit 3 is showing similar indicators of deterioration as Units 2, 4 and 1 did at the same period of their lifecycle. This deterioration includes cracking in the winding insulation and asphalt

seeping from the winding, all being indicators of the insulation breakdown. The Unit 3 stator winding was assessed, with the 2012 results from AMEC Americas Limited (AMEC) attached as Appendix A. This report concluded that the stator winding of Unit 3 has reached the end of its useful serviceable life and a planned replacement should be executed. Hydro is proposing this project to replace Unit 3 stator winding before a failure or unplanned outage of Unit 3 occurs.

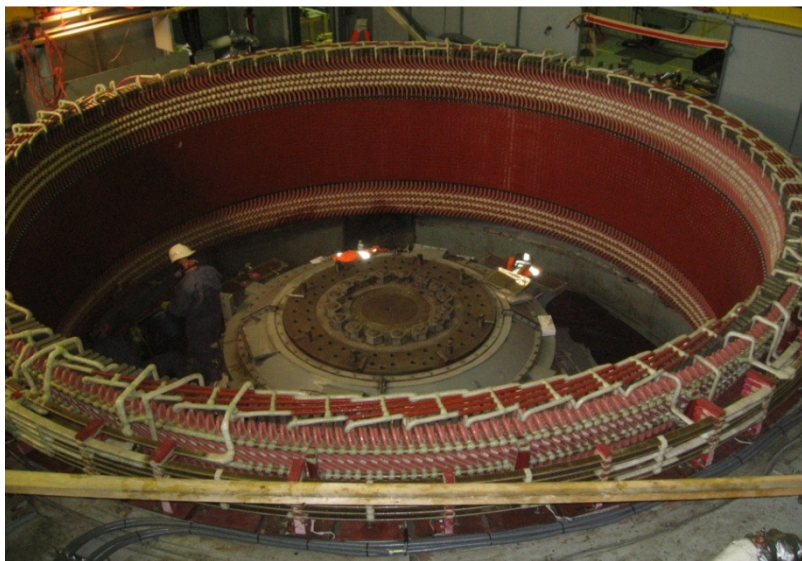
Figure 2 below shows the Unit 2 stator winding completed in 2010. The work to be completed on Unit 3 would be very similar in nature.

**Figure 2: Stator at Bay d'Espoir with Rotor Removed**

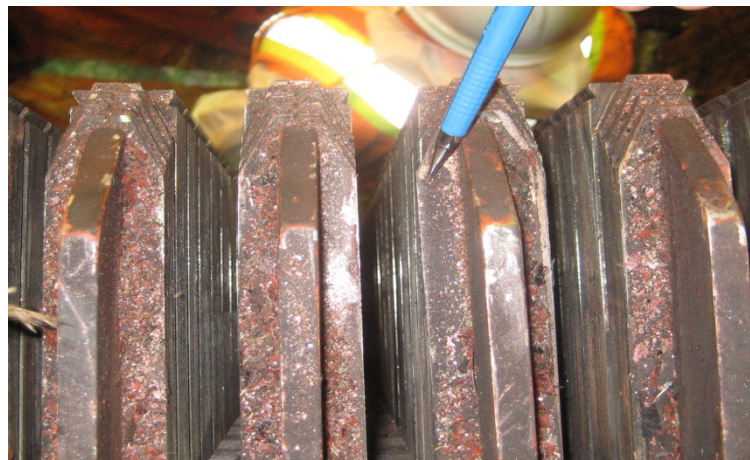
**Figure 4: Migration of Stator Core Laminations—Looking Downward with Stator Winding Removed**

Another area of concern involves the work previously completed on the removal of the stator winding from Unit 2, where the stator coils were found to be migrating from their stator core slots, or moving out of alignment. The stator core is a mechanical circular structure compiled from a series of steel laminations that physically supports the stator coils inside individual slots. During the removal of Unit 2, it was discovered that the laminations had shifted and were slowly moving out of alignment. The area of concern with

stator core migration is the tension normally on the coil in the core slot is now being migrated on a coil against the stator core and not a slot. The core begins to cut into the coil, eventually getting through the insulation to the conductor creating a coil failure and an electrical fault. The situation is analogous to cables chafing against each other and wearing through their insulation. Figure 4 shows the misalignment of the laminations discovered on Unit 2 in 2010. Unit 3 is similar in age and construction and concern is raised as it may exhibit similar issues.

The replacement of the stator winding involves the removal of the existing 360 stator coils along with the supply, installation and commissioning of new stator coils. The scope of work is to be completed by a contract manufacturer, including abatement if required, as was previously done on Units 2, 4 and 1. The work would also include an upgrade to the generator protection and the refurbishment of rotor pole components. This work is required to ensure the new stator will operate to its full capability.

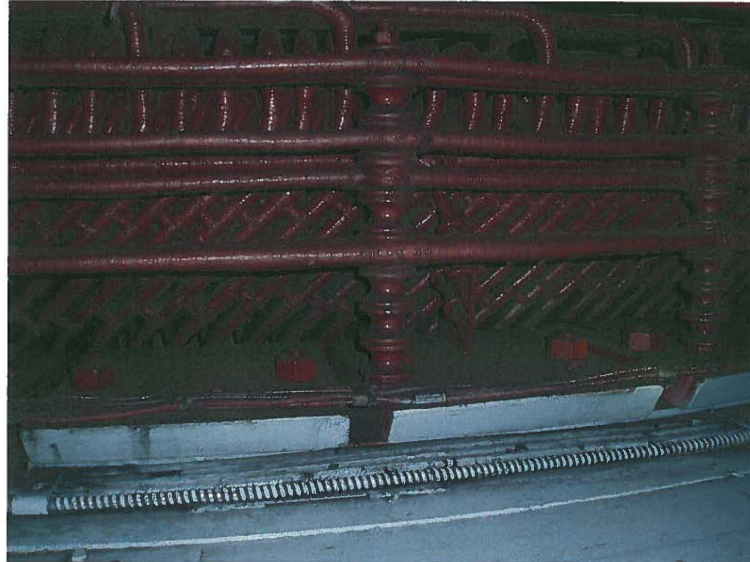
Photograph 009 – Stator top windings looking clean.

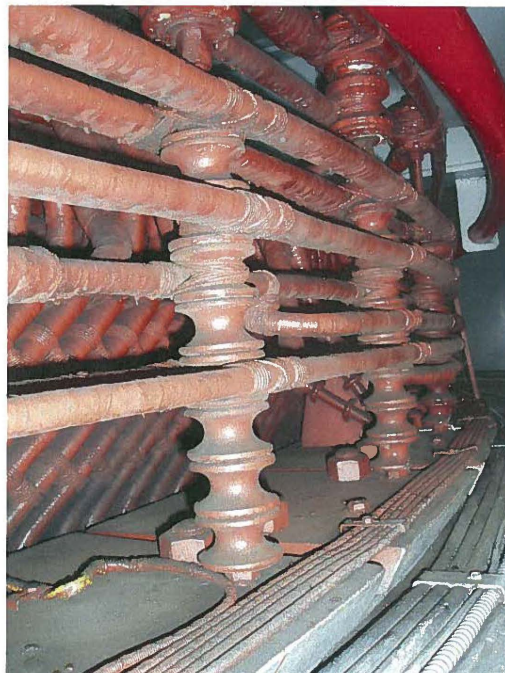
Photograph 013 – Stator top windings showing dusty conditions.

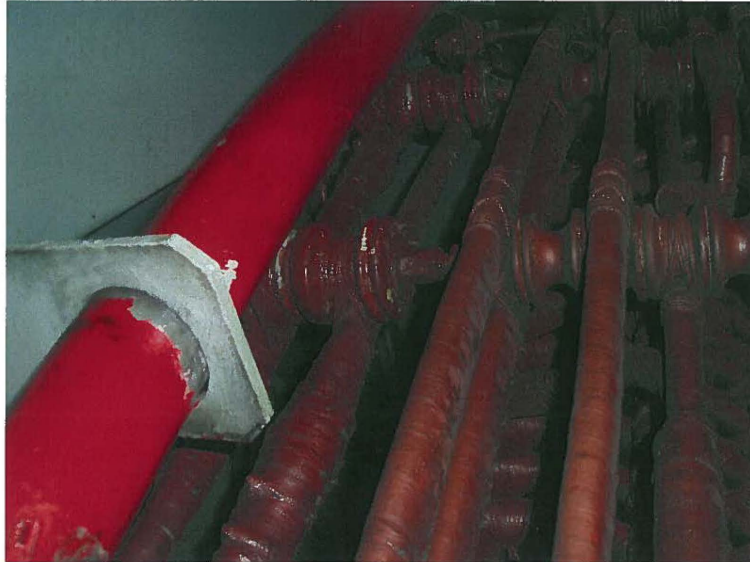
Photograph 016 – Indicates some vibration. See the paint stripped where the pipe slip fits in the bracket.

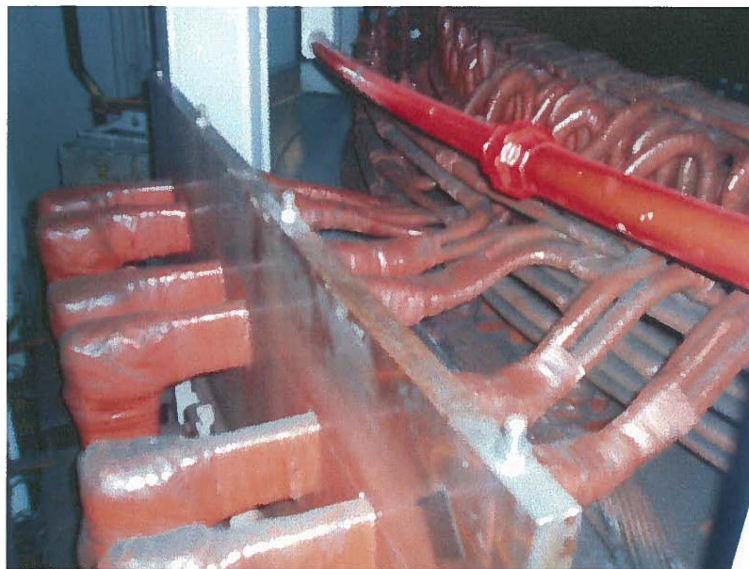
Photograph 020 – Terminations at one end of stator top windings indicates old dust and dirt contamination although there has been cleaning.

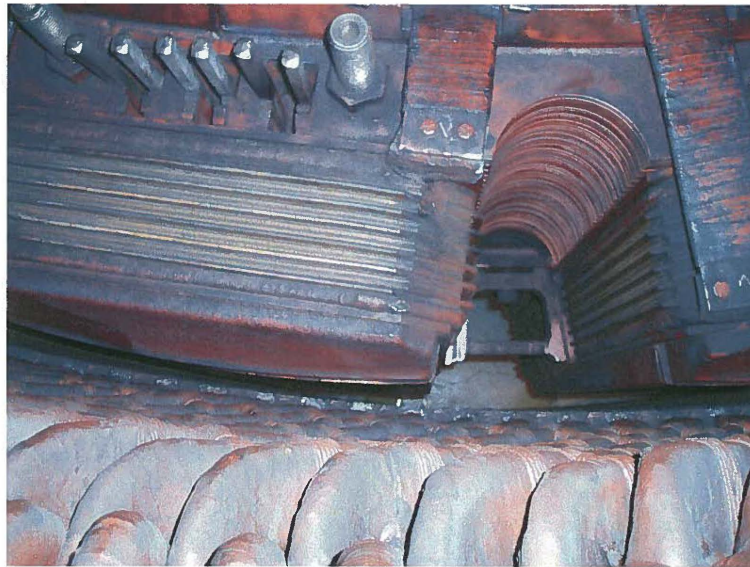
**Photograph 023**

Photograph 023 – Top of stator and rotor showing the air gap. Although cleaned still shows old contamination.

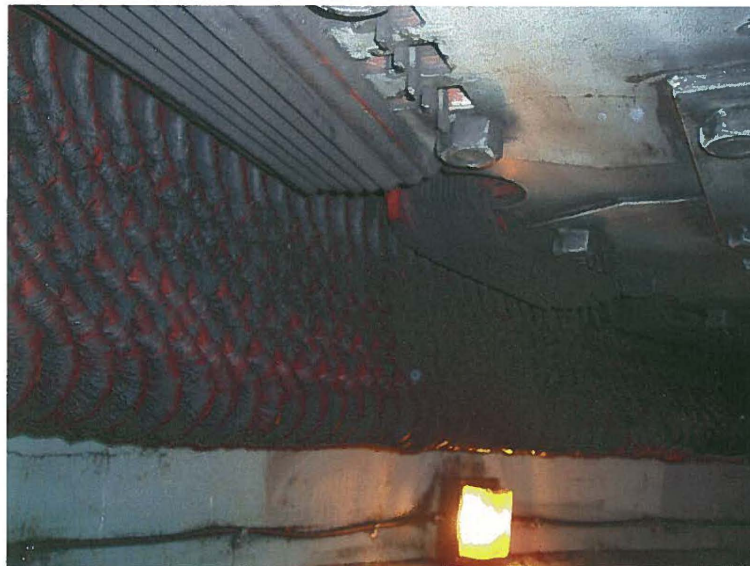
**Photograph 036**

Photograph 036 – Stator bottom windings showing age and ingrained dust and oil contamination.

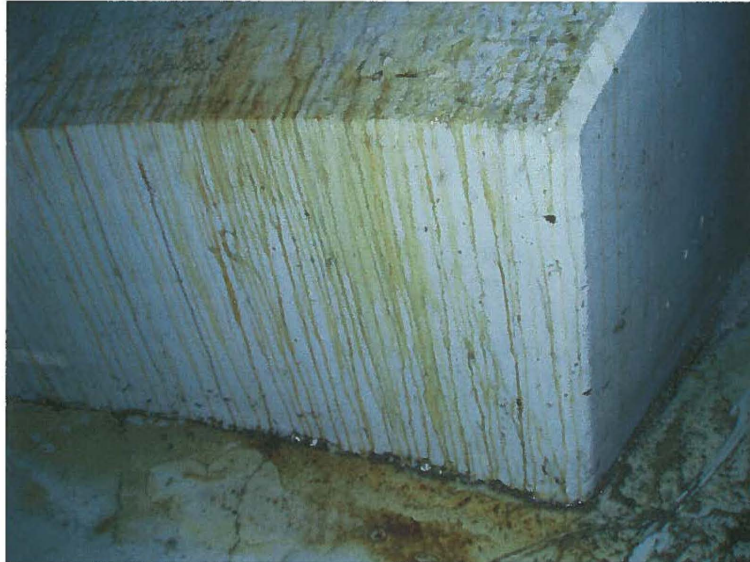
**Photograph 041**

Photograph 041 – Oil contamination on the underside of the generator. This area has been cleaned but still shows the old contamination.

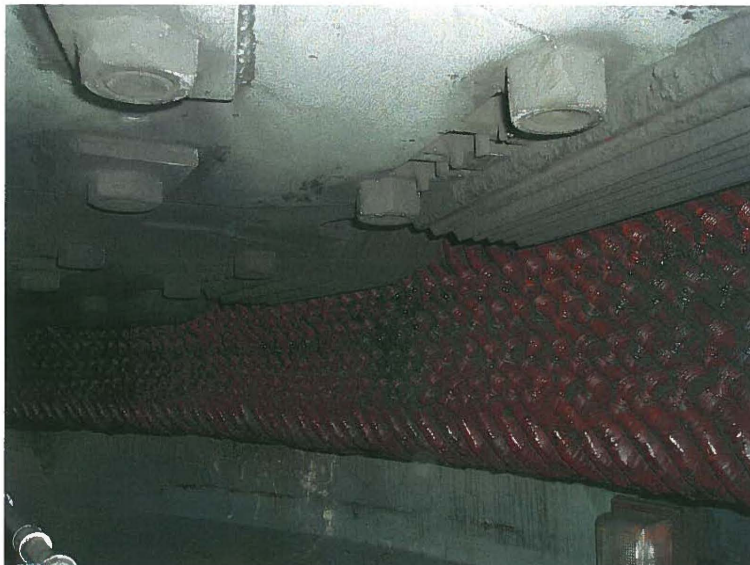
**Photograph 046**

Photographs 046 – Stator winding has been cleaned. Rotor does not appear to have been cleaned.

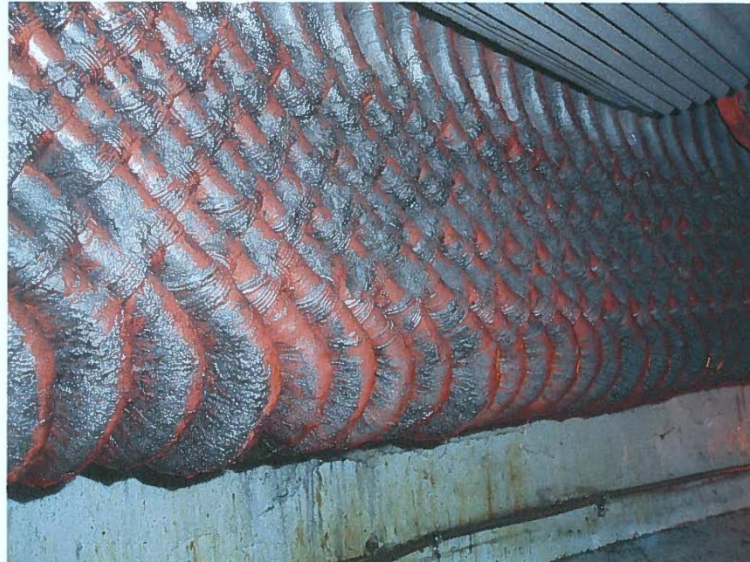
**Photographs 047**

Photographs 047 – Stator bottom winding. Although having been cleaned show oil and dust contamination from the years of service.

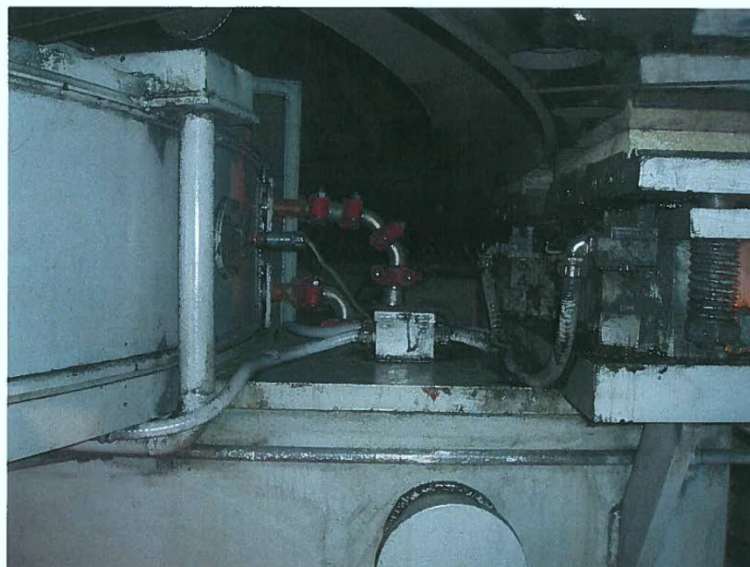
**Photograph 050**

Photograph 050 – Oil film near brakes. Can see silhouette of the junction box in the horizontal surface.

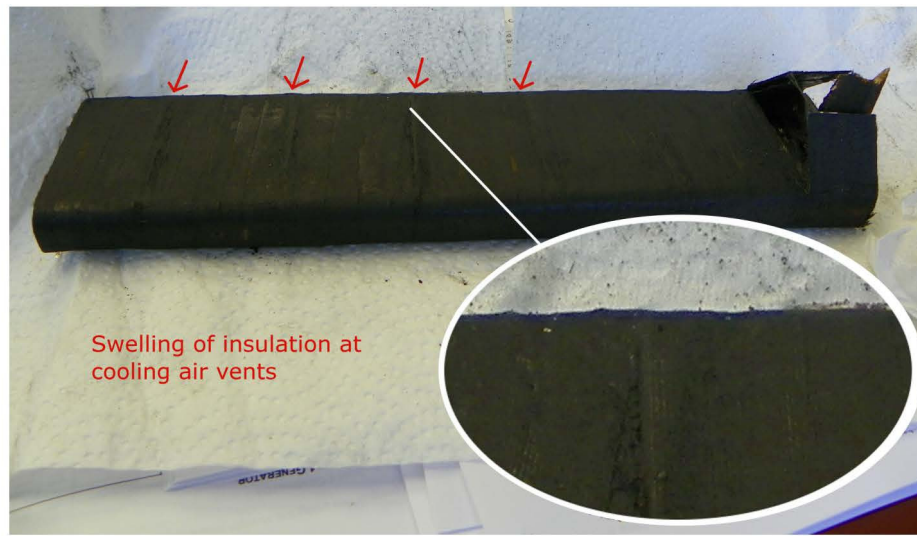
Air vent swell

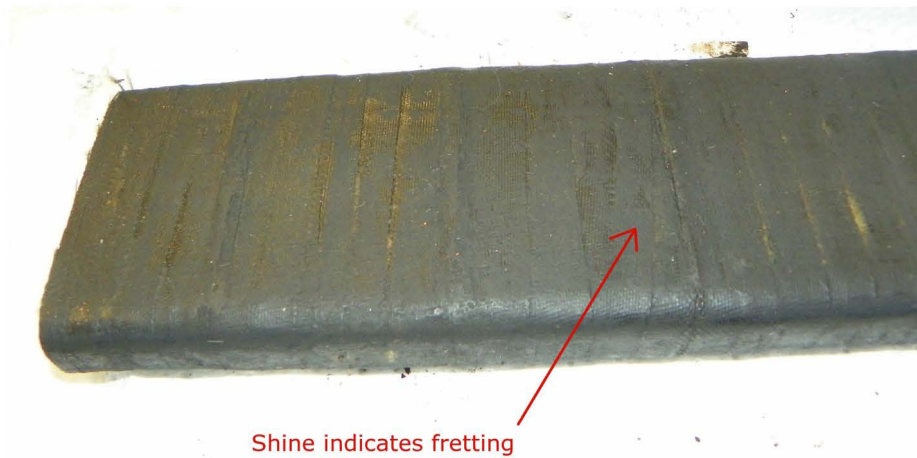
Fretting

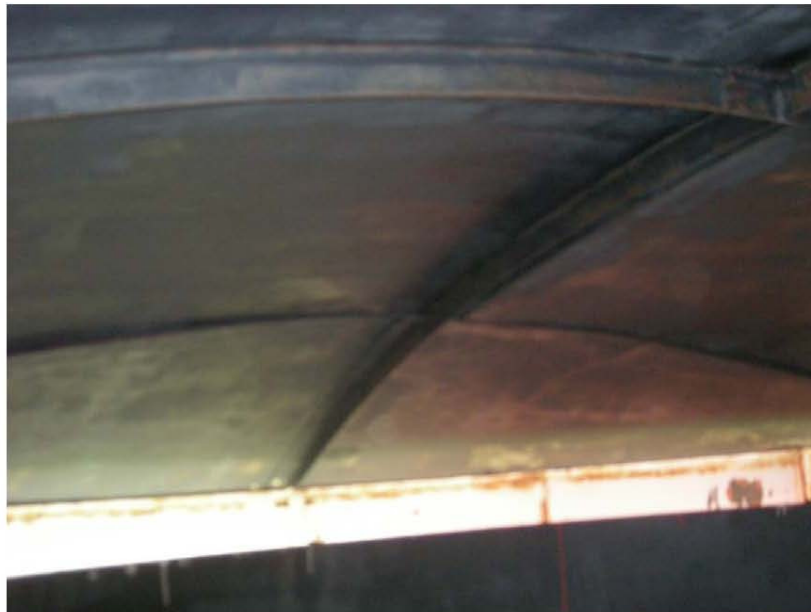
Figure 3-1: Tank Top Interior

The tank top as shown in Figure 3-1 is constructed with a series of stiffener ribs covered with lap jointed plates. The original drawings show a 1" (25 mm) lap between the roof plates, welded on the outside only. It was observed that the inside lap has opened up. It is unknown if this occurred during construction or if this occurred over time due to plate sagging.

The coating system on the tank top interior appears to be in good condition with some minor localized coating breakdown.

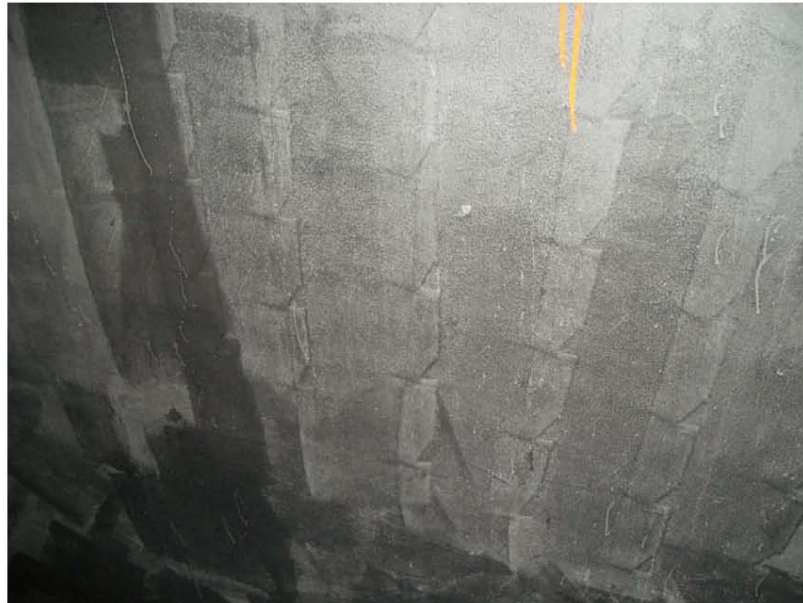
Figure 3-2: Tank Shell Interior Above Hot Water Heating System Inlets

From the top of the shell to roughly the mid-height as shown in Figure 3-2, the coating system appears to be intact with some minor localized breakdown.

It is recommended that all localized areas of coating breakdown on the tank shell interior be refurbished in accordance with SSPC-SP 11 and a coating system be applied.

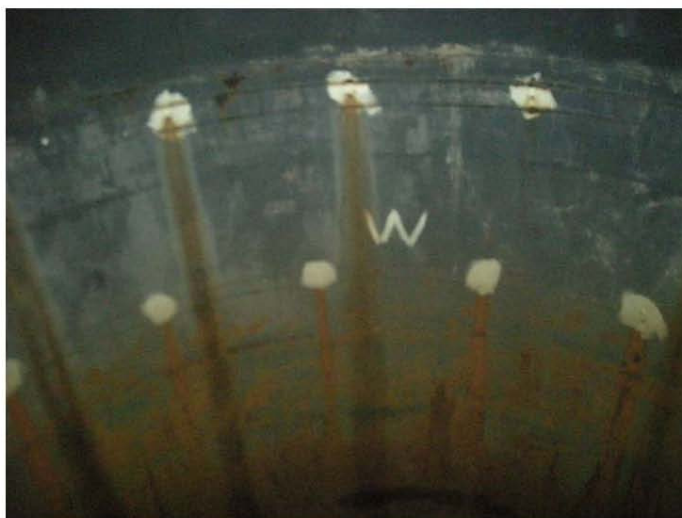
Figure 3-3: Tank Shell Interior at Mid-height Near Hot Water Heating System Inlets

At roughly the mid-height, there are two sets of inlet ports for the hot water heating system, one above the other as shown in Figure 3-3. The bottom ports, installed during the original construction of the surge tank are plugged and no longer operational. The top ports are
