**Re: Newfoundland and Labrador Hydro – 2014 Capital Budget Application**

**An Application to the  
Board of Commissioners of Public Utilities**

# **2014 CAPITAL BUDGET**

### **VOLUME I**

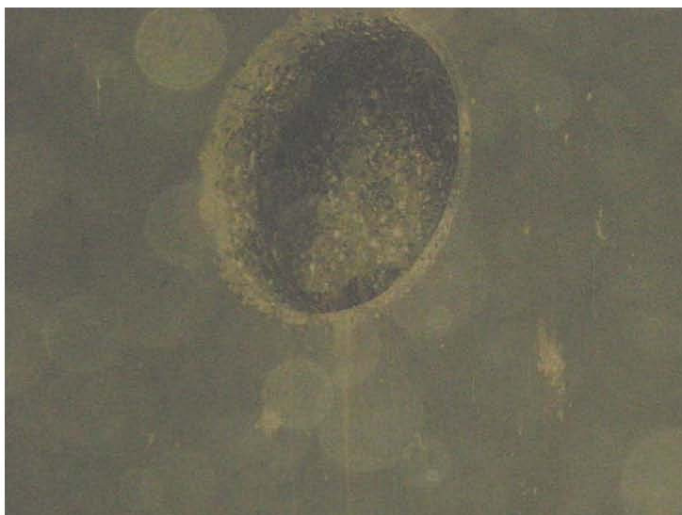
Figure 3-4: Tank Shell Interior at Bottom Showing Manhole

Around the manhole at the bottom of the tank shell, as shown in Figure 3-4, there appears to be some significant coating breakdown and corrosion.

It is recommended that all localized areas of coating breakdown on the tank shell interior be refurbished in accordance with SSPC-SP 11 and a coating system be applied.

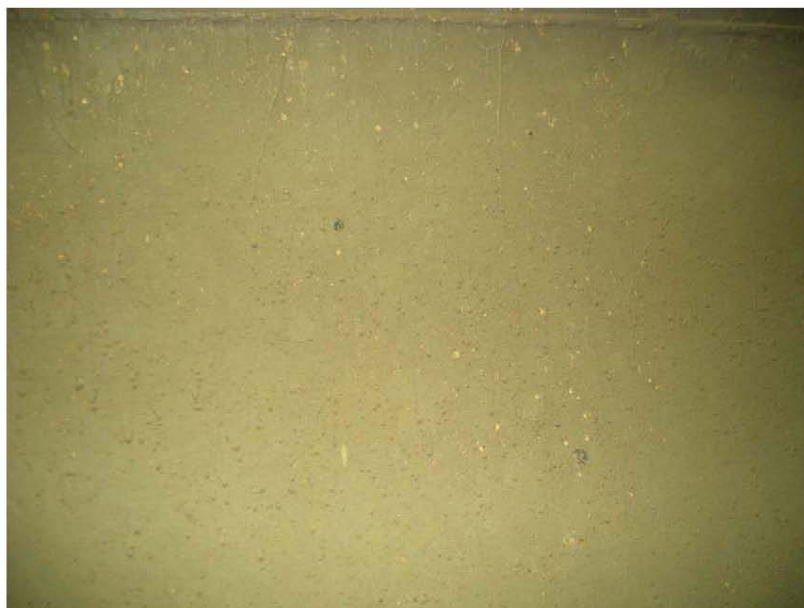
Figure 3-5: Interior of Tank Bowl

As shown in Figure 3-5 and Figure 3-6 (photos taken during the inspection), it appears that the tank bowl is coated similar to the riser. Also, NL Hydro's documentation (Newfoundland and Labrador Power Commission, Operating and Maintenance Instructions, Volume 1 prepared by ShawMont Newfoundland Ltd.) states that the interior of the tanks, riser and 50 ft of the pressure conduit were originally blasted and painted with three coats of tar epoxy with total thickness of 10 mils.<sup>[1]</sup>

The existing coating appears to be in good condition with some localized coating breakdown. It is recommended that these localized areas be refurbished in accordance with SSPC-SP 11 and a coating system be applied.

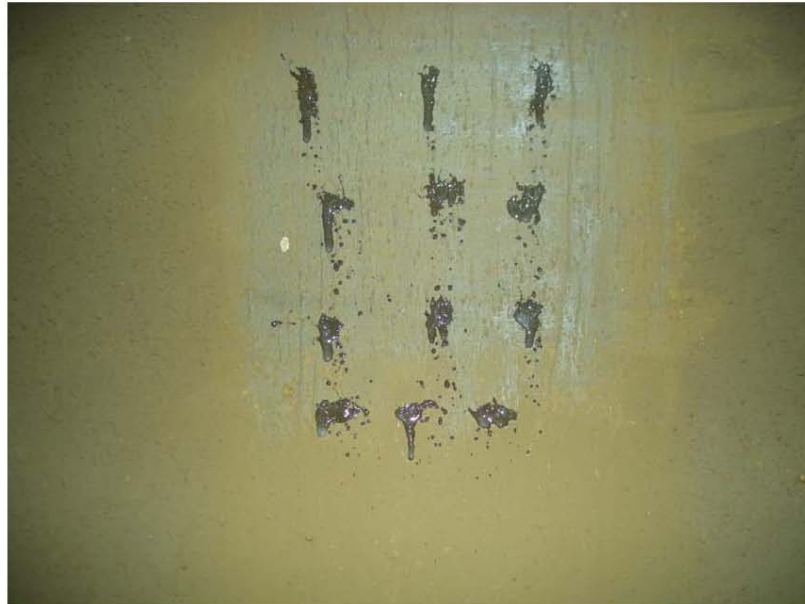
Figure 3-6: Interior of Tank Bowl with UT Couplant

Figure 3-6 shows couplant at attempted UT reading locations. Lighter area underneath couplant is from scrapping with wire brush.

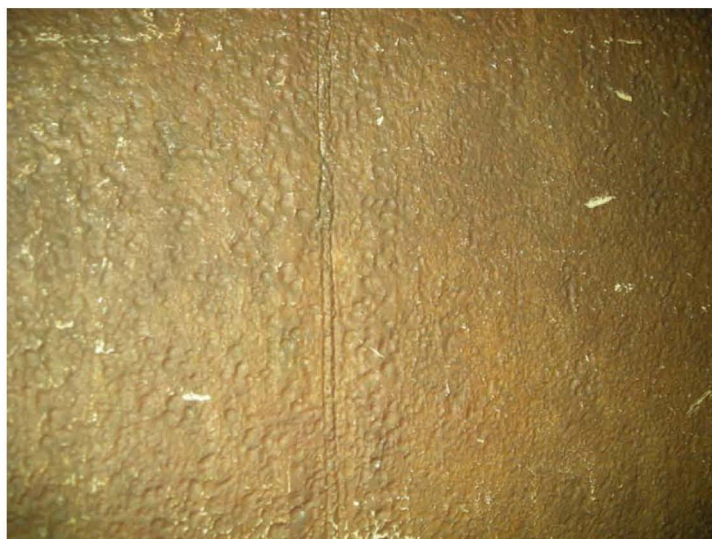
Figure 3-7: Interior of Riser

The riser appears to have experienced some corrosion prior to the application of the most recent coating system as shown in Figure 3-7Figure 3-7 and Figure 3-8Figure 3-8. The steel surface beneath the coating system is not smooth. This coating system appears to be in good condition.

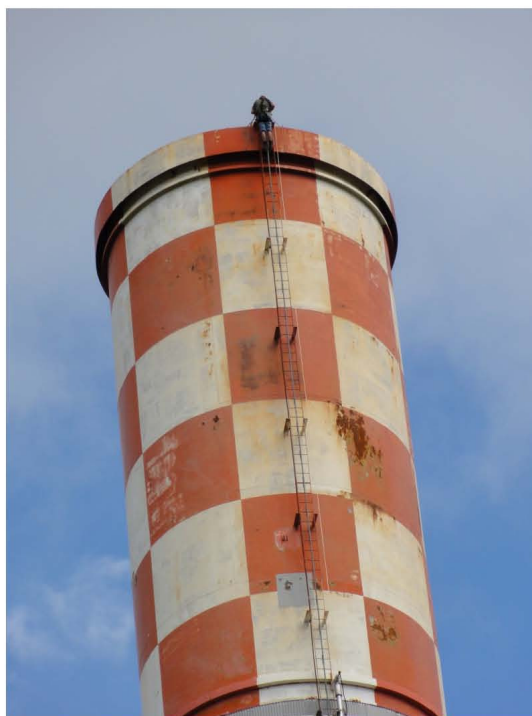
Figure 4-2: Surge Tank Shell Above External Insulation

The surge tank shell above the external insulation system has significant coating breakdown as shown in Figure 4-2. The coating system on Surge Tank #3 was in the worst condition of all three surge tanks. It is recommended that the areas of localized coating breakdown and corrosion be refurbished in accordance with SSPC-SP 10 and a compatible coating system be applied to the entire surge tank shell above the external insulation system.

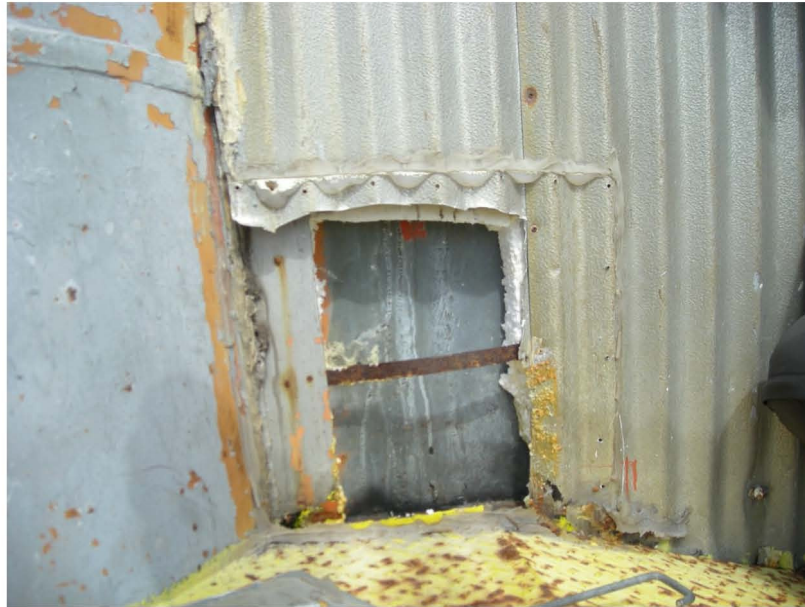
Figure 4-3: Cladding Removed Adjacent to Leg

Cladding and insulation was removed adjacent to the west leg on the upper balcony to expose the exterior of the surge tank shell bottom course and leg attachment as seen in Figure 4-3. There were no visible signs of corrosion in this area.

UT readings in a four by four grid pattern were taken in this area (see Section 4.2 of the RAT report). Readings 1a, 1b, 1c and 1d were taken on the 3/4" (19.1 mm) thick column plate. The results are consistent with the reference drawings and show little to no corrosion.

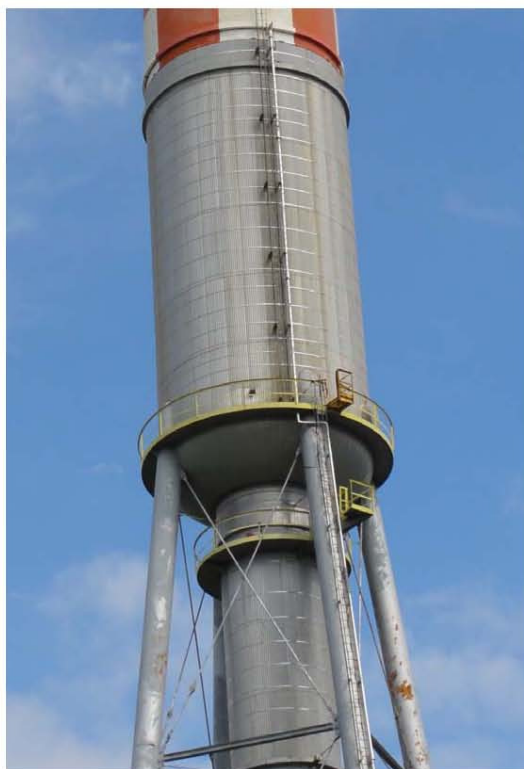
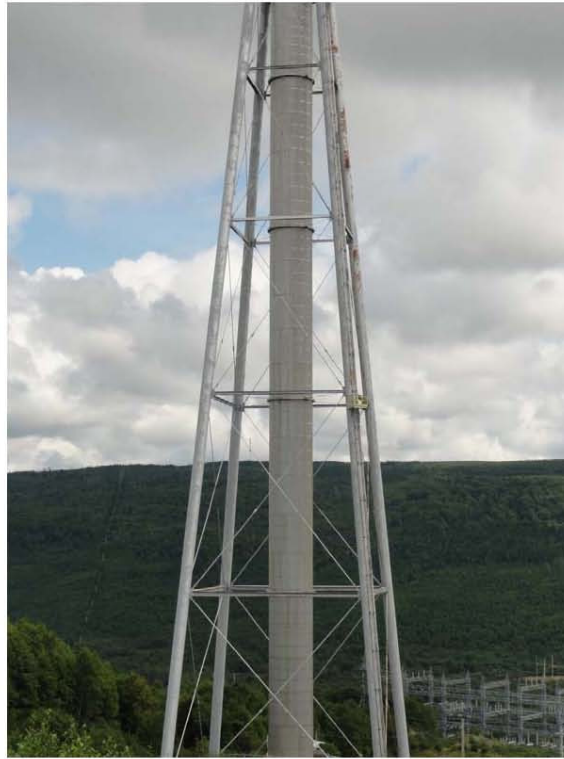
Overall, the external cladding was intact as shown in Figure 4-4 and Figure 4-5. There was some water staining present on both the surge tank shell and the riser. The water staining appears to be originating from the hot water heating system ring header piping on the surge tank shell and from the four attachment points of the horizontal rod bracing to the riser.

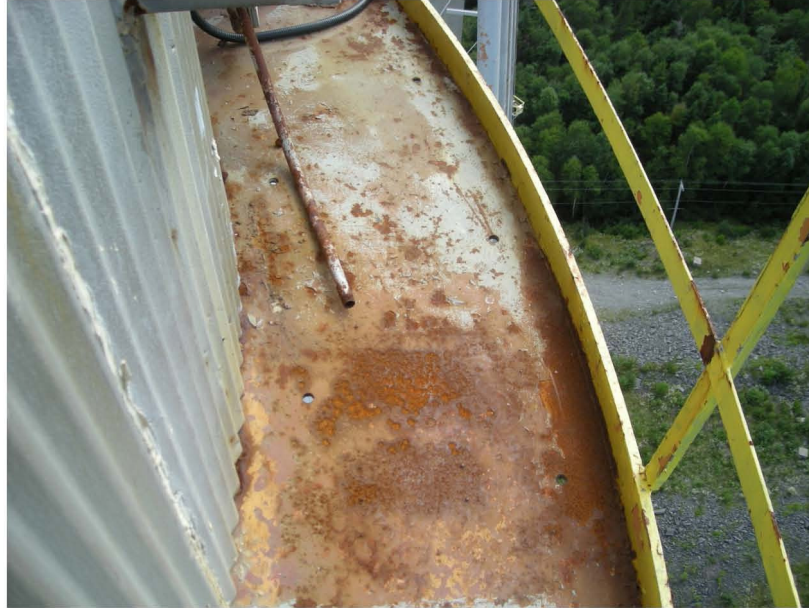
Figure 4-6: Compression Ring / Upper Balcony

The compression ring is a critical structural element located at the attachment of the legs to the surge tank shell, which also functions as the upper balcony. As shown in Figure 4-6, there was significant coating breakdown on the compression ring which has resulted in corrosion caused by pooled water. This was also reported as an issue in 2002. It was recommended in 2002 that more drain holes be added closer to the railing, where pooling was more prevalent. One area on the top balcony showed severe corrosion and it was suggested that a patch plate be welded in this location.<sup>[7]</sup>

From a comparison of Figure K-3 in the 2002 RAT report with Figure below, it is unclear if the recommendations reported in 2002 were acted on, but it is clear that the compression ring is in worse condition now than in 2002. It is recommended that the compression ring be

refurbished per the RAT 2002 report and in accordance with SSPC-SP 10 and a coating system applied.

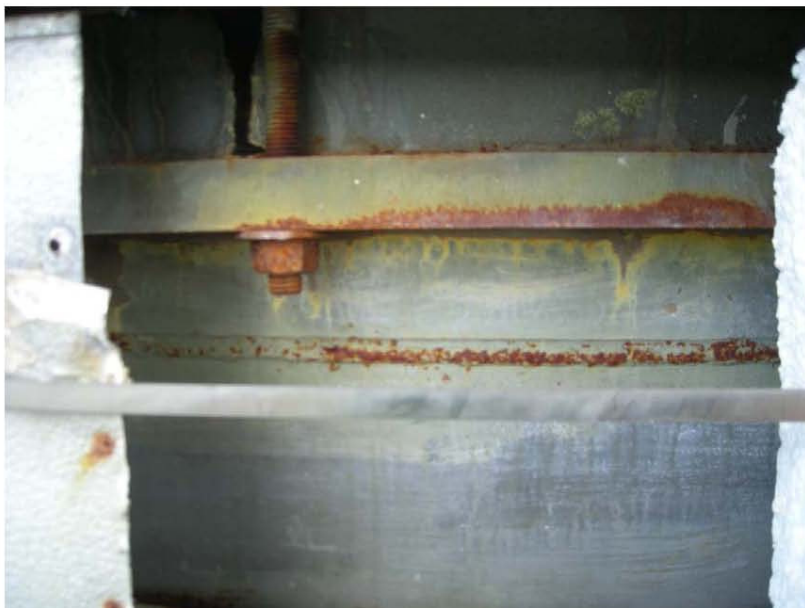
Figure 4-7: Cladding Removed Showing Expansion Joint at Lower Balcony

External cladding and insulation was removed on the lower balcony exposing the expansion joint as shown in Figure 4-7.

UT readings were taken in this area (see section 4.3 of the RAT inspection report). A series of 16 readings were taken in a 4x4 grid. Readings 1a, 2a, 3a and 4a (taken above the weld seam) were taken on 1/2" (12.7 mm) thick plate. The remaining readings were taken on 3/8" (9.5 mm) thick plate (below the weld seam). The results are consistent and show little to no corrosion in this area.

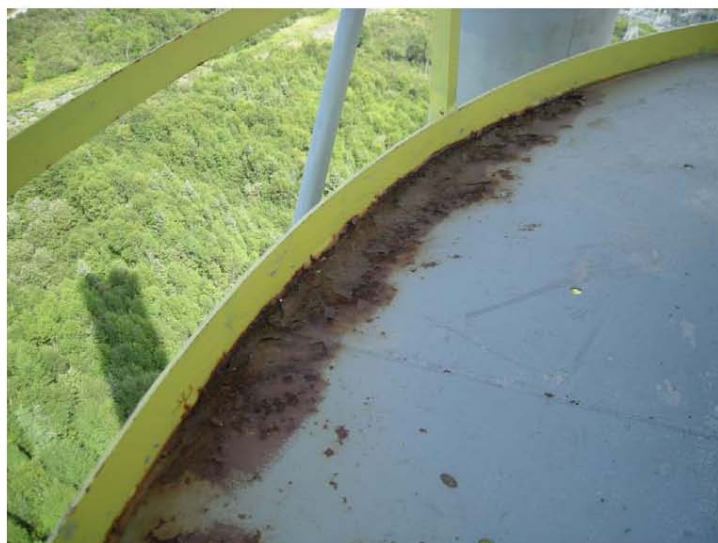
Figure 4-8: Lower Balcony

The lower balcony appears to be in good condition with some localized coating breakdown and corrosion, likely resulting from water build-up, as shown in Figure 4-8. It was in better condition than the upper balcony. The walkway from the ladder to the lower balcony shown in Figure 4-9 does not have a gate or chain at the ladder access point, which is a safety issue that should be corrected.

It is recommended that the lower balcony be refurbished in accordance with SSPC-SP 10 and a coating system applied.

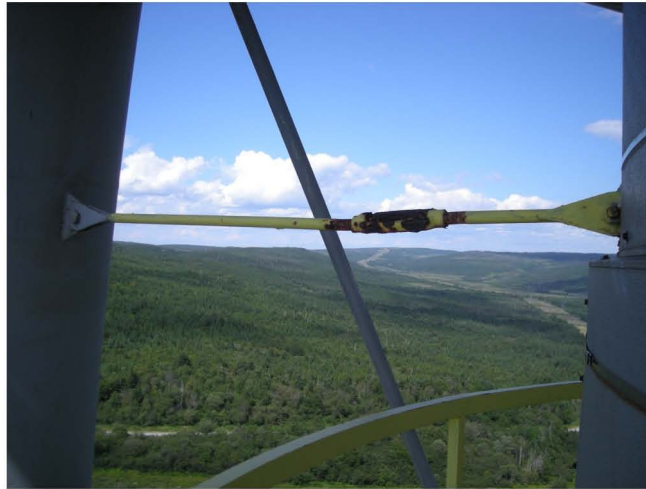
Figure 4-10: Erection Rods on Lower Balcony

RAT expressed concern that the turnbuckles and rod bracing as shown in Figure 4-10 are bent and show signs of heavy corrosion. From the reference drawings, these braces are noted as erection rods which were to be loosened after erection.

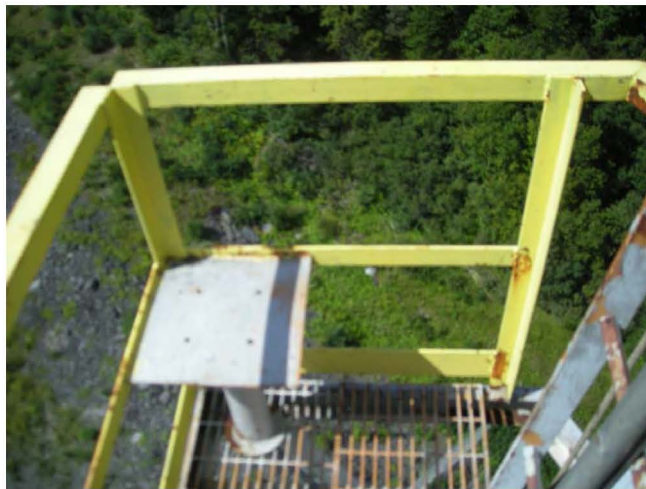
Figure 4-11: Lower Rest Platform (Crow's Nest)

Lower rest platform (referred to as the crow's nest by NL Hydro personnel) had some minor surface corrosion as shown in Figure 4-11. The grating hatch was functional.

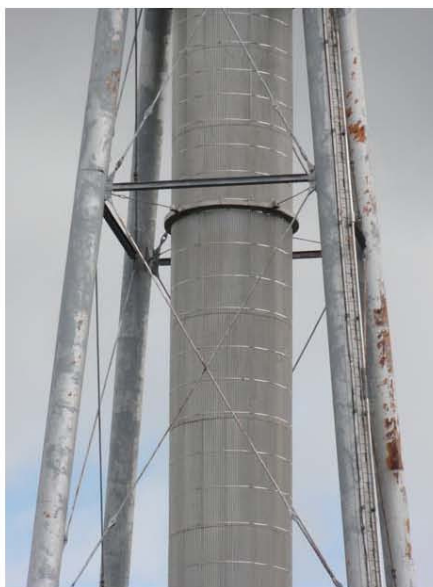
Figure 4-12: Structural Support Showing Coating Breakdown

The legs and struts had some coating breakdown as shown in Figure 4-12. It appears that the coating system was touched up in the past.

It is recommended that the areas of coating breaking be refurbished in accordance with SSPC-SP 10 and a compatible coating system be applied to the entire structure.

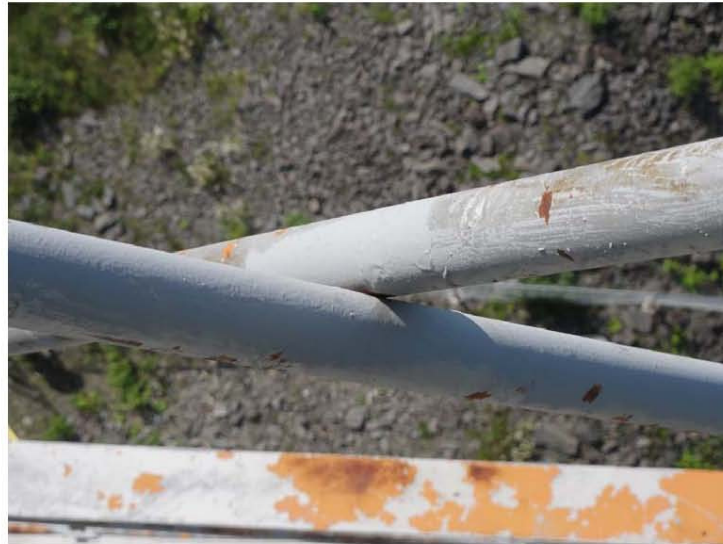
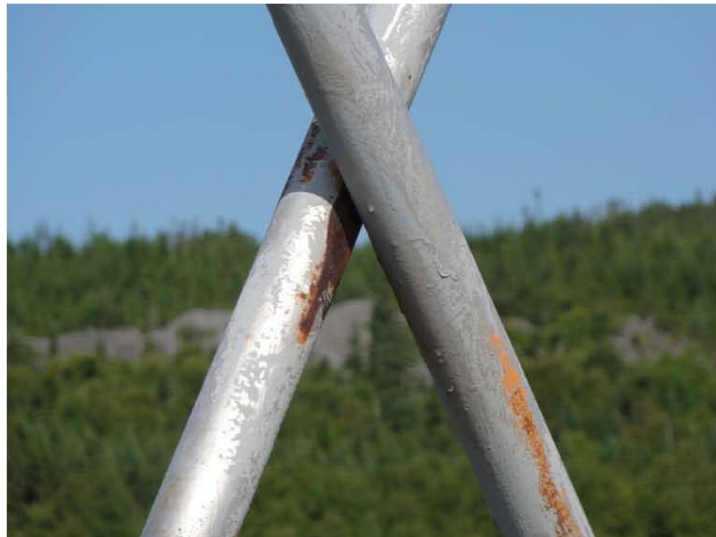
All diagonal bracing showed some signs of wear. Most appears to be in good condition with very little wear as shown in Figure 4-13. There are a few diagonal braces however with some excessive wear as shown in Figure 4-14. Wear of the diagonal bracing was also reported in 2002.<sup>[7]</sup>

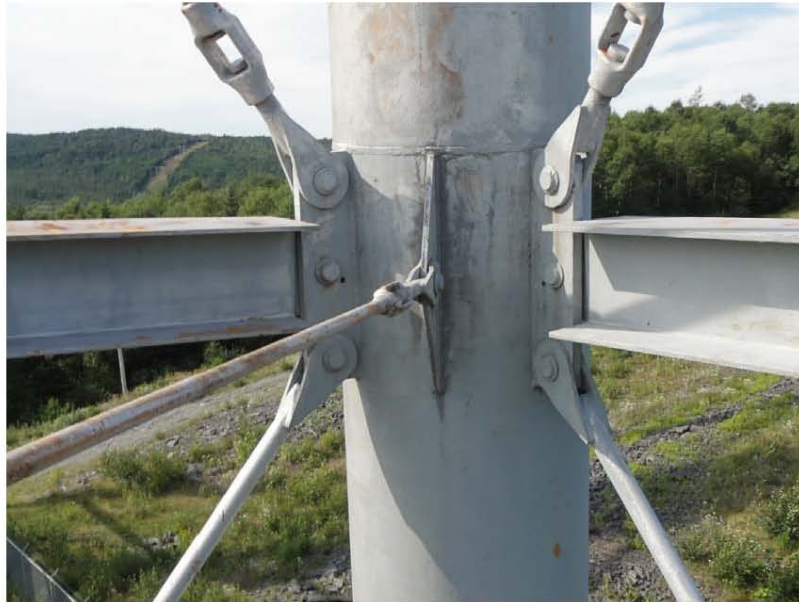
Figure 4-15: Typical Structural Support Connection

The connections appear to be in good condition with some minor coating breakdown as shown in Figure 4-15.

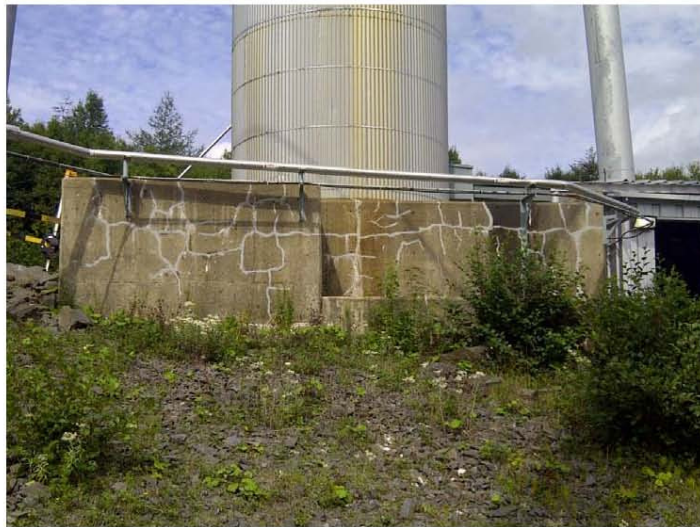
Figure 4-16: Riser Foundation

There was some minor efflorescence noted in a few areas with a larger area of efflorescence in one area on the downstream face of the riser foundation. There are no visible signs of oversteering or areas where the concrete has deteriorated to a point where portions of concrete have spalled off except for some minor surface deterioration in a few areas where water may not drain properly. It was noted that the foundations for Surge Tank 3 were more deteriorated in comparison to foundations for the other surge tanks.

Overall the visible foundation concrete appears to be in satisfactory condition.

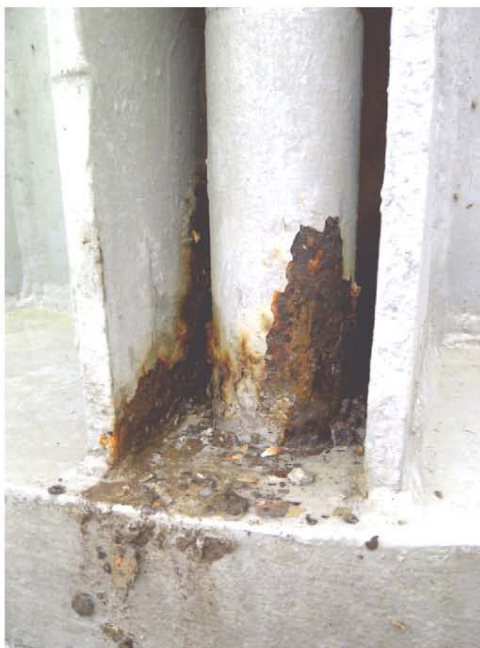
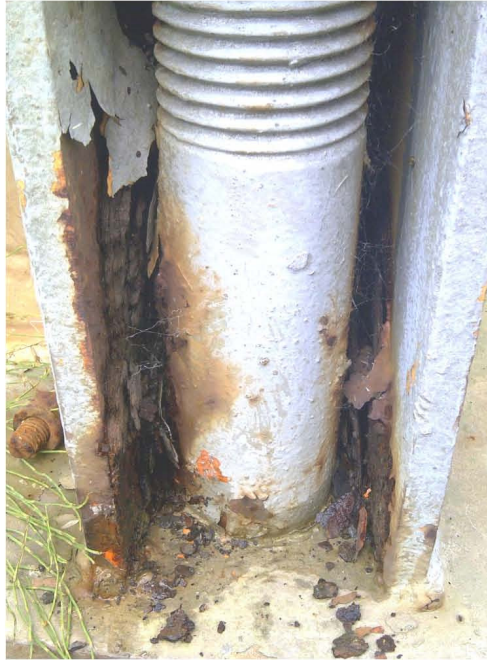
Most anchor bolts appear to be in good condition with some minor coating breakdown, with the exception of one anchor bolt on the north leg foundation and one anchor bolt on the west leg foundation. As shown in Figure 4-18 and Figure 4-19, there was significant coating breakdown corrosion at both the base of the anchor bolts and the anchor chairs. It is recommended that these anchor bolts be refurbished in accordance with SSPC-SP 10 and a coating system applied.

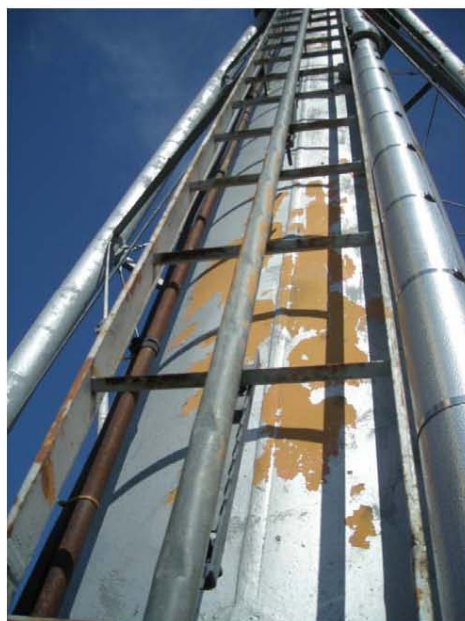
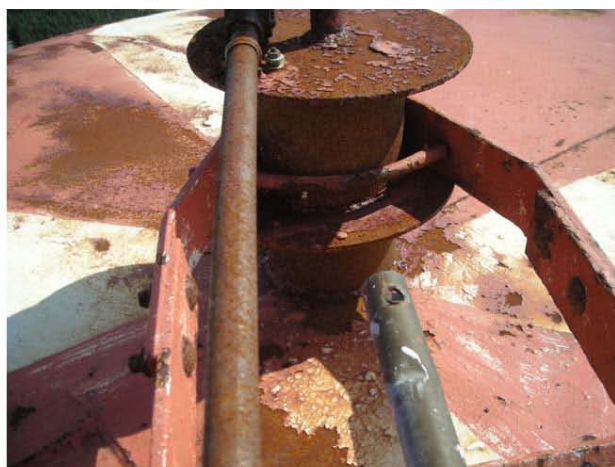
The ladder appears to be in good condition with some minor coating breakdown as shown in Figure 4-20. The painters post for tank top ladder was functional but has complete loss of coating as shown in Figure 4-21.

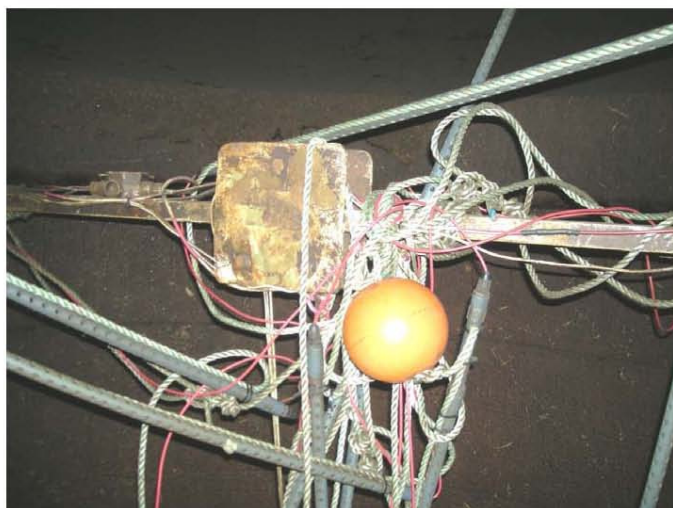
Figure 5-1: Tangled Cathodic Protection System at Top of Riser

A functional analysis of the CP system was not performed during the site inspection. Based on the RAT inspection report and as shown in Figure 5-1, the anodes, cabling, etc. have become intertwined. As we understand from our discussions with Mr. Trevor Arbuckle (NL Hydro), this is common each time the surge tank is dewatered. In addition, we understand the float support system never worked properly. It is our opinion the CP system is not functional and poses a hazard to the turbine runner and other components.

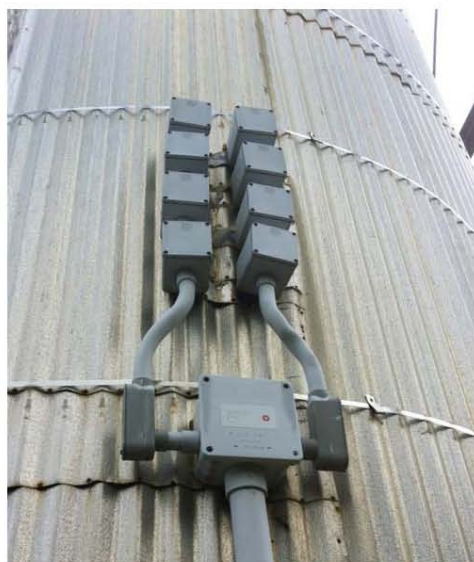
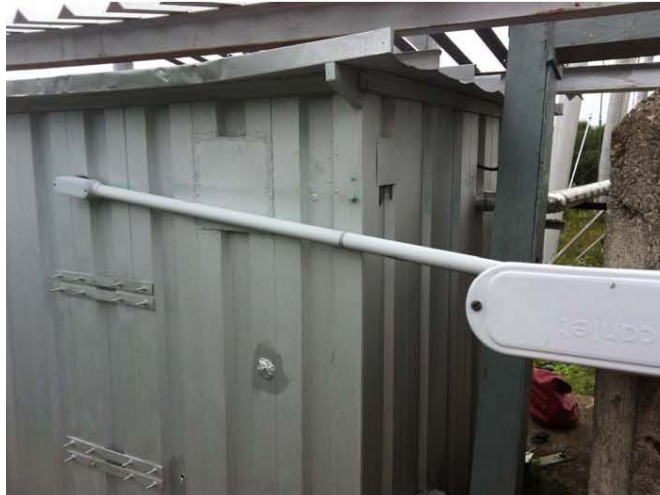
Exterior components such as the junction boxes located at the base of the surge tank are still in relatively good condition as shown in Figure 5-2. As shown in Figure 5-3, the conduit straps on the 2 inch rigid PVC conduit from the electrical shed to the CP junction boxes on the surge tank riser are broken; consequently, at the time of inspection the conduit was unsupported. A SWOP card was filled out and this issue was brought to the attention of Jakiul Hassan while on site.

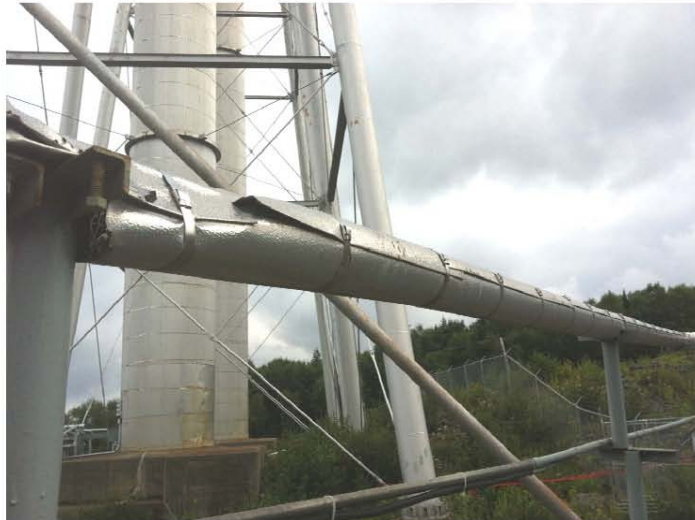
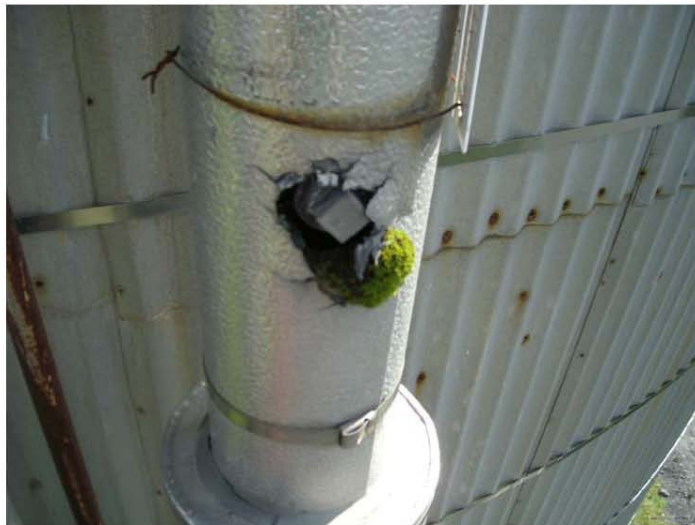
The hot water heating system piping insulation appears to be in good condition with the exception of a few areas as shown in Figure 5-4 and Figure 5-5.

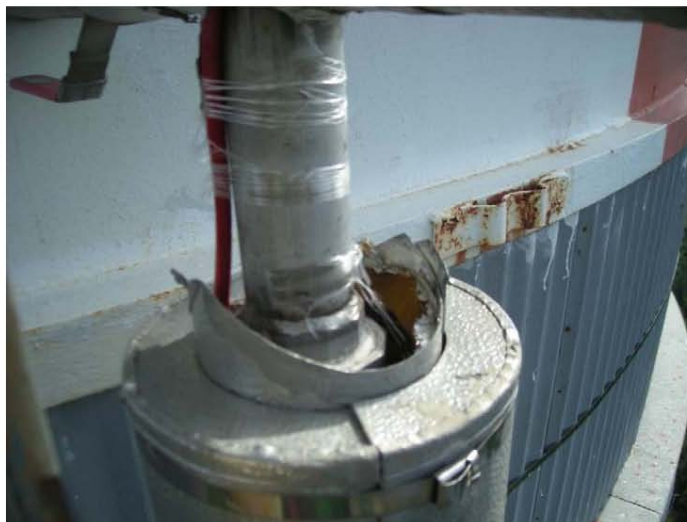
Figure 5-6: Top of Hot Water Heating System Piping Insulation

The top of the piping insulation at the tie-in to the surge tank is improperly flashed as shown in Figure 5-6.

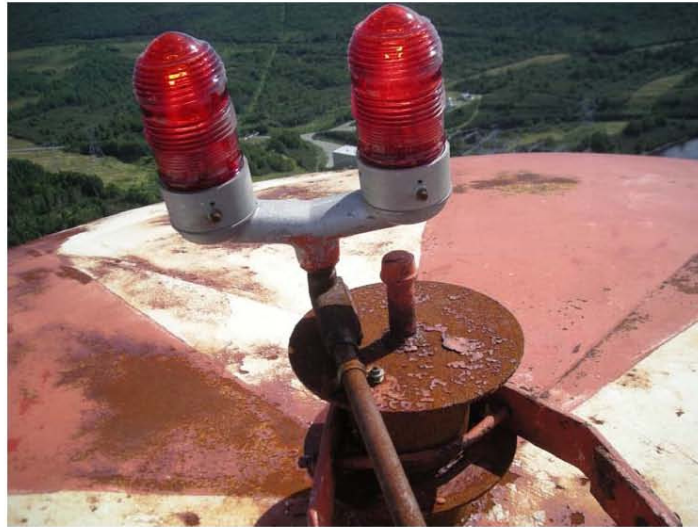
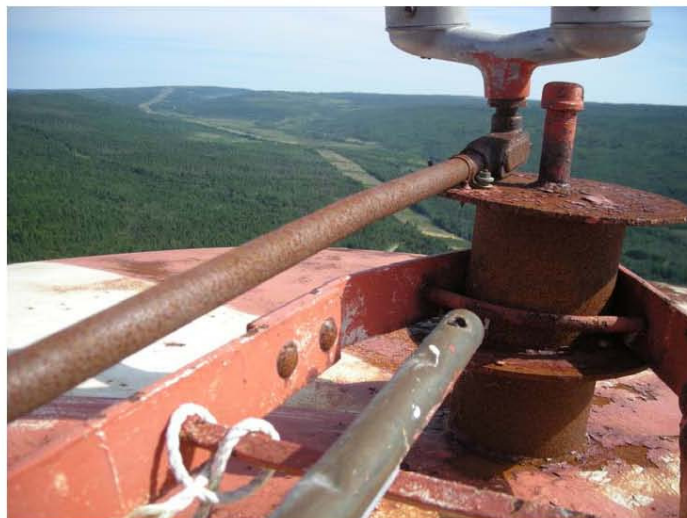
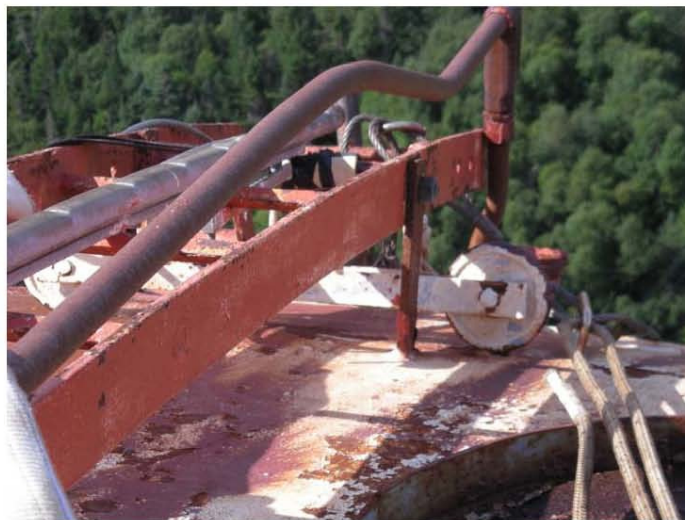
The existing aviation obstruction lighting as shown in Figure 5-10 was still in operation at the time of the site inspection. There is substantial corrosion to the rigid steel conduit which houses the electrical cables providing power to the two beacon lights as shown in Figure 5-11 and Figure 5-12. If there are plans to complete any work on this area of the surge tank, it is recommended that the conduit and obstruction lights be replaced at the same time to reduce labour costs. Consideration should be given to epoxy coated rigid galvanized steel conduit when replacing the existing conduit system as it provides additional corrosion resistance. When it is decided to install new obstruction lights, it should be noted that these lights are to be installed as per Canadian Aviation Regulations (CARs) Standard 621.

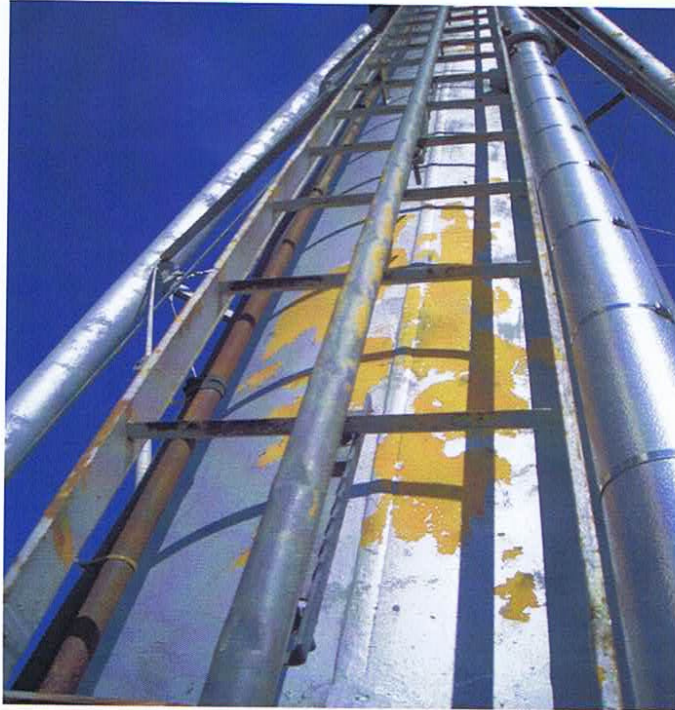
**Location:** Ladder

**Description:** General photo. Typical areas of coating break-down and corrosion.

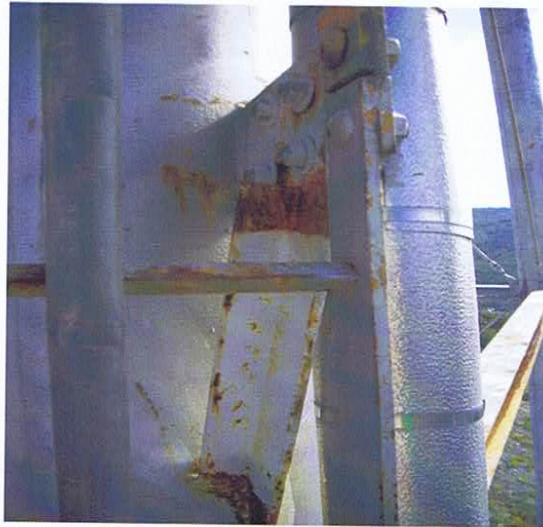
**Location:** Ladder

**Description:** General photo. Ladder bolted connection showing typical corrosion.

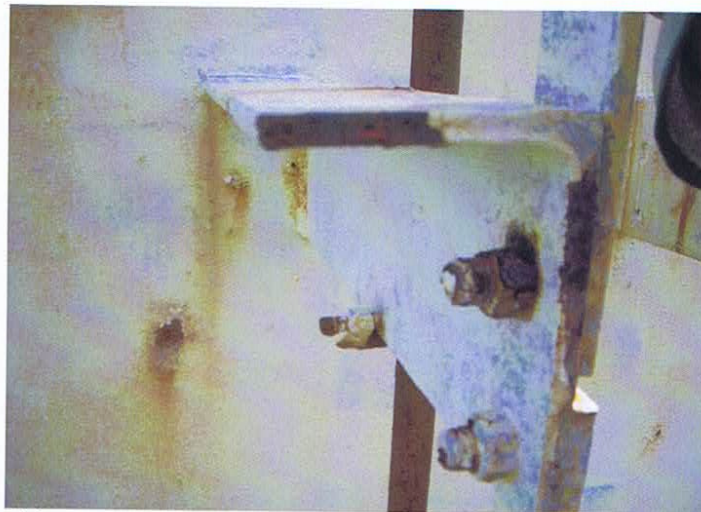
**Location:** Ladder

**Description:** General photo. Ladder bolted connection showing typical corrosion.

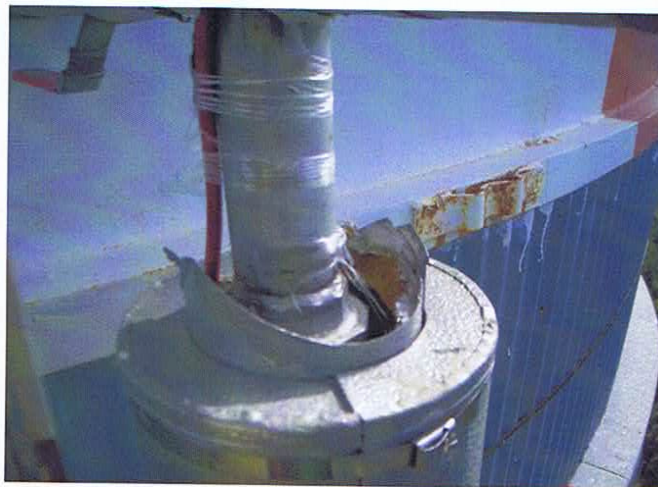
**Location:** Hot water heating system piping and heat trace (entering surge tank)

**Description:** Cladding cap missing, possible/potential area for water ingress.

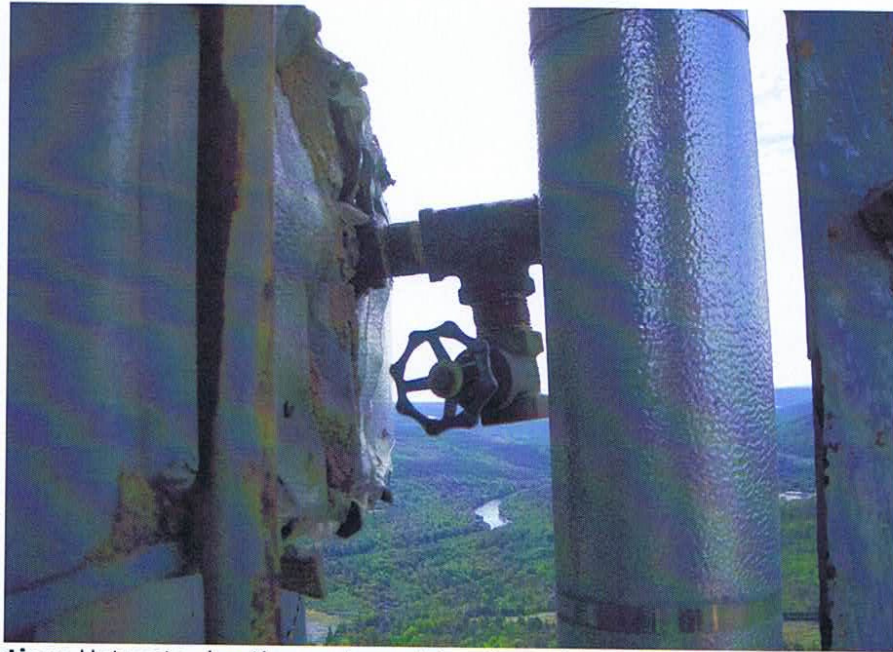
**Location:** Hot water heating system piping (entering surge tank)

**Description:** Cladding torn, possible water ingress.

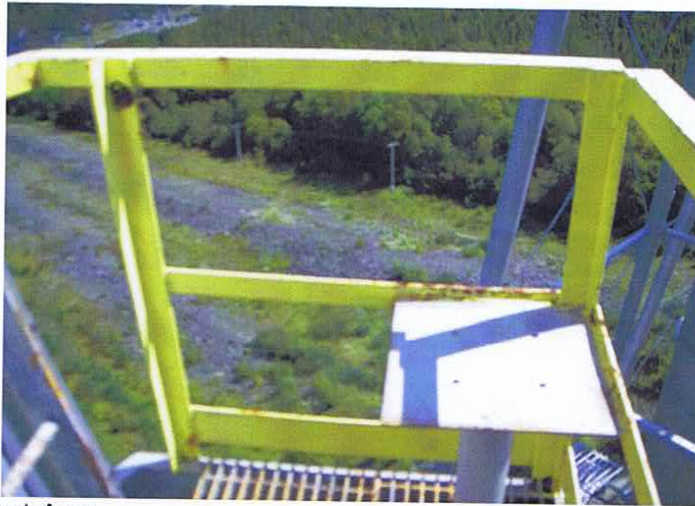
**Location:** Rest Area

**Description:** General Coating breakdown and corrosion on railings.

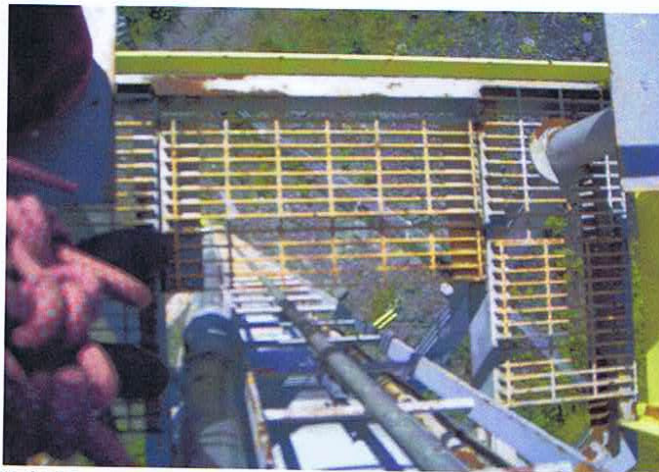
**Location:** Rest Area

**Description:** Coating breakdown and corrosion on grating.

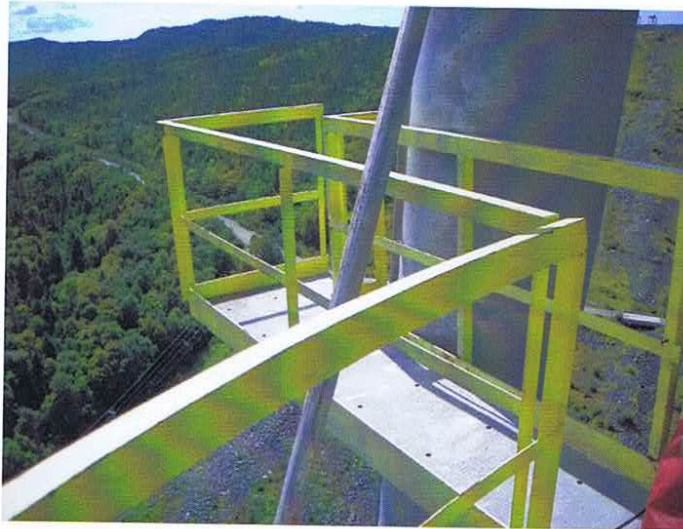
**Location:** Bottom Balcony

**Description:** Typical condition of handrails, minor coating breakdown.

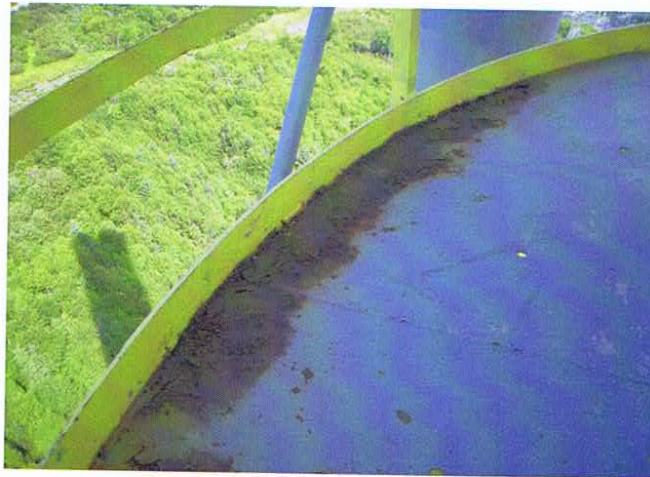
**Location:** Lower Balcony

**Description:** Localized corrosion on the balcony floor.

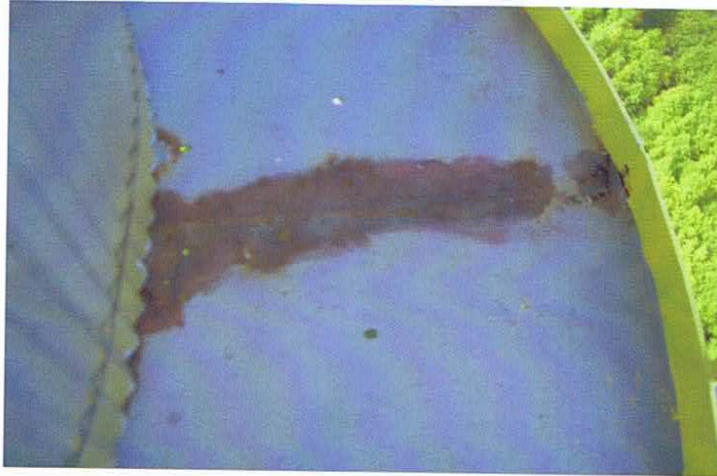
**Location:** Lower Balcony

**Description:** Localized corrosion on the balcony floor.

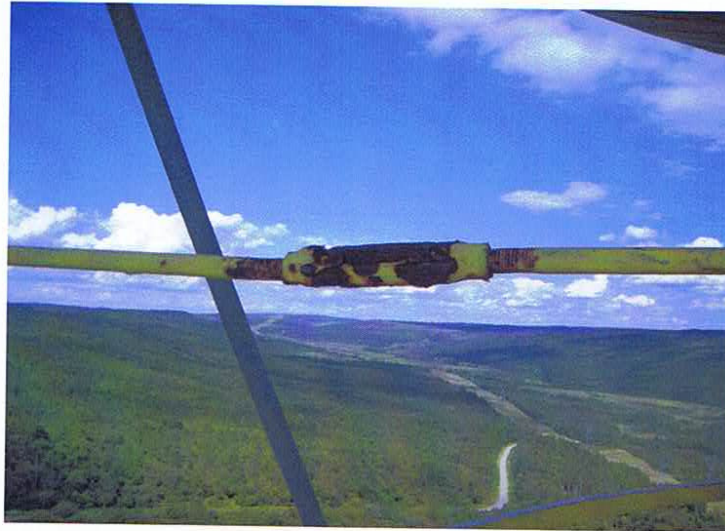
**Location:** Lower Balcony

**Description:** General photo. Rod braces are warped and have heavy corrosion

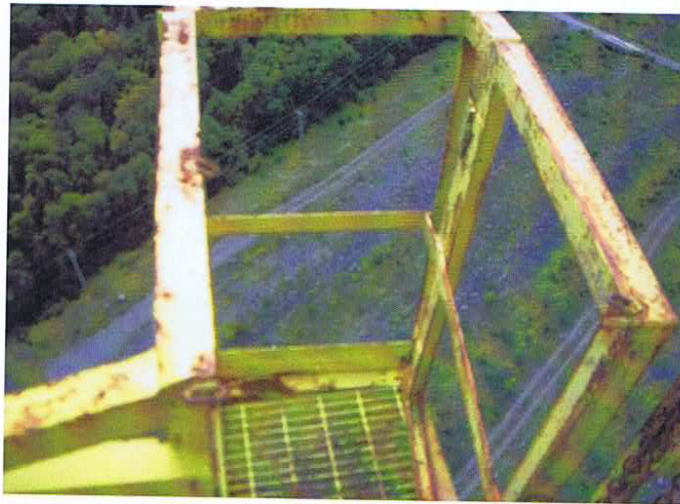
**Location:** Upper Balcony

**Description:** General photo, Corrosion on handrails.

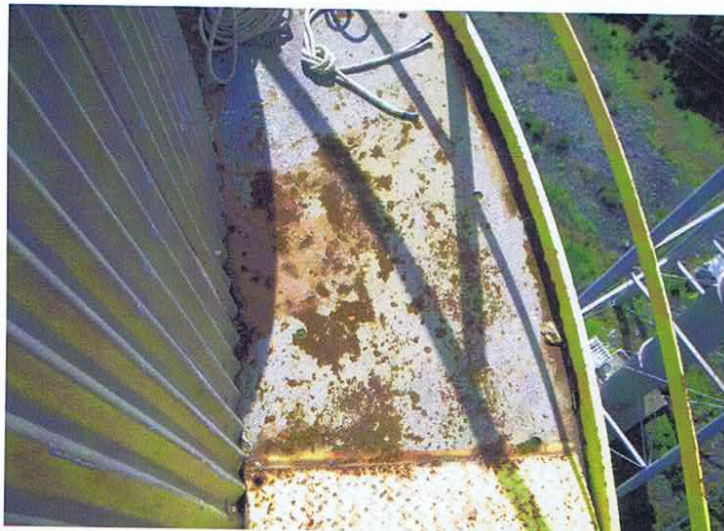
**Location:** Upper Balcony

**Description:** General photo, Corrosion of deck.

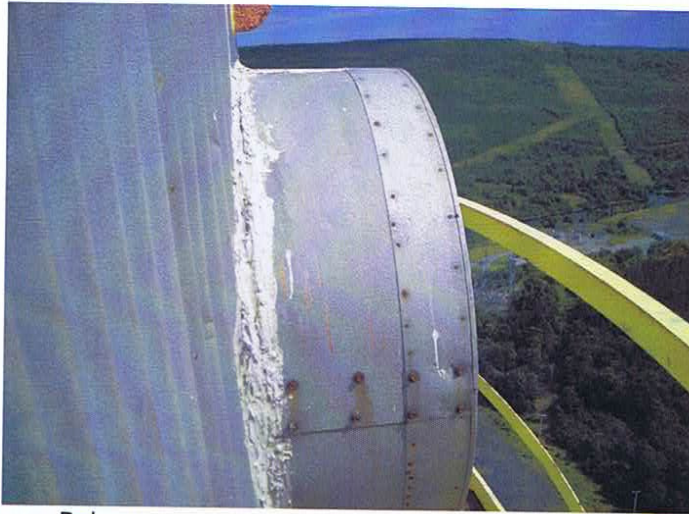
**Location:** Upper Balcony

**Description:** Manhole penetration, possible/potential water ingress.

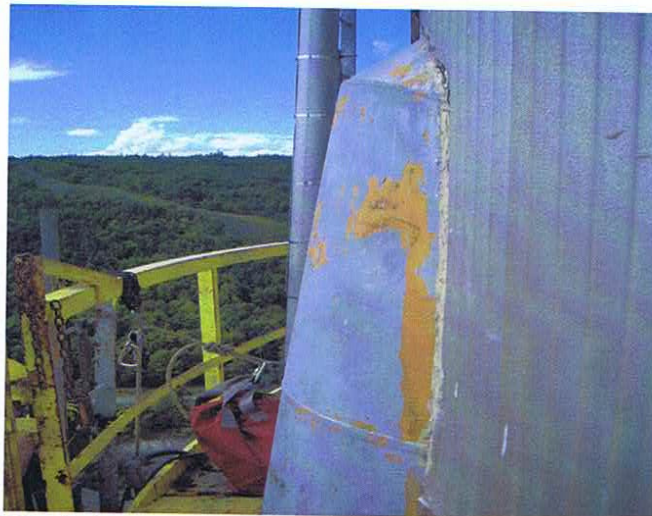
**Location:** Upper Balcony

**Description:** General photo. Tank leg penetration, possible/potential water ingress.

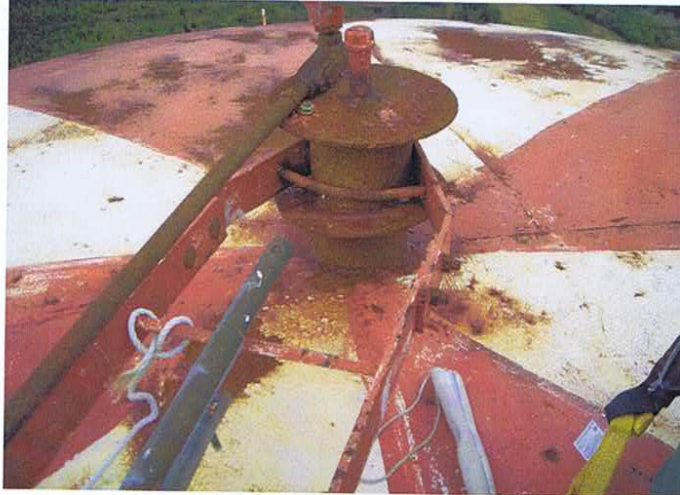
**Location:** Tank Top

**Description:** General photo of tank top condition and ladder swivel system, coating breakdown and corrosion.

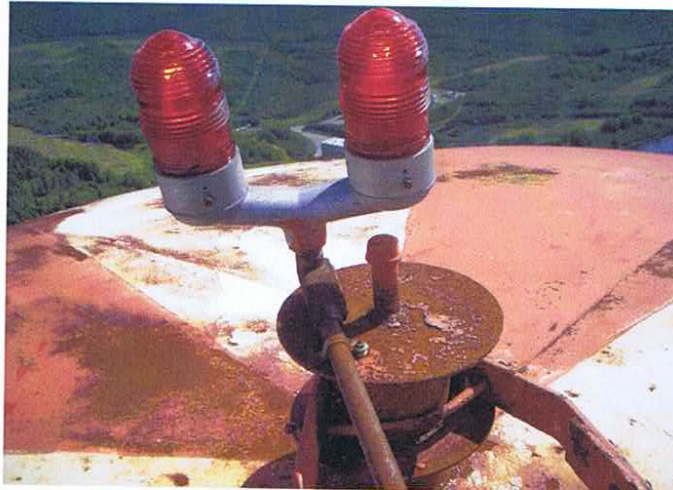
**Location:** Tank Top

**Description:** Aviation lights are active.

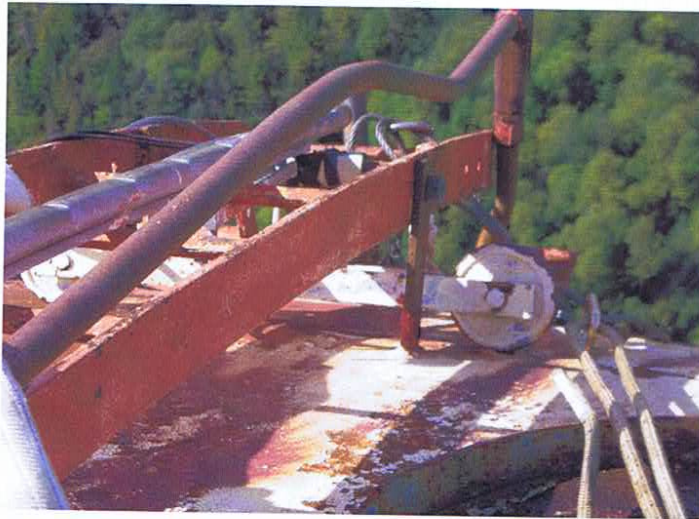
**Location:** Tank Top

**Description:** Swivel mechanism for ladder/fall arrest system functional.

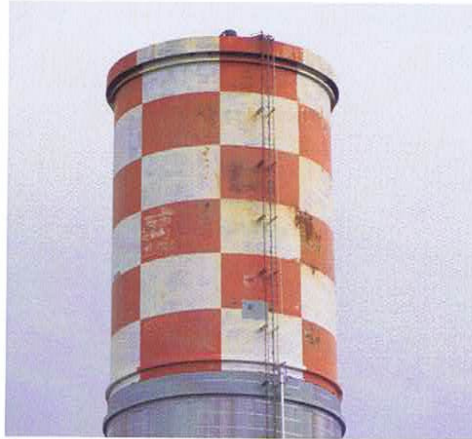
**Location:** Surge Tank

**Description:** General Photo. Typical photo of coating break-down/corrosion.

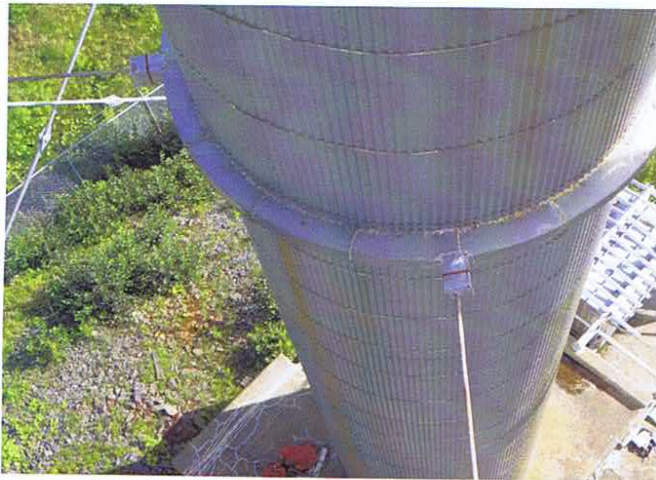
**Location:** Riser

**Description:** General photo. Good condition some water staining present.

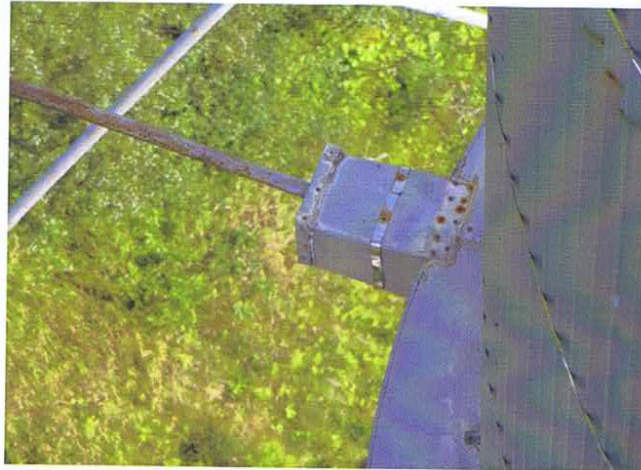
**Location:** Riser East Road Brace

**Description:** General Photo, showing overall condition of Rod Braces

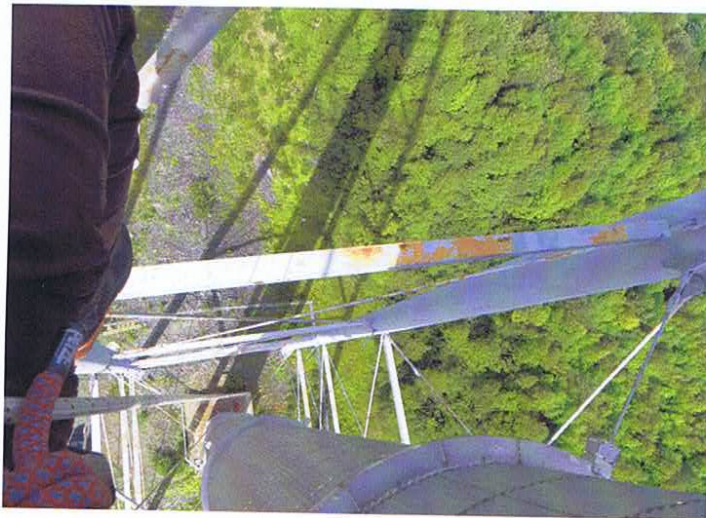
**Location:** Horizontal Steel Beams (West-North leg)

**Description:** General Photo showing coating breakdown on horizontal beams.
