**Re: Newfoundland and Labrador Hydro – 2014 Capital Budget Application**

**An Application to the  
Board of Commissioners of Public Utilities**

# **2014 CAPITAL BUDGET**

### **VOLUME I**

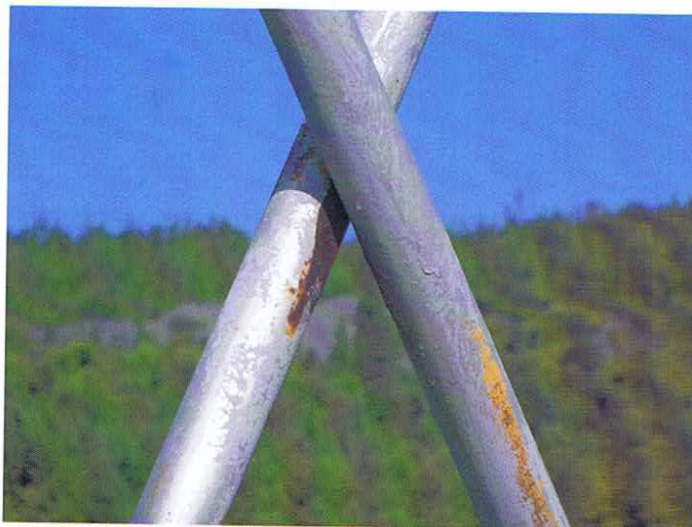
**Location:** Cross member (West-North)

**Description:** General photo, typical friction wear on the cross members on the tower.

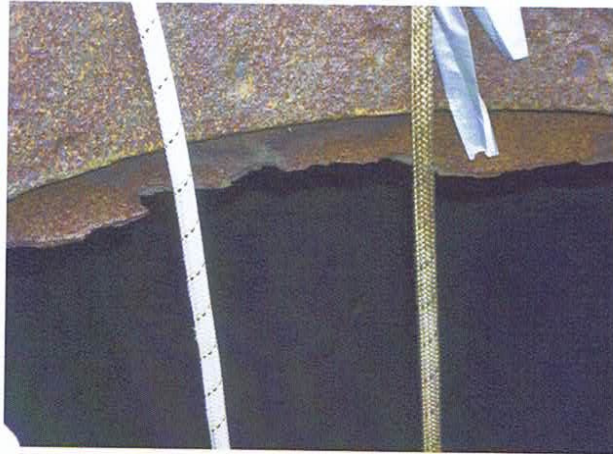
**Location:** Surge Tank (tank top looking west)

**Description:** Lap joint opening on tank top at manhole.

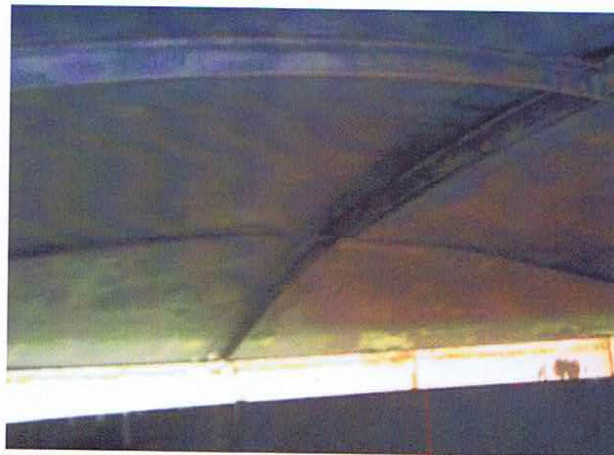
**Location:** Surge Tank (tank top looking east)

**Description:** Lap joint opening of tank top 2".

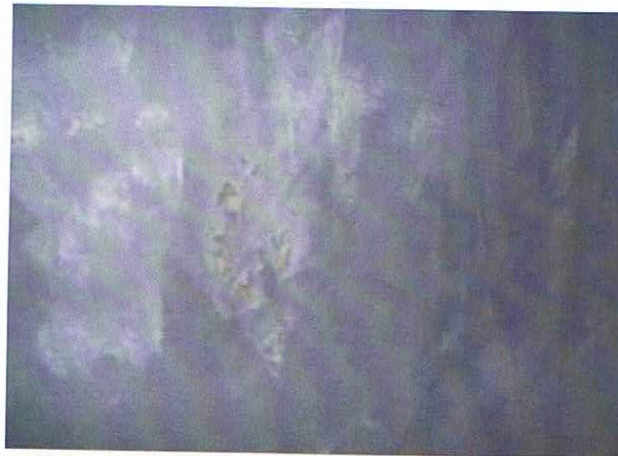
**Location:** Surge Tank

**Description:** Localized coating breakdown on tank shell.

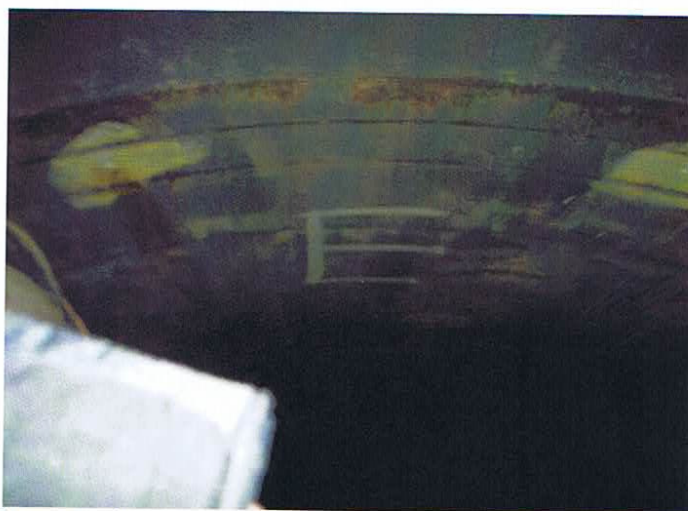
**Location:** Surge tank

**Description:** Corrosion along the weld seam on tank shell.

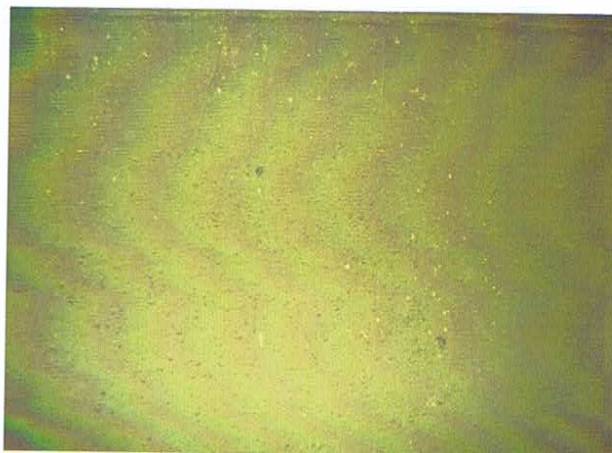
**Location:** Bowl

**Description:** It appears to be coated in drips from the coating applied to the sides of the tank. Recording ultrasonic thickness readings was not possible due to the condition of the surface.

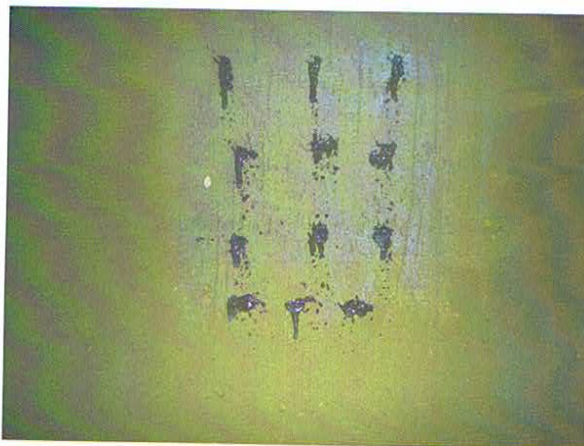
**Location:** Bowl

**Description:** UT couplant was applied to the surface of the bowl, however the coating was not uniform, this preventing the acquisition of UT readings without removing the coating.

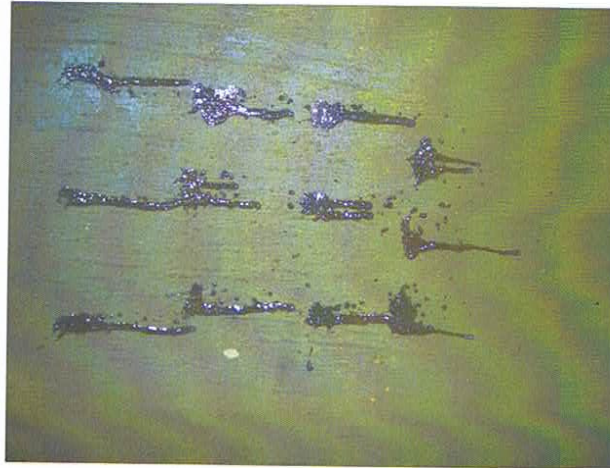
**Location:** Bowl

**Description:** UT couplant was applied to the surface of the bowl, however the coating was not uniform, this preventing the acquisition of UT readings without removing the coating.

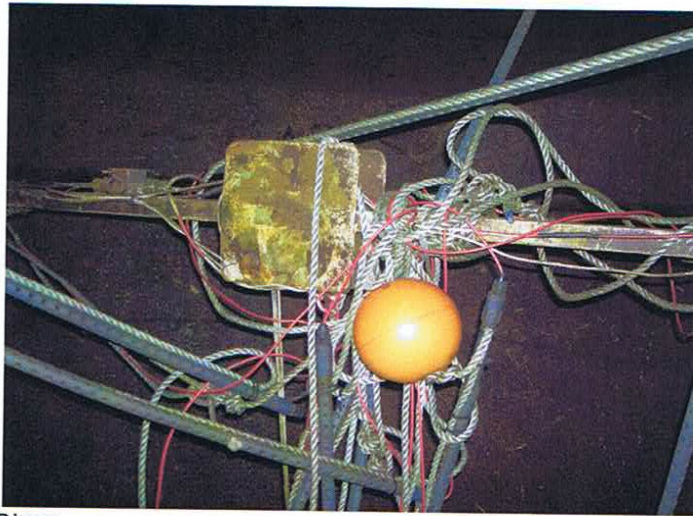
**Location:** Riser

**Description:** Tangled anodes, no warping in cross member

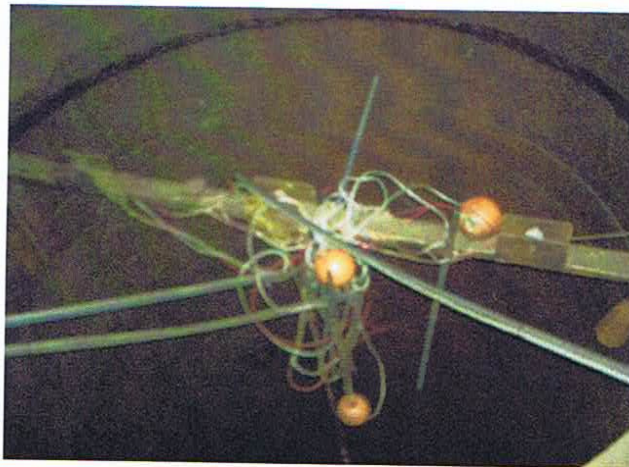
**Location:** Riser

**Description:** Tangled anodes, no warping in cross member

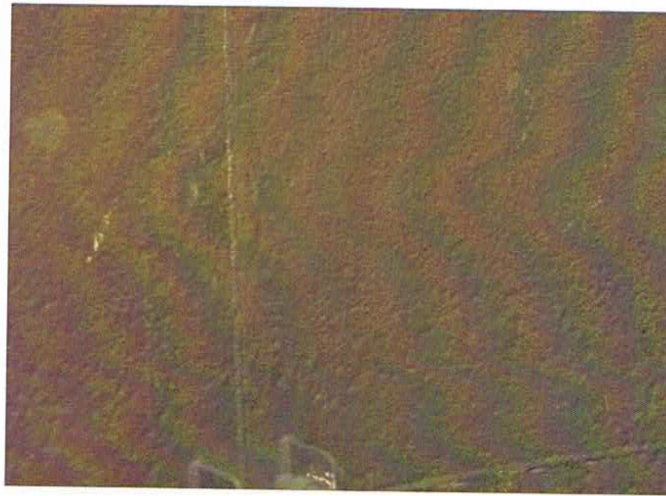
**Location:** Riser

**Description:** General photo. Typical pitting on riser shell.

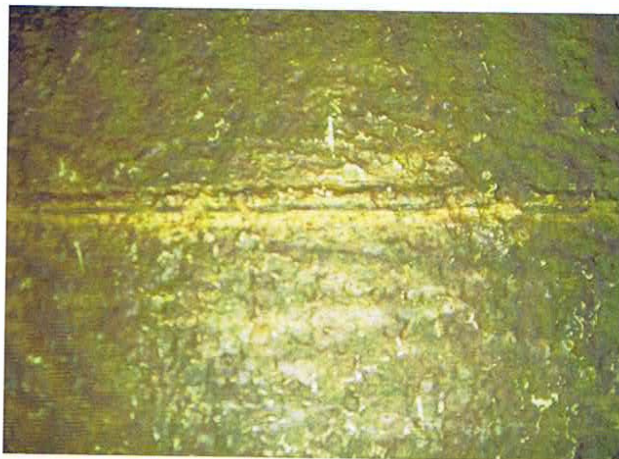
**Location:** Riser

**Description:** General photo. Typical pitting on riser shell.
