# **NEWFOUNDLAND AND LABRADOR HYDRO**

*January 11, 2013 Power System Outage Report*

December 2013

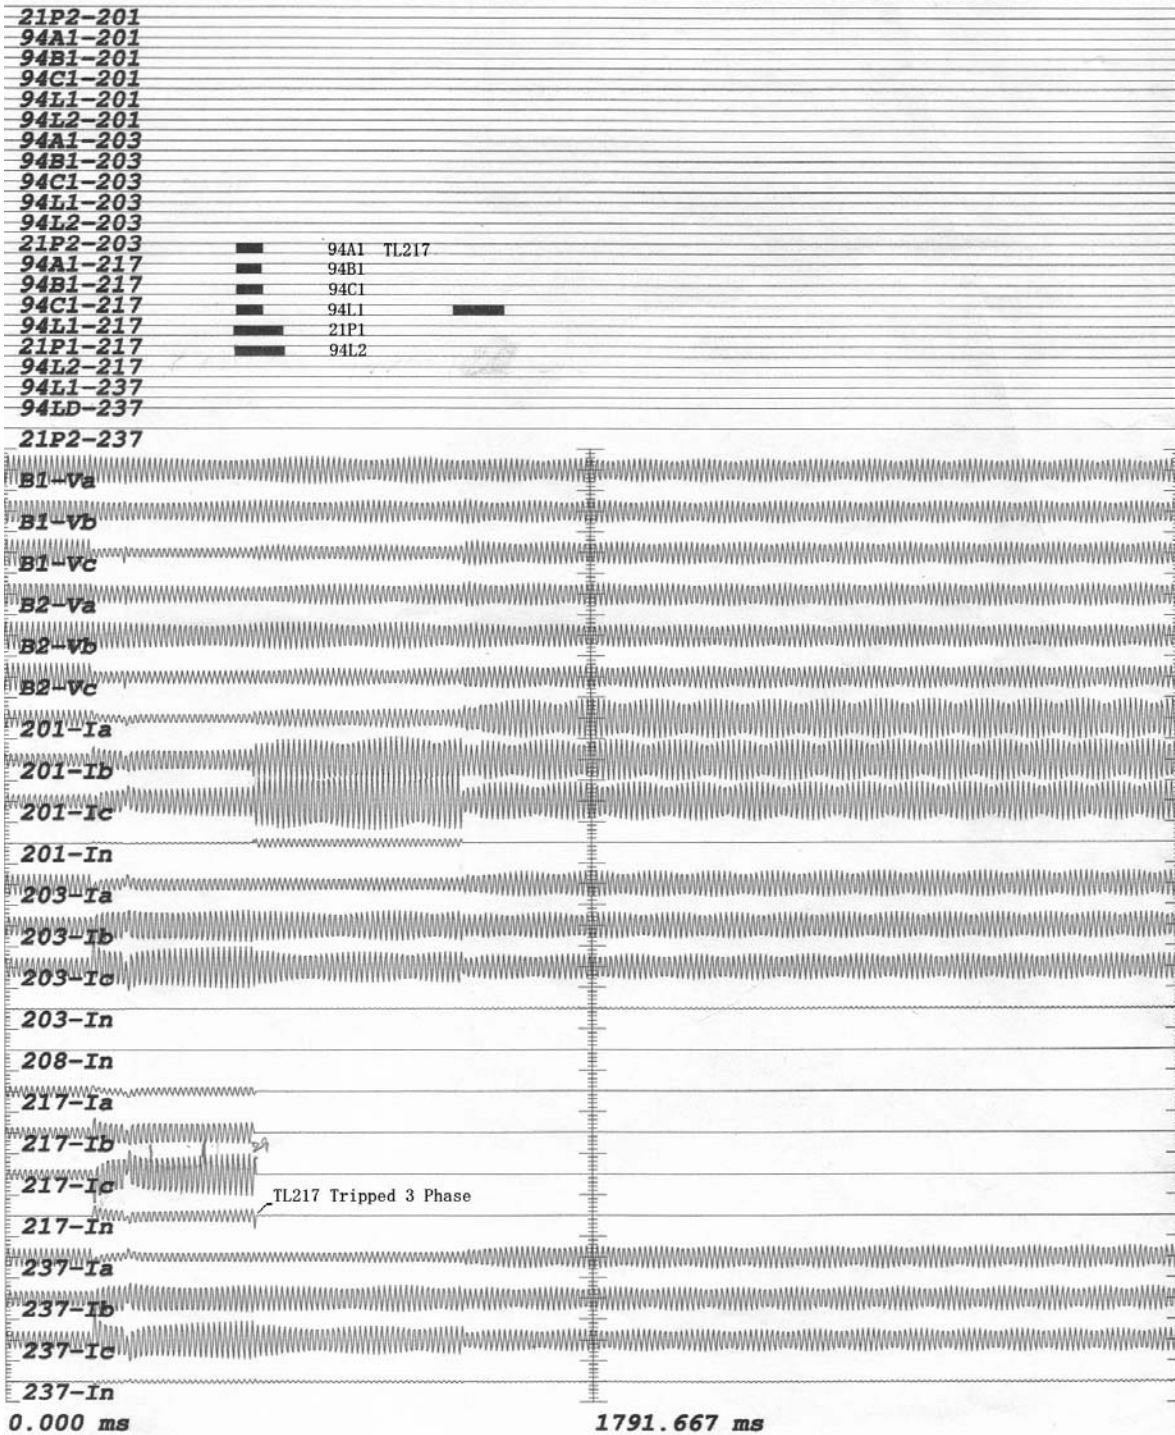
Figure 2-3: Western Avalon DFR Trace at 0642 Hours during B1L17 Fault

Figure 2-3 shows the Western Avalon DFR trace and the tripping of TL217 in 30 cycles via the Zone 2 time delayed ground distance protection, and indicates that both P1 and P2 protections operated correctly. After 64 cycles the fault migrated from where it started on the breaker

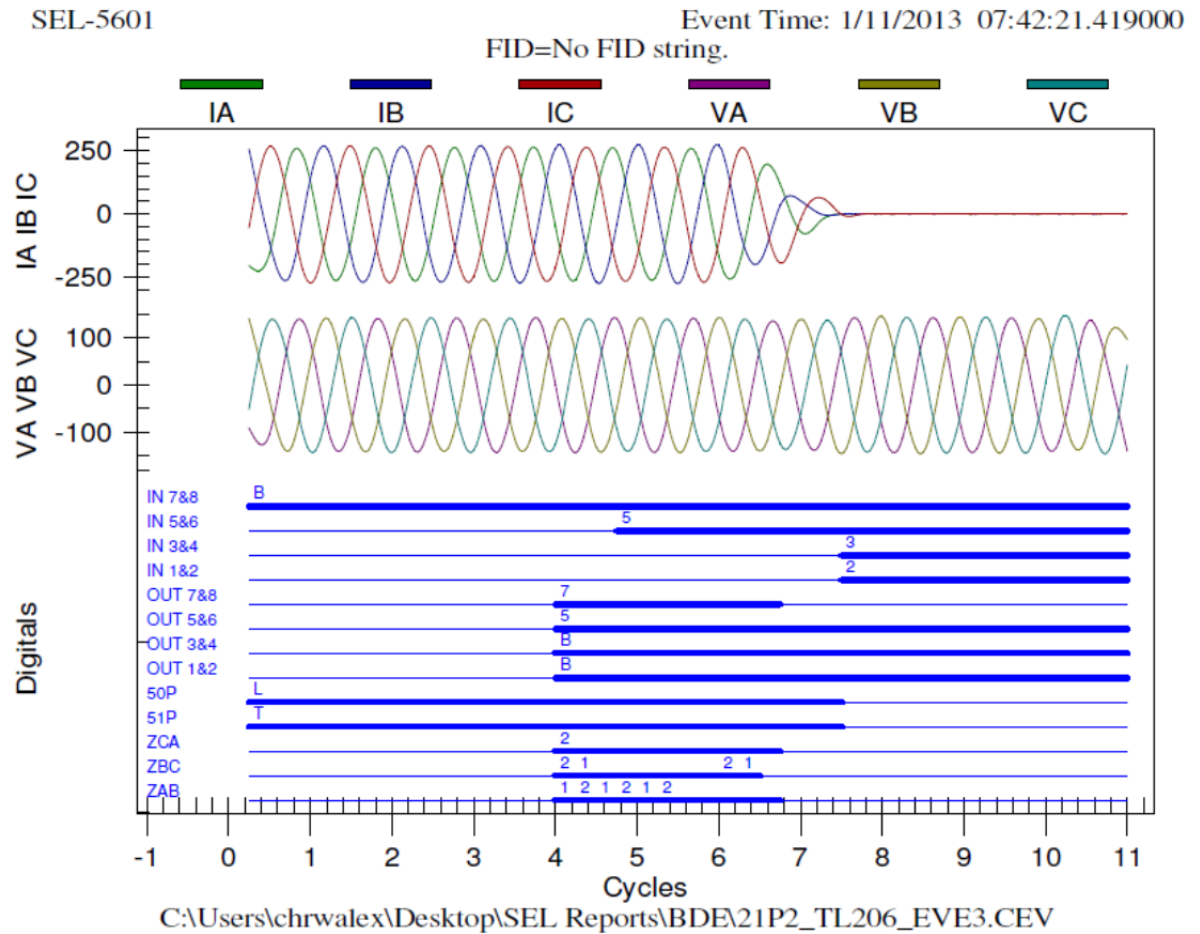
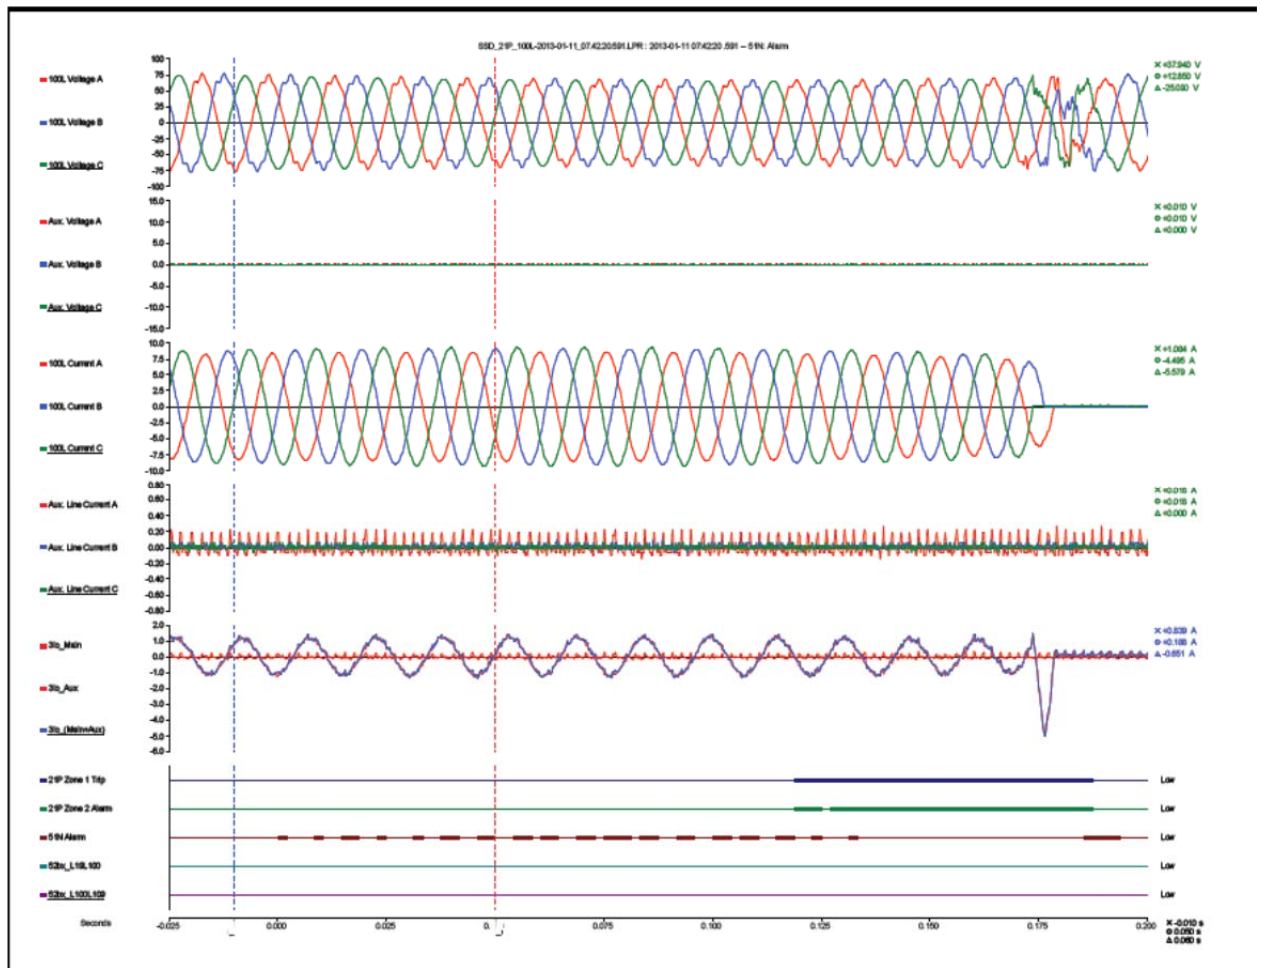
- There are two different types of digital protections which misoperated for this frequency event. They are the Schweitzer SEL 321 relay which is the P2 protection on the 230 KV lines and the ERLPhase LPRO2100 relay which is applied on some 138 KV and 66 KV lines (see sample reports from the relays showing operation at 0742 hours, Figures 2-14 and 2-15). Both seem to have experienced similar issues, with the Zone 1 elements operating for the large frequency excursions. Both manufacturers were

The manufacturer of the 230 KV line protection SEL 21 relays (Schweitzer) also suggested initially that a firmware upgrade might also correct the problem in conjunction with increasing the relay's current monitor setting. However, after further consideration, the recommended approach to prevent operation for frequency excursions is to supervise the distance elements with the load encroachment function. The setting for the load encroachment still has to be determined for the various relays. One recommendation is to set the load encroachment at a level above the Zone 2 setting of the relay to avoid any issues with operation of both the Zone 1 and Zone 2 protection. Another approach is to set the current monitors, 50PP1s which supervise the Zone 1 trips, to a level above the maximum load. SEL's recommendations for the setting values are still to be finalized. The SEL preliminary report outlining the reasons for the misoperations and the load encroachment approach is attached as Appendix B. The preferred solution is to use the load encroachment function. A setting of 100 ohms primary for all lines should be adequate based on the protection settings for the longest line on the system, TL206. This setting will accommodate a load of 529 MVA before blocking. The setting angles are PLAF=90, NLAF=-90, PLAR=90, and NLAR=270. This approach is preferred over the setting of the 50PP1 as it is independent of minimum fault levels.

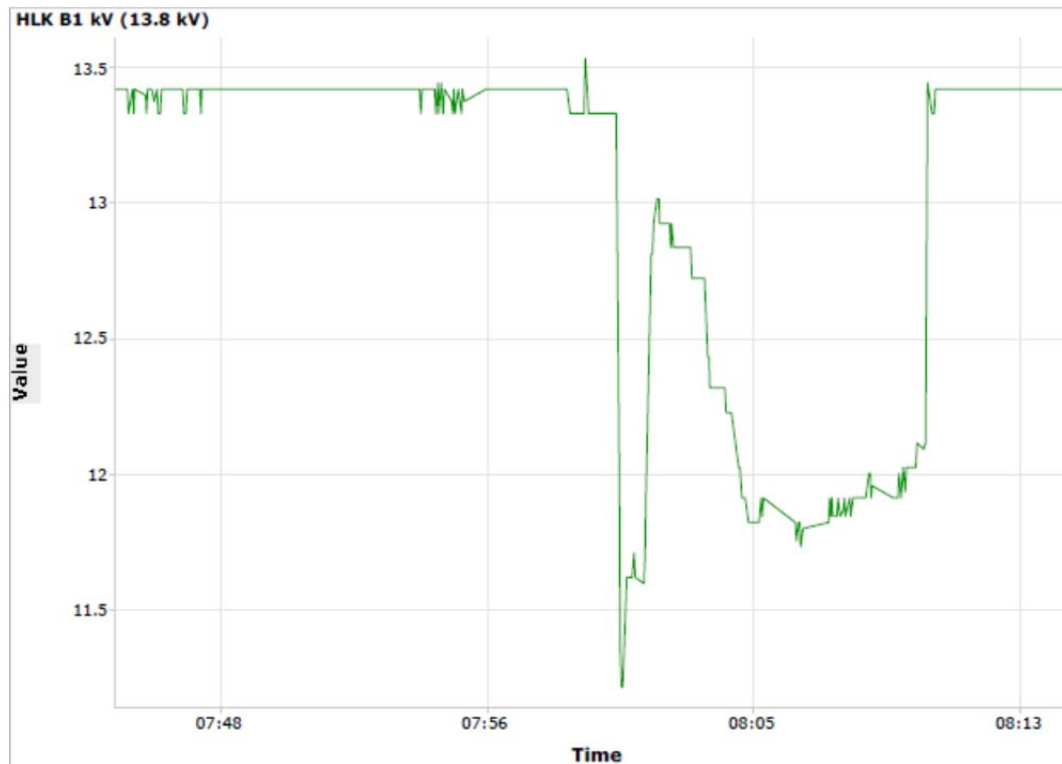
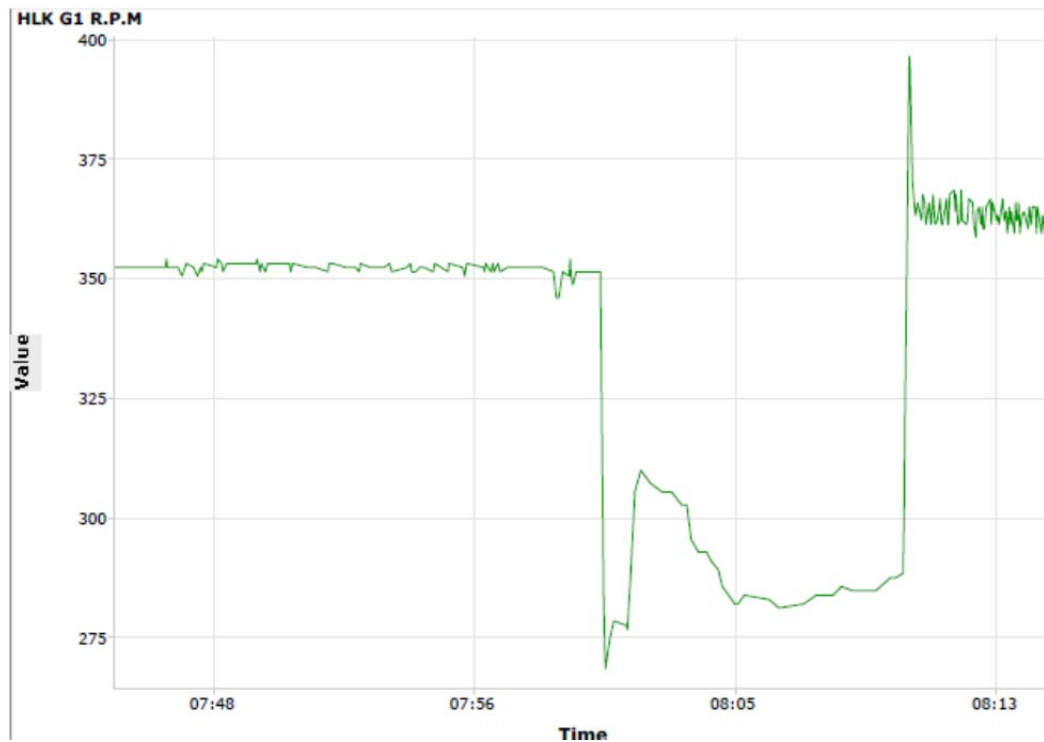
The overexcitation was mitigated somewhat by the operation of the Hinds Lake exciter volts per hertz monitor which functioned to keep this ratio within limits at the Hinds Lake unit. This protects the unit by decreasing the terminal voltage of the machine when the frequency decreased, as is evident in Figure 3-9 (a and b) which indicate the frequency and voltage at the unit at this time. The ratio of volts per hertz is being controlled at a maximum of approximately 1.07.

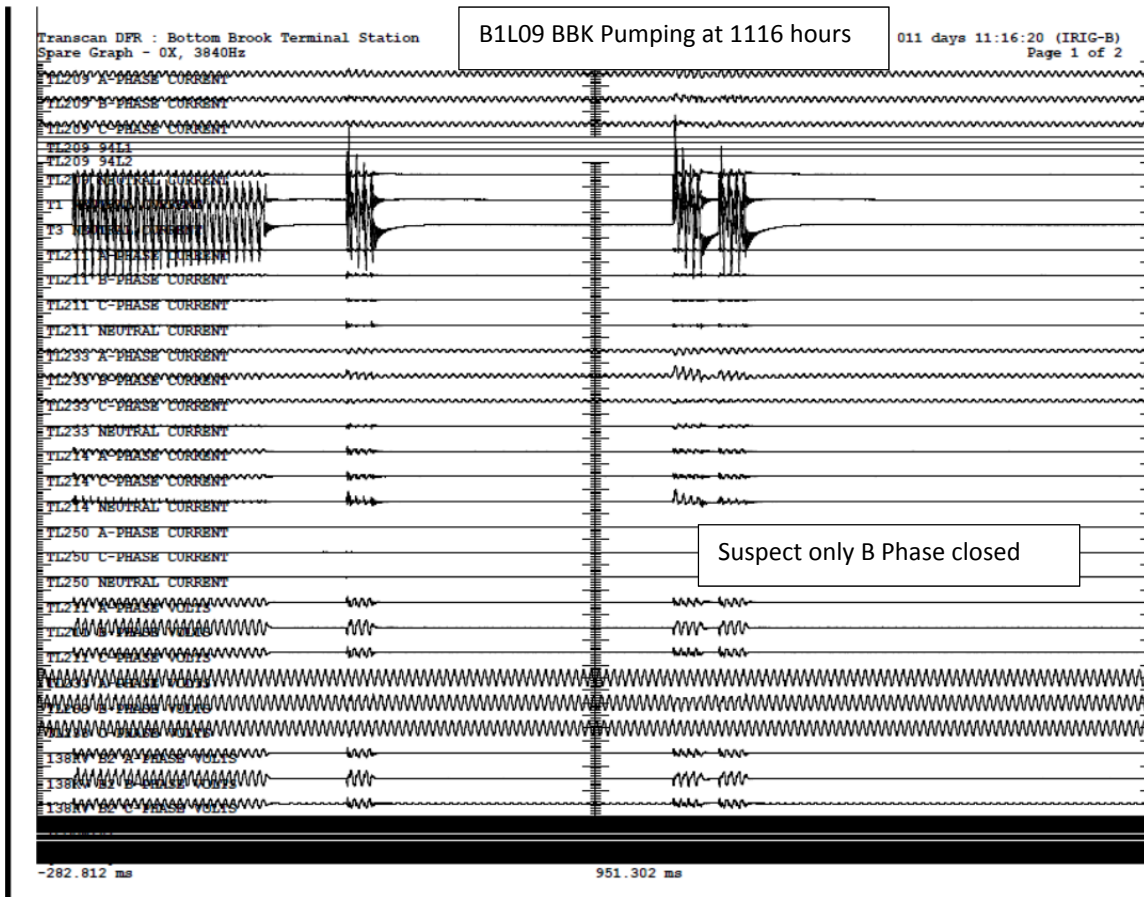
Figure 3-19: Bottom Brook DFR Trace at 1116 Hours Showing BBK Breaker B1L09 Pumping

- At 1116 hours the Bottom Brook breaker B1L09 was closed by the ECC but opened and closed multiple times due to suspected breaker air problems. TL214 and the Doyles station were connected at the time. The breaker ended up open, see Figure 3-19.

- At 1116 hours there was an issue with breaker B1L09 at Bottom Brook when it was closed to energize the station. It 'pumped' multiple times before ending up tripped. This can be seen in the Bottom Brook DFR trace, previous Figure 3-19. It is suspected that it only closed B phase. TL214 and the Doyles station were energized during the pumping operations.

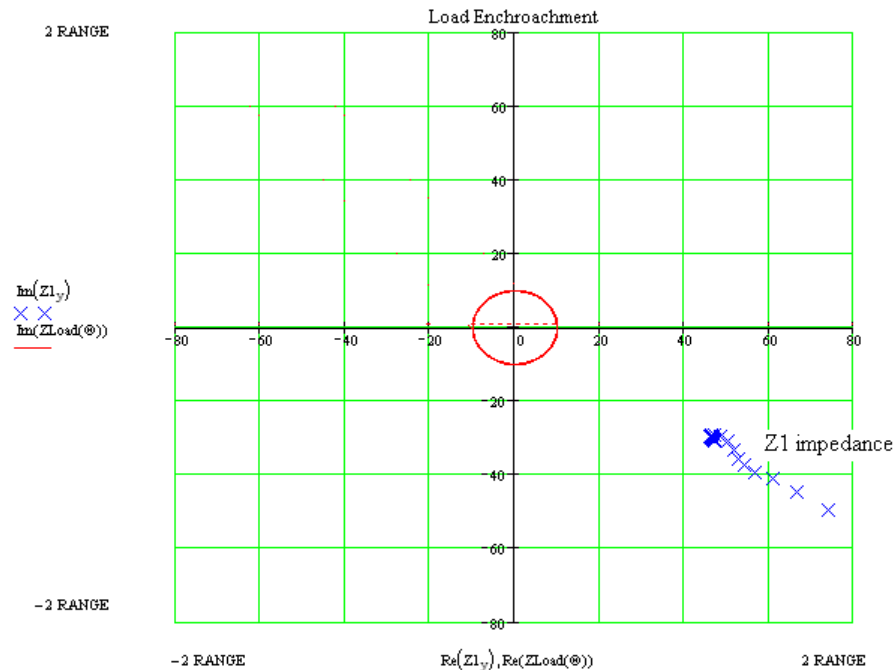
Fig.9 Plot of the load encroachment element characteristic, and the positive sequence impedance, note that the phase-to-phase distance elements fall within the load encroachment element.

With these settings the relay would have prevented the distance elements from asserting, however it must be pointed out that with these settings the load encroachment element will not block the relay for operating for any genuine phase-to-phase fault and the reason for this is that the phase-to-phase distance elements are a subset of the load encroachment element as shown in Fig. 9.
