**Supply Issues and
Power Outages Review
Island Interconnected System**

**Executive Summary of
Interim Report**

**The Board of Commissioners of Public Utilities
Newfoundland and Labrador**

The Liberty Consulting Group

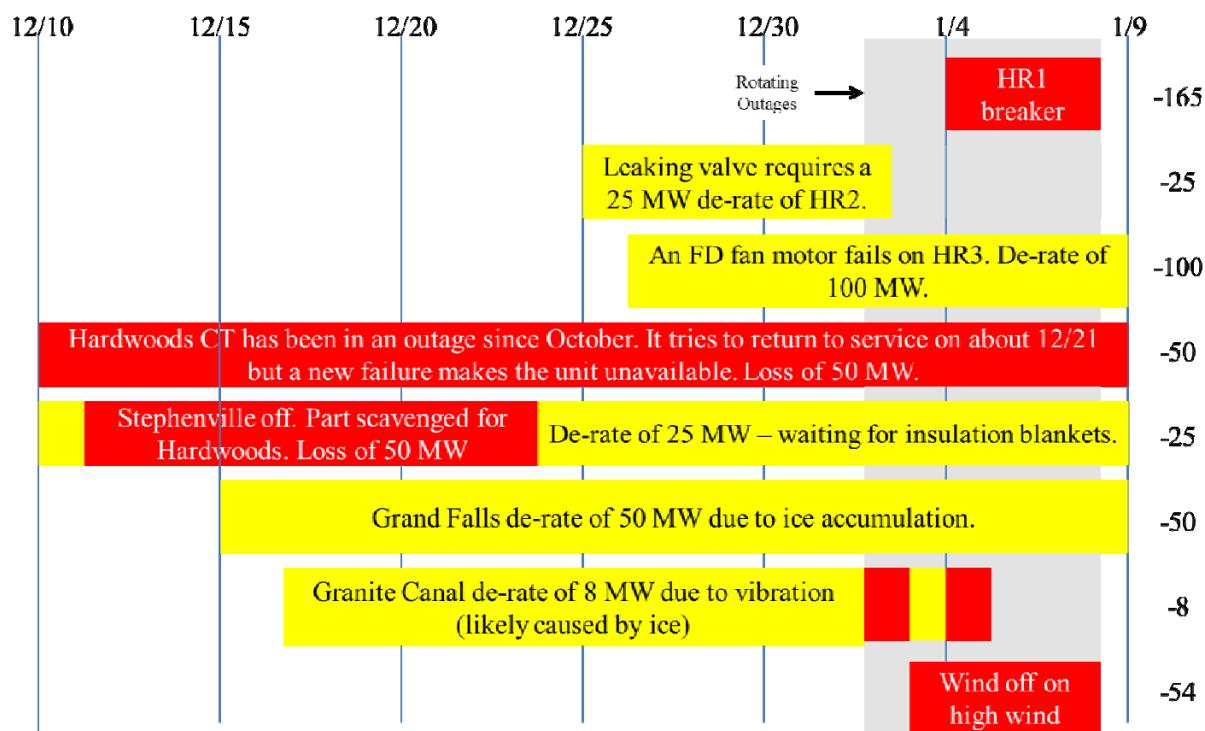
Table 2.1: Generation Unavailability Timeline

Hydro's policy is to have all its supply resources available for the winter by December 1st of each year. Should that goal not be met, the system enters the winter facing a higher degree of vulnerability. Some generating units were unavailable in December 2013. The diagram below shows that both 50 MW combustion turbines ("CTs") at Hardwoods and Stephenville were unavailable (red blocks) in the early part of the month. The Stephenville CT recovered only partially (yellow blocks) just before Christmas. In addition, unusual ice conditions made 58 MW⁴ of hydro resources unavailable for the last half of the month. These conditions left Hydro without access to about 133 MW going into Christmas. At about that time, two problems materialized at the Holyrood thermal generating station. A control valve failure (1 of 6) on the Unit 2 turbine led to a 25 MW de-rate,⁵ and the failure of a forced draft fan motor (1 of 2) on Holyrood Unit 3 led to a 100 MW de-rate.

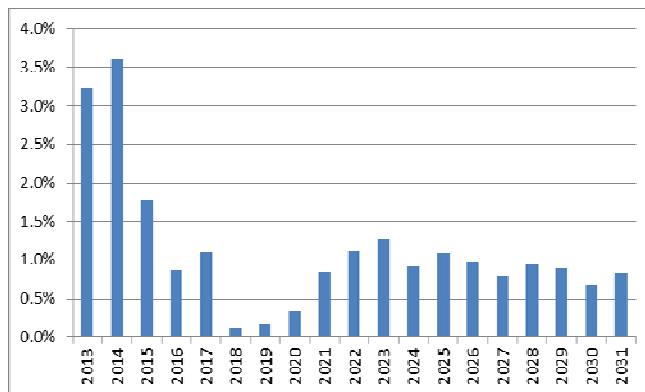
Table 2.2: IIS Peak Demand Forecasts

Table 2.2 below shows the annual growth in the forecast for peak demand on the IIS. The less than one percent per year growth predicted after 2015 appears low, but is consistent with most forecasts in North America, including those of Canada’s National Energy Board (“NEB”) and the US Energy Information Administration (“EIA”). The rapid growth of electric heating by customers on the IIS might suggest higher growth, but that is apparently offset by other factors in the forecast model. The higher values in the early years represent anticipated industrial growth, particularly the Vale facility.

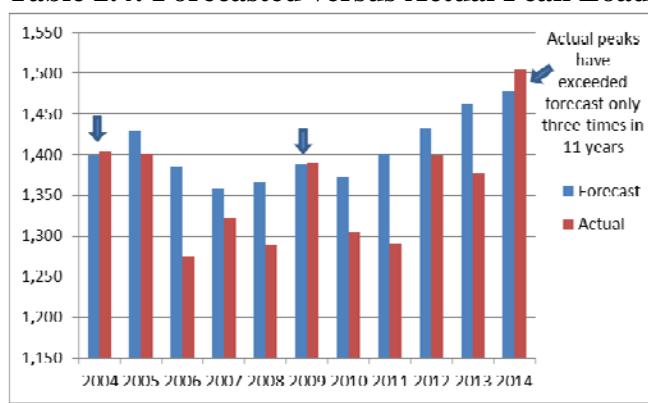
Table 2.4: Forecasted versus Actual Peak Loads

This Interim Report primarily focuses only on the next few years. Table 2.3 below shows forecasted peaks for these years. The actual peak for 2014 exceeded the forecast by 31 MW, or 2.1 percent (see Table 2.4). This variance is relatively small. Any overage at all, however, runs contrary to the long pattern of not exceeding forecasts. This result occurred three times in the last 11 years, and by a very narrow margin (less than a half of a percent) as illustrated in Table 2.4 below.

Given that experience, the overage in 2014 becomes more interesting. A similar analysis for Hydro by Ventyx notes that actual load exceeded the applicable forecast in only seven winter months out of 40 (or six in 39 if December 2013 is excluded).¹⁴ A monthly analysis can prove

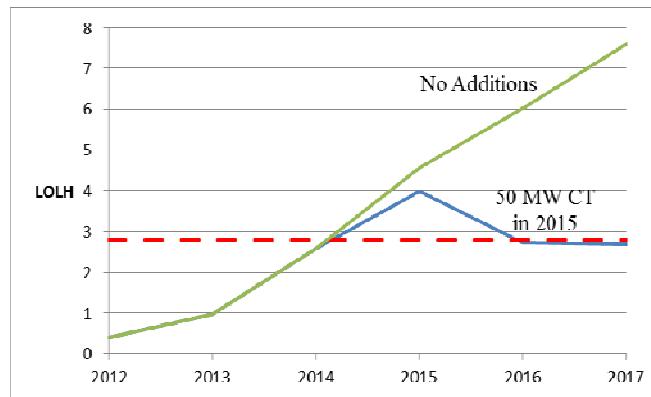
Table 2.6: LOLH versus 2.8 Criterion

Table 2.6 below shows where Hydro stands versus the 2.8 criterion. The estimate for 2014 showed a marginal situation – one that did not turn out well. Capacity deficits escalate sharply from now, producing an over-the-target and growing LOLH pending arrival of Muskrat Falls.

Hydro complied with its standard, but the risks that produced the supply shortage of January 2014 remain, and they will grow in the next few years. Nevertheless, we observe that current circumstances make the standard, whether it continues to be appropriate or not, a secondary issue for the next several years. The options available to meet a more typical North American standard are not practical from a timing perspective. This does not mean that improving reliability in the 2015-2017 windows should not be a first priority. It simply means that only a limited amount of actions are available. Even in the longer term, the standard may not become a central question for some time, should the arrival of Muskrat Falls, planned for 2017 cause the LOLH to drop precipitously,¹⁶ and remain low for a number of years.

Ventyx has recommended that Hydro revisit its reliability criterion after Muskrat Falls. Hydro agrees. This recommendation makes sense, but fails to address the importance of aggressive actions to improve supply reliability now, to the extent possible and practical. All of the mitigating actions that are practical need to be implemented as soon as possible.

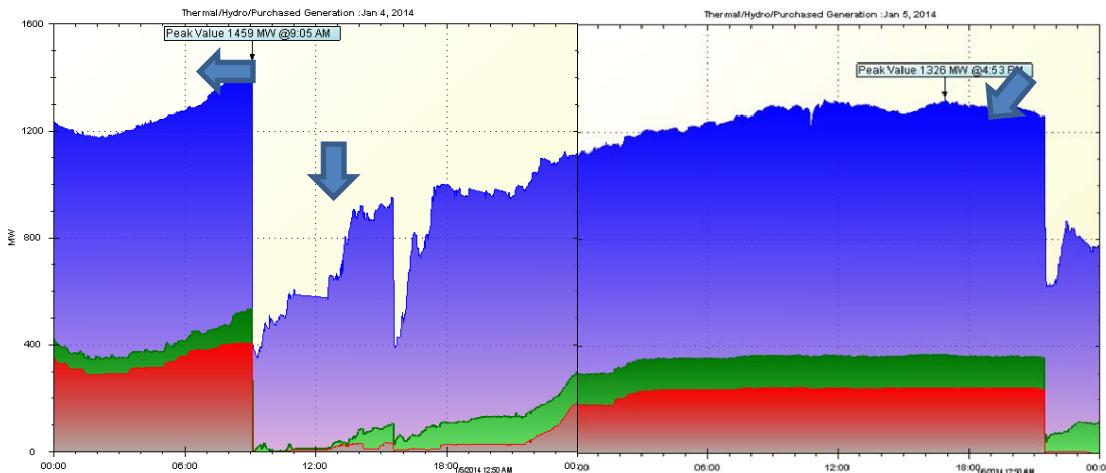
Illustration 3.6: Changes in Hydro's Generation Output

Illustration 3.6 below, shows how Hydro's sources of power changed as the events unfolded. The blue section shows hydro generation, the red section shows thermal generation, and the green section shows purchases.

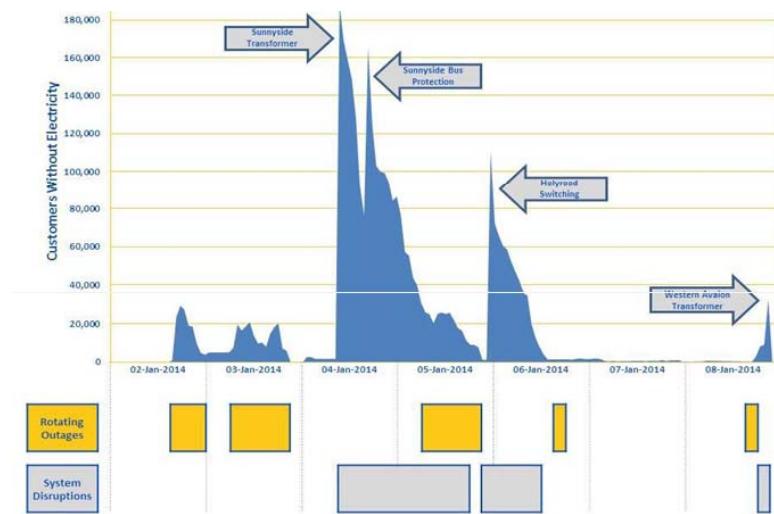
Illustration 3.7: Newfoundland Power Customers without Electricity

Illustration 3.7 below shows Newfoundland Power customer outages for the time period from January 4th through the 8th. The illustration summarizes the numbers of Newfoundland Power customers without electricity over time, because of the three outage events described above. This

chart also includes the effects on Newfoundland Power customers of the rotating outages addressed elsewhere in this report.

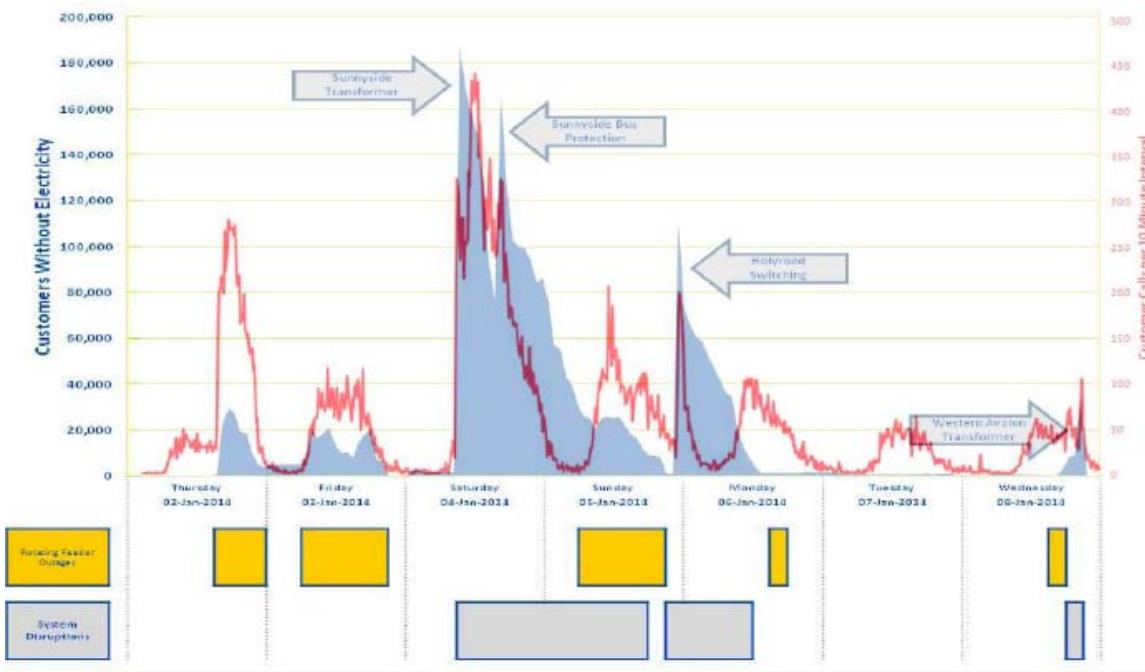
Illustration 5.1: Calls to Newfoundland Power during January 2014 Outages

Newfoundland Power's Customer Service Line received 52,612 calls during the January event (including 16,891 overflowed from Outage Line). However, 46 percent of these calls were received at a time when all incoming lines were in use. As a result, 24,073 callers received a “polite disconnect” notice, as shown from the Overflow Menu⁸² quoted below:
