LOWER CHURCHILL PROJECT

SITE VISIT REPORT JULY 14 TO 23, 2014.

Prepared for: Natural Resources Canada and Nalcor Energy

Date: September 19, 2014

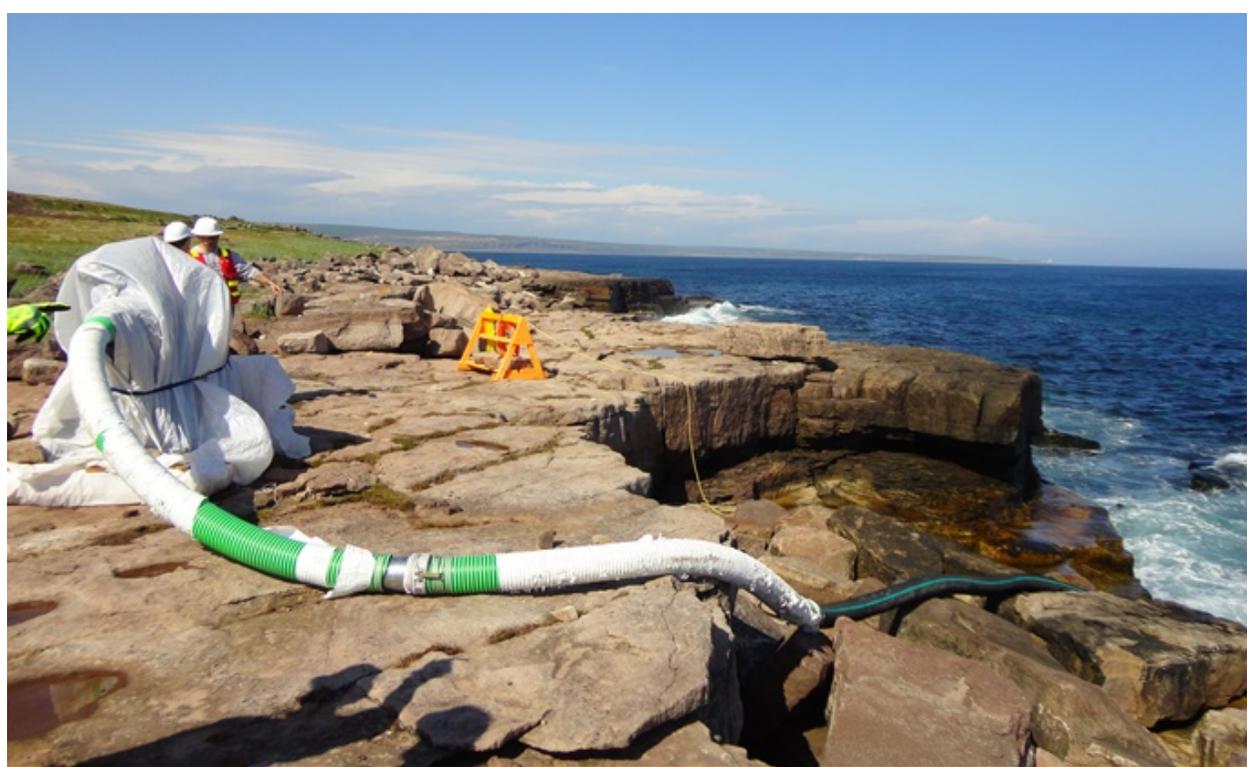
At the time of the site visit the directional drilling rig (Photo 2.1 in Appendix A), owned and operated by Direct Horizontal Drilling was set up on drill hole Forteau 2. The holes at this site are collared in competent, layered sandstone that has subhorizontal to gently inclined bedding (Photo 2.2 in Appendix A). As shown in Photo 2.3, the hole is collared near surface with 30 inch casing installed in a 36' boring. Inserts of 24" and 14" casing are telescoped into this and advanced in the hole as needed until sound bedrock is encountered. The main portion of the hole is drilled with a 14 3/4 " bit. The hole orientation and route are guided by a steerable bit that is oriented by compass guided instrumentation in non-magnetic rods (tool), 20 m behind the drill bit.

Photo 2.2: Forteau Directional Drilling. Subhorizontal bedded sandstone at the Forteau drilling site.

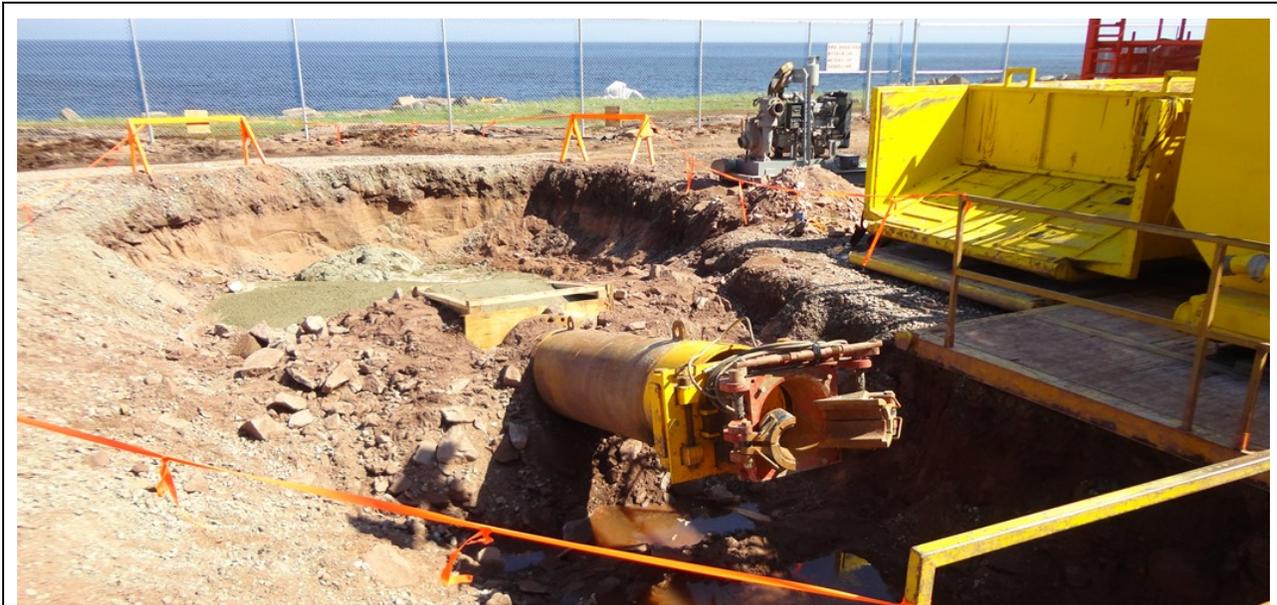
Photo 2.3: Forteau Directional Drilling. , Photo of borehole Forteau 2 showing the 30 inch casing collar. (July 15, 2014)

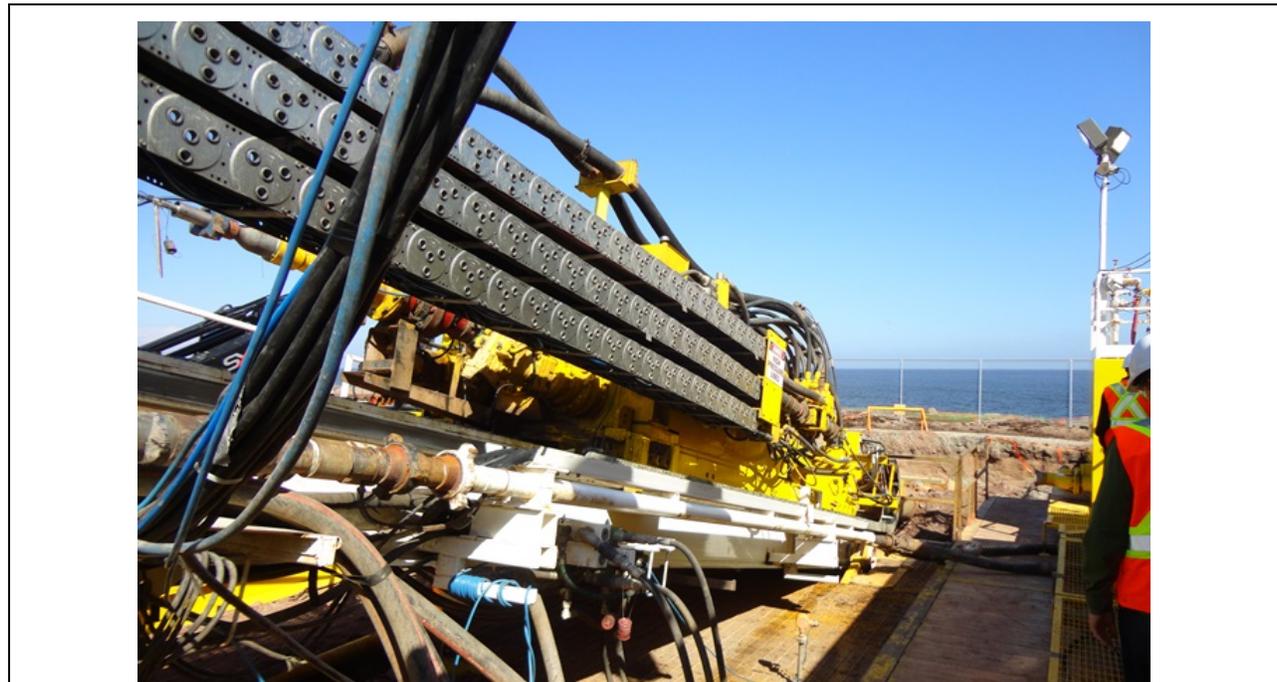
Photo 2.4: Forteau Directional Drilling. Drilling rig looking towards the drillhole Forteau 2.

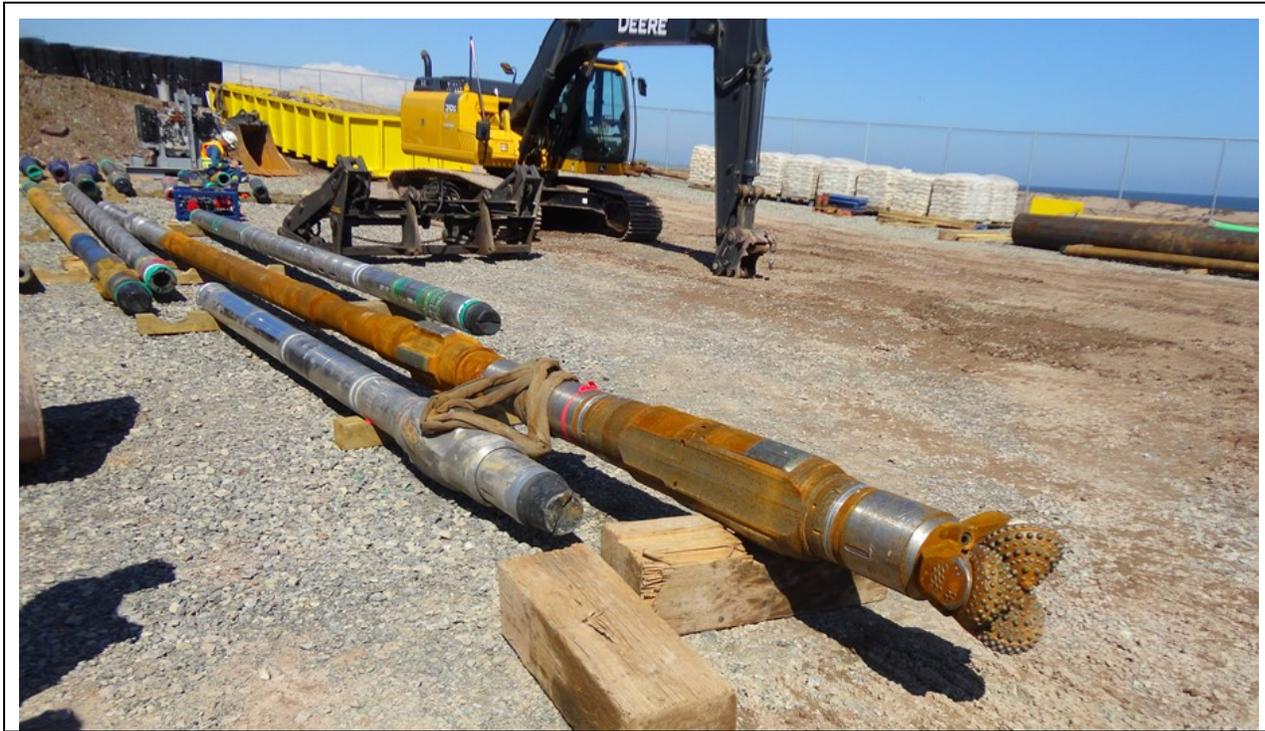
Photo 2.5: Forteau Directional Drilling. Drill bit and lower non-magnetic drill string components. (July 15, 2014)

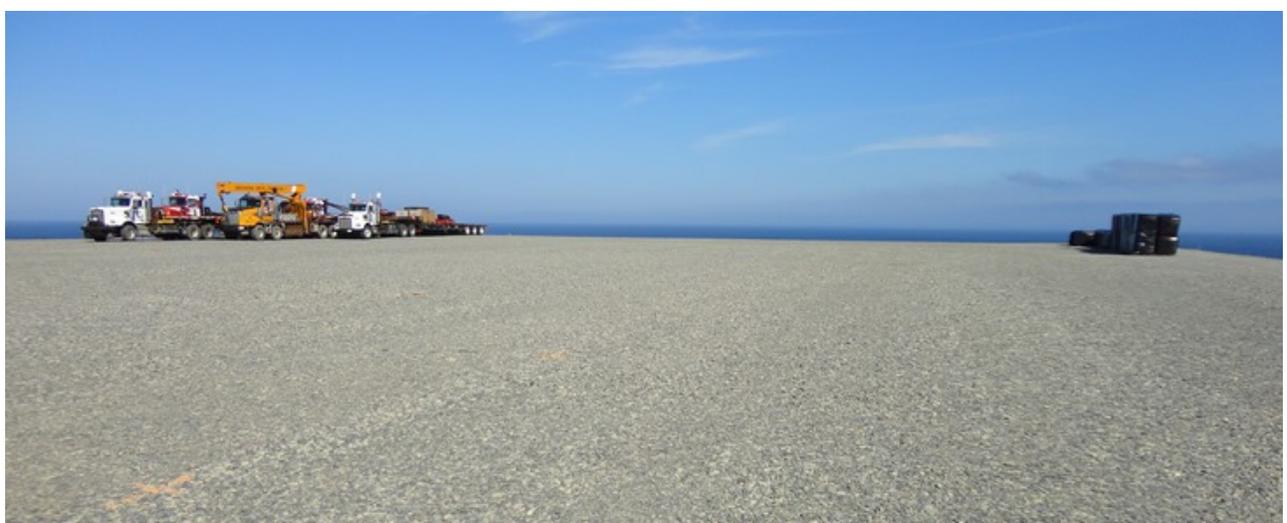
Photo 2.6: Forteau Directional Drilling. Graded fill at future transition compound site above the drilling site. (July 15, 2014)

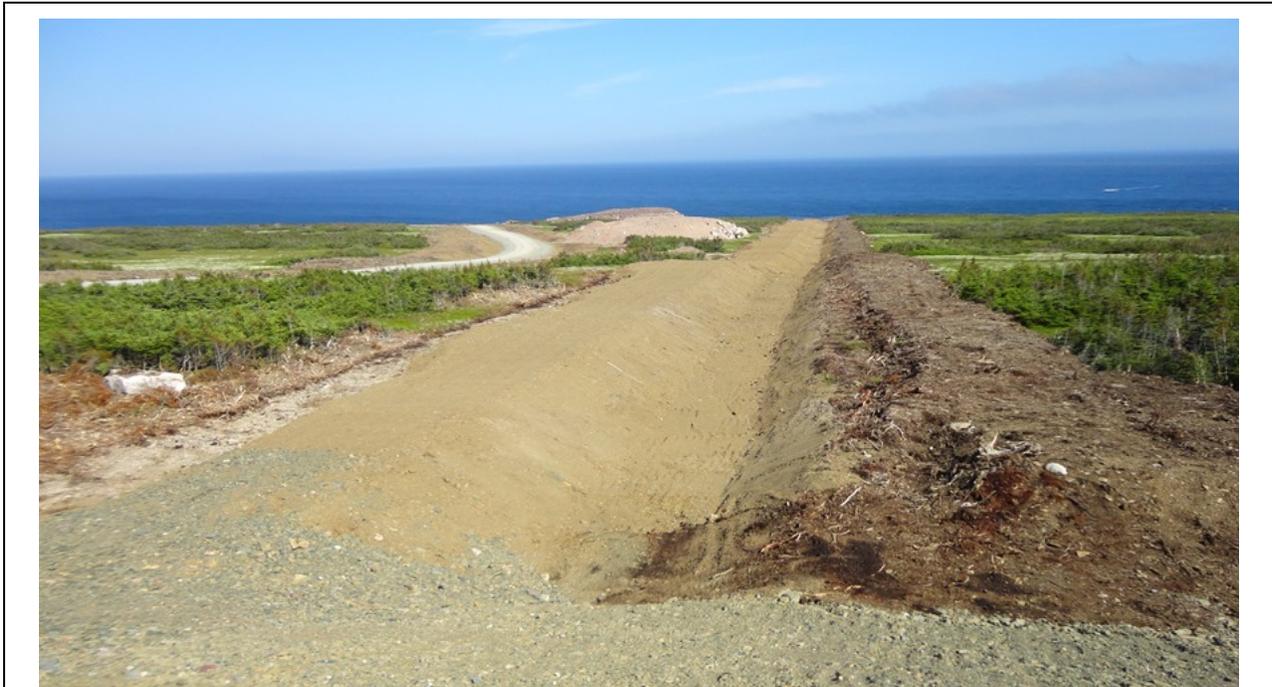
Photo 2.7: Forteau Directional Drilling. Excavated trench for the three cables between the transition compound and the drilling site. (July 15, 2014)

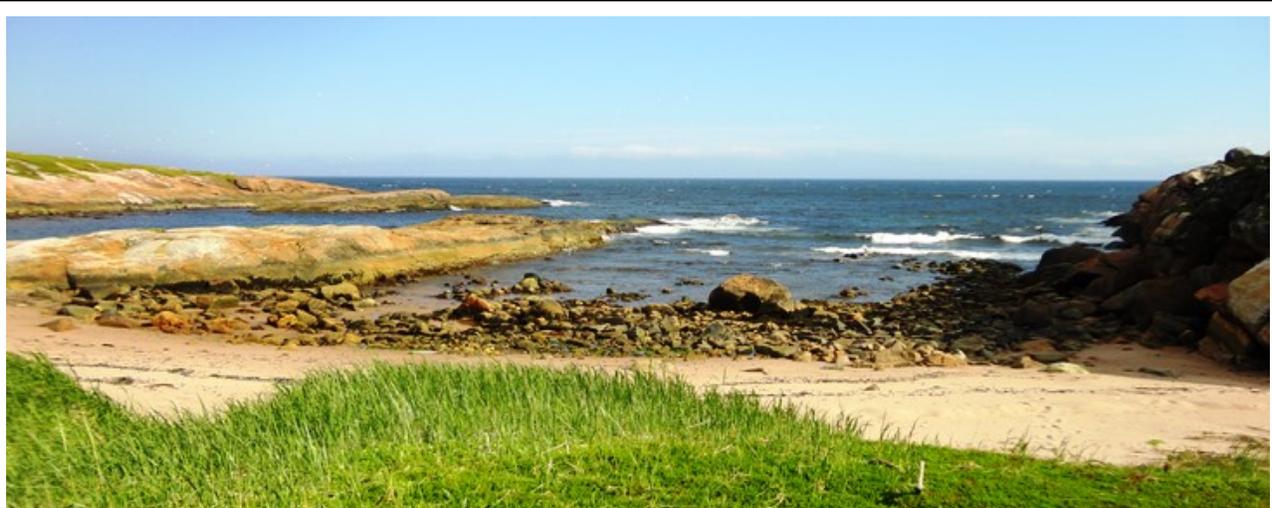
Photo 3.1: L'Anse au Diable Electrode Station site. The planned electrode pond site in a bedrock embayment. (July 15, 2014)

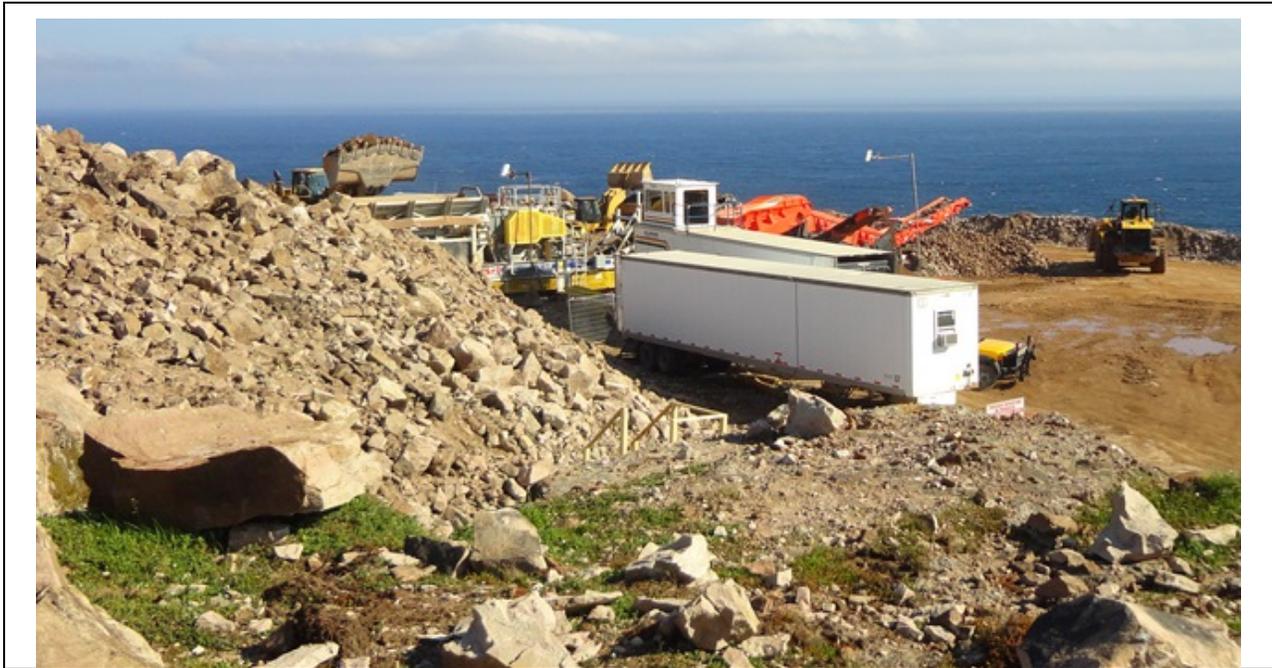
Work was progressing well at the time of the site visit. As can be seen on the photos in Appendix A, the quarrying operation has produced an 8 to 10 m high quarry face. The quality of blasting is good (Photo 4.1) and there is adequate equipment to blast, excavate and remove blasted rock from the face. The crushing and screening operation has produced a large stockpile of processed rockfill (Photos 4.2 and 4.3 Appendix A). The rock fill is made up of strong durable sandstone that is suitable for the intended use.

Photo 4.2: Forteau quarry. Crushing and screening plant in operation.

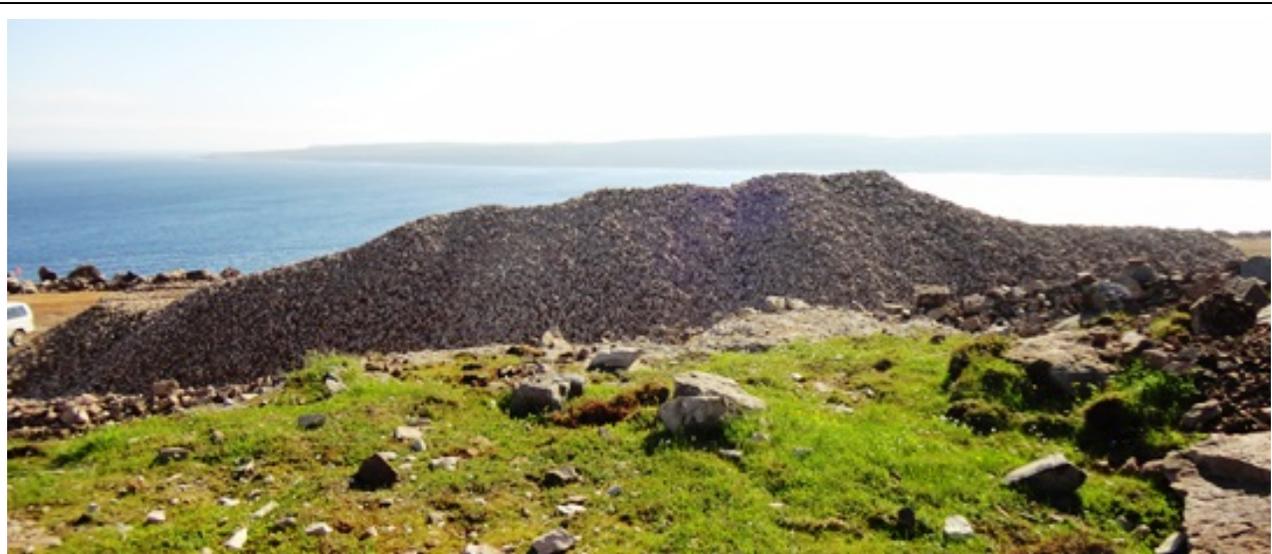
Photo 4.3: Forteau quarry. Stockpile of processed rockfill. (July 15, 2014)

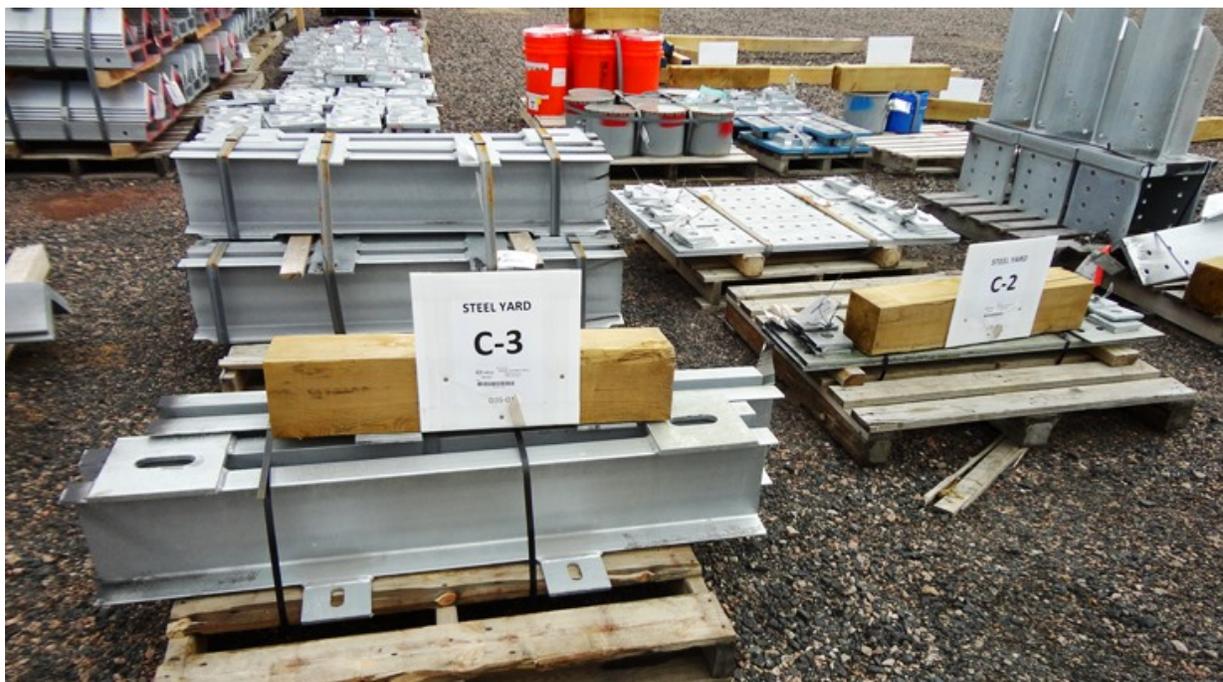
A main marshalling yard has been set up near Goose Bay (Photos 5.1 and 5.2). It is very well organized and has ample space for the planned quantities of construction materials for the various construction sites across Goose Bay, Muskrat Falls and the transmission lines.

Photo 5.2: Goose Bay Marshalling Yard. Labeled transmission components for tower foundation (July 16, 2014)

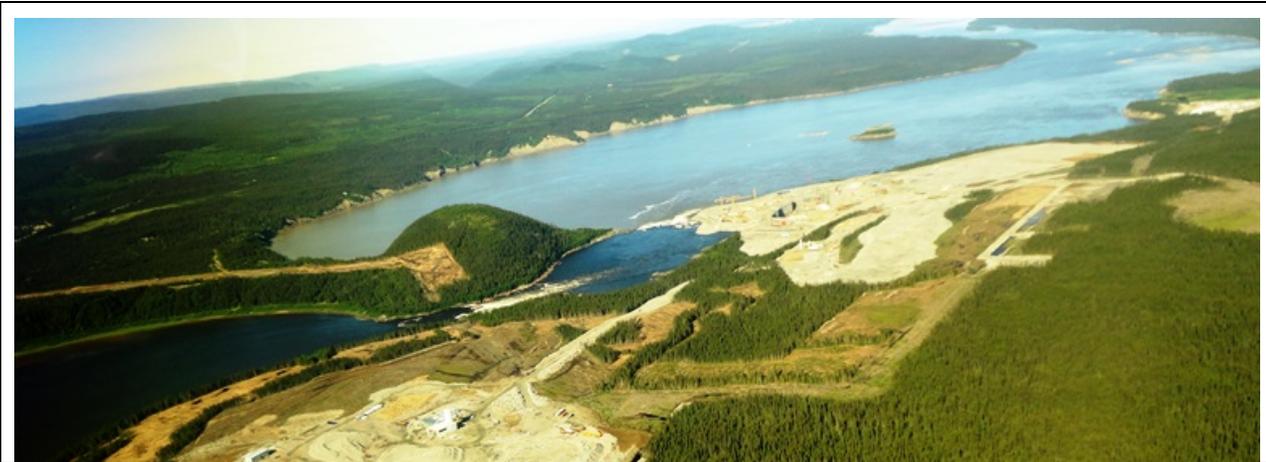
The North Spur is a 1000m long, 500m wide and 45 to 60m high ridge that connects the Muskrat Falls rock knoll to the north bank of the river (Photo 6.1). When the reservoir is impounded this feature will form a natural dam and become a major part of the river impoundment system. The feature is composed of unconsolidated mixed sand and marine silt/clay sediments. The depth to bedrock underneath the spur is in the range of 200 to 250 m. It contains a significant amount of glacio-marine silt/clay sediments, including horizons of highly sensitive clay strata, mixed with some sandy layers. The upstream and downstream slopes of this feature are subject to ongoing river erosion and mass wasting. This has contributed to local slope oversteepening of the slope, which triggers rotational sliding on both the downstream and upstream sides of the spur.

Photo 6.1: Panoramic view of the Muskrat Falls site looking towards downstream (July 18, 2014). The powerhouse/spillway site is visible on the upper right side of the photo. Transmission line clearing on the North Spur and reservoir clearing upstream of the falls are visible in the left side of the photograph.

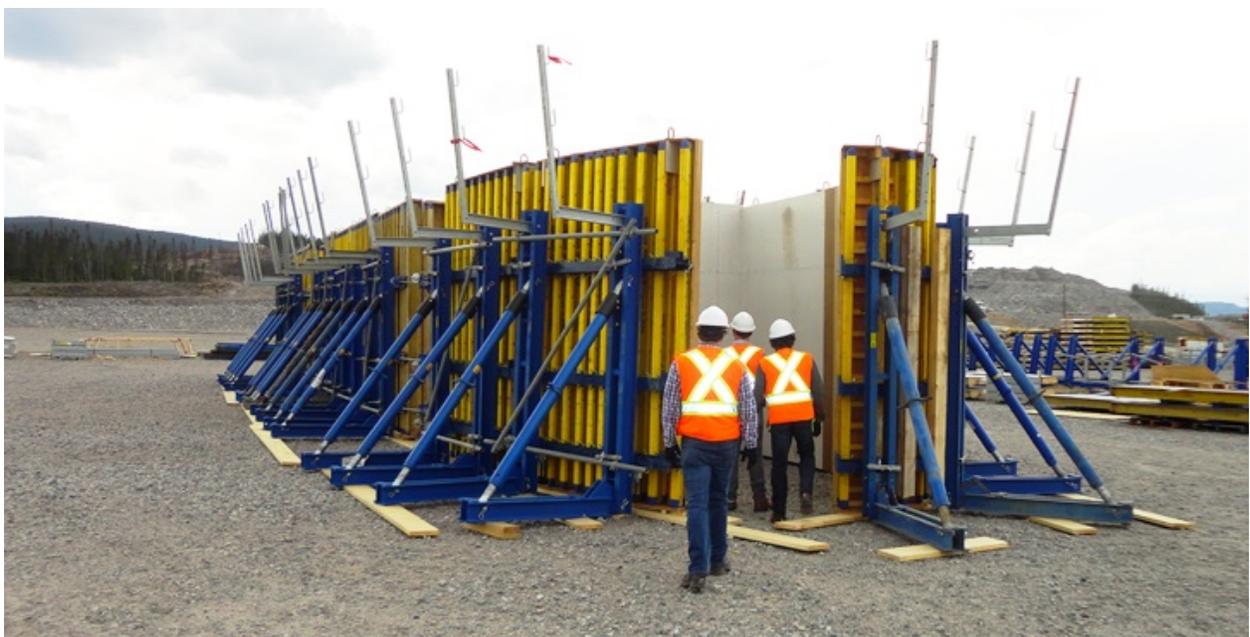
- Concrete works for the powerhouse and intake have commenced. Formwork was being erected at the time of the IE site visit (Photo 6.6 in Appendix A)
- A trial fitting of the pier formwork components was carried out (Photo 6.7 in Appendix A). The quality of the formwork was judged by the IE to be excellent.

Photo 6.7: Trial assembly of tailrace pier formwork. (July 17, 2014)

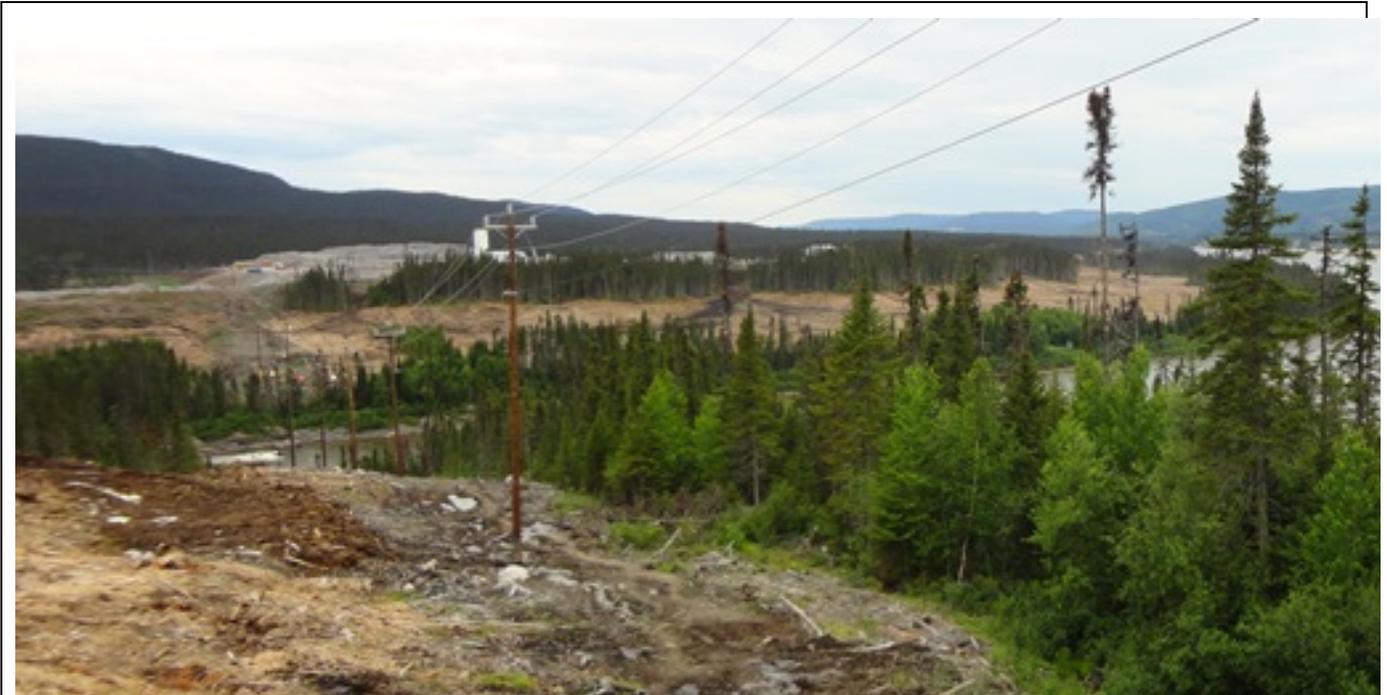
A brief site visit was made on July 16, 2014 (Photos 7.1 and 7.2 in Appendix A). As shown on the photographs most of the clearing for the transmission line at this site has been completed. This work has been done to a high standard.

Photo 7.1: North Spur. View from top of North Spur looking towards the upstream Churchill River. Note reservoir clearing in center field and right bank quarry aggregate stockpile in background. (July 16, 2014)

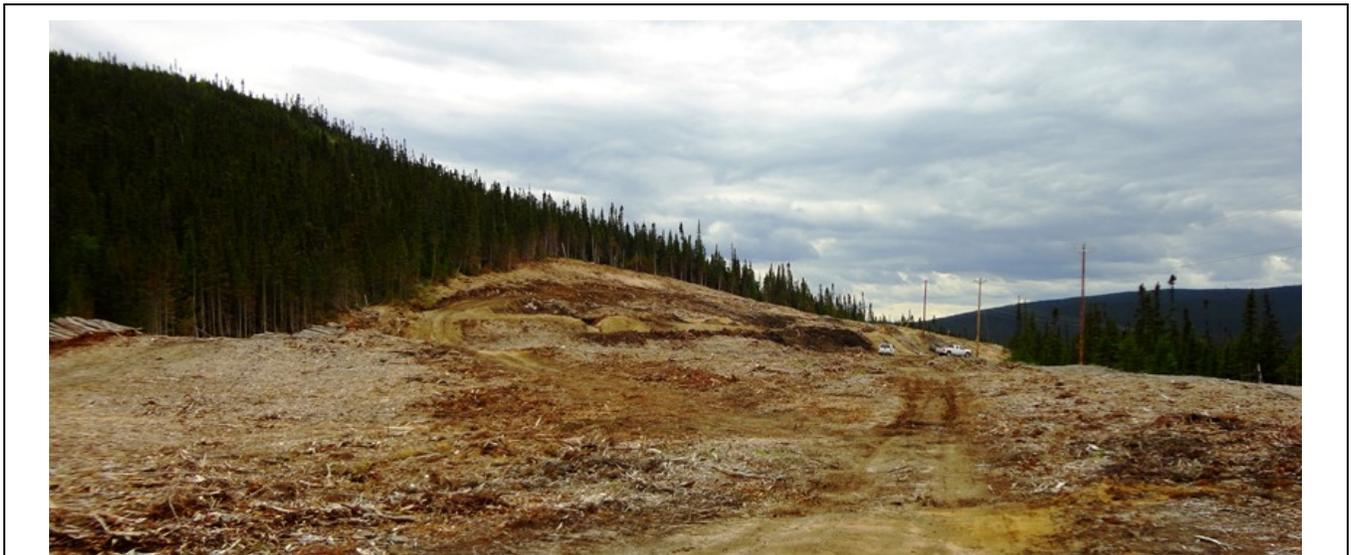
Photo 7.2: North Spur. Cleared transmission line corridor on top of the North Spur, looking northwest. (July 16, 2014)

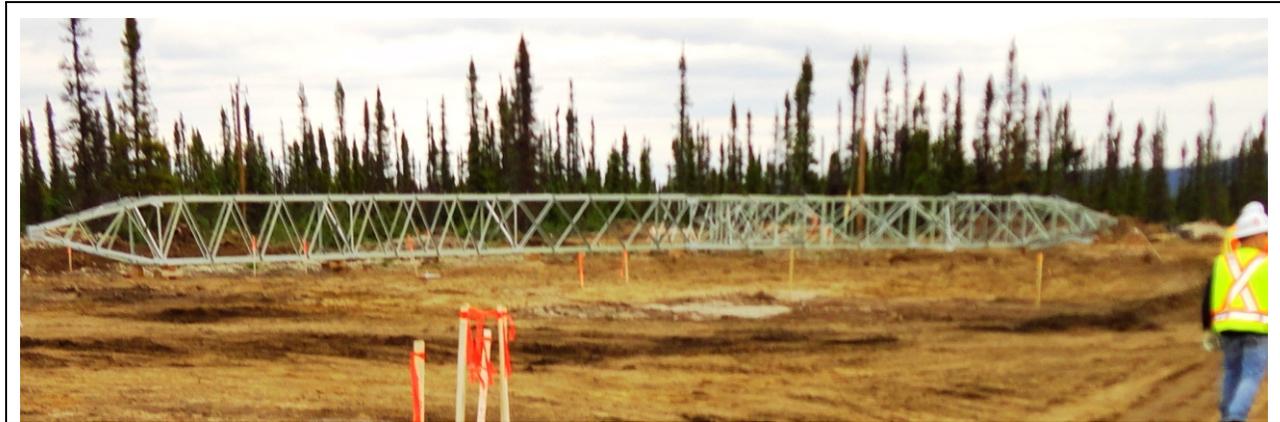
- Towers are being assembled in the field and a significant number of units (photo 8.1 in Appendix A) have been completed and are ready for erection. Vallard will have a minimum of 200 towers assembled before starting the erection. An important fact is that Nalcor have insisted that all galvanized tower assembly bolts be checked out for a proper fit in holes at the production facility. This minimizes significantly the risk of bolts misfit and the resulting schedule delay of the towers' site assembly.

Photo 8.1: Transmission Tower Erection and Foundations. Assembled single HVac tower unit. (July 17, 2014)

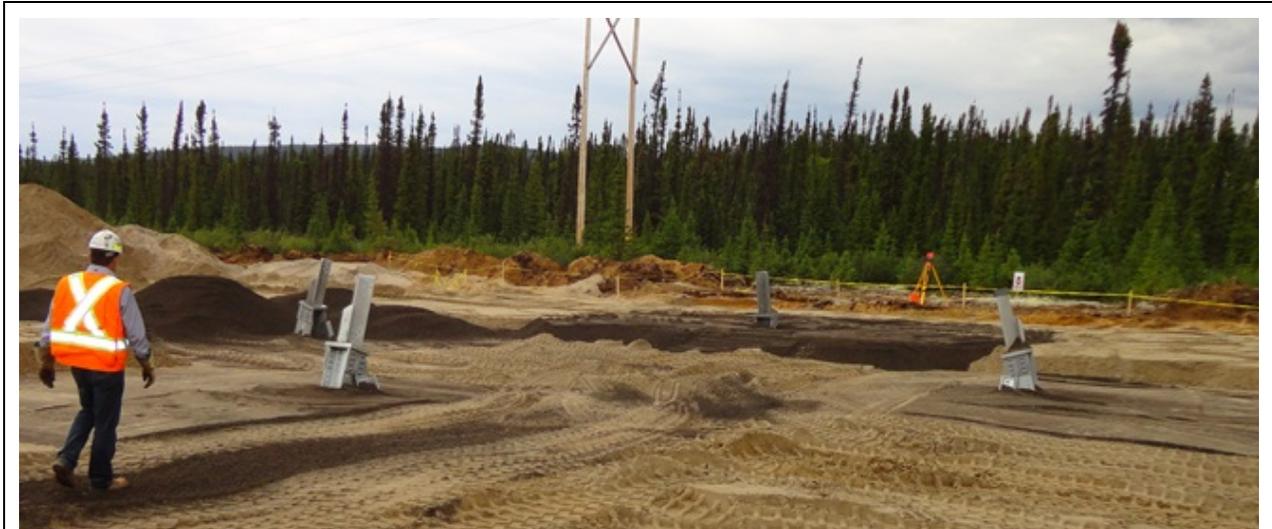
Photo 8.4: Transmission Tower Erection and Foundations. Tower footings installed and backfilled (four legged tower) (July 16, 2014)

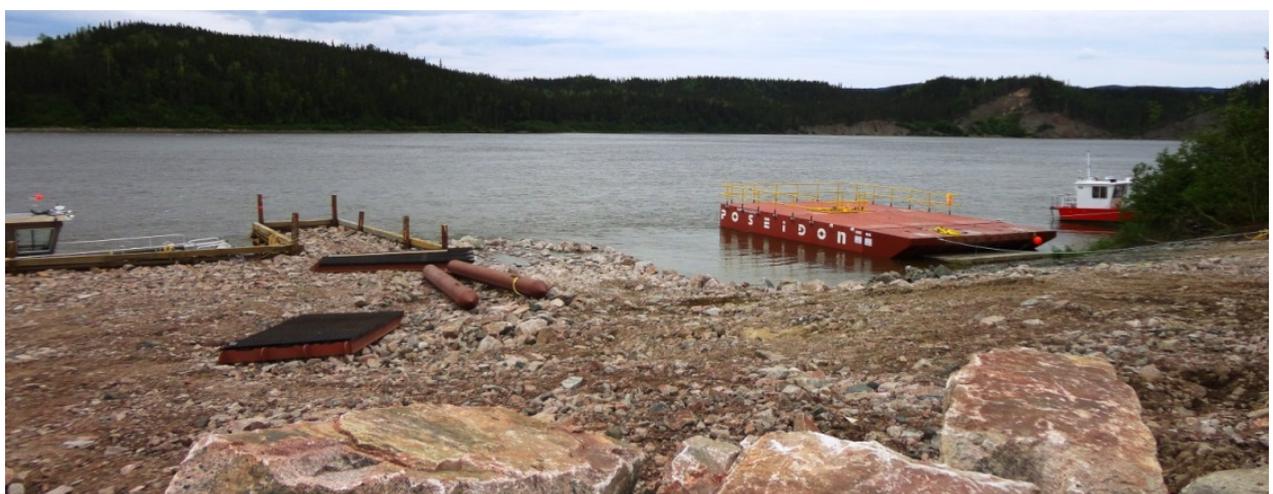
Photo 9.1: River crossing site in the upstream reservoir. (July 16, 2014)

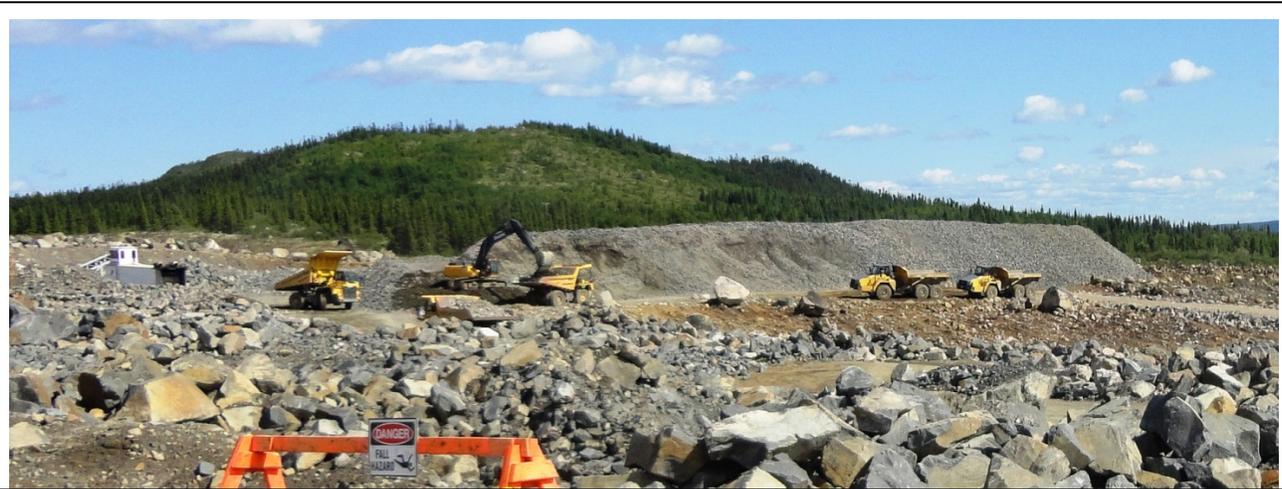
Photo 10.1: Churchill Falls New 315 kV substation and switchyard. Loading processed fill. Note stockpile of processed fill in the background and blasted rock in foreground. (July 18, 2014)

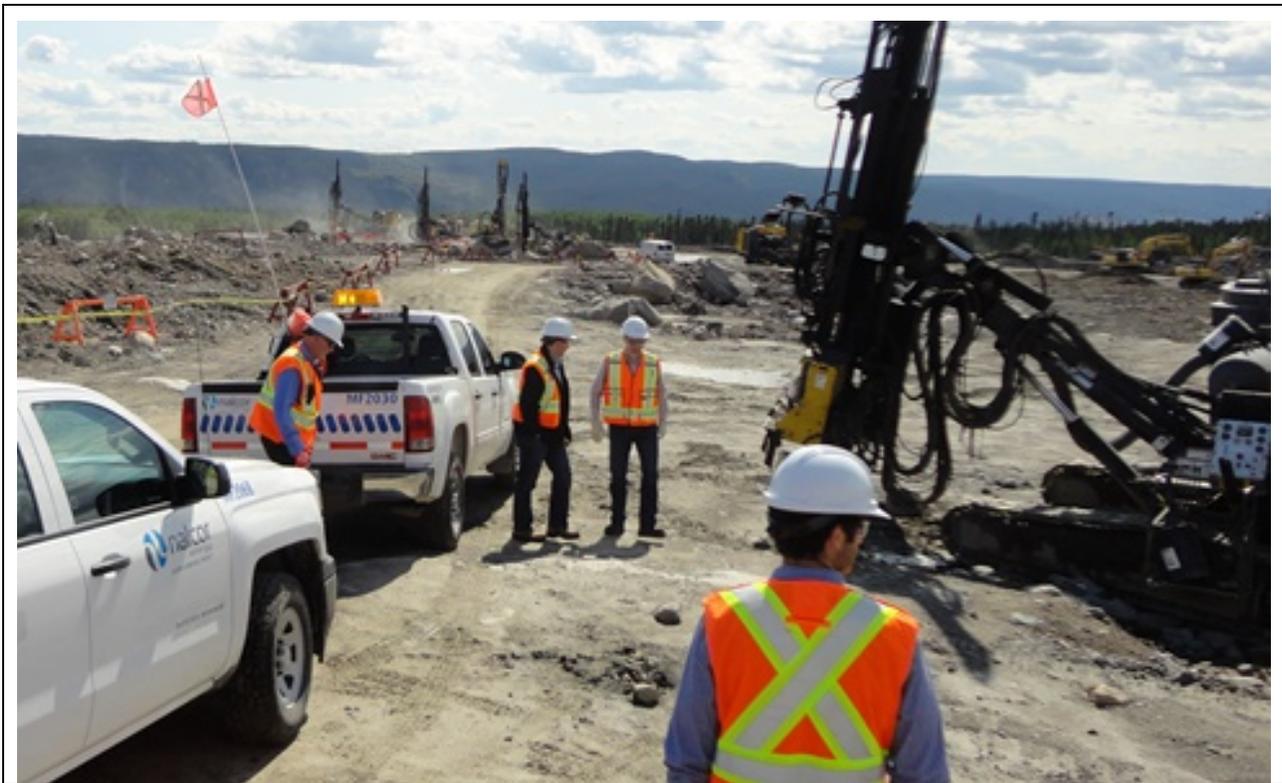
Photo 10.2: Churchill Falls New 315 kV substation and switchyard. Blast hole drilling in bedrock. (July 18, 2014)
