1 **Q. Please describe how distribution substation equipment repairs are prioritized and**  
2 **state the repair-by time limits for each prioritization.**

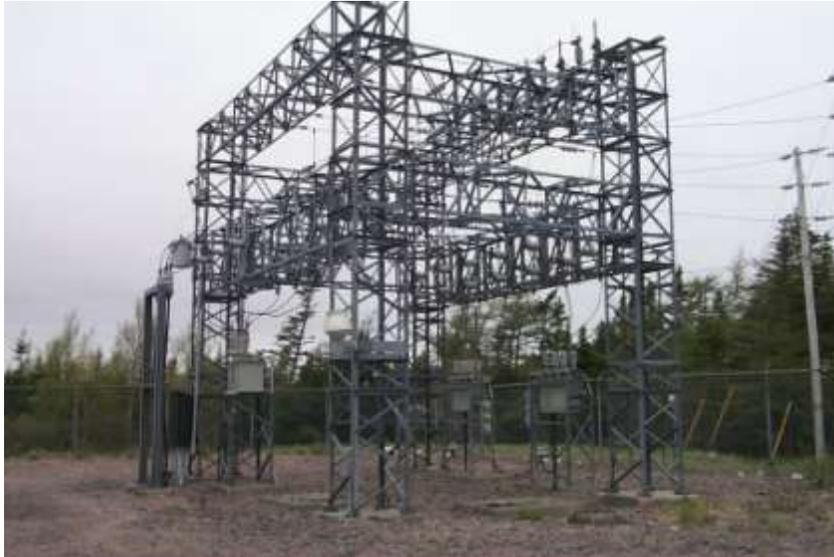
**Low Voltage Distribution Bus Structure (Feeder Infrastructure)**

The substation has 2 existing reclosers, a hydraulic recloser (HOL-01) and an intelligent Nulec recloser (HOL-02). The hydraulic recloser on HOL-01 is 30 years old and not capable of automation through the SCADA system.<sup>19</sup> The hydraulic recloser on HOL-01 will be replaced with a new intelligent recloser. The new feeder will also be equipped with an intelligent recloser thereby providing all 3 feeders with automation for monitoring and control from the System Control Center. This will provide a means of automated restoration of service which will improve service reliability for customers. With feeder automation, the Holyrood feeders will be added to the provincial under-frequency load shedding scheme.

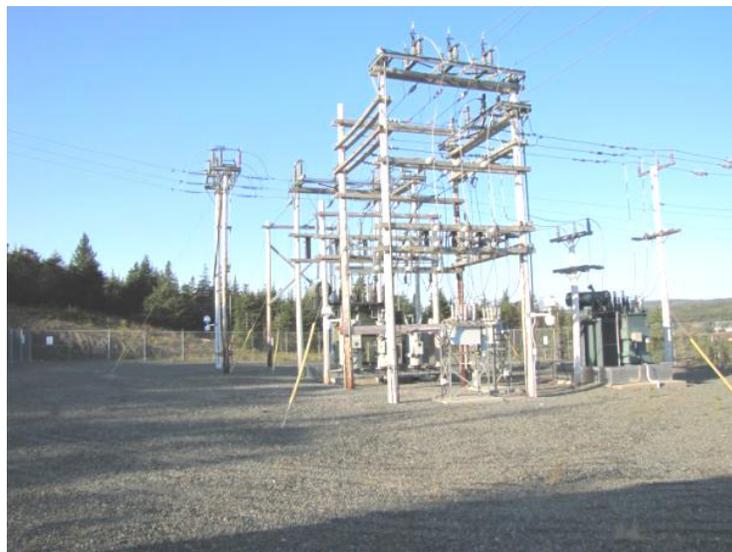
Maintenance records and on-site engineering assessments show that the 66 kV wood pole structures and bus and 25 kV wood pole structures and bus are in good condition.

**66 kV & 15 kV Wood Pole Structures and Bus**

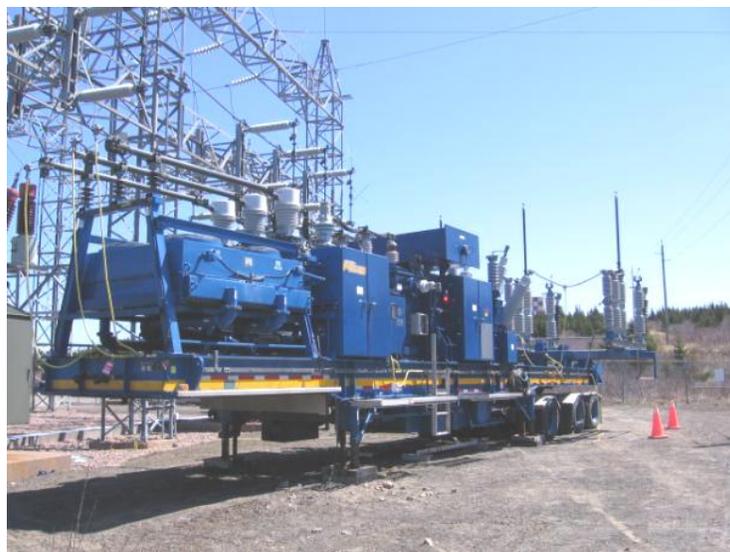
**Portable Substation P4**

The trailer will undergo an overhaul addressing rust damage and applying a rust inhibiting coating to the chassis. A fall arrest system and work platforms will be installed in areas where employees have to work aloft. External lighting will be provided at locations around the trailer.

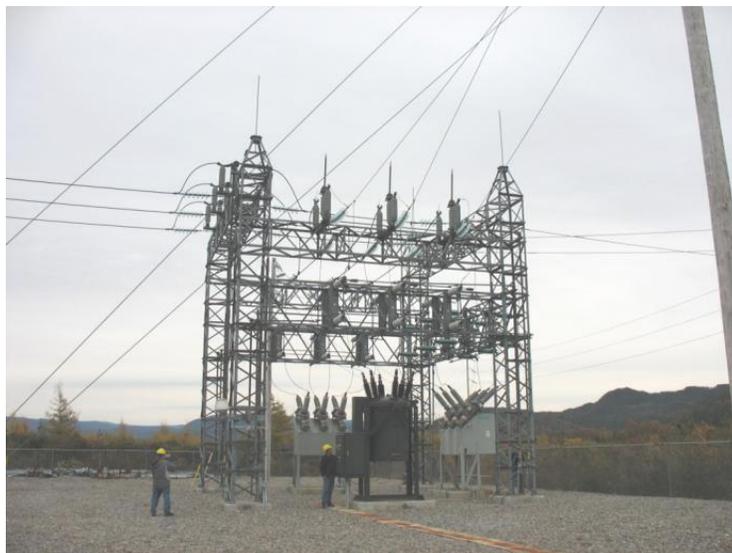
**66kV Steel Structures & Bus**

The switches on the structures are all in good condition, with the exception that the 401L-DB switch is deteriorated and as a result is difficult to operate. The switch is 1976 vintage and will be replaced due to its age and recent operating history.

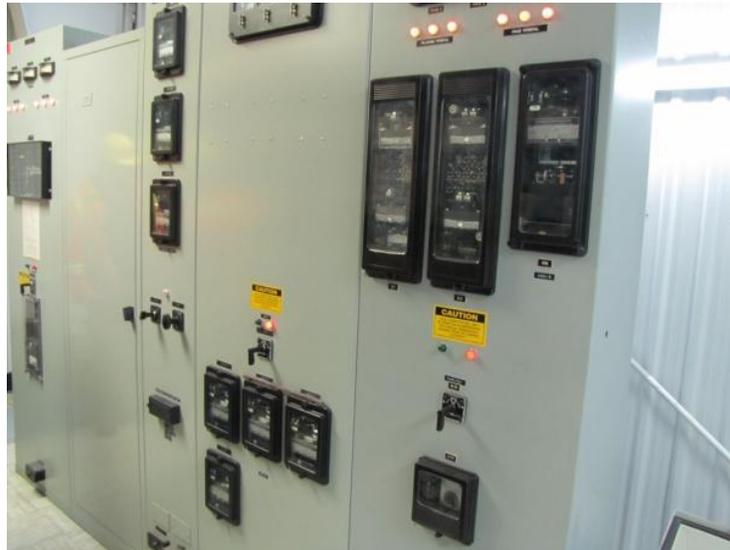
<sup>10</sup> Report 2.1 *Substation Strategic Plan* included with the 2007 Capital Budget Application identified that electro-mechanical relays contain moving parts and are prone to failure as they age, wear and accumulate dirt and dust. In the past five years Newfoundland Power has experienced increasing numbers of electro-mechanical relay failures.

**Transmission Line Electromechanical Relays**

communications package will be installed, to facilitate both automated and remote control of the various protection elements within the substation. This will provide the capability of remote management of the relays to monitor power system operation and analyze disturbances without travelling to the site.

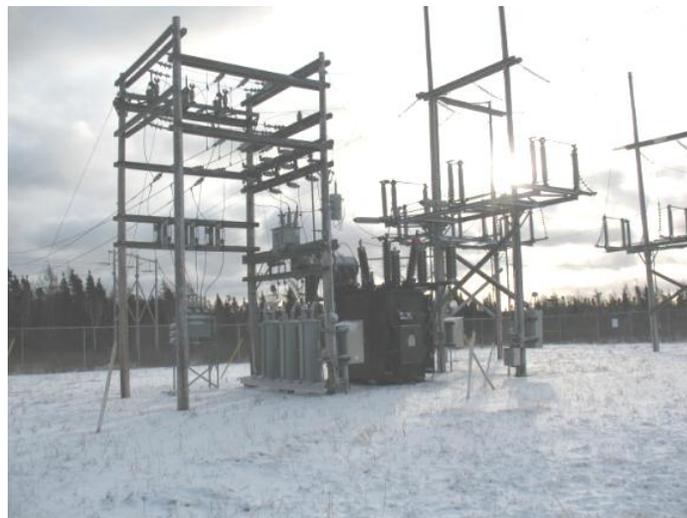
Maintenance records and on-site engineering assessments show that the 138kV and 25 kV wooden structures, foundations, buses and insulators are all in good condition. Standard varmint protection and vegetation management practices will be implemented.

**138kV & 25 kV Wooden Structures & Bus**

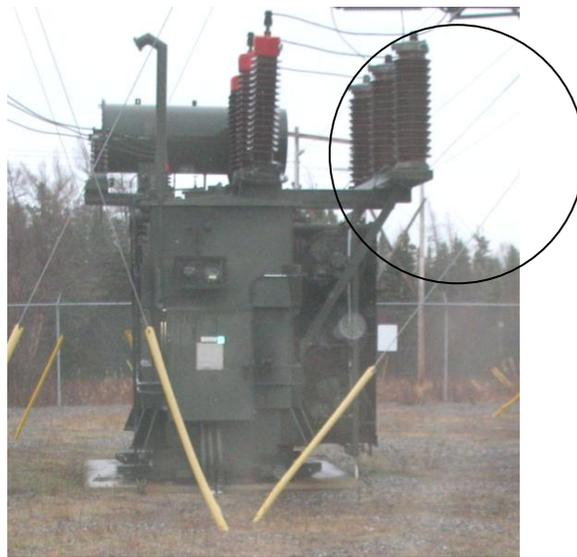
<sup>12</sup> Report *2.1 Substation Strategic Plan* included with the 2007 Capital Budget Application identified that until the early 1980's silicon carbide lightning arrestors were standard. The Company has experienced many failures of silicon carbide lightning arrestors as they age due to water leaking into the arrestor through failed seals.

**Power Transformer with Silicon Carbide Arrestors**

The portable substation will be installed and the power transformer GLN-T1 will be refurbished.<sup>11</sup> The lightning arrestors on this transformer are silicon carbide and will be replaced with metal oxide arrestors.<sup>12</sup>

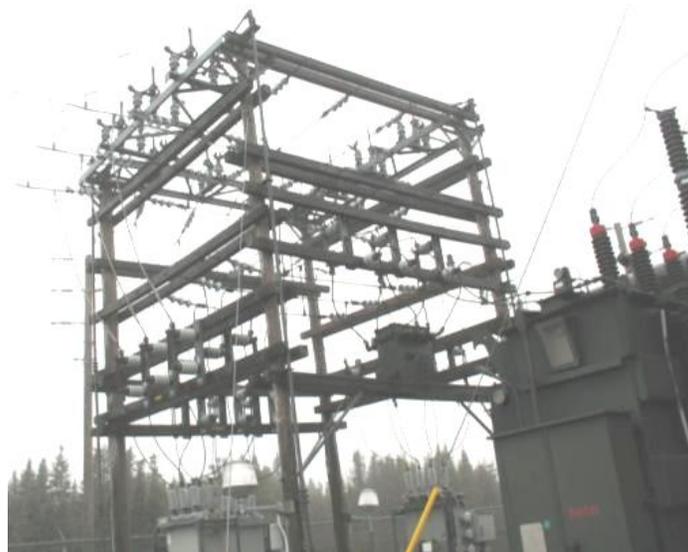
Maintenance records and on-site engineering assessments show that the 66kV and 12.5 kV wooden structures, foundations, buses and insulators are all in good condition. Standard varmint protection and vegetation management practices will be implemented.

**12.5 kV Wooden Structures & Bus**

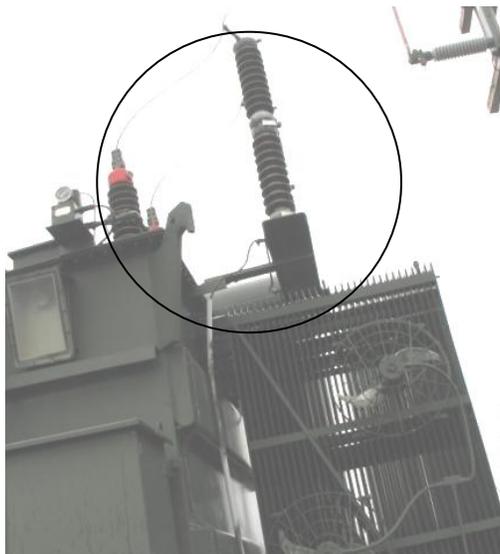
The power transformer TWG-T1 is in good condition. However, the lightning arrestors on this transformer are silicon carbide and will be replaced with metal oxide arrestors.<sup>15</sup>

**Power Transformer with Silicon Carbide Arrestors**

<sup>15</sup> Report 2.1 *Substation Strategic Plan* included with the 2007 Capital Budget Application identified that until the early 1980's silicon carbide lightning arrestors were standard. The Company has experienced increasing failures of this type of arrester as they age due to water leaking into the arrester through failed seals.

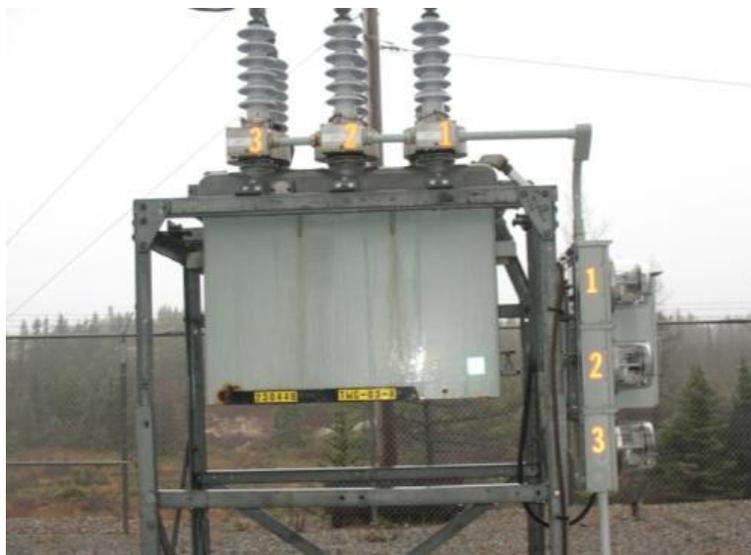
**Hydraulic Recloser on TWG-03 Feeder**

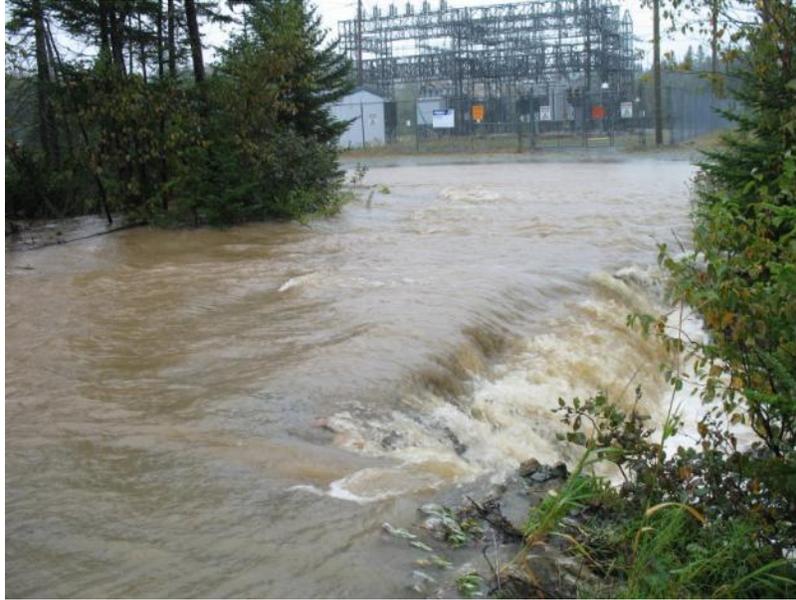
<sup>18</sup> Standing flood water in a substation poses a significant safety hazard to workers.

<sup>19</sup> Completing work in Kenmount substation during flood conditions will reduce response time and result in longer customer outages if line trucks or other equipment are unable to access the substation.

**Flooded Access Road to Kenmount Substation During Hurricane Igor**

To address the flooding problems a new access road will be constructed on the west end of the substation with a larger culvert system to handle the design flood. In addition, a berm will be constructed along the west side of the substation and connected to the access road to provide improved flood protection to the substation.

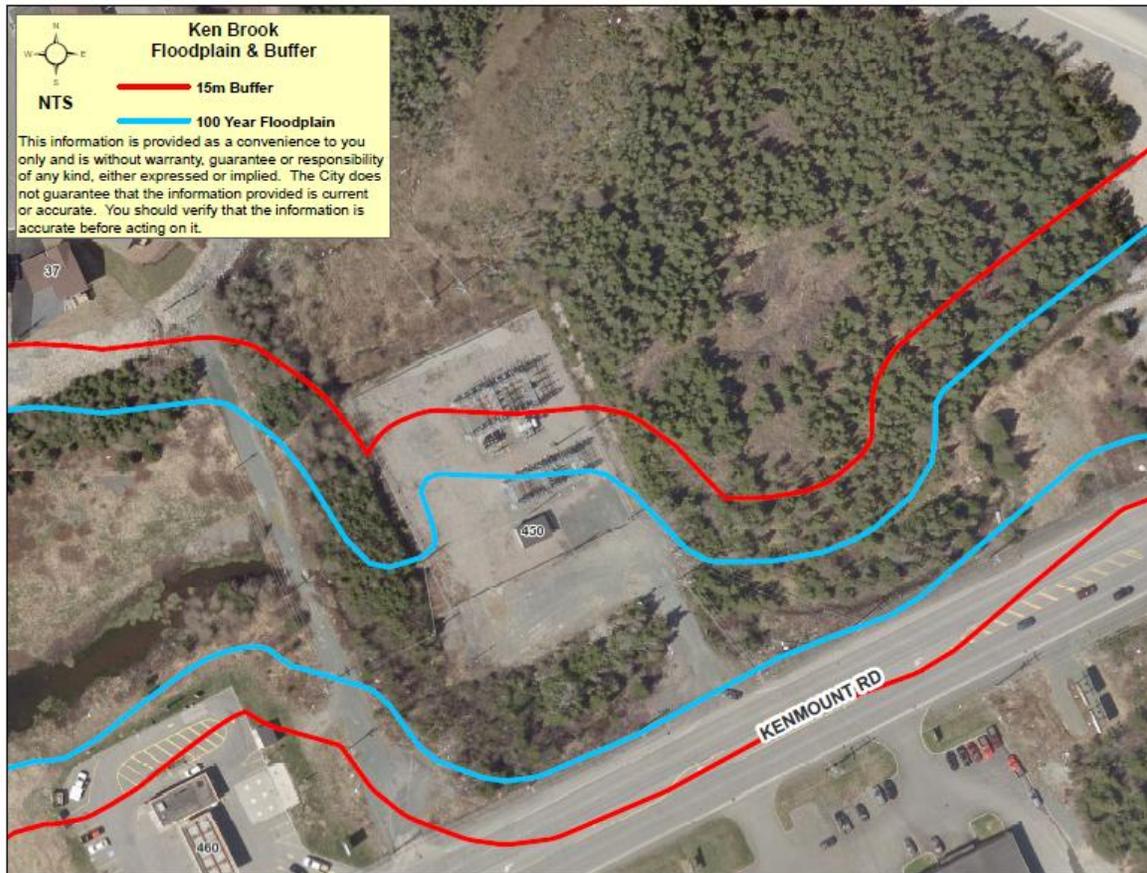
Flood mapping provided by the City of St. John's shows that the Kenmount Substation is located within a flood plain. With the amount of housing and commercial development ongoing in the area it is anticipated that flood events will be more severe in the future as runoff from these developments is adding to the stream flow on the south side of the substation.<sup>20</sup> Due to the development in the area the design capacity of the access road culvert is no longer adequate for the change in flow during peak rain events. The existing access road to the substation has a 1,525 mm culvert with a cross sectional area of 1.82 m<sup>2</sup> to pass water. In comparison about 150 metres downstream on Ladysmith Drive the City of St. John's has recently installed a 6100 mm × 2290 mm box culvert with a cross sectional area of 14 m<sup>2</sup>. The box culvert installed by the City of St. John's has a cross sectional area 7.7 times larger to pass flow from the same stream.

**Kenmount Road Substation  
1 in 100 Year Flood Plain<sup>21</sup>**

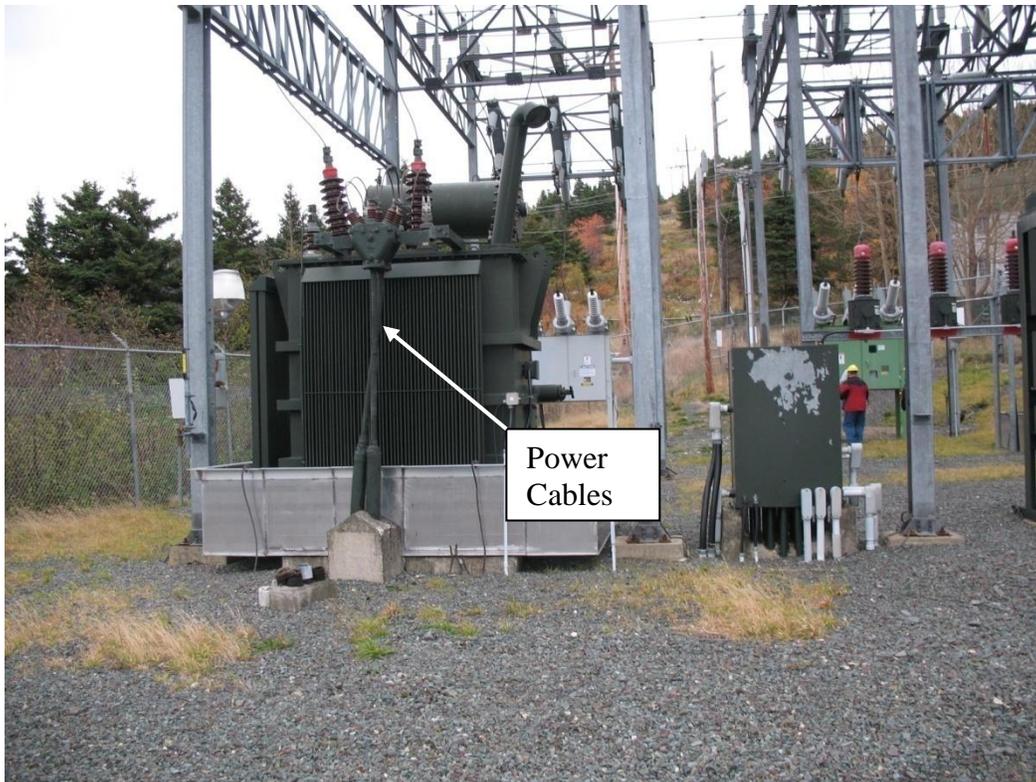
1966 Vintage Power Cables

The power cables for T1 and T3 are 1966 and 1971 vintage, are deteriorated and will be replaced.<sup>4</sup> The lightning arrestors on the 66 kV side of T1 are gap type and will be replaced with new metal oxide arrestors.<sup>5</sup>

<sup>4</sup> Report 2.1 *Substation Strategic Plan* included with the 2007 Capital Budget Application identified that power cable failures begin to occur when cables are about 35 years old. The Heart's Content power cables are 39 and 44 years of age and will be replaced during the 2012 refurbishment and modernization of the substation.

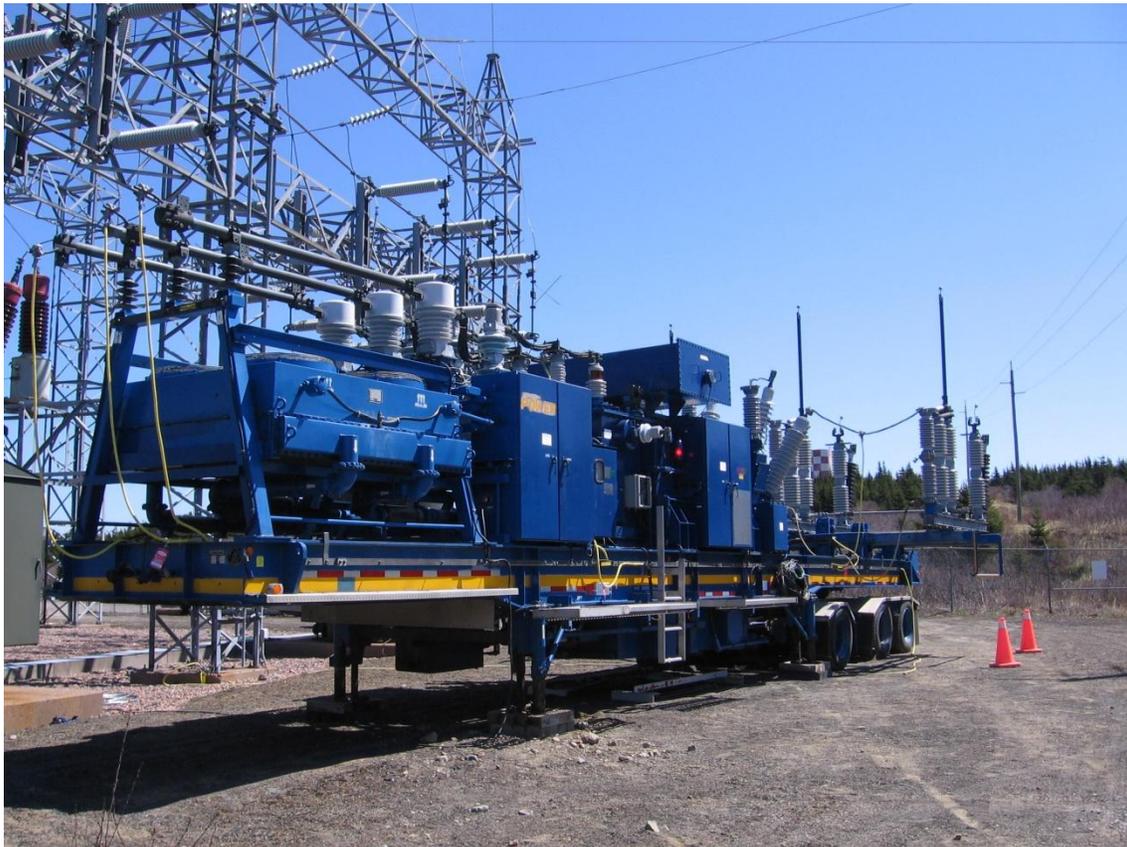
**Portable Substation P4**

The trailer will undergo an overhaul addressing rust damage and applying a rust inhibiting coating to the chassis. A fall arrest system and work platforms will be installed in areas where employees have to work aloft. External lighting will be provided at locations around the trailer.

The alarm annunciation panel has had several failures and will be replaced. The protection relays will be replaced with microprocessor based protection relays.<sup>8</sup> A digital metering system for power, voltage and current will be provided.

The control wiring associated with the protection and control of the portable substation is original wiring showing signs of deterioration and will be replaced. Deteriorated termination and junction boxes will be replaced.

Online monitoring of transformer gas and oil analysis will be provided to protect the transformer. High voltage linkages connecting the power transformer to the switches are deteriorated and will be replaced. The batteries and charging system are at the end of life and will be replaced.

In 2012 engineering for the refurbishment will be completed with the actual refurbishment taking place in 2013. This is the first comprehensive refurbishment of this portable substation since its purchase. Refurbishment of portable substation P4 will ensure its continued availability for the next decade.

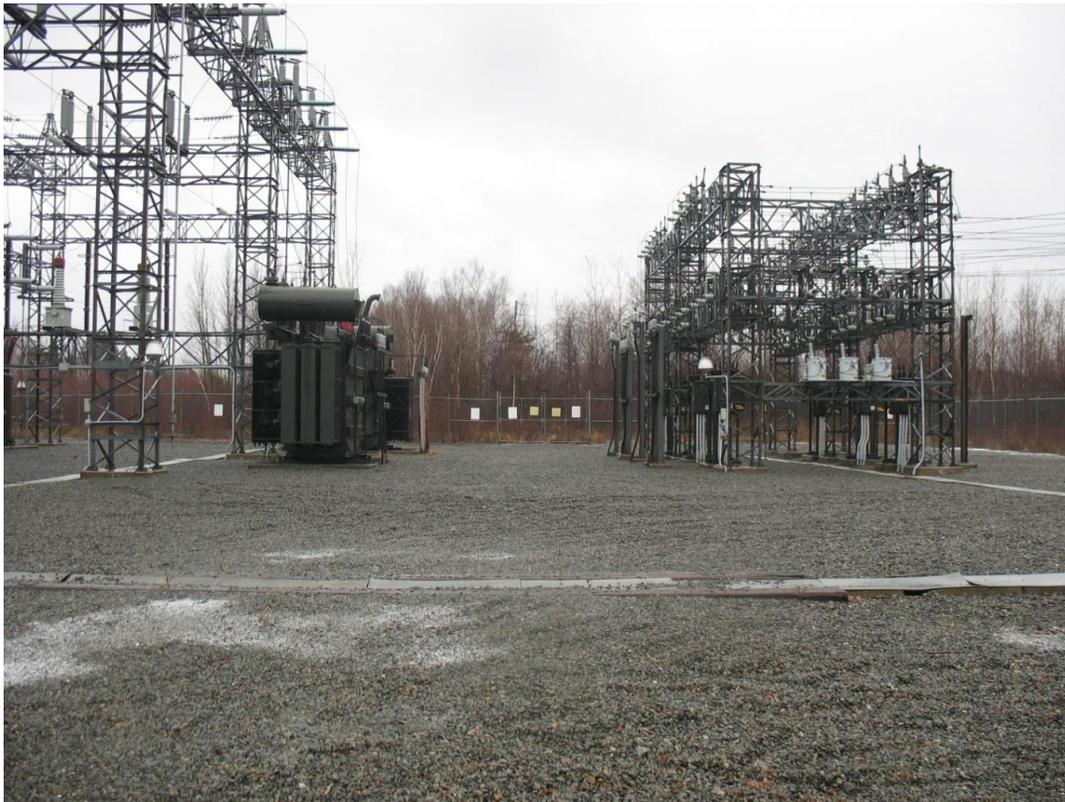
**138kV & 25 kV Steel Structures & Bus**

Maintenance records and on-site engineering assessments show that the 138 kV, 66 kV and 25 kV steel structures, foundations, buses and insulators are in good condition.

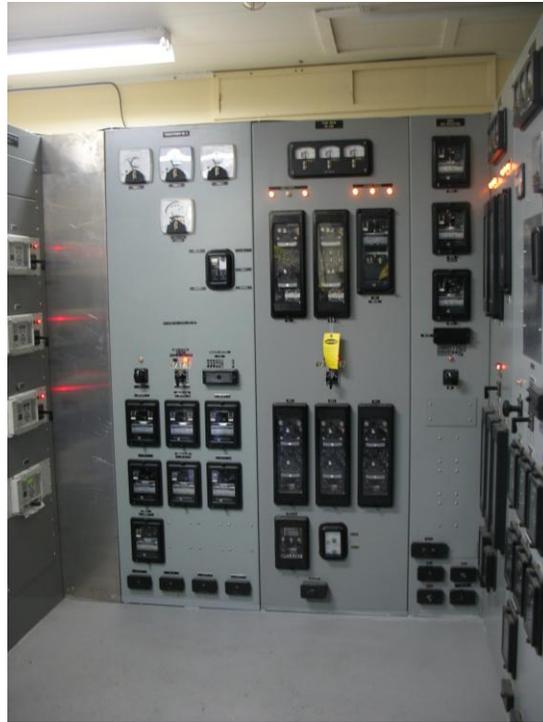
**Transmission Line Electromechanical Relays**

The relays for the transmission lines and bus protection are 1976 vintage electromechanical type and will be replaced with new microprocessor based relays<sup>11</sup>.

<sup>11</sup> Report 2.1 *Substation Strategic Plan* included with the 2007 Capital Budget Application identified that electro-mechanical relays contain moving parts and are prone to failure as they age, wear and accumulate dirt and dust. In the past five years Newfoundland Power has experienced increasing numbers of electro-mechanical relay failures.

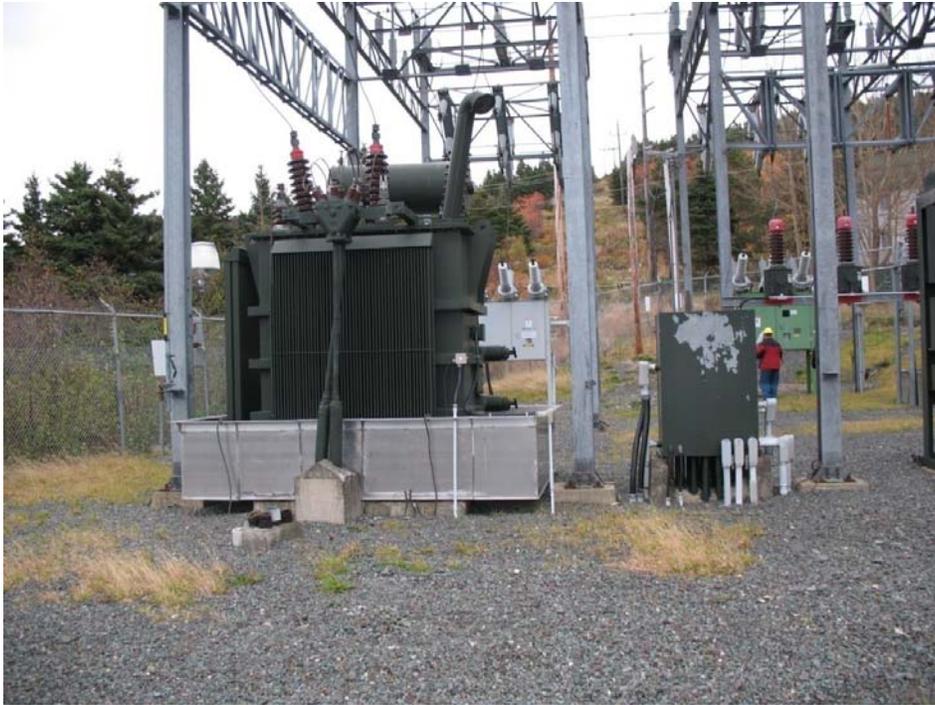
1966 Vintage Power Cables

The power cables for both T1 and T3 are 1966 and 1971 vintage, are deteriorated and will be replaced.<sup>2</sup> The lightning arrestors on the 66 kV side of T1 are gap type and will be replaced with new metal oxide arrestors.<sup>3</sup>

<sup>2</sup> Report 2.1 Substation Strategic Plan included with the 2007 Capital Budget Application identified that power cable failures begin to occur when cables are about 35 years old. The Heart's Content power cables are 39 and 44 years of age and will be replaced during the 2011 refurbishment and modernization of the substation.

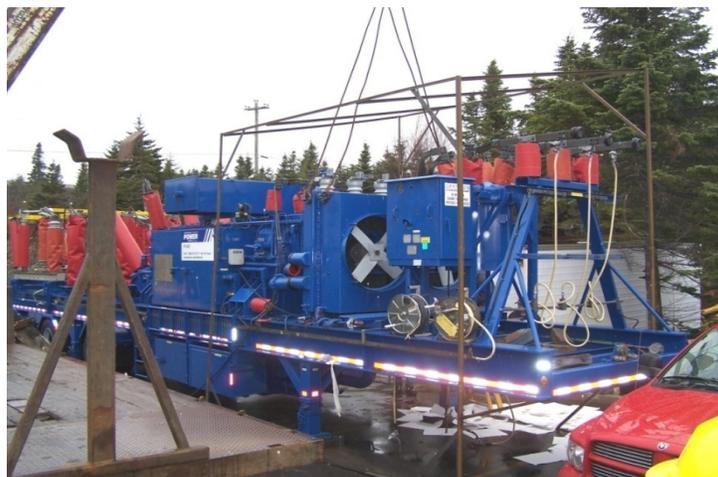
**Portable Substation P3**

Portable substation P3 was purchased in 1977. It is used to respond to power transformer failures and for carrying out planned transformer and substation maintenance. Of the approximate 190 power transformers in service on Newfoundland Power's system, P3 can provide backup for 68% of them.

This is the first comprehensive refurbishment of this portable substation since its purchase over thirty years ago. Purchase of a comparable new portable substation would cost approximately \$5 million. Refurbishment of portable substation P3 will ensure its continued availability for the next decade.

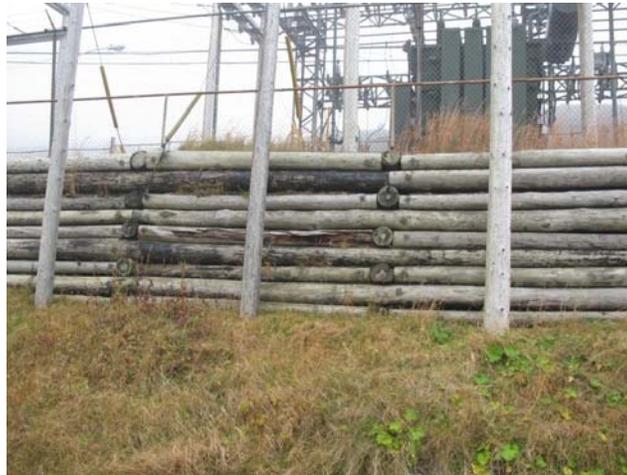
**Deteriorated Retaining Wall**

Maintenance records and on-site engineering assessments show the 66 kV wood pole structure and 12.5 kV steel structures are in good condition. The concrete foundations, buses and insulators are in good condition. However, the retaining wall for the substation is deteriorated and will be replaced.

The new retaining wall will enclose a larger area than is currently enclosed and new fencing will be installed along the top of the retaining wall to replace the existing deteriorated fencing.

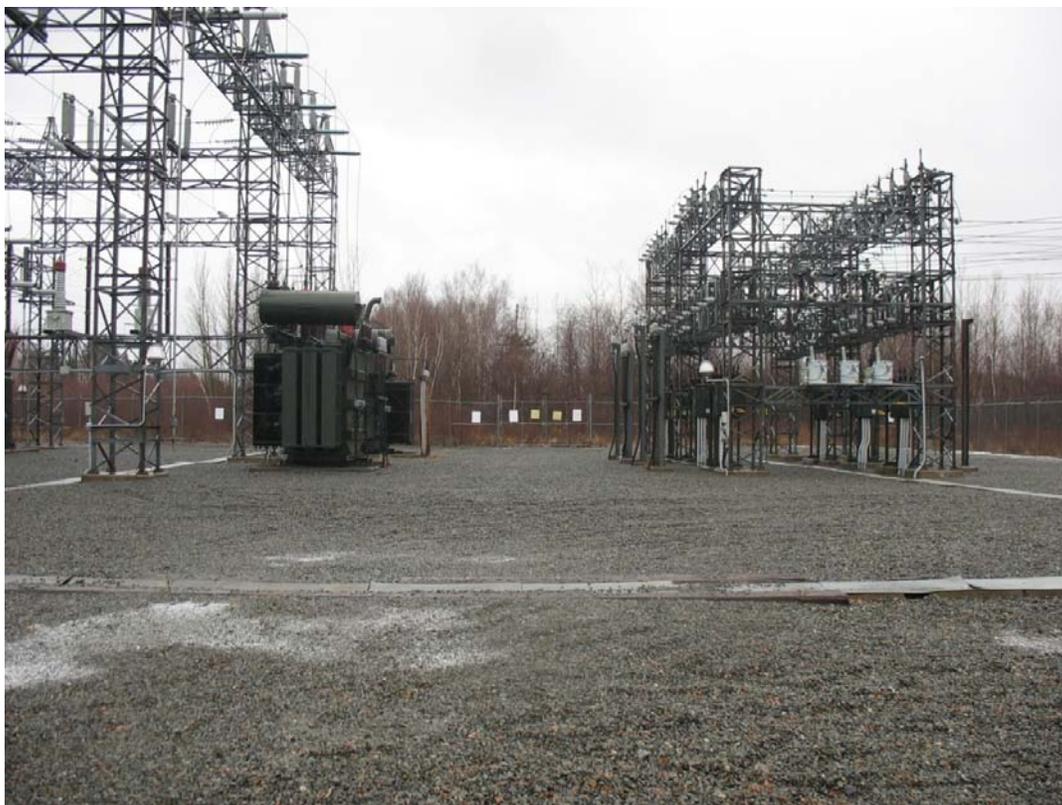
**138kV & 25 kV Steel Structures & Bus**

Maintenance records and on-site engineering assessments show that the 138 kV, 66 kV and 25 kV steel structures, foundations, buses and insulators are in good condition.

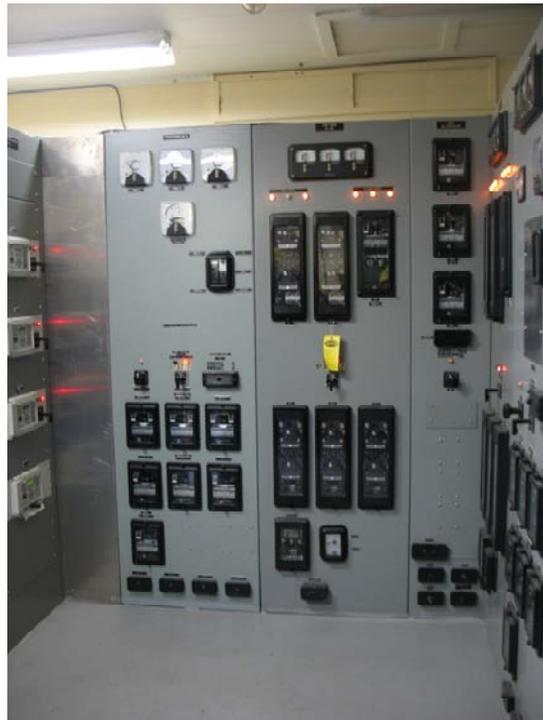
**Transmission Line Electro Mechanical Relays**

The relays for the transmission lines are 1976 vintage electro mechanical type and will be replaced with new micro processor based relays<sup>10</sup>.

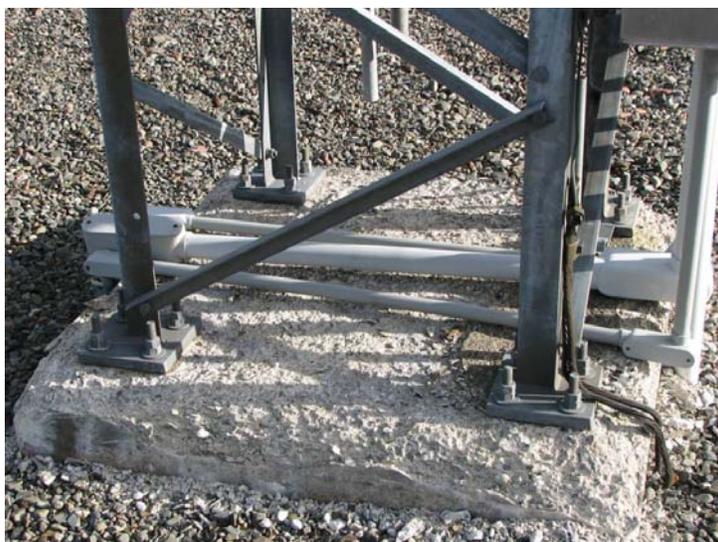
**25 kV Structure Foundation**

Ground grid improvements and a new control building; protection from small animal risks; and concrete foundation repairs also comprise part of the required work on this substation.

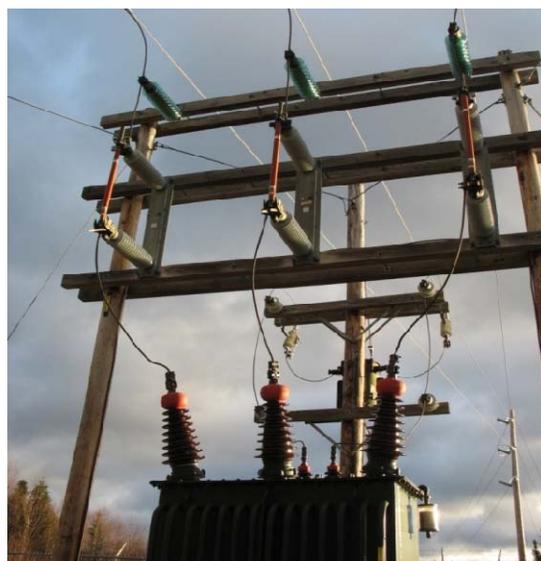
**Station Service Transformer Structure**

Lightning arrestors are planned to be installed for protection of the 66 kV station service transformer at this substation. Lightning arrestors will reduce the potential for future long duration outages which would result from a lightning strike at the transformer. In turn, this will improve security of supply for customers in the Notre Dame Bay area served by Newfoundland Power and Hydro.

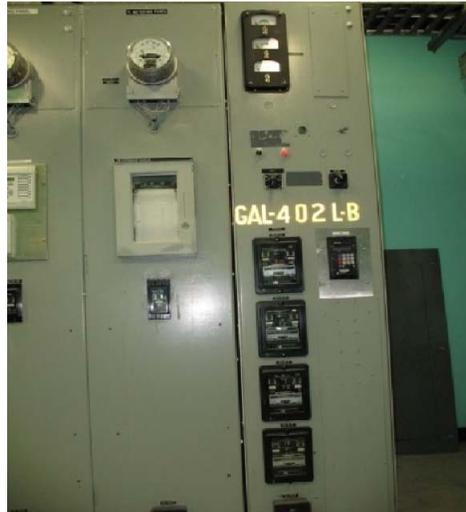
**Transmission Line Protection Relays**

The original transmission line electro-mechanical relays will be replaced with new electronic digital protection relays. A 66 kV potential transformer and fuse will be installed on transmission line 401L and used to improve protection for the transmission line. Defective insulation, deteriorated structures, and deteriorated metering tanks require replacement. Remote monitoring of transformer alarms and improved transformer protection are also planned.

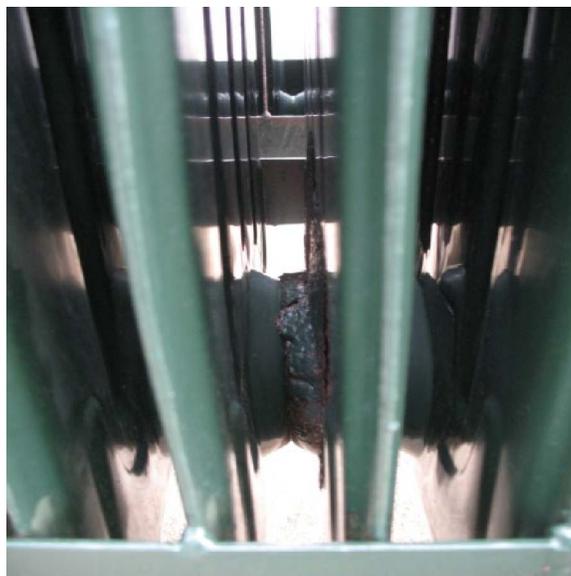
Inspection indicates significant rust on the transformer's radiators. These radiators will be replaced in 2010. In addition, a deteriorated AC panel at the substation requires replacement.

**Gillams Transformer Radiator Deterioration**

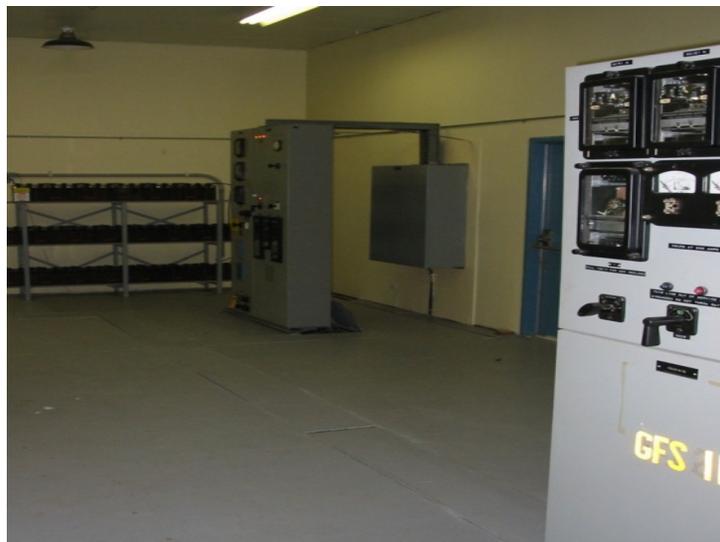
The switchgear building currently houses the 4 kV equipment for the four 4 kV feeders, the transmission line protection panel and the 125 V DC battery bank in one room. A battery room will be constructed within the switchgear building for the 125 V DC battery bank and a wall constructed to separate the protection panels from the switchgear. This will provide the required thresholds of arc flash safety for personnel working in the building.

**Grand Falls - Single Room Switchgear & Control Building**

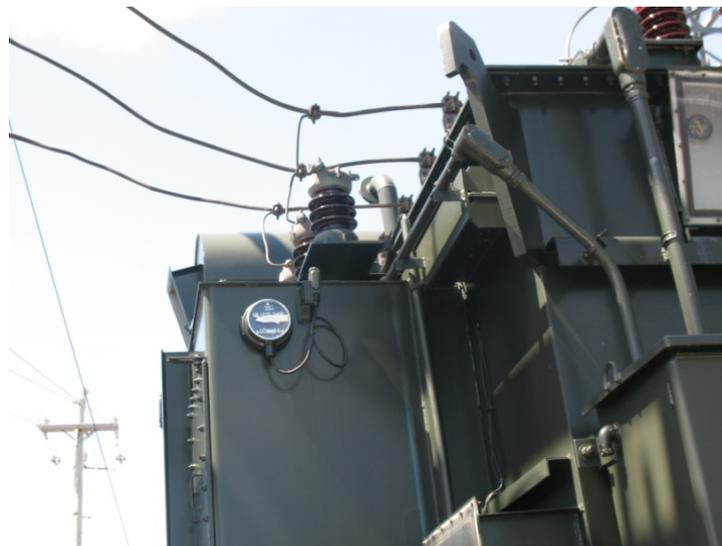
**WES-T1 Low Voltage Lightning Arrestors**

Metal oxide lightning arrestors will be installed on the 13 MVA power transformer. A 66 kV potential transformer at the termination of transmission line 116L will be relocated to permit safe work access.

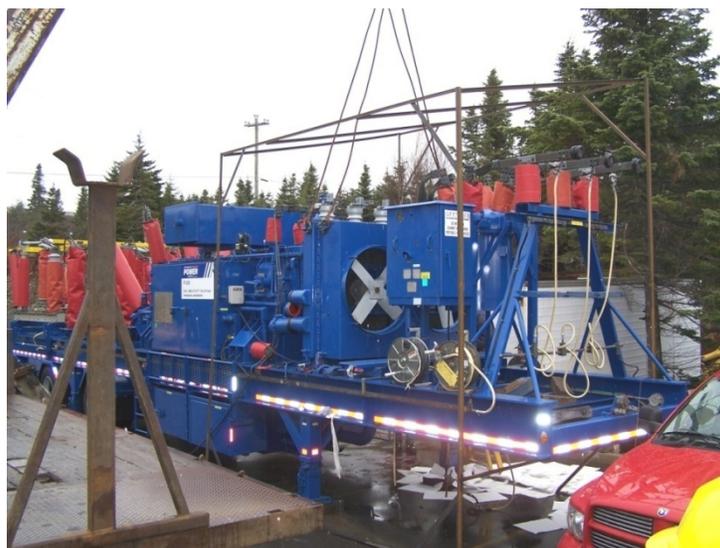
**Portable Substation P3**

The manual hydraulic jacks on the unit have deteriorated and they will be replaced with a motorized system. The alarm panel has had several failures and will be replaced. The protection relays are thirty two year old electro mechanical type and will be replaced with new electronic digital protection relays.

The control wiring associated with the protection and control of the portable substation is original wiring showing signs of deterioration and will also be replaced.
