**Re: *Reliability and Resource Adequacy Study Review*  
Summary of Findings from L3501/2 Failure Investigations**

# Summary of Labrador-Island Link Failure Investigations

# Summary of Findings from L3501/2 Failure Investigation

Turnbuckle Failures

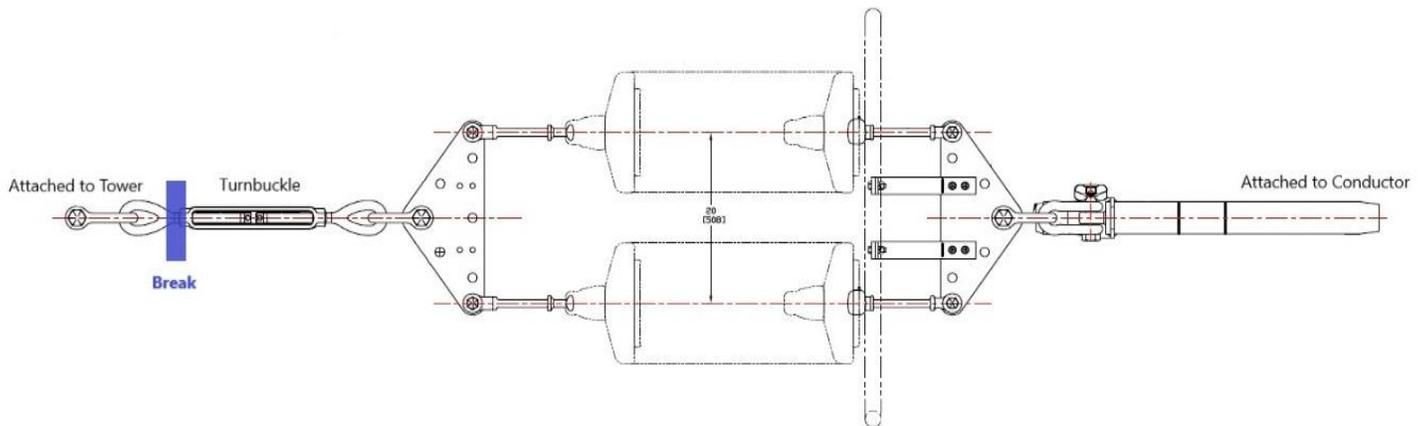
Figure 1: Dead-End Assembly

2 During December 2022, there were three failures on Structures 1872, 1806, and 1014 on transmission  
3 line L3501/2. While each of the failures occurred at different structures, times, and locations along the  
4 line, they were similar in failure type. All three consisted of a turnbuckle failing in the pole conductor  
5 dead-end assembly, which is connected to a dead-end tower. A turnbuckle is a piece of hardware in this  
6 assembly that is used to adjust the sag and tension of the cable. A dead-end assembly and the location  
7 of the break are shown, highlighted in blue, in Figure 1.

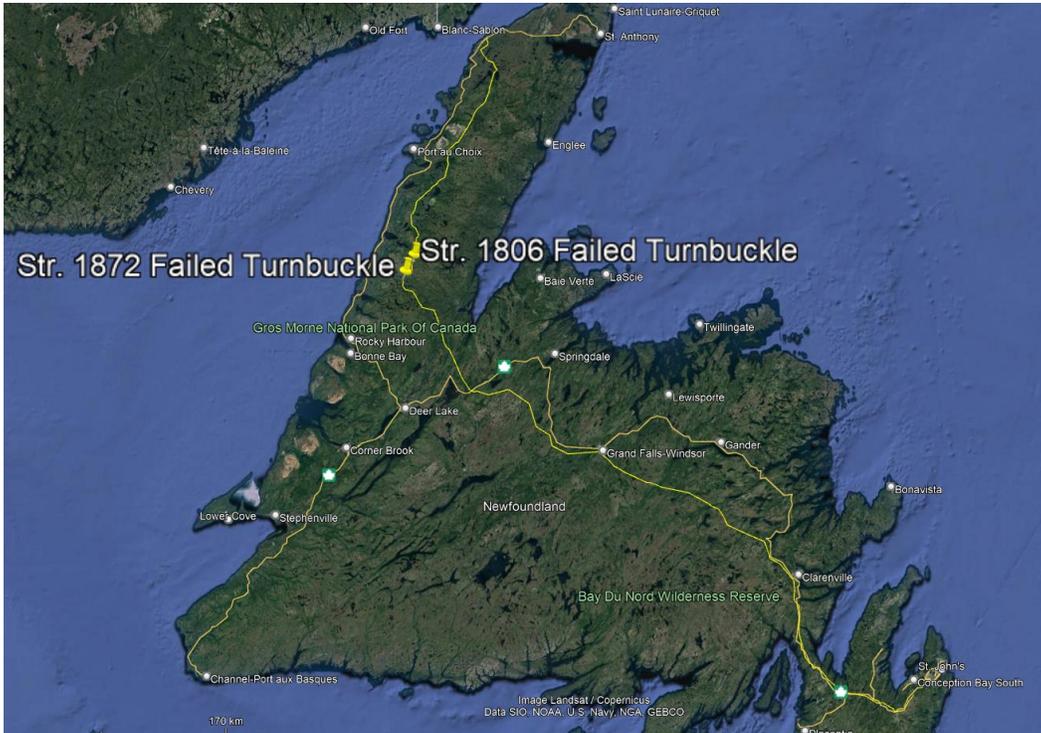
**Figure 9: Map of the Island Showing the Locations of Turnbuckle Failures on Structures 1872 and 1806**

7 Structures are numbered sequentially along the line, starting at Muskrat Falls. As Figure 9 shows,  
8 Structures 1872 and 1806 are located 60 km and 75 km from the highway, respectively, in a remote  
9 location in the Long Range Mountains, which is only accessible by the transmission line access roads.  
10 The access roads are cleared of snow if winter access to the towers is required.

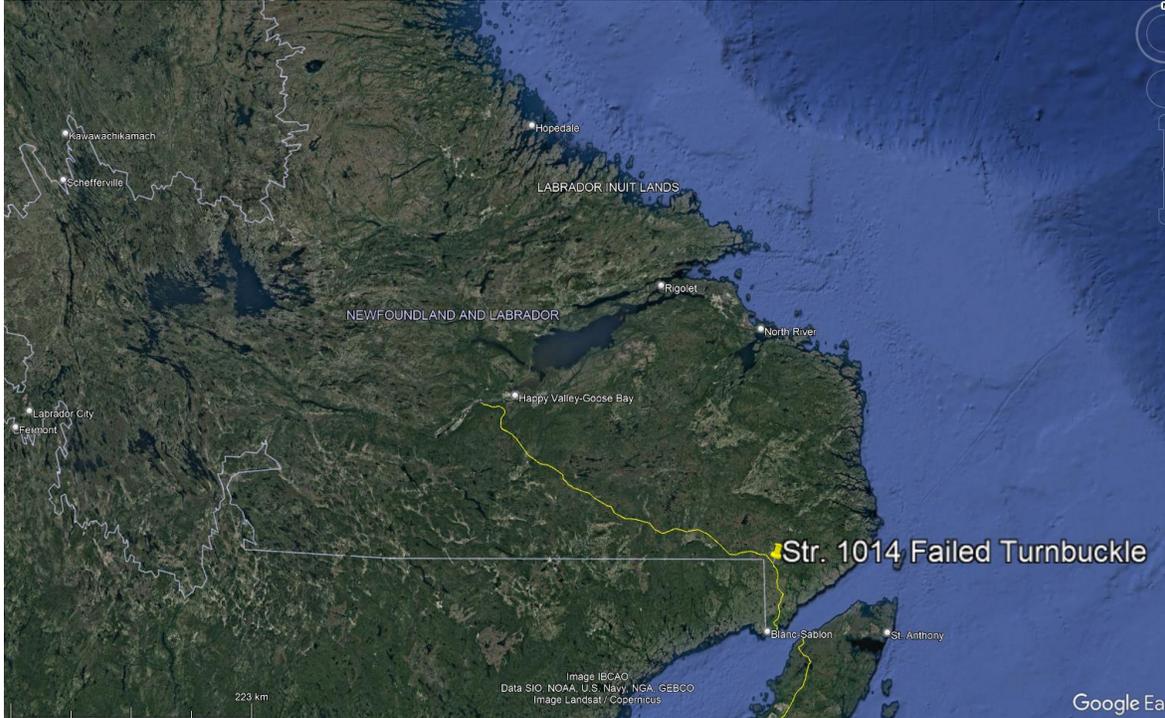
**Figure 10: Map of Labrador Showing Location of Turnbuckle Failure on Structure 1014**

- 1 As Figure 10 shows, Structure 1014 is located in Labrador, near the southwest coast. The structure is
- 2 located in a remote location 60 km from the closest highway, requiring access via transmission line
- 3 access roads.

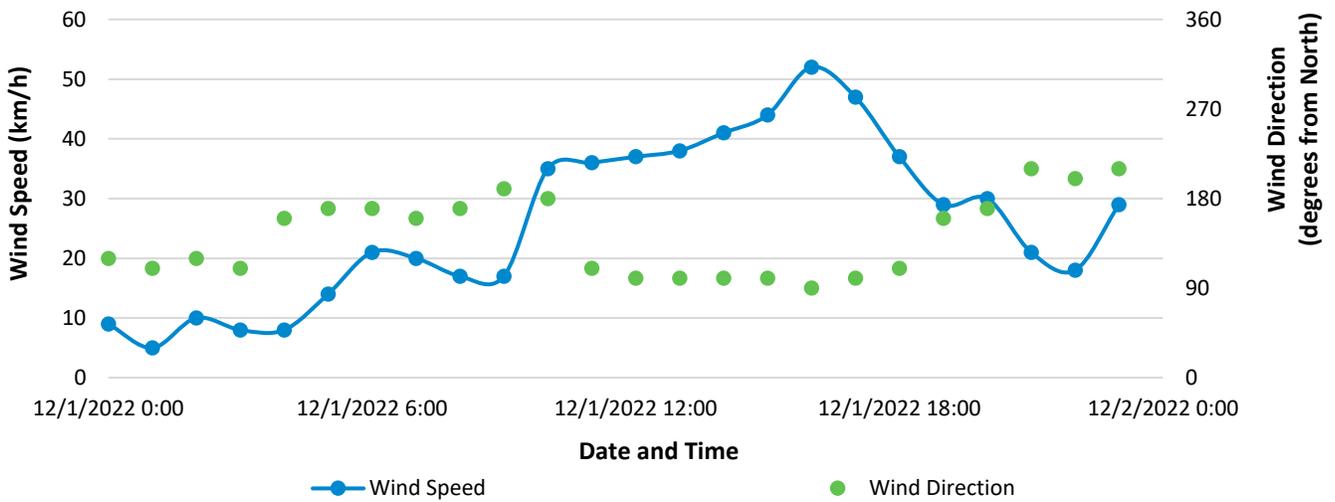
**Chart 2: Daniel's Harbour Wind Data for December 1, 2022**

The wind speed at Daniel's Harbour on the day of the failure, December 1, 2022, ranged from 5 km/h to 52 km/h, with an average speed of 26 km/h. Winds on the day of the failure were not extreme or above design loads, which is indicative of fatigue failure due to movement over the life of the line. The wind direction varied from east to south, as shown in Chart 2.

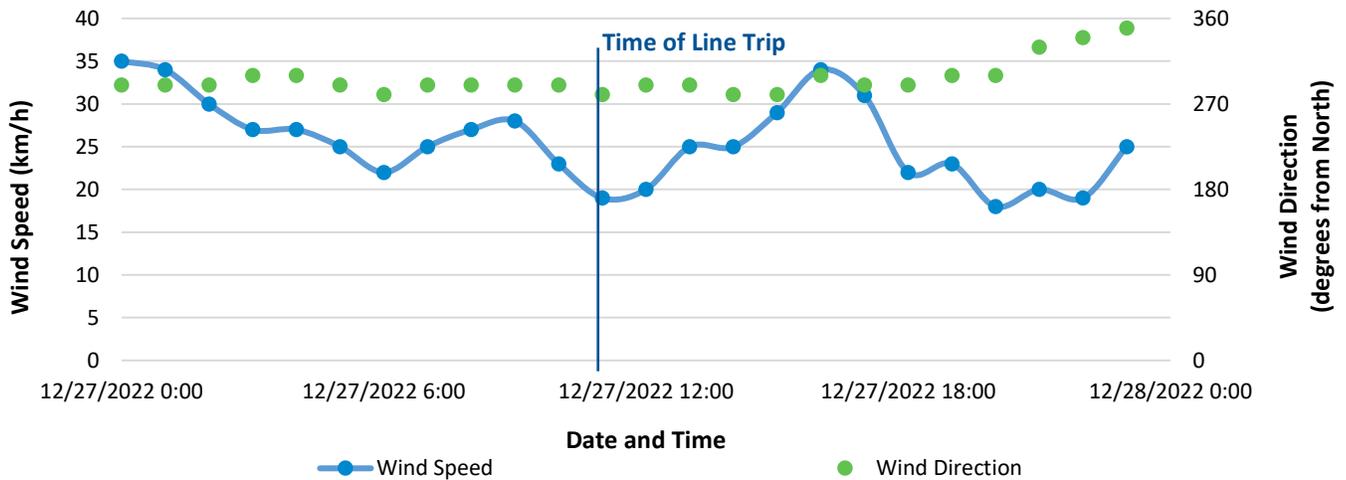
Chart 4: Daniel's Harbour Wind Data for December 27, 2022

- 4 The wind speed at Daniel's Harbour on the day of the failure, December 27, 2022, ranged from 18 km/h
- 5 to 35 km/h, with an average speed of 26 km/h. Winds on the day of the failure were not extreme or
- 6 above design loads, which is indicative of fatigue failure due to movement over the life of the line. The
- 7 wind direction varied from west to north, as shown in Chart 4.

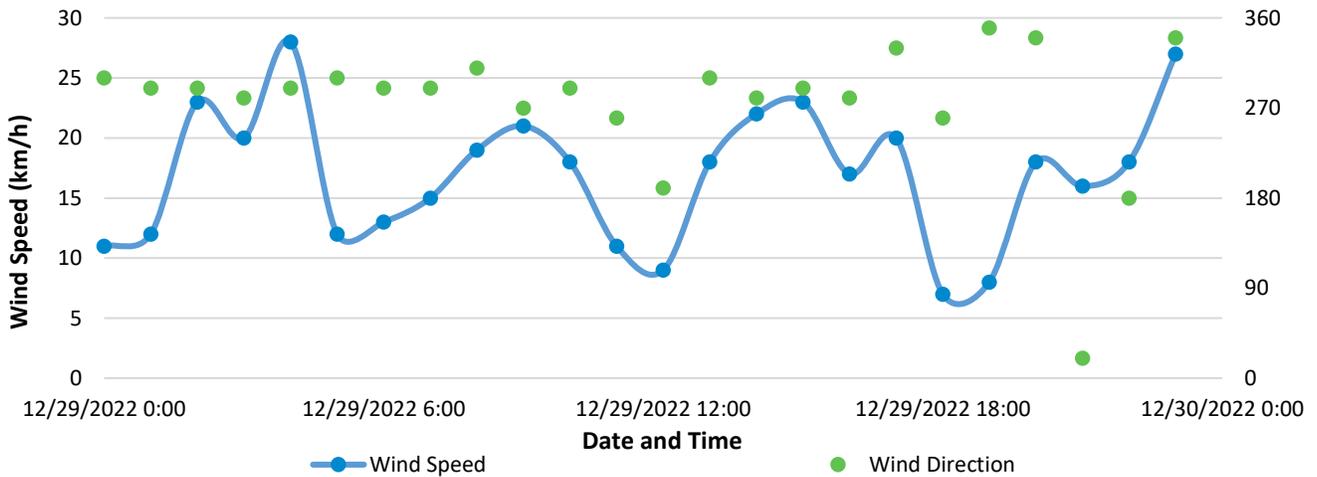
**Chart 6: Blanc-Sablon Wind Data for December 29, 2022**

- 4 The wind speed at Blanc-Sablon on the day of the failure, December 29, 2022, ranged from 7 km/h to
- 5 28 km/h, with an average speed of 17 km/h. Winds on the day of the failure were not extreme or above
- 6 design loads, which is indicative of fatigue failure due to movement over the life of the line. The wind
- 7 direction varied from west to northwest, as shown in Chart 6.

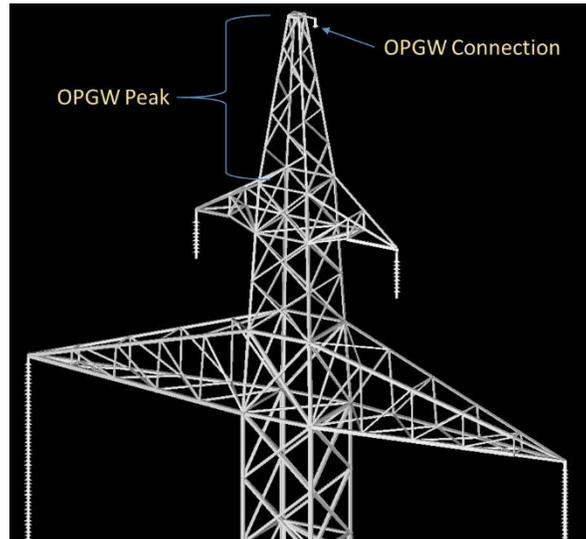
**Figure 1: Tower Drawing showing OPGW Peak**

2 During December 2022, there were failures on Structures 1230 and 1231 on transmission line L3501/2.  
3 The failures of these two structures were similar; the top peak of the tower where the OPGW connects,  
4 as shown in Figure 1, failed. The OPGW wire itself did not fail, nor did the rest of the tower.

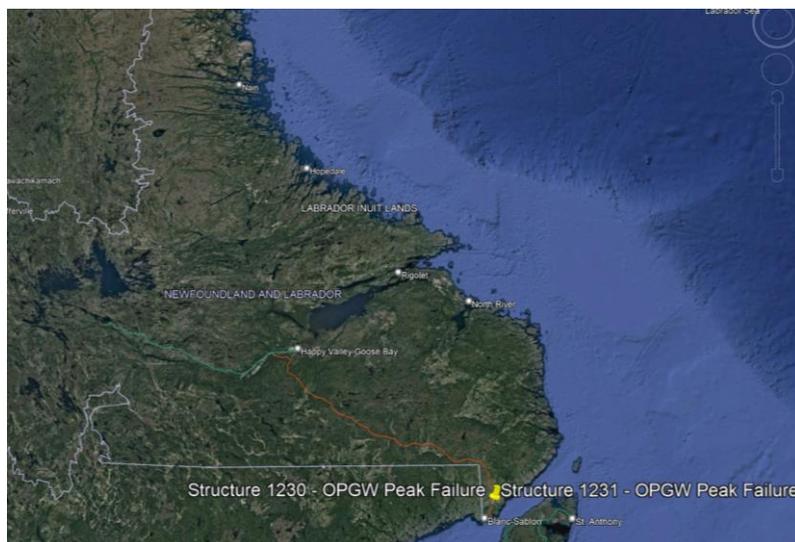
**Figure 5: Map of Labrador Showing Location of OPGW Peak Failures**

2 Structures are numbered sequentially along the line, starting at Muskrat Falls. Figure 5 and Figure 6  
3 show the location of Structures 1230 and 1231—near the southwest coast of Labrador, 11 km from the  
4 closest highway. Galloping has been observed in this section of the line. A study was completed to  
5 identify areas of the line that were susceptible to galloping based on factors including past observations  
6 and damage, ice accumulation, and wind direction; it was determined that this area was highly  
7 susceptible to galloping. A capital program is currently underway to complete the installation of airflow  
8 spoilers to mitigate galloping in this region as well as other areas that have experienced line damage and  
9 where galloping has been observed.

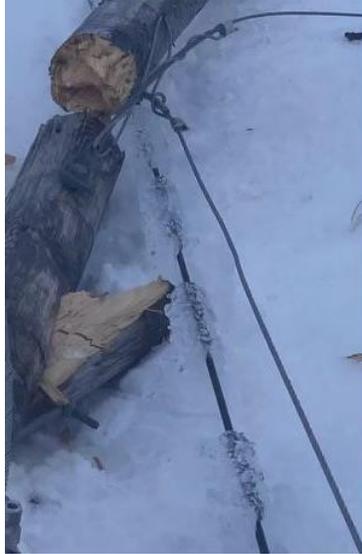
8    There was snow on the ground and significant ice on the lines in the area of Structures 1230 and 1231 at  
 9    the time of the failure. At the same time as the failures at Structures 1230 and 1231, a freezing rain  
 10    event caused significant damage to a distribution line approximately 20 km away, in Red Bay on the  
 11    south coast of Labrador. The event near Red Bay caused approximately 30 mm to 40 mm of radial glaze  
 12    ice accumulation on the lines, as shown in Figure 7 and Figure 8. The ice accumulation led to the failure  
 13    of more than 20 wooden distribution poles and multi-day customer outages.

**Figure 7: Distribution Line Failure from Freezing Rain in Red Bay**

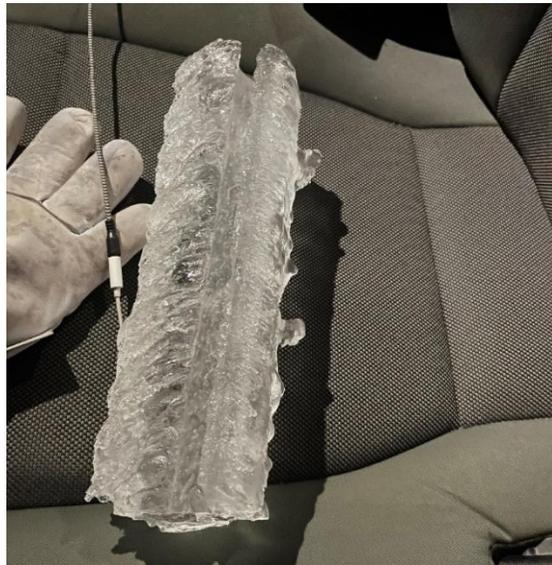
**Figure 8: Ice Sample from the Distribution Line in Red Bay**

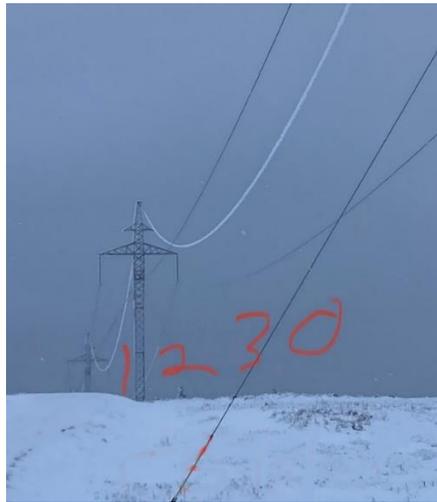
- 1 Before the failure, a line patrol was initiated to evaluate the effect of the ice storm on the LIL's electrode
- 2 wood pole line and steel tower line in the Labrador Straits. During this patrol, significant icing was
- 3 observed on L3501/2; however, the ice thickness appeared to be less than the design thickness of
- 4 50 radial mm. Figure 9 and Figure 10 show ice accumulation on the OPGW at Structures 1230 and 1231
- 5 before the failures. From the available pictures, the ice thickness on the OPGW at Structures 1230 and
- 6 1231 is estimated to be approximately 20 mm to 30 mm of radial glaze ice. After the failure, there was

- 1 no ice on the OPGW; this could be due to ice shedding before the failure or the ice could have shed due
- 2 to the dynamic forces that occurred during the failure.

**Figure 9: Ice on OPGW at Structure 1230 before Failure**

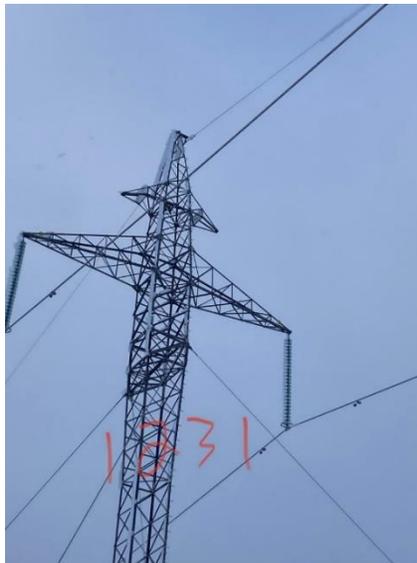
**Figure 10: Ice on OPGW at Structure 1231 before Failure**

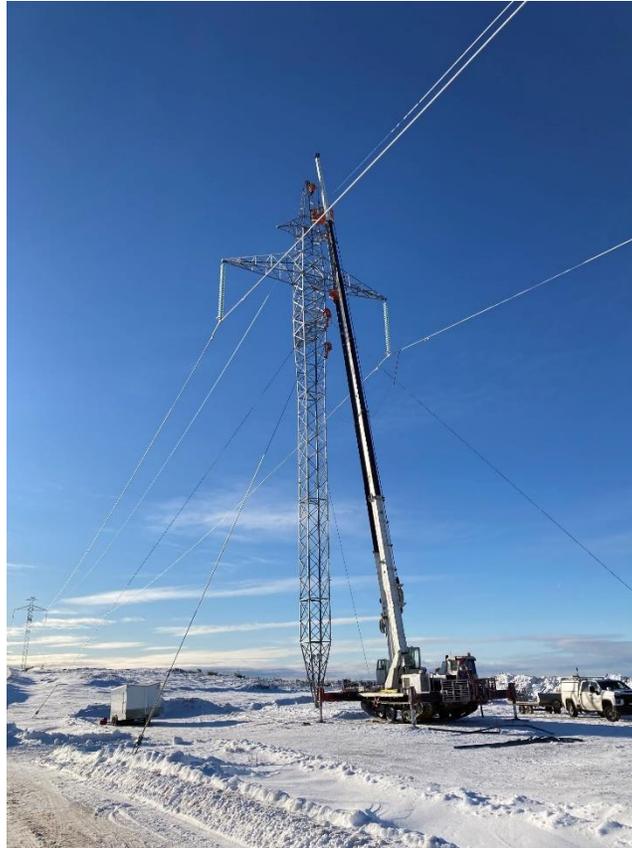
**Figure 12: New OPGW Tower Peak Installed**

9 The OPGW tower peaks were replaced at Structures 1230 and 1231 and the existing OPGW wire was  
10 reconnected to the towers. Crews later returned to this area to further troubleshoot the damaged fibre  
11 signal and verify if a section of OPGW should be replaced when the weather is more favourable. Pictures  
12 of the repairs are provided as Figure 11 and Figure 12.

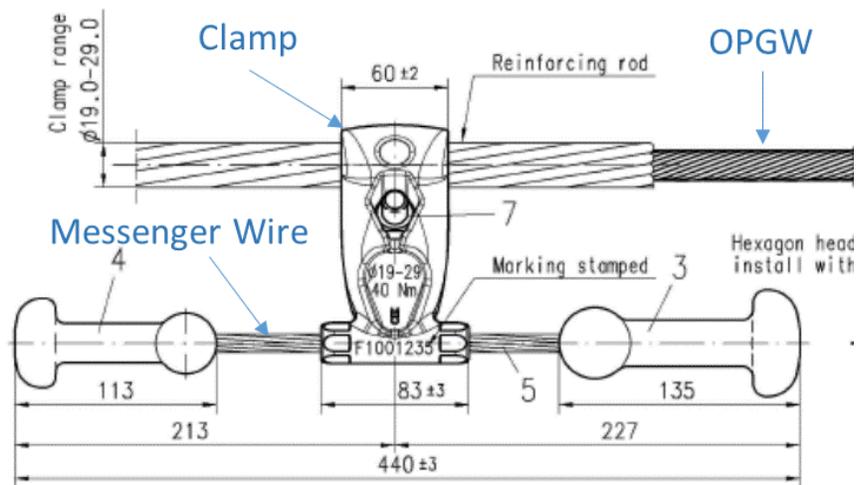
7 The line has also experienced issues with the Stockbridge damper, as shown in Figure 16, which is  
8 installed on the line to control Aeolian vibration.<sup>20</sup> Damper failures, which do not cause an outage to the  
9 line, could be caused by inadequate damping, ice loads, or galloping and have been identified  
10 throughout the line during routine inspections. Through testing of the dampers and vibration monitoring  
11 of the line, it was determined the dampers currently installed on the electrode conductors and OPGW  
12 are not adequately controlling the vibration. There is a capital project proposed for 2024 to specify new  
13 damper requirements and purchase new dampers for the line. Damper failures were found near the  
14 failed Structures 1230 and 1231, exhibiting significant damage to the clamp of the damper and bending  
15 in the messenger wire as shown in Figure 17 and Figure 18.

**Figure 16: OPGW Stockbridge Damper**

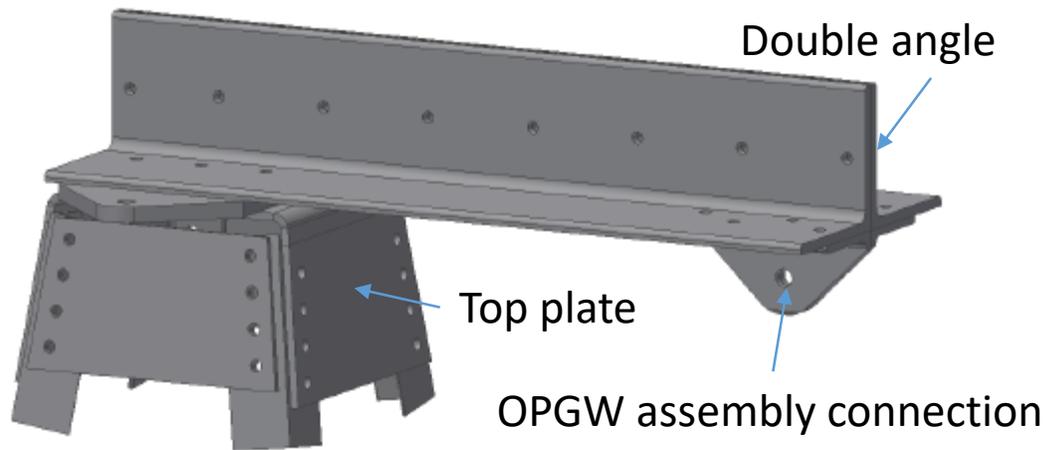
During December 2022, there were failures on Structures 2135 and 2136 of Hydro’s transmission line L3501/2. The failures of these structures were similar—the double angle member at the top of the tower that connects to the top plate and the OPGW suspension assembly connection, as seen in Figure 1, detached from the tower, falling into the pole crossarm, resulting in a communication system outage. The OPGW cable itself experienced some damage but remained attached to the assembly and double angle.

Figure 1: Top of Tower

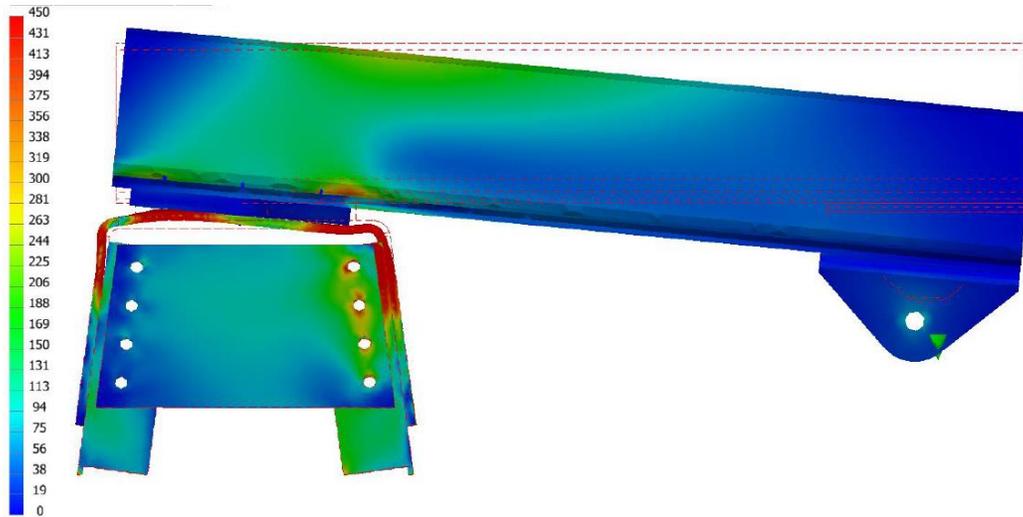
Figure 12: Model of Top Plate Bending

1 Based on the issues found in the review of the type A3 tower, the top plate connections of the other  
2 tangent towers were reviewed. Further analysis is required to review the top plate design of the  
3 remaining tower types; however, based on a preliminary review of the designs, Hydro believes it is  
4 unlikely that this same design error is present in other tower types; no other similar failures have  
5 occurred to date.

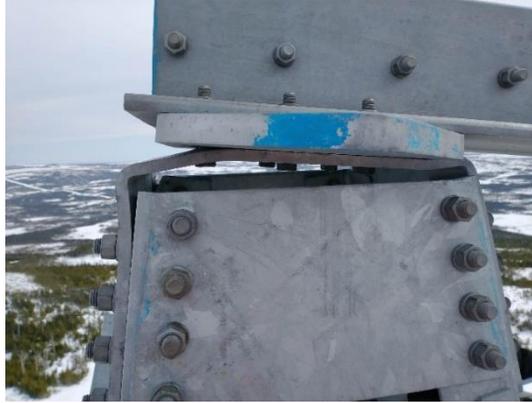
10 On July 6, 2021, there were two corrective work orders related to top plates entered on Structure 2135  
11 and Structure 2136, respectively. The damage was discovered during a routine inspection; work orders  
12 were entered to replace the top plate of each structure due to bending. As seen in Figure 13, the top  
13 plate at Structure 2136 is bent; however, the bolted connections between the top plate and double  
14 angle remained intact. Similar damage was incurred on the top plate of Structure 2135. As this had not  
15 been observed anywhere else on the line and no significant icing events had been recorded, the bent  
16 plates were assumed a manufacturer or construction quality defect and were replaced. The work orders  
17 both noted completion as September 7, 2021.

Figure 13: Bent Plate at Structure 2136 in 2021

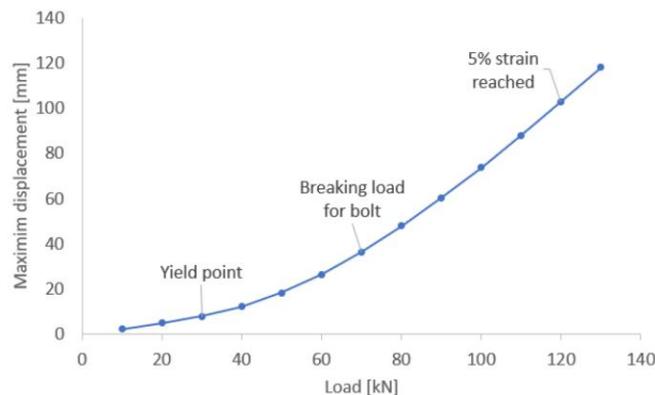
The results of the analysis are summarized in Figure 14, which shows the vertical load on the OPGW connection versus the displacement of the connection. The vertical design load for the OPGW connection is 95 kN.<sup>9</sup> The yield point of the connection is calculated at 36 kN, which is approximately one-third of the design load and is considered low for yielding of the plate. Based on the model, the outermost bolts break at 70 kN (or 74% of the design load) and the 5% strain of the top plate is reached at 120 kN.

Figure 14: Vertical Load versus Displacement

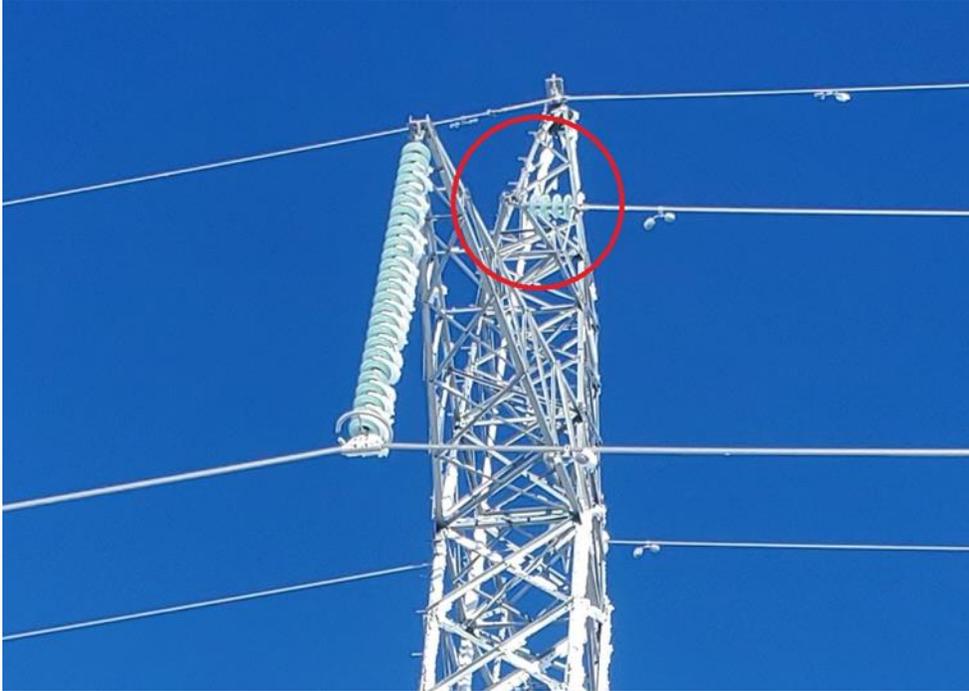
8 A full mechanical break of both the conductive aluminum and steel-reinforcement strands occurred at  
 9 Structure 515, as shown in Figure 2 and Figure 3, resulting in the electrode cable dropping to the ground  
 10 on the western side between Structures 514 and 515. As a result of the cable break at Structure 515, the  
 11 cable experienced western longitudinal loading, resulting in severe bird caging of the aluminum strands  
 12 at the clamp on the adjacent Structure 514, as shown in Figure 4 and Figure 5.

Figure 2: Structure 515

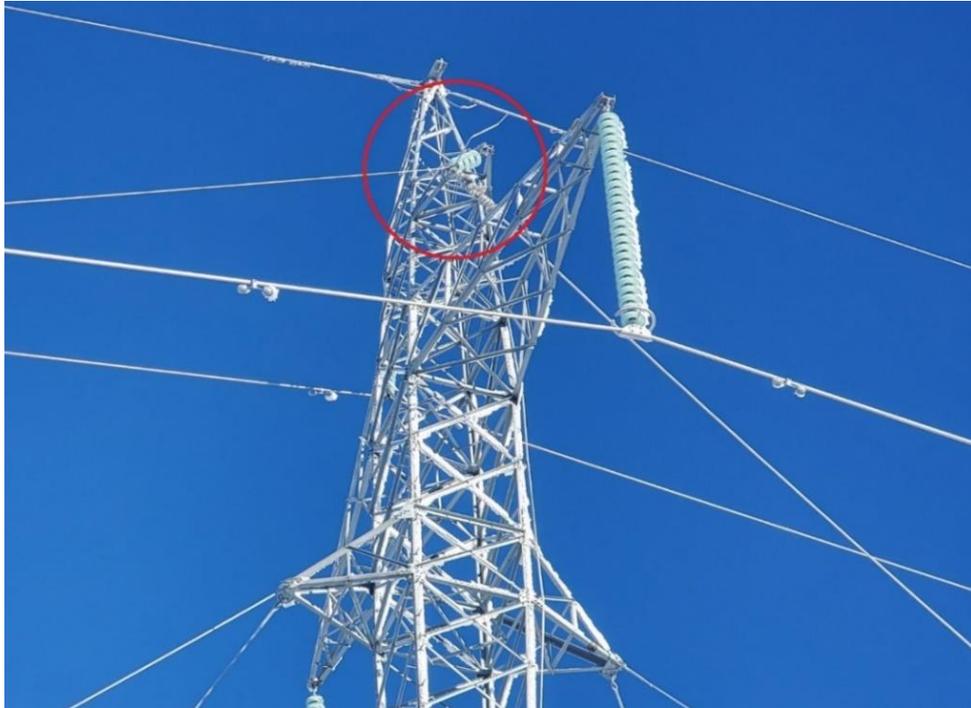
**Figure 4: Structure 514**

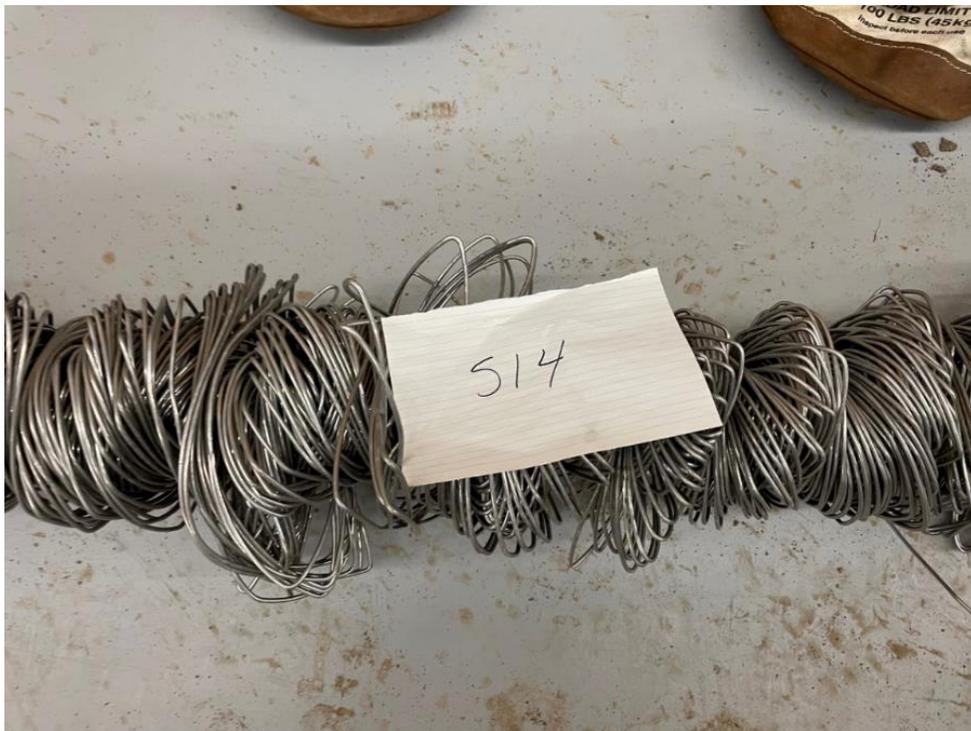
**Figure 5: Electrode Cable Bird Caged at Structure 514**

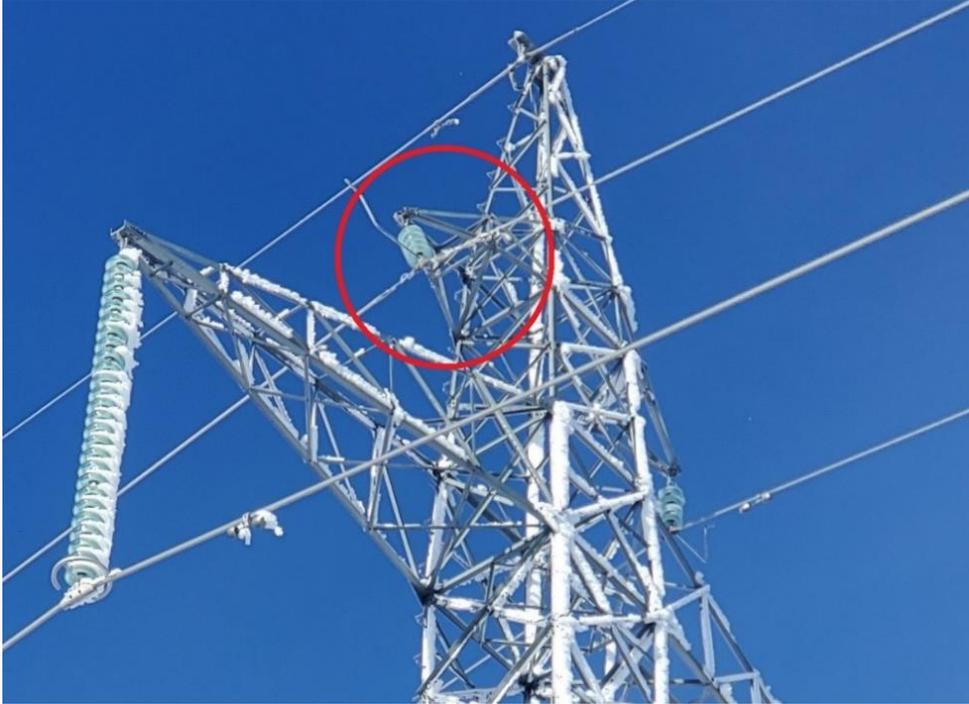
13 Electrode damage at Structure 517 (Figure 6) was isolated but appeared to be similar to Structure 515  
 14 damage; all of the aluminum strands were broken but the steel strands were still intact, as shown in  
 15 Figure 7. All damages to EL2 were repaired, and the cable was restored to its original condition.

**Figure 6: Structure 517**

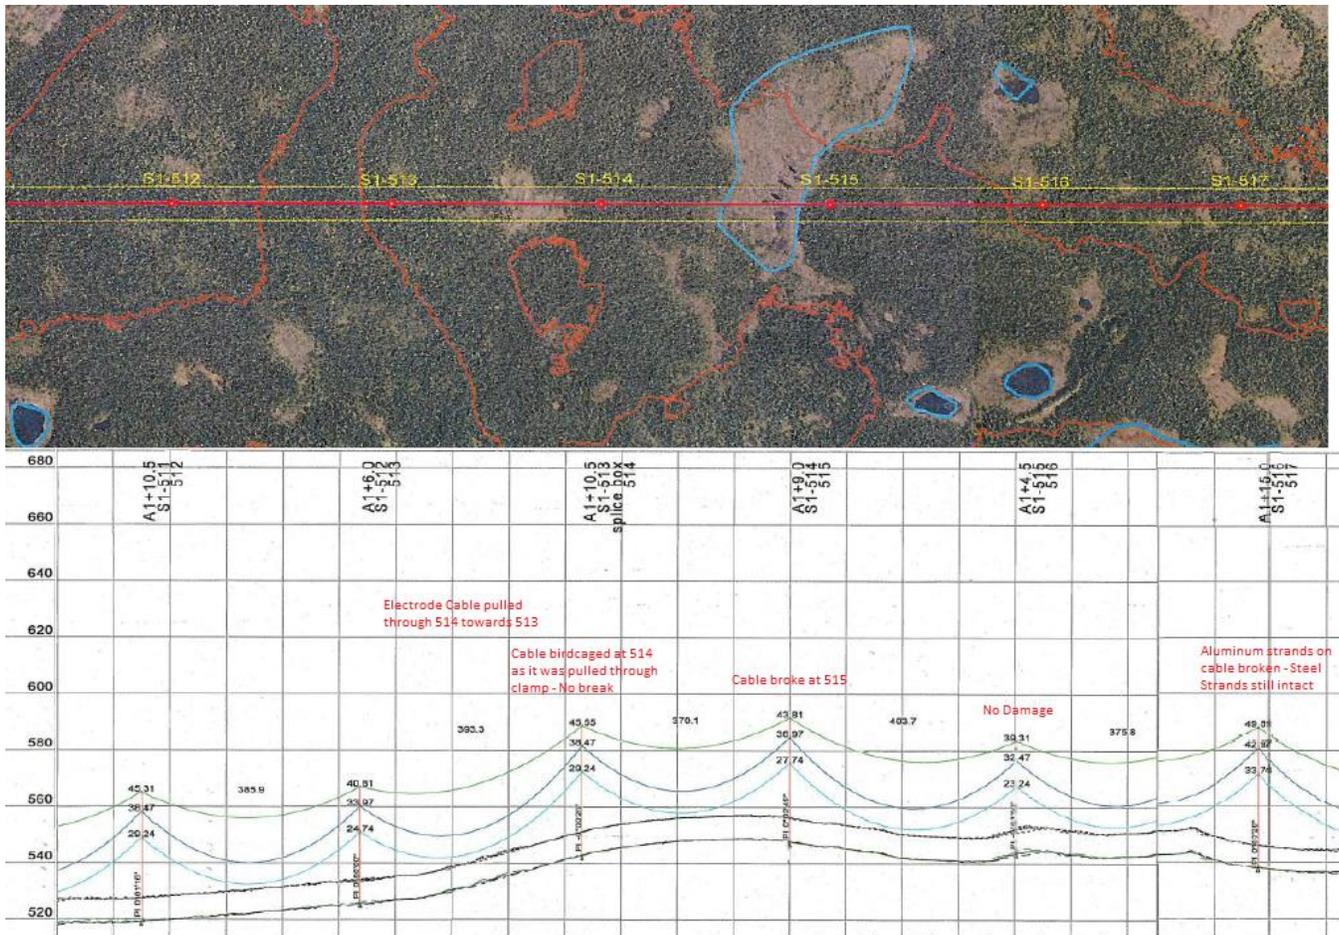
**Figure 10: Plan and Profile View**

- 1 As can be seen in Figure 10, there is no significant increase in the relative elevation between the
- 2 structures. However, the overall elevation is over 500 m, which is typically conducive to conditions that
- 3 support the formation of wet snow/rime ice<sup>10</sup> in the atmosphere. This aligns with the type of ice
- 4 accumulation observed during this event and prior events experienced in this area.
- 5 The electrode damage associated with this failure is very similar to the event experienced in 2021;
- 6 however, during the 2021 storm, significant damage was caused to both the electrode cable and the
- 7 tower crossarm. This indicates that the weather events responsible for the 2022 failure were not as
- 8 extreme as the ones experienced in 2021.

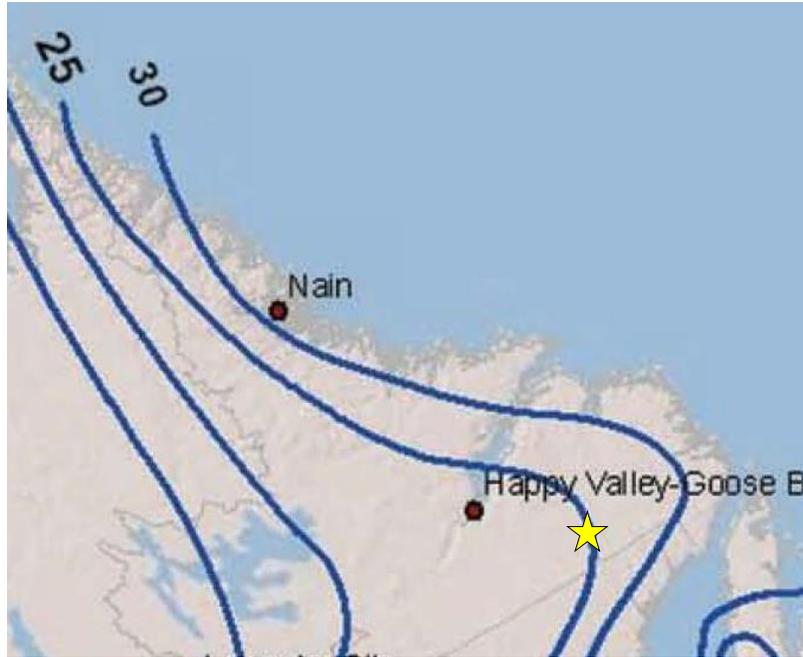
Figure 11: CSA Recommended Ice Loading Map

- 1 respectively.<sup>14</sup> Based on this information, a design ice load of 50 mm of radial glaze ice<sup>15</sup> was selected
- 2 for this zone.

<sup>14</sup> CSA C22.3 No. 60826-10 recommended reference loading for the region ranges from 25 mm to 30 mm for a 1:50-year return period, as seen in Figure 11. This reference load must be multiplied by a spatial factor of 1.3 and a height factor of 1.15 for a comparison to the 50 mm design load.

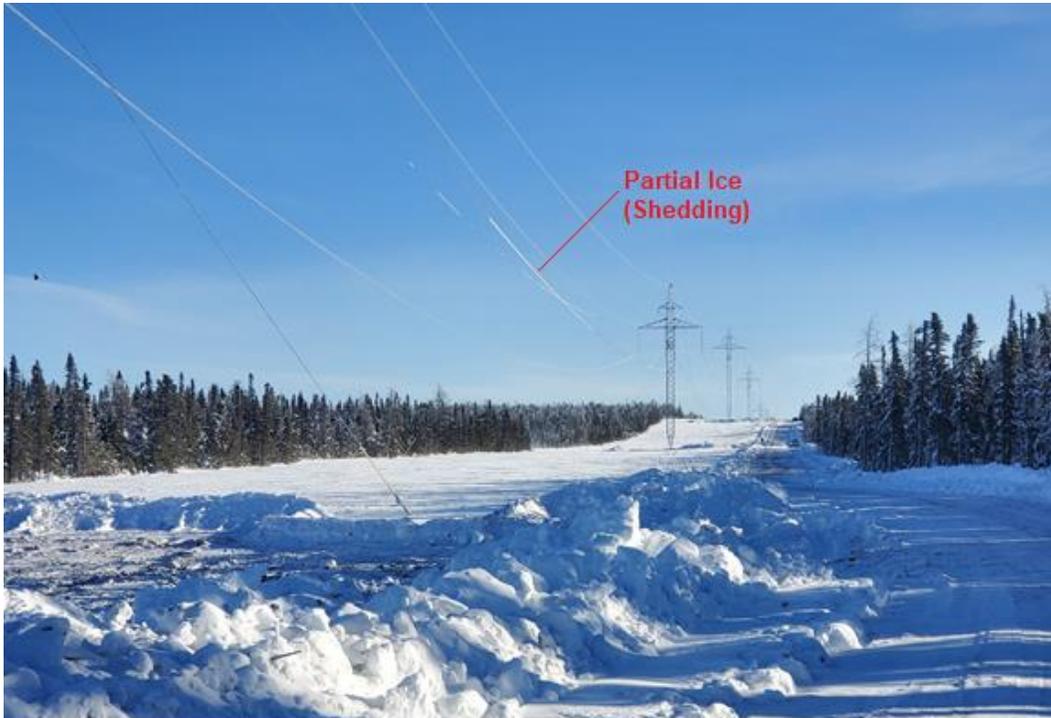
Figure 14: Cables with Partial Ice Accumulation (Indication of Ice Shedding)

5 The pictures included in Figure 12 to Figure 16 were taken during a snowmobile patrol, which was  
6 completed by Hydro's Operations team upon receiving notification of the fault. It is evident from the  
7 photos that significant icing had accumulated over time on the cables. Figure 13 and Figure 15 show ice  
8 accumulation on the towers; it is assumed that when ice is not present on the lines but is present on the  
9 towers ice shedding has occurred.

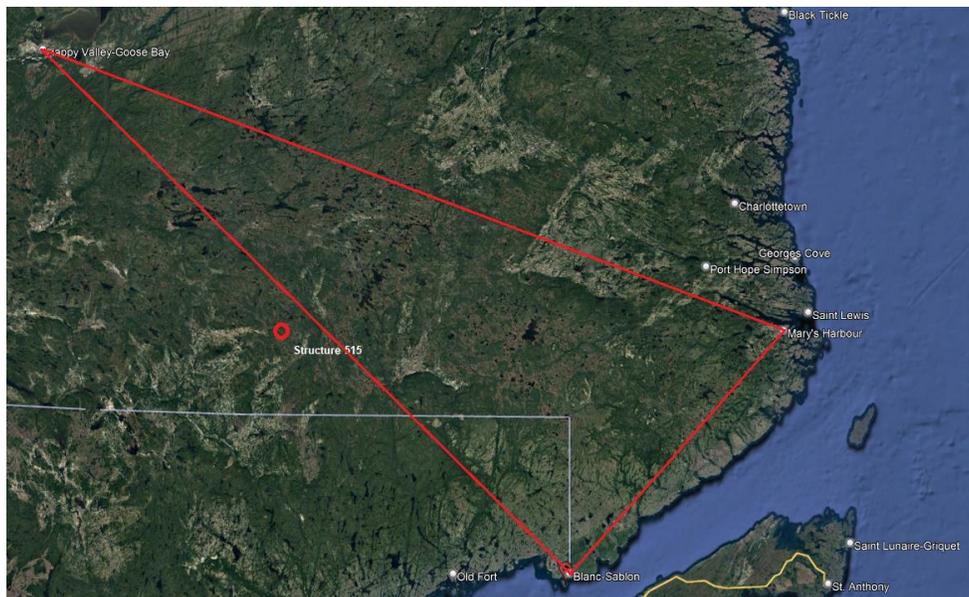
**Figure 17: Location of Weather Stations in Relation to Failure Location**

4 There are currently no weather stations located in direct proximity to Segment 1 of the LIL; however,  
5 there are several weather stations within the general geographic area from which information has been  
6 collected for this investigation and upon which the design was informed. These weather station  
7 locations include Happy Valley-Goose Bay (northwest of the LIL failure area), Mary's Harbour (southeast  
8 of the LIL failure area) and L'Anse-au-Loup-Blanc-Sablon (southeast of the LIL failure area), as shown in  
9 Figure 17.

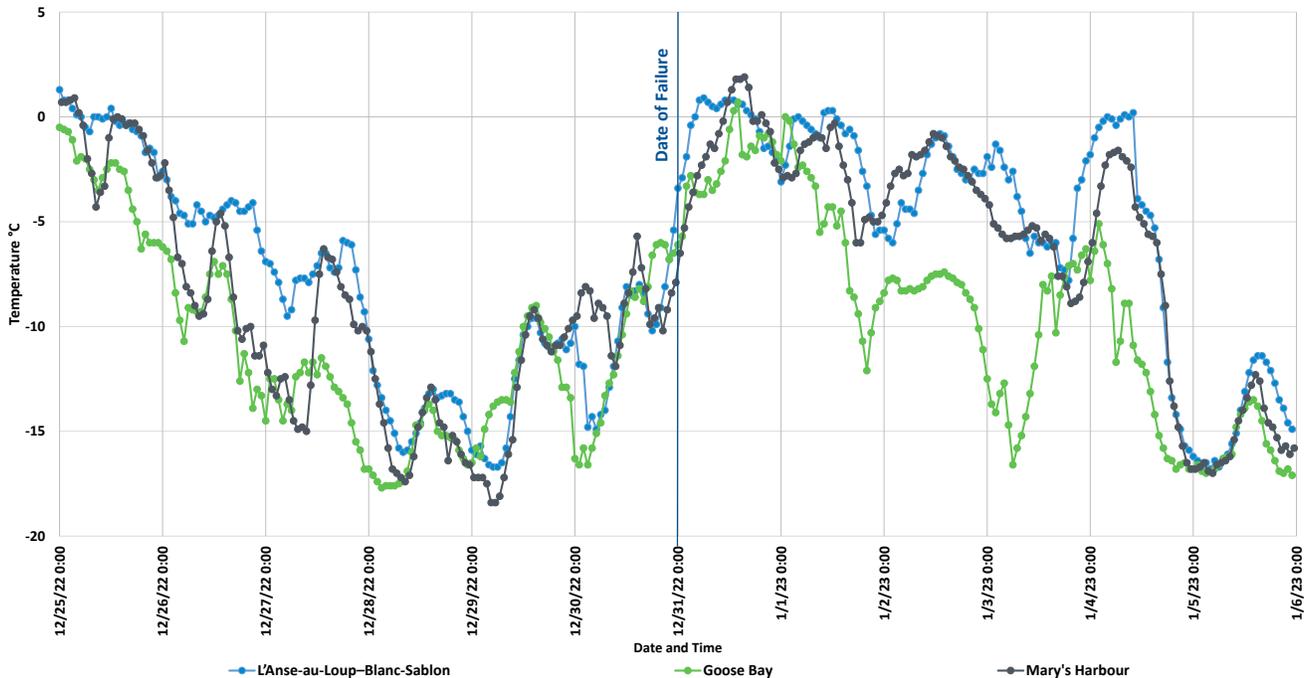
Figure 18: Weather Station Temperature Data

- 1 In the days prior to the failure event, the temperature ranged from 2°C to -18°C, as shown in Figure 18.
- 2 The wide range in temperatures created conditions that were conducive to the accumulation of an ice
- 3 mixture on the cables that consisted of both glaze and rime ice. On December 30, 2022, the
- 4 temperature again rose above the 0°C mark, which could have caused ice softening and shedding,
- 5 resulting in unbalanced longitudinal loading on the cables.

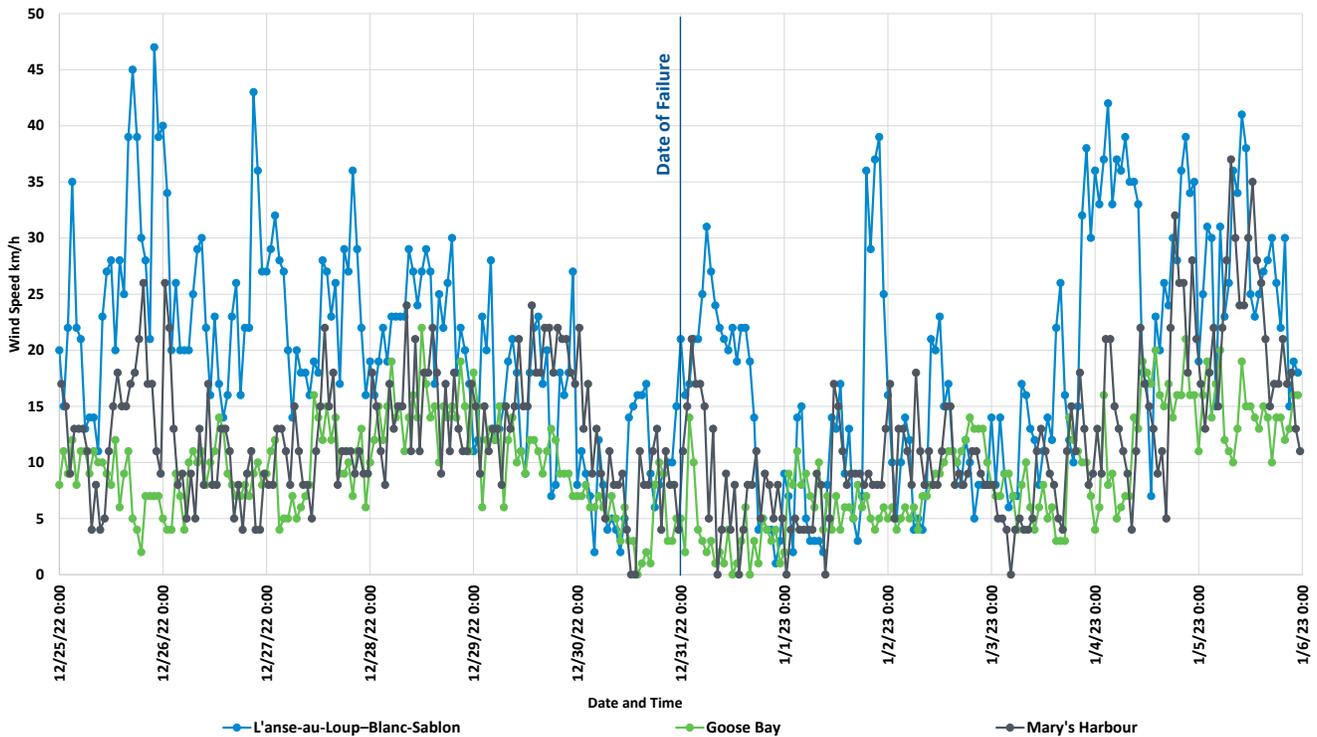
Figure 19: Weather Stations Wind Data

- 6 Figure 19 provides information on the wind speeds recorded at the three existing stations within the
- 7 geographic region. Winds during the event varied considerably throughout the regions but for the most
- 8 part were considered to be lower in magnitude, which is indicative of fatigue failure due to movement
- 9 over the life of the line. For the purpose of the investigation and analysis, the average wind speed was
- 10 approximated as 22 km/hr; however, since there is a broad spatial arrangement between these stations,
- 11 this value may be conservative when compared to winds at the actual failure site.

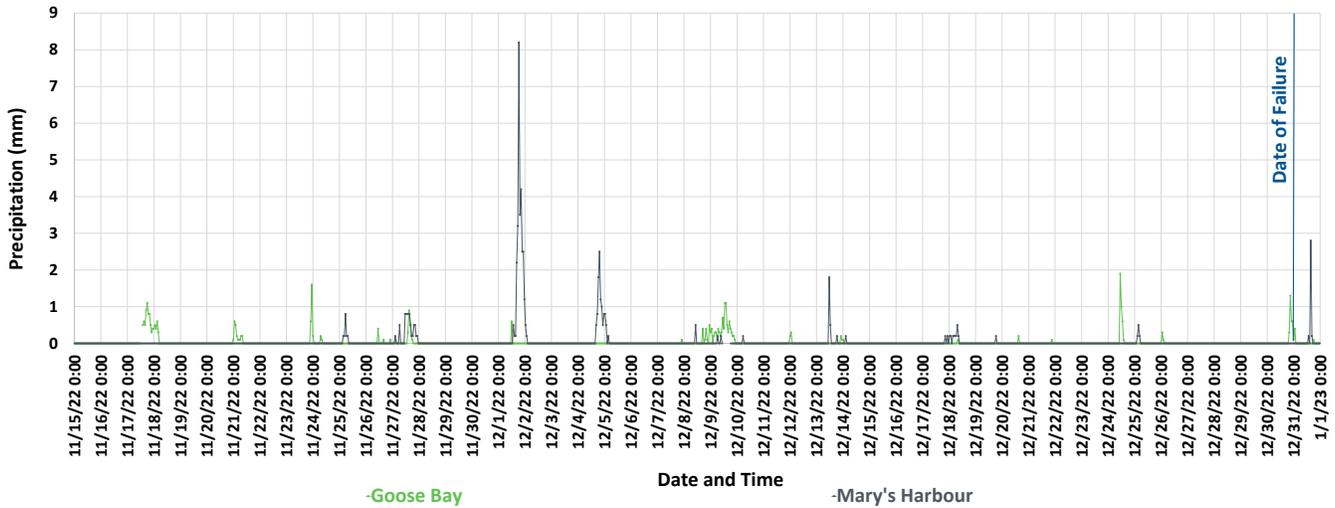
Figure 20: Weather Stations Precipitation Data

- 1 Figure 20 identifies precipitation events within the region between mid-November 2022, and the end of
- 2 December 2022, just before the failure event. No significant precipitation was recorded directly before
- 3 the failure event at any of the weather stations in the geographic area, which indicates that the ice
- 4 accumulation shown in the pictures may have developed over a longer period before the failure.
- 5 Multiple light precipitation events over an extended period of cold temperatures, as is typical in
- 6 Labrador, have the potential to result in a buildup of ice over time.

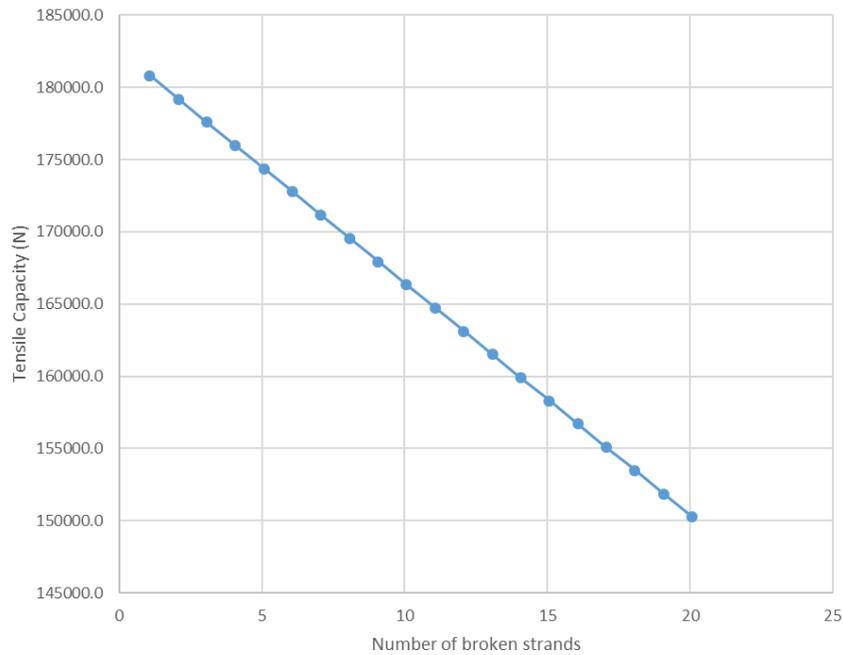
**Figure 21: Electrode Conductor Strength Reduction with Damaged Strands**

4 The laboratory testing also indicated that there is no validation that the clamp did or did not impact the  
5 integrity of the cable. If premature failure occurred on any of the individual strands as a result of  
6 damage caused by the conductor clamp, there would have been a reduction in tensile capacity. Figure  
7 21 shows how the strength of the cable decreases with the presence of the damaged strands. As the  
8 cable capacity lowered and the load continued to increase due to extreme ice accumulation, other  
9 strands would have experienced a localized load increase, causing them to eventually fail and ultimately  
10 resulting in a catastrophic failure of the cable. Four aluminum strands that are broken in a different  
11 location than others are shown in Figure 22; this location is near the top of the clamp. It is hypothesized  
12 that this is the location where the failure was initiated.

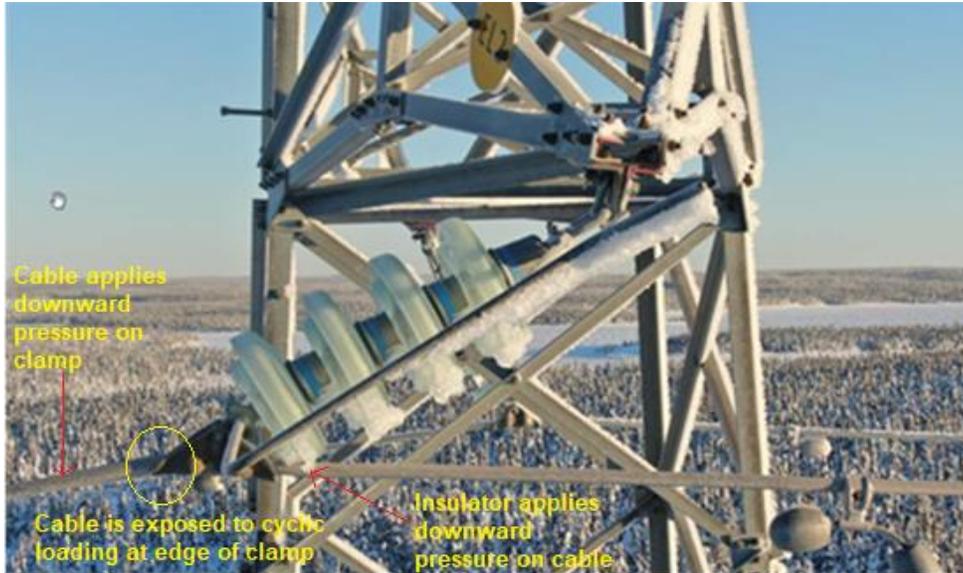
**Figure 24: Longitudinal Pull on Insulator**

1 This occurrence presents another possible theory—as the insulator gets pulled out due to unbalanced  
2 ice loading, the glass portion of the insulator pushes downward on the aluminum portion of the cable,  
3 resulting in the wearing and denting of the individual cable strands. In turn, this downward thrust causes  
4 an upward motion on the clamp, pinching the cable between the downward force due to the insulator  
5 on one side and the weight of the cable on the other (see Figure 24). As this cycles back and forth with  
6 imbalance, it has the potential to result in increased localized stress at both the edge of the saddle and  
7 the clamp. If an alternate style of clamp was utilized that allowed the cable to slide, the cable may not  
8 become pinched. While it may still result in slippage through the clamp, armour rods would provide  
9 additional protection for the cable in this scenario, as any direct force from the clamp or insulator would

- 1 failed, the capacity of the cable would have been reduced, making it more susceptible to applied loading
- 2 and premature failure.
