1	Q.	Please	provide copies of reports or other documentation that describe the latest condition			
2		of the following assets and any work completed to date addressing the following issues:				
3						
4		a.	Bay d'Espoir penstocks;			
5						
6		b.	Hinds Lake rotor resistance;			
7						
8		С.	Granite Canal control system;			
9						
LO		d.	Upper Salmon rotor rim cracking;			
11						
12		e.	Hinds Lake bearing coolers;			
13						
<b>L</b> 4		f.	Cat Arm spherical control valves;			
15						
16		g.	Hardwoods combustion can failures;			
<b>L</b> 7						
18		h.	Hardwoods bellows failures/cracking;			
19						
20		i.	Holyrood boiler tube issue, variable frequency drive issues, air flow limitations,			
21			hydraulic fluid issues;			
22						
23		j.	Stephenville vibration issues;			
24						
25		k.	Hardwoods combustion can failures;			
26						
27		l.	Hardwoods bellows cracking issue;			
28						
29		m.	All Holyrood boiler tube failure studies;

1		n. All "Quarterly Report on Performance of Generating Units" reports; and
2		
3		o. Exploits frazil ice issues.
4		
5		
6	A.	The reports referenced below provide an overview of the latest condition of the asset(s)
7		and any work completed to

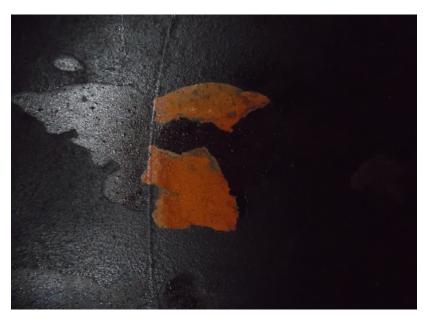
Figure 3-7: General Conditions of Coating throughout Penstock (b)

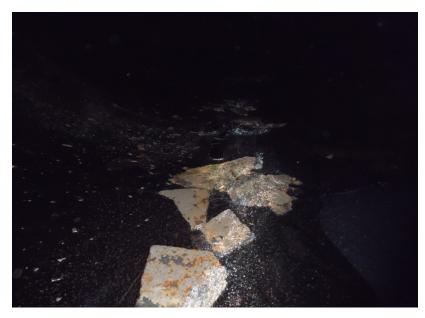
The penstock structure and welds were found to be in good condition and there were no visible signs of pitting corrosion or other deterioration in the steel; however the coatings showed failure throughout (see Tacten report). The structure and welded connections have been protected by a buildup of sludge along the length of the penstock. This sludge buildup has reached a critical mass and now falls off in large sections under its own weight, this leaves the bare steel unprotected from corrosion. The old coating can be seen on the backside of fallen sludge sections as shown in Figure 3-8.

Figure 3-8: General Conditions of Coating throughout Penstock (c)

1. It would appear that the penstock interior has a protective coating applied (see Figure 3-8) and this coating has failed throughout the penstock. This coating was probably intended to provide protection from corrosion and erosion. Assuming this coating was part of the original design philosophy the penstock should be recoated. The internal surface should be water blasted or wet abrasive blasted if there is not a suitable profile present after cleaning for proper application of the protective coating system. A moisture cure coating would be appropriate for the application environment and anticipated high humidity during surface preparation and coating operations. Wasser MioZinc 100 and 2 coats of MC Tar would be suitable for this surface preparation and service environment.

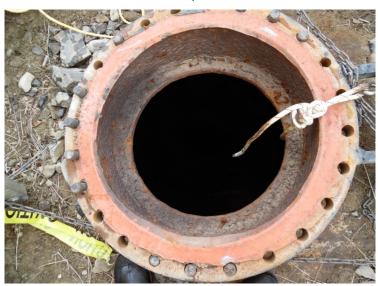
Penstock penetrations were all found to be in good condition. The access hatch located at the surge tank is below grade and it was noted that loose rocks in this area could fall into the penstock. Loose rocks should be removed before future work and inspections as it presents a safety risk and could allow rocks into the penstock which could cause damage.

Figure 3-9: General Conditions of Penetrations – Access Hatch Bottom of Surge Tank

- 4. Loose rocks around the surge tank access hatch should be removed before future work and inspections. These rocks pose a safety hazard and cause damage to the turbine.

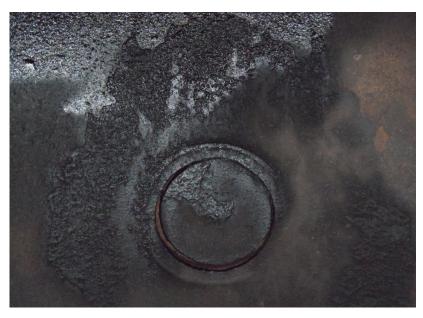
Figure 3-10: General Conditions of Penetrations - Can 8a

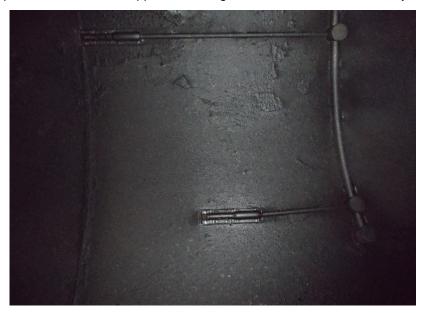
Figure 3-11: General Condition of Flow Meter Sensors in Can 9a (a)

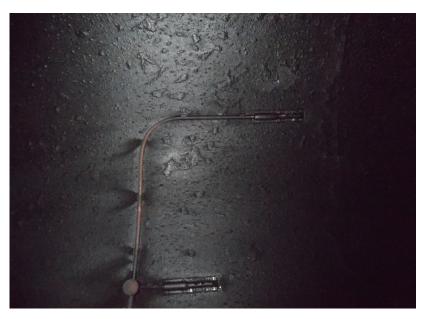
Figure 3-12: General Condition of Flow Meter Sensors in Can 9a (b)

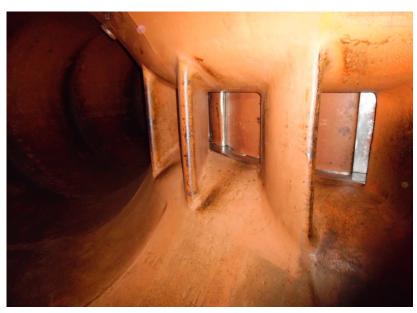
The scroll case was in excellent condition. The steel plate was coated and some of the coating has been damaged. From the photographs it is believed that the damaged coating is due to erosion from debris in the water.

Figure 3-13: General Condition of Scroll Casing (a)

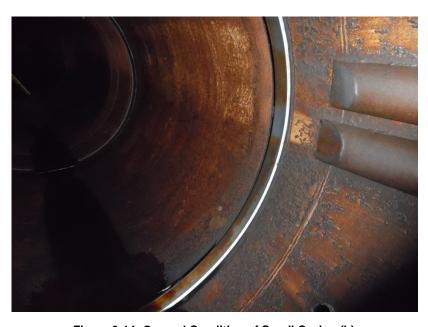
Figure 3-14: General Condition of Scroll Casing (b)

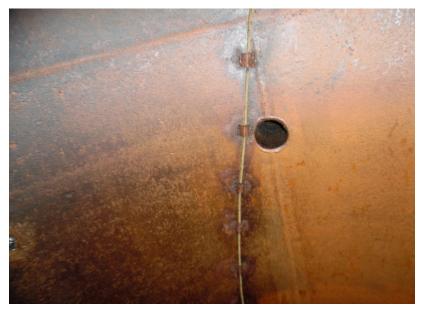
Figure 3-15: General Conditions of Penetrations – Scroll Case (a)

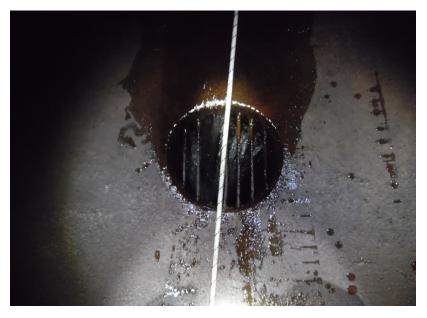
Figure 3-16: General Conditions of Penetrations – Scroll Case (b)

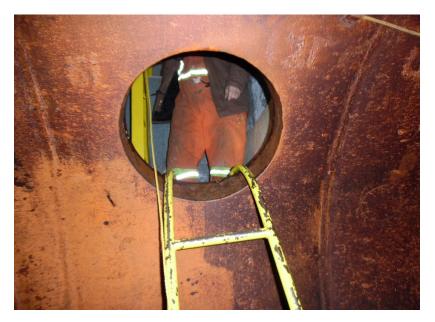
Figure 3-17: General Conditions of Penetrations – Exit Hatch in Scroll Case

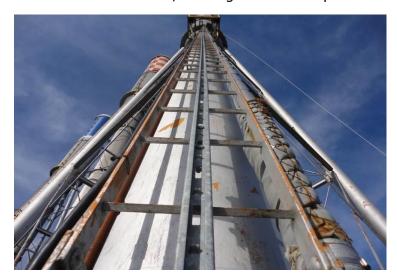
General condition of ladder, coating breakdown present.

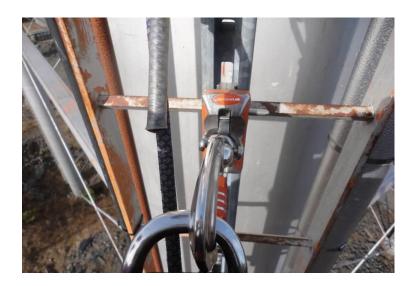
General condition of ladder brackets.

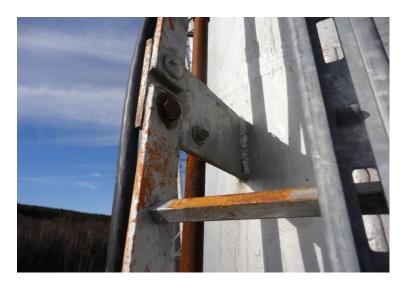
General condition of ladder on tank portion of the tower.

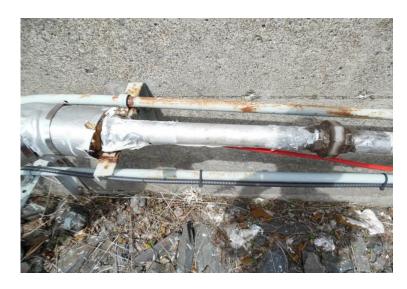
Sample photo showing insulation and cladding not reinstated.

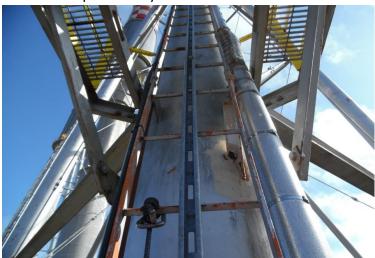
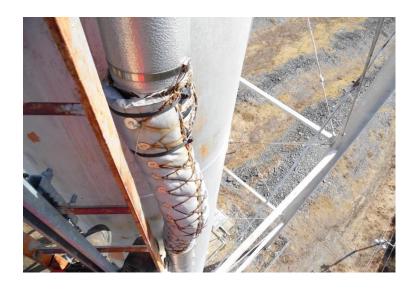
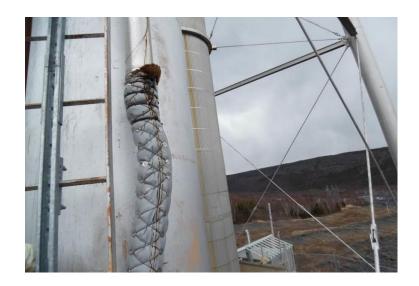
The system was in overall good condition with the exception of connection points # 3, 5, 8, 11, 13, 15, 18, 19, 21 where there are insulation bags or damaged cladding potentially allowing water ingress leading from the control shed to the base of the legs.

Following three photographs show insulation bags or damaged areas that could potentially lead to water.

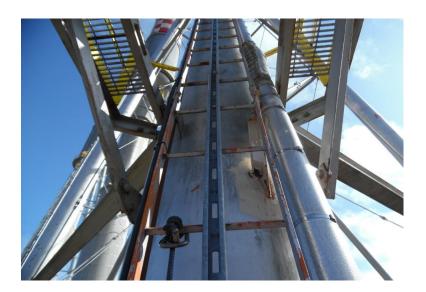
Photo of bottom brackets.

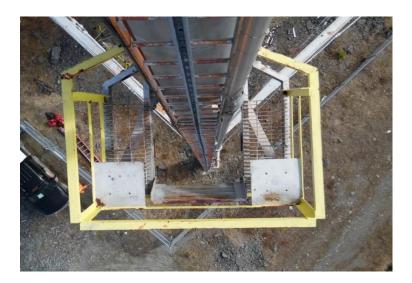
General Condition of rest area from above.

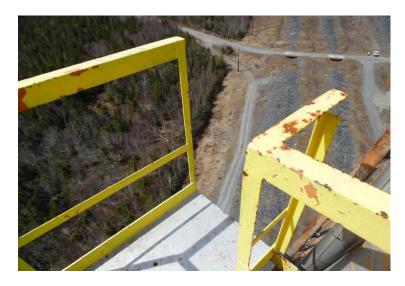
Missing barrier door and coating breakdown.

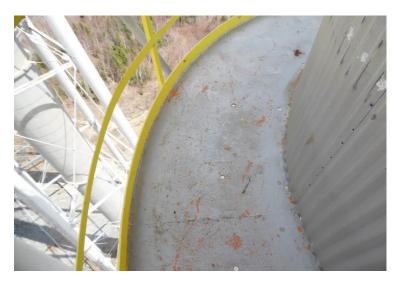
General condition of balcony and rails, coating breakdown.

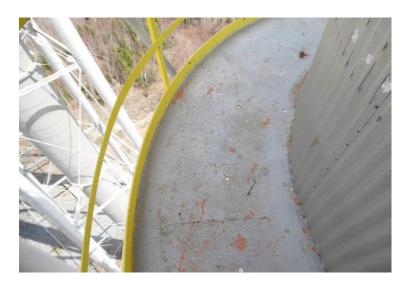
General condition of balcony and rails, coating breakdown.

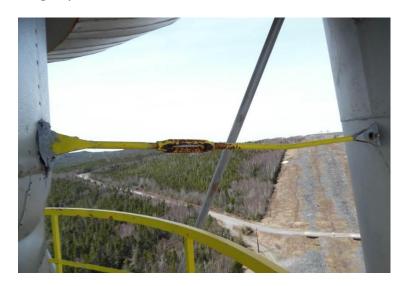
General condition of 4 turnbuckles on balcony, coating breakdown and slightly bent.

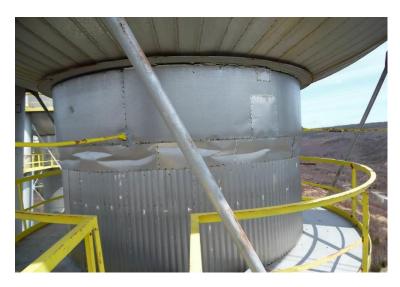
General condition of cladding on 1st balcony level.

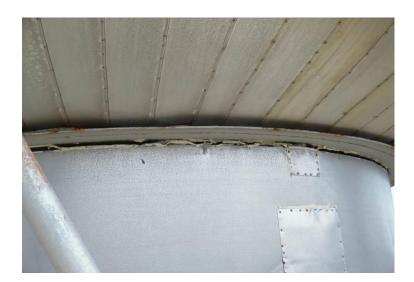
Silicone breakdown (360 degrees), potential water ingress between bowl and riser connection

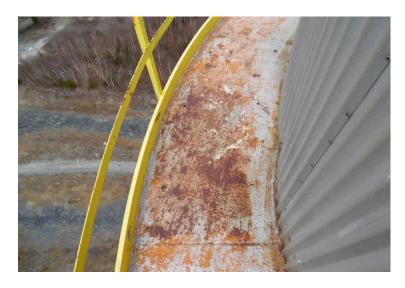
Coating breakdown on balcony and railings

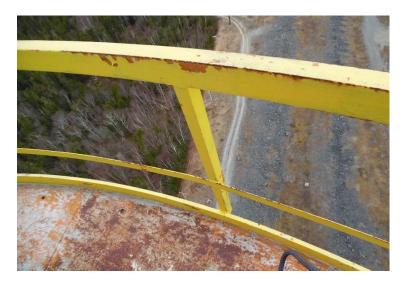
Coating breakdown on balcony and railings

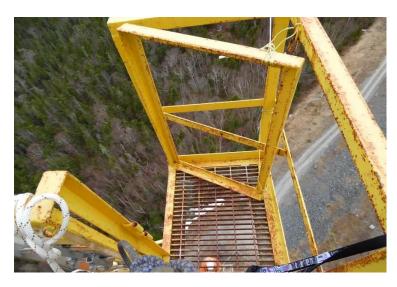
Lower hinge missing on balcony gate

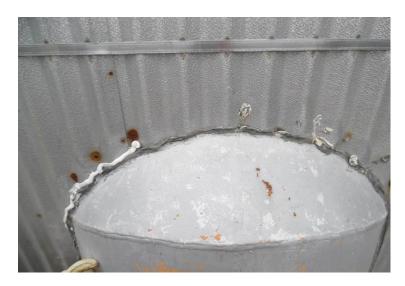
General condition of all 4 leg connection points, possible water ingress, silicone failing.

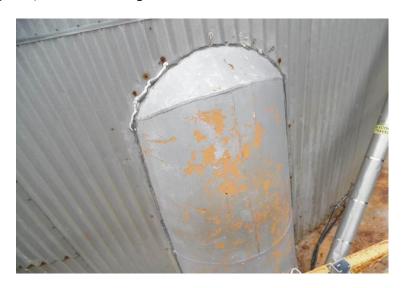
General condition of all 4 leg connection points, possible water ingress, silicone failing.

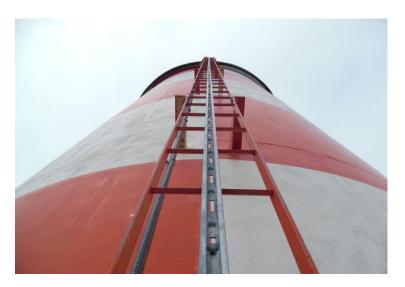
General condition of ladder and ladder connections.

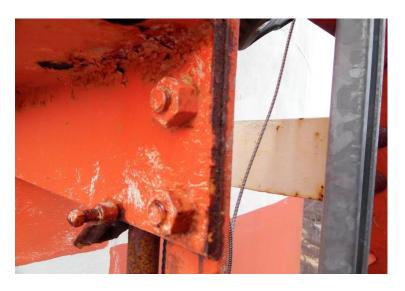
General condition of ladder and ladder connections.

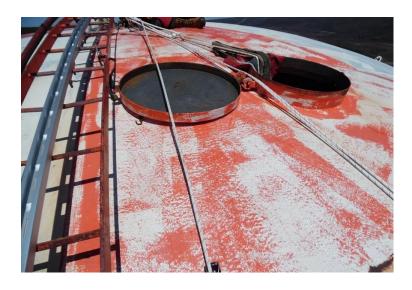
Condition of tank roof/ladder and hatchway.

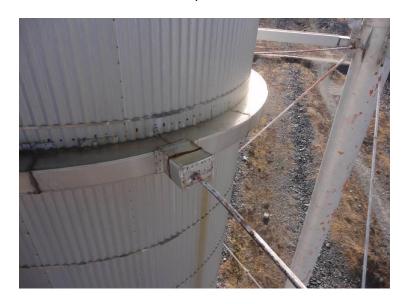
Exterior cladding of riser is in good condition. Banding Missing #6 in first connection,  $2^{nd}$  connection #4,  $3^{rd}$  connection #1 is loose and hanging.

General condition of connection points to riser.

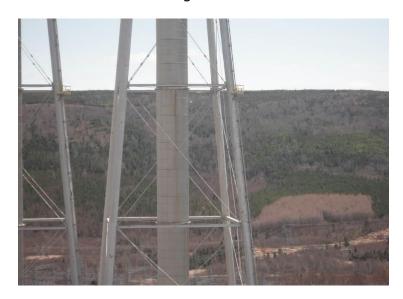
General condition of cladding on riser.

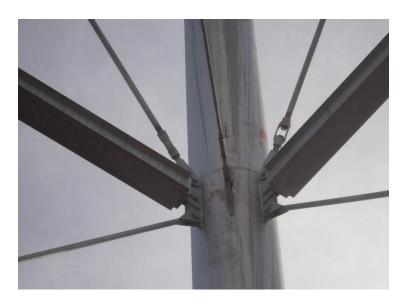
General condition of connections into legs. Minor coating breakdown.

Tank exterior - The legs, beams and bracing should be prepared by high pressure water jetting @5000psi to remove all grey paint that is not tightly adhered (Adhesion of 250 psi or greater). All areas that show signs of corrosion or failure of the primer coat should be prepared to SSPC-SP2 and SSPC-SP 3 and primed accordingly. The moisture cure system is advantageous here as well as it is suited for the surface preparation and service environment Wasser MioZinc 100, MioMastic 100, MC Luster would be appropriate for exterior service.

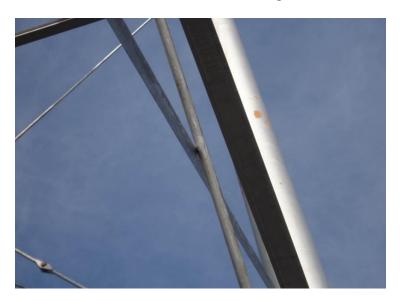
General condition of cross braces on the surge tank.

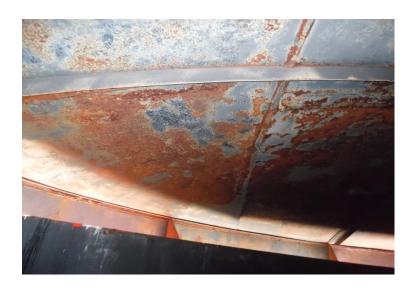
General condition of underside of tank roof. Coating breakdown.

Tank Interior - The interior of the surge tank should be wet abrasive blasted, sweep blasting the entire surface and blasting those areas that require it to bare metal. A moisture cure coating would be appropriate for the application environment and anticipated high humidity during surface preparation and coating operations. Wasser MioZinc 100 applied to all bare metal areas and weld seams and 2 coats of MC Tar would be suitable for this surface preparation and service environment.

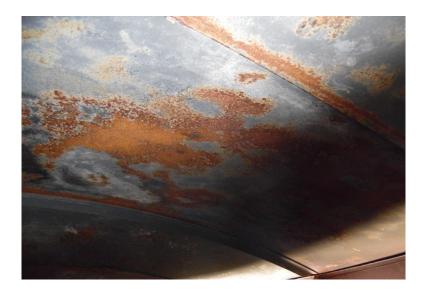
General condition of underside of tank roof. Coating breakdown.

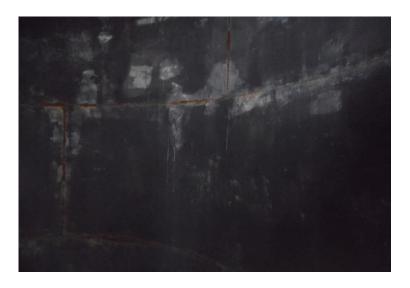
General condition of tank top before water line. Minor coating breakdown and minor corrosion present on welds.

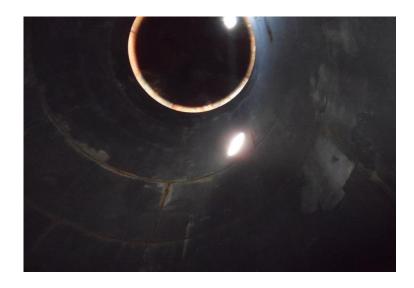
General condition of tank top before water line. Minor coating breakdown and minor corrosion present on welds.

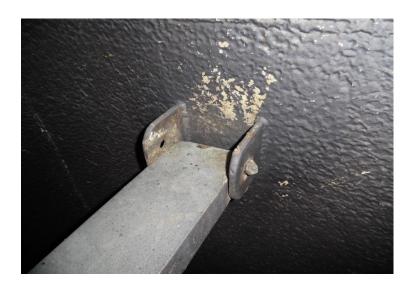
General condition of riser cross braces and coatings inside of riser. Bent and missing bolts.

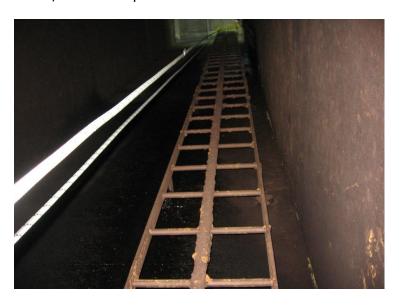
General condition of ladder leading from head gate to bottom of penstock, corrosion present.

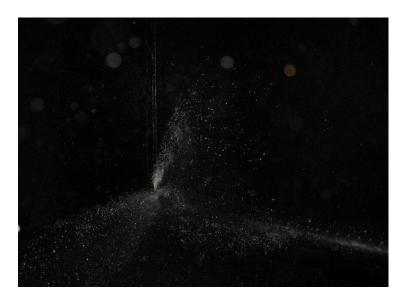
Facing the head gate, Top left, bottom left and bottom right water flow is present.

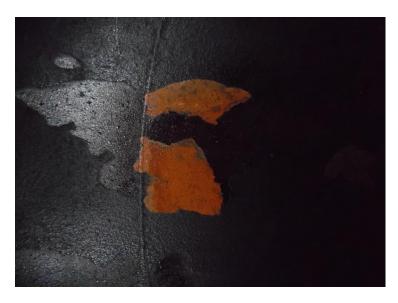
General condition of coating throughout the penstock.

Penstock - The penstock should be water blasted or wet abrasive blasted if there is not a suitable profile present after cleaning for proper application of the protective coating system. A moisture cure coating would be appropriate for the application environment and anticipated high humidity during surface preparation and coating operations. Wasser MioZinc 100 and 2 coats of MC Tar would be suitable for this surface preparation and service environment.

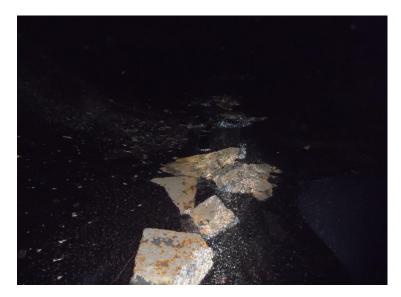
General condition of coating throughout the penstock.

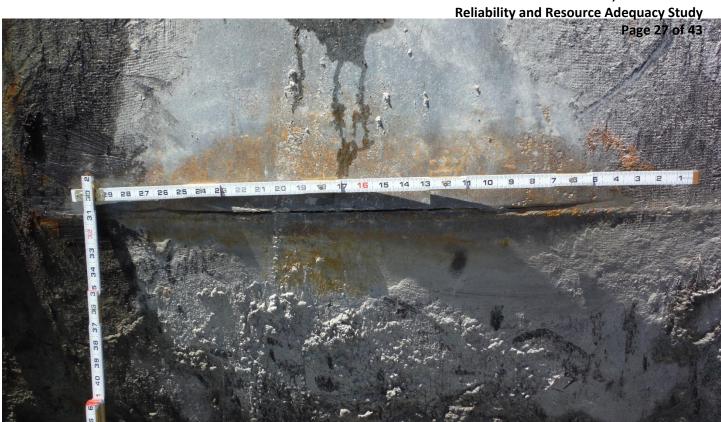
- The crack was observed to be in the base material (penstock plating) and not through the weld material (Photo 2). This cracked area is in what is considered the heat effected zone where the welding process heats the base material enough to alter the properties without melting it. This zone tends to be more brittle than the original base material.

Photo 2-C rack in Penstock plate along longitudinal weld

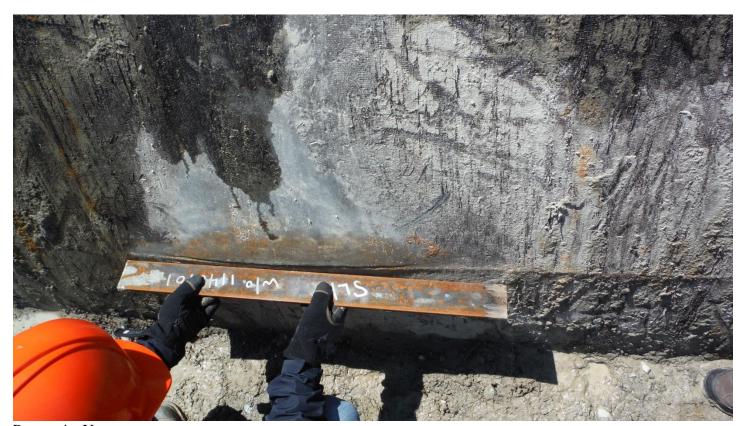
PHOTO 3 – MEASURING VISIBLE LENGTH

- The crack was located at Station 0+260 as measured from the intake (Photo 1) and was measured to be 24.5 inches long from what could be seen visually (Photo 3). Per Drawing F-106-C-7, this location approximately corresponds to Bend No. 3A.

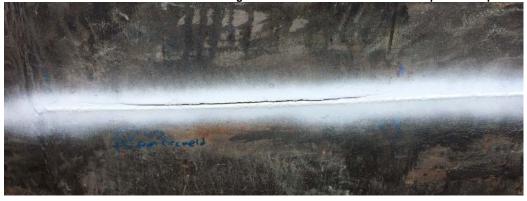
Magnetic particle inspection was carried out in the area on either side of the crack found in penstock #1 to ensure no surface cracks extended from either end. No difference in length was noted from the ultrasound inspection on previous report.

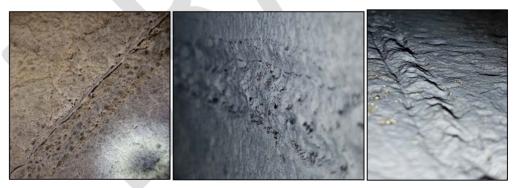
Throughout the upper section of the penstock it was noted that longitudinal seams were experiencing extensive pitting, material loss and well defined notches along the heat affected zone (HAZ) of the welds. This excess material loss and notching contributes to high stresses, crack initiation and propagation. Refer to Figure 3-3 and Figure 3-4 for images of the notching, excessive pitting, and material loss.

Figure 3-3: Longitudinal Seams in Penstock No.1 Section 16

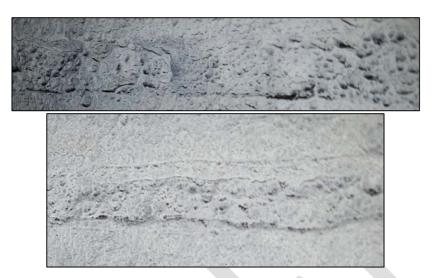
Figure 3-4: Longitudinal Seams in Penstock No.1 Section 16

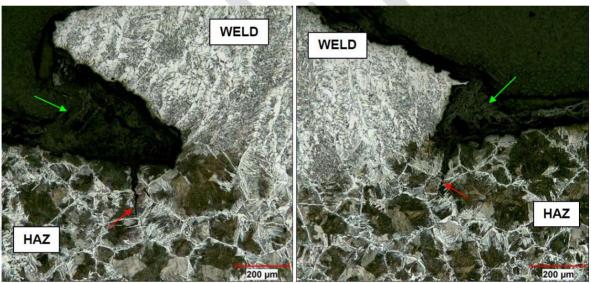
Figure 3-5: Coupon #1 Micro of HAZ Transgranular Cracks

The macroetch and microetch of coupon #1 (longitudinal) show surface pitting and advanced stages of preferential corrosion with cracks initiated from the cavities and are progressing through the HAZ.

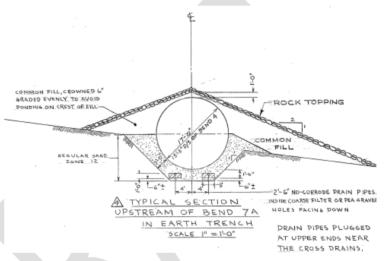
The construction drawing shows a detail that has cover thicknesses in multiple locations below one foot. Construction drawing detail below:

Figure 3-8: Design Drawing Half Trench

When analyzing the backfill it was determined that backfill is structurally integral to the penstock and provides needed support along the center line. In the area where the penstock cracks occurred, the depth of backfill is less than 2 feet and some sliding and sloughing has occurred. This has been shown to increase the stress level by approximately 100% in the area of longitudinal welds locations. Refer to the finite element stress analysis completed for the backfilling of the excavated areas in Appendix G.

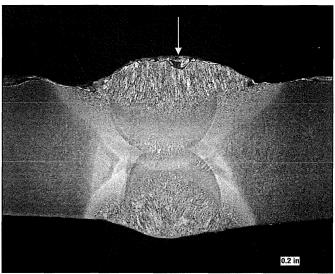
Figure 2: Photomacrograph of the Section 1, which had discontinuities at both toes (red arrows) and porosity (yellow arrow) on the face on one side of the weld.

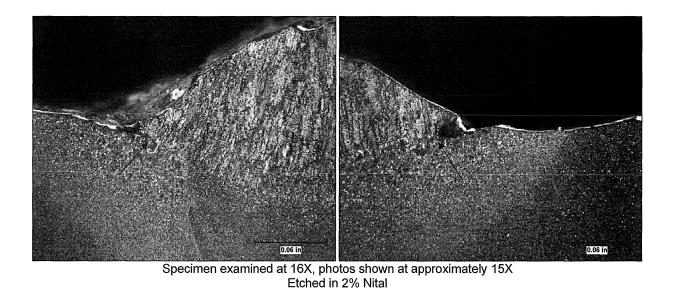
Figure 3: Photomacrographs of the Section 1. The discontinuities at the toes of the weld were revealed to be cracks propagating along the fusion line of the weld (red arrows).

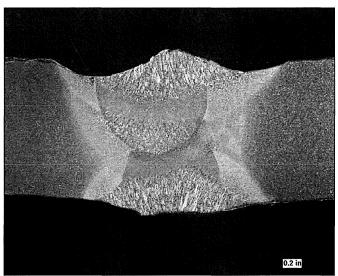
Figure 4: Photomacrograph of the Section 2, which had discontinuities at both toes (red arrows) on one side of the weld.

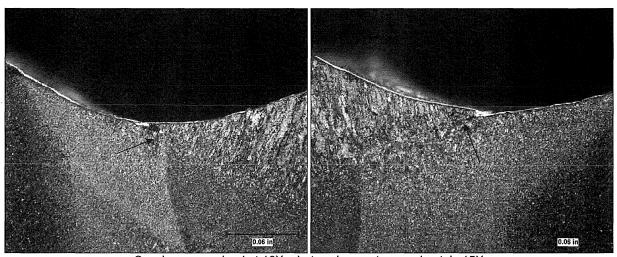
Figure 5: Photomacrographs of the Section 2. The discontinuities at the toes of the weld were revealed to be cracks propagating along the fusion line of the weld (red arrows).

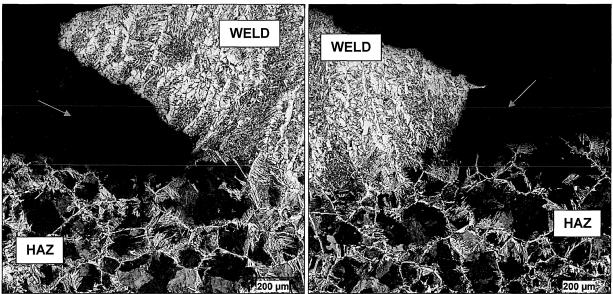
Figure 1: Photomicrographs of the Section 1 weld coupon at the "FL" locations. Transgranular cracks (red arrows) propagated through the HAZ of the weld from cavities located at the both toes on the face of the weld. Both cavities were filled with corrosion product (green arrows). The HAZ microstructure at the toe of the weld consisted of relatively coarse-grained pearlite with intergranular ferrite. The weld microstructure consisted of columnar ferrite and pearlite.

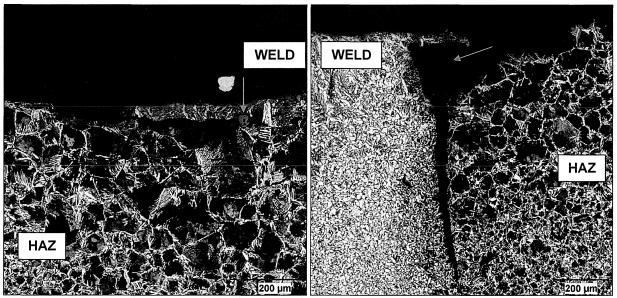
Figure 3: Photomicrographs of the Section 2 weld coupon at the "FL" locations. Transgranular cracks (red arrows) propagated through the HAZ of the weld from a cavity located at one toe on the face of the weld (right), and from an overlap at the other toe on the face of the weld (left). The cavity was filled with corrosion product (green arrow, right). An inclusion was observed within the overlap (green arrow, left). The HAZ microstructure at the toe of the weld consisted of relatively coarse-grained pearlite with intergranular ferrite. The weld microstructure consisted of columnar ferrite and pearlite.

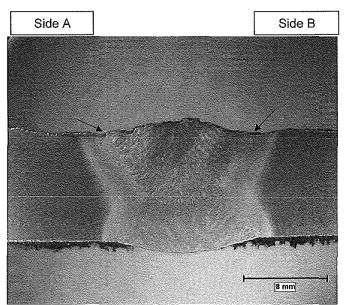
Figure 2: Photomacrograph of the Section 1, showing the pitting along the surface within the HAZ/at the weld toes along the inside diameter.

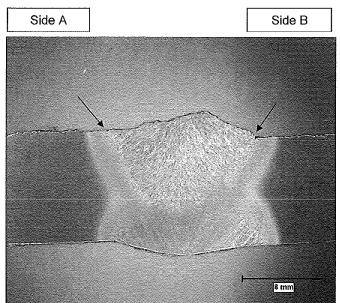
Figure 3: Photomacrograph of the Section 2, showing the pitting along the surface within the HAZ/at the weld toes along the inside diameter.

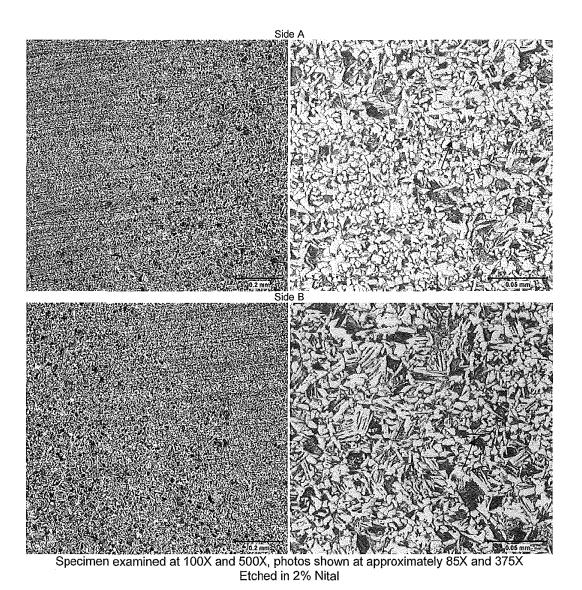
Figure 6: Photomicrographs of the Section 1 "Side A" and "Side B" weld coupon at the "FL +1" locations; where the HAZ microstructure showed a fairly uniform mixture of ferrite and pearlite, with a more refined grain size. At a higher magnification some sulphide inclusions were observed (refer to red arrows).

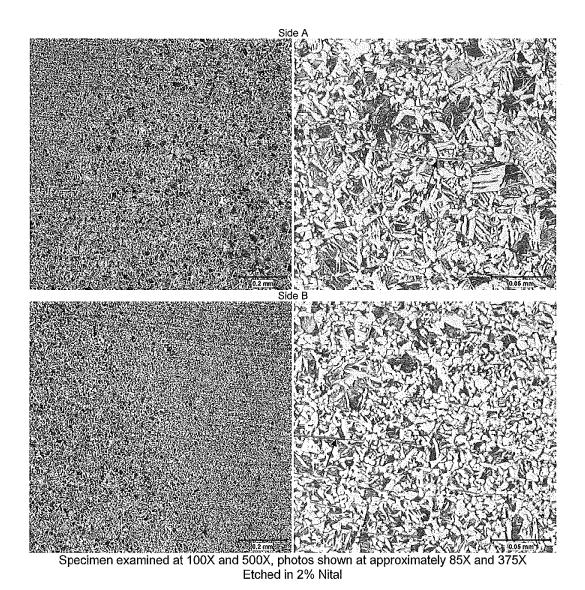
Figure 9: Photomicrographs of the Section 2 "Side A" and "Side B" weld coupon at the "FL +1" locations; where the HAZ microstructure showed a fairly uniform mixture of ferrite and pearlite, with a more refined grain size. At a higher magnification some sulphide inclusions were observed (refer to red arrows).

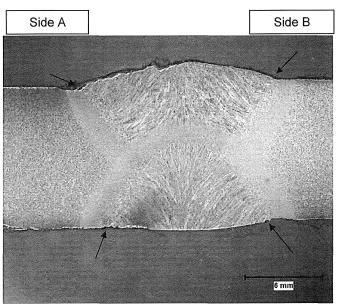
Figure 2: Photomacrograph of the Section 1, showing the pitting along the surface within the HAZ/at the weld toes.

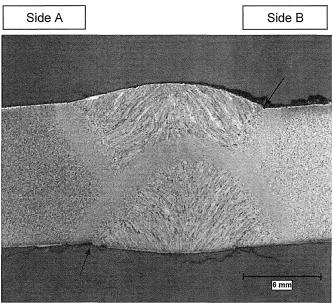
Figure 3: Photomacrograph of the Section 2, showing the pitting along the surface within the HAZ/at the weld toes.

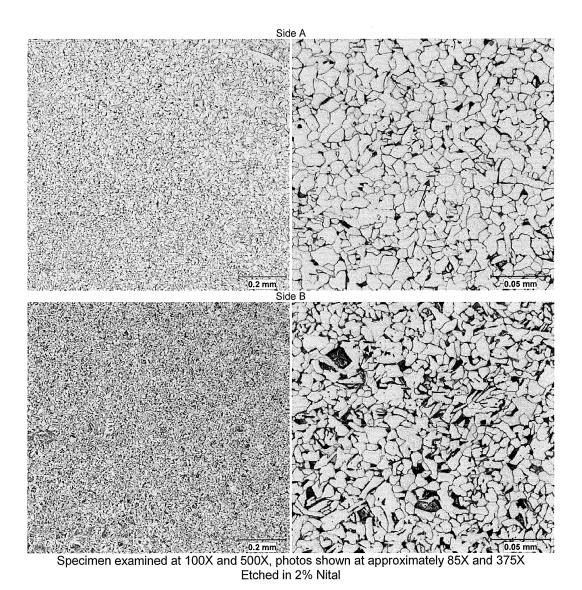
Figure 6: Photomicrographs of the Section 1 "Side A" and "Side B" weld coupon at the "FL +1" locations; where the HAZ microstructure showed a fairly uniform mixture of ferrite and pearlite, with a more refined grain size. At a higher magnification some sulphide inclusions were observed (refer to red arrows).

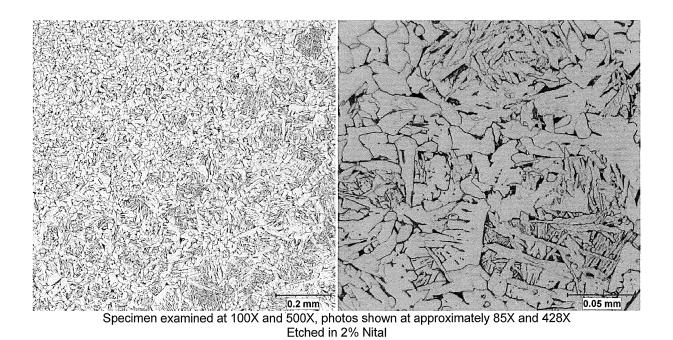
Figure 7: Photomicrographs of the Section 2 "Side A" weld coupon at the "FL" location, where a relatively coarse grain HAZ of ferrite and some pearlite was observed.

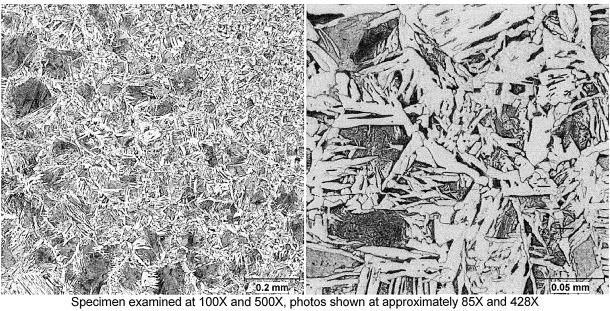
Figure 8: Photomicrographs of the Section 2 "Side B" weld coupon at the "FL" location, where a relatively coarse grain HAZ of ferrite and pearlite was observed.

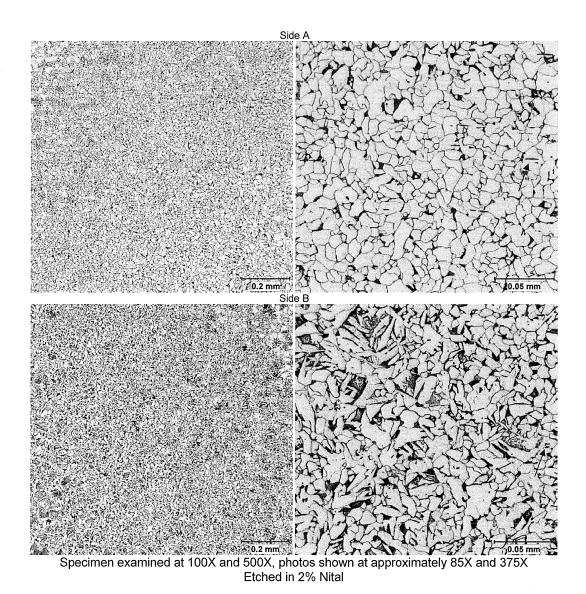
Figure 9: Photomicrographs of the Section 2 "Side A" and "Side B" weld coupon at the "FL +1" locations; where the HAZ microstructure showed a fairly uniform mixture of ferrite and pearlite, with a more refined grain size. At a higher magnification some sulphide inclusions were observed (refer to red arrows).

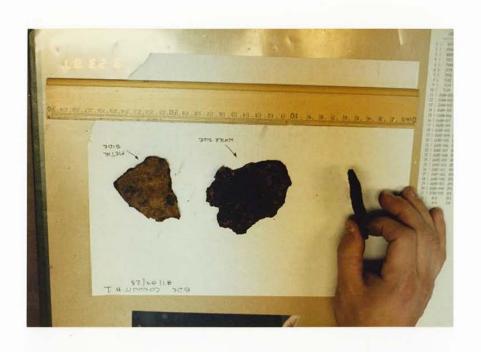
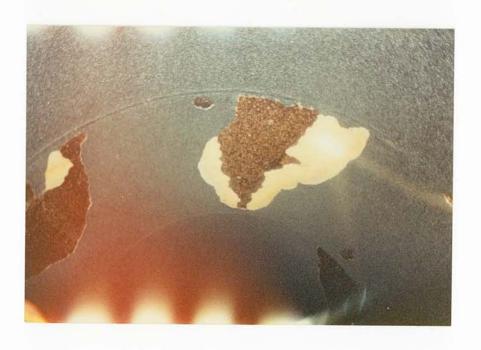
PHOTOGRAPHS OF #1 PRESSURE CONDIST INTERIOR CONTING.

In the conduit itself, all section welds were visually inspected with no damage being found. The conduit plating was also inspected. Throughout the length of the complete conduit there is a heavy build-up of what appears to be rust/organic, magnetic material approx. .200 inch to .300 inch thick. This buildup has sheared off in a sheet fashion at numerous locations, especially adjacent to section welds and by as much as 25% in the following areas: (Ref. Drawing F-106-C-11, Appendix 1).

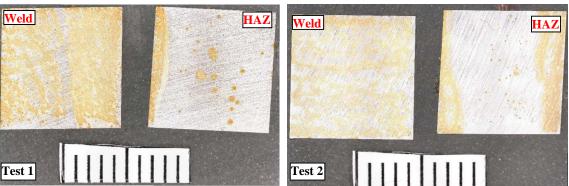
shown in Figure 4, HAZ was protected in both tests against the WELD. Based on the observations, it can be suggested that the weld has the least corrosion resistance in the galvanic setup and BM shows the best corrosion resistance.

Figure 4. Low magnification morphology of WELD/HAZ couple Sample 1.

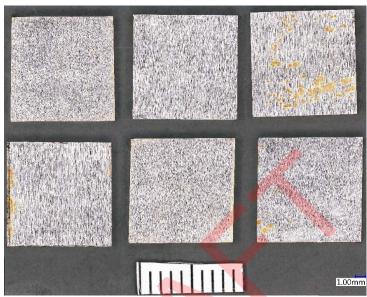
As it can be observed in Figure 11, samples show no significant corrosion after on hour of exposure to similar solution used for galvanic test. This indicates the severity of galvanic corrosion for this design.

Figure 11. Low magnification morphology of all reference samples after normal corrosion.

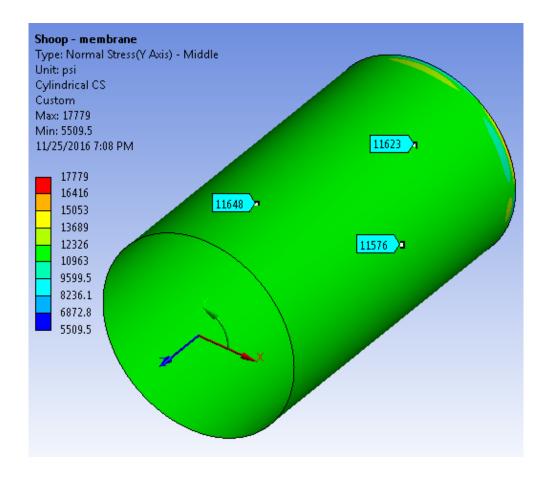
**Figure 16**: LS1 - Membrane hoop stress. Allowable for continuous plate  $Sa_{pA285} = 20000 \cdot psi$ . Ignore minor spikes at the boundary. No overstress.

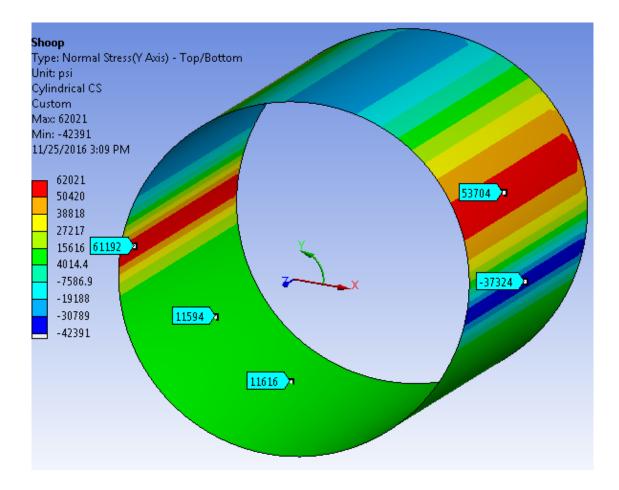
**Figure 17**: LS1 - Total hoop stress. Allowable for continuous plate  $Sa_{|A285|} = 30000 \cdot psi$ . 100% overstress, more if longitudinal welded joint efficiency at 3 and 9 o'clock is taken into account.

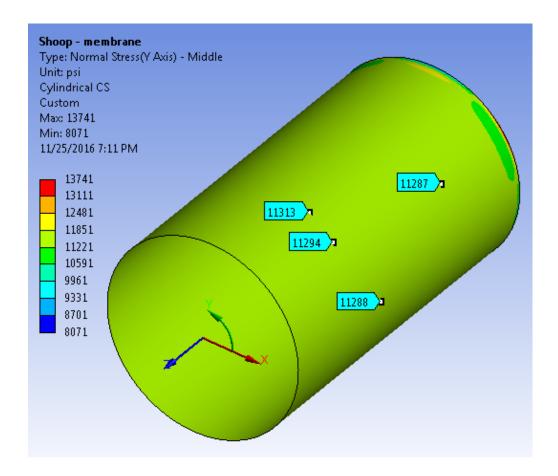
Figure 18: LS2 - Membrane hoop stress. Allowable for continuous plate  $Sa_{pA285} = 20000 \cdot psi$ . Ignore minor spikes at the boundary. No overstress.

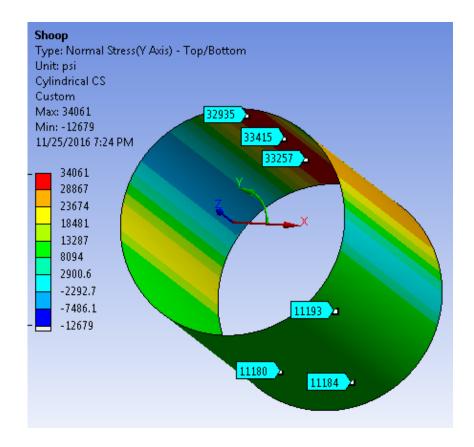
Figure 19: LS2 - Total hoop stress. Allowable for continuous plate  $Sa_{|A285|} = 30000 \cdot psi$ . 12% overstress.

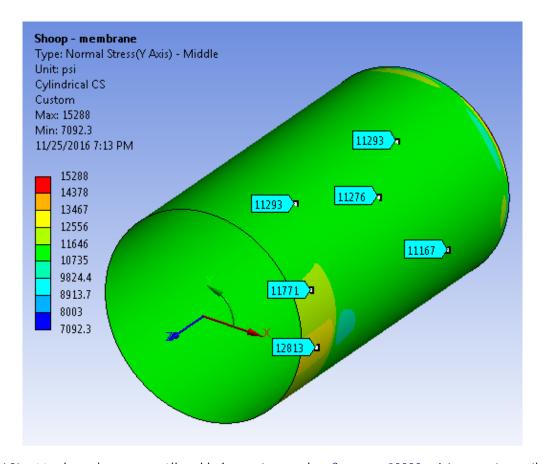
**Figure 20**: LS3 - Membrane hoop stress. Allowable for continuous plate  $Sa_{pA285} = 20000 \cdot psi$ . Ignore minor spikes at the boundary. No overstress.

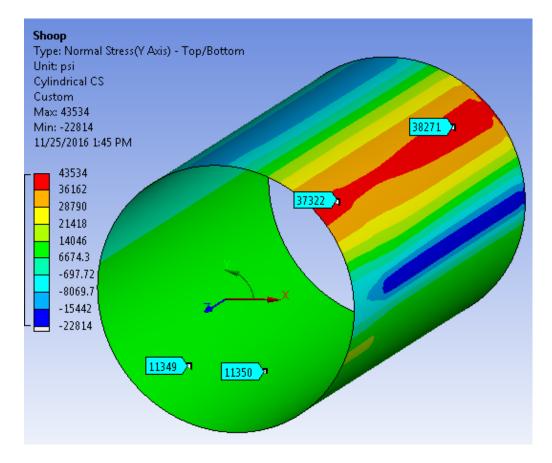
Figure 21: LS3 - Total hoop stress. Allowable for continuous plate  $Sa_{A285I} = 30000 \cdot psi$ . 45% overstress, more if longitudinal welded joint efficiency at 3 o'clock is taken into account.

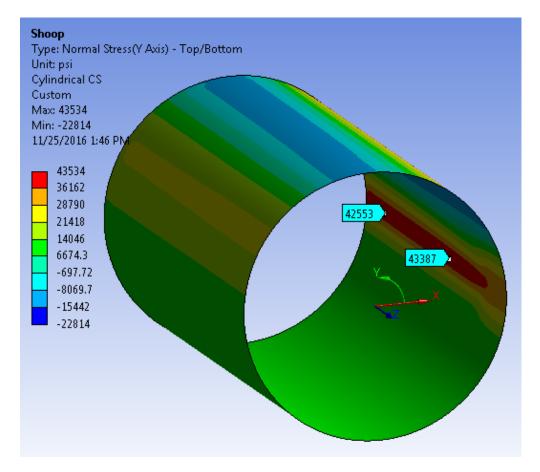
Figure 22: LS3 - Total hoop stress. Allowable for continuous plate  $Sa_{|A285|} = 30000 \cdot psi$ . 45% overstress, more if longitudinal welded joint efficiency at 3 o'clock is taken into account.

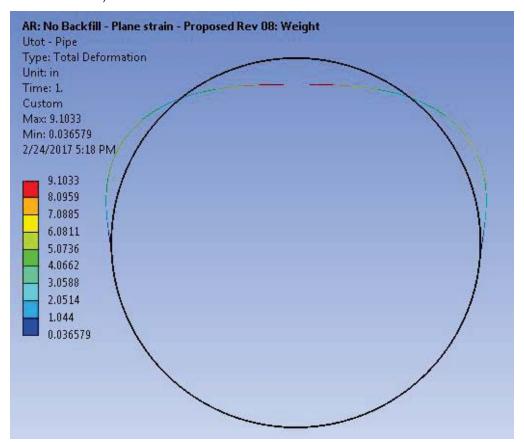
Figure 23 Model 1, LC1 - Penstock Total Deformation

Maximum deformation of 9.1 in. occurs at the top of the penstock.  $\label{eq:maximum}$

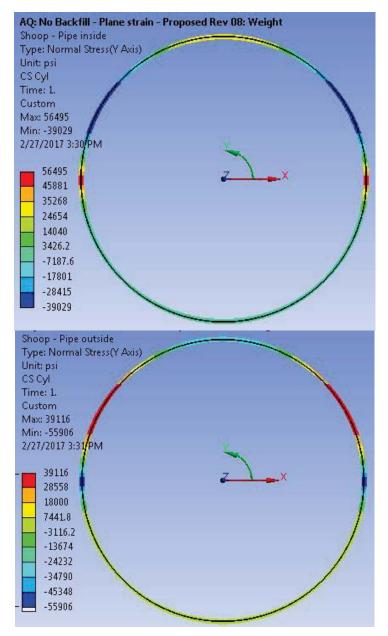
Figure 24 Model 1, LC1 - Penstock Hoop Stress: Inside Surface (upper) - Outside Surface (lower)

Stresses are indicated as tension (positive values) and compression (negative values) which represents hoop stress resulting from shell bending. Areas where hoop stress exceeds a magnitude of 21,000 psi (allowable stress) is considered to be in a state of overstress. For the internal wall this correlates to areas shown in yellow through red and light green through dark blue. For the external wall this correlates to areas shown in orange through red and light green through dark blue.

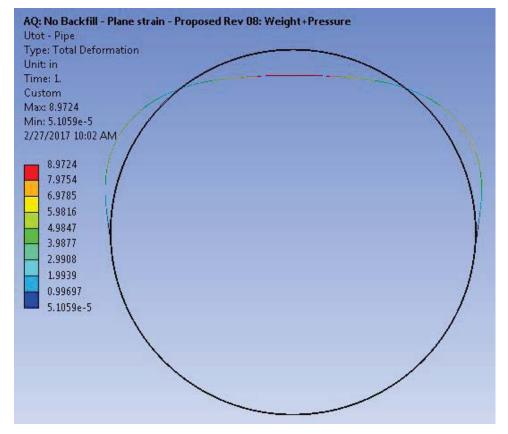
Figure 25 Model 1, LC2 - Penstock Total Deformation

Max deformation of 8.97 in. occurs at the top of the penstock.

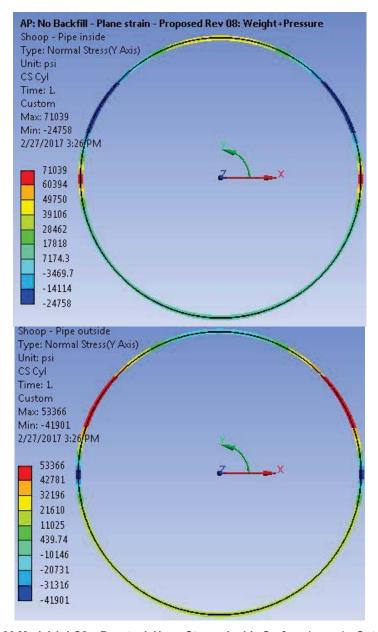
Figure 26 Model 1, LC2 – Penstock Hoop Stress: Inside Surface (upper) - Outside Surface (lower)

Stresses are indicated as tension (positive values) and compression (negative values) which represents hoop stress resulting from shell bending. Areas where hoop stress exceeds a magnitude of 21,000 psi (allowable stress) is considered to be in a state of overstress. For the internal wall this correlates to areas shown in light green through red and dark blue. For the external wall this correlates to areas shown in yellow through red and blue through dark blue.

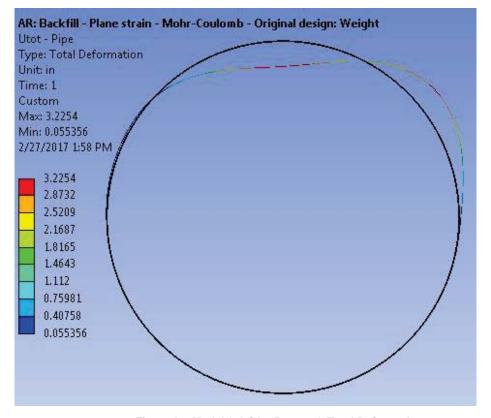
Figure 27 Model 2, LC1 – Penstock Total Deformation

Maximum deformation of 3.23 in. occurs at the top of the penstock, 2.90 in. occurs at 2 o'clock.

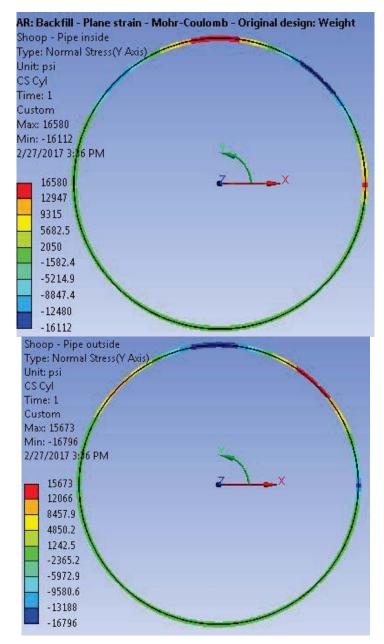
Figure 28 Model 2, LC1 – Penstock Hoop Stress: Inside Surface (upper) - Outside Surface (lower)

Stresses are indicated as tension (positive values) and compression (negative values) which represents hoop stress resulting from shell bending. Areas where hoop stress exceeds a magnitude of 21,000 psi (allowable stress) is considered to be in a state of overstress. For the internal wall there is no overstress for this case. For the external wall there is no overstress for this case.

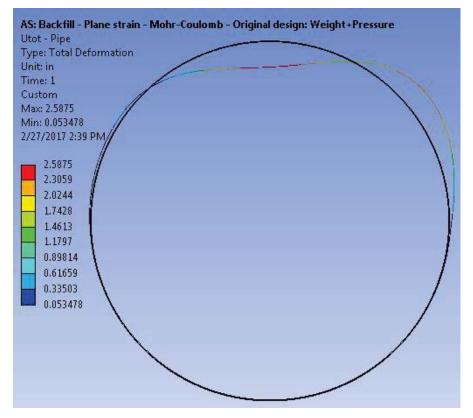
Figure 29 Model 2, LC2 - Penstock Total Deformation

Maximum deformation of 2.58 in. occurs at the top of the penstock, 2.3 in. occurs at 2 o'clock.

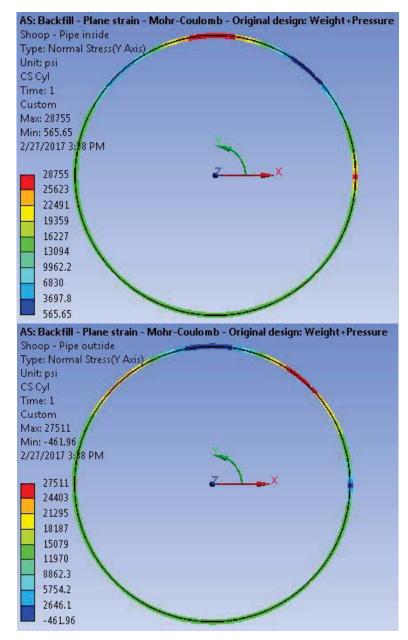
Figure 30 Model 2, LC2 - Penstock Hoop Stress: Inside Surface (upper) - Outside Surface (lower)

The results from model 2 show the penstock will be overstressed for load combination 2 (self-weight, water weight and internal pressure). However, the backfill is prone to localized failures and these areas will behave more like model 1.

Stresses are indicated as tension (positive values) and compression (negative values) which represents hoop stress resulting from shell bending. Areas where hoop stress exceeds a magnitude of 21,000 psi (allowable stress) is considered to be in a state of overstress. For the internal wall this correlates to areas shown in yellow through red. For the external wall this correlates to areas shown in orange through red.

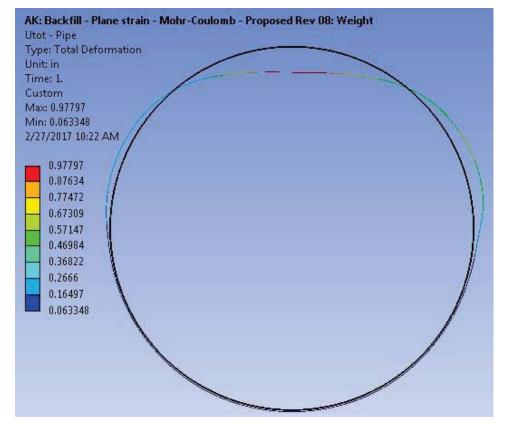
Figure 31 Model 3, LC1 - Penstock Total Deformation

Maximum deformation of 0.98 in. occurs at the top of the penstock.

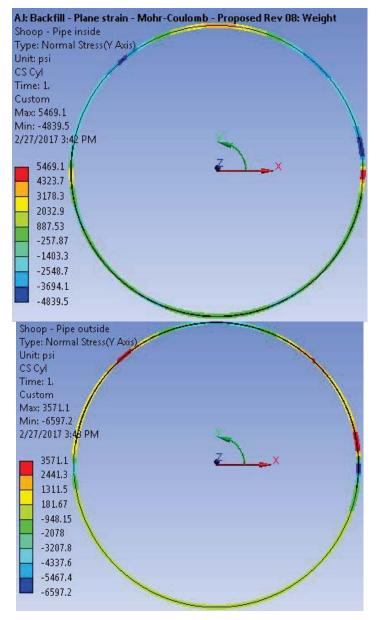
Figure 32 Model 3, LC1 - Penstock Hoop Stress: Inside Surface (upper) - Outside Surface (lower)

Stresses are indicated as tension (positive values) and compression (negative values) which represents hoop stress resulting from shell bending. Areas where hoop stress exceeds a magnitude of 21,000 psi (allowable stress) is considered to be in a state of overstress. For the internal wall there is no overstress for this case. For the external wall there is no overstress for this case.

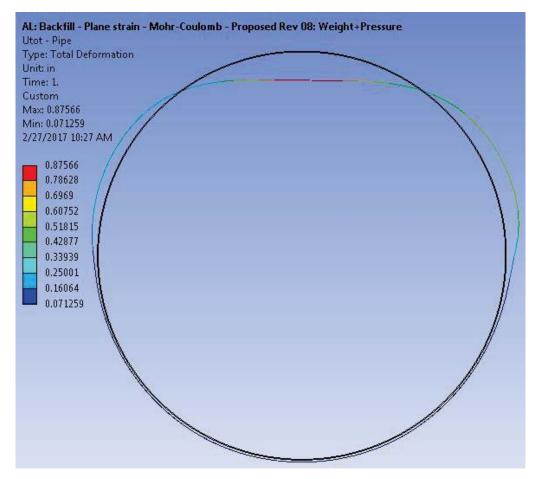
Figure 33 Model 3, LC2 - Penstock Total Deformation

Max deformation of 0.88 in. occurs at the top of the penstock.

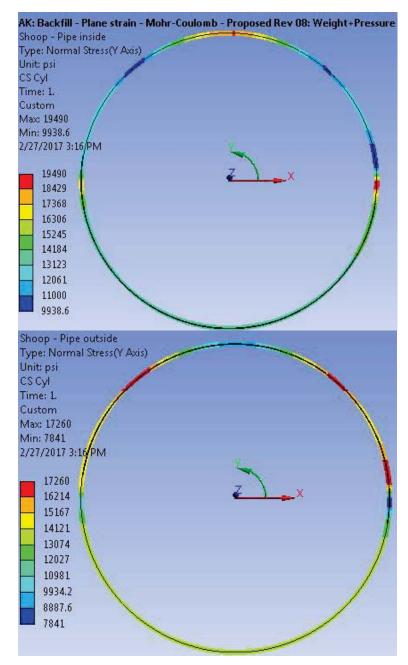
Figure 34 Model 3, LC2 - Penstock Hoop Stress: Inside Surface (upper) - Outside Surface (lower)

The results from model 3 show the penstock will be slightly overstressed for load combination 2 (self-weight, water weight and internal pressure). However, the backfill will be less prone to failures and the stresses should remain consistent.

Stresses are indicated as tension (positive values) and compression (negative values) which represents hoop stress resulting from shell bending. Areas where hoop stress exceeds a magnitude of 21,000 psi (allowable stress) is considered to be in a state of overstress. For the internal wall there is no overstress for this case. For the external wall there is no overstress for this case.

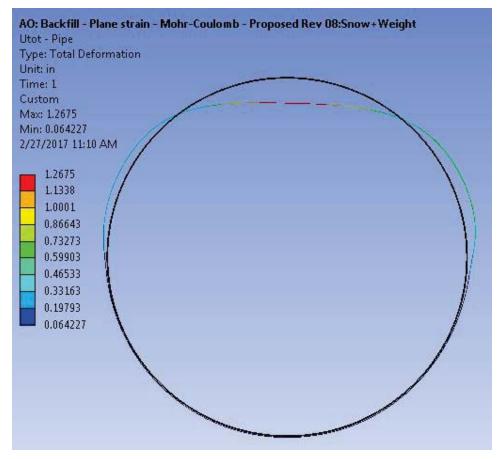
Figure 35 Model 3, LC3 - Penstock Total Deformation

Maximum deformation of 1.27 in. occurs at the top of the penstock.

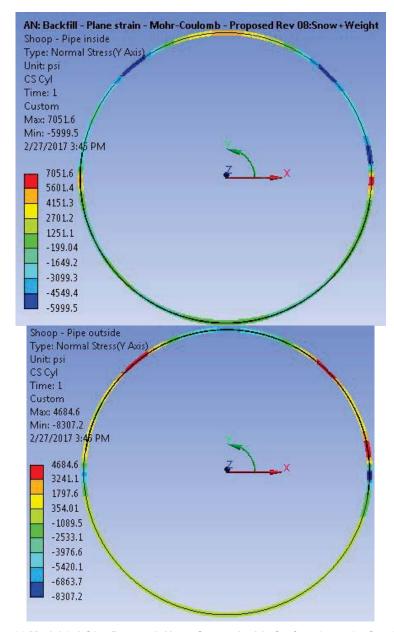
Figure 36 Model 3, LC3 – Penstock Hoop Stress: Inside Surface (upper) - Outside Surface (lower)

Stresses are indicated as tension (positive values) and compression (negative values) which represents hoop stress resulting from shell bending. Areas where hoop stress exceeds a magnitude of 21,000 psi (allowable stress) is considered to be in a state of overstress. For the internal wall there is no overstress for this case.

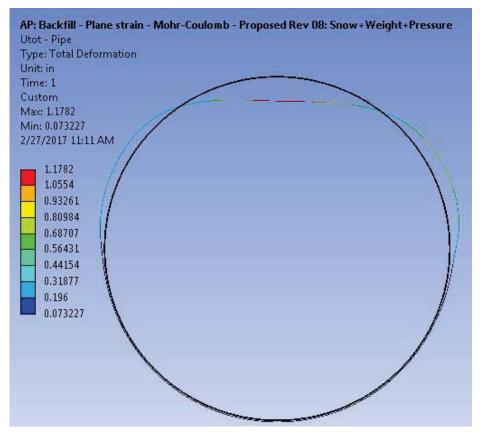
Figure 37 Model 3, LC4 - Penstock Total Deformation

Maximum deformation of 1.18 in. occurs at the top of the penstock.

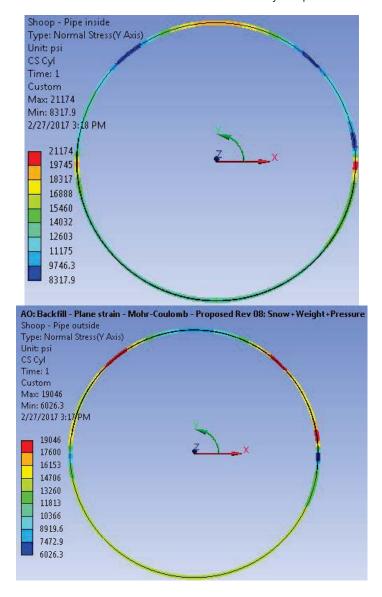
Figure 38 Model 3, LC4 – Penstock Hoop Stress: Inside Surface (upper) - Outside Surface (lower)

Stresses are indicated as tension (positive values) and compression (negative values) which represents hoop stress resulting from shell bending. Areas where hoop stress exceeds a magnitude of 21,000 psi (allowable stress) is considered to be in a state of overstress. For the internal wall this correlates to areas shown in red. For the external wall there is no overstress for this case.
