1	Q.	Please	provide copies of reports or other documentation that describe the latest condition			
2		of the following assets and any work completed to date addressing the following issues:				
3						
4		a.	Bay d'Espoir penstocks;			
5						
6		b.	Hinds Lake rotor resistance;			
7						
8		С.	Granite Canal control system;			
9						
LO		d.	Upper Salmon rotor rim cracking;			
11						
12		e.	Hinds Lake bearing coolers;			
13						
<b>L</b> 4		f.	Cat Arm spherical control valves;			
15						
16		g.	Hardwoods combustion can failures;			
<b>L</b> 7						
18		h.	Hardwoods bellows failures/cracking;			
19						
20		i.	Holyrood boiler tube issue, variable frequency drive issues, air flow limitations,			
21			hydraulic fluid issues;			
22						
23		j.	Stephenville vibration issues;			
24						
25		k.	Hardwoods combustion can failures;			
26						
27		l.	Hardwoods bellows cracking issue;			
28						
29		m.	All Holyrood boiler tube failure studies;

1		n. All "Quarterly Report on Performance of Generating Units" reports; and
2		
3		o. Exploits frazil ice issues.
4		
5		
6	A.	The reports referenced below provide an overview of the latest condition of the asset(s)
7		and any work completed to

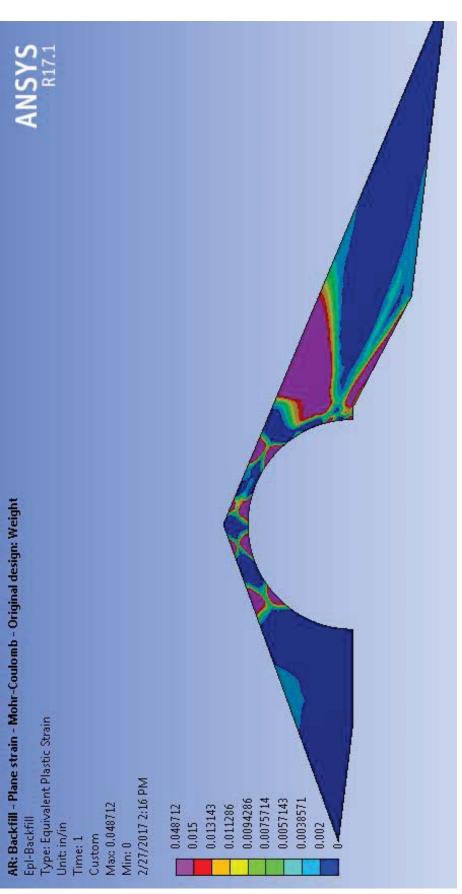
Figure 39 Model 2, LC1 - Equivalent Plastic Strain in Backfill

For the original backfill configuration (Figure 5), the backfill slope has a potential risk of instability. Figure 39 and Figure 40 shows the equivalent plastic strain plots from Model 2, where the blue color represents the soil remaining elastic, and the other colors indicate that the soil is in plastic state (prone to large deformation if a continuous zone is formed). As shown, the thin soil cover is prone to be negatively impacted by deformation of the penstock. At the north slope, the upper and the relatively lower plastic zones are getting close to forming a continuous zone. Additional negative external impacts (excessive penstock vibration, rainfall and etc.) could have triggered the instability during the penstock design life. This identified potential instability mode is consistent with the observed slope failure at the site, which occurred at the north side of penstock.

The large extent of the plastic zone (from 12 to 3 o'clock) indicates that the original design has a potential risk of slope instability (sloughing).

- Due to the criticality of the backfill to the integrity of the penstock, we recommend
  reinstatement of any sloughing/sliding backfill to its original profile in this construction
  season. The backfill material should be sloped/shaped such that it is not susceptible to
  surface erosion. This should be considered as a temporary mitigation, to reduce
  excessive stresses in the penstock.

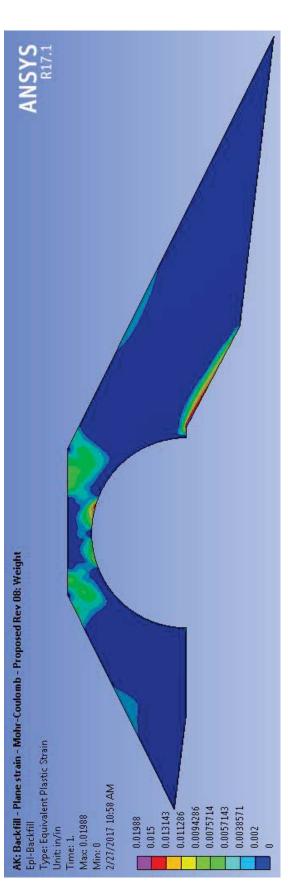
Figure 41 Model 3, LC1 - Equivalent Plastic Strain in Backfill

The extent of the plastic zone is localized, the backfill is stable.

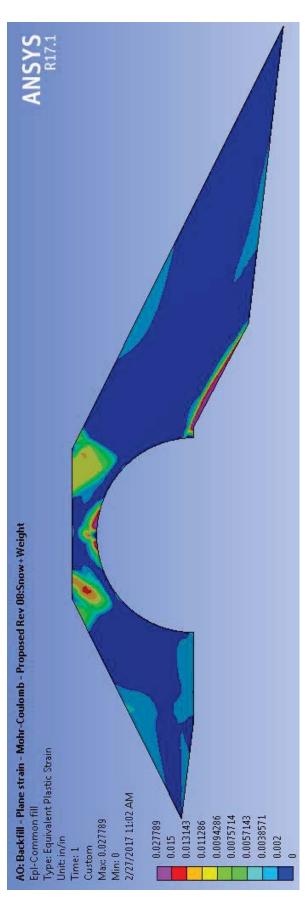
Figure 43 Model 3, LC3 - Equivalent Plastic Strain in Backfill

The extent of the plastic zone is localized, the backfill is stable.

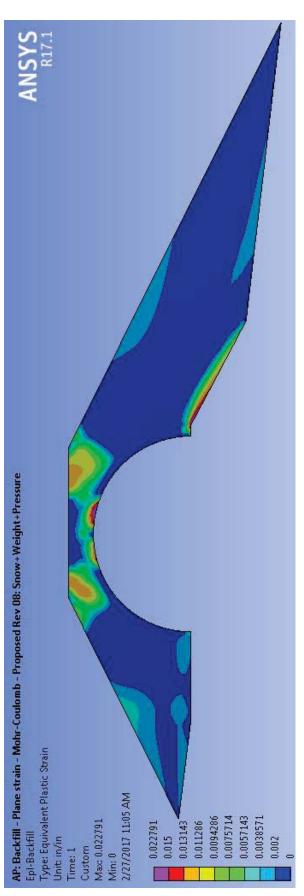
Figure 44 Model 3, LC4 - Equivalent Plastic Strain in Backfill

The extent of the plastic zone is localized, the backfill is stable.

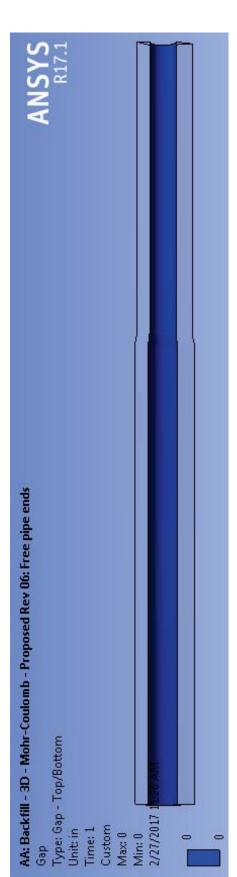
Figure 45 Model 4, LC2 - Gap between the Penstock and Bedding

The gap is 0 in. all along the interface; the bend is not expected to rise.

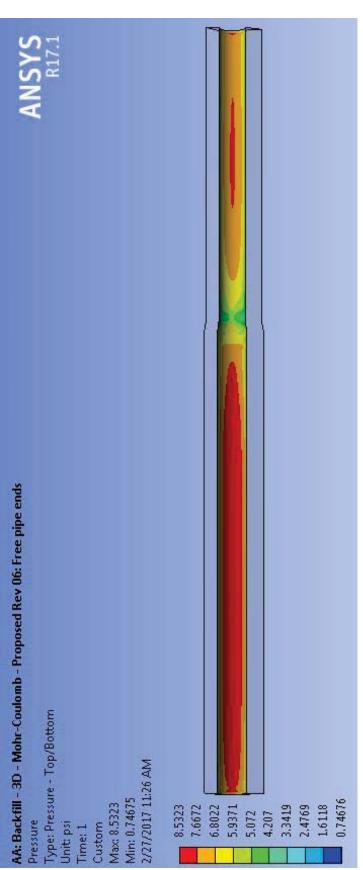
Figure 46 Model 4, LC2 - Contact Pressure between the Penstock and Bedding

The pressure is above 0 psi all along the interface; the bend is not expected to rise.

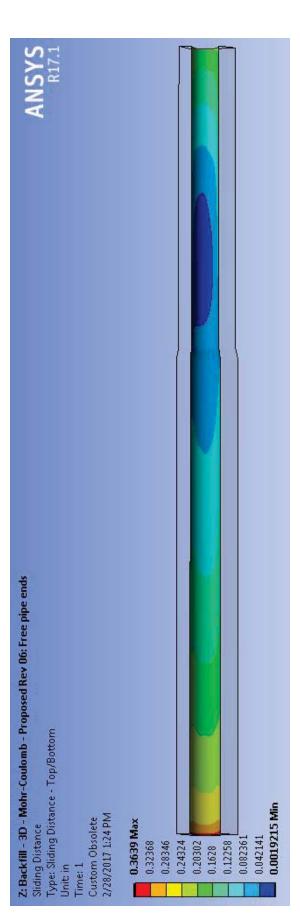
Figure 47 Model 4, LC2 - Sliding Distance between the Penstock and Bedding

The penstock in the model is not constrained at the ends and is expected to undergo contraction in axial direction upon application of internal pressure. The model predicts sliding at the bend of 0.05 in.

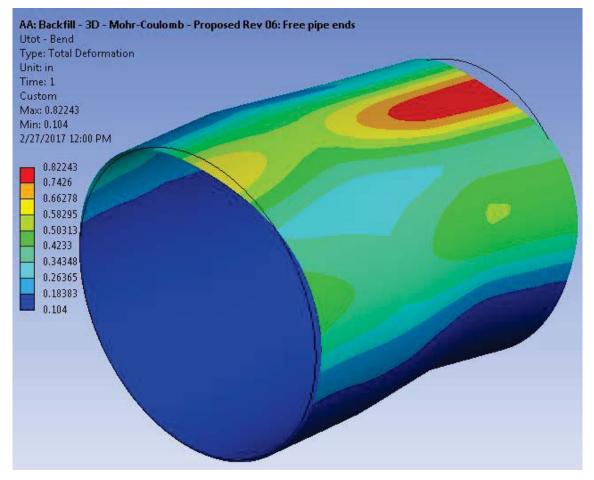
Figure 48 Model 4, LC2 - Total Deformation in Bend 4A

The deformation is mostly radial. The deformation is consistent with 2D models.

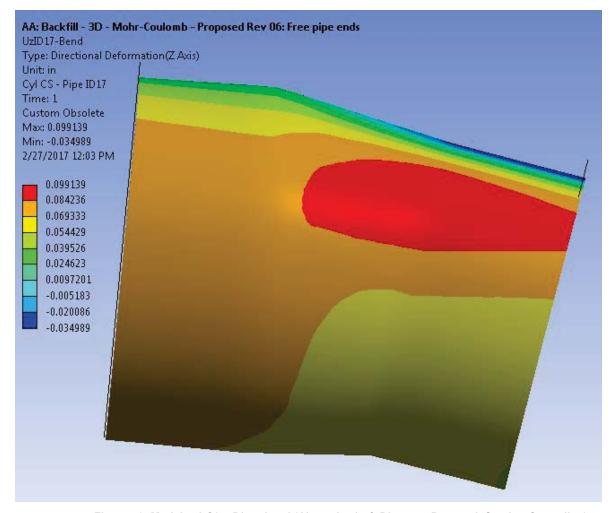
Figure 49 Model 4, LC2 – Directional (Along the 17-ft Diameter Penstock Section Centerline)
Displacement of Bend 4A

The intent of the 3D model (Model 4) is to calculate the displacements at Bend 4A. The penstock in the model is restrained only by gravitational forces resulting from water, steel, and backfill weight as well as the friction between the soil and steel. The results (Figure 45 and Figure 49) show that the bend does not get separated from the bedding (contact gap is zero). The displacements at the bend are small (in the order of 0.06 in. excluding radial deformation) and are not a concern.

The bend displacement is very small.

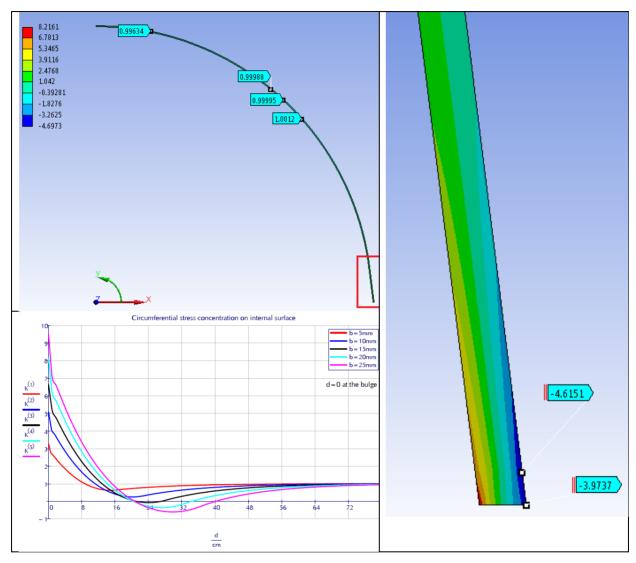
Figure 7-3: Influence of Non-Circular Geometry at Longitudinal Welds Under Pressure

- The geometrical discontinuity due to peaking at the longitudinal weld seam creates very high localized bending stresses.
- The unsymmetrical as-built backfill creates unsymmetrical backfill loads resulting in large deflection of the empty shell and higher stresses during penstock filling (σ<sub>0</sub>-red line and σ<sub>1</sub>-blue line in Figure 7-1); however, the stresses in penstock under full pressure are not impacted in the same manner by the unsymmetrical backfill (σ<sub>2</sub>-black line in Figure 7-1).

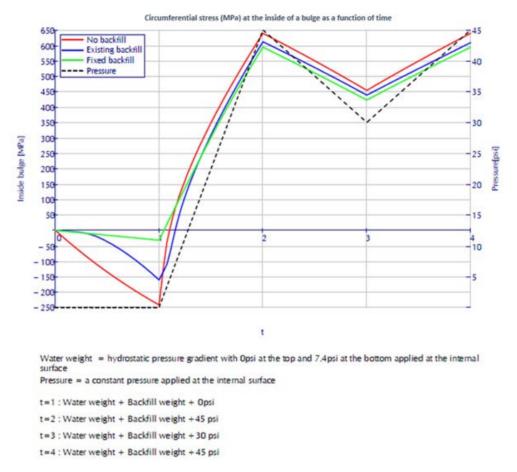
Figure 7-4: Linear Variation of Maximum Bending Stress at the Weld with Pressure and Change in Backfill

- Figure 7-4 shows that when the penstock is empty and filling with no internal pressure (t=1) the maximum bending stress reduces from 250 MPa to 150 MPa if the backfill is symmetrical relative to the as-is unsymmetrical backfill. However, with internal pressure applied, the maximum bending stress at the weld seam reverses to about 650 MPa and the backfill has little or no impact on the amplitude. However, variations in pressure (30 to 45 psi) increases the maximum bending stress from 450 MPa to 650 MPa. It is concluded from this analysis that improving the backfill significantly reduces circumferential bending stress during de-watering/watering up and when the penstock is empty but has insignificant effect on a pressurized penstock. This information was extracted from a theoretical linear elastic model. This allows a comparison of stresses only as the material thickness remains constant and the material does not self-relieve stresses that exceed yield. In reality, material strain hardening takes place progressively in ductile materials once the stresses exceed the yield stress of the material. It is likely that these stresses are lower in the penstock as at the location of high stress the material permanently deforms which reduces the localized stress.

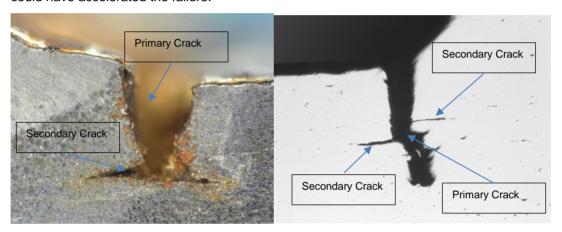
Figure 8-2: Primary Cracks (Vertical) and Secondary Cracks (Horizontal)

Two different types of cracks were discovered through macro examination and are shown in Figure 8-2. The primary cracks (through thickness) generally propagate from the toe of the weld through the heat affected zone (HAZ). All observed crack micro examinations had pearlitic structures which is a desirable trait and would indicate that the cracks were not caused by brittle structures. There is evidence of bending and high tensile loading when analyzing the micro photographs. Several of the samples had secondary cracking (interplanar) present. The secondary cracks appear to follow sulphide inclusions that are present within the base material and can likely be attributed to the presence of said inclusions. It seems unlikely the secondary cracking is the primary cause of the rupture but could have accelerated the failure.

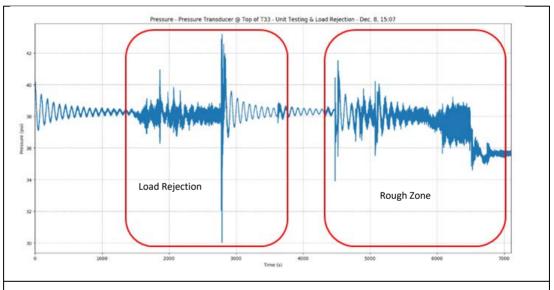
Figure 8-4: Pressure Measurement in Penstock at Can 33 during Rough Zone and Load Rejection

- A load rejection results in pressure rise of 10% at the powerhouse (259 psi+26 psi). The corresponding pressure waves up the penstock cause fluctuations in pressure at Can 33 of the order of ±17%(±6.8 psi) in the area where the rupture occurred (Figure 8-4). The corresponding fluctuation in the maximum stress is 280 ± 25 MPa during load rejection (Figure 8-5). Load rejection occurs between 1500 and 3500 seconds and the peak was at approximately 2700 seconds.
- The fluctuations in maximum stress during rough zone operation are of the order of ±7 MPa (1.0) ksi) and ±5 MPa (0.7 ksi) with two units and one unit in the rough zone, respectively (Figures 8-5 and 8-6). This is interesting as it was not anticipated that the rough zone operations would result in significant stress fluctuations in the penstock. Rough zone occurs from approximately 4500 seconds onward.

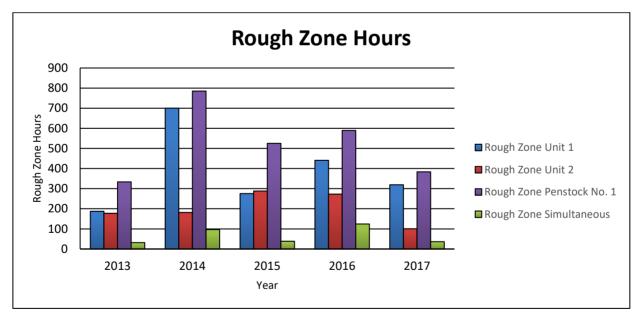
Figure 8-7: Rough Zone Trends

Newfoundland and Labrador Hydro provided the last five years of operational data to Hatch for analysis. The operational data provided shows decreasing amounts of starts/stops for each unit over the five years analyzed, and high hourly time spent within the rough zone (between 25 to 40 MW based on the measured test results). In general, eliminating unnecessary starts/stops is a common recommendation to increase the life of a hydraulic turbine. However, in this instance operating the units at low loads to meet the power demand resulted in these units spending an increased amount of time operating in the rough zone. The amount of time spent within the rough zone over the last five years is shown in Figure 8-7, and the number of annual starts/stops is shown in Figure 8-8.

Analyzing the data and approximating the total hydraulic rough zone time shows that over the last five years Penstock No. 1 averaged more than 400 hours in the hydraulic rough zone per year, with a peak of over 800 hours in 2014. Tt should be noted that 2016 and 2017 had significant down time for repairs and the duration of rough zone operation was reduced as a result.

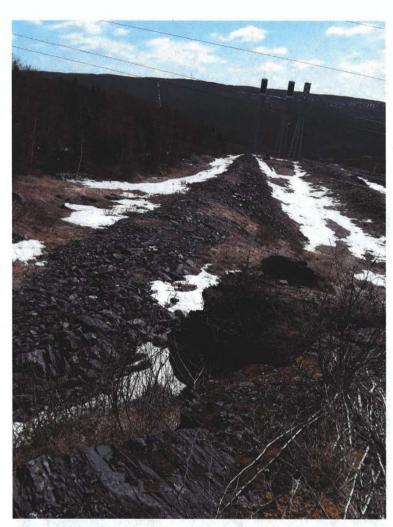
Photo 1 - Penstock Exterior below intake

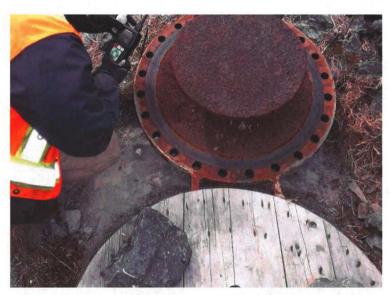
Photo 2 - Typical exterior condition near manhole

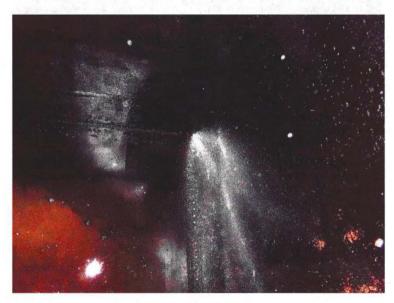
Photo 3 - Leakage from Headgate

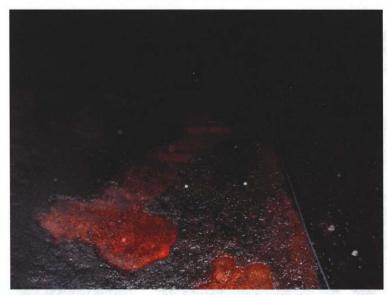
Photo 5 - Typical penstock condition with areas of missing coating

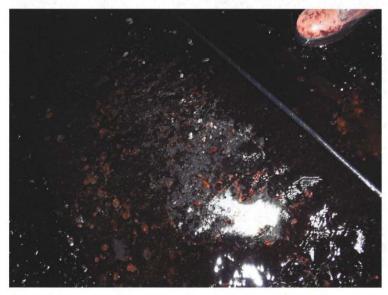
Photo 7 - Typical invert condition with water flowing and organic buildup

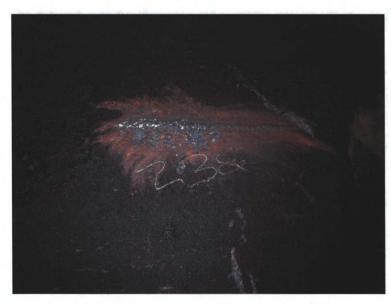
Photo 9 - Weld with minor pitting (238 feet downstream of intake)

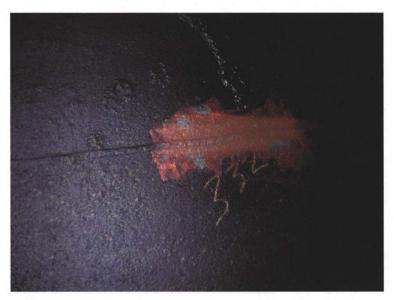
Photo 10 - Weld in fair condition with minor pitting (332 feet downstream of intake)

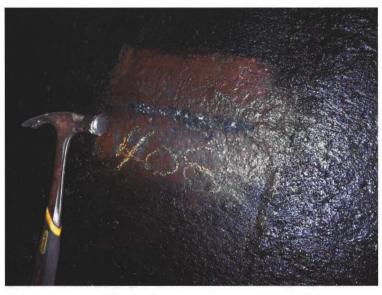
Photo 11 - Weld in fair condition but flatter than welds upstream (408 feet downstream of intake)

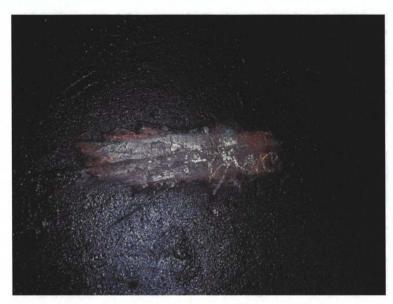
Photo 12 - Weld in fair condition but flatter than welds upstream (566 feet downstream of intake)

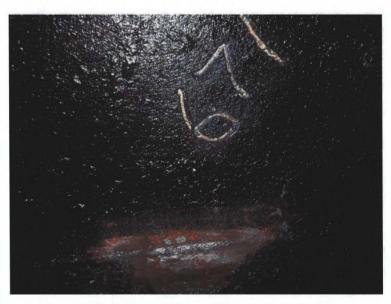
Photo 13 - Weld in fair condition, flat (671 feet downstream of intake)

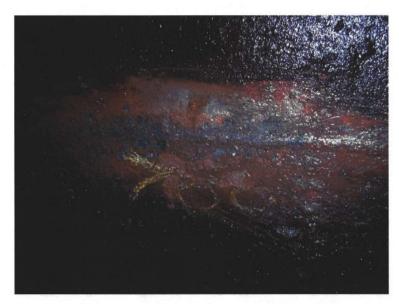
Photo 14 - Weld in fair condition, flat (700 feet downstream of intake)

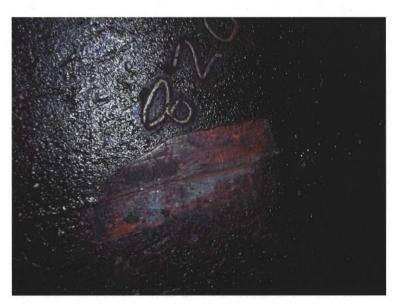
Photo 15 - Weld in good condition (820 feet downstream of intake)

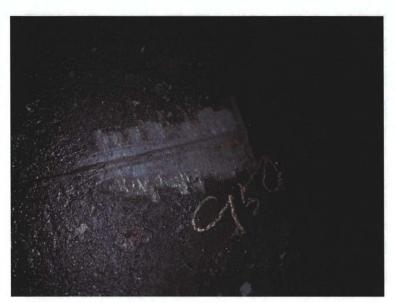
Photo 16 - Longitudinal weld in good condition (950 feet downstream of intake)

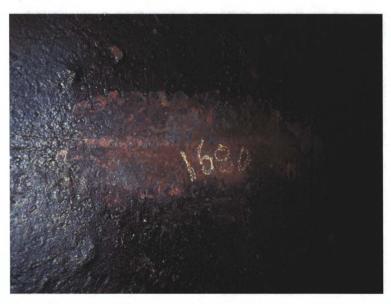
Photo 17 - Longitudinal weld in good condition (1680 feet downstream of intake)

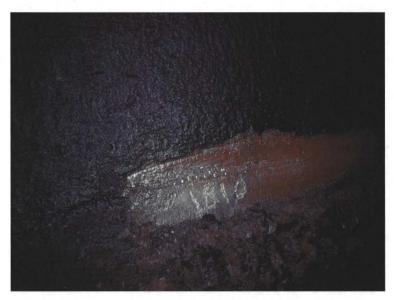
Photo 18 - Longitudinal weld in good condition (1810 feet downstream of intake)

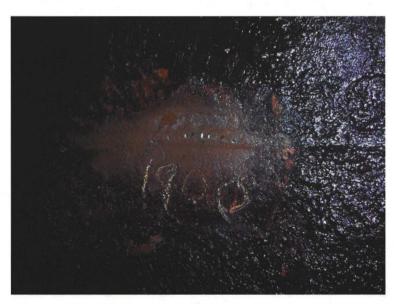
Photo 19 - Longitudinal weld in good condition (1900 feet downstream of intake)

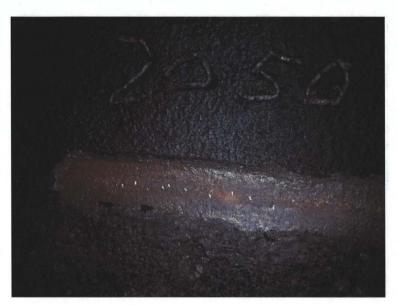
Photo 20 - Longitudinal weld in good condition (2050 feet downstream of intake)

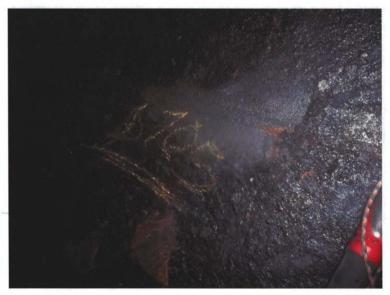
Photo 21 - Longitudinal weld in good condition (705 feet downstream of surge tank)

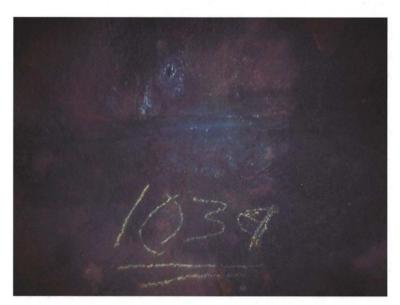
Photo 22 - Longitudinal weld in good condition (1039 feet downstream of surge tank)

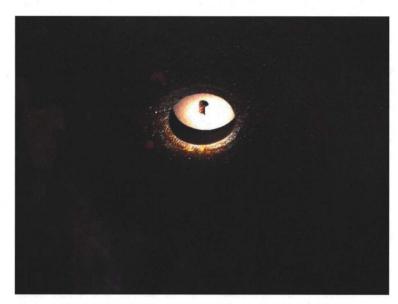
The manholes were in fair condition with moderate corrosion of the interior surface of the manhole. The bottom plate was missing, Photo 23, at the unopened manhole approximately midway between the intake and surge tank (approximately STA 12+22 (CH 370.3)). The manhole at the surge tank was at approximately STA 22+20 (CH 672.7) and the opened manhole in the lower section was approximately at STA 33+10 (1003.0).

Photo 23 - Missing manhole plate midway between intake and surge tank

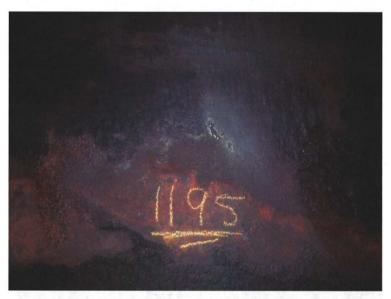
Photo 25 - Typical coating condition (1195 feet downstream of surge tank)

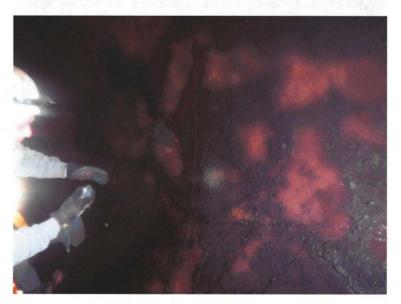
Photo 26 - Missing coating in bifurcation

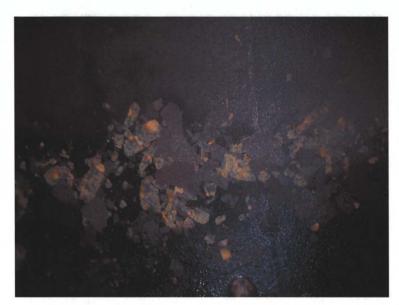
Photo 27 - Coating flaked off sitting on penstock invert (various locations in penstock)

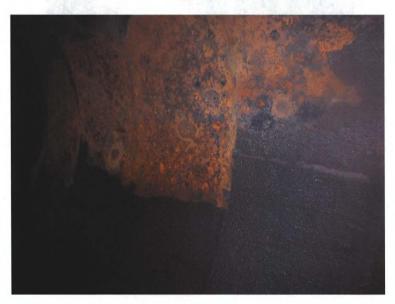
There was evidence of localized delamination throughout the penstock and at the bifurcation (Photo 5, Photo 28 and Photo 29). At STA 1+93 (CH 58.5), the coating begins to deteriorate and is more pronounced on the left from invert to about two-thirds of the diameter. At STA 2+64 (CH 80) there is fresh coating loss and at STA 4+77 (CH 144.5) there is a patch on the ceiling. The amount of delamination may be due to temperature and weather conditions during application (if field applied) and potential scour at changes of elevation of the penstock.

Photo 28 - Delaminated layers (coating likely) in bifurcation upstream of scroll case

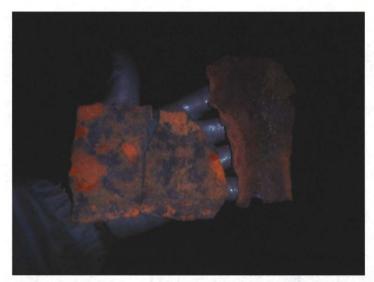
Photo 29 - Delaminated layers in scroll case

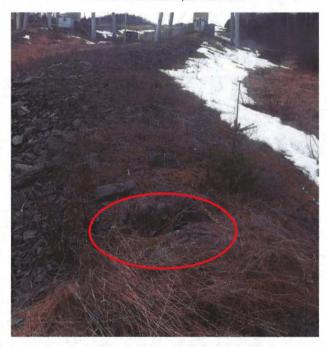
NL Hydro personnel excavated holes in designated areas around the crown of the penstock to expose the steel. Typical exterior shell conditions can be seen in Photo 2. The coating was examined and steel thickness measurements were taken at the exterior locations. The depth of cover varied from several inches to over several feet. The location of the holes was estimated from the drawings and is shown in Appendix A. Drainage for the penstock is important to maintain support for the penstock and should be repaired. Excessive ground water can erode support for the penstock and potential increase the potential of failures. Drainage also gives a method to monitor potential leakage. The broken culvert appears to have separated at joint. The culvert is shown in Photo 30.

Photo 30 - Damaged culvert

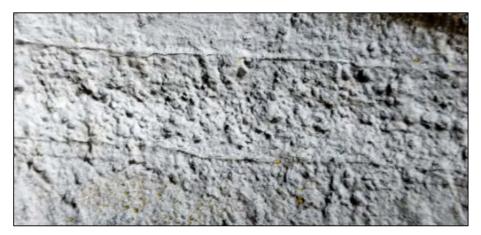
Figure 2-1: Can 239

Downstream of the Surge Tank, Can 239 (reducer of 15'-3" diameter to 13'-6", plate thickness ~20.64 mm) was inspected and found to be in better condition than that upstream of the Surge Tank; however, there were scattered linear indications detected. These shallow indications had a depth of 2-3 mm, ranging in length from 25-100 mm. Given the thickness of the plate in this area, this metal loss is substantially less than that observed upstream of the Surge Tank. Samples of indications from Can 239 are shown in Figure 2-1 below.

Pitting corrosion and shallow indications were observed during the condition assessment in several regions of the penstock where the welds were not fully refurbished. It is expected that the minor indications observed provide a representative sampling of the inspected areas, and that other such minor indications are probable in areas which were not fully inspected. It is Hatch's opinion these defects do not present a substantial risk of failure within the next several years and that emergency repairs for these two areas are not warranted at this time. Understanding that a penstock refurbishment project is planned for execution in the next three years, these sections should be inspected annually until this refurbishment is completed. Any further deterioration of these welds should be carefully investigated to determine if immediate weld refurbishment is required.

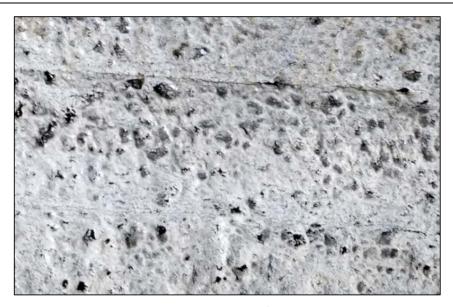
Figure 2-2: Can 362

Downstream of elbow No. 8C, Can 362 was noted to also have scattered shallow linear indications of length 25-75 mm, shown in Figure 2-2 below. This weld seam is in better relative condition with minor pitting.

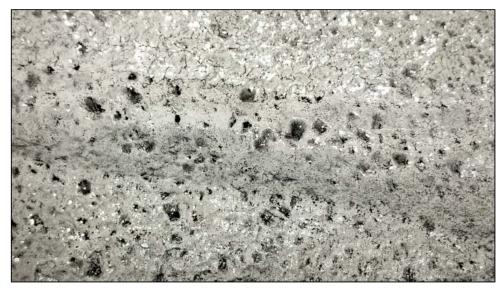
Figure 2-3: Can 389

Figure 2-3 shows Can 389 as a general representation of weld quality in the area, with better relative condition and no detectable indications, showing some pitting corrosion (uniformly distributed between the base metal and weld metal).

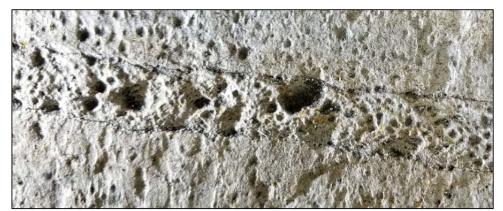
Figure 3-1: Can 29

For comparison, Figure 3-1 and 3-2 show portions of the longitudinal seams of the 17' diameter penstock section upstream of the Surge Tank, closer to the intake. This section of the penstock has a plate thickness of approximately 11mm. During the weld refurbishment works the cracking in this section was determined to have an average 4-5 mm depth, which corresponds to 36-45% of the plate thickness. One seam (Can 116) was noted to have cracking to a depth of approximately 8mm (72.7% of the plate thickness). The condition of these longitudinal weld seams show significant corrosion of the welds in the form of pitting and preferential corrosion of the weld metal and heat affected zone (HAZ). With the loss of weld metal, the weld to base metal interface has a notch with a depth of approximately 2-3 mm and visible cracking in this area.

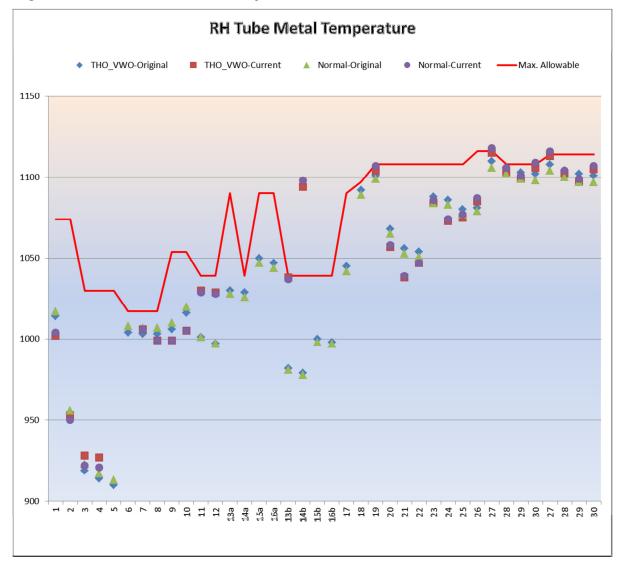
Figure 4.1 Reheater Metal Temperatures

Figures 4.1 to 4.3 illustrate the tube metal temperature behavior for the reheater, secondary superheater, and primary superheater. A review of predicted performance data after the reheater modification indicates that several tube metal temperatures exceed the original maximum allowable temperature for the given tube material and thickness. The tube rows in question are as follows:

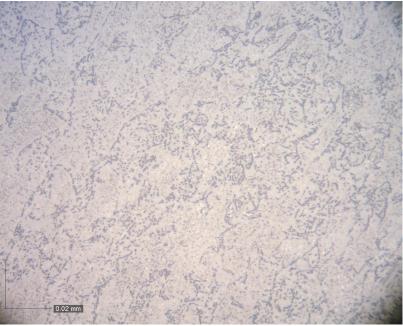
Figure 1: Representative Microstructure of Lower Reheat Tube #1 from the East at Lower West Side of Bend at South End. Microstructure Consists of Spherical Carbide Particles Fairly Evenly Distributed Throughout a Matrix of Ferrite Grains. Some Carbides Have Begun to Migrate to the Ferrite Grain Boundaries.

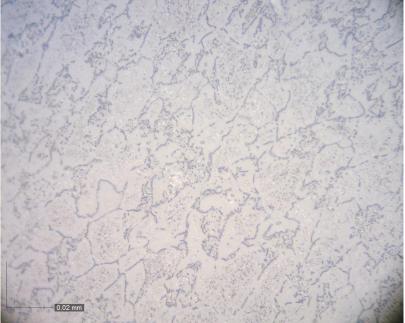
Figure 2: Representative Microstructure of Lower Reheat Tube #19 from the East at Bottom of Bend at South End. Microstructure Consists of Spherical Carbide Particles Fairly Evenly Distributed Throughout a Matrix of Ferrite Grains. Some Carbides Have Begun to Migrate to the Ferrite Grain Boundaries.

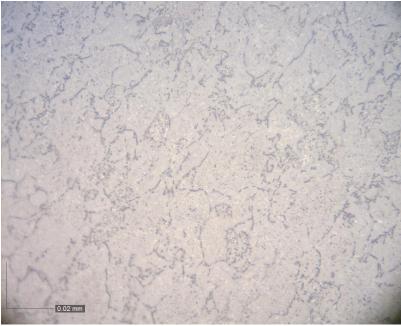
Figure 3: Representative Microstructure of Lower Reheat Tube #43 from the East at Bottom of Bend at South End. Microstructure Consists of Spherical Carbide Particles Fairly Evenly Distributed Throughout a Matrix of Ferrite Grains. Some Carbides Have Begun to Migrate to the Ferrite Grain Boundaries.

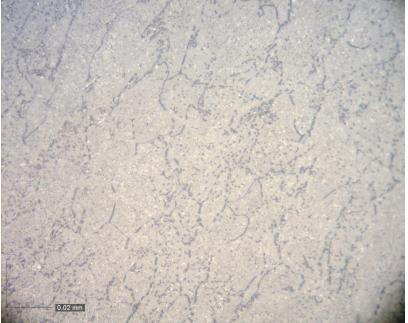
Figure 4: Representative Microstructure of Lower Reheat Tube #60 from the East at Lower East Side of Bend at South End. Microstructure Consists of Spherical Carbide Particles Fairly Evenly Distributed Throughout a Matrix of Ferrite Grains. Again, Some Carbides Have Begun to Migrate to the Ferrite Grain Boundaries.

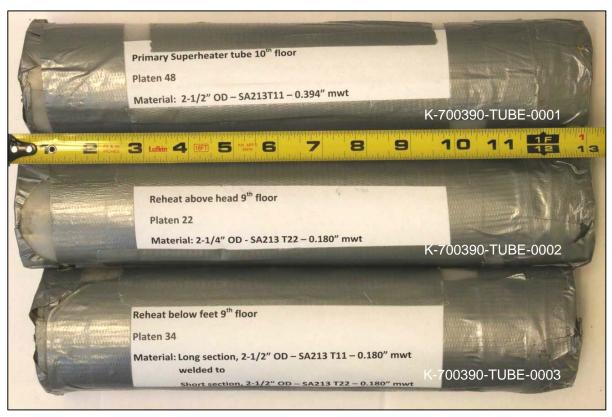
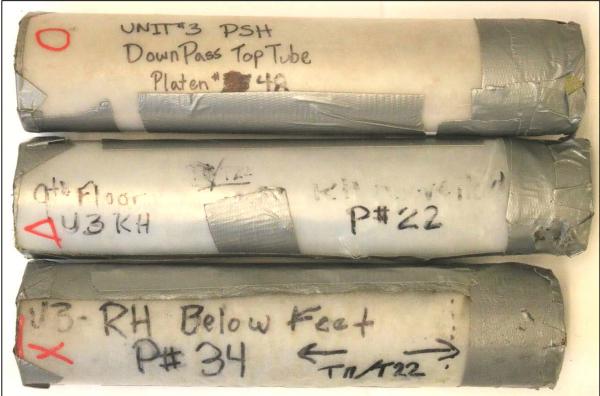
Figure 1. As-received photographs of three N&LP Holyrood Unit 3 boiler tube samples.

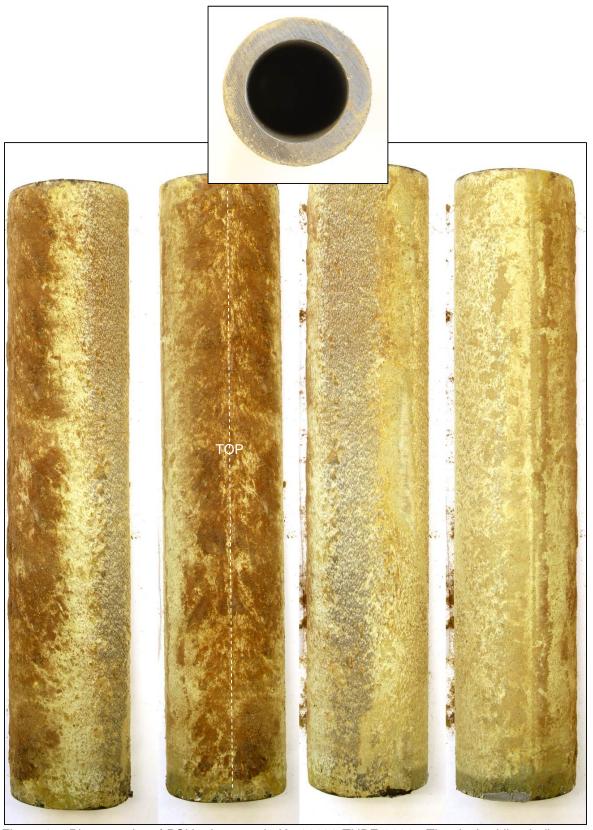
Figure 2. Photographs of PSH tube sample K-700390-TUBE-0001. The dashed line indicates the top of the tube.

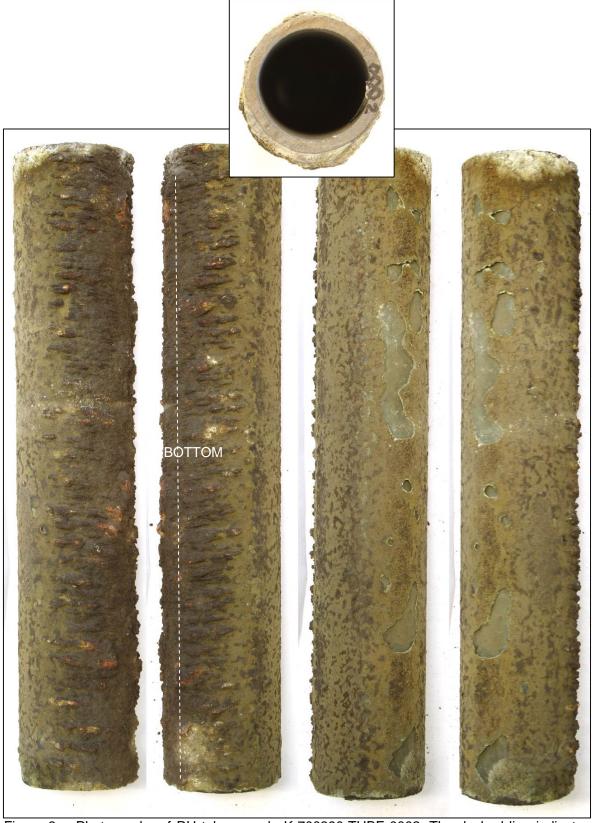
Figure 3. Photographs of RH tube sample K-700390-TUBE-0002. The dashed line indicates the bottom of the tube.

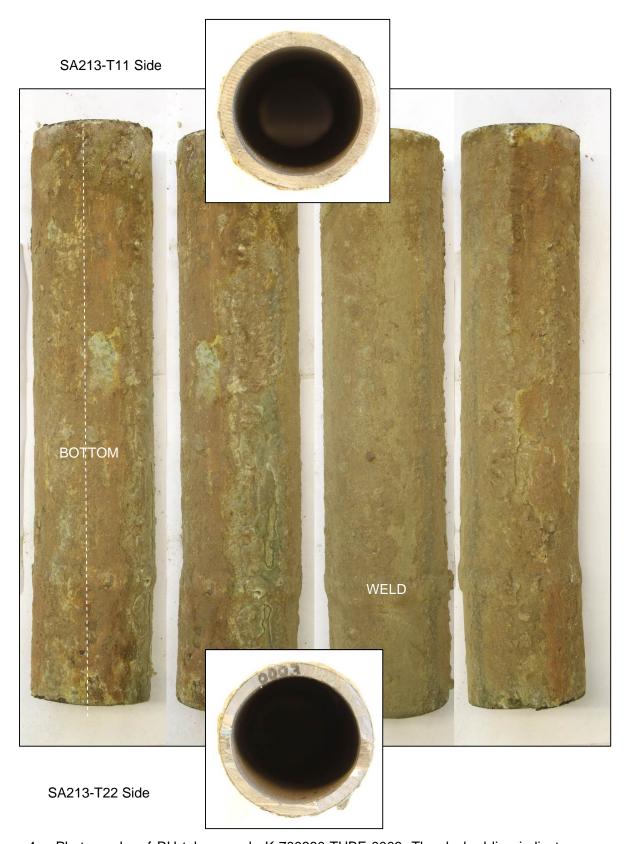
Figure 4. Photographs of RH tube sample K-700390-TUBE-0003. The dashed line indicates the bottom of the tube.

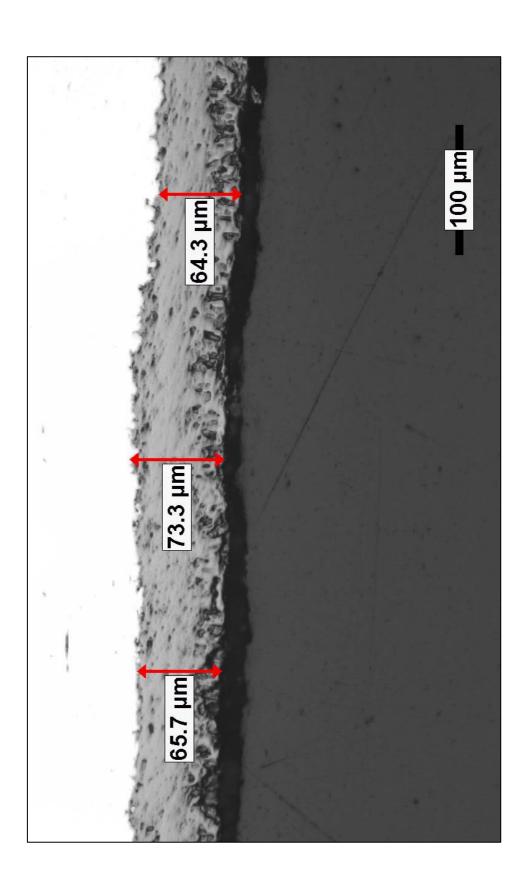
Figure 11. Representative optical micrograph of the ID oxide layer on K-700390-TUBE-0001 at 270°.

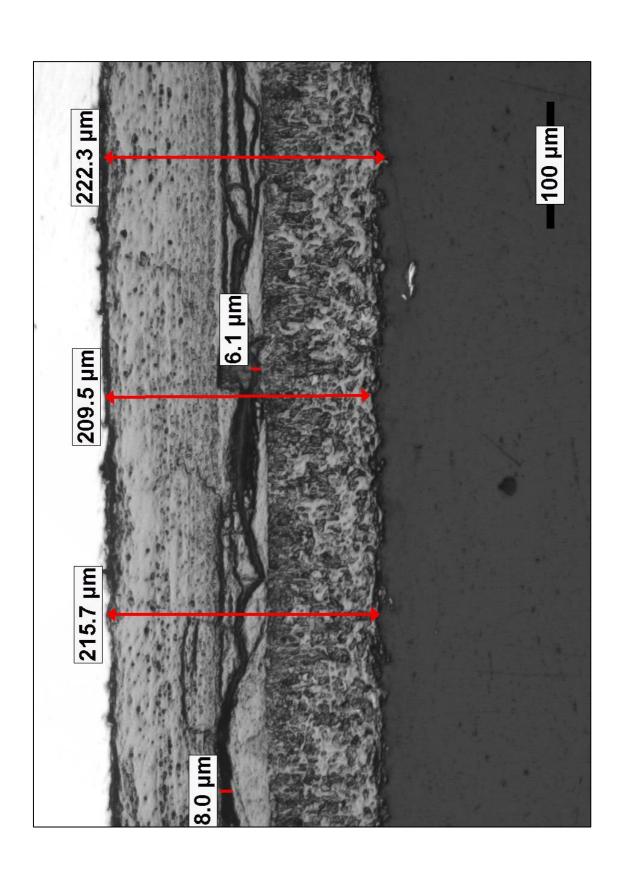
Figure 12. Representative optical micrograph of the ID oxide layer on K-700390-TUBE-0002 at 90°.

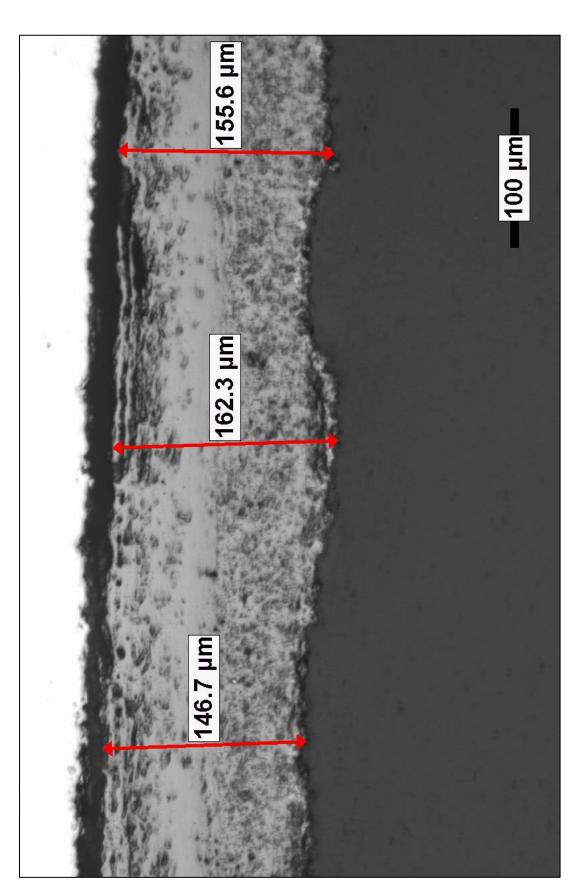
Figure 13. Representative optical micrograph of the ID oxide layer on K-700390-TUBE-0003 at 90°.

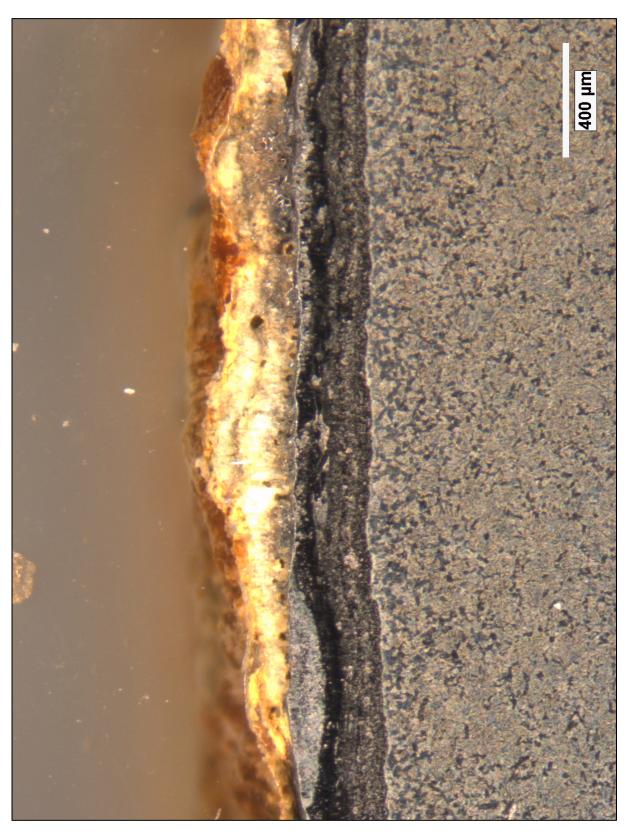
Representative optical micrographs of the oil ash deposits on each of the three tube sections are presented in Figures 14 to 16. These images reveal the multi-layered nature of the OD surface deposits.

Figure 14. Optical micrograph of the OD oil ash deposit layer on K-700390-TUBE-0001 at 180°.

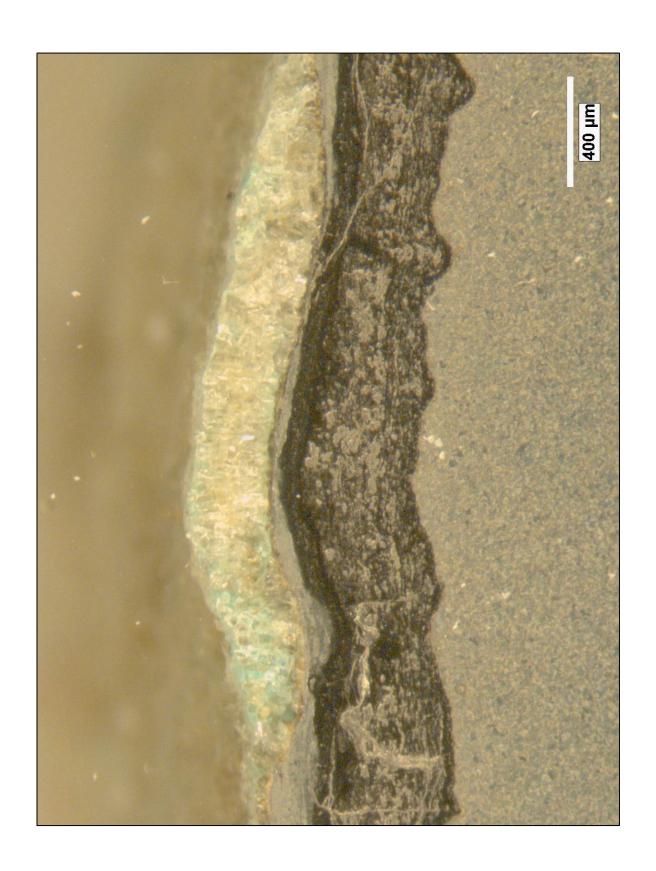
Figure 15. Optical micrograph of the OD oil ash deposit layer on K-700390-TUBE-0002 at 180°.

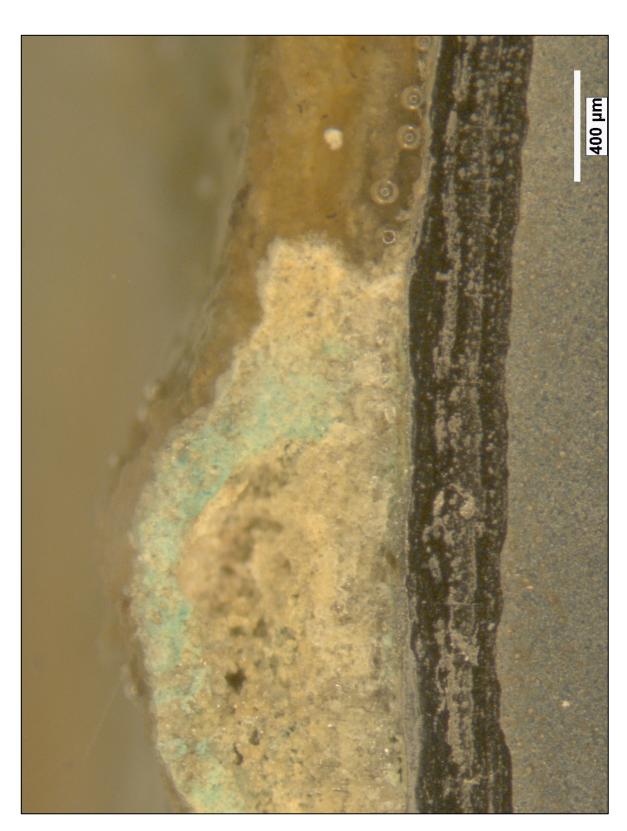
Figure 16. Optical micrograph of the OD oil ash deposit layer on K-700390-TUBE-0003 at 180°.

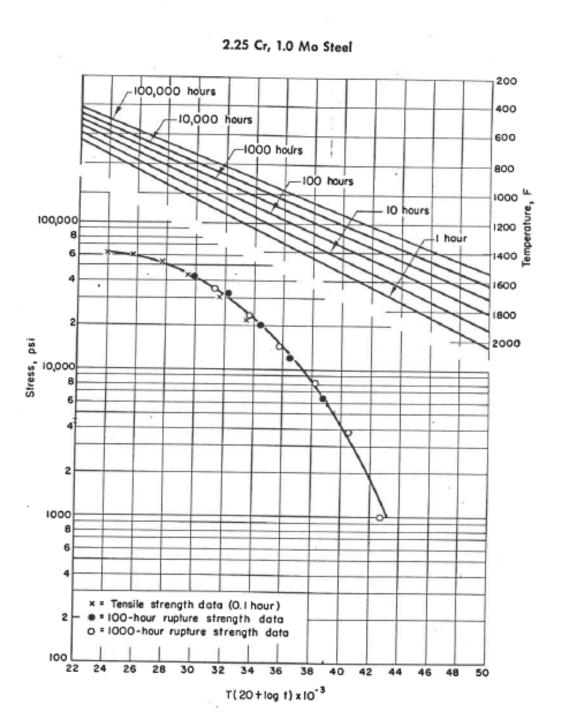
Where  $t_r$  is the creep rupture life, T the temperature in  ${}^{\circ}R$  and the LMP value is stress-dependent. A representative Larsen-Miller plot for 2-1/4Cr-1Mo (T22) steel is given in Figure 21.

Figure 21. Variation of Larson-Miller stress rupture parameter for 2-1/4Cr-1Mo (T22) steel [10].

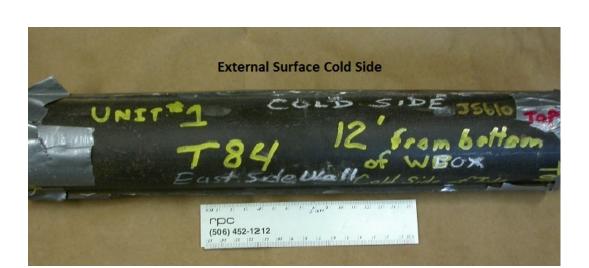
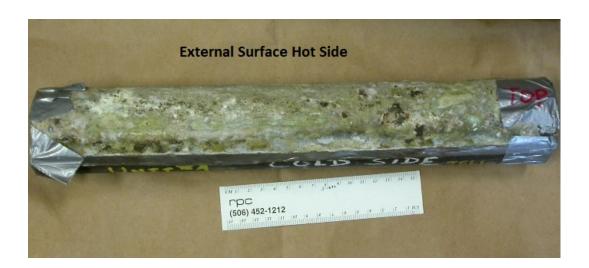
Figure 1. The top photograph shows the external surface on the cold while the bottom photograph the hot side of the waterwall tube section. The cold side has a thin mill scale and the hot side is covered with grayish white deposits. The external surface has been marked as Unit #1, east side wall, 12' from the bottom of w. box.

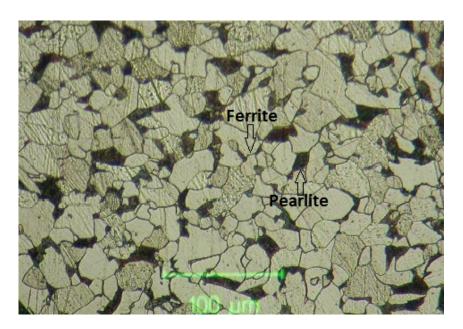
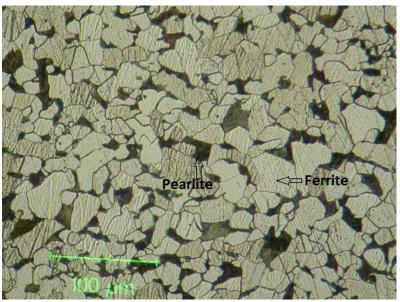
Photomicrographs from the cross-section prepared through waterwall tube #84. The microstructures on the hot (top) and cold (bottom) sides of the tube are very similar. The microstructure consists of ferrite and lamellar pearlite. Some of the lamellar pearlite colonies are aligned in a banded formation, suggesting that the tubes were hot-worked (e.g. hot-rolled or hot-extruded). The scale bar is in microns.

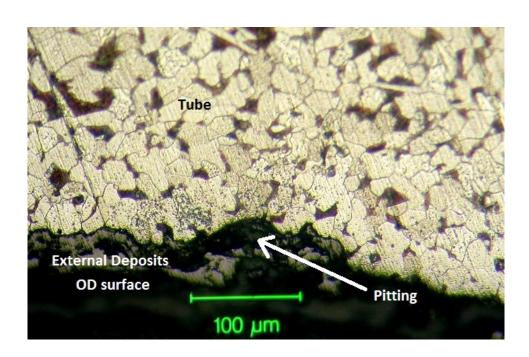
Photomicrograph from the cross-section prepared through waterwall tube #84. The external surface shows an adhered deposit and minor pitting, less than 200 microns deep. The scale bar is in microns.

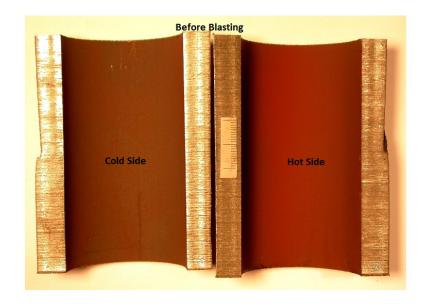
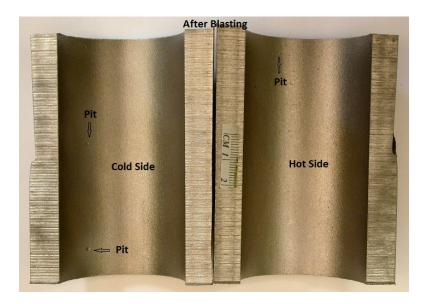
Figure 5. Photographs show the DWD test specimens, one from each of the hot side and cold side, from waterwall tube #84. The photographs show the tube internal surface, prior to testing (top) and after sandblasting clean (bottom). Before the test, the tube interior shows a relatively thin well-adhered oxide deposit all around with no significant spalling of the oxide deposit, as can be seen in the top photograph. After cleaning, minor pitting was noted on both the hot and cold side internal surface of tube #84 (see close-up in Figure 6). Ruler is graduated in millimeters.

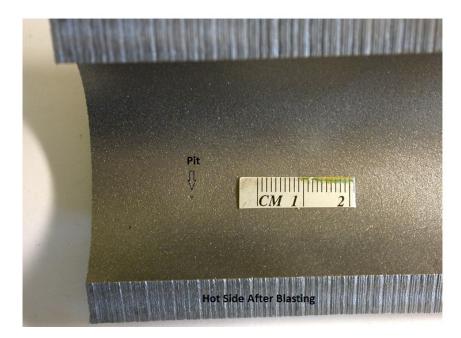
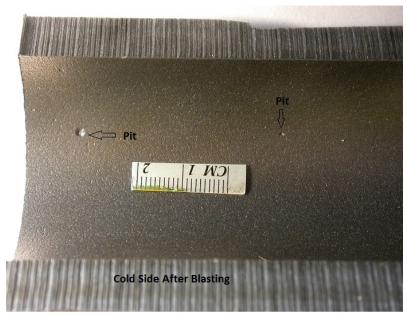
Figure 6. Photographs show the pitting on the tube hot side (top) and cold side (bottom) internal surface, after sandblasting clean. The maximum pit depth on the hot side was measured to be 0.15 mm (0.006 in) and on the cold side was 0.25 mm (0.010 in). Ruler is graduated in millimeters.

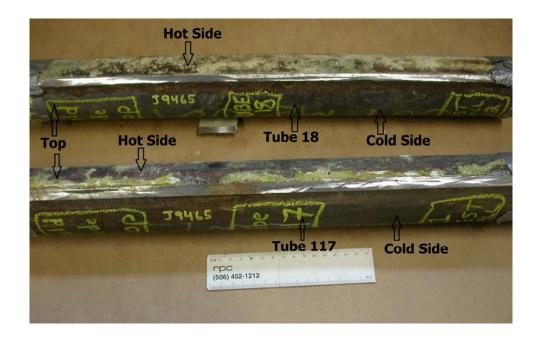
This photograph shows the tube sections (Tubes 117 and 18) received. The hot sides were covered with a heavy accumulation of whitish dark deposits while the cold sides with dark brown deposits on the outside surfaces of the tubes.

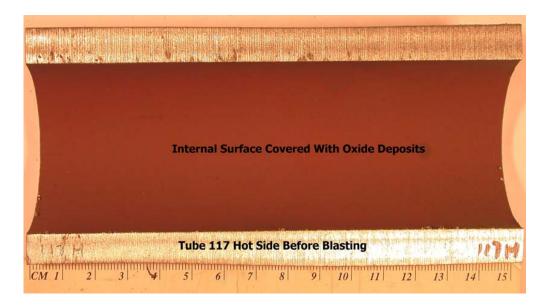
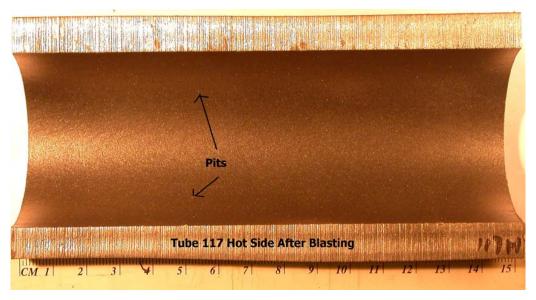
Figure 2. Magnifications: Top 90% full scale, Bottom 90% full scale. Photographs showing the internal surface before (top) and after (bottom) blasting on the hot side of Tube 117. Before blasting the internal surface was covered with oxide deposits. After blasting the oxide deposit layer was removed and a few tiny pits were noted.

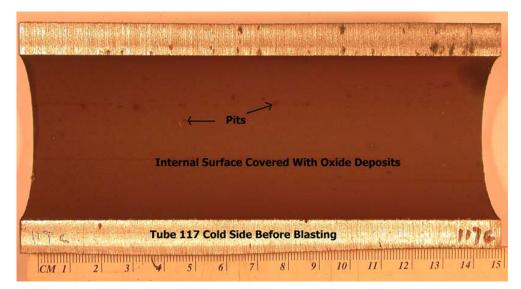
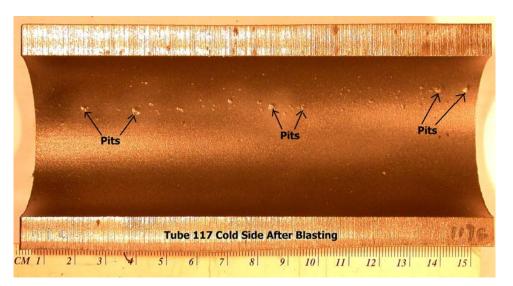
Figure 3. Magnifications: Top 90% full scale, Bottom 85% full scale. Photographs showing the internal surface before (top) and after (bottom) blasting on the cold side of Tube 117. Before blasting the internal surface was covered with oxide deposits and some pits were also noted. After blasting the oxide deposit layer was removed and the pits, which had been noted before blasting, became very clearly seen. It appears that these pits were concentrated in a narrow band along the whole length of the section on the cold side of the tube. The maximum depth of the pitting on this section was measured to be about 0.013" or about 6% of the wall thickness.

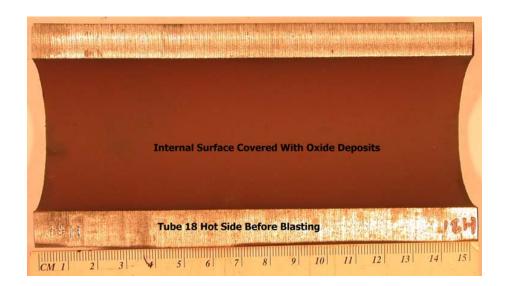
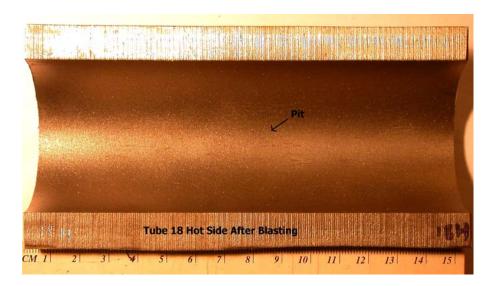
Figure 4. Magnifications: Top 80% full scale, Bottom 80% full scale. Photographs showing the internal surface before (top) and after (bottom) blasting on the hot side of Tube 18. Before blasting the internal surface was covered with oxide deposits. After blasting the oxide deposit layer was removed and a few tiny pits were noted.
