1	Q.	Please	provide copies of reports or other documentation that describe the latest condition			
2		of the following assets and any work completed to date addressing the following issues:				
3						
4		a.	Bay d'Espoir penstocks;			
5						
6		b.	Hinds Lake rotor resistance;			
7						
8		С.	Granite Canal control system;			
9						
LO		d.	Upper Salmon rotor rim cracking;			
11						
12		e.	Hinds Lake bearing coolers;			
13						
<b>L</b> 4		f.	Cat Arm spherical control valves;			
15						
16		g.	Hardwoods combustion can failures;			
<b>L</b> 7						
18		h.	Hardwoods bellows failures/cracking;			
19						
20		i.	Holyrood boiler tube issue, variable frequency drive issues, air flow limitations,			
21			hydraulic fluid issues;			
22						
23		j.	Stephenville vibration issues;			
24						
25		k.	Hardwoods combustion can failures;			
26						
27		l.	Hardwoods bellows cracking issue;			
28						
29		m.	All Holyrood boiler tube failure studies;

1		n. All "Quarterly Report on Performance of Generating Units" reports; and
2		
3		o. Exploits frazil ice issues.
4		
5		
6	A.	The reports referenced below provide an overview of the latest condition of the asset(s)
7		and any work completed to

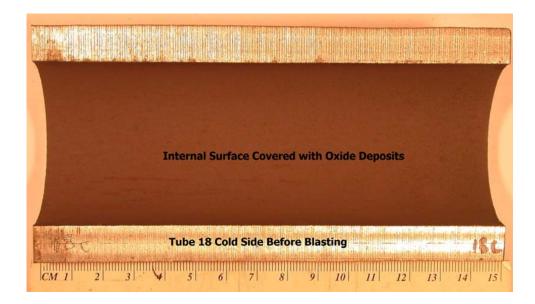
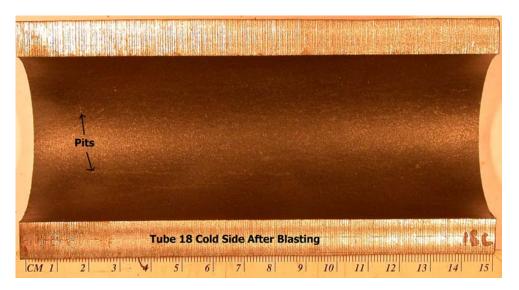
Figure 5. Magnifications: Top 85% full scale, Bottom 85% full scale. Photograph showing the internal surface before (top) and after (bottom) blasting on the cold side of Tube 18. Before blasting the internal surface was covered with oxide deposits. After blasting the deposit layer was removed and a few tiny pits were seen.

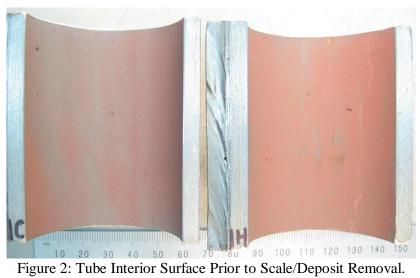
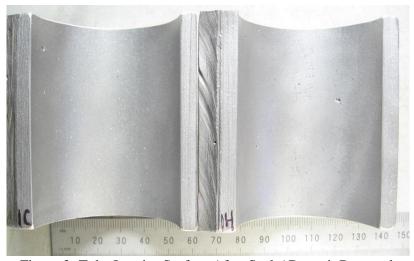
Figure 3: Tube Interior Surface After Scale/ Deposit Removal.

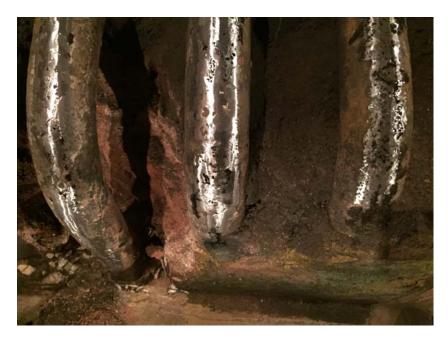
**Photo #1:** Image of every other antler tube having a bend. The bends have thinning close to 70% of remaining wall on the extrados in the cleaned areas.

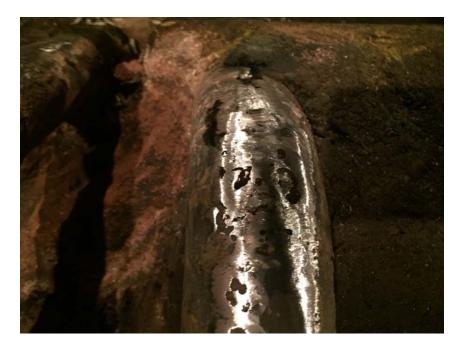
**Photo #2:** Image shows OD pits on some of the antler tube bends are deeper than the cleaned areas, now less than 70% remaining wall.

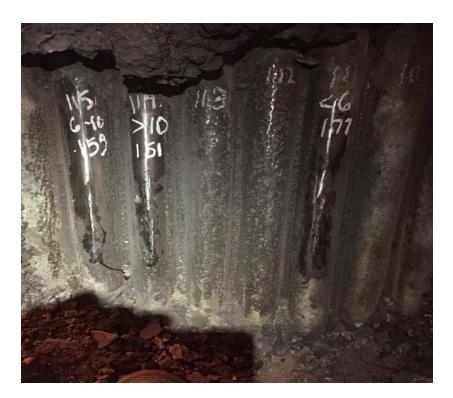
**Photo #3:** Image shows front side of lower slope tubes approximately 4 ft. above the leak area. Three are cleaned for UTT scanning.

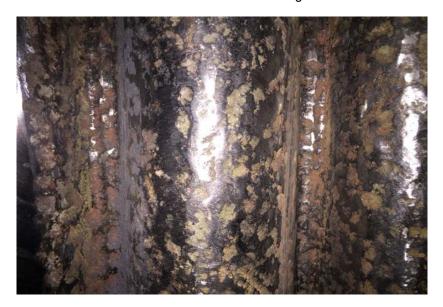
**Photo #4:** Images of pitting on the same tubes. Tubes have been exposed to oil ash deposits for extended periods. The pitting is active.

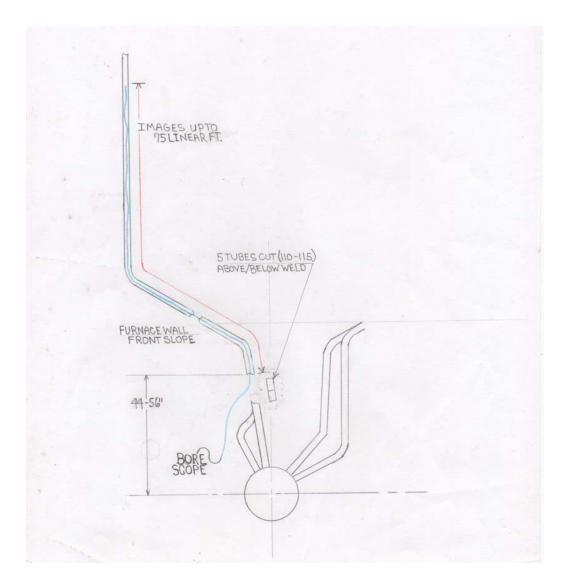
Shows Remote Video Scope access to view tube IDs from failed tube area. The Blue represents the probe with camera lens. The scope was pushed into the tubes on a best effort basis as far as the crew could get it. It went just over 75 linear feet up the front wall on one of the tubes, and between 50 to 60 linear feet into the other 4 cut tubes.

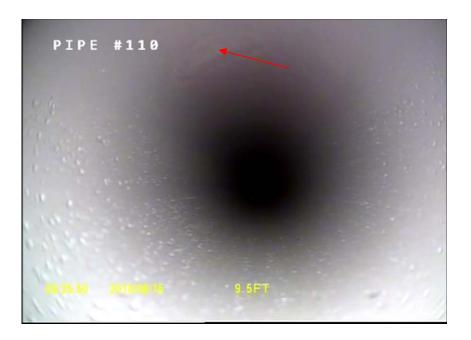
**Photo #5:** View of corrosion formation on the hot side of the tube.

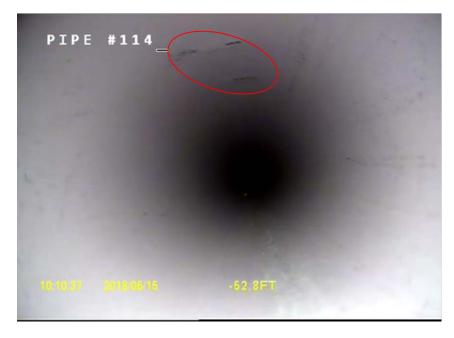
**Photo #6:** Image of hot side deposit beginning to exfoliate. Could be similar corrosion as in Photo # 5 above. This tube has an additional layer of deposits possibly resulting in under-deposit corrosion.

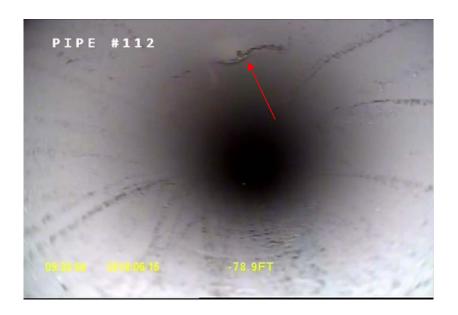
**Photo #7:** View of hot side of tube exfoliation. Approximately one (1) foot in from transition weld.

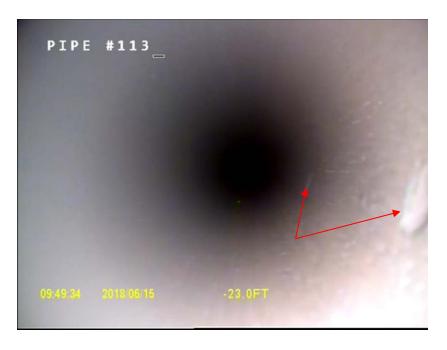
**Photo #8:** View of deep pitting approximately 37 feet into the tube (In the burner area).

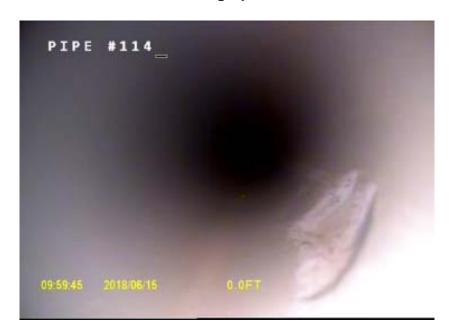
**Photo #9:** Image is a pit in a smooth layer of deposit.

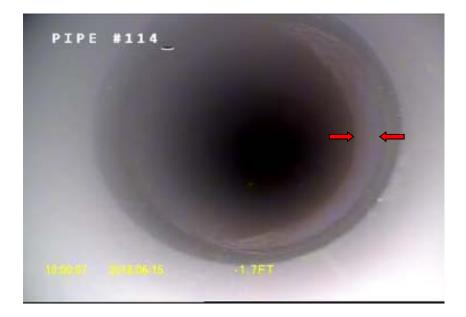
**Photo #10:** Image of deposit layer. It doesn't take much of a slope or offset to collect layers of deposits, affecting flow and heat transfer.

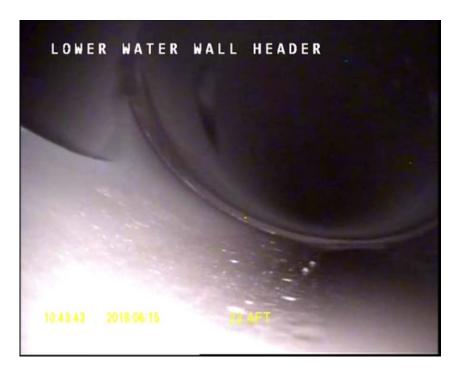
**Photo #11:** Header Girth with weld ring taken from 22 feet in.

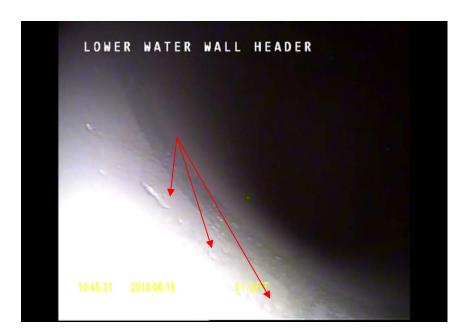
**Photo #12:** Minor pitting surrounds drain.

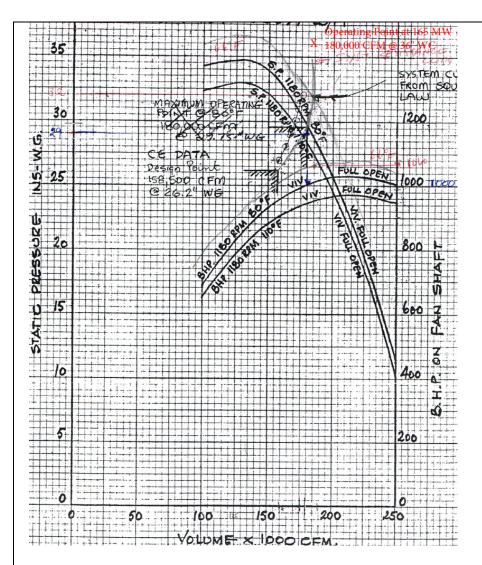
Fan Curve for Unit 2 FD fans (2)

**Discussion** – Centrifugal fans are fixed volume devices that are limited by the static pressure or back pressure in the system they are discharging into. The fan curve on the next page illustrates that as the static pressure increases, the fan capacity decreases. The design point for full load operation is 158,500 CFM at 26.2" of water. The illustrated system curve shows that as the system static pressure increases above about 30 " of water, further increases in static pressure will not result in any significant increase in air flow. Testing at high loads demonstrated a fan discharge pressure in the range of 32 to over 36" of water. In order to get more air to the boiler to increase steam generation, the system static pressure must be reduced.

Higher than normal pressure drops were measured across the steam coil air heaters, the air side of the Ljungstrom air heaters, the boiler furnace, the economizer and the gas side of the Ljungstrom air heaters. These high pressure drops have to be a result of either higher than normal flows, or flow restrictions of some kind. Each one of these possibilities will be discussed individually.

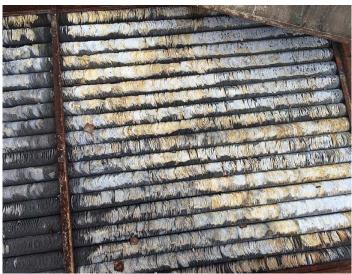
Steam coil air heaters are located at the outlet of the FD fan under the Ljungstrom air heaters. These steam coils preheat the incoming combustion air to protect the Ljungstrom air heater and breaching to the stack from corrosion. These heaters consist of banks of 1" OD tubes with 2 ¼" OD aluminium fins on them to enhance heat transfer. Over the years, these light gauge fins can be bent and deformed which will restrict air flow through the elements. Additionally, debris drawn in by the fans and material carried through from off line cleaning can plug off the air passages between the tight spaced fins further restricting air flow.

Damaged Fins in Steam Coil Air Heater - Unit 1

It appears that all of the above areas are contributing to the air flow issues on the boiler. (See tables in appendix 1) Differential pressures across all of these components point to signs of plugging and restriction. Every effort should be made to ensure the air heaters, economizer and superheater and reheater gas lanes are clean in unit 1 before it returns to service.

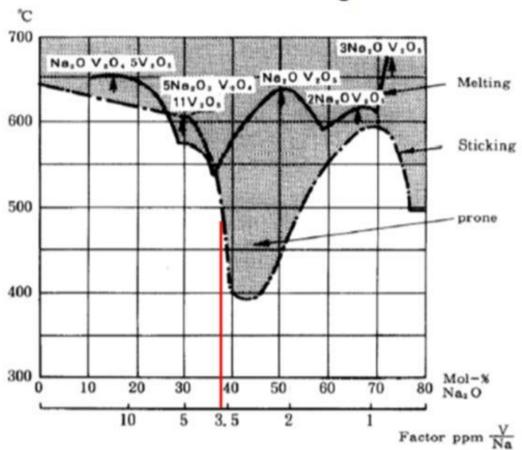
### Figure 5 V / Na Eutectic Diagram

e) Indeed, as is shown from the red line I have drawn on Fig 5 below, showing the measured Va/Na ratio of 4.0 for the fuel oil, this is in the zone where the report suggests that molten deposits are likely and additive injection would be recommended.

- f) Given the combination of the above factors and the fact that you have reported that some of the deposit has been found to be magnetic, I would hazaerd a guess that, ceasing the use of MgO additives, has promoted vanadium attack in the upper zones of the furnace ausing pregressive corrosion releasing iron scale type deposits that have subsequently found their way ito the APH producing progressive build up and fouling. In that case, on examining the long term fouling over the APH you might find that it would slowly start to progress after a reasonable delay after when additive injection was ceased.
- g) Moreover, given the long term operation of the plant, if this were the main factor that has changed, it must remain the main suspect. (I'm sure I could quote Sherlock Holmes more correctly if I took time to look up the quote. ③)

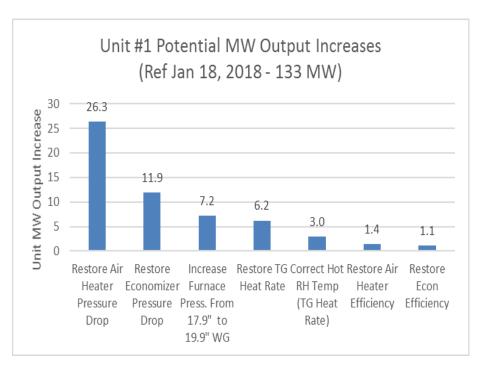
The higher than design air flows are due to underestimation of the combustion air quantity as indicated by the OEM boiler supplier data sheets (Appendix 8.1) and are therefore not considered 'correctable'.

Figure 1 Unit #1 Potential MW Output Increases

If both air heater and economizer pressure drops are restored, the full rated 174.2 MW will be achievable on both units without exceeding the current 20" WG furnace pressure alarm point limit. According to site reports, cleaning of these heating surfaces has proven very difficult in the past. Unless more effective methods can be employed such as chemical cleaning the most effective means of reducing furnace pressure would be to replace the fouled air heater elements. Replacement of economizer surfaces would very likely not be economically viable.

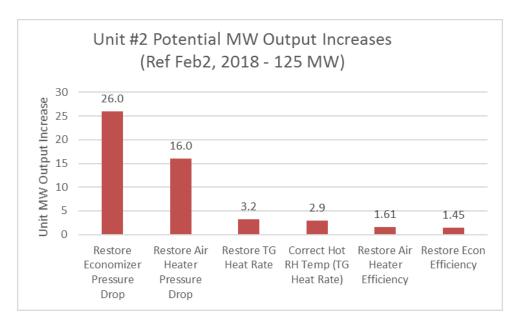
Figure 2 Unit #2 Potential MW Output Increases

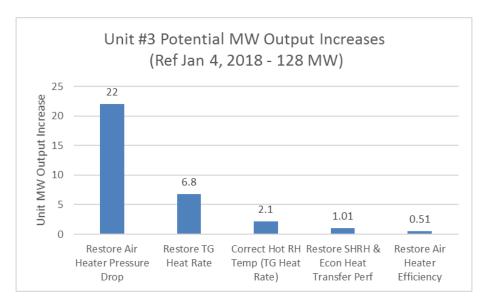
With reference to the Jan 4, 2018 operating point (128 MW), increases in unit load capability as per Figure #3 would be possible for fixed fuel input. The largest contributor to unit efficiency reductions is turbine – generator inefficiencies. The largest boiler related contributor to the increase in unit heat rate is low hot reheat temperature.

Figure 3 Unit #3 Potential MW Output Increases

The required FD fan duty is higher than design primarily due to higher than expected air heater pressure drop and higher than design Unit heat rate (lower than design unit efficiency). Full load operation would be restored given the current FD fan VIV restrictions if the fouled hot end air heater elements are replaced with the proposed "ARVOS" elements and if the existing cold end baskets are clean and in good condition.

The heat transfer effectiveness of the Unit #3 superheater and reheater declined significantly during the time period from Oct 2017 to Jan 2018. These surfaces should be inspected for cleanliness to determine the cause of this decline. Sootblowing patterns and/or blowing pressures may need to be revised to improve cleanliness.

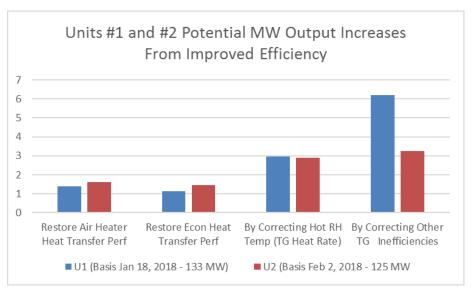
Figure 4 Units #1 and #2 Potential MW Output Increases from Improved Efficiency

A significant portion of the increased T-G heat rate is due to lower than design hot reheat steam temperatures. Unit #2 was operating at 898 F at the turbine in February 2018 leading to a T-G heat rate increase of approximately 1.5%. The reheaters on Units #1 and 2 should be inspected to identify the cause of the performance shortfall.

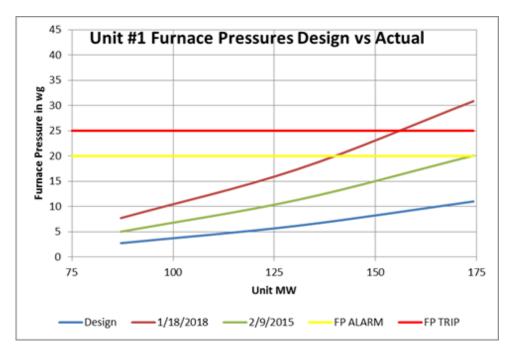
Furnace pressure is driven by the pressure drops of the 'downstream' boiler components. These are the superheater/reheater, economizer, air heater, flues to stack. The predicted and actual pressure drops (i.e. the furnace pressure) for Units #1 and #2 are illustrated in Figures 4 and 5.

Figure 5 Unit #1 Furnace Pressure Design Vs Actual

The original pressure drops were almost doubled at the times when full load was nearly (170 MW) achieved in the 2015/2016 data with furnace pressures approaching the 20" wg alarm. Between that time and 2018, pressure drops increased even further, predominantly due to increases in economizer and regenerative air heater pressure drops. As these pressure drops increased, unit load was restricted in step. It is not known if the pressure drop increases were gradual or associated with particular operating scenarios. A review of all operating data between 2015-2016 and current would be required to reveal trends.

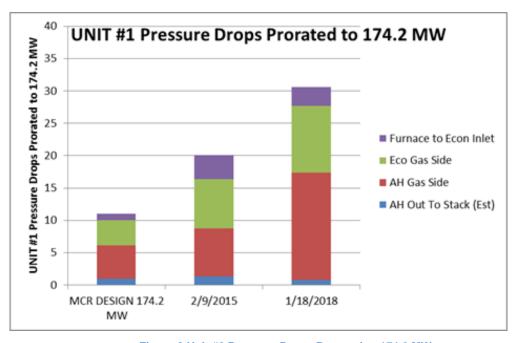
The predicted, 2015/2016, and current flue gas pressure drops by boiler component are shown in Figures 6 and 7. Pressure drops were prorated from actual operating conditions to 174.2 MW for illustration. The 174.2 MW output is not currently achievable on either unit with the current furnace pressure constraint. For Unit #1, the air heater is the largest contributor to current total pressure drop. For Unit #2, the economizer is currently the largest pressure drop contributor.

The superheater and reheater pressure drops are also significantly higher than design, indicating fouling in these components and / or tube misalignment. The magnitude of this contribution to furnace pressure is small relative to the air heater and economizer. Hot reheat temperatures are currently much lower than design, which combined with the high pressure drop suggests that the cleanliness of these surfaces is also poor.

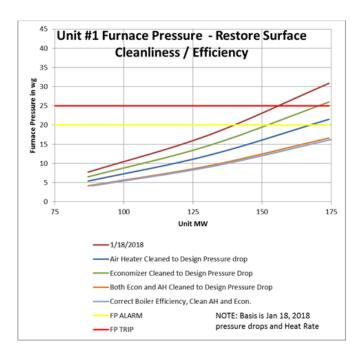
Figure 9 Unit #1 Furnace Pressure - Restore Surface Cleanliness/Efficiency

Figures 8 and 9 illustrate the current load limitations of Units 1 and 2 and the expected increases in load capability if:

- The air heater pressure drops can be restored to original design
- The economizer pressure drops can be restored to original design
- Both air heater and economizer pressure drops are restored to original design
- Both air heater and economizer pressure drops and boiler efficiency restored to original design. (Reduced stack temperature will be associated with cleaner surfaces)

If cleaning air heater surfaces is not possible, replacement of heating surfaces which are fouled would restore air heater pressure drop.

Replacement of economizer surface is likely not economically viable if conventional cleaning methods are ineffective. Other methods of cleaning such as the use of explosives or acoustic shock methods (Shock pulse) should be considered.

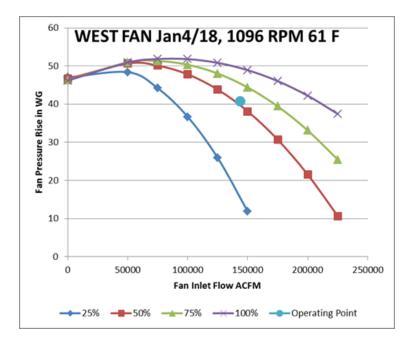
Figure 11 West FD Fan Jan 4/18 Unit #3

The combination of turbine heat rate increases, boiler efficiency reduction, air heater leakage, and higher than design combustion system excess air increase the required airflows as discussed above. The increased flows inherently increase the system pressure drop by approximately 26% relative to the original design. Pressure drop increases of a similar magnitude are observed due to changes in flow path resistance, such as dampers throttled, burner air register settings, boiler convection pass and air heater fouling. The expected performance for each fan as operating on Jan 4, 2018 is illustrated in Figures 10 and 11. The curves are based on the original Sheldons Eng. fan curve (Ref Appendix 8.5), corrected for inlet air density and fan RPM.

Under the Jan. 4, 2018 operating conditions, the FD fans would have been capable of delivering the required air flow to the unit if operated at the rated 1150 RPM and 100 % VIV opening. On that day, the fan speed was limited to approximately 1080 RPM and the VIV's were in the 54%/70% east/west position with the unit at 128 MW. The required fan duty to make 150 MW per the Jan 4 data is illustrated in Figure 12. This curve is based on the original Sheldons fan curve. A correction was required for lower than design inlet air temperature (Sheldons Fan Curve temperature basis was 105 F).

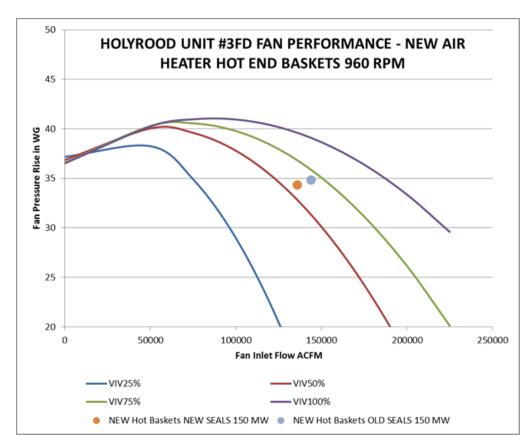
Figure 14 FD Fan Performance - New ARVOS Air Heater Hot End Elements Unit #3

Figure 13 illustrates the estimated fan operating points @ 960 RPM with the proposed air heater upgrades.

- Air Heater Outlet plenum pressure setpoint reduced due to reduced air heater pressure drop
- There is a savings in fan power as shown (estimated) in Table 13.

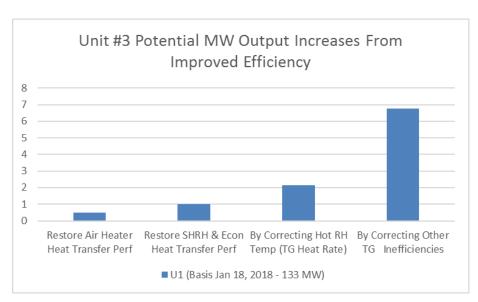
Figure 15 Unit #3 Potential MW Output Increase from Improved Efficiency

As discussed above, the major deficiencies in the Unit #2 performance as they affect efficiency as based on the January 2018 data are the higher than expected Turbine-Generator heat rate and reheat cleanliness / hot reheat temperature. The low heat transfer effectiveness of the superheater and reheater surfaces is not a major factor in terms of boiler efficiency due to the relatively good thermal performance of the air heaters and economizers. The significant reduction in superheater and reheater Kf values should be investigated i.e. the surfaces should be inspected for cleanliness. Increases in sootblowing frequency and/or blowing pressures may be necessary to maintain cleanliness of these surfaces.

Figure 14 illustrates the additional unit output that that would be expected if the boiler and T-G inefficiencies are corrected.

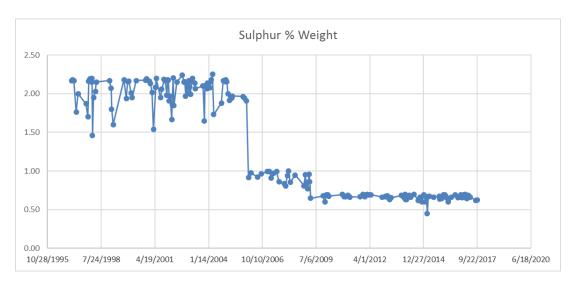
Figure 16 Fuel Oil Sulphur % by Wt. (1995-2017)

The fuel oil analysis data in the NLH supplied spreadsheet database was reviewed. From a combustion and heating value standpoint, the fuel analysis in recent years is very close to the Unit #3 original design fuel. Combustion calculations were therefore based on the Unit #3 design fuel. The Sulphur content has been consistently below 1% since early 2009 per Figure 15. The Vanadium (V2O) content dropped significantly in late 2005 and is currently consistently less than 50 ppm per Figure 16. Overall the fuels currently burned are better than 'typical' Bunker fuels with lower than normal levels of both Sulphur and Vanadium.

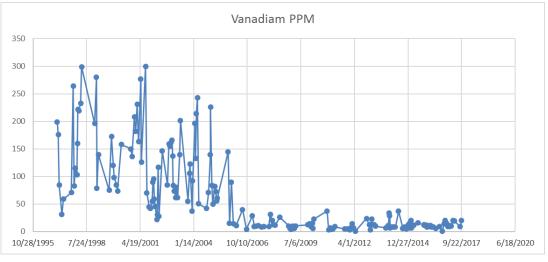
Figure 17 Fuel Oil Vanadium PPM (1995-2017)

Interactions of Vanadium, SO<sub>2</sub> / SO<sub>3</sub>, and unburned carbon in the products of combustion lead to air heater fouling. These deposits can block the flue gas passages on air heater heating surfaces, increasing pressure drop and reducing heat transfer effectiveness. Finned tube economizers may also be affected during start-up and very low load operation. Unburned carbon is the largest component of these deposits and it is typically highest during start-up and low load operation.

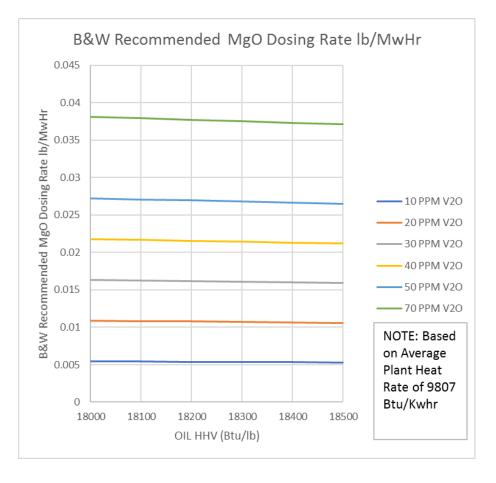
Figure 21 B&W Recommended MgO Dosing Rate lb/Mwhr

Fuel oil additives reduce the potential for high temperature corrosion and low temperature fouling due to the fuel oil Vanadium. These issues are linked to the catalysing effect of Vanadium on high temperature tube metal corrosion and on the conversion of SO2 to SO3. MgO added to the fuel stream is effective in reducing these effects. B&W recommends a minimum dosing rate of 1 lb MgO per lb V2O in the fuel oil to reduce the potential for both corrosion and fouling. Figure 20 illustrates this recommended dosing rate per unit MWhr output based on an average unit heat rate of 9807 Btu/Kwhr. If a higher dosage rate is recommended by the supplier of the additive due to the specific composition of his additive package, the higher recommended dosage rate should be implemented.

NLH discontinued the use of the plant fuel oil additive system in 2014. The decision to take the system out of service may have been based on the improved fuel quality in 2006 and 2009. Load limitations started to occur in 2015 and 2016 on Unit #1 and #2 respectively and 2017 on Unit #3. No significant changes are seen in the fuel analysis between 2009 and 2015. With no other apparent changes in operating conditions, the MgO system was most likely reducing the tendency towards fouling of the air heater surfaces. It is recommended that the MgO dosing system is returned to service.

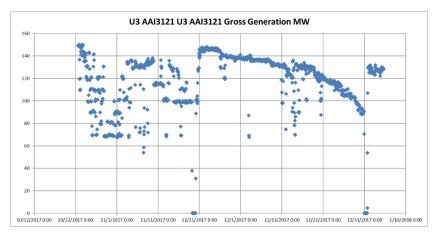
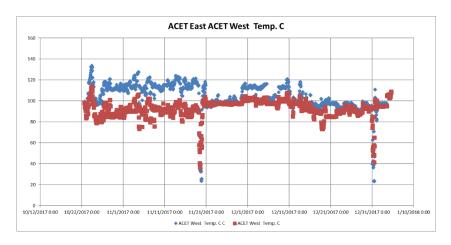
Figure 24 Air Heater ACET Oct 2017- Jan 2018 Unit 3

Gaps in the chart data correspond to times when unit was off line or the differential pressure measurement was not available. The most rapid rise in differential index was during the November operating time frame. During this time period the unit operated for significant periods at loads less than 100 MW. The ACET for the west air heater was significantly lower than the east side, often dropping to as low as 80 C (176 F). The B&W recommended minimum ACET for regenerative air heaters on oil fired units is 190 F (88C). Although the operating ACET was not significantly lower than recommended there is a correlation between low ACET and increased draft loss.

Air heater differential pressure measurements were not available from mid December until a short shutdown on December 31 as the economizer gas outlet gas pressure transmitter appeared to be malfunctioning (Pegged?). During this time period, load dropped rapidly and the ACET's were at even lower levels. This further suggests that low ACET is leading to high rates of air heater pressure drop increase. Note that the air heater differential did not increase during the period from Nov 21 to mid December when the ACET was maintained above 100 C and unit load was above 140 MW. Based on this, a minimum 100 C (212 F) ACET target is recommended.

Figure 21 shows a significant drop in the differential index on or about November 20 and another on December 31, suggesting that the air heaters were washed at that time.

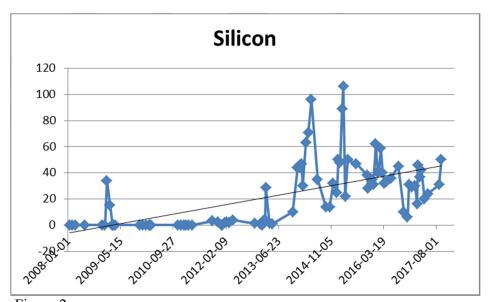
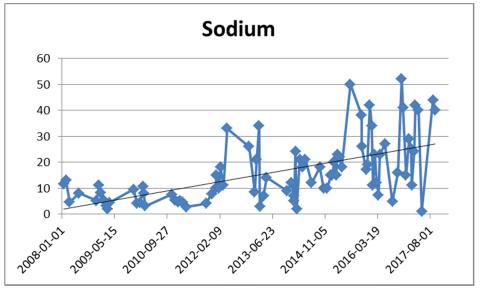
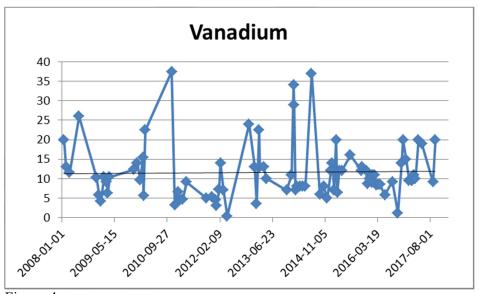
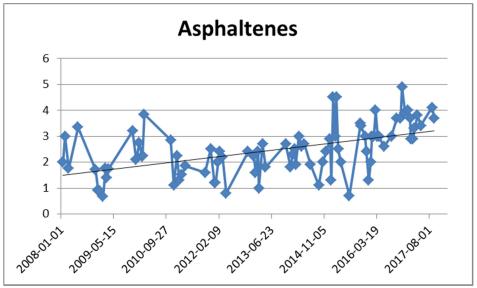
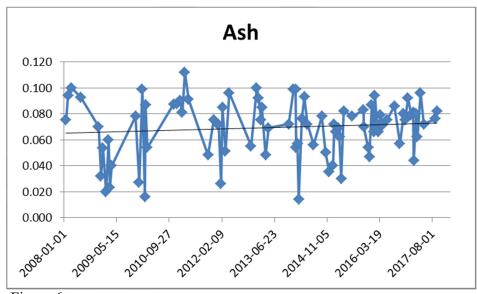
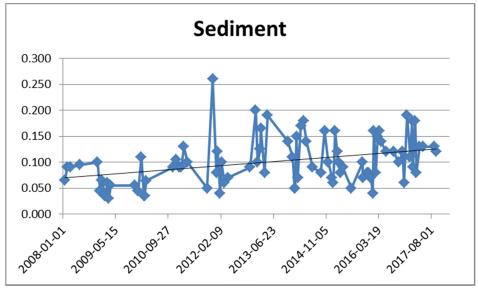
As the primary cause of unit deratings appears to be boiler fouling, fuel quality is an important consideration. Fuel analysis for deliveries between January 2008 and December 2017 were obtained. This covers the period from before performance degradation began to the present. Fuel constituents which are likely to contribute to fouling were reviewed and the constituents likely to contribute to fouling were plotted in the graphs below.

It should be noted that for almost all deliveries the fuel supplied met the specification, that exceedances were few and relatively small. However, as the trend lines in the graphs indicate, fuel quality has deteriorated with regards to constituents which tend to contribute to fouling and as will be seen in the pressure drop graphs, increased pressure drop correlates with a deterioration in fuel quality.

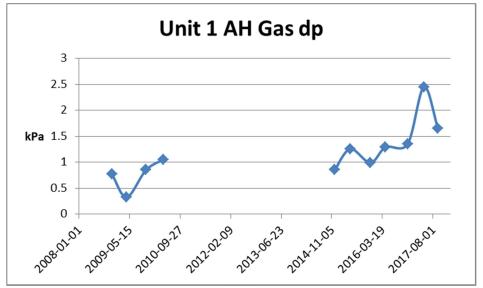
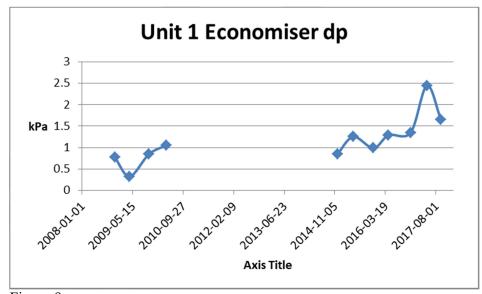
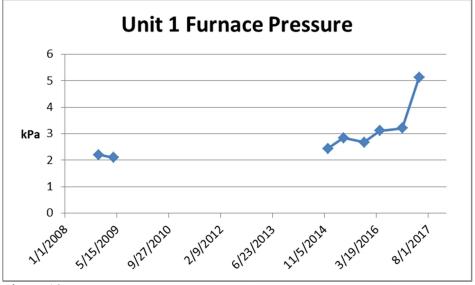
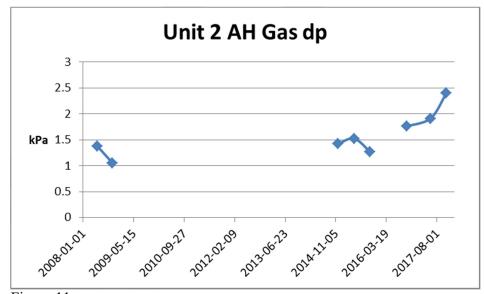
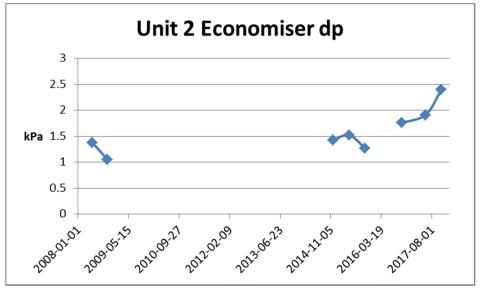
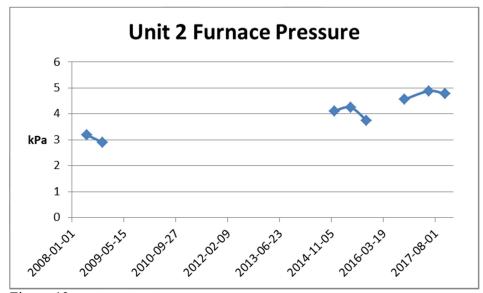
Unit performance data was obtained from Etapro to identify how fouling has changed in recent years. As with fuel data, the period from January 2008 and December 2017 was used to review the period from before performance degradation began, to the present. Unfortunately, there is a data gap in Etapro from Spring 2011 to Fall 2014 for which no data is available. The methodology used for each unit was to select a unit load at which data was available in each year in the early Fall (unit still clean after summer maintenance) and Spring (unit fouled after the operating season). This was done so that the air and gas flows would be similar for both the clean and fouled conditions. The data gap is unfortunate but it does cover the period before the unit deratings begin and therefore probably does not affect the inferences drawn from the data. Unit 1 data was obtained at 150 MW, Unit 2 at 120 MW and Unit 3 at 140 MW. The results are presented in the graphs below. Any gaps in the graphs, other than the Spring 2011 to Fall 2014 period, are due to the preferred unit loading not being available at a particular time.

It is unfortunate that such a large gap exists in the Etapro data. Anecdotal information suggests that the boiler pressure drop increases started in the period after the data gap and the graphed data tend to support this suggestion. The graphs clearly show the increased pressure drop at the end of each operating season, which occurs despite performing air heater washes. The graphs also show a reduction in pressure drop following the summer maintenance operations, when the boilers are cleaned. From 2014 to 2017, the graphs demonstrate that, despite thorough cleaning during the summer outages, boiler pressure drop has steadily increased.

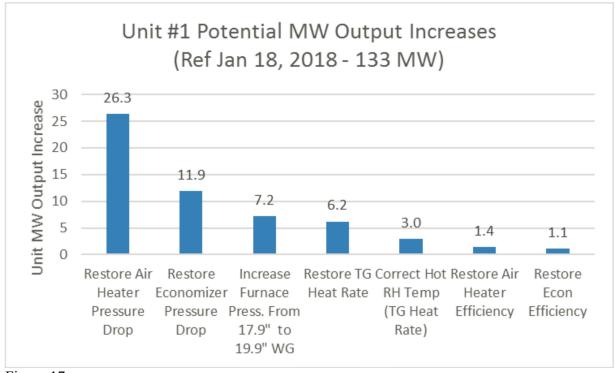
The B&W analysis identified the primary sources of performance degradation and their relative affects on the capacity of the unit. Figure 17 below from the report presents their conclusions.

Figure 17 indicates that, as suspected, the two principal contributors to the inability of Unit 1 to achieve rated output are fouling of the regenerative air heater and economizer. Fouling of the regenerative air heater can be corrected by cleaning or replacing the air heater baskets and fouling of the economizer can be corrected by cleaning economizer tubing. Both these activities are relatively simple to implement and can be performed within normal planned outage schedules.

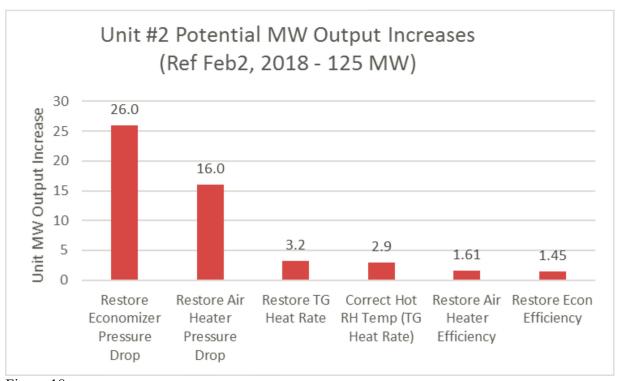
The B&W analysis identified the primary sources of performance degradation and their relative effect on the capacity of the unit. Figure 18 below from the report presents their conclusions.

Figure 18 indicates that the problems with Unit 2 are essentially identical to those of Unit 1 and the actions which are practical to implement to correct them are the same.

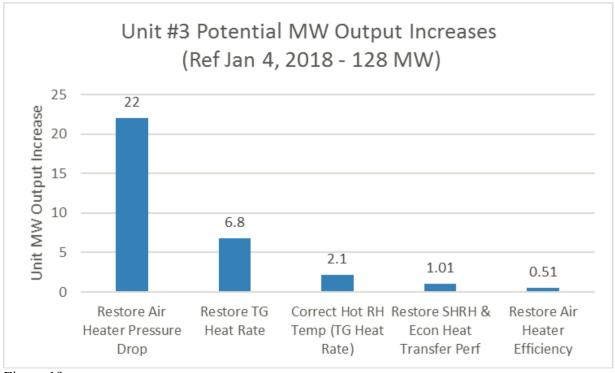
The B&W analysis identified the primary sources of performance degradation and their relative effect on the capacity of the unit. Figure 19 below from the report presents their conclusions.

Figure 19 indicates that, as with Units 1 and 2, the principal cause of loss of capacity for Unit 3 is fouling of the regenerative air heater. What is different about Unit 3 is that fouling of the economizer does play a less significant role in the inability of this unit to reach rated capacity. It is concluded that this is because the economizer of Unit three is formed from bare tubes while those of Units 1 and 2 are formed from finned tubing, which is more prone to fouling and more difficult to clean, both while on line using sootblowers and offline using manual methods. Discussions with operating staff revealed that there is a duct vibration problem which is preventing the forced draft fans being used to full capacity and which is contributing to the loss of unit capacity.

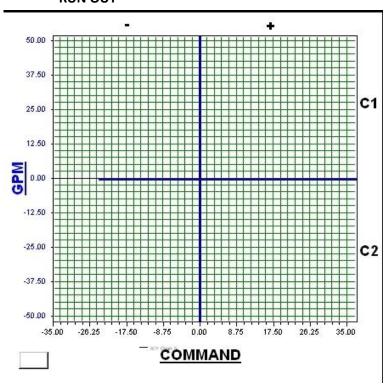
Parker Servo Valve 450-1180 2313 PHSA021358

Heavy Contamination Hard Over Chemically Cleaned Rebuilt Replaced O-Ring Replaced Filter

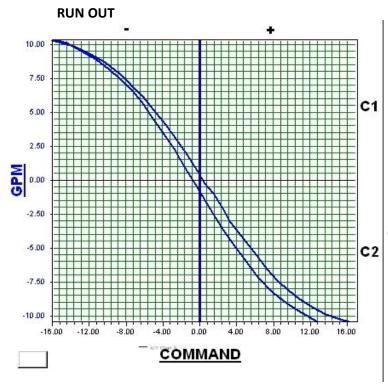
Parker Servo Valve 415-1294 6036 PHSA021358

NOTES: Heavy Contamination Replace O-Ring Replace Filter Chemically Cleaned

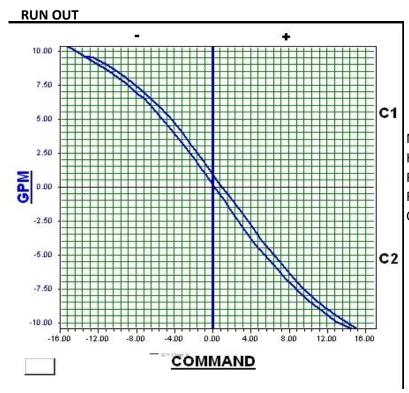
Parker Servo Valve 415-1294 389 PHSA021358

### NOTES: Heavy Contamination Replaced O-Ring

Replaced Filter
Chemically Cleaned

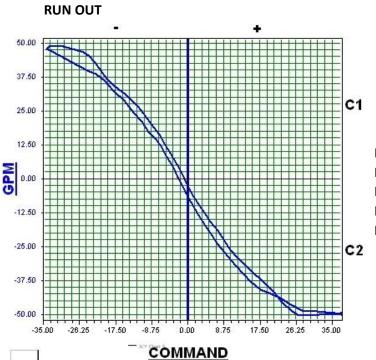
Parker Servo Valve 450-1180 296 PHSA021358

### NOTES: Heavy Contamination Replaced O-Ring

Replaced Filter
Marginal Leakage

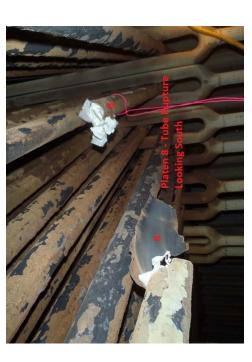
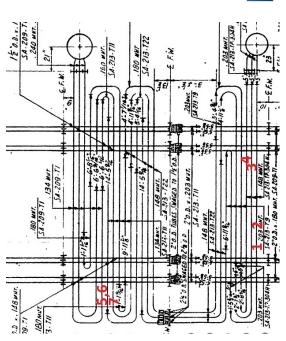
- On Permit Jan 6<sup>th</sup>
- Obvious Leaks in lower RH tubes, platens 5, and 8.
- Plant air through RH Drains and performed ultrasonic test and found pin holes in Platen 18, 28 and 29.
- Total of 7 leaks present.

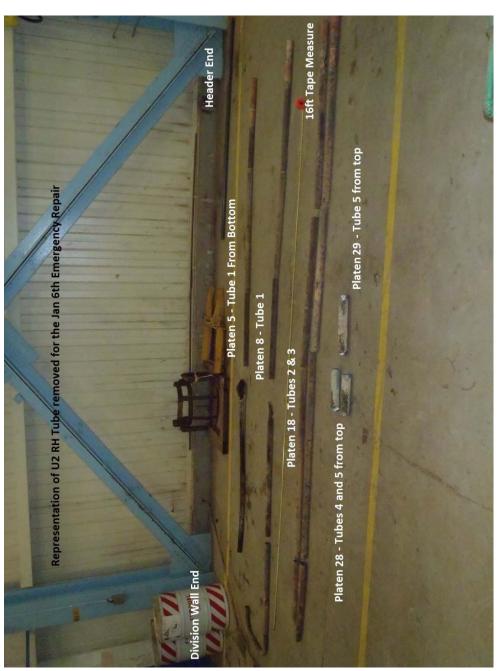
Unit #2 - Reheat Leaks Material Removed

talled Platens 5 and 8

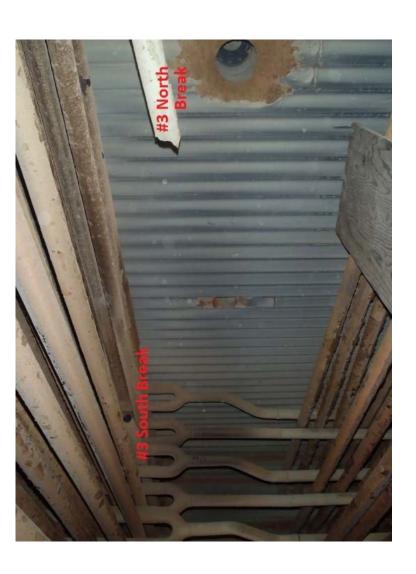
- **Unit Back On-Line**
- Jan 16<sup>th</sup> De-rated to 140MW
- Leak Suspected
- Jan 19<sup>th</sup> Another RH Tube Leak Detected
- Same Indicators
- Jan 19<sup>th</sup> re-mob
- Inspection
- On Permit Jan 20<sup>th</sup>
- Obvious Leak platen 3.
- Ultrasonic test and found no more leaks

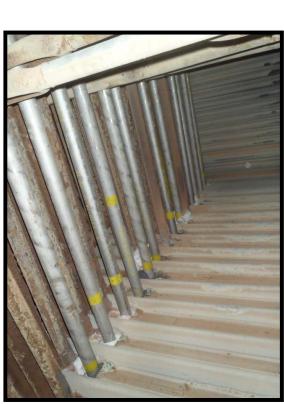
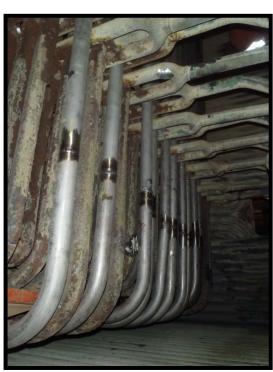
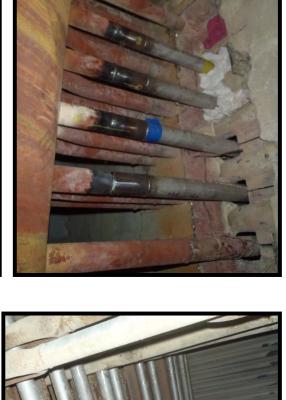
- Work Done
- Analyze UT data and Repair as Many as Possible – demand dictated
- Jan 20th Jan 31st
- Repaired the 23 thinnest bottom tubes
- Around the clock
- Start up with De-rate to 120MW on Feb 3rd
  - Up-side Lessons Learned for Project
- Result Major Push for Capital RH Project for 2016 outage

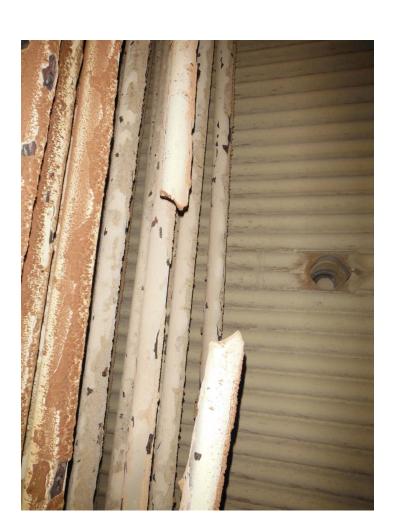
- On Permit Feb 18<sup>th</sup>
- Obvious Leak in lower RH tubes on platen 4.
- Plant air through RH Drains and performed ultrasonic test no further leaks.

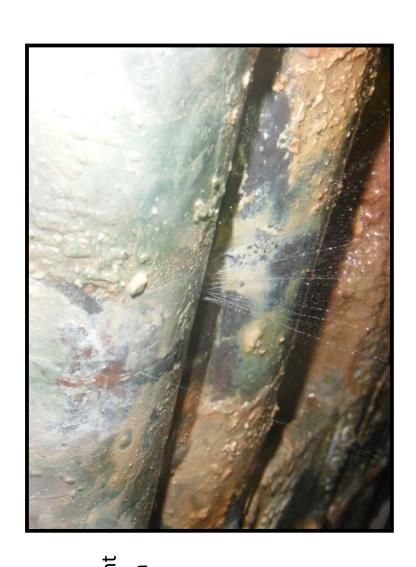
- 12-13K KPA
- Hold for 15mins +
- Leak on SH Tube Attachment
- Successful SPT on Sept 11th
- Alstom Performed Analysis
- Not Overstressed
- Fatigue Cracking
- Cyclic Thermal Expansions
- Inspect Several Locations
- Similar (50 every 6 yrs)
- High Stress at Bottom

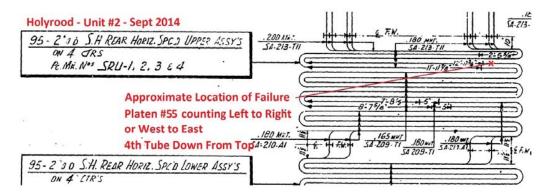
Figure 1: Location of LTSH attachment failure

The location of the attachment failure can be seen in the figures below:

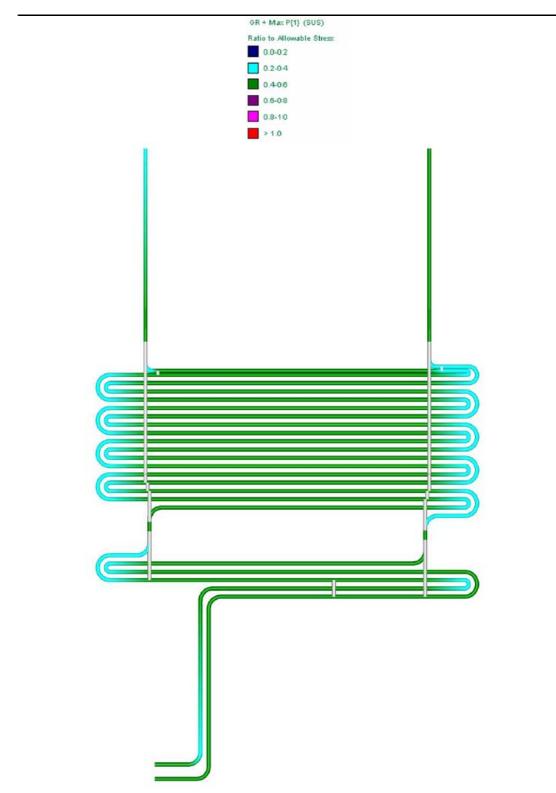
Figure 4: Pressure and dead weight sustained stress (SUS) ratio

- The thermal stress at the failure location is in the range of a few ksi vs an allowable stress of 25 ksi.
- The pressure hoop stress at the failure location is 11.6 ksi vs an allowable stress of 15 ksi.
- The pressure and dead weight sustained stress induced at the failure location is approx. 6.5 ksi vs an allowable stress of 15 ksi.

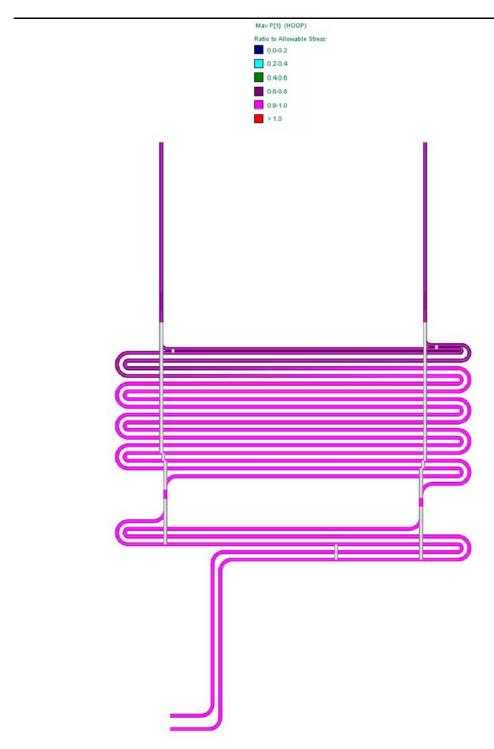
Figure 5: LTSH hoop stress ratio

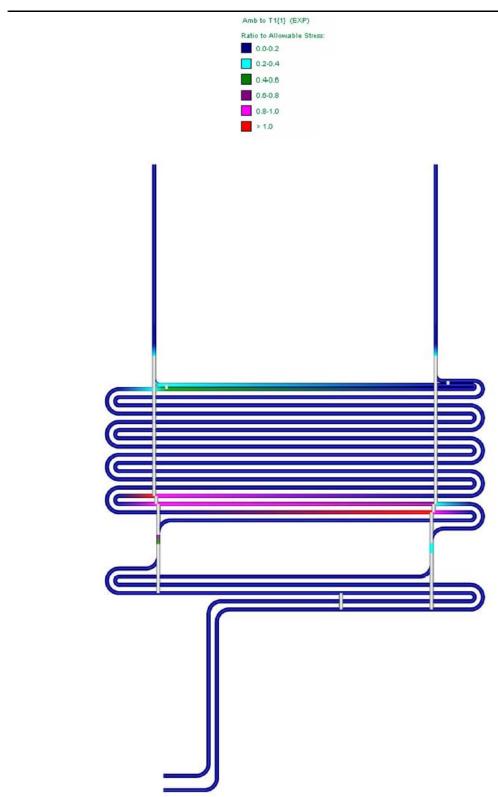
Figure 6: LTSH thermal displacement stress ratio – Expansion Stress (EXP)

This analysis has also shown the superheater tie plates at the bottom of the upper bundle that offsets 1" to match the vertical supports of the lower bundle is over-stressed in a design criterion. Refer to Figure 7 below for offset location. The over-stress is seen by the red tubing in Figure 6. The investigation shows that failure due to over-stressing beyond the yield point of the material is not likely, but is a high stress location on a design criterion. Alstom has not been notified of failures at these locations, but may be a location where further inspections should be taken to ensure that crack initiation or crack propagation is not occurring.

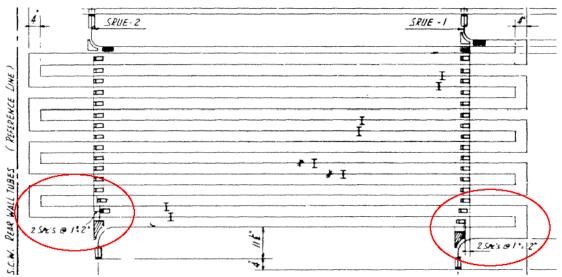
Figure 7: Upper LTSH Assembly - Highlighted Support Attachment Offsets

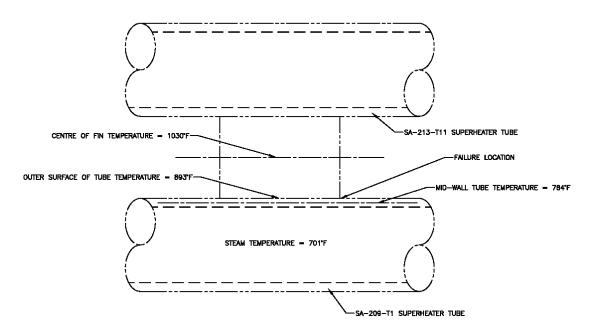
Figure 8: Predicted temperature distributions at the failed superheater attachment

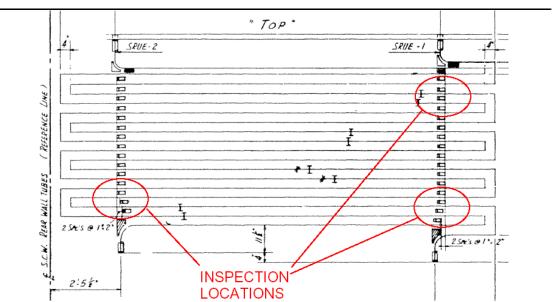
Figure 9: LTSH Attachment Inspection Locations

Since the stress analysis has also indicated a high stress point at the attachments near the offsets at the bottom of the upper assemblies, Alstom would also recommend to inspect the attachments in that location frequently. See Figure 9 below for inspections of attachment locations:

The current welding specification for these attachments is to weld the complete length of the tie plate to the tube. It is also recommended that when replacing any of the tie plate attachments, to weld not only the length of the attachment, but also to wrap the weld around the edges. This would reduce concentrated stress points in the welds.

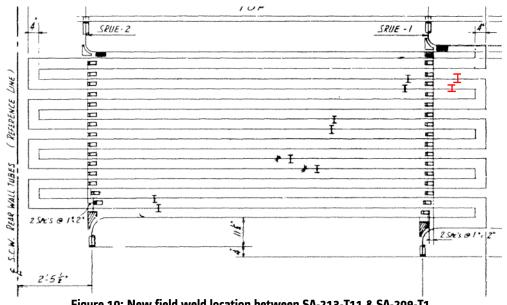
Figure 10: New field weld location between SA-213-T11 & SA-209-T1

Also, when replacing any tubing or attachments in the failure location, it is recommended to replace the tubing with SA-213-T11. This would carry the existing field weld and material change from SA-213-T11 to existing SA-209-T1 past the attachment. See Figure 10 below:

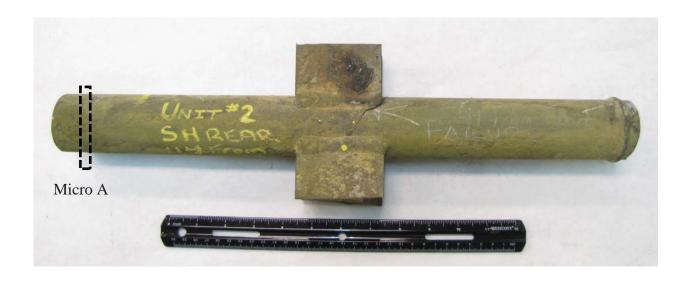
**Figure 1.** Shown is the sample as it appeared when received by the TTT-M, along with the approximate location from where a metallographic section was taken.

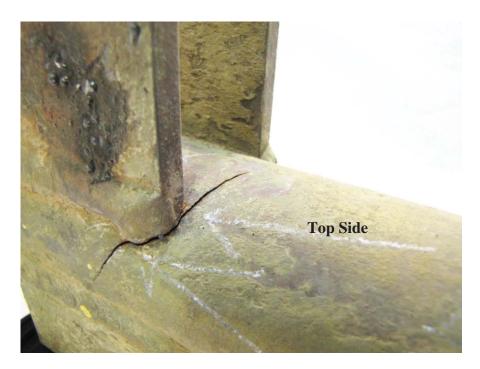
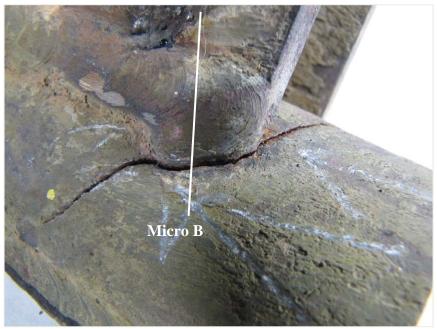
As shown in Figure 4, the failure was a non-ductile crack that followed the toe of the tieplate attachment weld before progressing in a circumferential direction. The sample was sectioned and split to expose the fracture surface. The majority of the original fracture surface had been damaged as a result of operating for an extended period of time after the failure occurred. Based on the limited remaining evidence, the location and pattern of the fracture would indicate that the crack initiated at the OD surface of the tube at the toe of the tie-plate attachment weld. There was no evidence of any welding defect along the remaining fracture surface. The remaining intact tie-plate attachment welds on the sample were examined and showed no evidence of cracking.

**Figure 4.** Close-up views of the failure site is shown, along with the approximate location from where a metallographic section was taken.

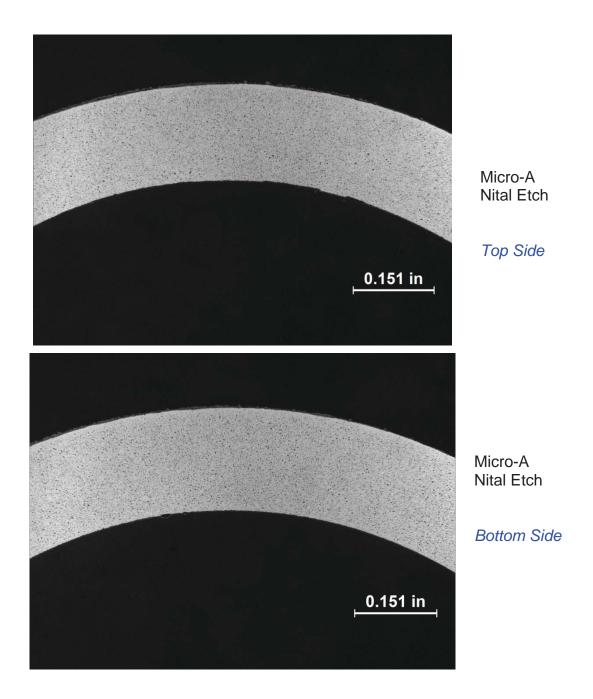
The general condition of the macrostructure and microstructure away from the leak site is presented in Figures 6 and 7. As shown, this area contained no evidence of cracking or significant wastage. A microscopic examination of the material structure revealed no signs of microstructural degradation (overheating or creep damage) in any of the areas examined. In fact, the condition of the microstructure was normal for service-exposed SA-209, T1 material.

**Figure 6.** Profiles of the tube wall from the top and bottom sides at the Micro A location are shown.

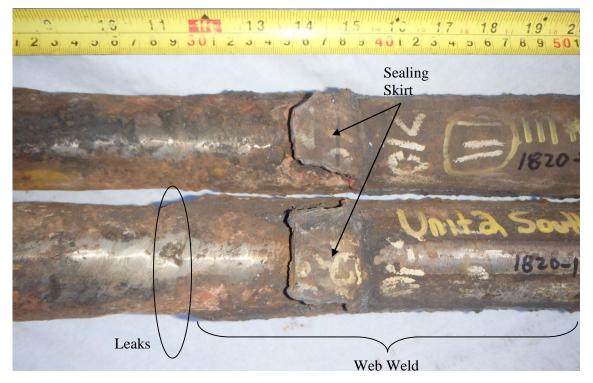
Figure 2: Close Up External Views of Through Wall Perforations on Tube #114

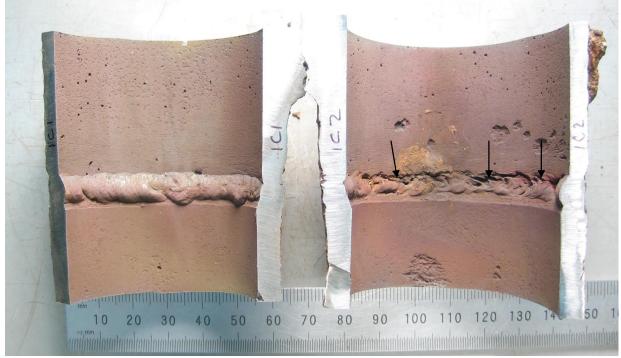
Figure 4: View of Internal Surfaces of Tube #114 Showing Leaks (Arrows) Coinciding with Circumferential Weld. Internal Pitting of Tube Segment Above Circ. Weld Was Noted.

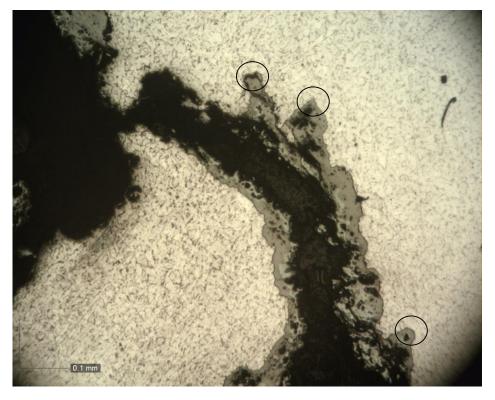
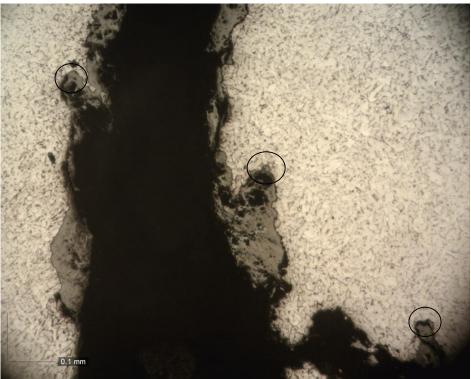
Figure 7: Numerous Secondary or Occluded Pits (Circled) Were Associated with The Crack Near the Internal Surface.
