1	Q.	Please	provide copies of reports or other documentation that describe the latest condition			
2		of the following assets and any work completed to date addressing the following issues:				
3						
4		a.	Bay d'Espoir penstocks;			
5						
6		b.	Hinds Lake rotor resistance;			
7						
8		С.	Granite Canal control system;			
9						
LO		d.	Upper Salmon rotor rim cracking;			
11						
12		e.	Hinds Lake bearing coolers;			
13						
<b>L</b> 4		f.	Cat Arm spherical control valves;			
15						
16		g.	Hardwoods combustion can failures;			
<b>L</b> 7						
18		h.	Hardwoods bellows failures/cracking;			
19						
20		i.	Holyrood boiler tube issue, variable frequency drive issues, air flow limitations,			
21			hydraulic fluid issues;			
22						
23		j.	Stephenville vibration issues;			
24						
25		k.	Hardwoods combustion can failures;			
26						
27		l.	Hardwoods bellows cracking issue;			
28						
29		m.	All Holyrood boiler tube failure studies;

1		n. All "Quarterly Report on Performance of Generating Units" reports; and
2		
3		o. Exploits frazil ice issues.
4		
5		
6	A.	The reports referenced below provide an overview of the latest condition of the asset(s)
7		and any work completed to

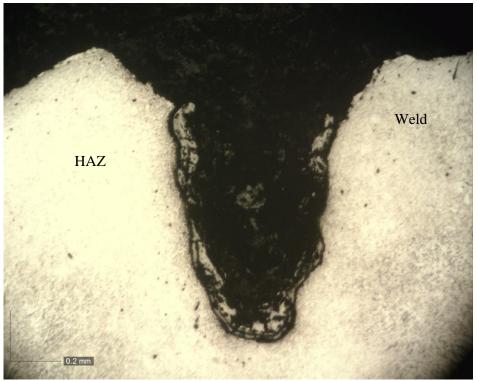
Figure 8: Deep, V-Shaped Cracks Were Observed Originating at the Weld Toe at The External Surface. These Were Filled with Corrosion Deposit.

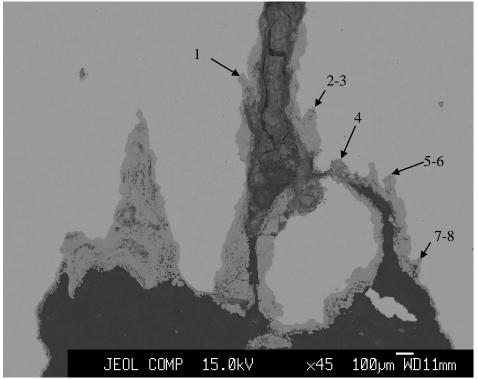
Figure 9: SEM Compositional View of Crack Origin at Internal Tube Surface. Secondary Corrosion Pitting Where EDS Analysis of Deposit Was Performed is Highlighted.

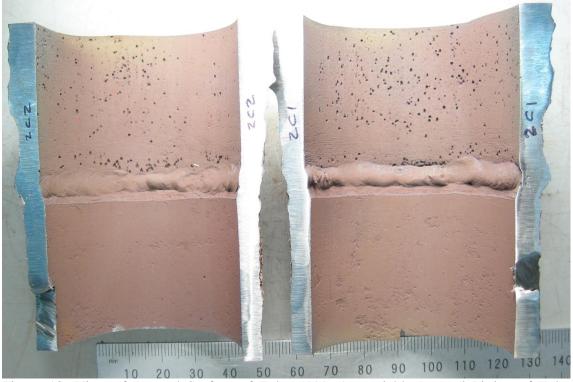
Figure 10: View of Internal Surface of Tube #111. Appreciable Internal Pitting of Tube Segment Above Circ. Weld Was Noted.

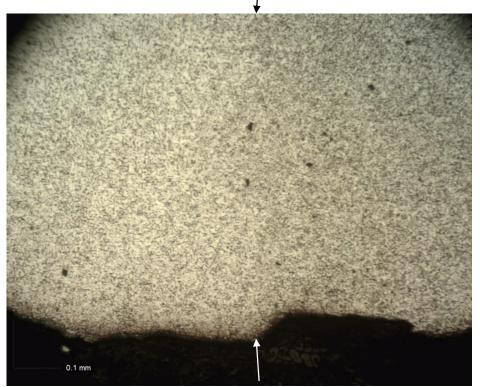
Examination of numerous cross sections found no evidence of the initiation of any cracks at the weld fusion lines. There was no evidence of any corrosion fatigue damage initiating at the interior, Figure 12; nor was there evidence of any thermal fatigue cracking initiating at the tube exterior surface, Figure 13.

Figure 12: Cross Sectional View of Tube #111 Typical of Interior Surface at Weld Root. Arrows Indicate Fusion Line with Weld on Left Side. No Evidence of Corrosion Fatigue Cracking Was Observed.

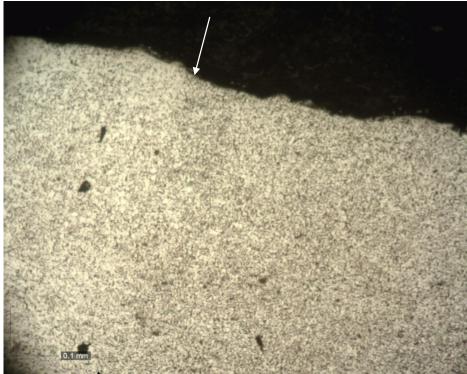
Figure 13: Cross Sectional View of Tube #111 Typical of Exterior Surface at Weld Crown.

Arrows Indicate Fusion Line with Weld on Left Side. No Evidence of Thermal Fatigue Cracking Was Observed.

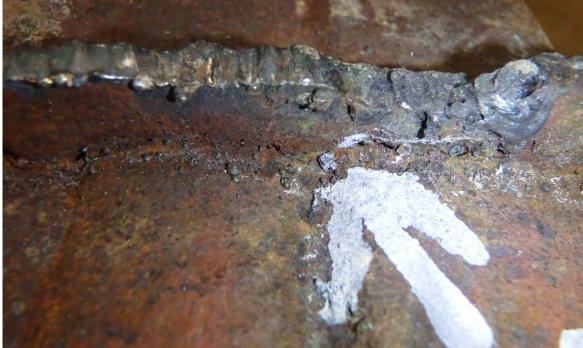
Figure 2: Close Up External View of Leak on Tube #1.

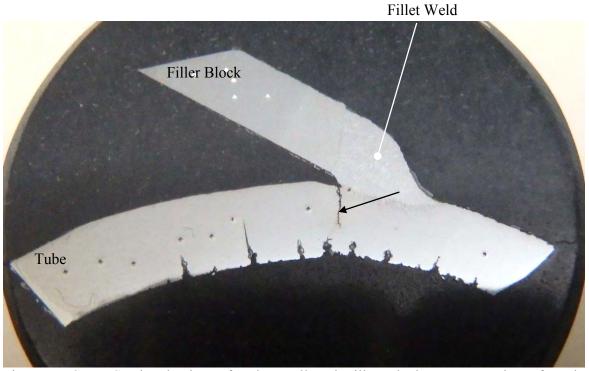
Figure 5: Cross Sectional View of Tube Wall and Filler Block Near Location of Leak.

Numerous Indications Are Evident Originating at The Internal Surface. The Arrow
Highlights the Singular Crack Propagating from the Weld Root Into the Tube.

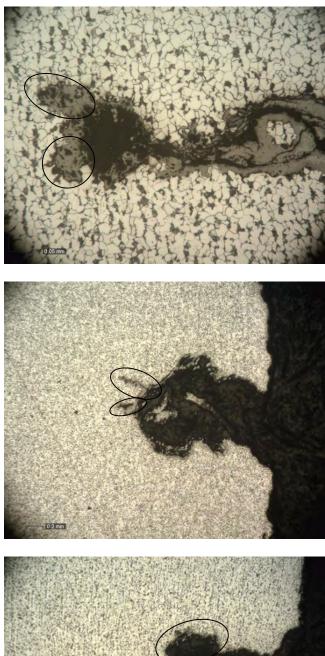
Figure 6: Microscopic Views of Typical Tube Internal Cracks. Variation in Crack Width is Evident. Occluded Pits Are Circled. Corrosion Product Is Visible Within Cracks.

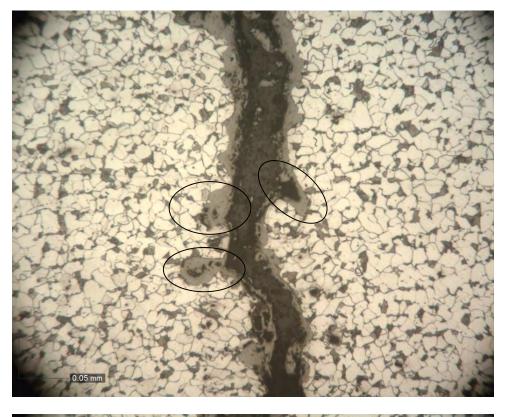
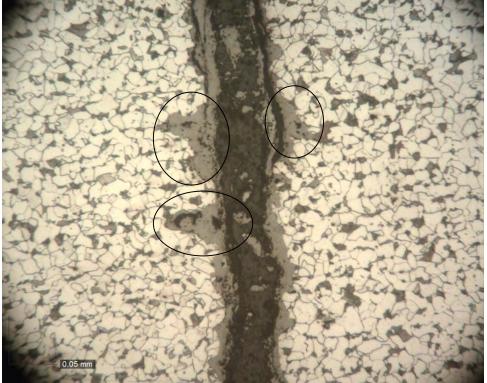
Figure 7: Microscopic Views of Singular Crack Originating at Tube External Surface. Crack Was Transgranular with No Visible Branching. Shallow, Random Occluded Pits Were Observed (Circled) Crack Was Filled with Corrosion Deposit.

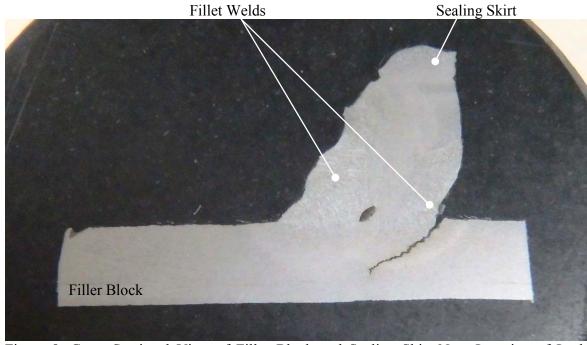
Figure 8: Cross Sectional View of Filler Block and Sealing Skirt Near Location of Leak Showing Singular Crack Propagating Across the Filler Block.

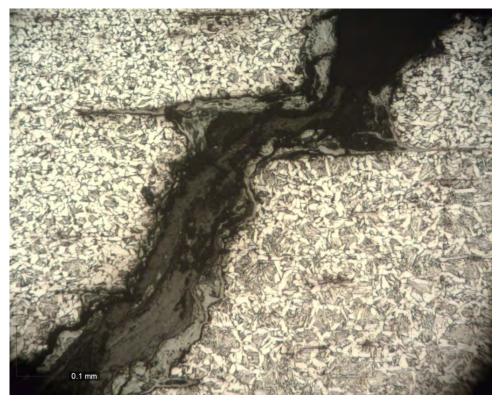
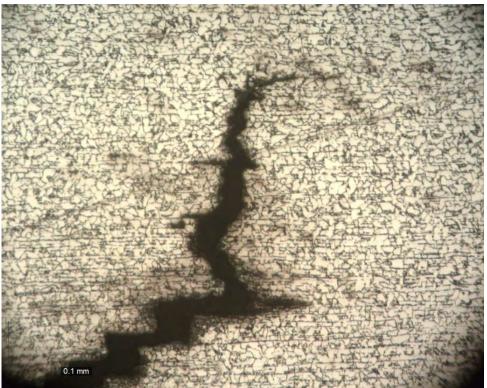
Figure 9: Microscopic Views of Singular Crack Propagating Across Filler Block. Crack Was Transgranular with No Visible Branching. Arrows Highlight Stringers. Crack Was Filled with Corrosion Deposit and Had A "Stepped" Appearance.

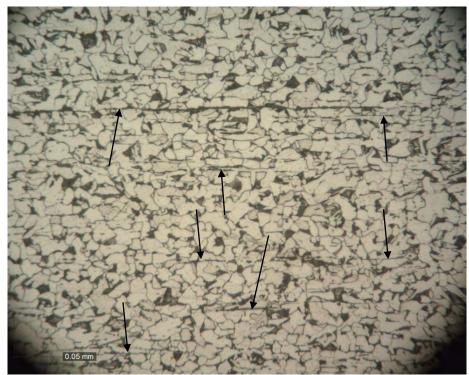
Figure 10: Microstructure of Filler Block Consists of Banded Pearlite in a Ferrite Matrix. There Were Numerous Stringers (Arrows) Evident Throughout This Material.

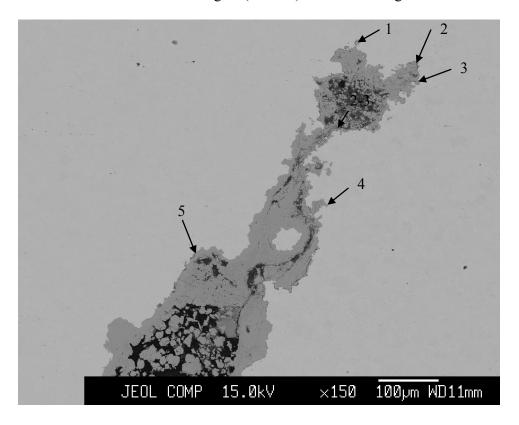
Figure 11: SEM Compositional View of Crack Originating at Internal Tube Surface.
Occluded Pitting Where EDS Analysis of Deposit Was Performed is Identified.

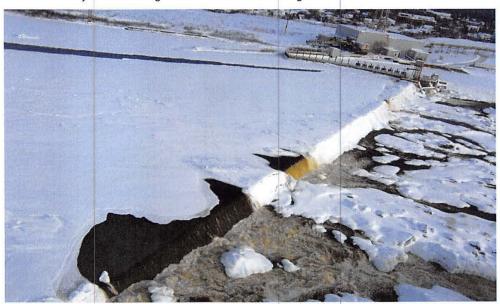
In mid-November there was snow on the ground prior to a warm weather event and significant rain on November 28 which resulted in tripling of the flow in the Exploits River through the following day. These high flows resulted in the loss of flash boards from the headpond dam for a crest length of approximately 200 ft late on November 29. This section of failed boards adjacent to the right abutment is evident in Figure 2-1.

Figure 2-1: Headpond Dam - Right Side (looking downstream)

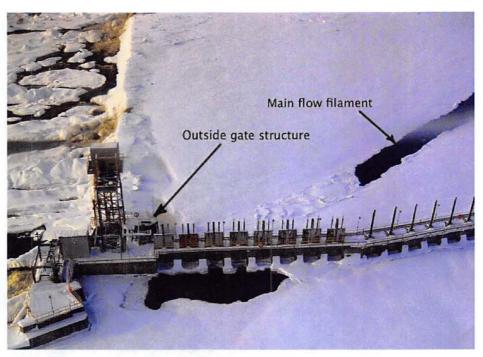
The onset of the 5-day spate of very low temperatures precipitated the initial stages of ice cover formation on the headpond and in the intake channel. A second consequence of the 5-day spate of low temperatures was the production of a very large volume of frazil ice in the open water reaches and rapids in the river upstream of the headpond. This frazil ice deposited in the relatively low velocity areas of the headpond until the headpond storage volume was filled. Thereafter, the inflowing frazil was carried directly into the intake channel along the main filament of flow through the headpond. This filament of flow in the headpond is evident at the top of Figure 2-1 (see open water) and is further illustrated at the intake structure in Figure 2-4. Local telescoping of the ice cover at the end of the open water lead is clearly evident.

Figure 2-4: Intake Structure and Upstream Area Showing Main Flow Filament to Intake

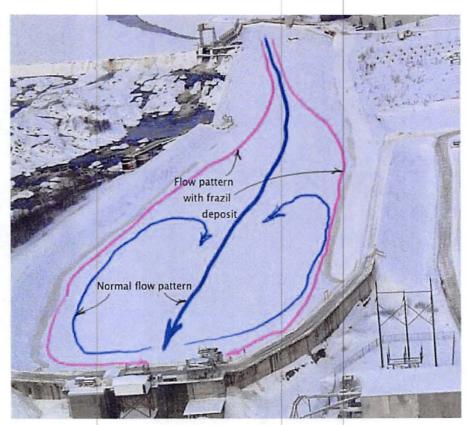
Figure 2-5: Flow Pattern in Intake Channel

At some point in this progression, the main flow filament in the intake channel shifted from the centre line of the channel to lines of lower hydraulic resistance adjacent to and paralleling the right and left banks. This flow pattern is illustrated in Figure 2-5. Under this ice condition, the hydraulic conveyance of the channel is much reduced, inhibiting seriously the ability of the power station to generate electrical energy.

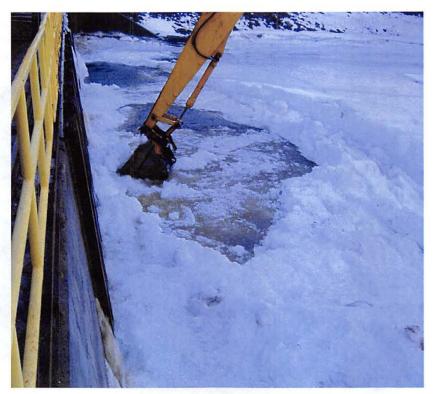
Figure 2-6: Excavation of Ice at Intake Face

Also, with the frazil storage capacity of the channel being full, all on-going inflow of frazil arrived and accumulated at the power intakes. To keep the intakes open and operating and the generating station operable to some degree, excavation of accumulated ice from the intake face was undertaken as illustrated in Figure 2-6.

Evident in the Figure 2-6 is the "crowning" of the deposited ice across the channel, with the frazil deposits along the main normal flow filament raising the ice surface level above the levels at the banks of the channel; i.e. above the "clear" ice filaments evident in Figure 2-5 and to a lesser extent in the background of Figure 2-6.

It was found that the frazil deposits at the intake were very dense, requiring the use of a wrecking ball to break an opening for the back hoe to be able to begin excavation.

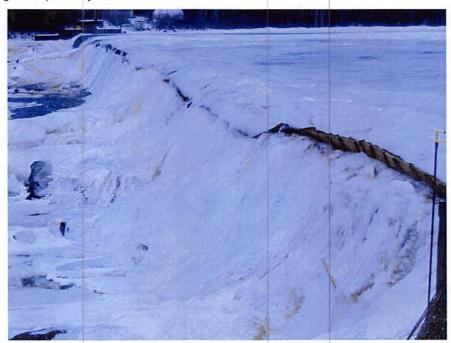
Figure 2-7: Ice Pushed on to and Over the Dam

Late on December 14, in spite of declining flows, the nascent headpond ice cover telescoped, pushing ice onto and over the dam. Figure 2-7 shows the end result.

With the persisting supply of frazil ice to the generating station intakes, power production continued to be seriously inhibited.
