Newfoundland and Labrador Hydro

Project Report Volume III

Hardwoods and Stephenville Viability Assessment

> H365408-00000-210-066-0003 Rev. 1 June 27, 2022

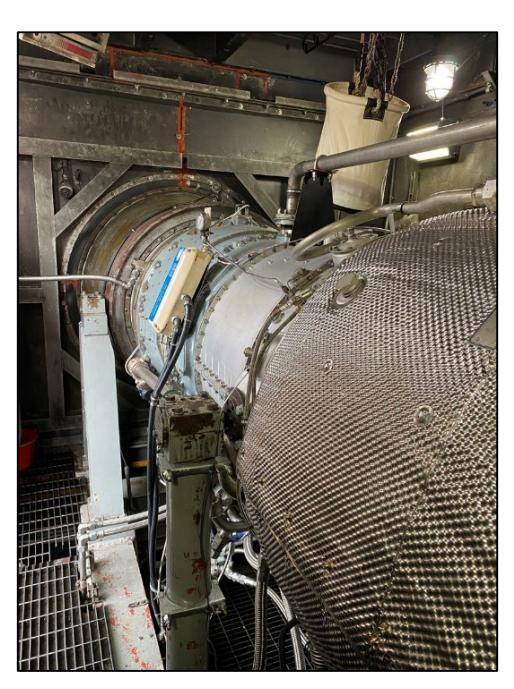
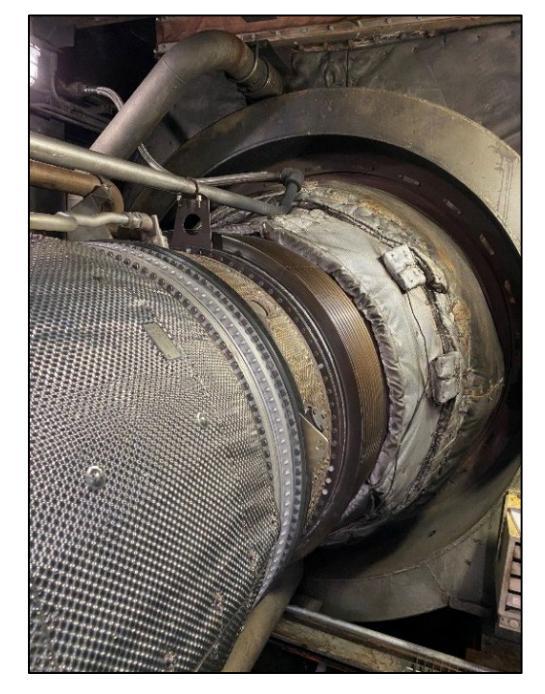
The Temperature Monitoring System and Vibration Monitoring System on Unit A Rolls Royce Olympus C Gas Generator Engine is nearing end of life and replacement is recommended. A borescope was conducted on Unit A that showed signs of carbon buildup on the turbine and on several nozzles. It is recommended that the nozzles are cleaned in an ultrasonic solvent bath and evaluated for replacement.

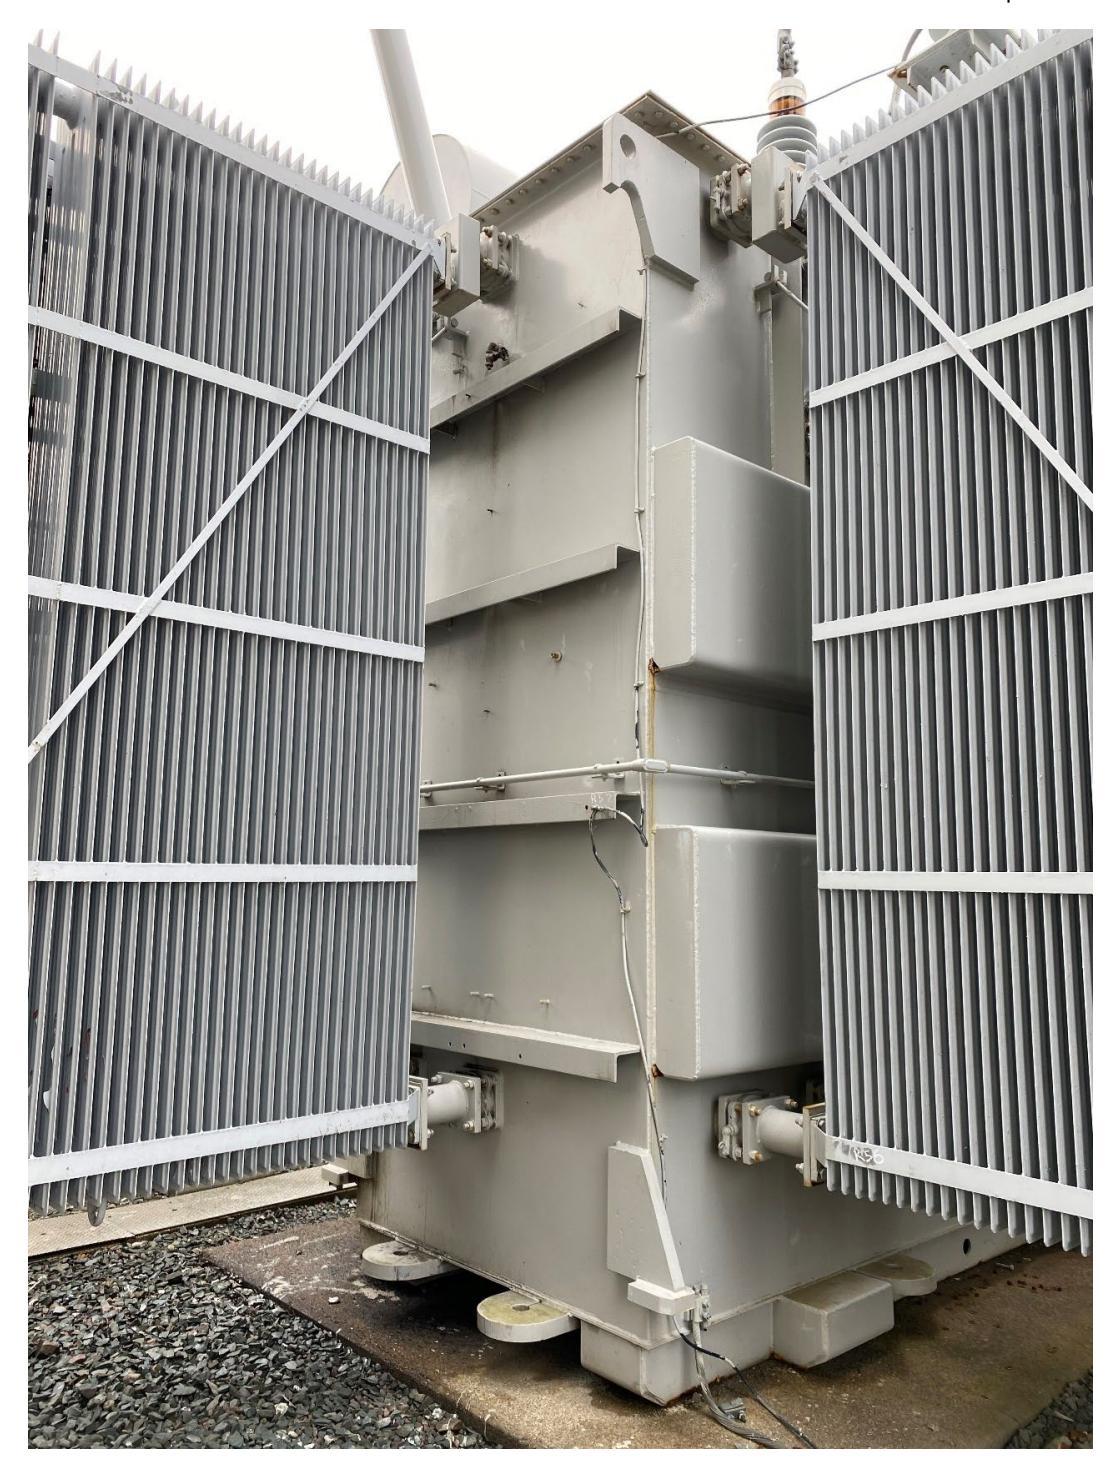
The fans and cooler on the northeast side of the Main Transformer are showing signs of corrosion. It is recommended that the fans are replaced and the Cooler repainted. The replacement of the transformer is required by 2025 due to PCB containing oil. Any repairs should be considered against the mandated replacement.

¹The main transformer fans and cooler on the northeast side are heavily rusted. The transformer is in working condition but will need to be replaced in 2025.

Figure 4-33: Transformer
PUB-NLH-280, Attachment 1 Reliability and Resource Adequacy Study Review Page 180 of 314

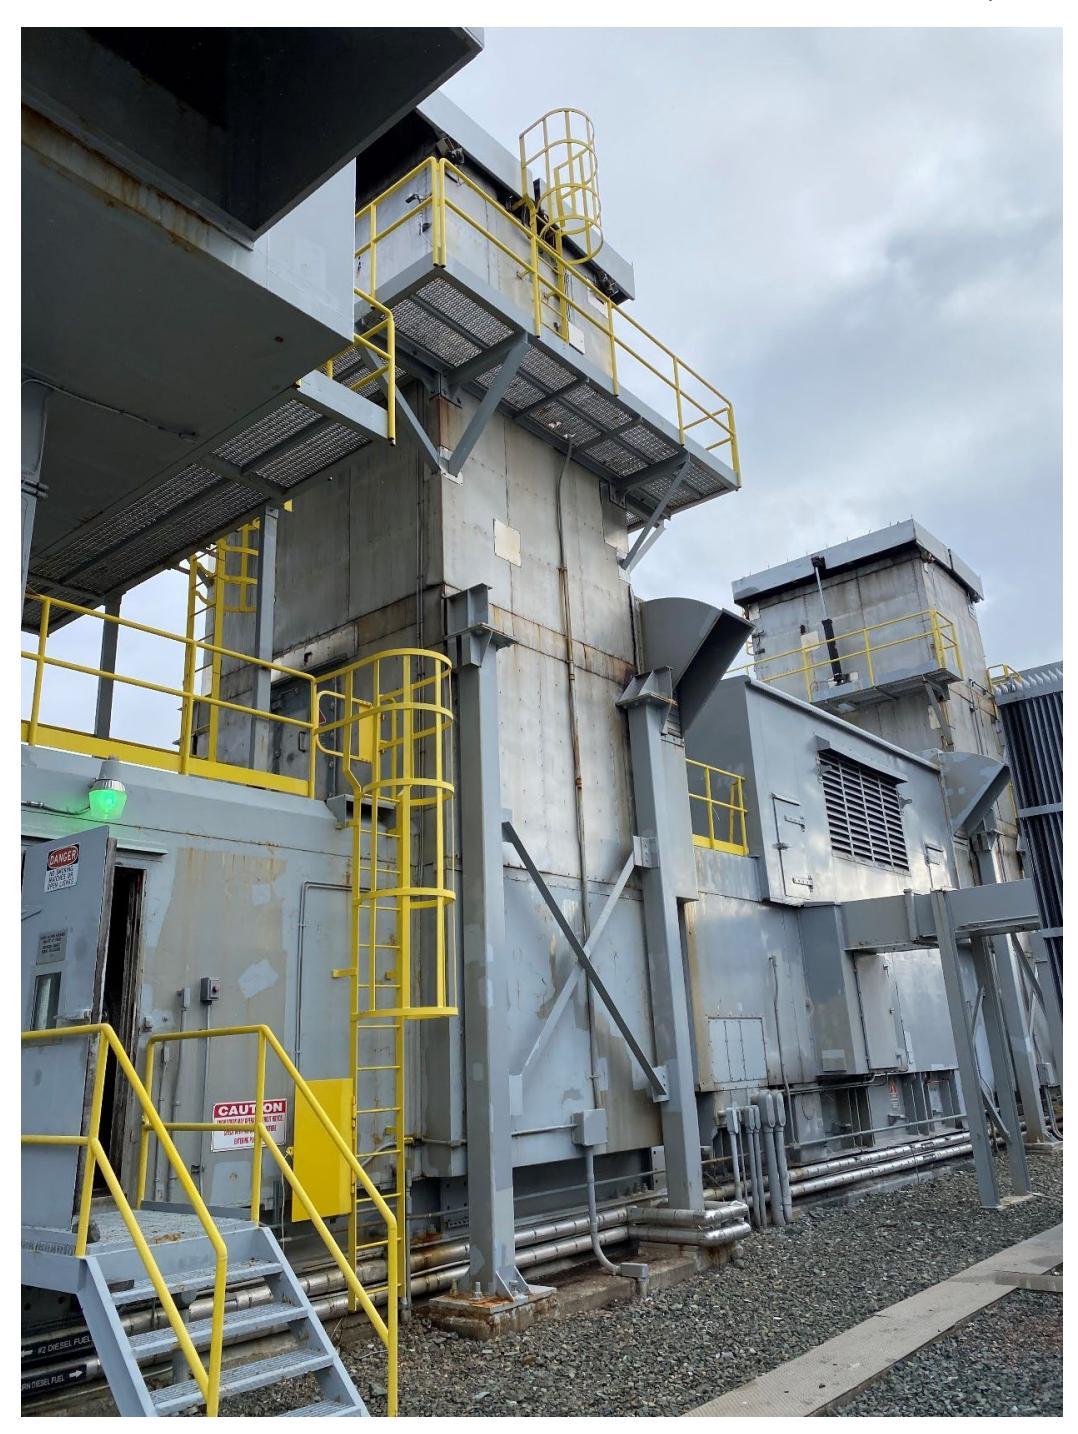
The Power Station Buildings and Exhaust Stack envelopes show signs of rust and corrosion. Grinding to bare metal and repainting is recommended to stop the advancing corrosion.

Figure 4-39: Exhaust Stacks and Generator Envelope

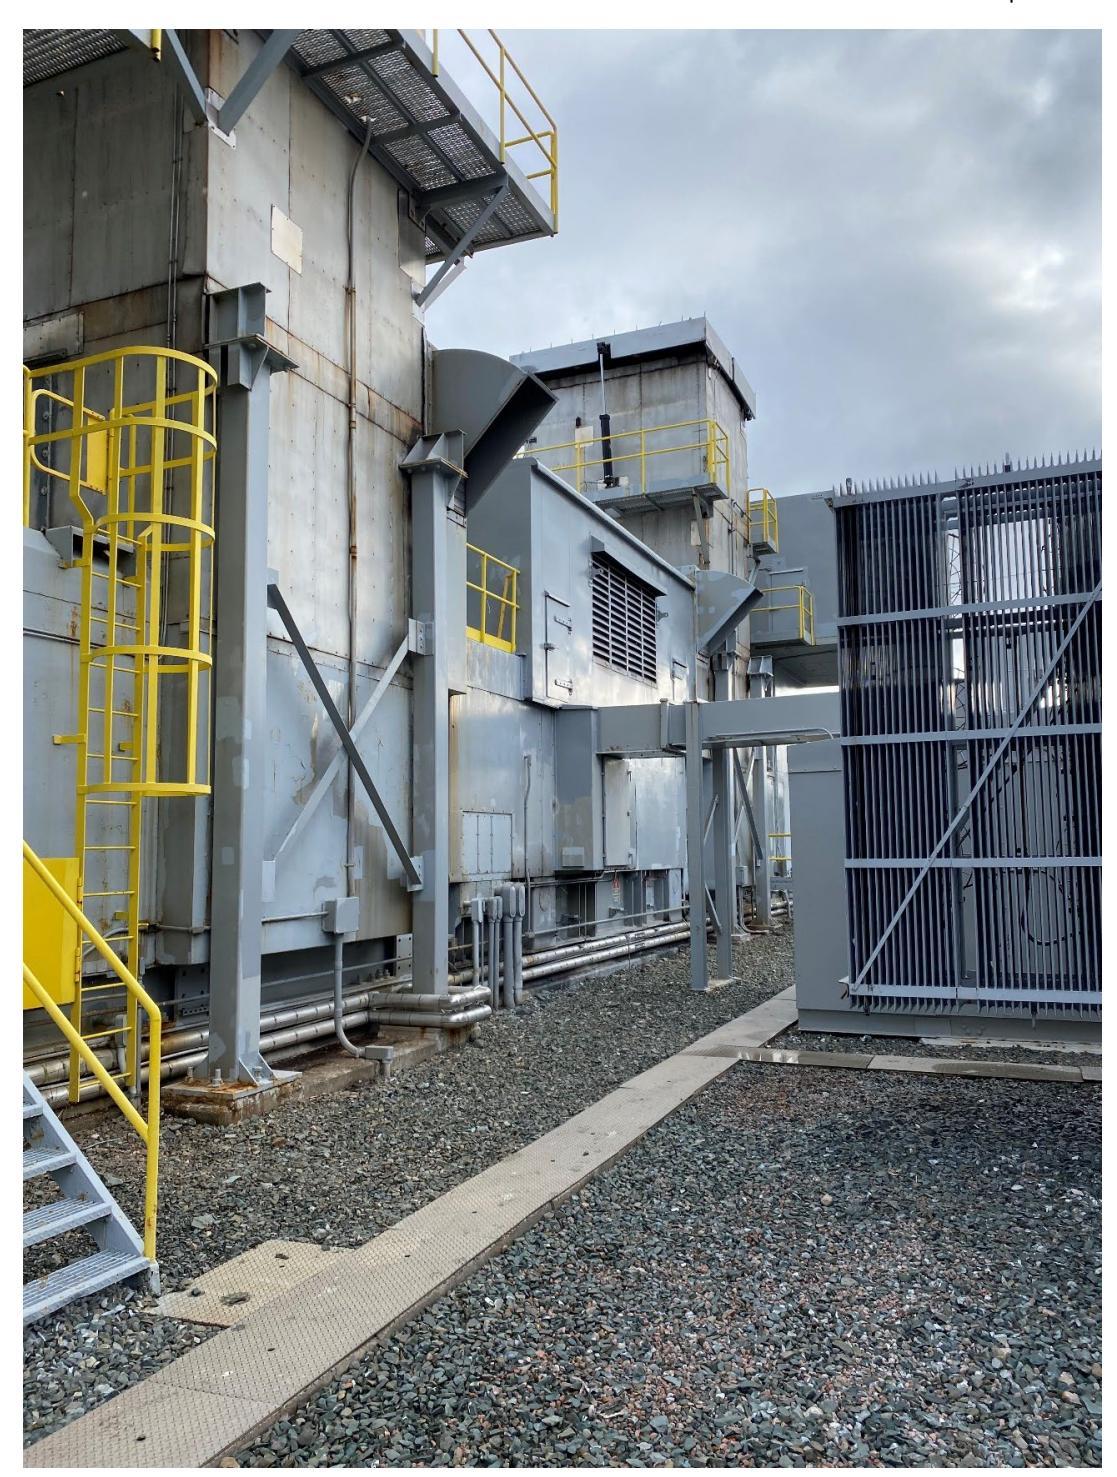
Figure 4-40: Exhaust Stacks and Generator Envelope

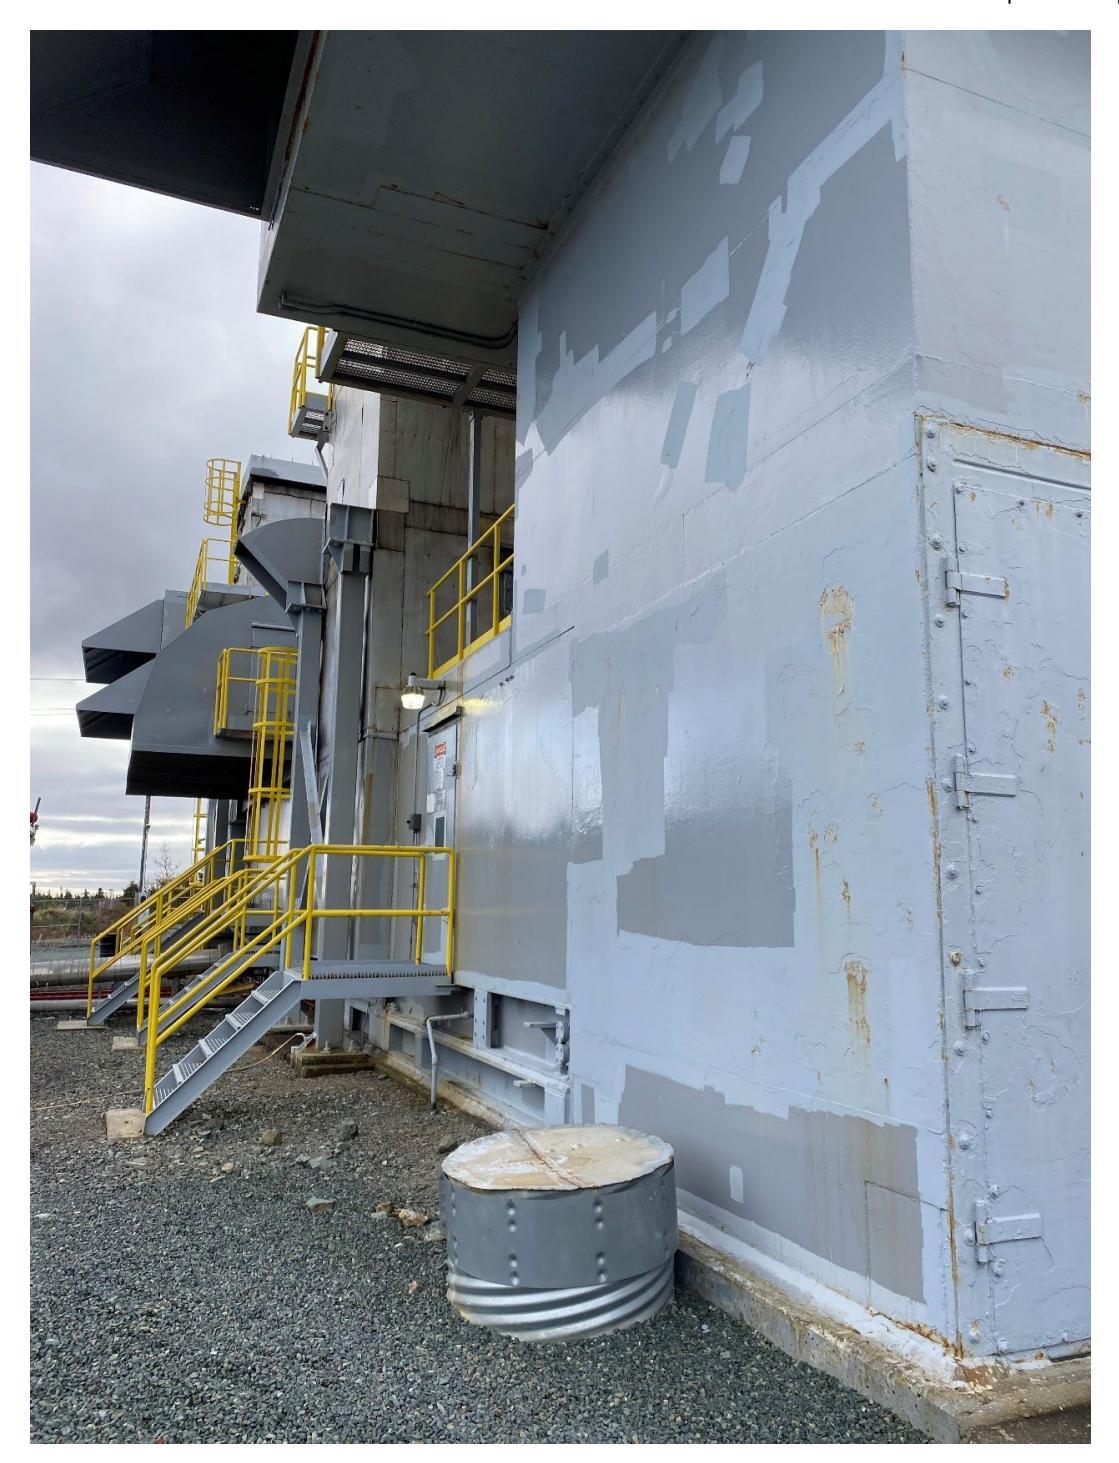
Figure 4-45: Structure Envelope

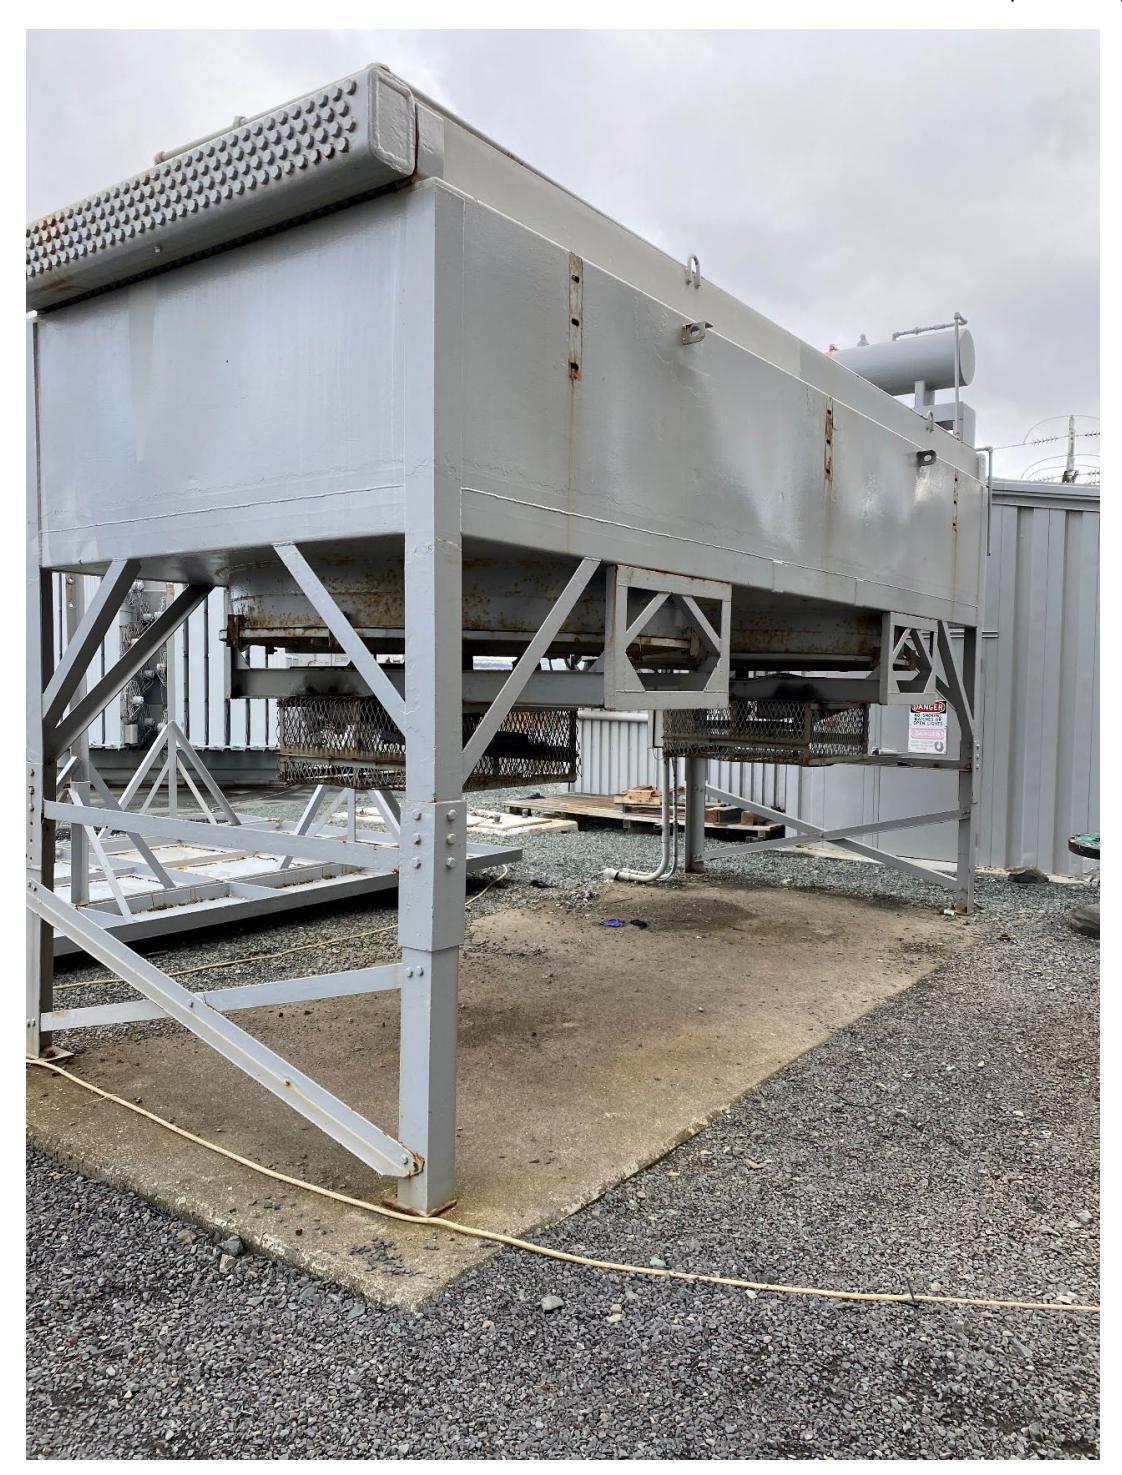
The Main Lube Oil Cooling System / Glycol Cooler is in poor condition. The cooling fins require combing to straighten, and the cooler requires power washing.

Figure 4-48: Glycol Cooler

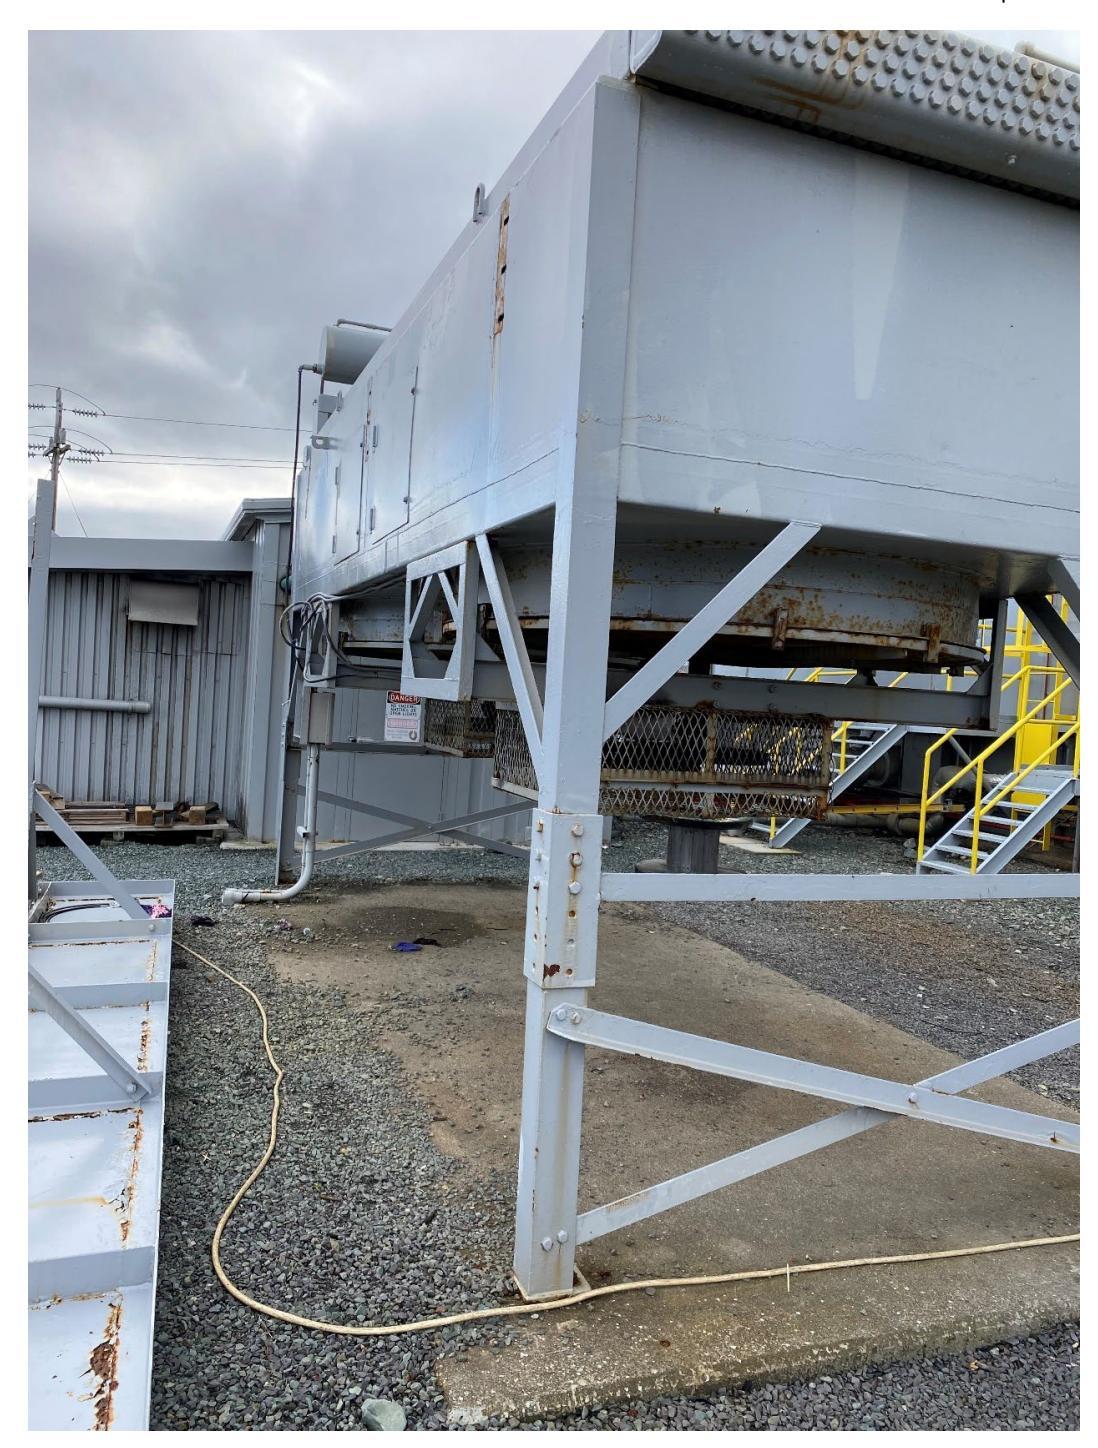
Figure 4-49: Glycol Cooler

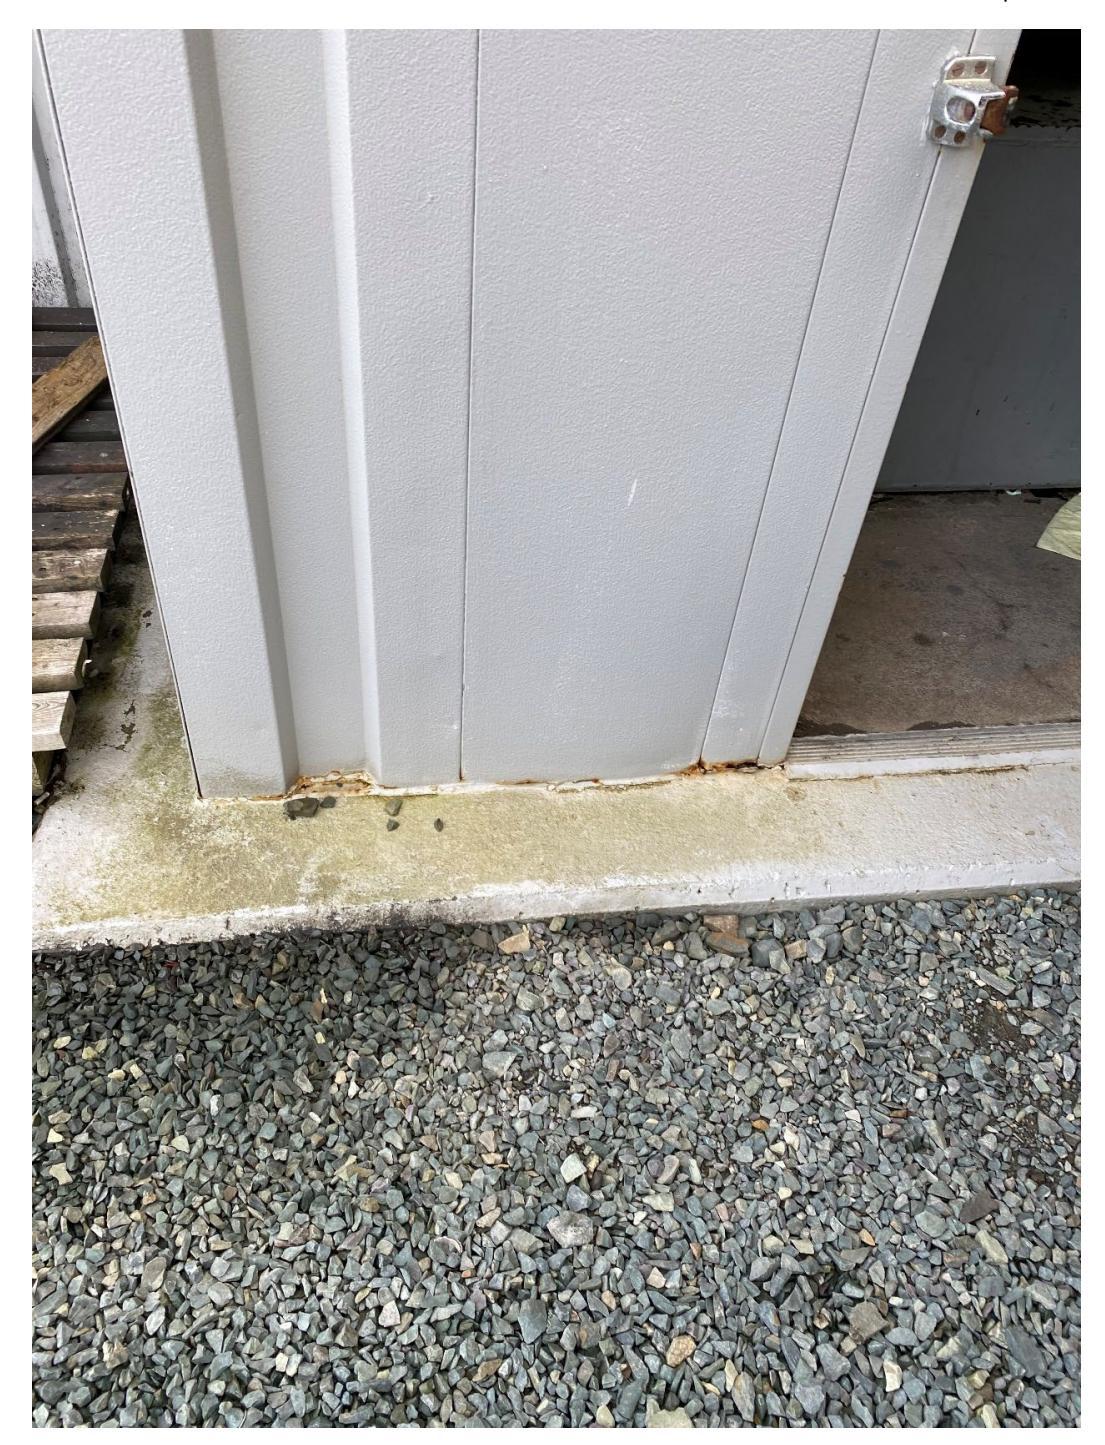
Figure 4-50: Structure Envelope

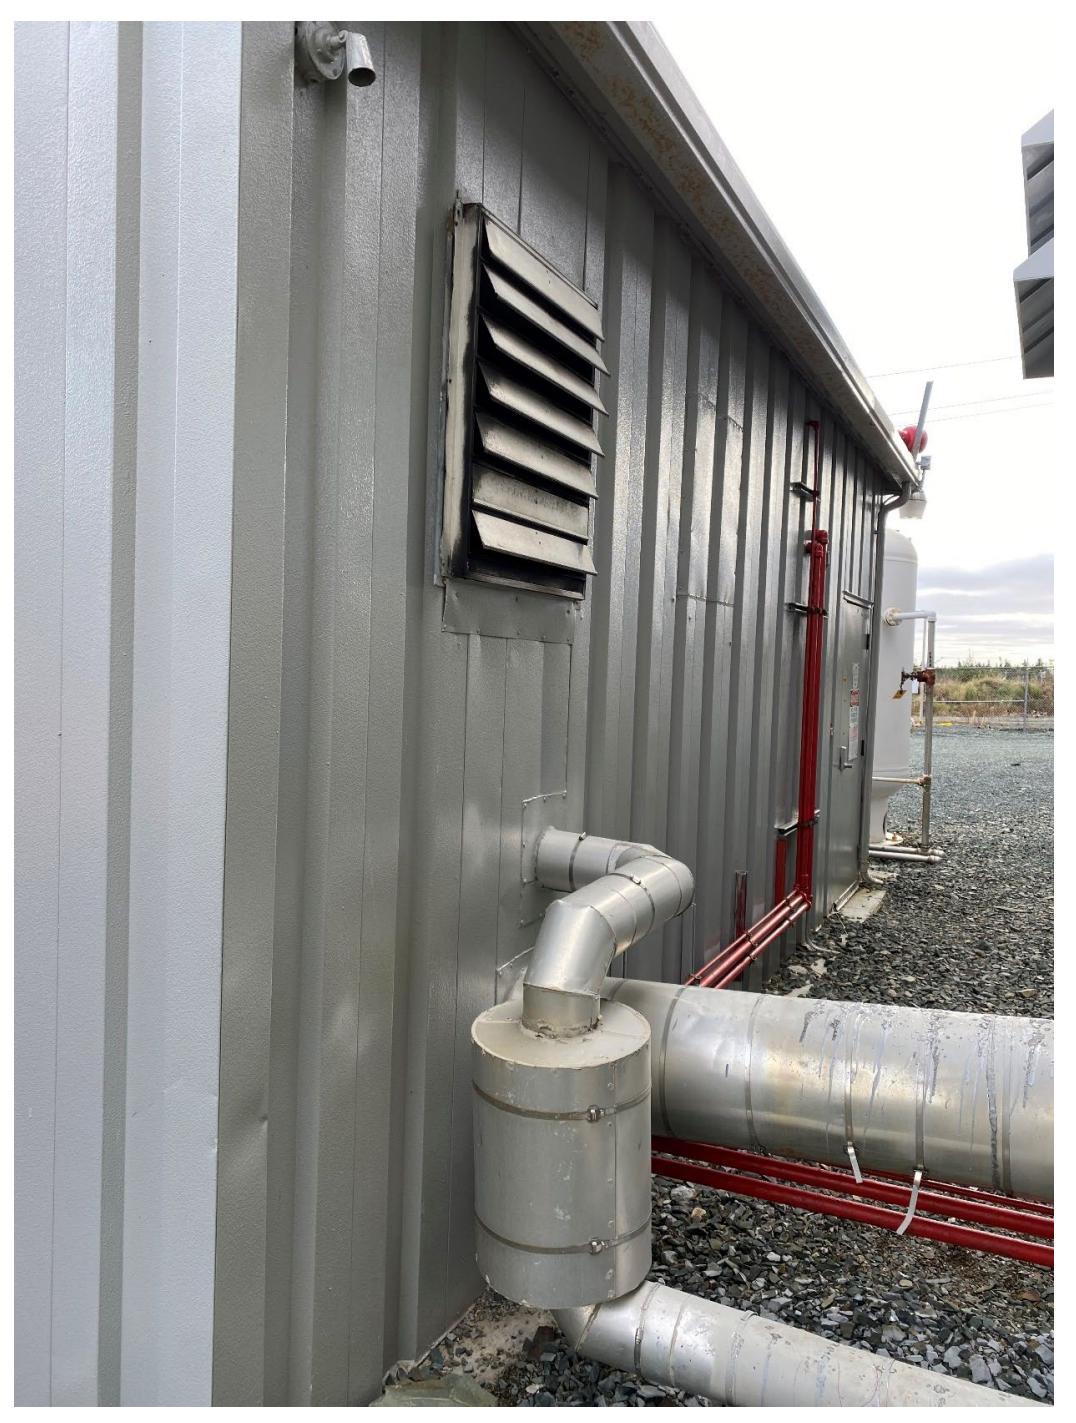
Figure 4-51: Structure Envelope

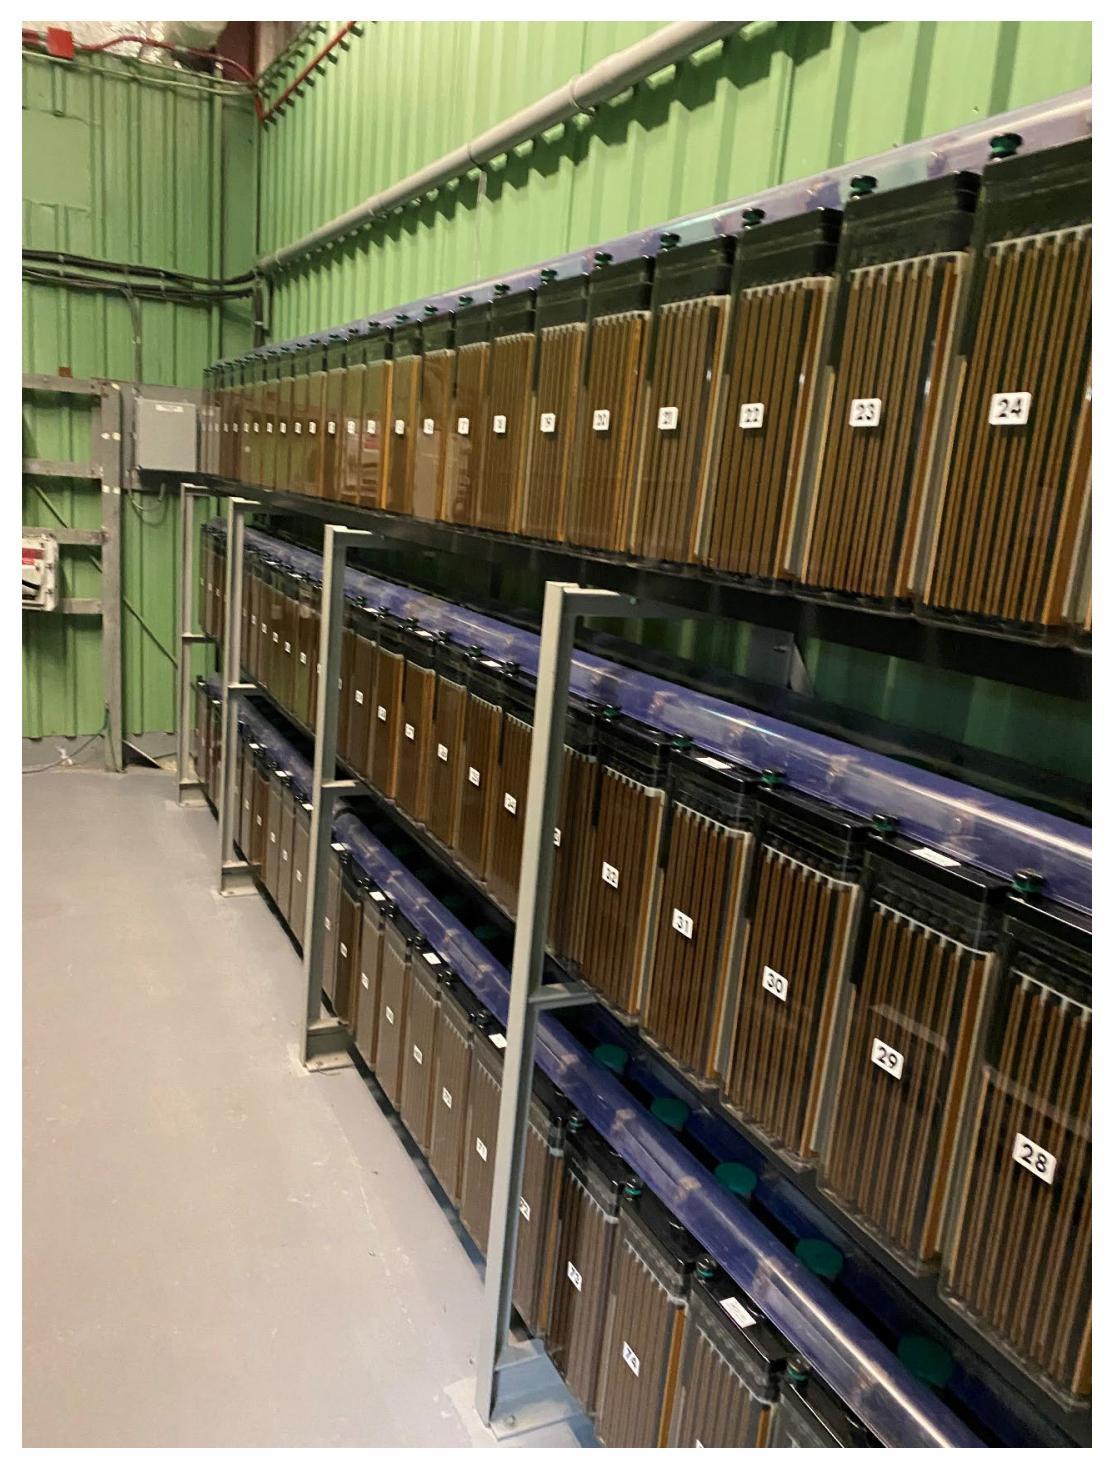
Figure 5-19: DC Batteries

The station DC supply equipment includes acid batteries which have not been replaced in the recent past. If NLH considers the DC supply batteries a critical asset, then replacement with upgraded batteries is recommended.

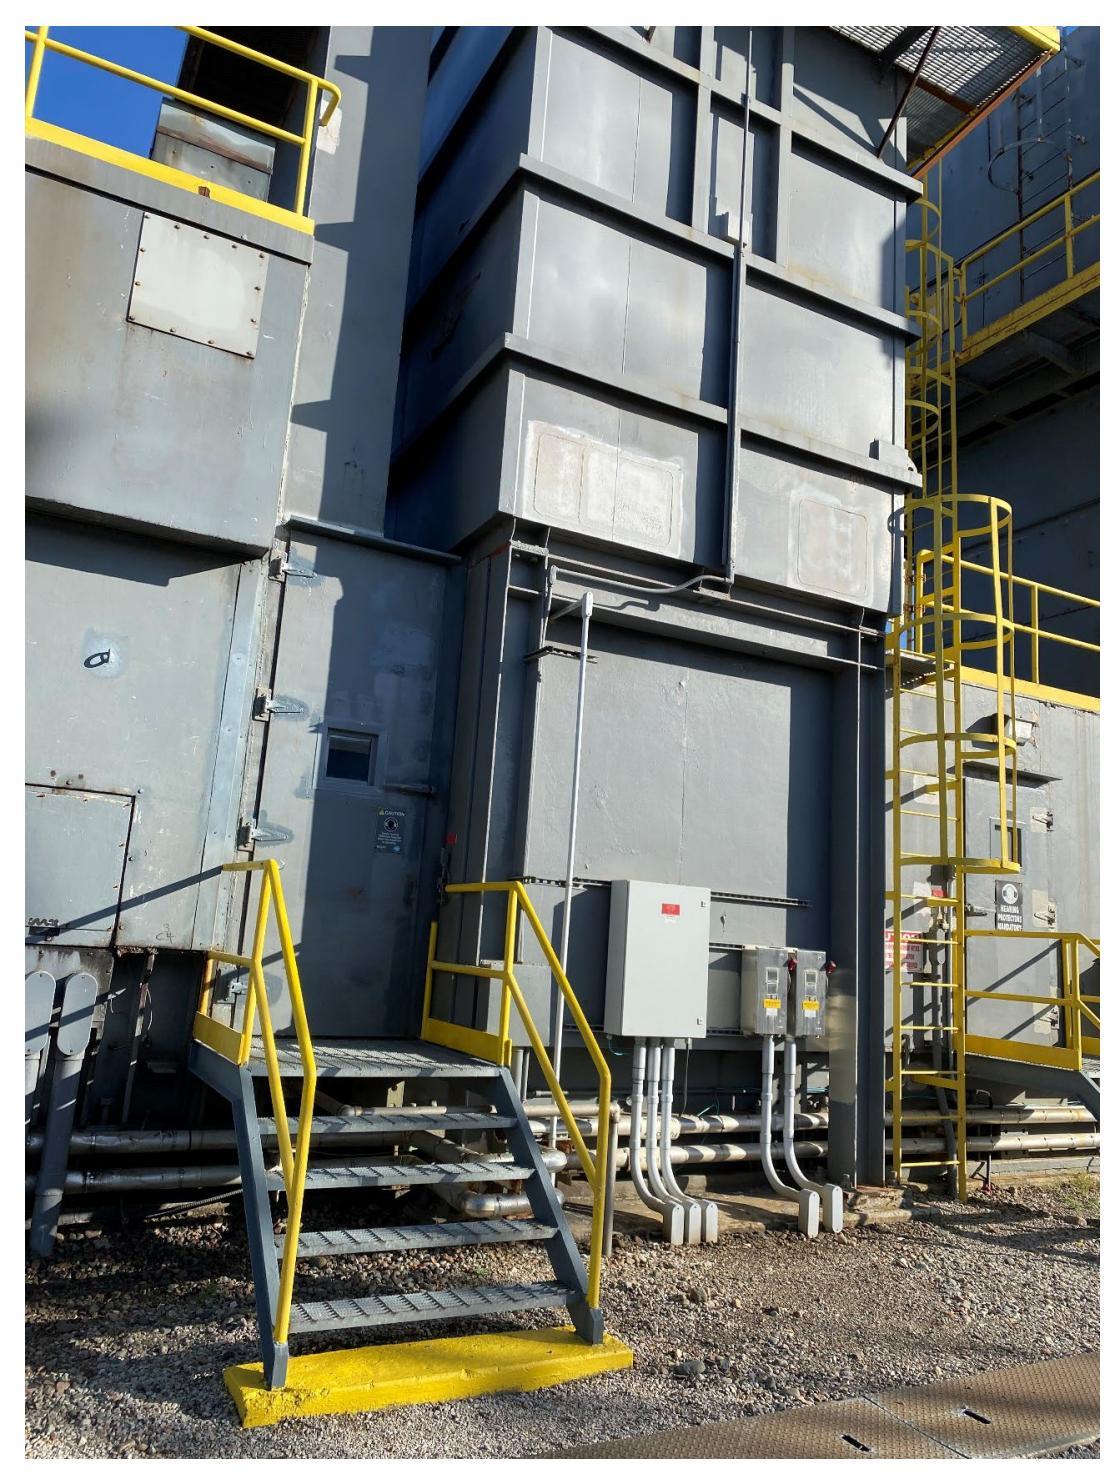
Figure 5-37: Exhaust Stack

The plant given its age is generally in good running condition with a few assets needing attention. The Exhaust Stack on Unit A has a small heat leak and there is movement of the insulation. The insulation should be replaced as necessary and firmly reattached. All thermal damage to the stack shell and coating systems should be repaired.

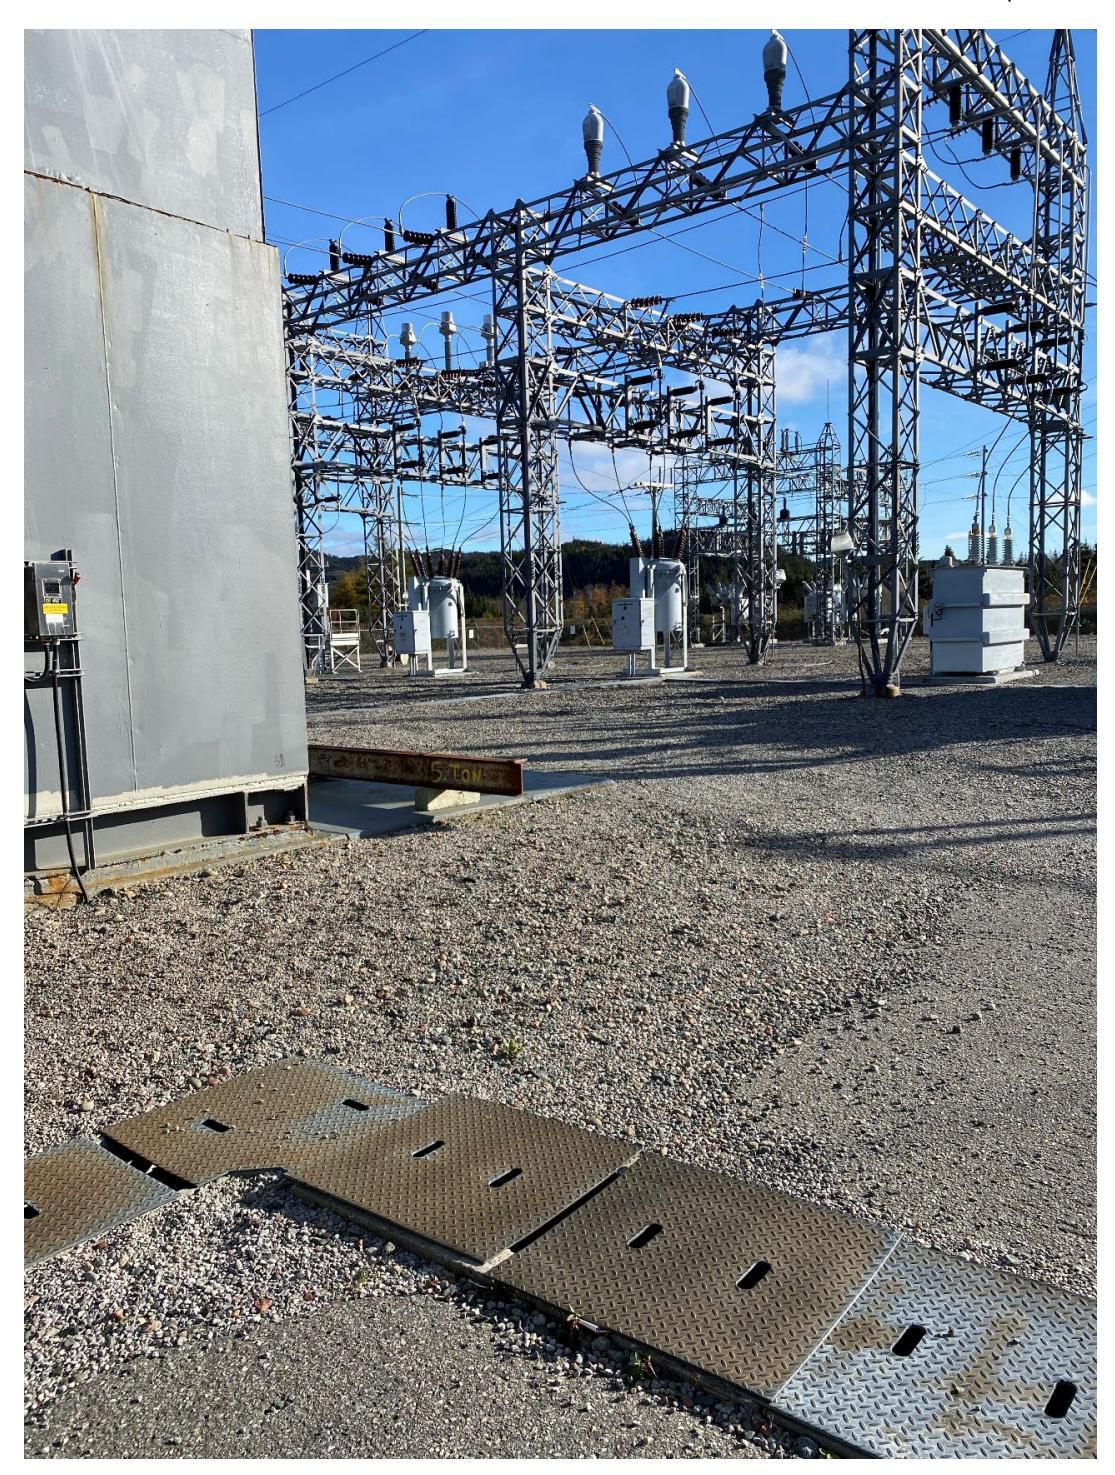
Figure 5-38: Terminal Station

The replacement of the main transformer is required by 2025 due to PCB containing oil.
