1 Q. **Reference: Application, Schedule 1: Upgrade Report – Penstock 1 Life Extension – Bay**
2 **d'Espoir, Appendix J, Page 26 of 51..**

PENSTOCK NO. 1 INSPECTION AND EVALUATION

BAY D'ESPOIR HYDROELECTRIC DEVELOPMENT PENSTOCKS 1-3 INSPECTION PROJECT

2670021_003RP
April 2020

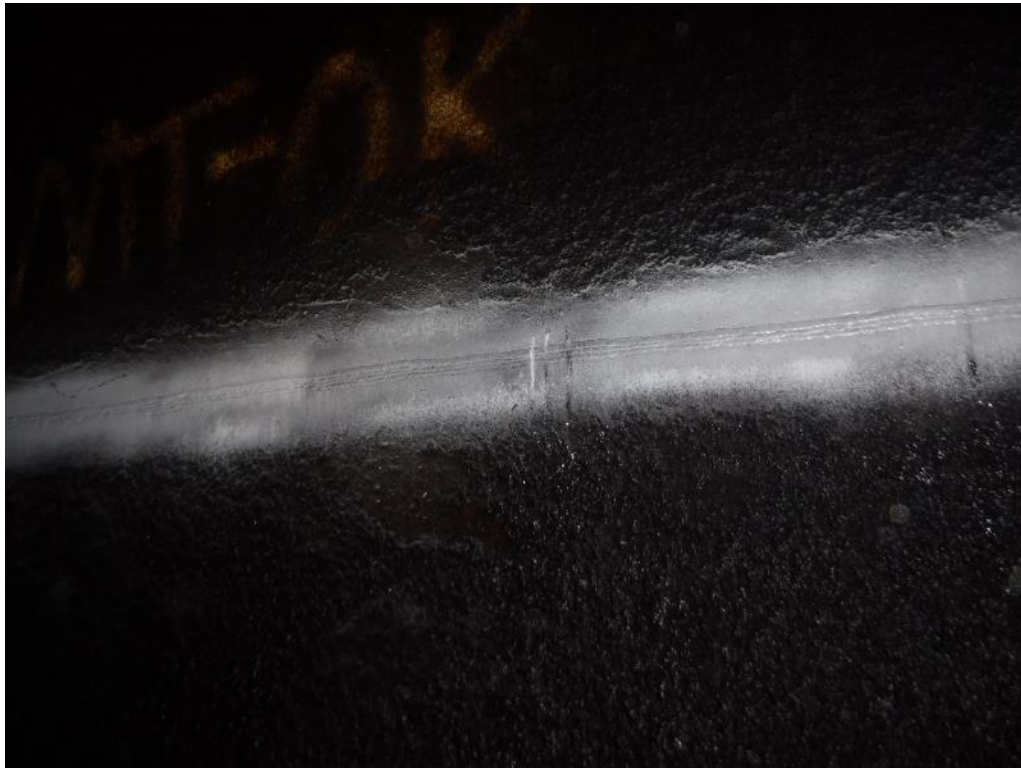
PHOTO 4 PREVIOUSLY REPAIRED WELD WITH CONTRAST PAINT

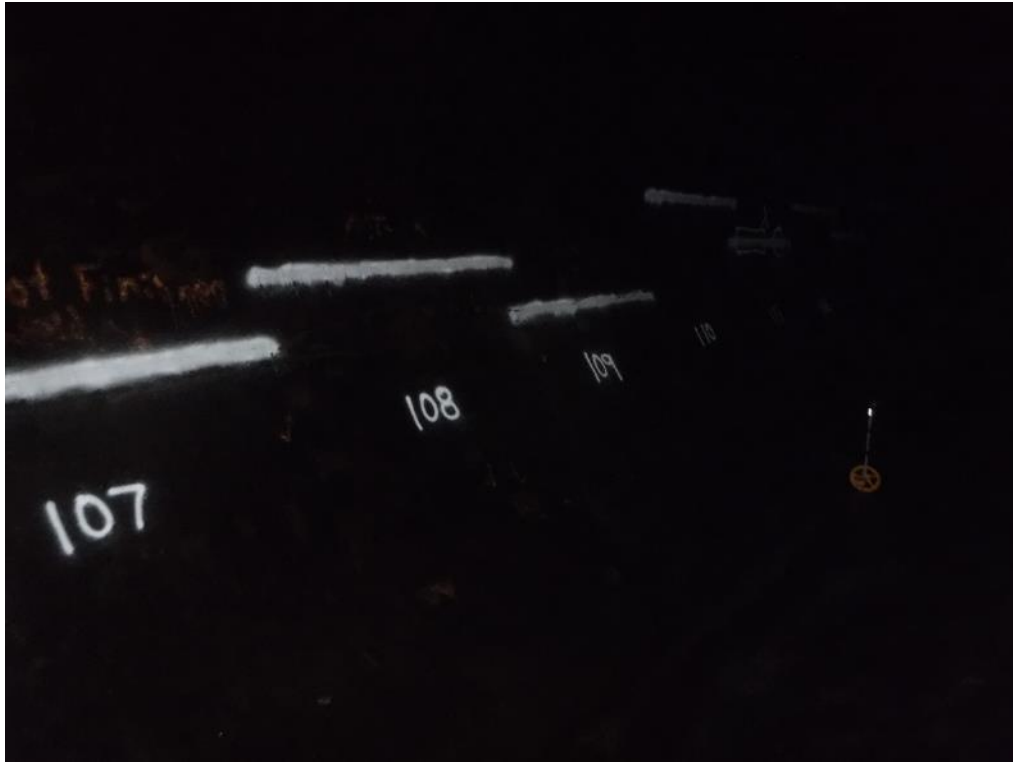
PHOTO 9 WELD TESTING OF EVERY CAN NEAR CAN 106'S CRACKED WELD

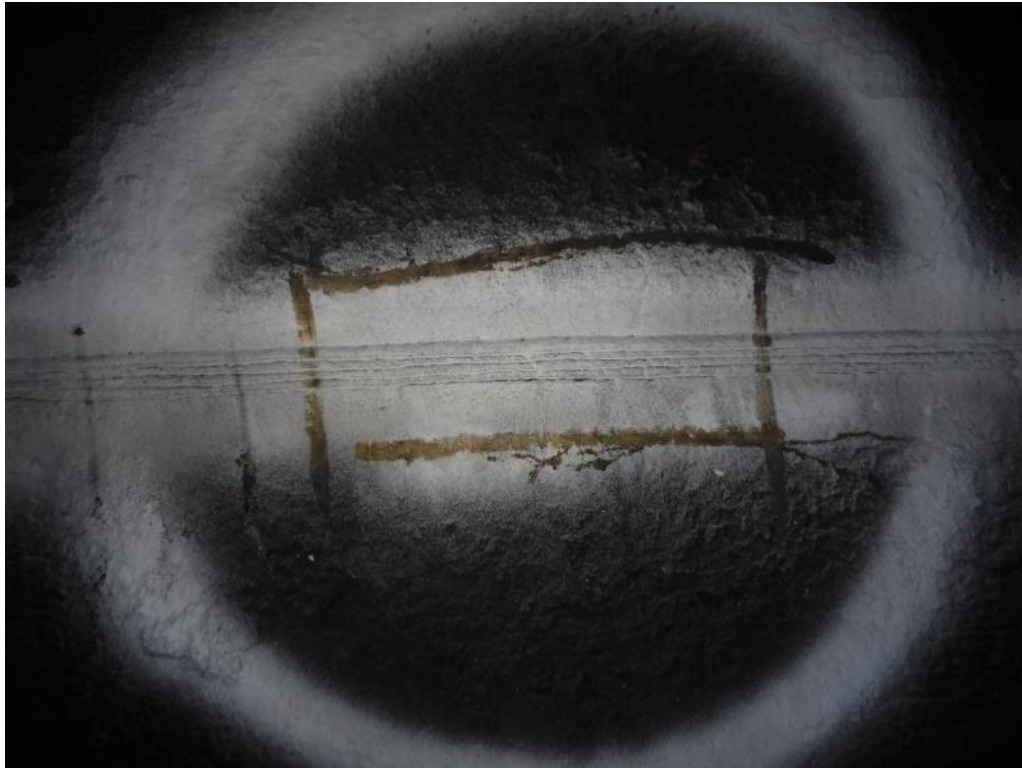
many other microscopic cracks in the welds. In addition, Penstock No. 2 was inspected in 2017 and Penstock No. 3 in 2018. Acuren performed MT tests on the full length of 40 longitudinal welds and a few feet of 30 circumferential welds for this inspection. In addition to the crack found along the longitudinal weld on the right side of Can 106 (Photos 6 to 8) which lead to the dewatering of the penstock, an indication was found along the longitudinal weld on the left side of Can 111 (Photos 10 and 11) . No other cracks or indications were discovered from the MT testing.

PHOTO 11 INDICATION OF ISSUE CAN 111 WELD NEAR SPRING LINE

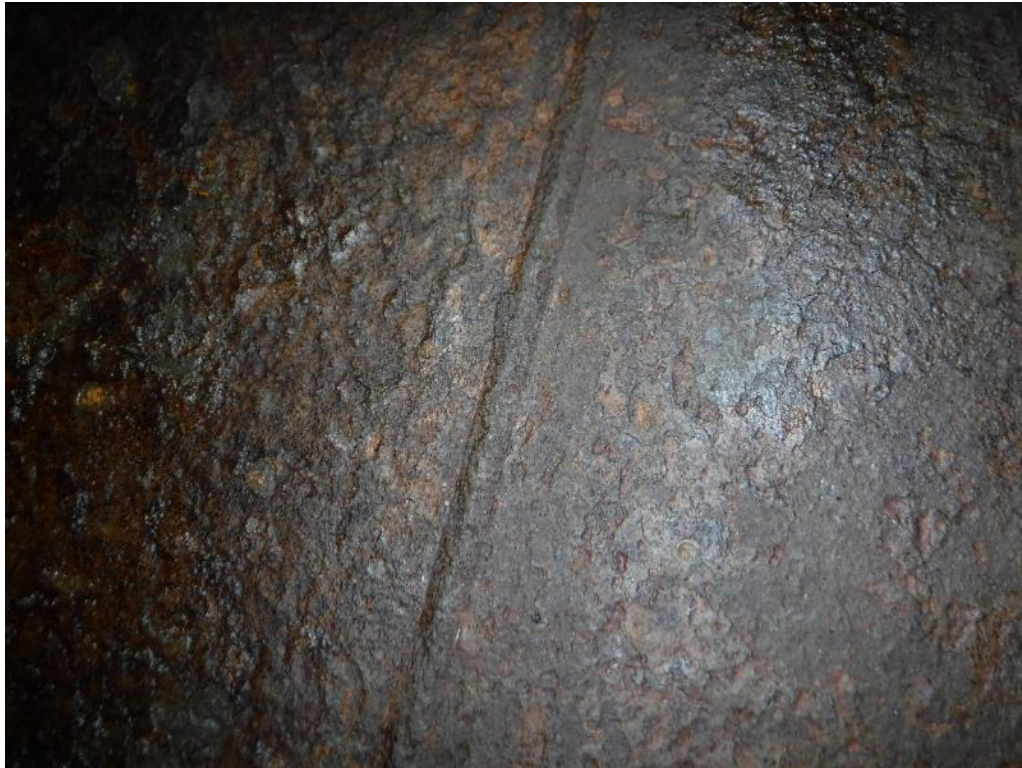
PHOTO 13 ORIGINAL CIRCUMFERENTIAL WELD CAN 194

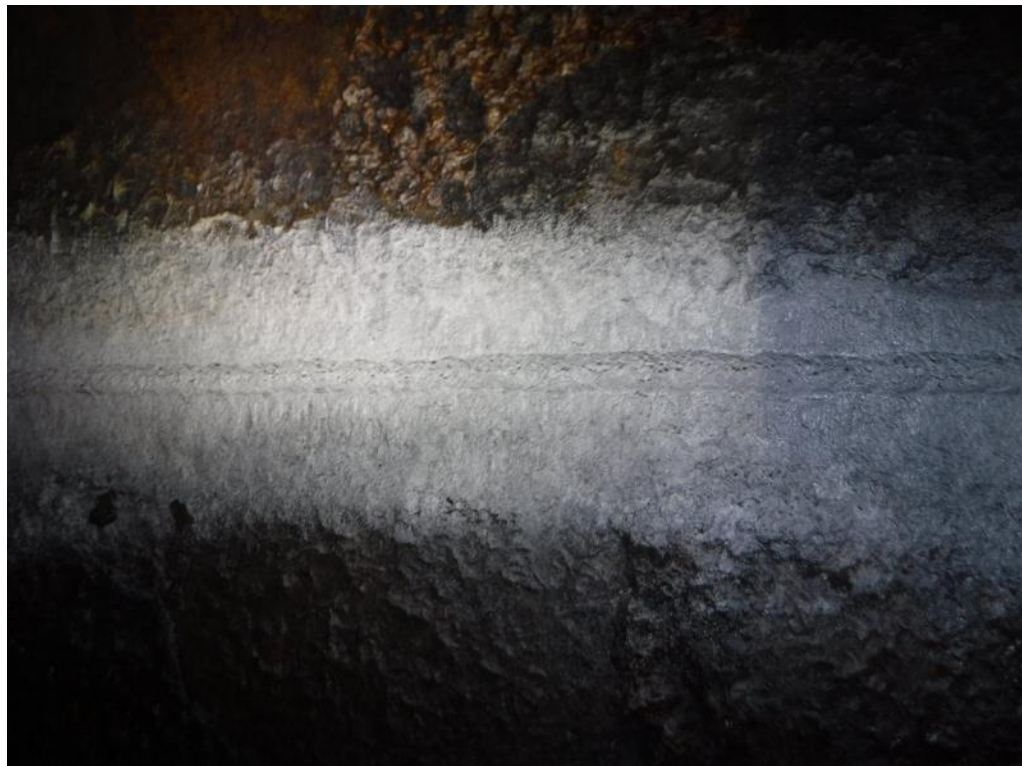
PHOTO 14 ORIGINAL HORIZONTAL WELD CAN 201

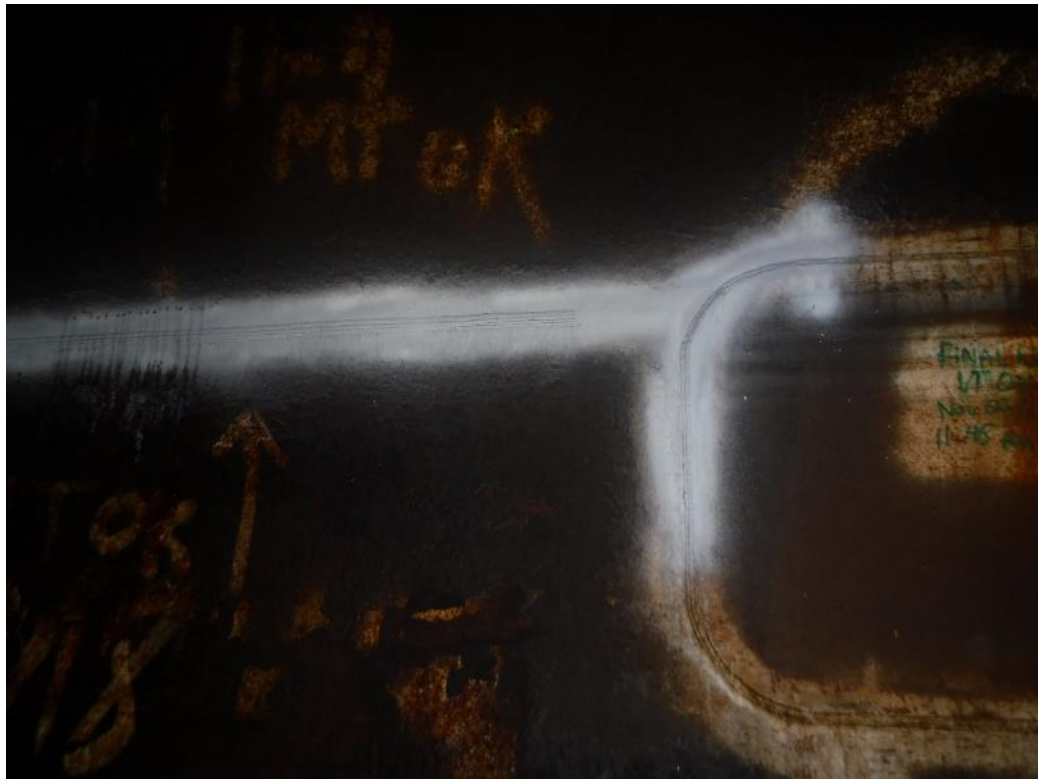
PHOTO 16 **WELD TEST INCLUDED PART OF DOUBLER PLATE WELD**

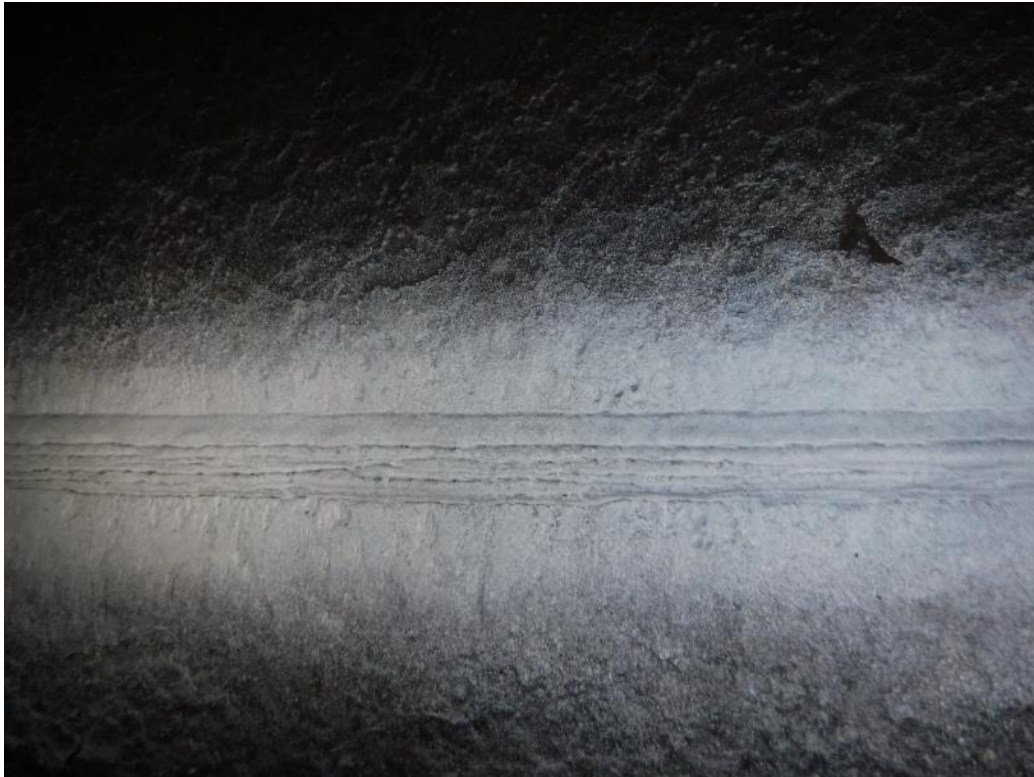
PHOTO 17 TEST OF PREVIOUSLY REPAIRED WELD CAN 123

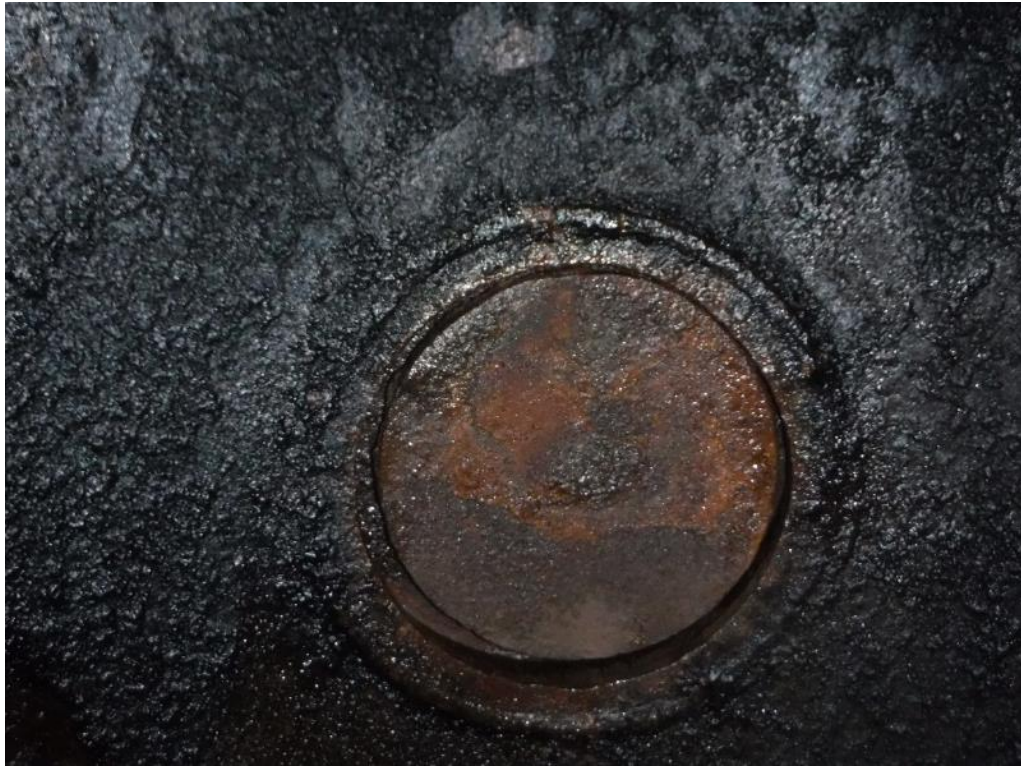
PHOTO 21 MANHOLE 3 NOT OPENED.

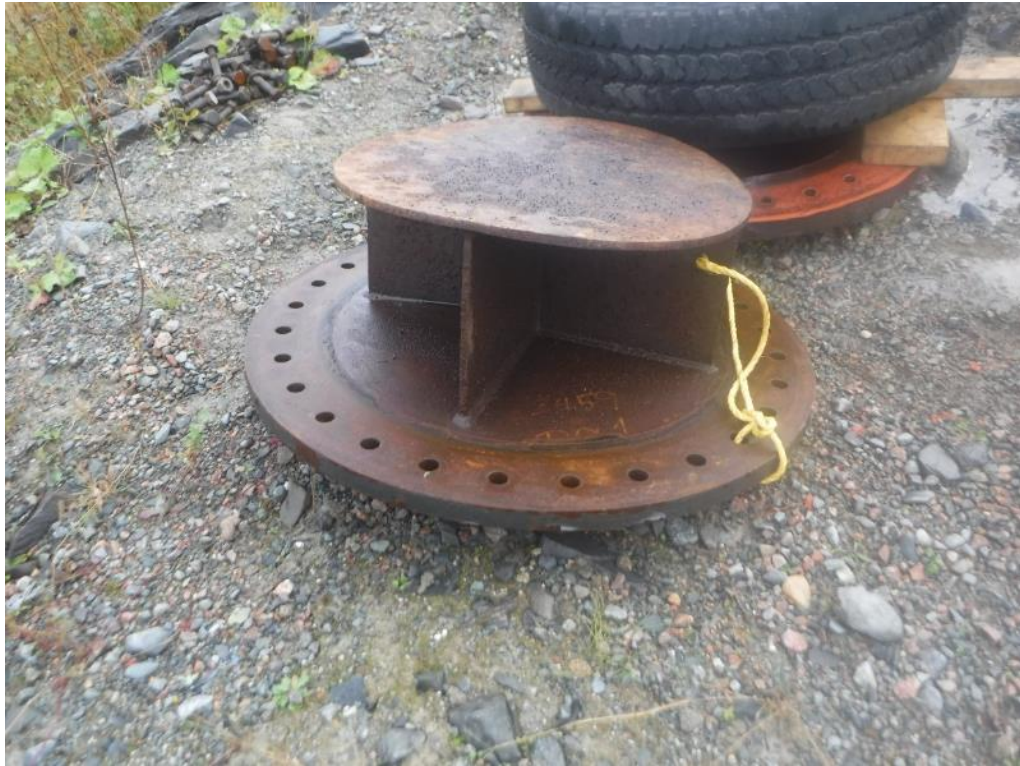
The crack location that resulted in the leak was covered with a tarp (Photo 28). Other features noted along the penstock route included open Manhole No. 1 (Photo 25), a piezometer just upstream of the crack location (Photo 27), and a pressure monitor (Photo 32) and closed Manhole No. 3 (Photo 33) that all appeared to be in good condition. No drainage wells were observed. It is recommended that bushes and alders growing in a few locations on the upper end of the penstock should be removed.

PHOTO 25 MANHOLE 1 COVER WITH REINFORCING PLATES

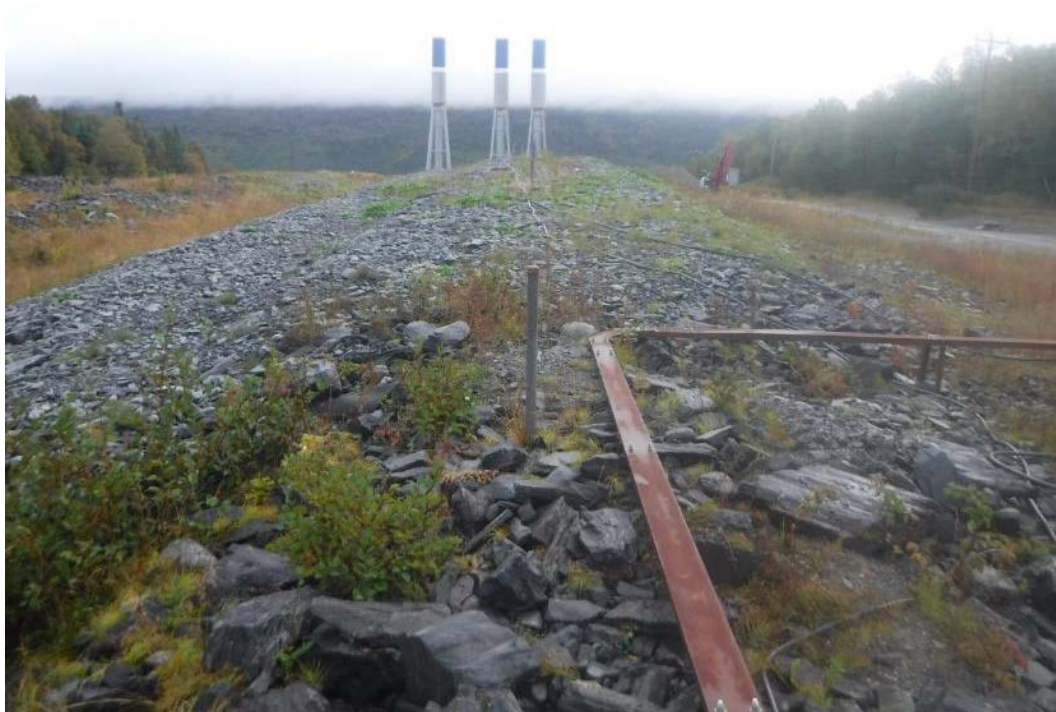
The exterior of the penstock was inspected on September 26, 2019. The ground surface was generally rock covered with steep slopes in many areas and short vegetation (Photo 26). There was no snow present and the ground was reasonably dry limiting slip potential. The grade nominally followed the penstock slope between the intake and the switchyard. Deeply buried sections under the dam and switchyard were not inspected from the exterior.

PHOTO 26 LOOKING DOWNSTREAM TOWARD SURGE TANKS ALONG PREVIOUSLY REPAIRED AREA

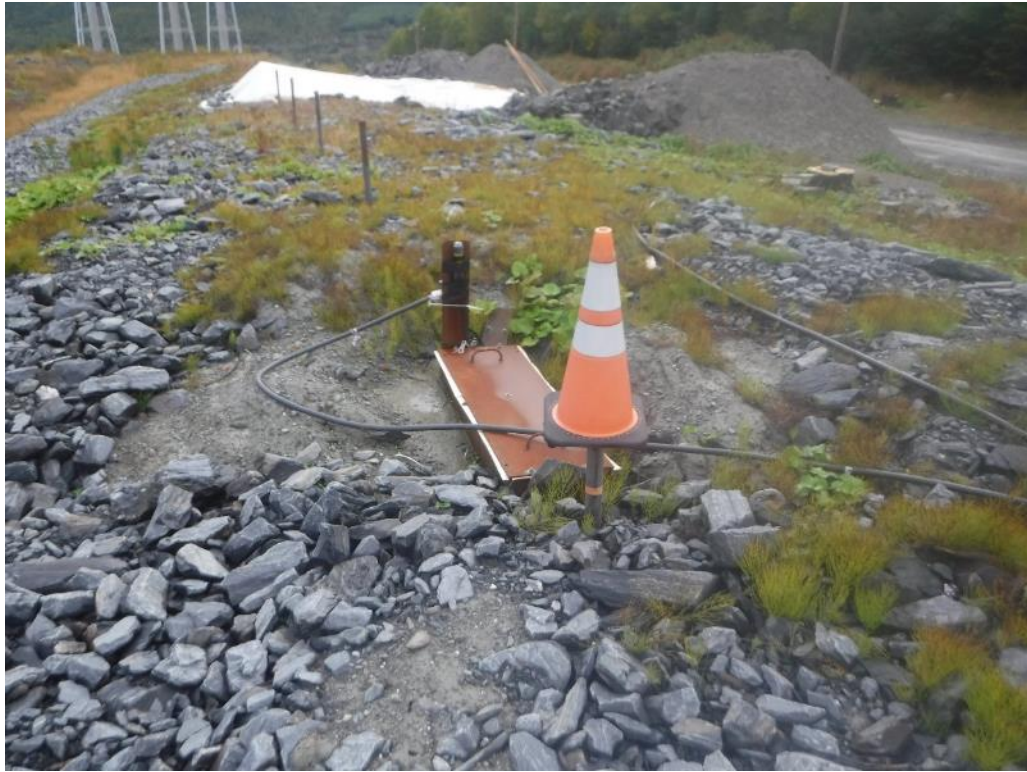
PHOTO 27 **PIEZOMETER LOCATION JUST UPSTREAM OF CRACK LOCATION**

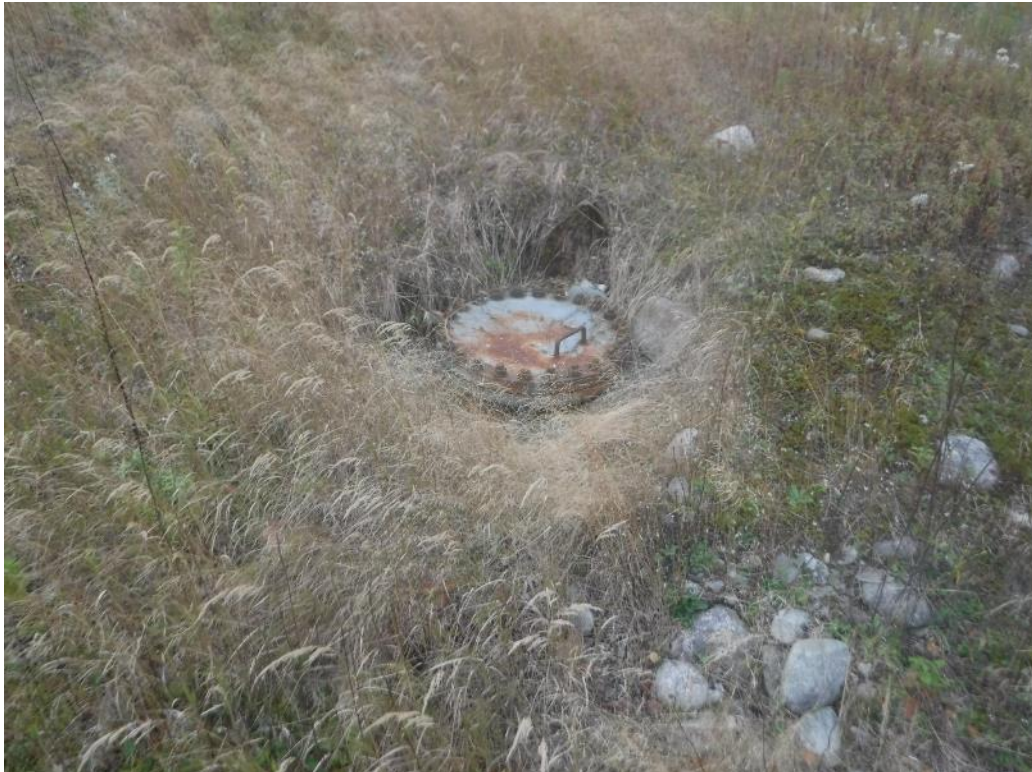
PHOTO 33 **MANHOLE 3 AT TOP OF STEEP SLOPE**

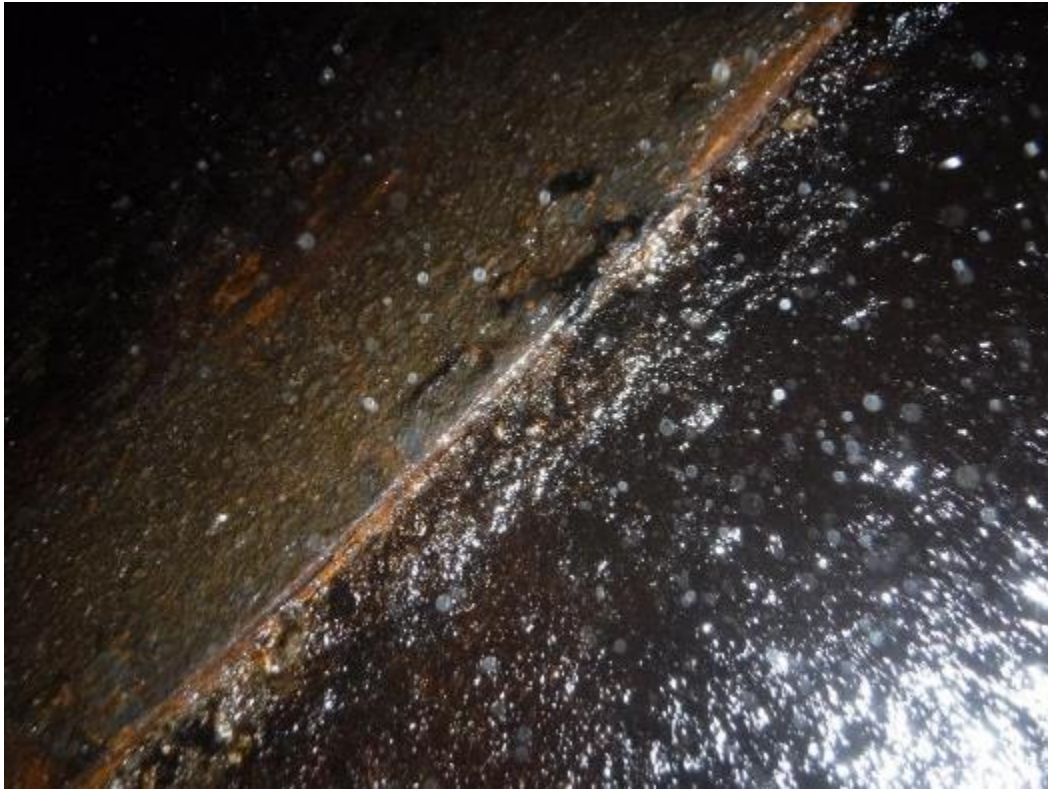
The concrete of the intake structure was in fair condition with no significant deterioration or wear, except the transition from the concrete to steel penstock showed significant deterioration all around and especially the lower left side area (Photo 3). The headgate seals appeared to be in good condition with only minor leakage of the headgate apparent from the bottom left corner of the headgate when looking upstream (Photo 1). The headgate skin plate also appeared to be in good condition. A full inspection of the gate members and gate embedments was not performed and was outside the scope of work.

Photo 3 Concrete to Steel Transition Right Side

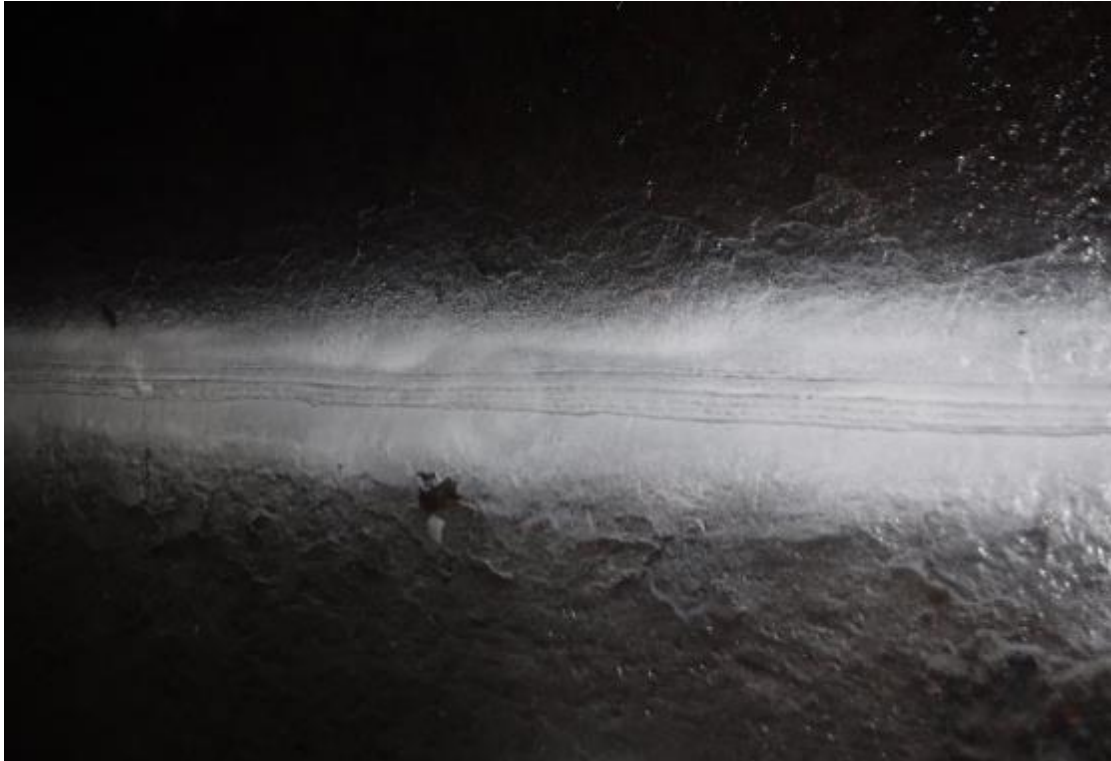
Photo 6 Typical repaired weld with contrast paint tested this year

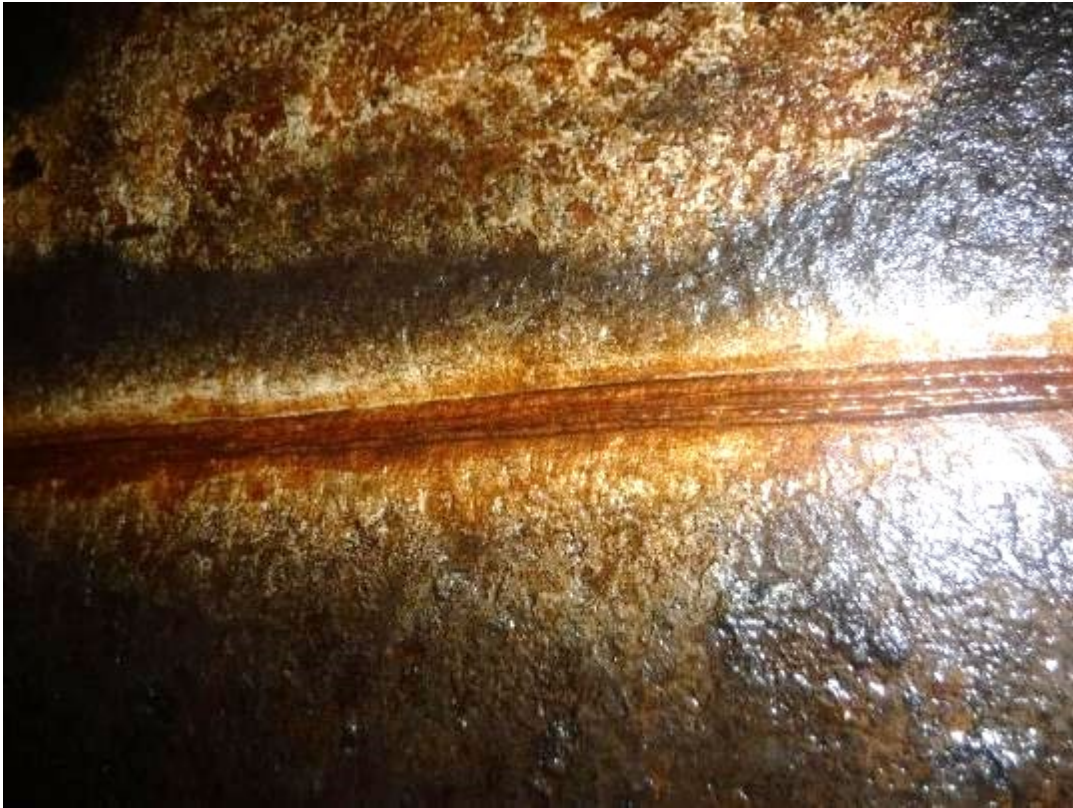
Photo 7 Typical repaired weld not tested this year

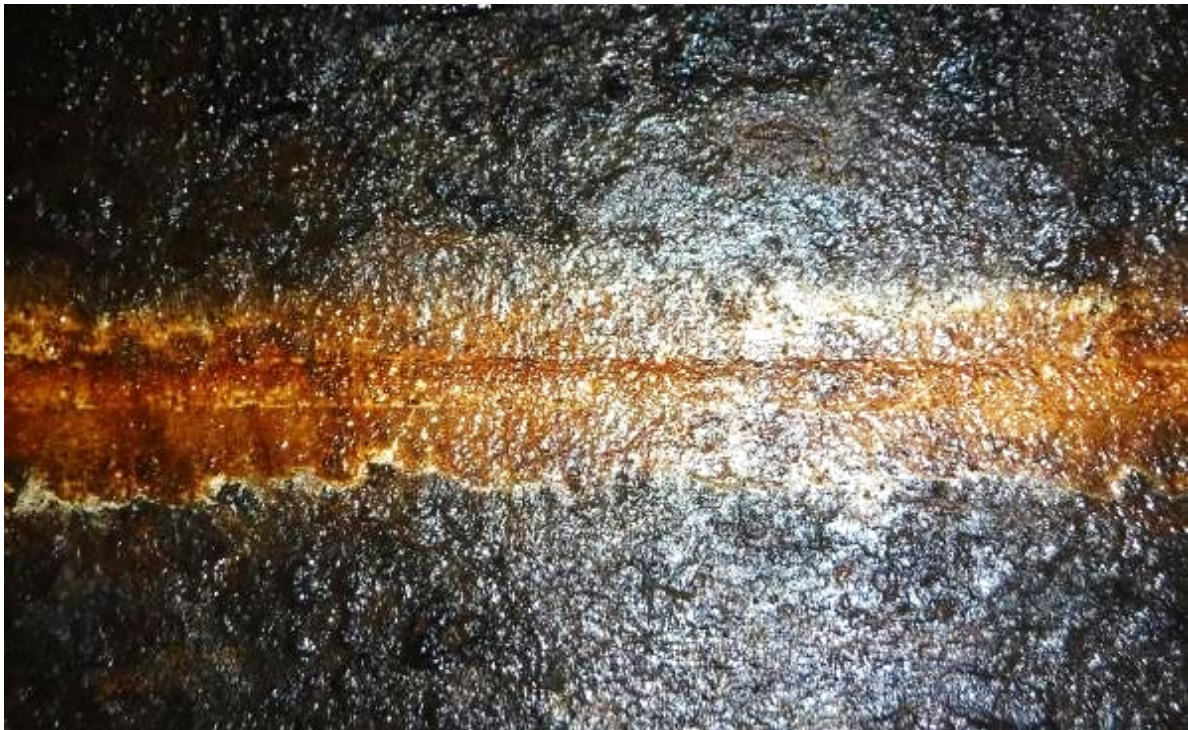
Photo 9 Typical original weld previously tested but not in 2020

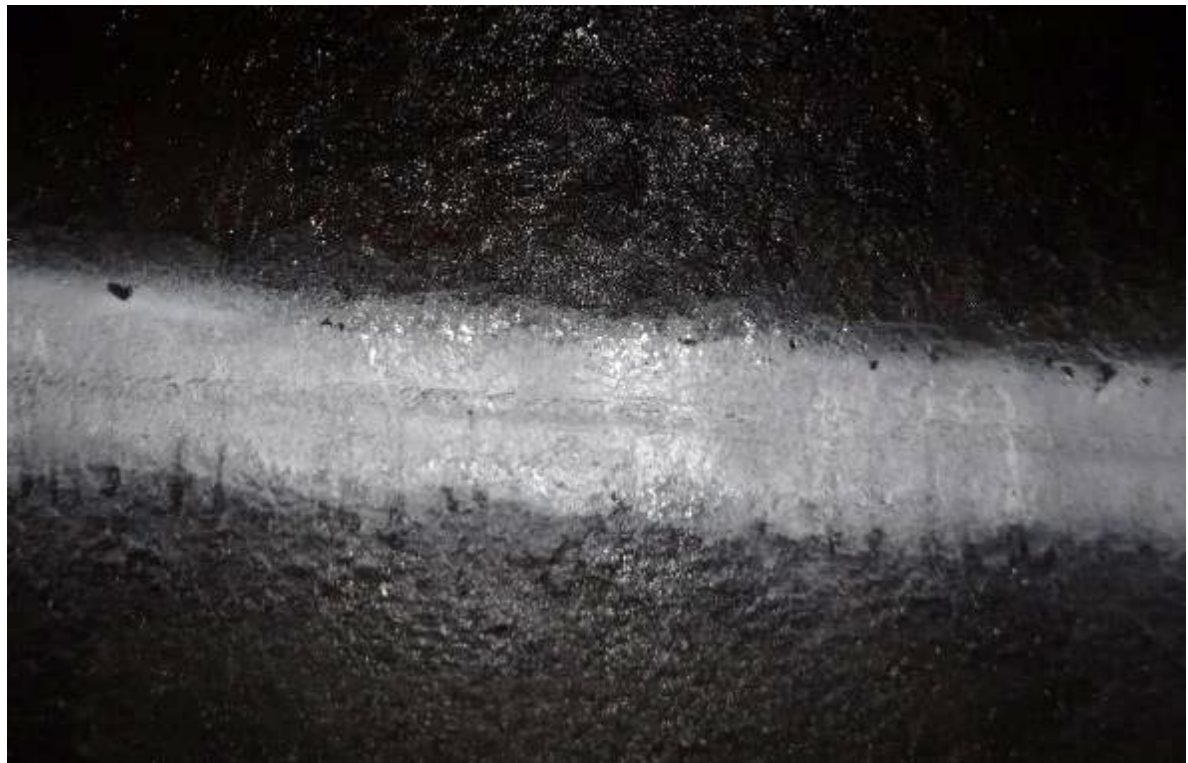
Photo 10 Typical original weld with contrast paint tested this year

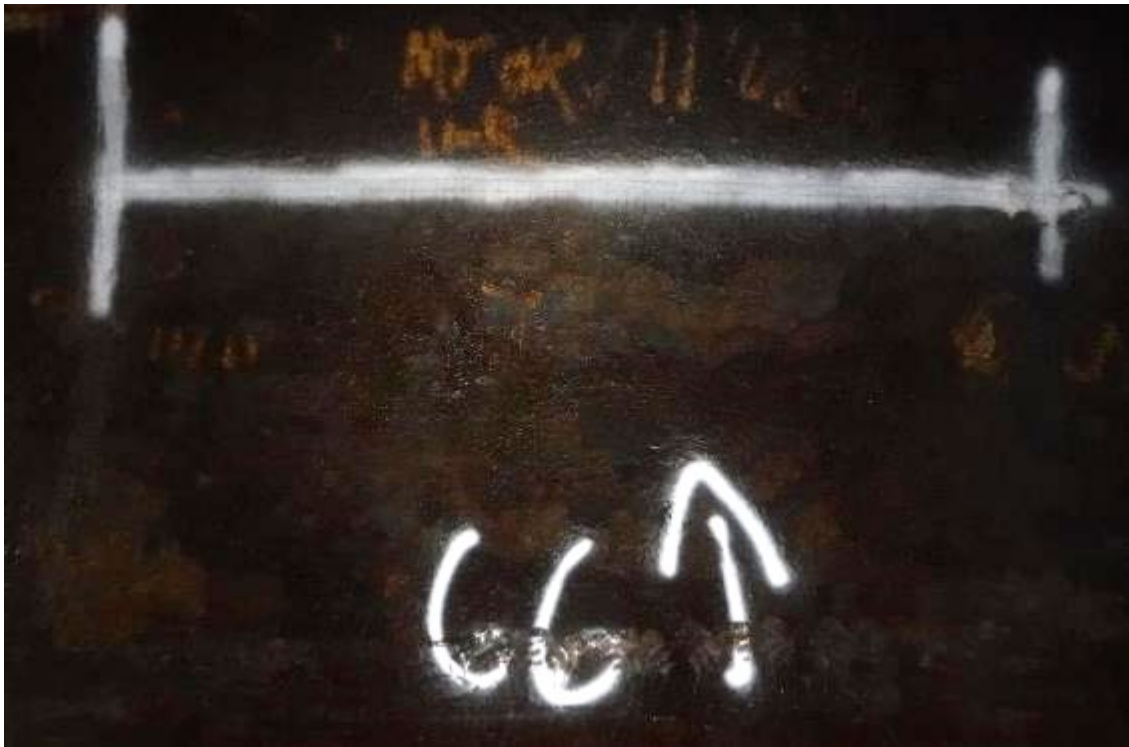
Photo 13 Tested weld Can 66

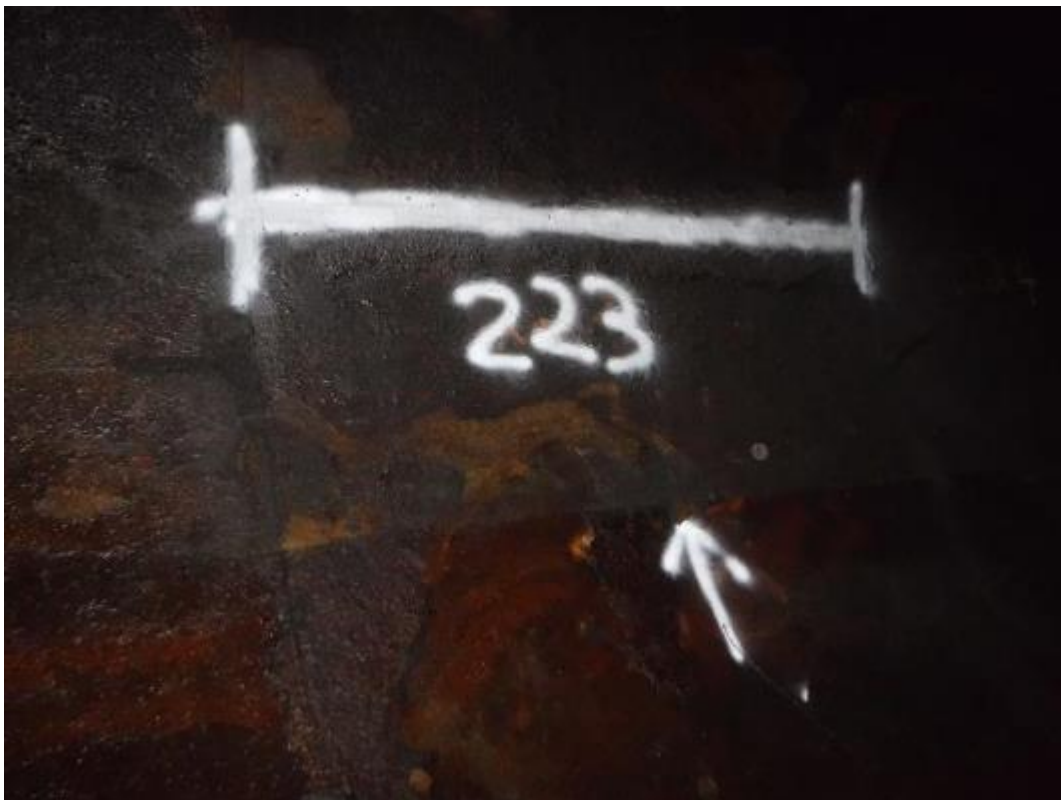
Photo 16 Tested weld Can 233

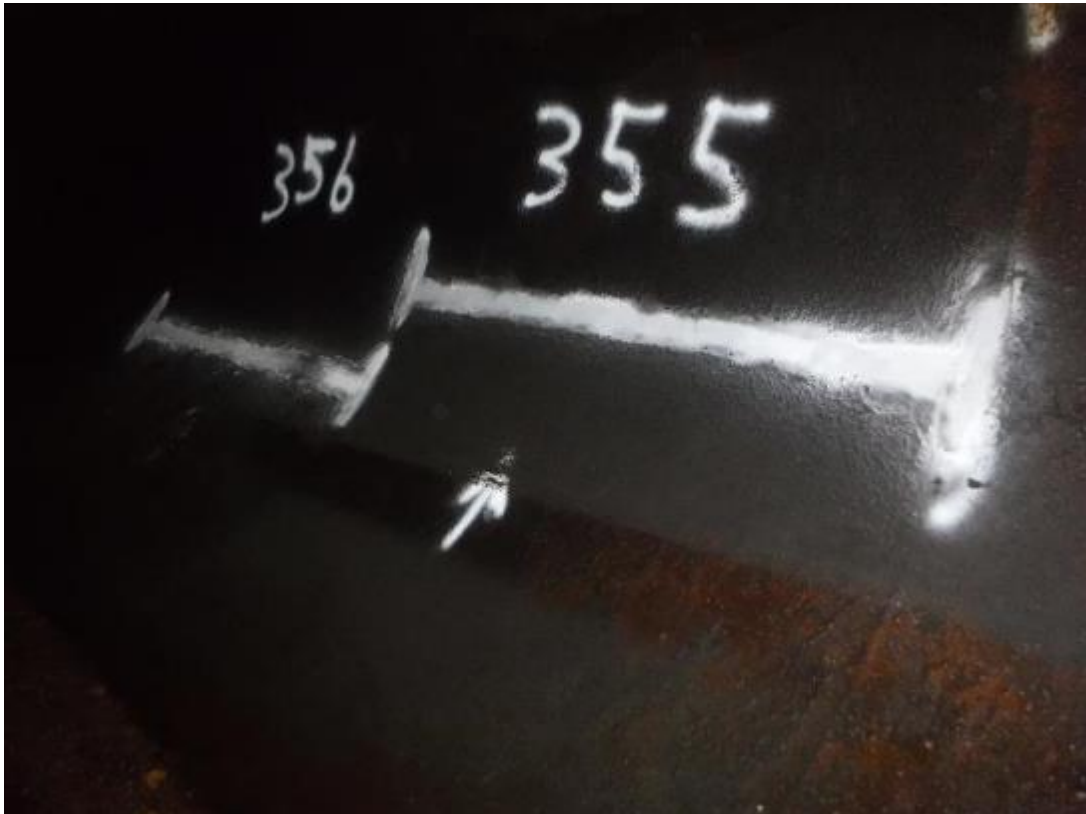
Photo 18 Tested weld Can 355

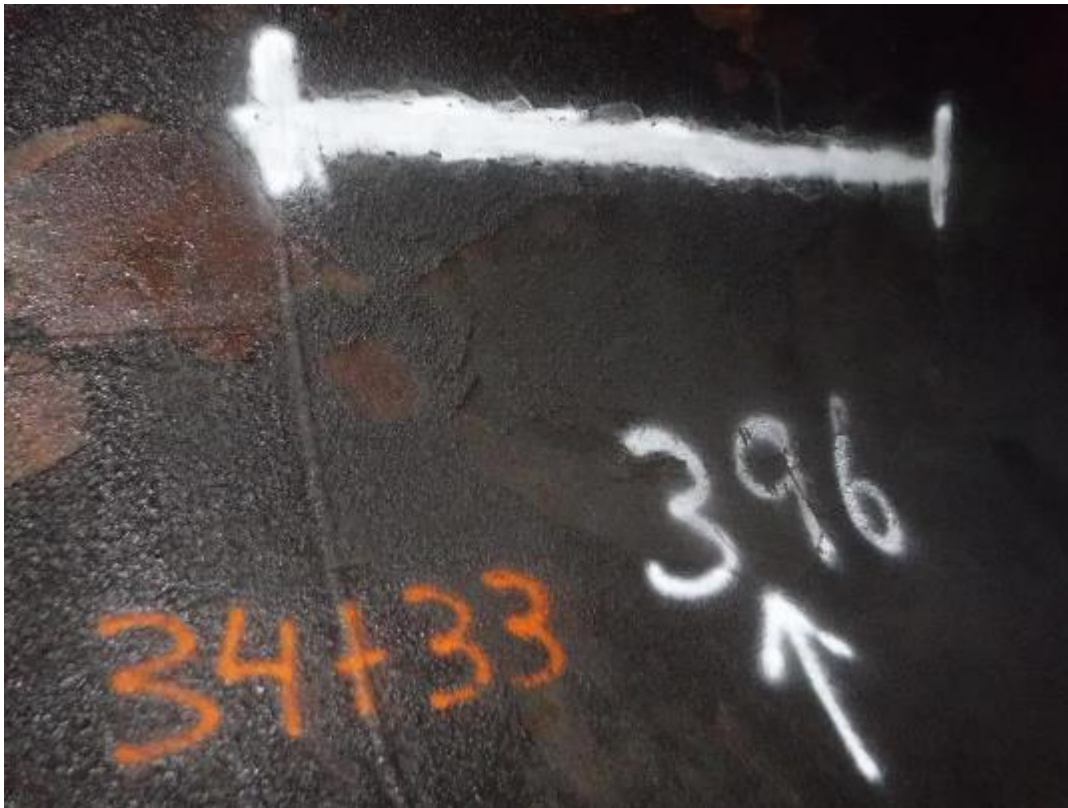
Photo 19 Tested weld Can 396

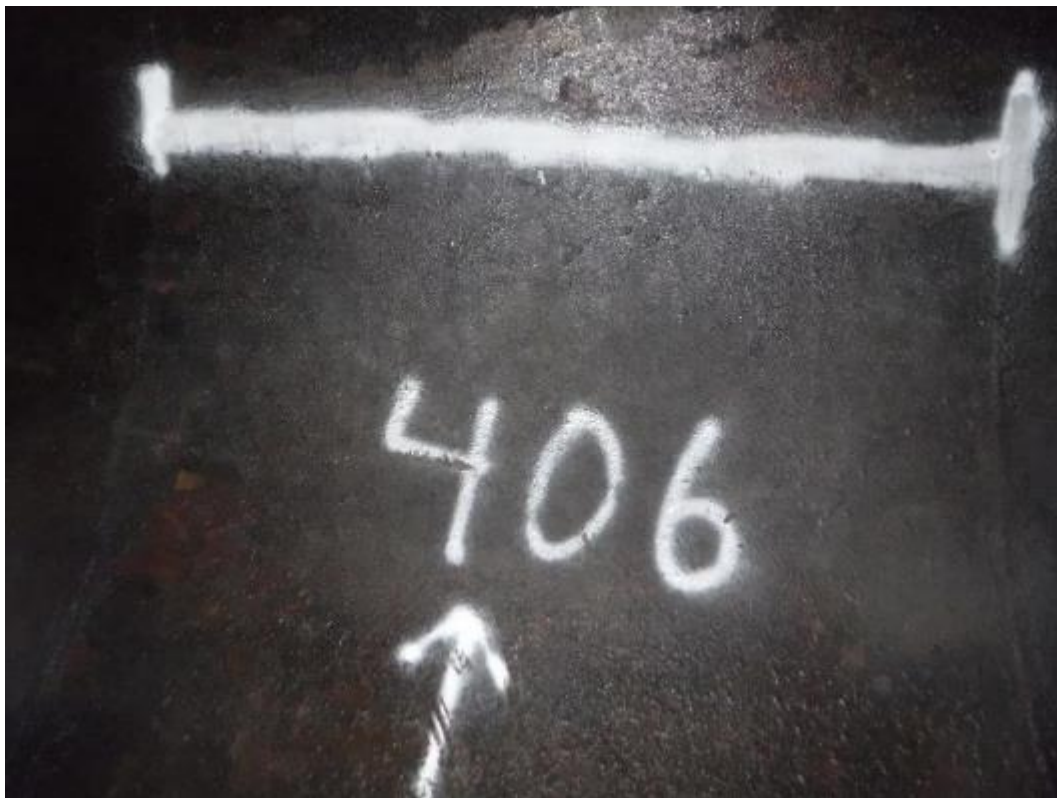
Photo 20 Tested weld Can 406

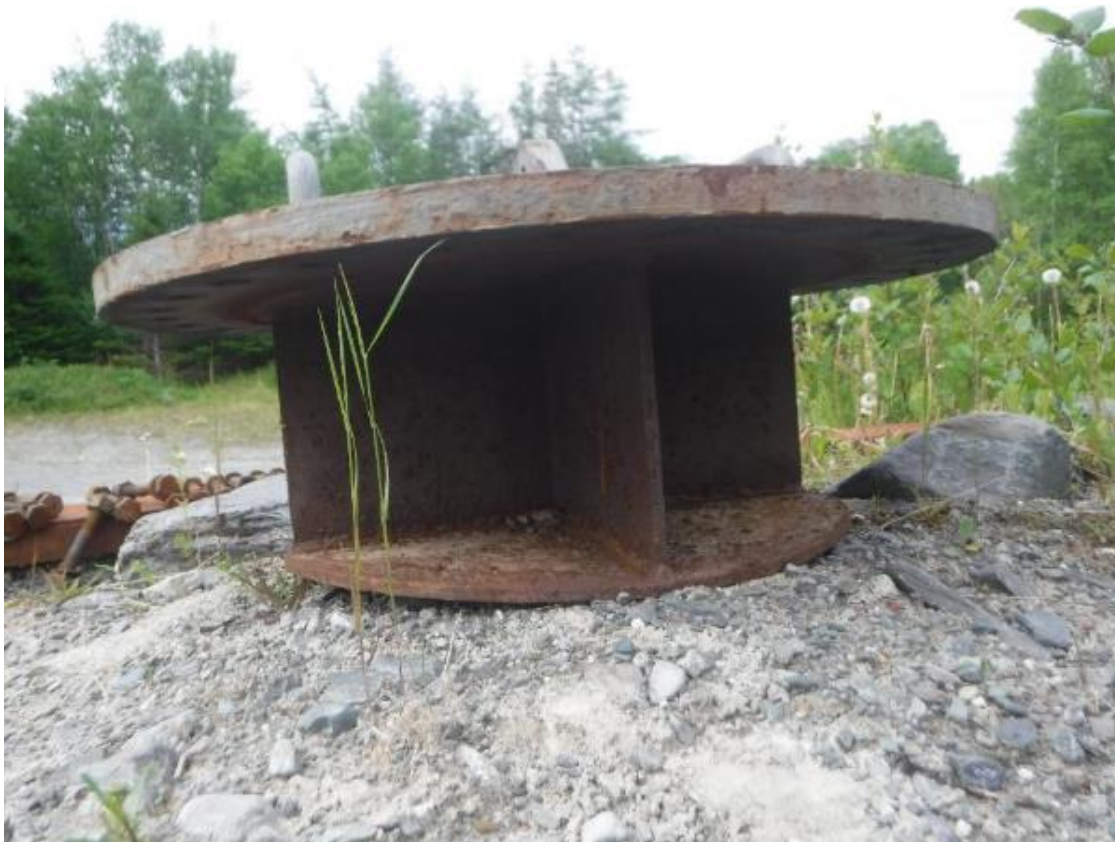
The manholes were in fair condition with moderate corrosion of the interior surface of the manholes (Photo 27).

Photo 27 Cover for Manhole No. 2 (Second Downstream of Intake)

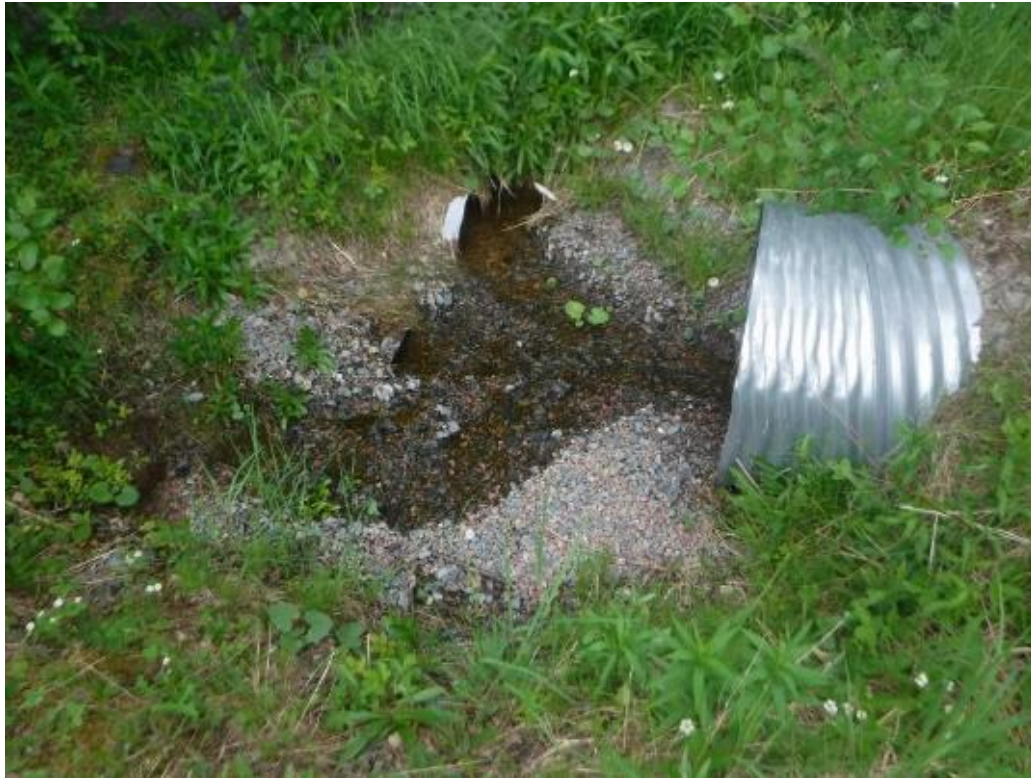
At monitoring point N2 the flow was about 2 to 3 gpm as estimated by eye (Photo 42). The weir bucket has significant moss and organics making it difficult to determine sediment load though no sediment is obvious. The bucket should be cleaned to facilitate sediment monitoring.

Photo 42 Drain outlet at N2

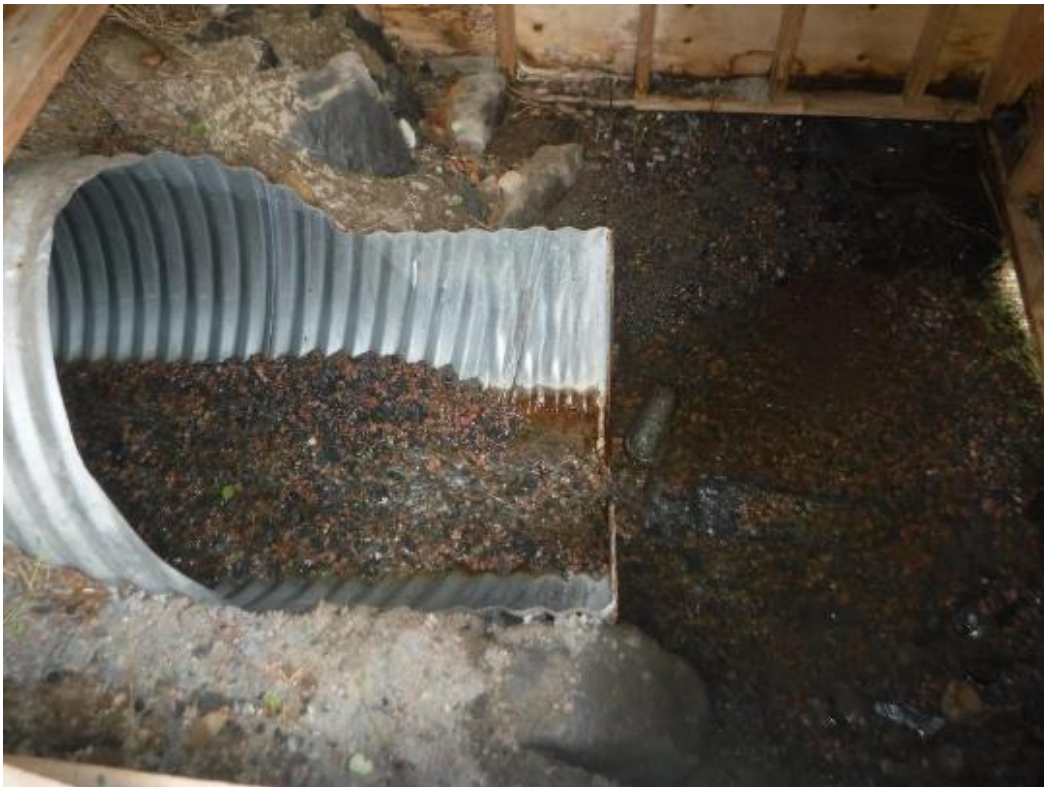
At monitoring point N1 the flow was about 5 gpm as estimated by eye (Photo 43). There is significant gravel build up obstructing the incoming pipes. The gravel should be cleaned out of the two upstream culverts to facilitate flow and monitoring.

Photo 43 Drain at N1 upstream of monitoring shed

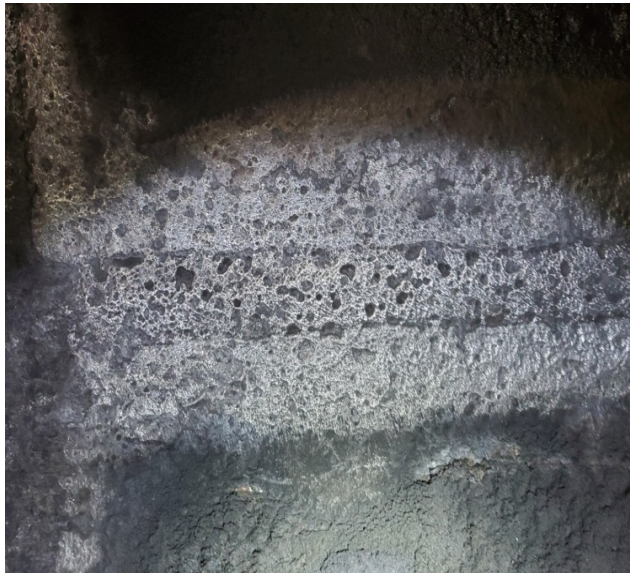
Figure 1. Can 336 - Pitting in Right Horizontal Weld
 Pre-Inspection (12" Section)

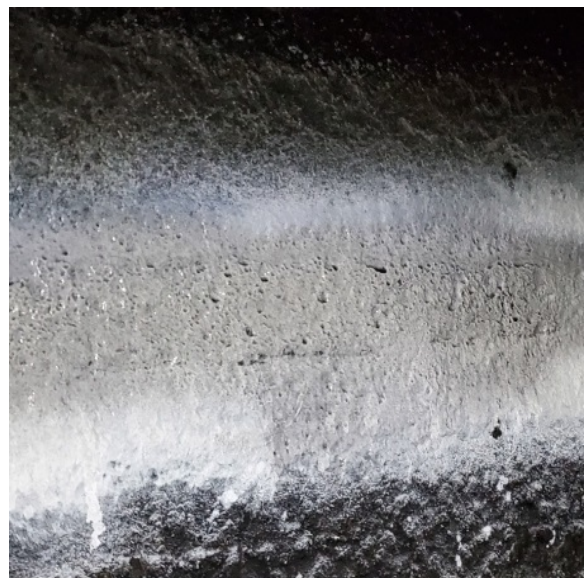
Figure 2. Can 336 - Pitting in Right Horizontal Weld
 Post-Inspection (12" Section)

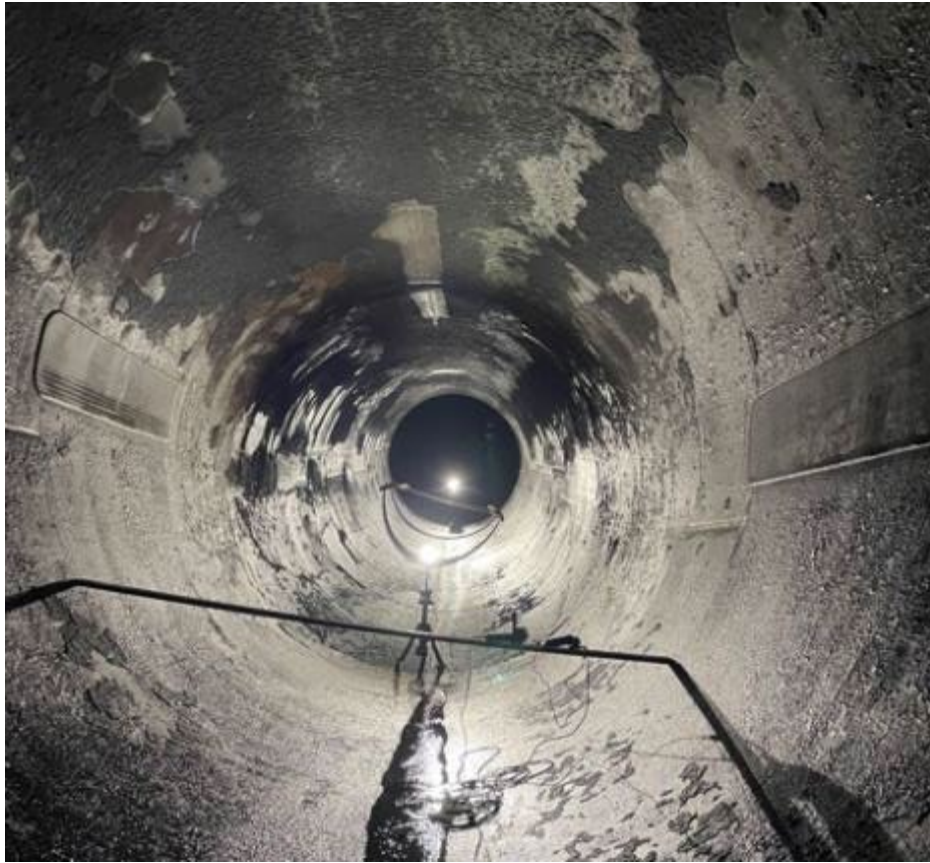
PHOTO 1 TYPICAL CONDITIONS IN 17 FT DIAMETER SECTION
