1 Q. **Reference: Application, Schedule 1: Upgrade Report – Penstock 1 Life Extension – Bay**
2 **d'Espoir, Appendix J, Page 26 of 51..**

PENSTOCK NO. 1 INSPECTION AND EVALUATION

BAY D'ESPOIR HYDROELECTRIC DEVELOPMENT PENSTOCKS 1-3 INSPECTION PROJECT

2670021_003RP
April 2020

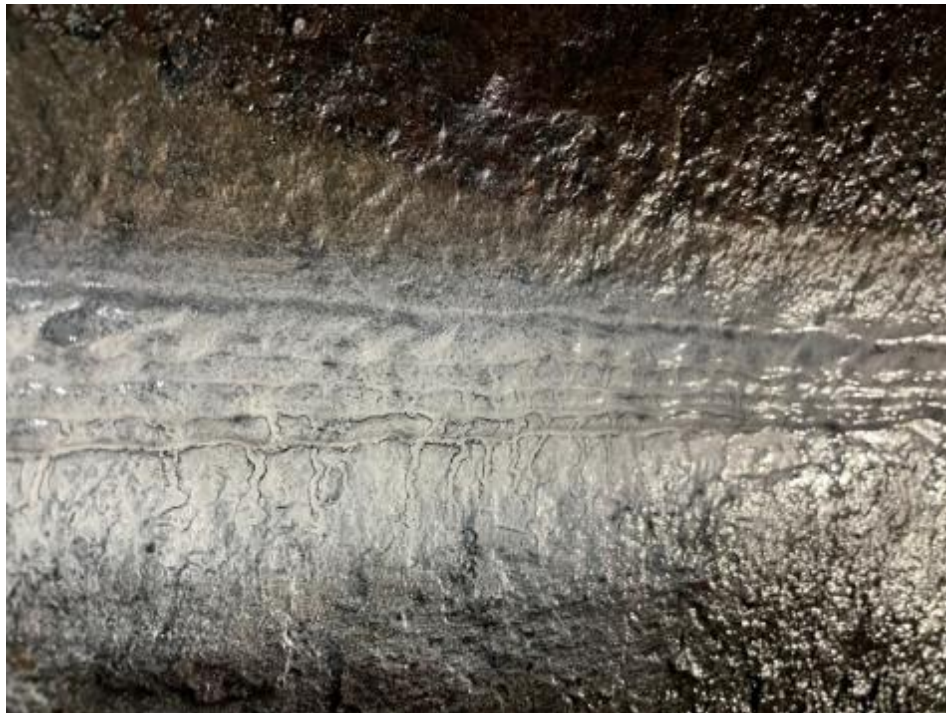
PHOTO 2 TYPICAL PREVIOUSLY REPAIRED WELD (CAN 12)

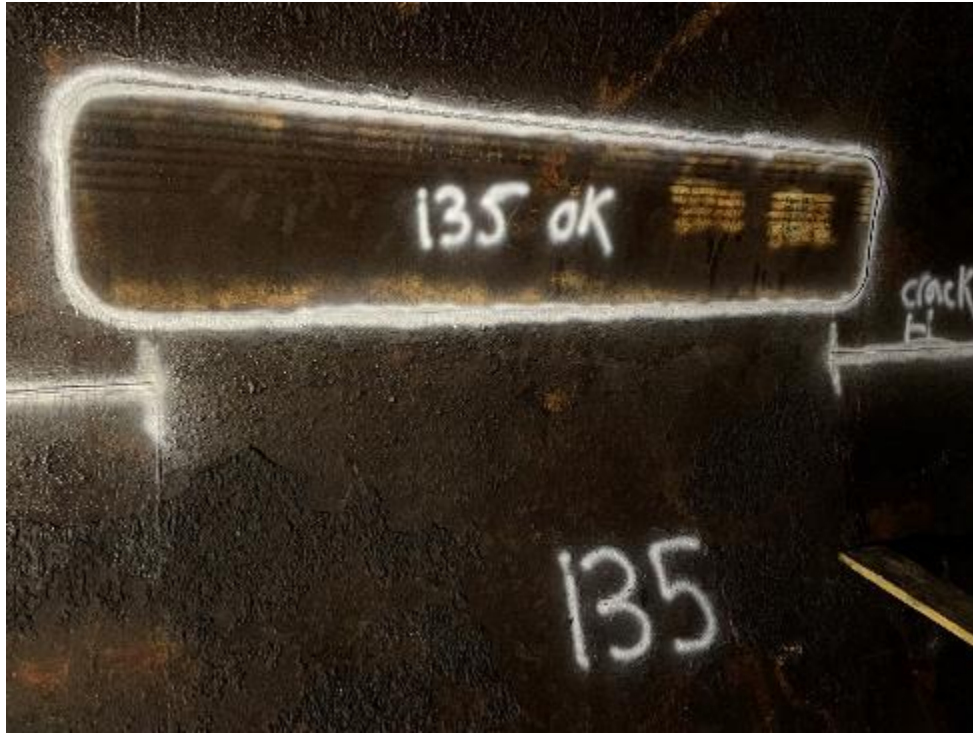
PHOTO 3 TYPICAL REINFORCING PLATE

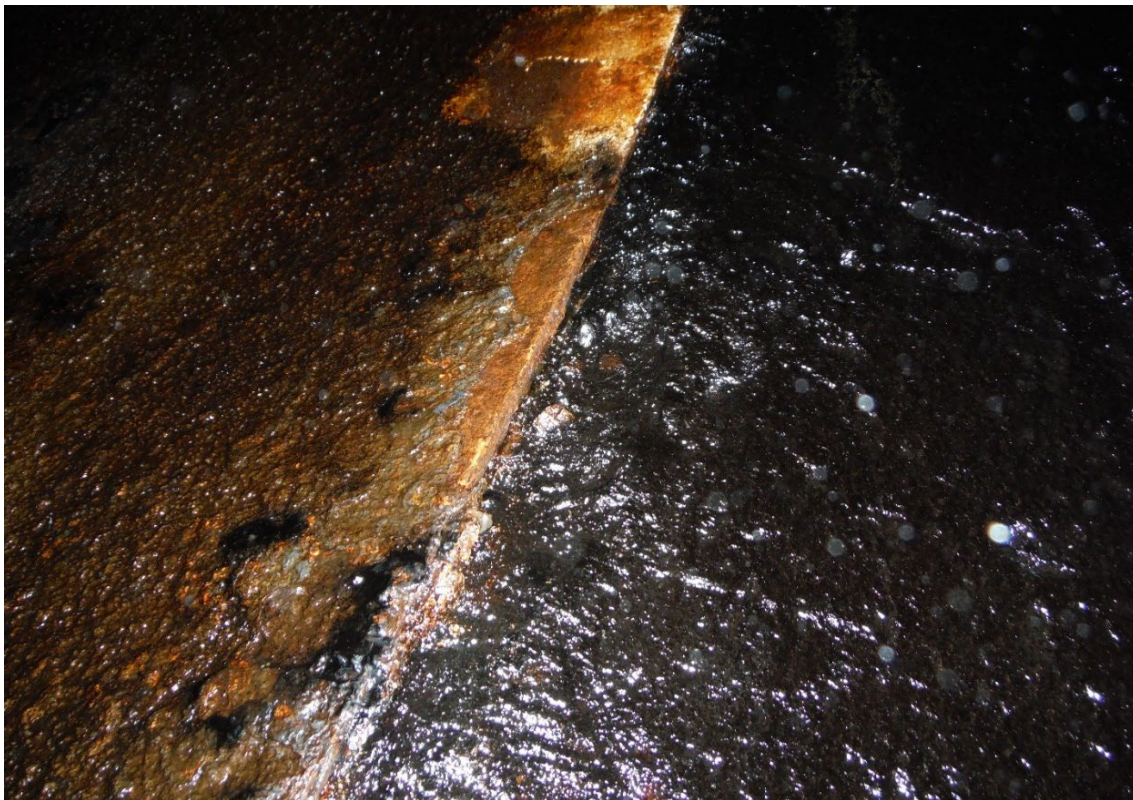
Photo 2 **Concrete to Steel Transition**

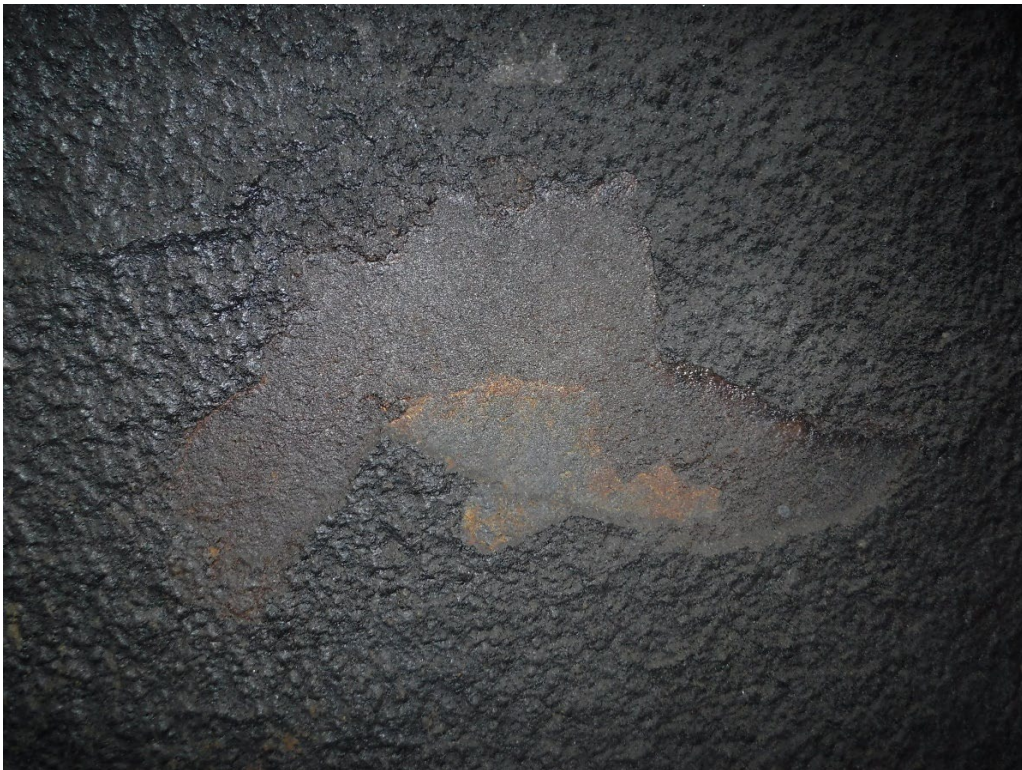
Photo 4 Organic Layer with Steel Beneath

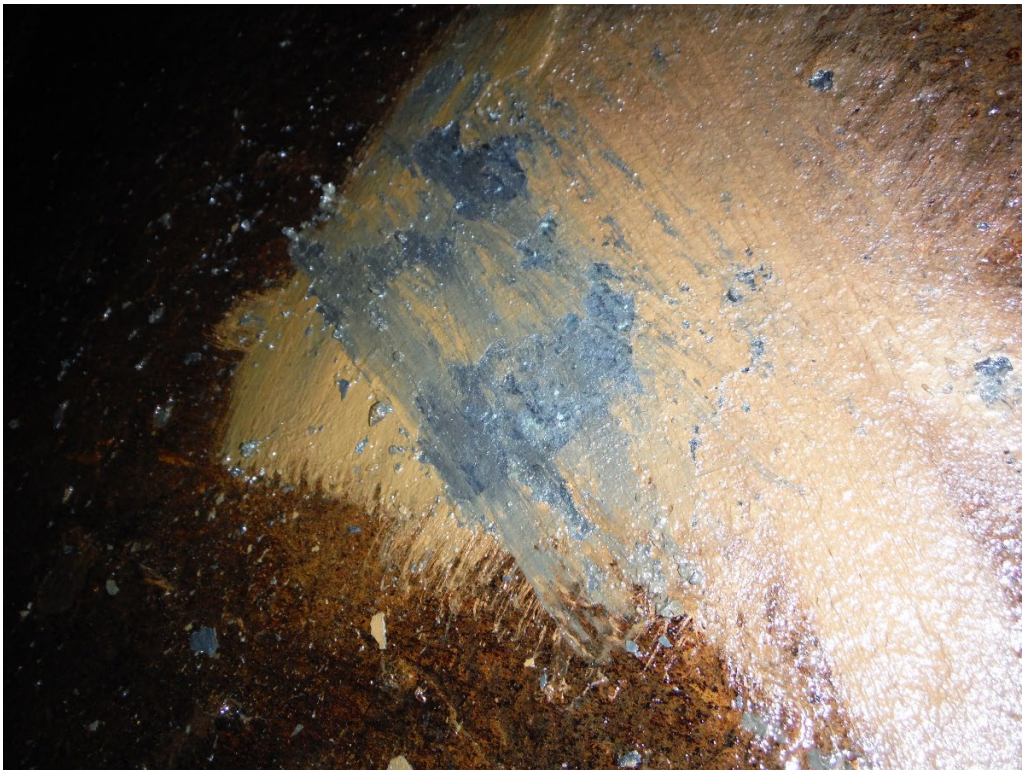
Photo 6 Plating lightly scraped; Shallow pitting and some section loss

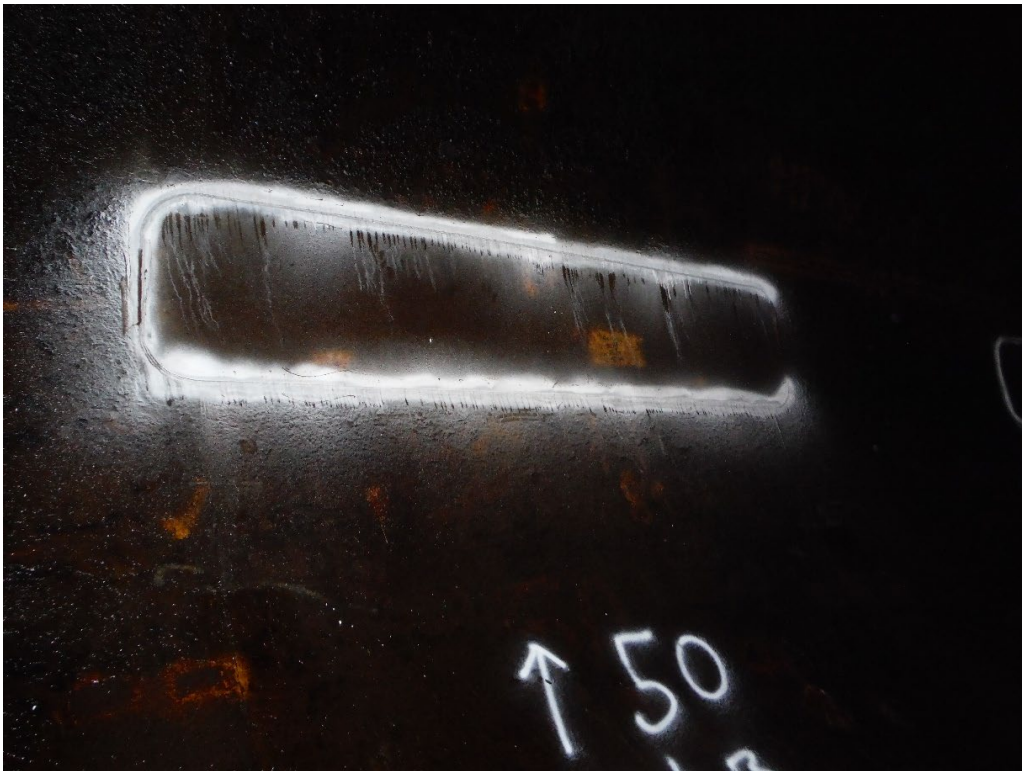
Photo 8 Plate repair welds tested. Can 50

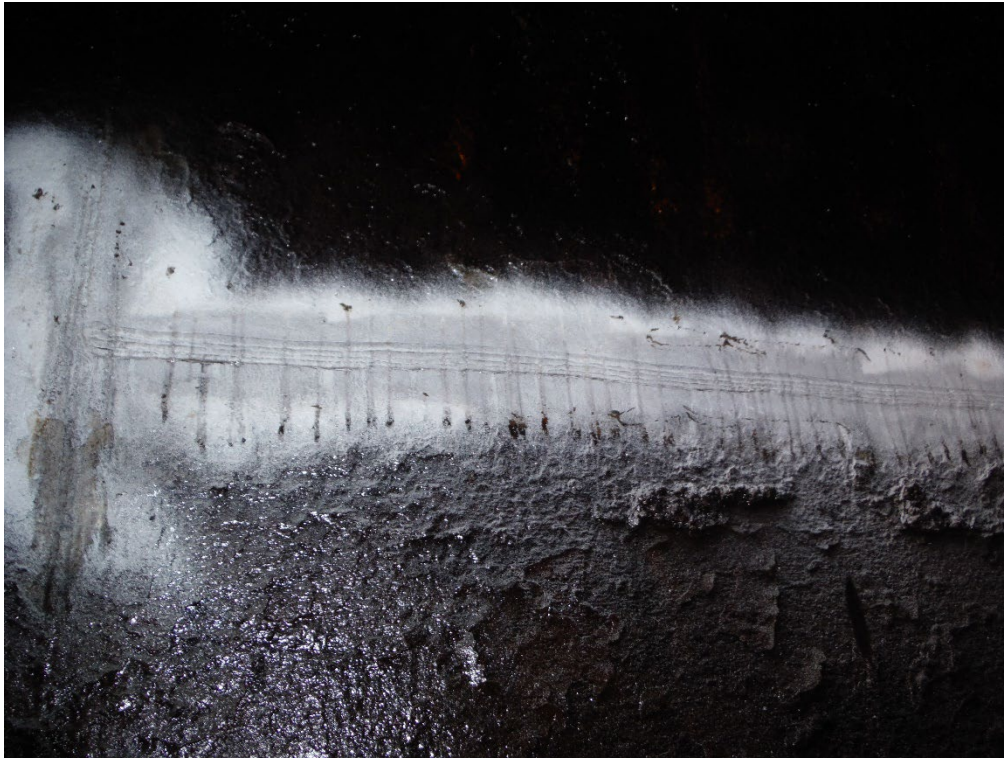
Photo 9 Previously repaired weld retested; Typical Condition

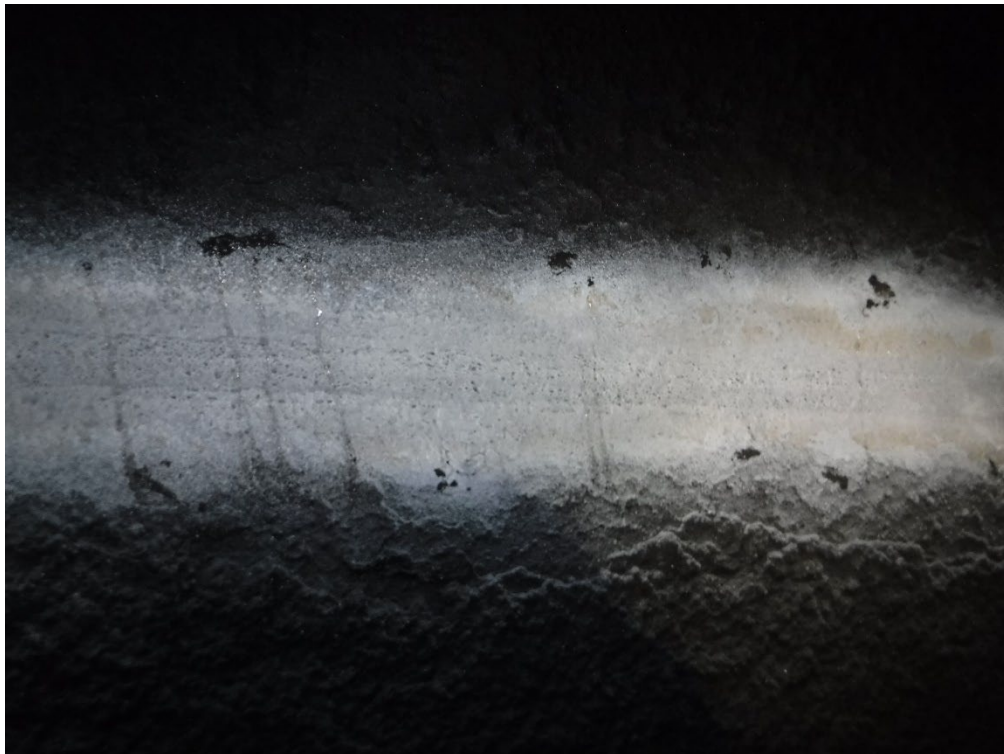
Photo 10 Original weld not tested previously; Can 268; Typical Condition

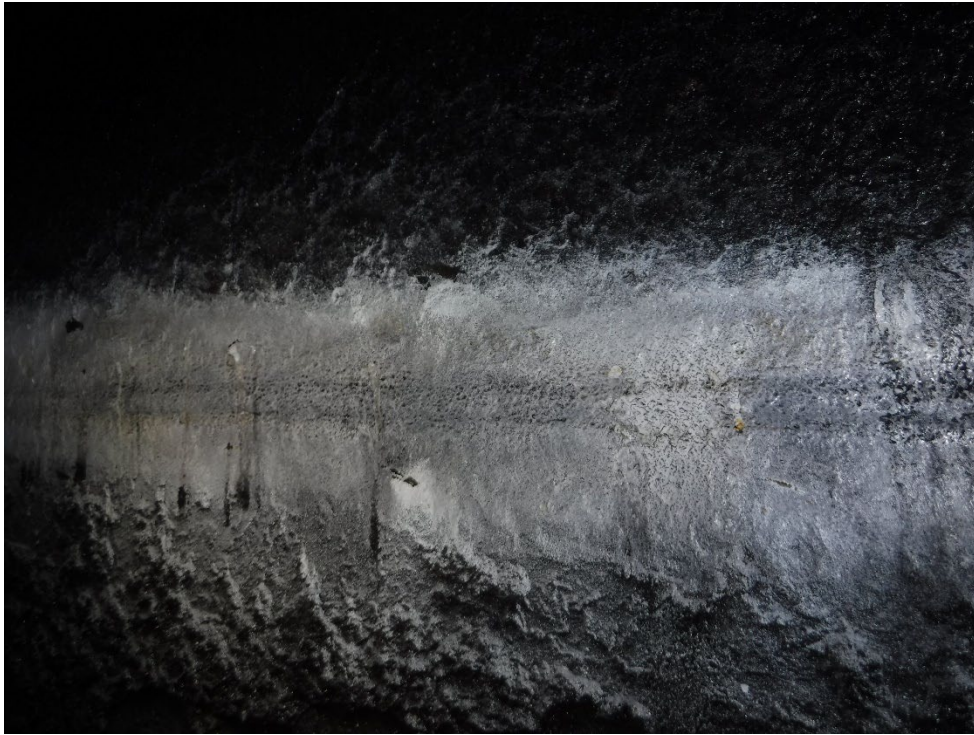
Photo 11 Original weld not tested previously; Can 188; Typical Condition

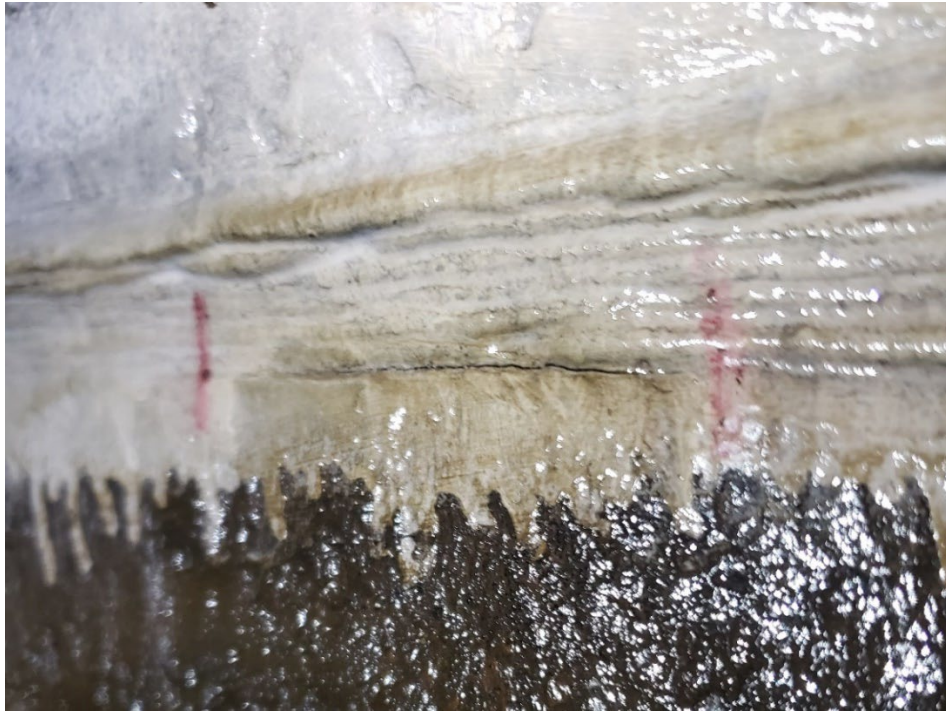
During the inspection, four (4) indications were identified. The first indication was found in Can 146 at the toe of weld around a doubler-plate. The indication was removed by grinding and did not require welding. The second indication, a 3-inch-long crack, was found in Can 145 along the south longitudinal weld (Photo 13) which required repair by welding. Additionally, a twelve-inch section of weld erosion was noted in both of cans 98 and 103, on the north sides of the penstock. Mr. Vella was notified upon the discovery of each indication or crack. NLH was immediately notified, and a repair crew was mobilized on site the following day with repairs be completed Wednesday April 28th. The planned inspection was modified such that cans upstream and downstream of the crack were inspected and tested. Testing and inspection of the cans continued until five consecutive cans upstream and downstream of each identified indication were tested without finding further indications. MT details for the indications and crack can be found in Appendix C of this report including repair of the crack in Can 145.

Photo 13 Longitudinal Weld Crack Can 145 North Side

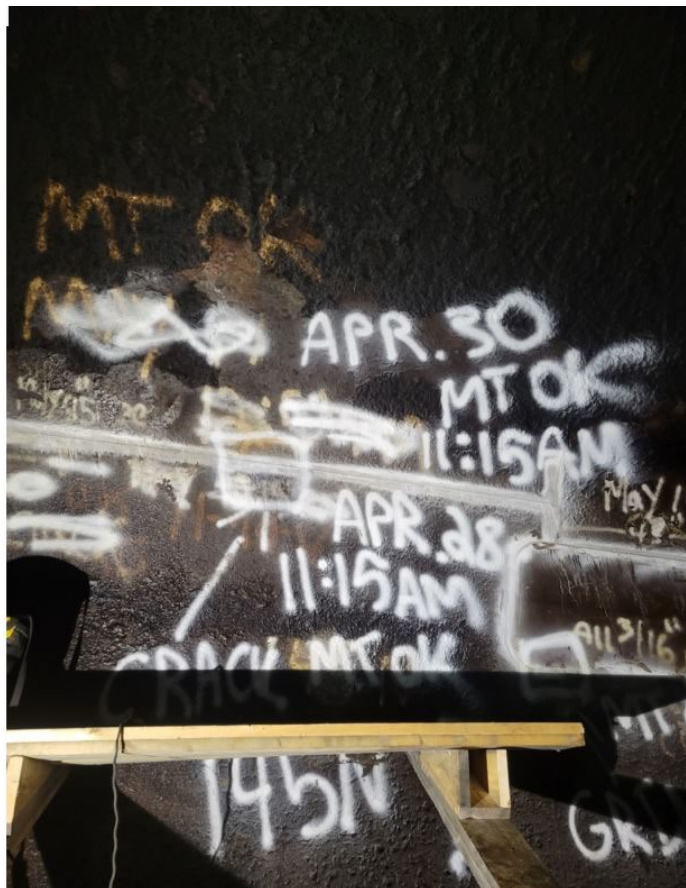
Photo 14 Weld repaired and marked Can 145

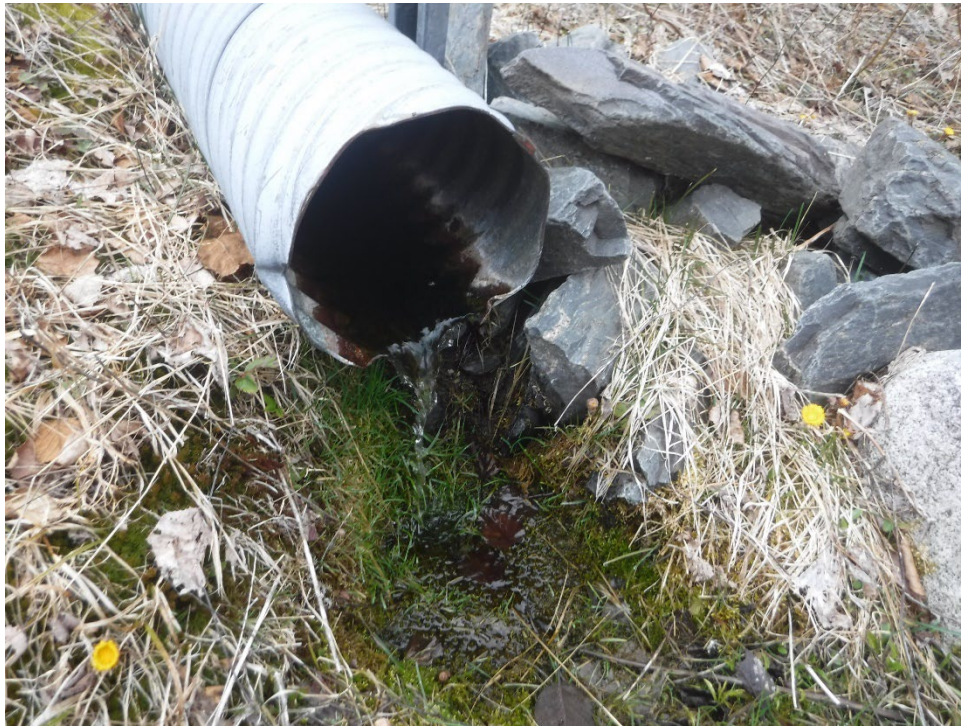
About 2 gpm was found coming from the flow pipe at FP 3 (Photo 17). The newer manhole near Station 100 m was not opened and appear to be in good condition from the outside. The alder bushes upstream of manhole 1 and covering Penstocks 1 and 2 should be cut back (Photo 18). The new rip rap areas are in good condition and do not appear to have changed since they were installed (Photo 19). The cover over the remainder of the penstock is uneven in places but does not require remediation (Photo 20).

Photo 17 Flow Pipe, FP 3

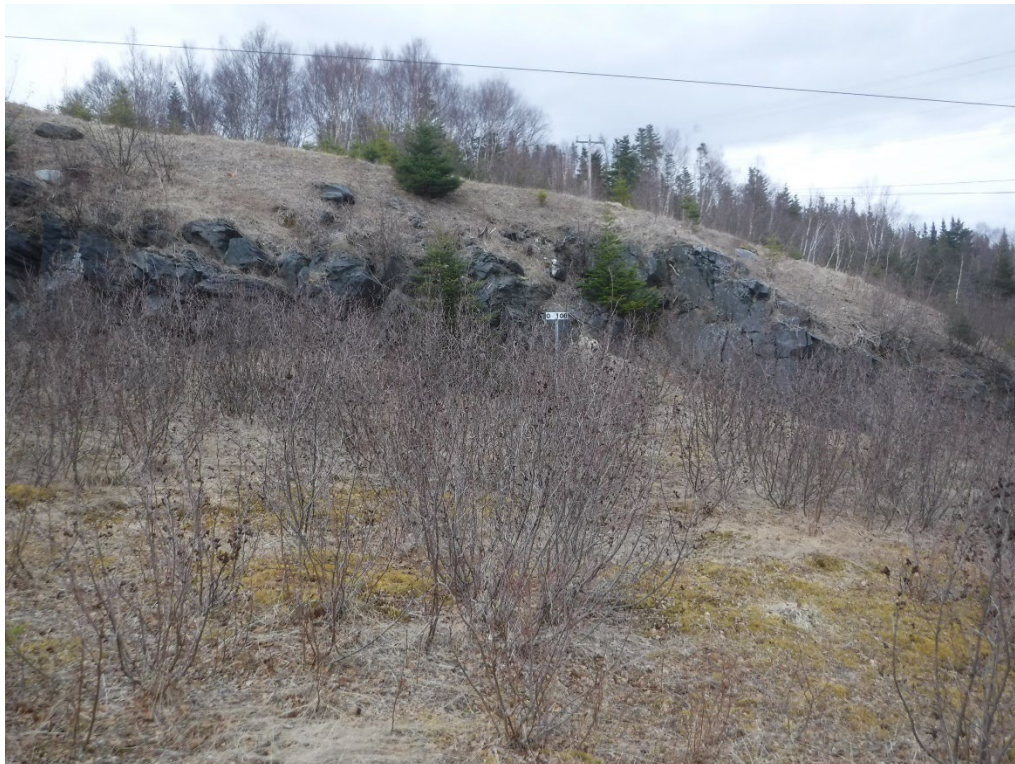
Photo 18 Alder bushes on top of P1 and P2 at Station 100

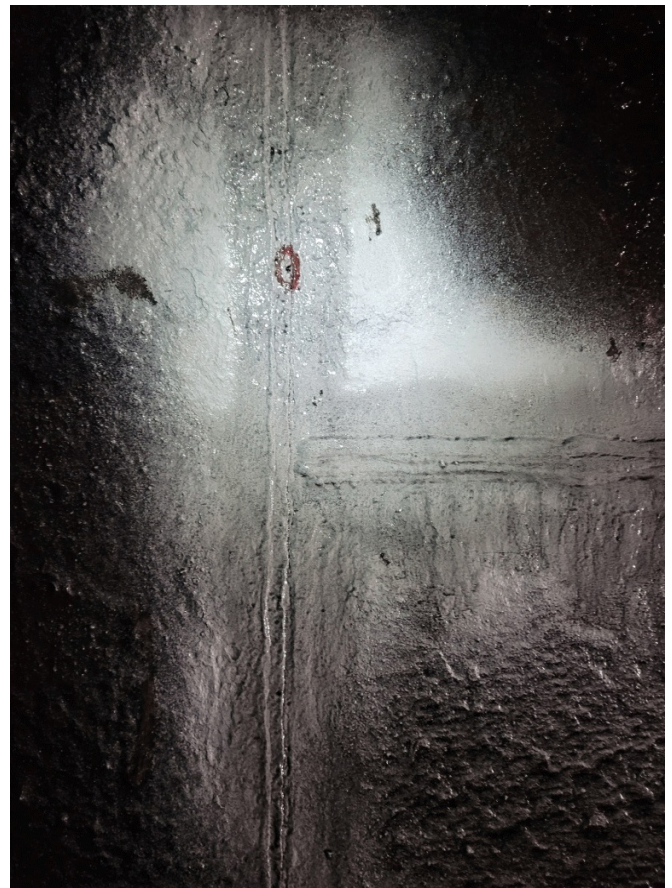
Figure 2. Can 98 North - Indication Noted

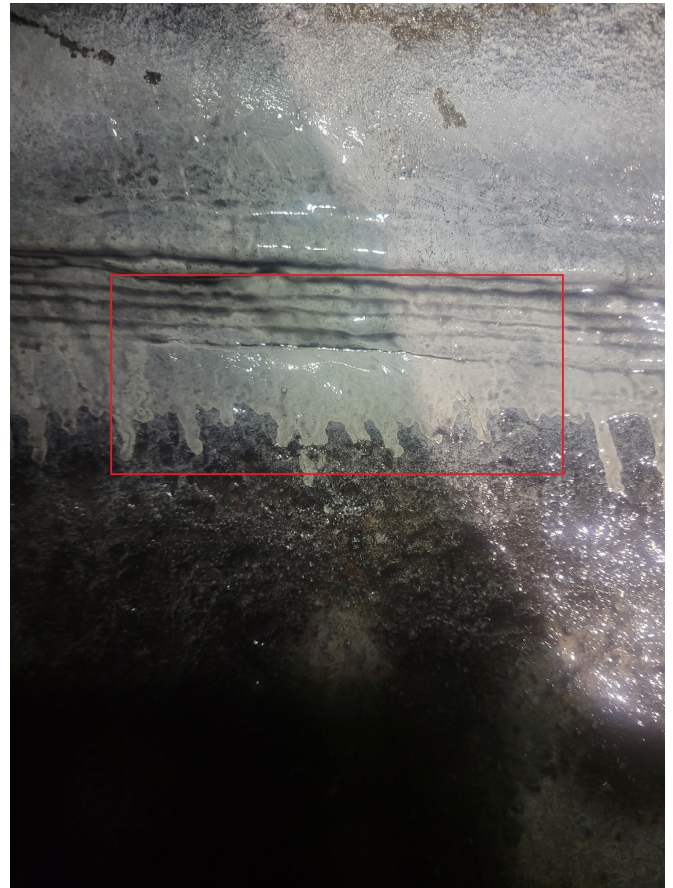
Figure 6. Can 145N - 3" Crack Indication Noted
*Refer To Report 22-318 For Repair

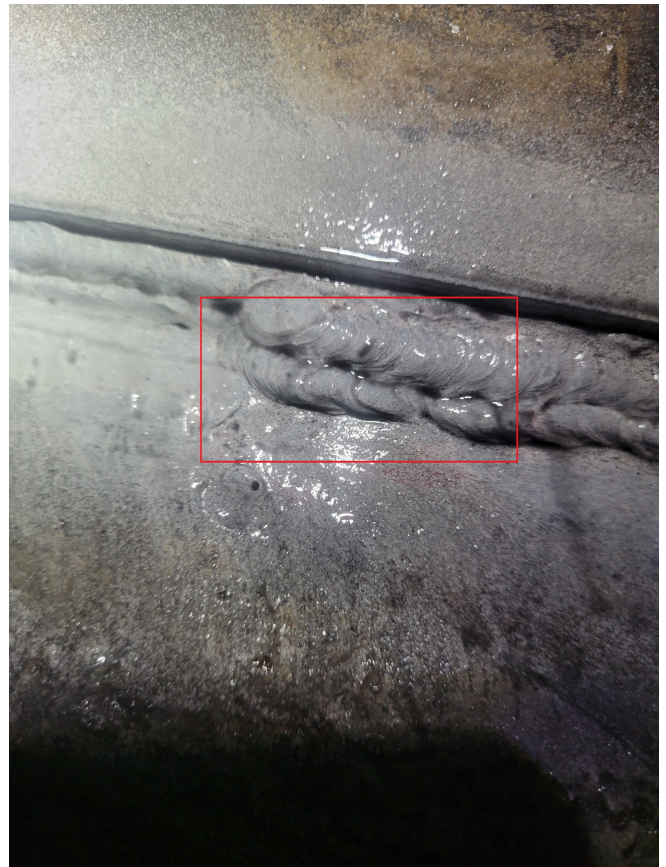
Figure 8. Can 145N - Indication Noted
*Refer To Report 22-318 For Repair

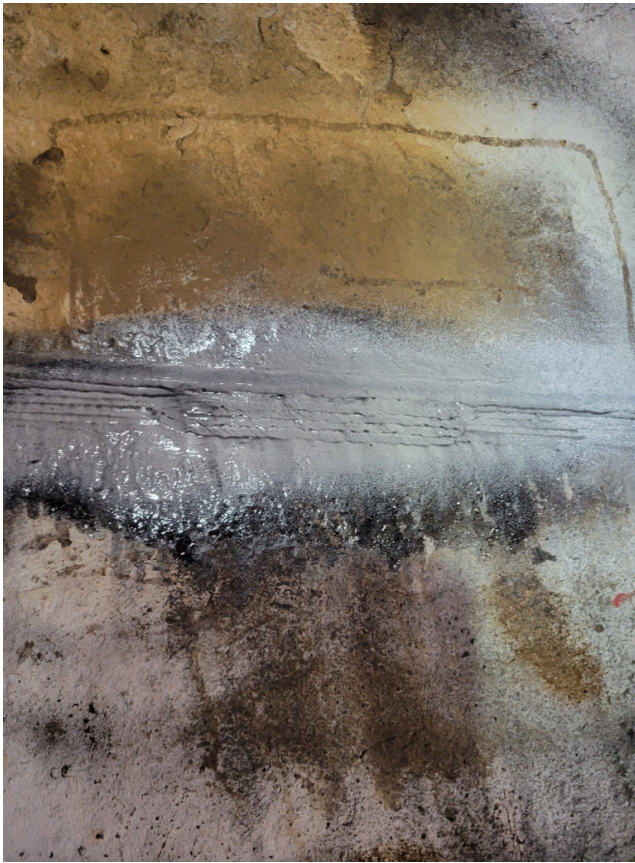
Figure 3. 145N Weld Repaired - Checked at 11:15 AM April 28th 2022 (Post Welding)

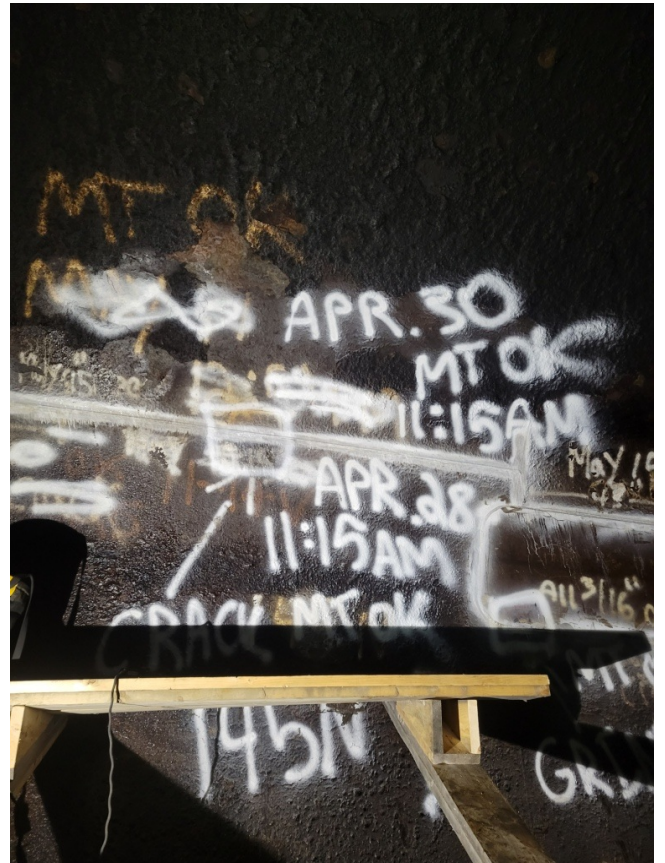
MPI carried out on all ground areas to ensure defects were removed. All MPI inspections were carried out after 48 hr hold time and found acceptable. Nil cracks.

Figure 4. 145N Weld Repairs - Post 48 Hour Hold - Checked at 11:15 AM April 30th 2022

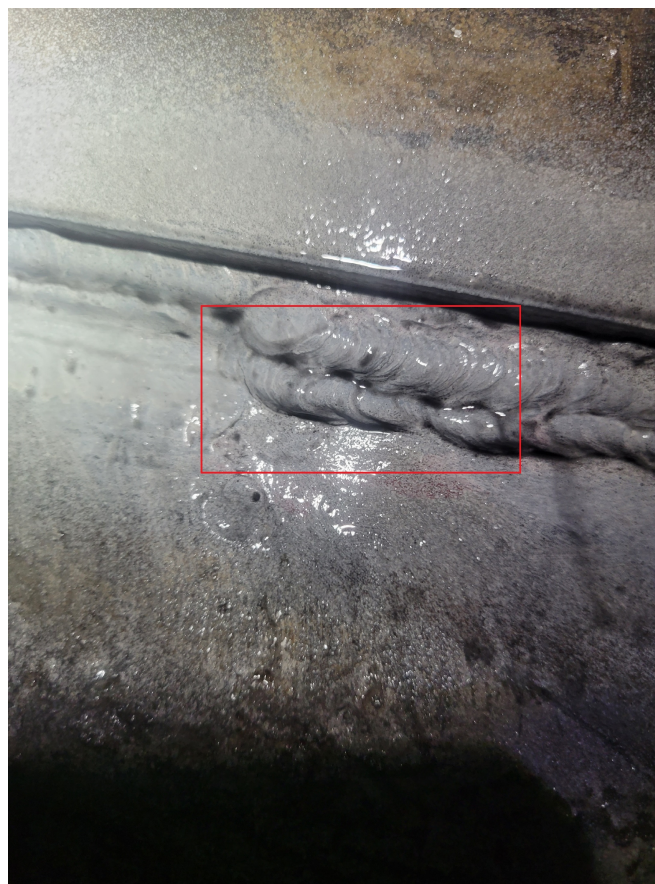
Figure 6. Can 146N - Indication Noted

Figure 7. Can 146N - Indication Removed With Grinding - No Welding Needed
