PENSTOCK 3 INSPECTION AND EVALUATION

BAY D'ESPOIR HYDROELECTRIC DEVELOPMENT
PENSTOCKS 1-3 INSPECTION PROJECT

May 2026

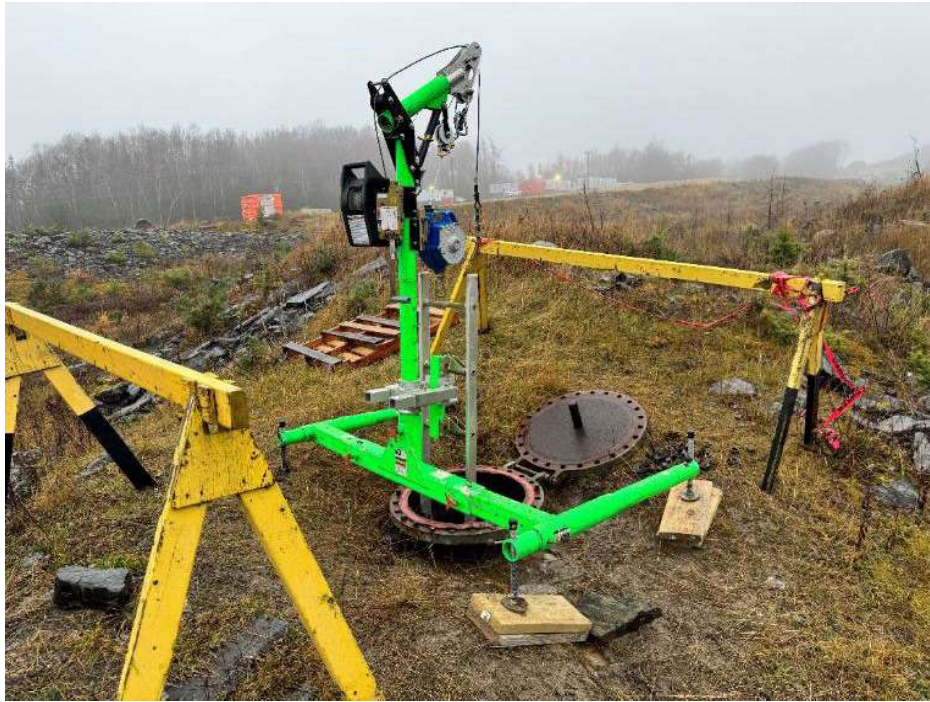
Photo 1 TRR's Access Setup at Manhole 2

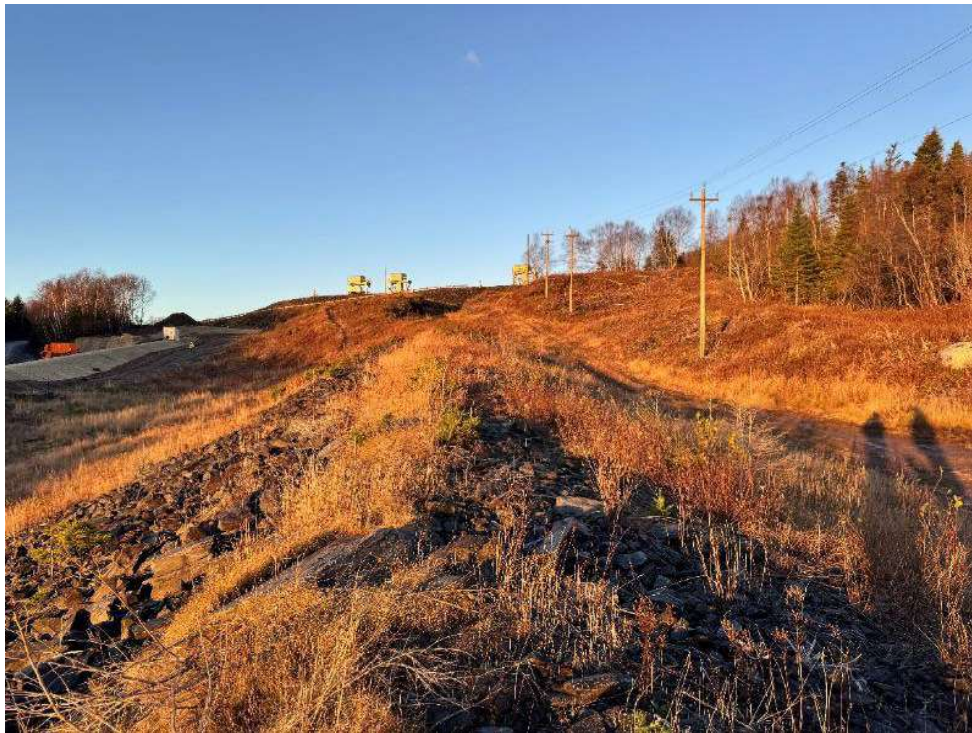
Photo 5 Condition of exterior inspection

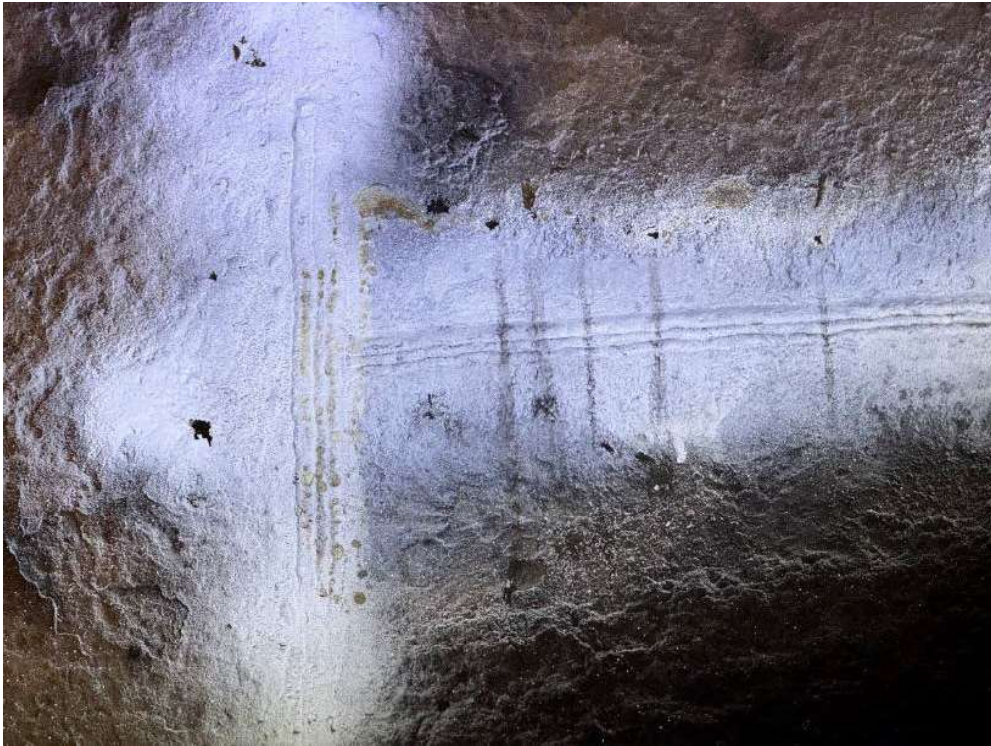
Photo 13 Close-up of circumferential and longitudinal weld tested at Can 7N

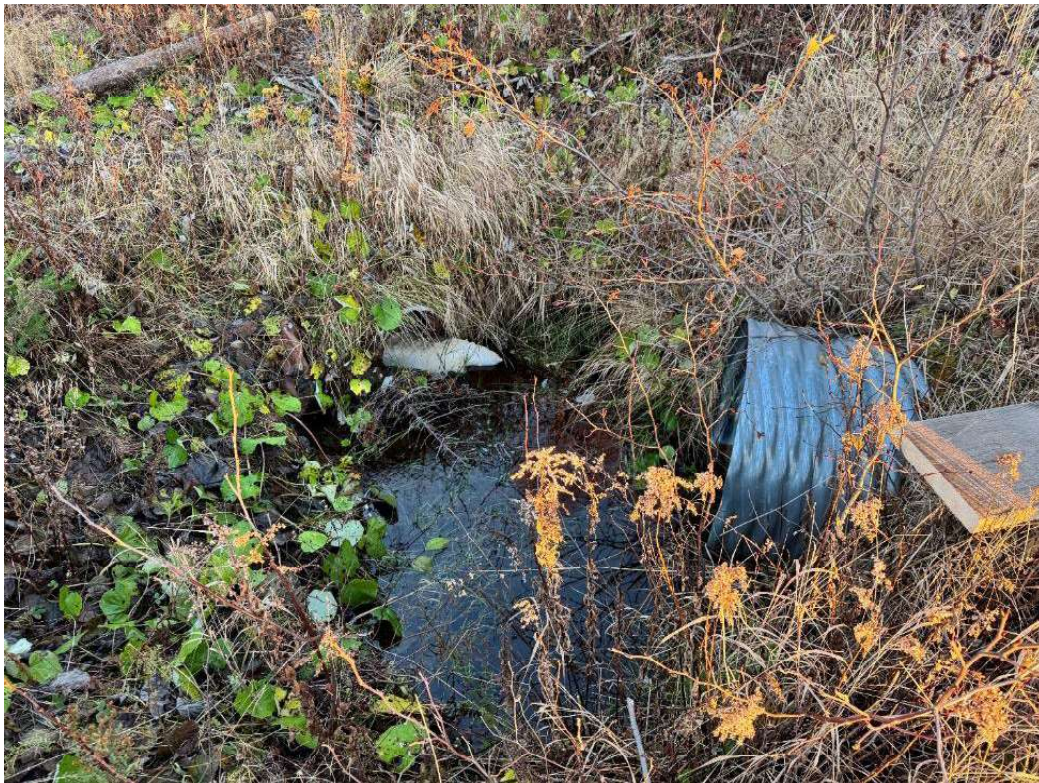
Photo 32 Condition of culvert with water flow to weir at N-1

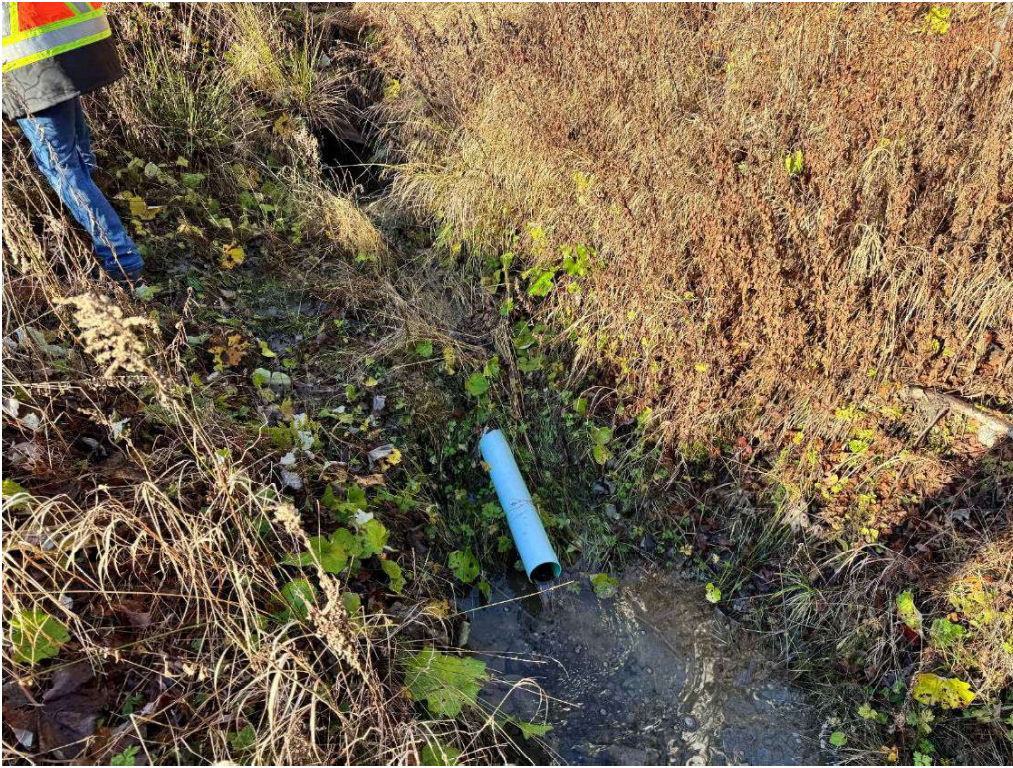
Photo 33 Flow through drainage pipe at STA. 0+903

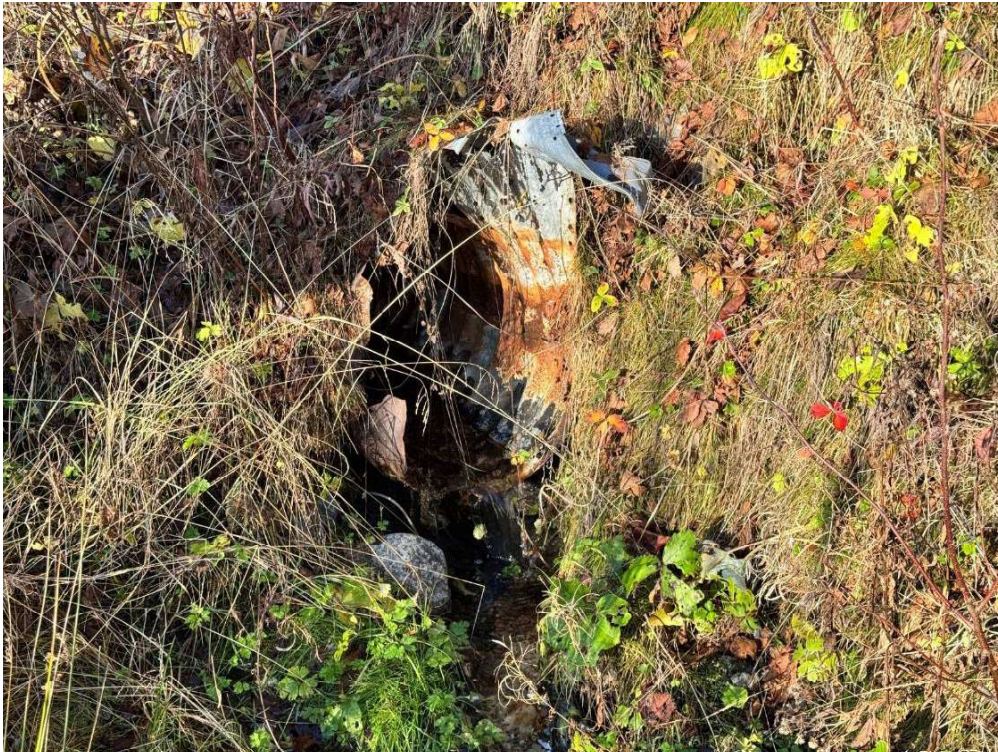
Photo 34 Condition of culvert at STA. 0+722

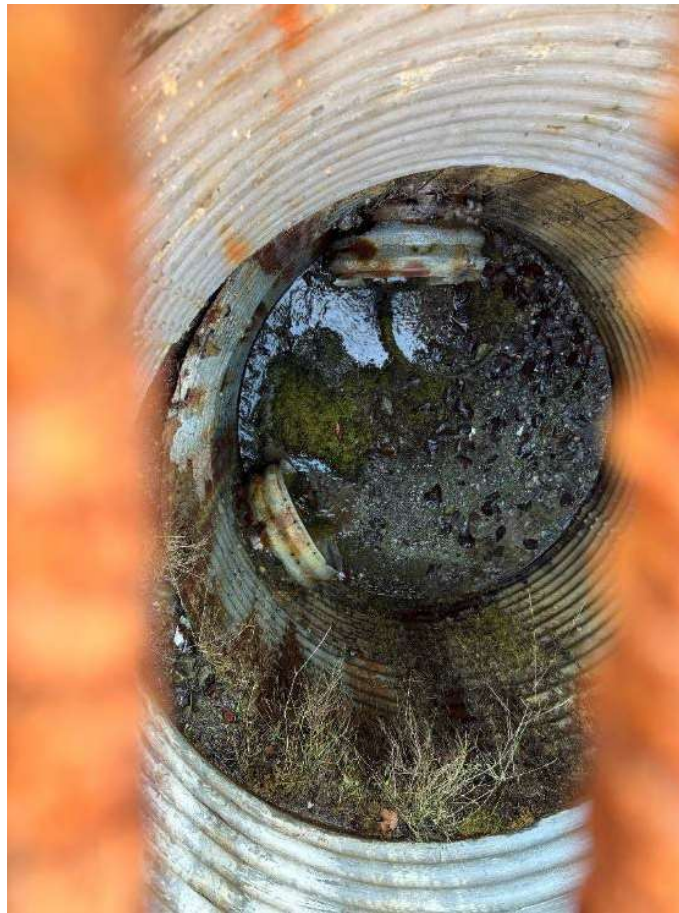
Photo 35 Condition of observation well downstream and to left of surge tank

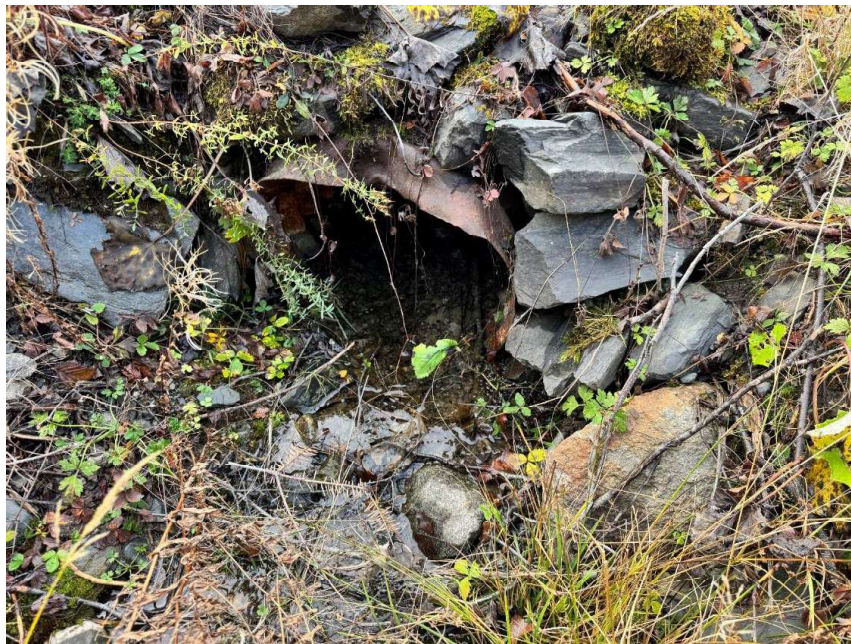
Photo 36 Condition of culvert directly upstream of bridge crossing

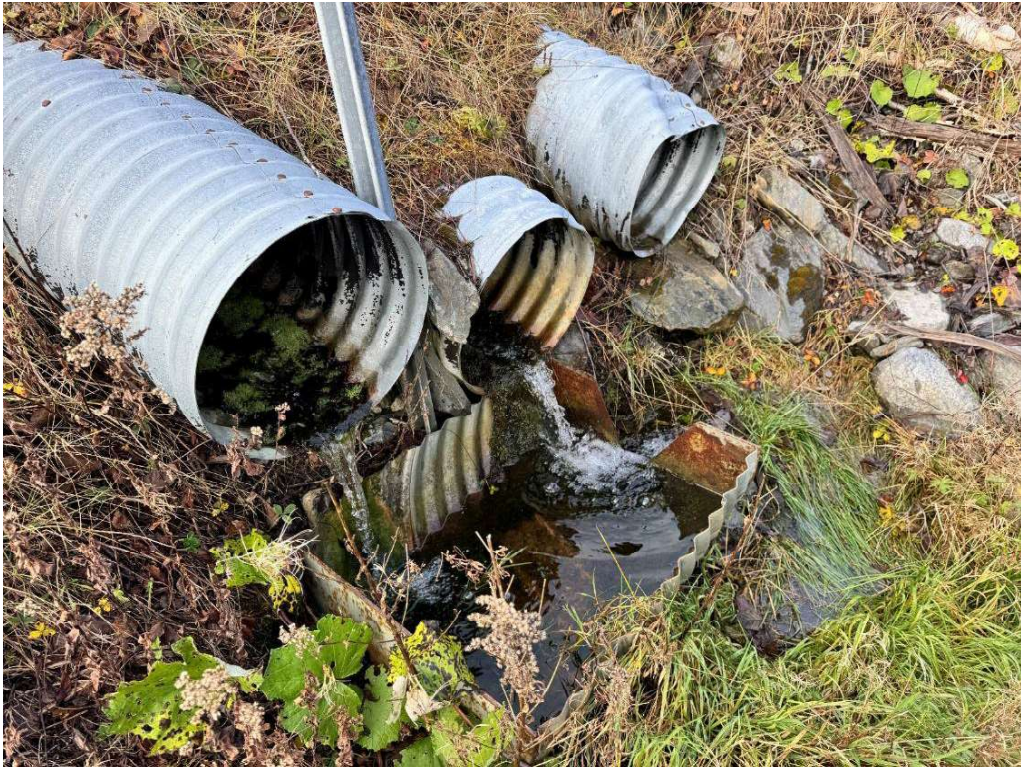
Photo 37 Condition of culverts at N-2 Weir

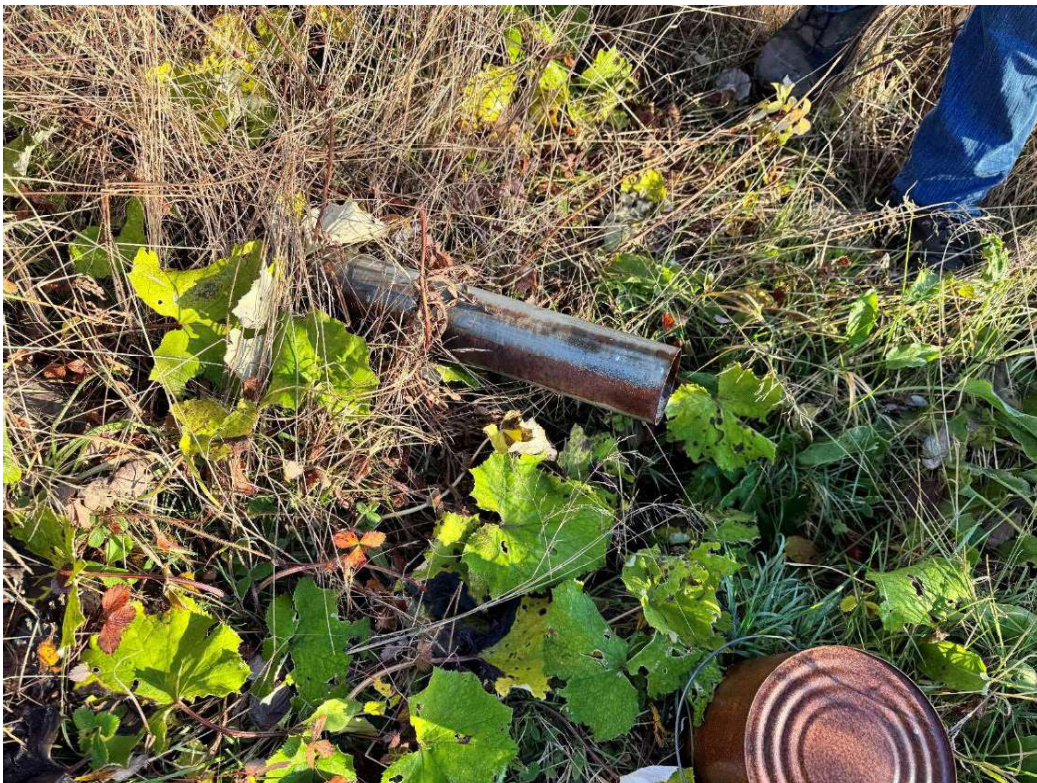
Photo 38 Condition of drainage pipe directly downstream of surge tank concrete base

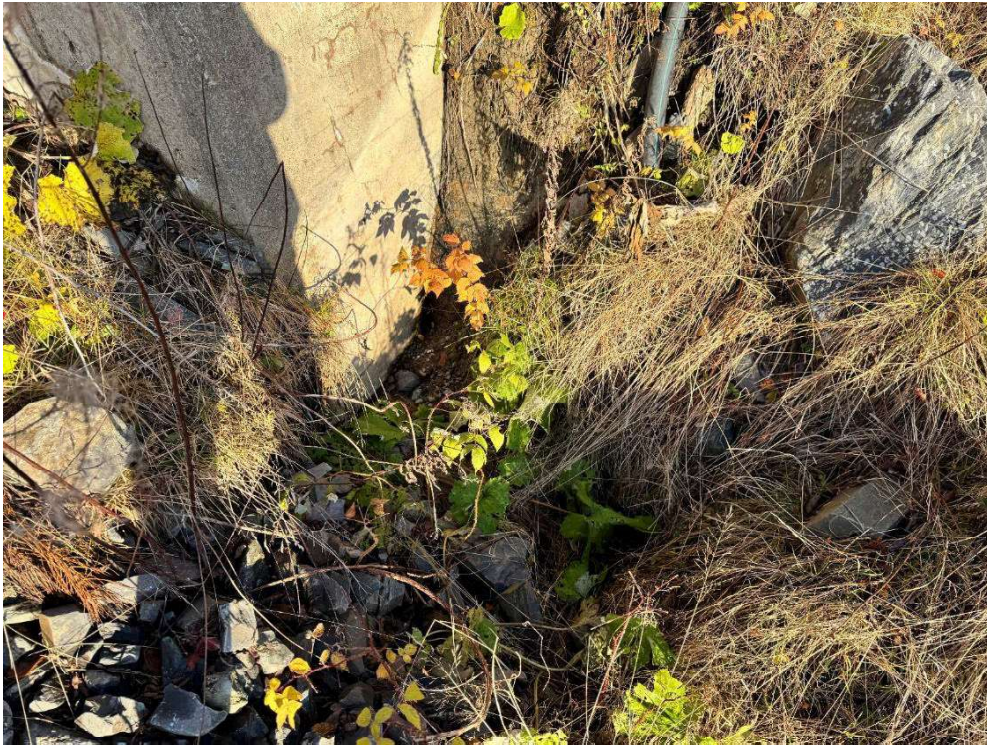
Photo 39 Condition of concrete at right side of downstream face of surge tank concrete base

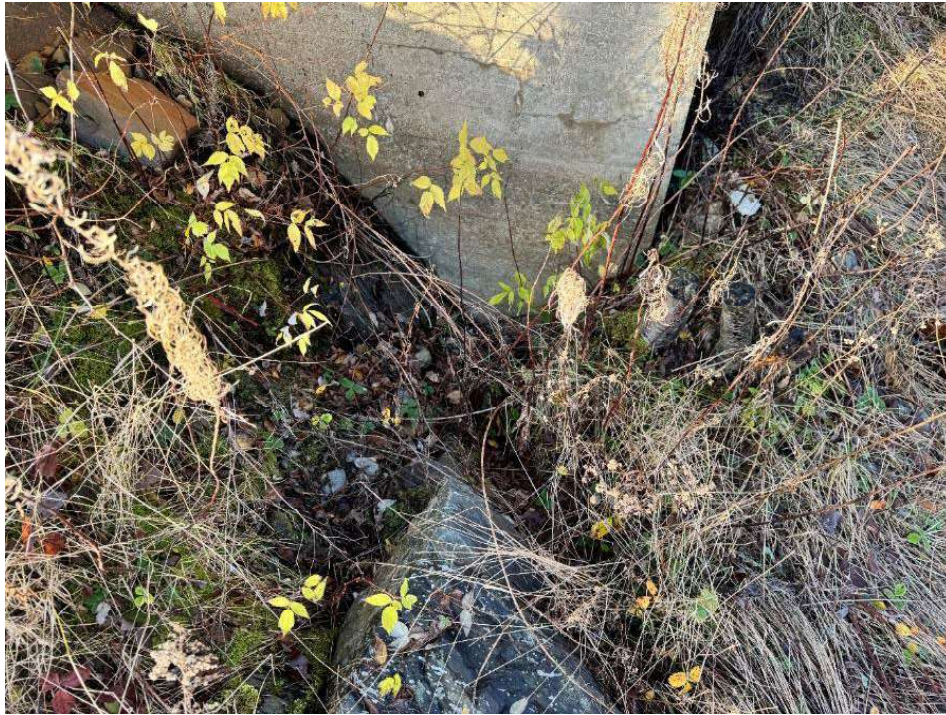
Photo 42 Condition of concrete at left side of downstream face of surge tank concrete base

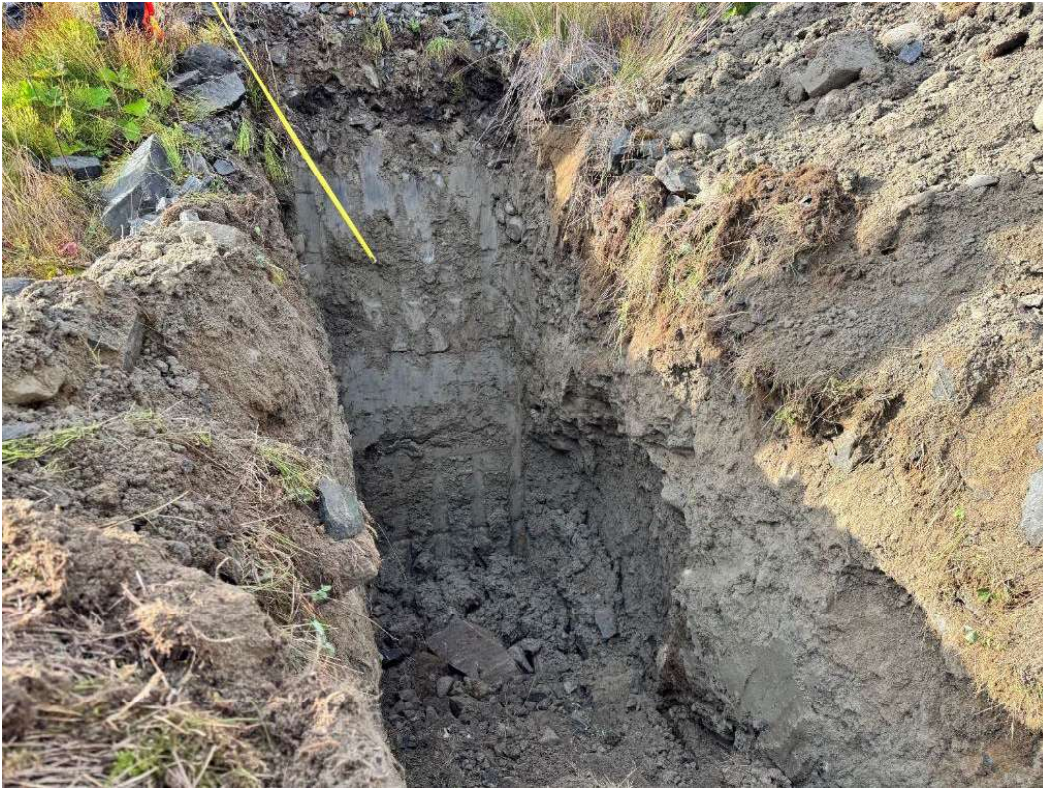
Kleinschmidt engineer Youssef Abdeldayem had observed test pits being excavated on September 23, 2025, prior to the November 2025 inspection (see Photos 42 and 43). The test pits were completed at several locations along the length of Penstock 3 upstream of the bridge crossing. Following completion of the work, the excavated areas were backfilled and restored to normal conditions. During the November inspection, remnants of the excavation activity (e.g., disturbed ground/backfill evidence) were still visible at select locations.

Photo 43 Test pit conducted at exterior of P3 (Sept 23rd 2025)

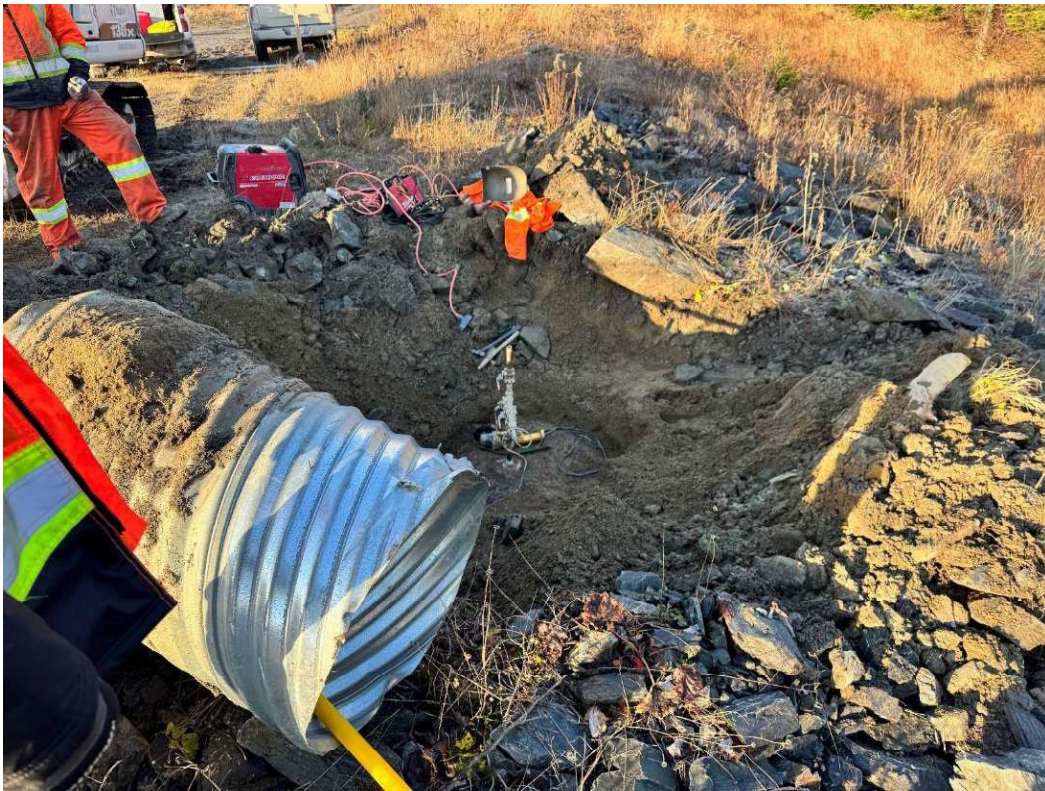
Photo 45 Work conducted by NLH crew along exterior of penstock during inspection

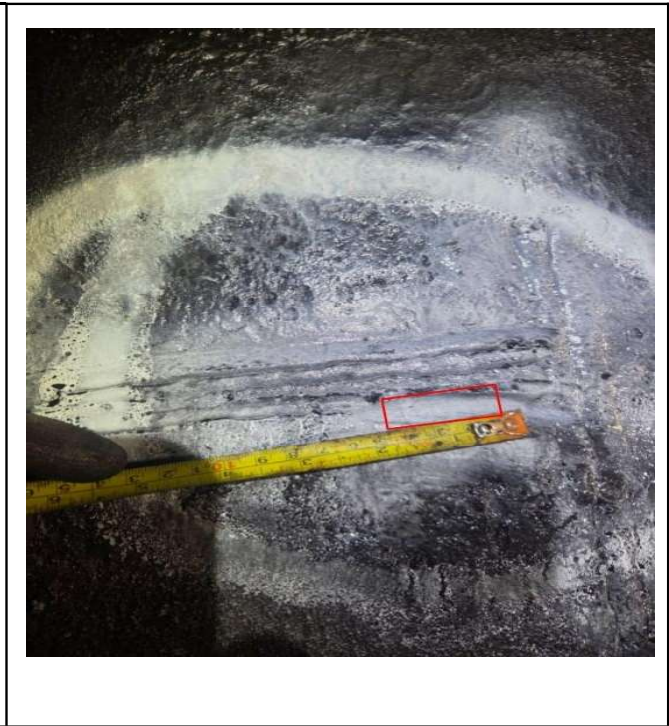
Indications noted and still in welds on the follow cans :
Can 17S, 35N, 67S, 77S, 79S, 102S, See below for location and approximate size. All other areas were found to be acceptable as per the above noted criterial.

Figure 13. Can 102 South - Indication #7

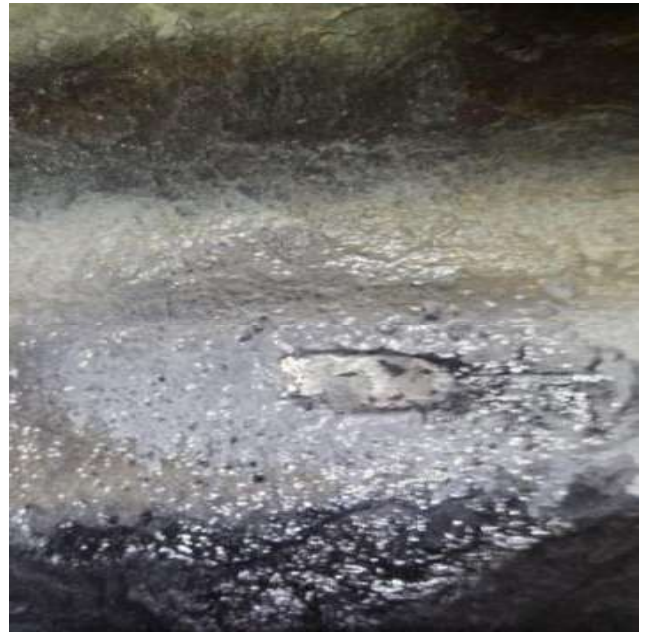
Figure 17. Can 263 South - Post Grinding

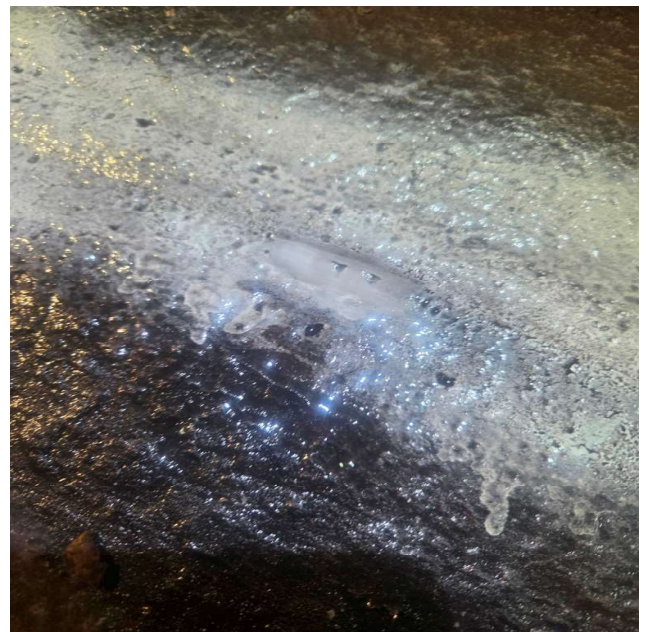
Figure 19. Can 303 North - Post Grinding - Indication Removed

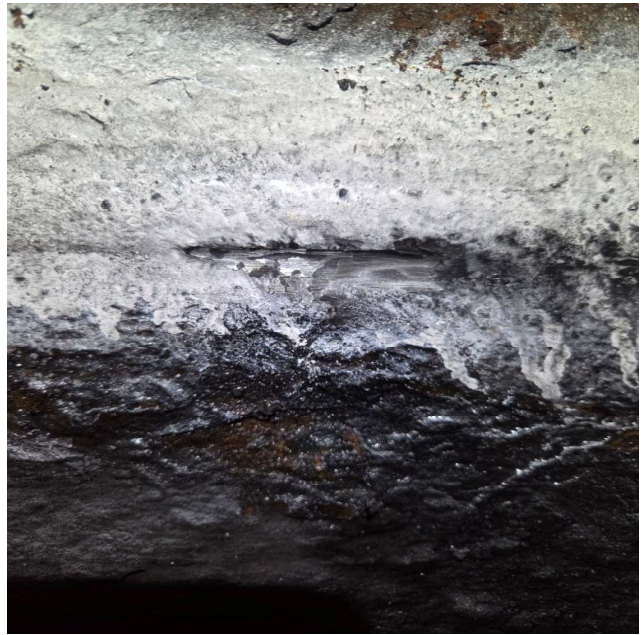
Figure 24. Can 353 North - Post Grinding
