**Re: Newfoundland and Labrador Hydro – Request to File Report on Frazil Ice at Bay d'Espoir
Hydroelectric Generating Station – Hydro's Reply**

Frazil Ice at Bay d'Espoir Hydroelectric Generating Station

April 30, 2026

A report to the Board of Commissioners of Public Utilities

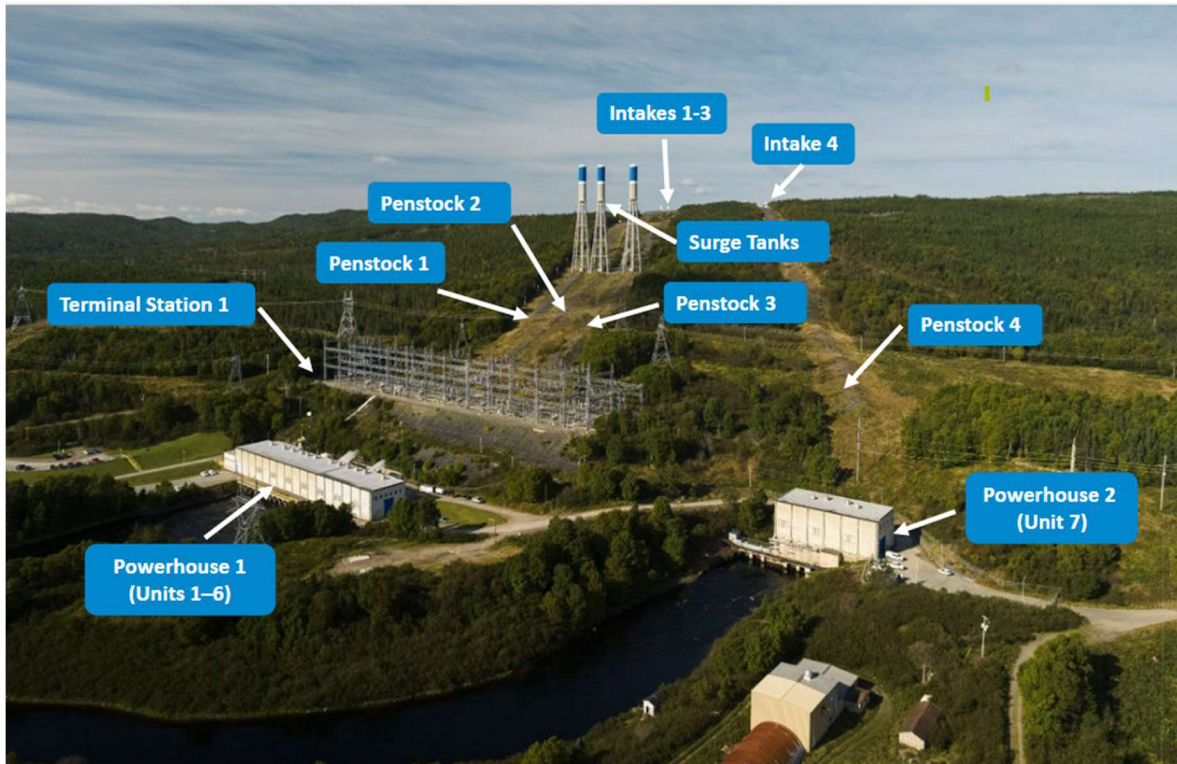
Figure 5: BDE Generating Station Site Layout

8 BDE, as shown in Figure 5, is a critical generating asset on the Island Interconnected System, providing
9 an installed capacity of 613.4MW. The existing facility includes seven generating units across two
10 powerhouses and relies on four penstocks to supply water from the intakes to the generating units.

1 BDE Powerhouse 1 consists of six 76.5 MW units (Units 1–6), supplied by Penstocks 1–3 via Intakes 1–3,
 2 with each penstock and intake controlling the flow of water to two units. BDE Powerhouse 2 consists of
 3 one 154.4 MW unit (Unit 7), supplied by Penstock 4 via Intake 4.
