Q. NLH-NP-003 Reference: "2024 Capital Budget Application," Newfoundland Power Inc., June 22, 2023, sch. B, Gander Building Renovation, pp. 126–127.

General Properties Building Condition Assessment – Gander

Roof Condition Assessment

Report No. 1904860.00

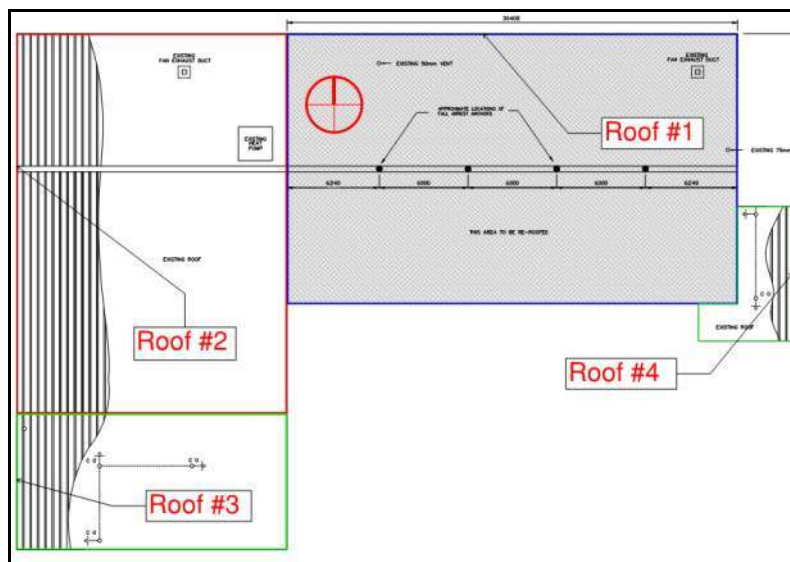
Figure 1: Roof plan provided by NL Power.

The building is a one-storey office space with attached storage and parking space. The building is approximately 2,275 square meters and 10 meters in height. The original building (Roof #1) was constructed circa 1983. The building expanded through phasing which included the construction of the storage (Roof #2) and parking bay (Roof #3) and front vestibule (Roof #4); dates of additions are unknown. Roof replacement of Roof #1 was completed in 2004 (approximately 15 years old). Architectural drawings for 6 Magee Road were provided by NL Power for our review; the roof assembly consists of three assemblies.
