**Re: Quarterly Report on Asset Performance in Support of Resource Adequacy for the Twelve Months Ended September 30, 2025**

# Quarterly Report on Asset Performance in Support of Resource Adequacy

Attachment 1: L3501 Failure Investigation – Ice Storm Central Labrador – January 2025

## L3501 Failure Investigation

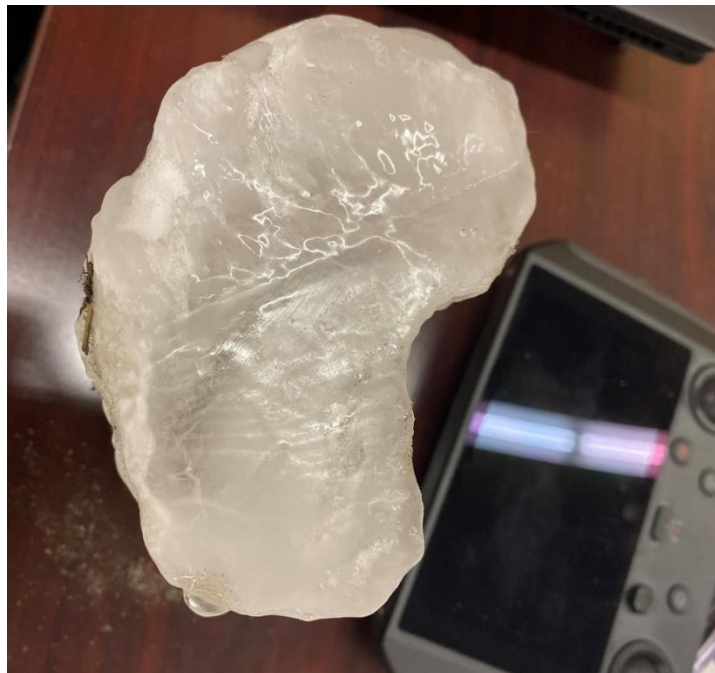
There were observations of significant icing on the lines on January 13, 2025, as seen in Figure 10. An ice sample that fell from EL1 was collected, measured, and weighed. The sample measured approximately 6"×5"×4.5" and weighed 4 lbs. From this sample, the equivalent radial thickness was estimated to be 50 – 75 mm at a density of 0.7 g/cm<sup>3</sup>. Figure 11 through Figure 14 contain photos of various ice samples collected from the event.

**Figure 11: Ice Sample from EL1**

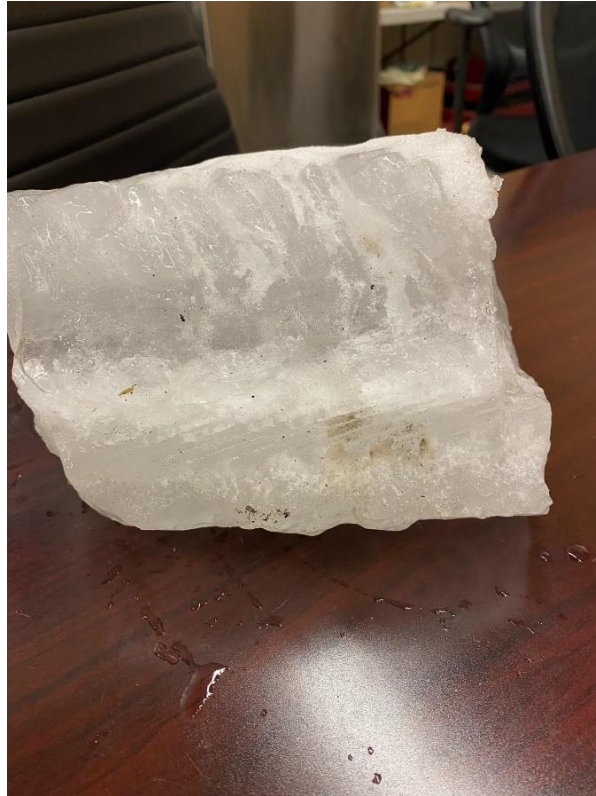
**Figure 12: Ice Sample from EL1**

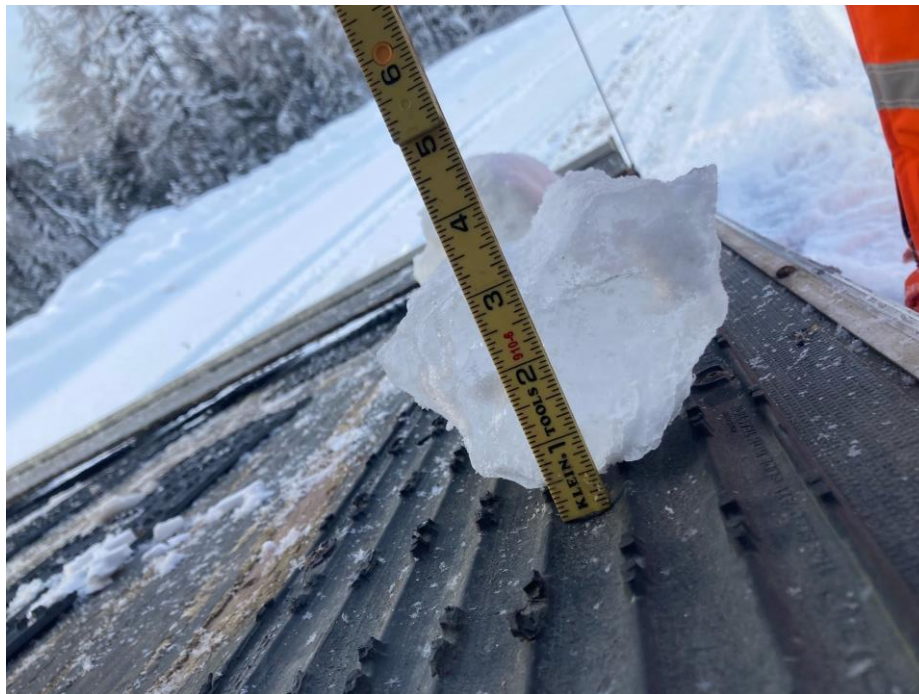
**Figure 13: Ice Sample from EL1**

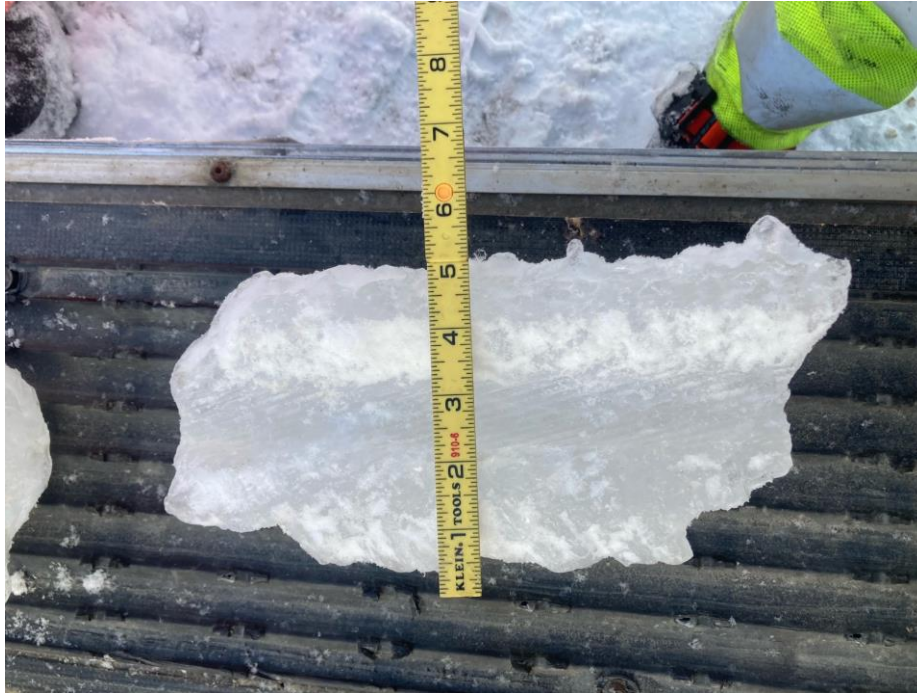
**Figure 14: Ice Sample from EL1**

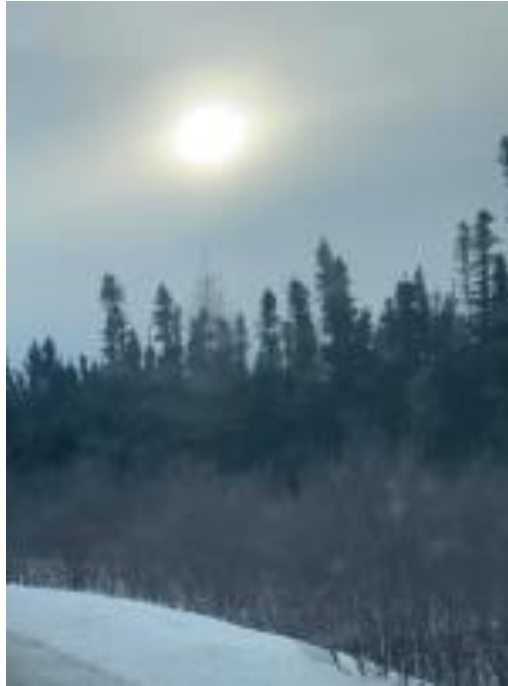
- 1 Following the event, a significant increase in snow and ice accumulation was observed near the location
- 2 of the damaged structures. Refer to Figure 18 and Figure 19 for comparison of the minimal snow and ice
- 3 on the trees near Goose Bay, as compared to the significant snow and ice accumulation near the
- 4 damaged structures.

**Figure 18: Accumulation of Ice and Snow on Trees Near Goose Bay**

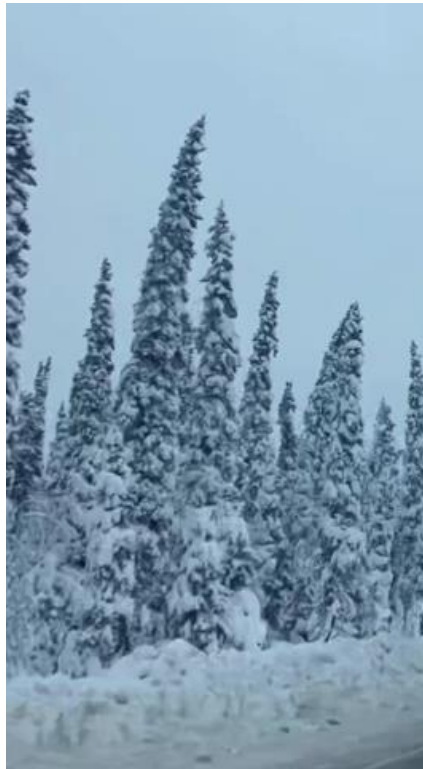
**Figure 19: Accumulation of Ice and Snow on Trees Near Damage Site**

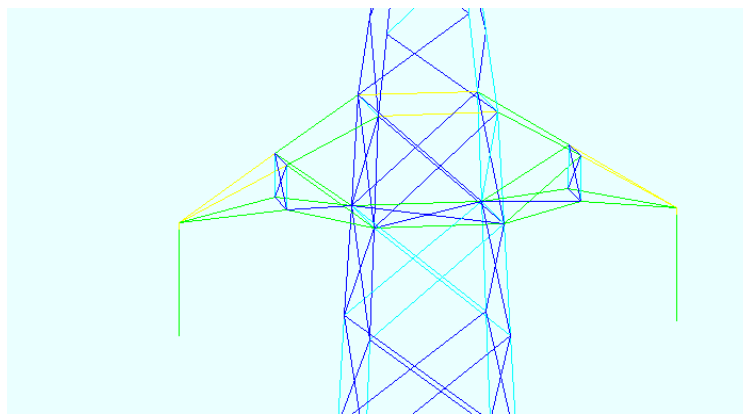
- 1 accretion modeling and in-field experience that have proven there is less ice accretion on the larger
- 2 diameter conductor(s).
- 3 Balanced modelling showed failures on S127 at the electrode cross arms starting at 80 mm of radial ice.
- 4 This result is above the in-field observations for this particular icing event. Table 5 shows the comparison
- 5 of the structure damaged in the field to the structures above 100% utilization in the model based on
- 6 balanced loading conditions.
- 7 Figure 21 and Figure 22 show the model results under various radial ice thicknesses for balanced loading
- 8 conditions for S127. The results indicate that the balanced ice loads would have to be higher than what
- 9 was observed in order to induce failure at S127.

**Figure 21: Model of S127 with 70mm of Balanced Radial Ice – No Failures**

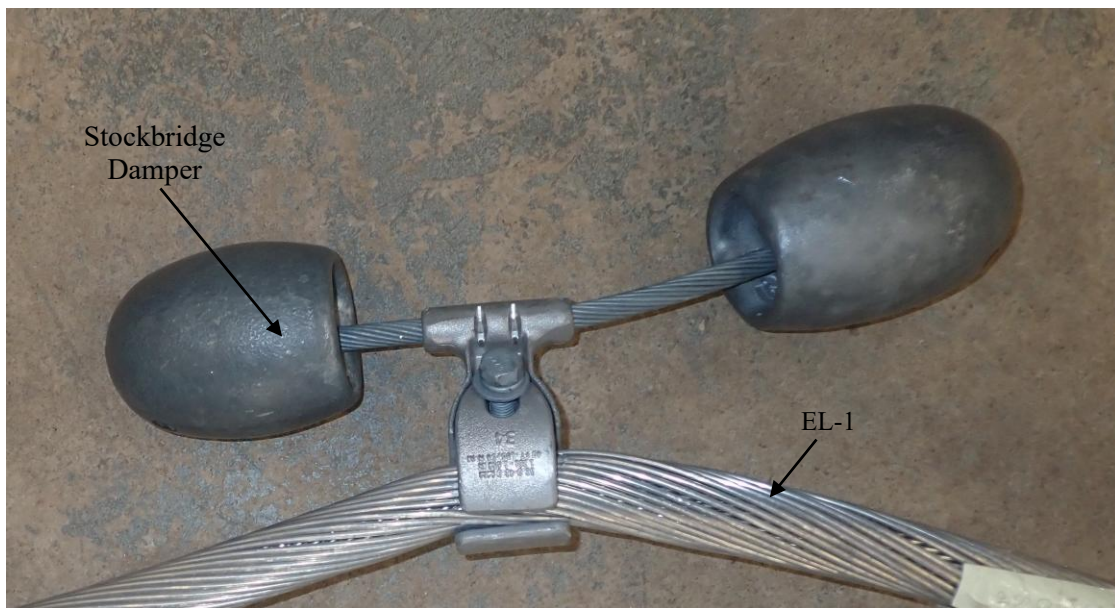
Figure 2-2: Side view of the Stockbridge damper observed attached to the south side section at a distance of approximately 38 inches from the failed end of the conductor.

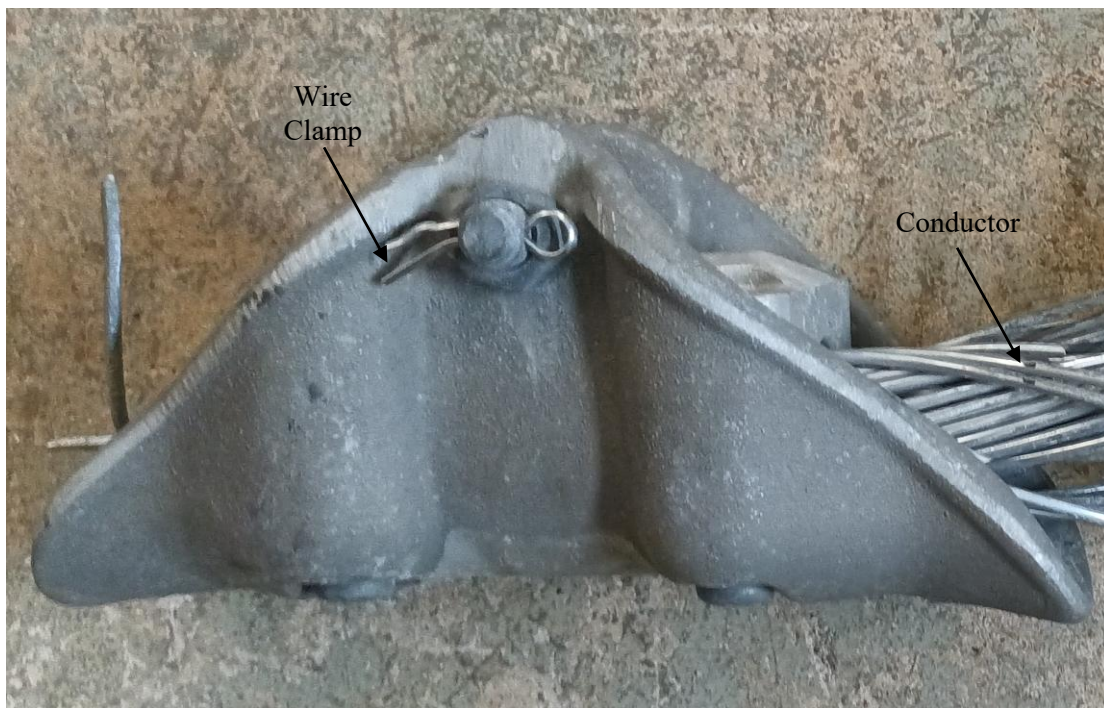
*Figure 2-4: Image showing a side view of a typical wire clamp (from 2024 conductor failures), which was utilized for the attachment of the conductor to the crossarm suspension insulator.*

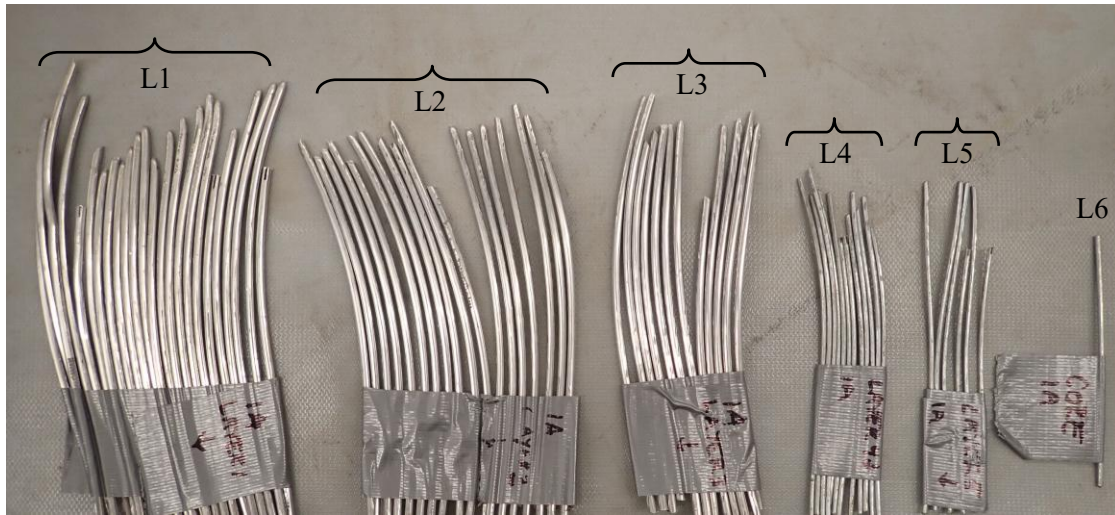
Figure 2-5: Image showing the wire strands associated with the individual layers (L1-L6) of the conductor subsequent to disassembly.

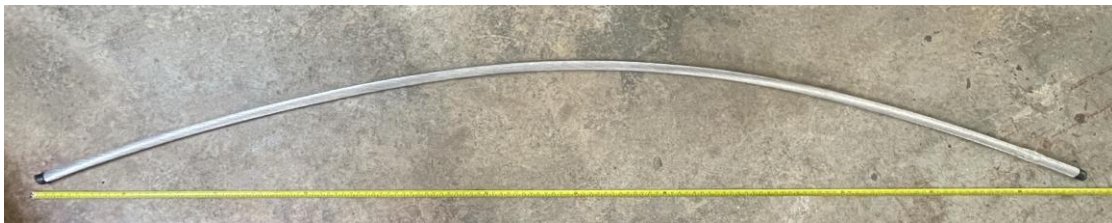
Duplicate uniaxial tension tests were conducted on the approximately 13 foot long segment of intact, service exposed conductor provided by NL Hydro (Figure 3-1) to determine if the conductor met the original rated tensile strength requirements for a Grackle ACSR 54/19 conductor. Section 3.1 details the results of the uniaxial tension tests conducted.

*Figure 3-1: Image showing the approximately 13 foot length of the service exposed (used) conductor provided by NL Hydro as received for analysis.*

The results of the testing indicated that the applied forces when the outer aluminum wire strands selectively fractured for the two tests were approximately 175.3 kN and 175.7 kN, respectively. The selective fracture of the outer aluminum wire strands resulted in a reduction of the applied forces for the two tests to approximately 83.6 kN and 82.7 kN, respectively. With continued applied deflection to the samples, the applied forces for the two tests increased to approximately 114.8 kN and 114.3 kN, respectively, which resulted in the fracture failure of the inner steel reinforcing wire strands. Measurements indicated that the overall fracture failure of the two conductors occurred between a distance of approximately 50 cm and 60 cm from the beginning of one of the epoxy filled terminations (Figure 3-4). Of relevance to the current investigation was that the maximum force generated by both of the tests conducted (175.3 kN and 175.7 kN) were approximately 6 percent below the minimum rated tensile strength requirements for a Grackle ACSR 54/19 (size 1192.5 kcmil) conductor specification (187 kN) [2].

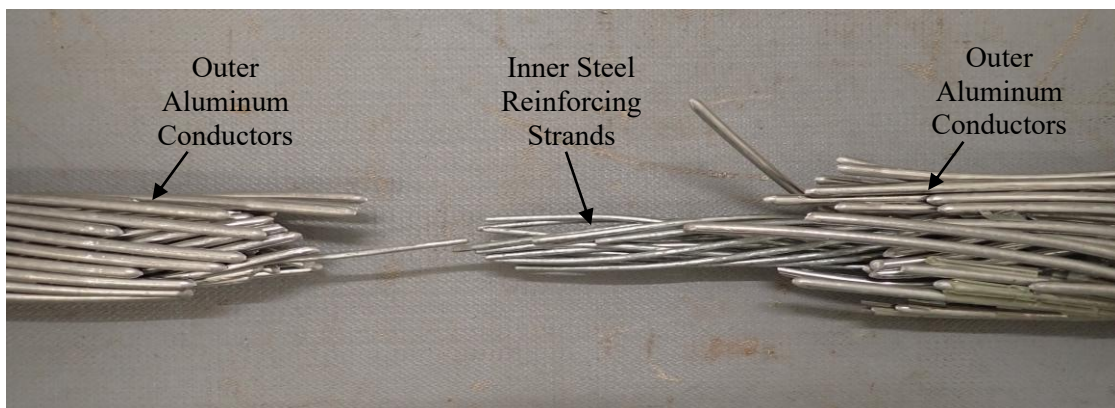
Figure 3-5 is a close-up view of one of the conductors showing the relative positions of the outer aluminum and the inner steel reinforcing wire strand failures subsequent to testing, which is consistent with that expected for the failure of a Grackle ACSR conductor. Samples of the fractured ends of the outer aluminum wire strands were removed from the failed conductor for additional characterization. Figures 3-6 through Figure 3-8 contain side view images of representative examples of the fractured aluminum wire strands and the steel core strands. Of note was the similarity between the fracture surfaces generated by the uniaxial tension testing and the fracture surfaces associated with in service failure of conductor EL-1 (Figure 2-6, Figure 2-7 and Figure 2-10). Also similar to the in service failure of conductor EL-1 was the presence of a few partial through wire indications (Figure 3-9), as well as localized strand on strand brinelling (Figure 3-10) in the individual aluminum wire strands associated with the uniaxial tension tests.

*Figure 3-5: Representative example showing the relative positions of the outer aluminum and the inner steel reinforcing wire strand failures subsequent to tension testing.*
