**Re: Quarterly Report on Asset Performance in Support of Resource Adequacy for the Twelve Months Ended December 31, 2025**

# Quarterly Report on Asset Performance in Support of Resource Adequacy

For the Twelve Months Ended December 31, 2025

# LIL Strengthening Overview

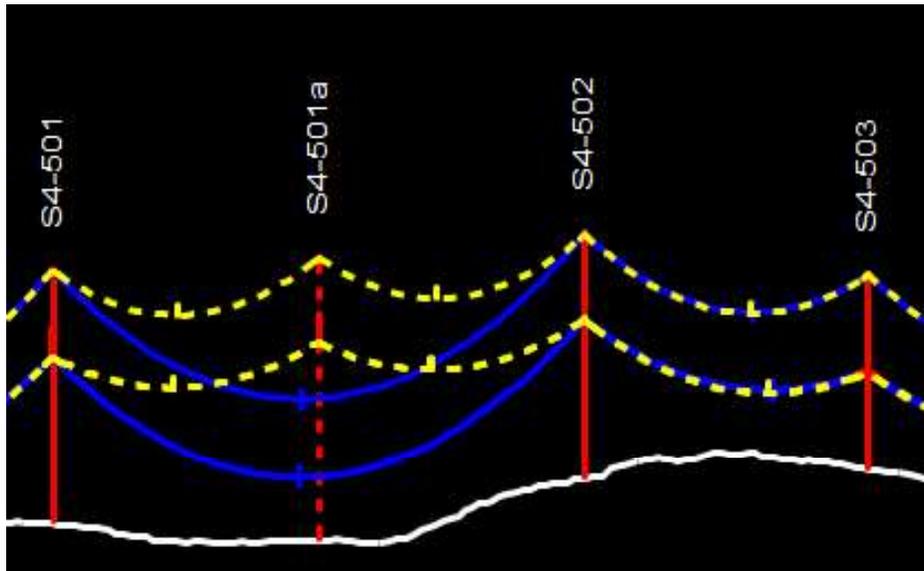
Figure 1: Profile for S4-502 (2469)

In the figure below, the blue catenaries represent the existing condition with no mid-span structures at 'Max ice' MAX SAG FE. The yellow catenaries represent the catenaries when one mid-span structure is added "S4-501A", also at 'Max ice' MAX SAG FE. The tick marks represent the low point on the conductor delineating the weight spans. A second mid-span structure was not considered because the ahead span is already short.

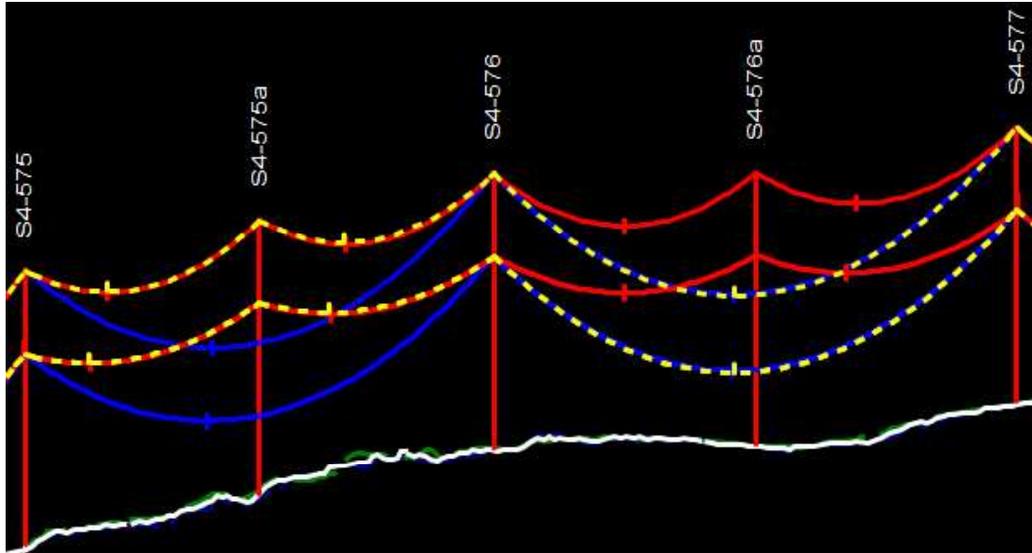
Figure 3: Profile for S4-576 (2543)

In Figure 3, the blue catenaries represent the existing condition with no mid-span structures. The yellow dotted catenaries represent the catenaries when one structure is added at the back span, while the red catenaries are for 2 mid-span structures added (one AS and one BS). All catenaries are shown at 'Max ice' MAX SAG FE.

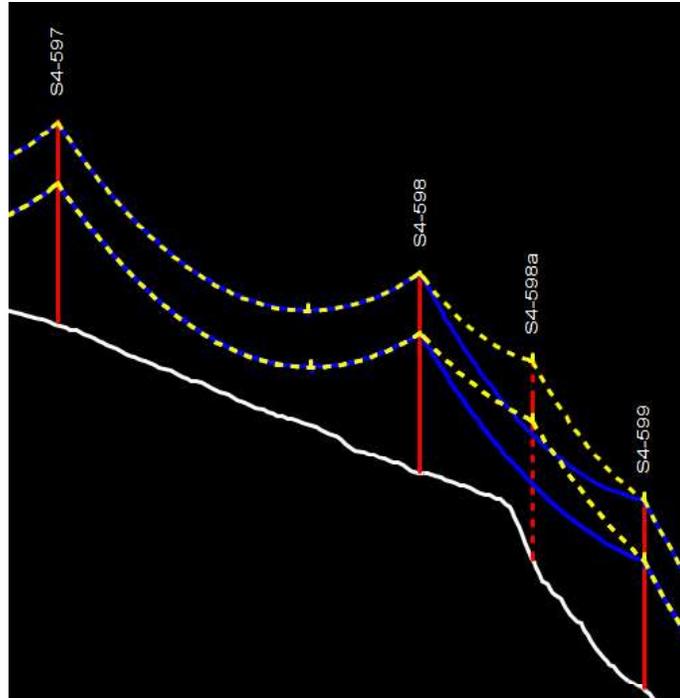
Figure 4: Profile for S4-598 (2565)

In Figure 4, the blue catenaries represent the existing condition with no mid-span structures. The yellow dotted catenaries represent the catenaries when one structure is added at the ahead span. All catenaries are shown at 'Max ice' MAX SAG FE.

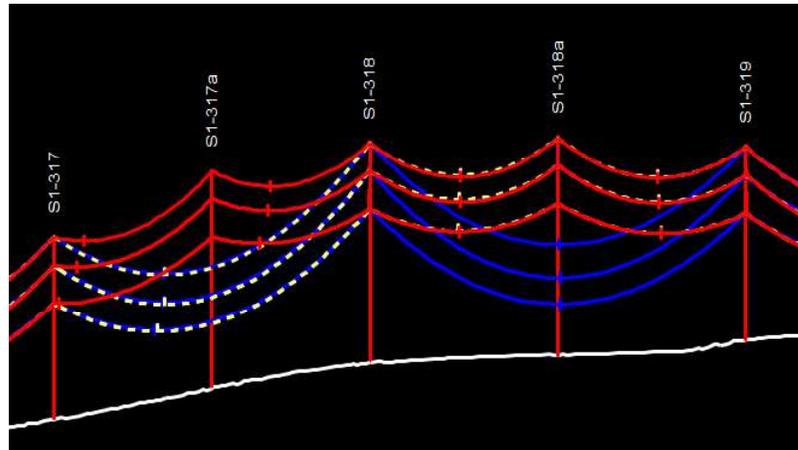
Figure 5: Profile for S1-318 (319)

Condition	Total Wind Span	Back Weight Span*	Ahead Weight Span*	Total Weight Span*
Existing	419 m	252 m	232 m	484 m
One mid-span structure	305 m	250 m	108 m	358 m
Two mid-span structures (AS & BS)	209 m	129 m	109 m	238 m
Change (1 Structure)	-114 m (27%)	-2 m	-124 m	-126 m (26%)
Change (2 Structures)	-210 m (50%)	-123 m	-123 m	-246 m (51%)

In Figure 5, the blue catenaries represent the existing condition with no mid-span structures. The yellow dotted catenaries represent the catenaries when one structure is added at the ahead span, while the red catenaries represent the catenaries when two mid-span structures are added (AS and BS). All catenaries are shown at 'Max ice' MAX SAG FE.

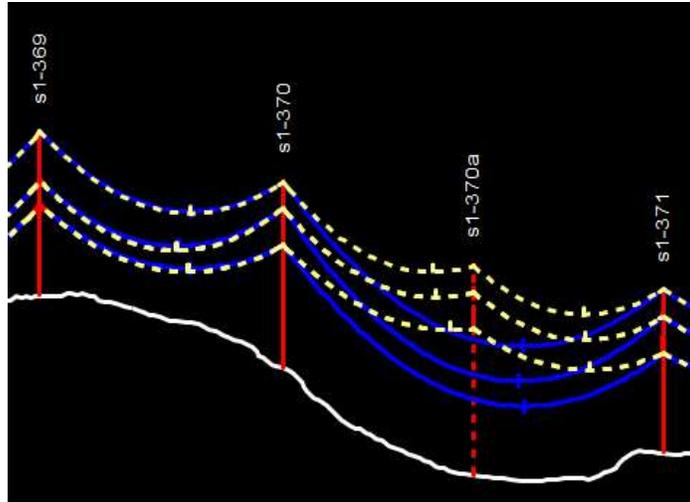
Figure 7: Profile for S1-370 (371)

Note that the added mid-span structure S1-370a is the tallest A1 extension (+18 m) available and only achieves a weight span reduction of 92 m. The weight span ratio is only reduced from 2.4 to a minimum of 1.8 because of the topography of the span.

In Figure 7, the blue catenaries represent the existing condition with no mid-span structures, while the yellow dotted catenaries represent the catenaries when one structure is added at the ahead span. catenaries are shown at 'Max ice' MAX SAG FE.

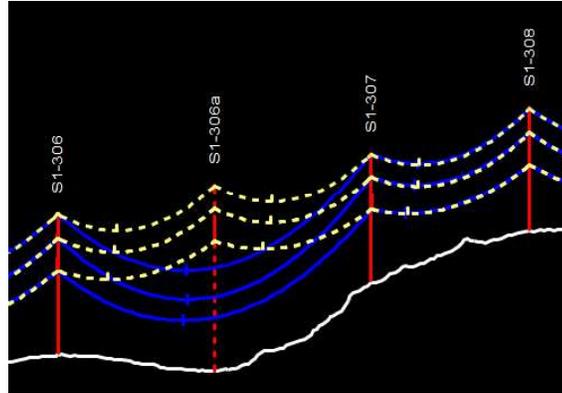
Figure 8: Profile for S1-307 (308)

Condition	Total Wind Span	Back Weight Span*	Ahead Weight Span*	Total Weight Span*
Existing	337 m	265 m	56 m	321 m
One mid-span structure	225 m	151 m	57 m	208 m
Change (1 Structure)	-112 m (33%)	-114 m	1 m	-113 m (35%)

In Figure 8, the blue catenaries represent the existing condition with no mid-span structures. The yellow dotted catenaries represent the catenaries when one structure is added at the ahead span. All catenaries are shown at 'Max ice' MAX SAG FE.

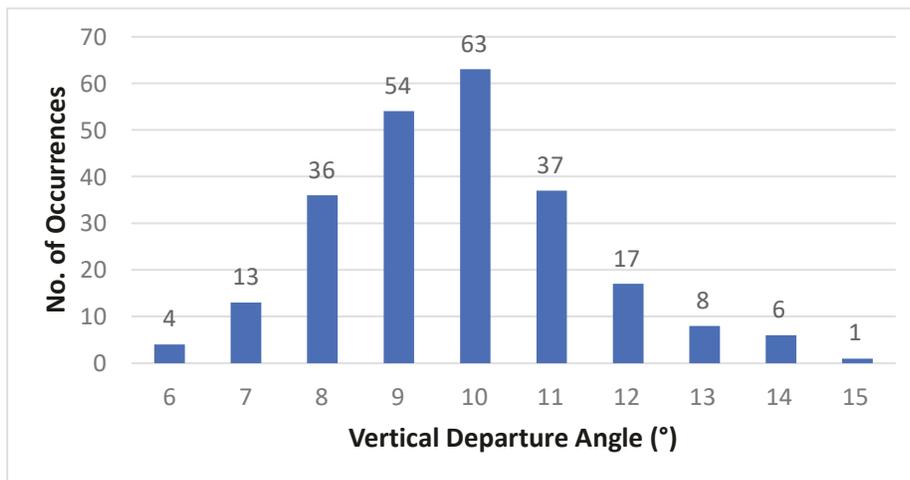
Figure 1: Vertical Departure Angles

The electrode conductor drop on the tower type A1 electrical clearance drawing ILK-JY-SD-6200-TL-D99-0012-01-A3 is listed as 270 mm. This value is dependent on the vertical departure angle and describes decreased electrical clearance due to the conductor descending from the suspension clamp elevation before surpassing the tower width. The distribution of as-built occurrences of vertical departure angle for a condition of 0°C, no ice, no wind, max sag FE is shown in Figure 1 below.

The maximum vertical departure angle considered in this report is 14°. Note that the single occurrence of 15° may be neglected because a high vertical departure angle is not coincident with a high transverse swing angle. This is because a high vertical departure angle is correlated to a large weight span which will limit the transverse swing angle. As per Figure 2 below, the as-built conductor drop will be considered as 200 mm.

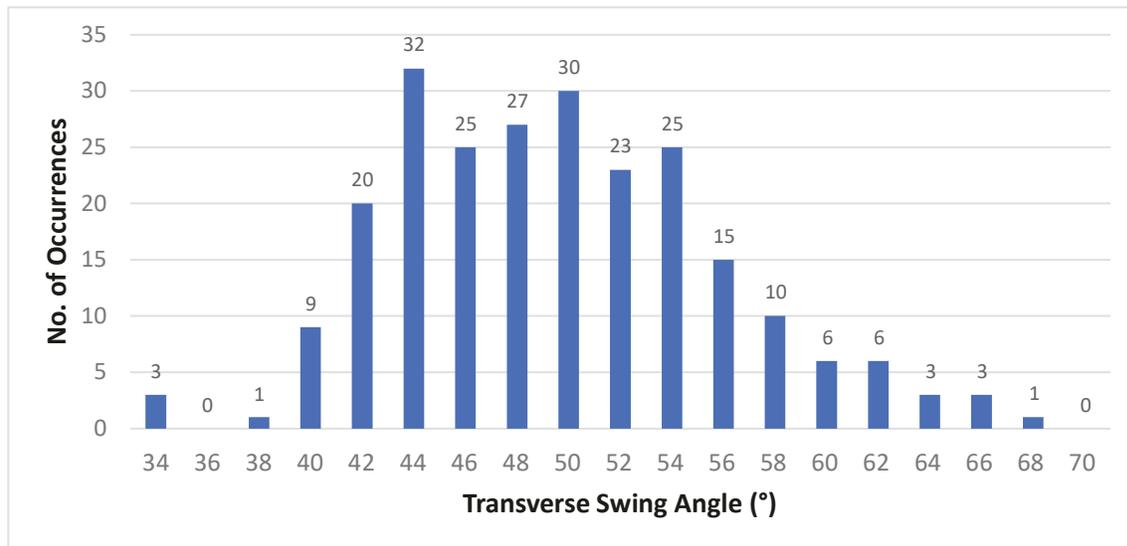
Figure 3: Transverse Swing Angles

The transverse swing angle on the tower type A1 electrical clearance drawing ILK-JY-SD-6200-TL-D99-0012-01-A3 is listed as 70°. The distribution of as-built transverse swing angles under maximum wind swing condition is presented in below in Figure 3.

Both improvement options rely on a reduced maximum transverse swing angle. Improvement option 1 can accommodate a transverse swing angle of 67° before violating electrical clearance to the cage. Improvement option 2 can withstand a transverse swingle of 66° before violating electrical clearance to the bottom of a new straight bottom cross-arm chord.

Towers positions that exceed this maximum 66° transverse swing angle could be brought below the maximum with the addition of conductor weights. The preferred style of conductor weight to avoid interfacing with existing hardware and limit impacts on electrical clearance is Maclean Power Systems (MPS) HDW-100-SS, see Figure 4. Weight should be placed close to the suspension clamp to avoid adding energized diameter to the conductor at the conductor drop position. Due to the limited cases where the swing limit is exceeded, this hardware detail is not considered in scope for the drawing deliverable.

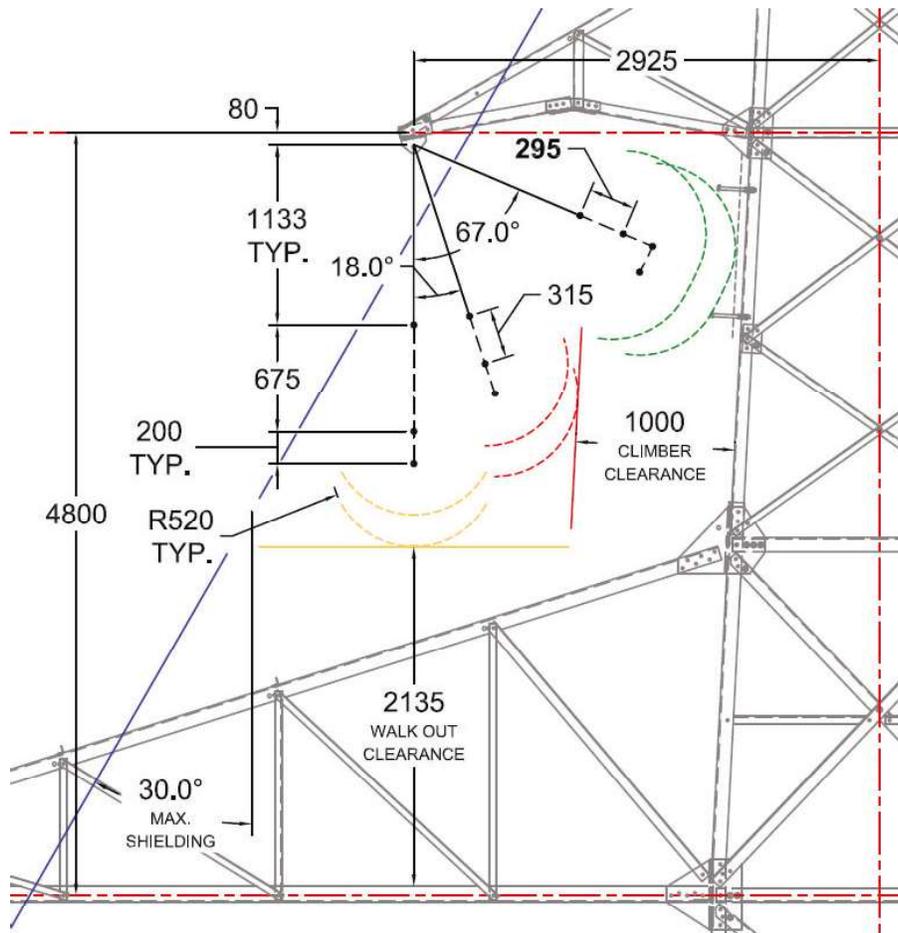
Figure 5: Option 1 Permissible Length Increase

The permissible increase for option 1 was determined to be 295 mm governed by the maximum wind swing case with electrical clearance to the cage, see Figure 5. Note that the EDT (0°C, 0 Pa) limit at 11° transverse swing and the REDUCED WIND SWING (-20°C, 296 Pa) limit at 47° swing are not shown because the required electrical clearances are the same and are covered by the MAXIMUM WIND SWING (-20°C, 788 Pa) limit at 67°. See previous section for justification of reduction of transverse swing angle from 70°. Note that electrode shielding angle improves with additional insulator length.

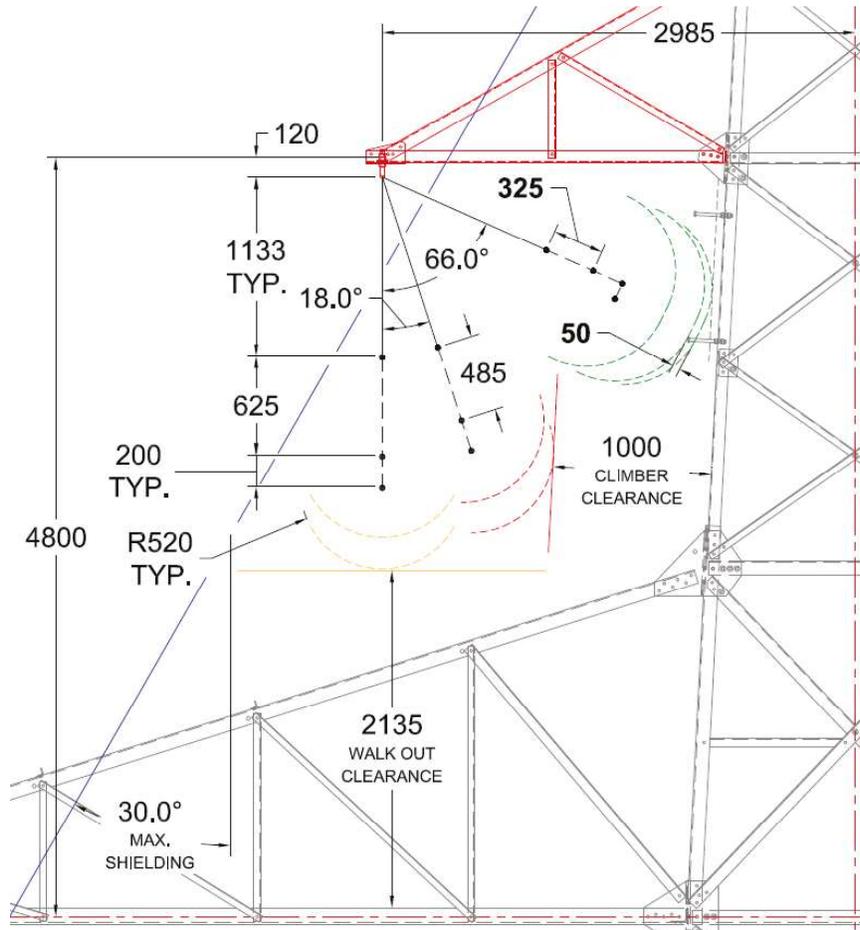
Figure 6: Option 2 Permissible Length Increase

The permissible increase for option 2 after considering the new proposed arm geometry was determined to be 325 mm governed by the maximum wind swing case with electrical clearance to a climbing bolt. As with option 1, the EDT (0°C, 0 Pa) limit at 11° transverse swing and the REDUCED WIND SWING (-20°C, 296 Pa) limit at 47° swing are not shown because the required electrical clearances are the same and are covered by the MAXIMUM WIND SWING (-20°C, 788 Pa) limit at 66°. See previous section for justification of reduction of transverse swing angle from 70°. As with option 1, the electrode shielding angle improves with additional insulator length.

Note that an additional 50 mm of insulator length for a total of 375 mm increase may be included if the step bolt is removed. NL Hydro confirmed March 11, 2025 that the removal of the climbing bolt is acceptable.

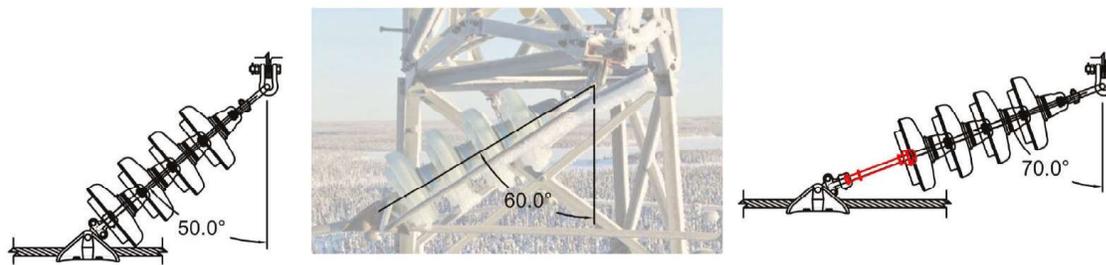
Figure 7: Longitudinal Articulation Angle

Ignoring broken wire cases, the maximum required longitudinal angle from the design loading drawings ILK-SN-CD-6200-TL-DD-0065-01-C1 & ILK-SN-CD-6200-TL-DD-0065-02-C2 and the additional loading table included in the RFP is  $33^\circ$  for load case “UBI EL1 64 mm 70/100%.” Because this is within the permissible range for the existing assembly, the target articulation angle is not defined. Photo 22 from the *Failure Investigation Report – L3501/2 Tower and Conductor Damage (2021)* shows a longitudinal swing angle of approximately  $60^\circ$ , see Figure 7 (middle).

Both options presented feature hardware length increase on the energized end to increase the longitudinal articulation angle. The permissible articulation is now expected to exceed  $70^\circ$ , see Figure 7 (right). The longitudinal articulation of the socket tongue fitting to suspension clamp was confirmed by SLACAN to also exceed  $70^\circ$  (approximately  $80^\circ$ ).

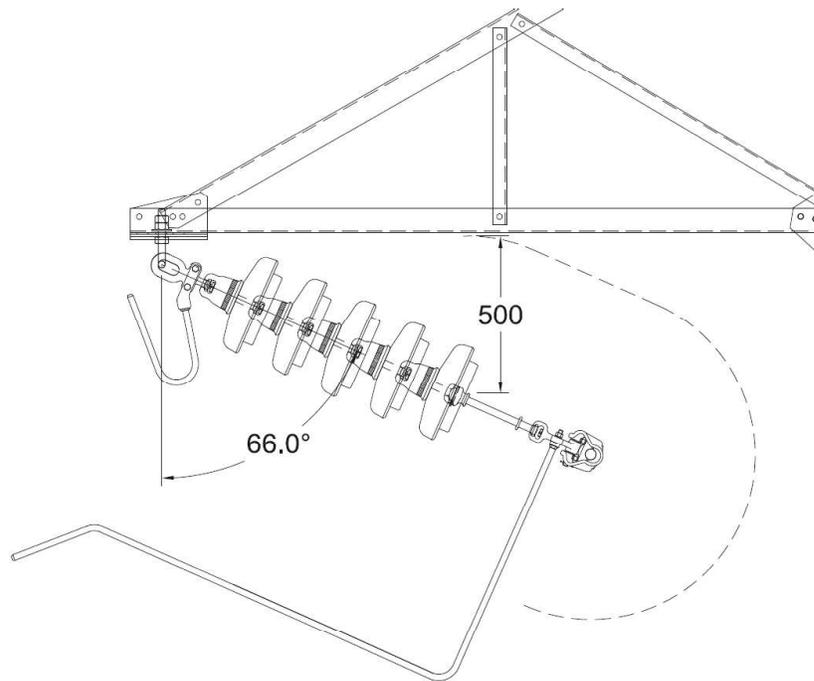
Figure 11: Option 2 Minimum Electrical Clearance

The bottom chord of the cross-arm will be set level to simplify detailing, fabrication, and erection as well as avoid high axial forces in the bracing. This requires a maximum transverse swing angle of 66° to maintain electrical clearance to the bottom of the cross-arm, see Figure 11, and transverse swing angle section for justification. Bottom chord plan bracing will be framed on the top of the bottom face to avoid reductions in electrical clearance.

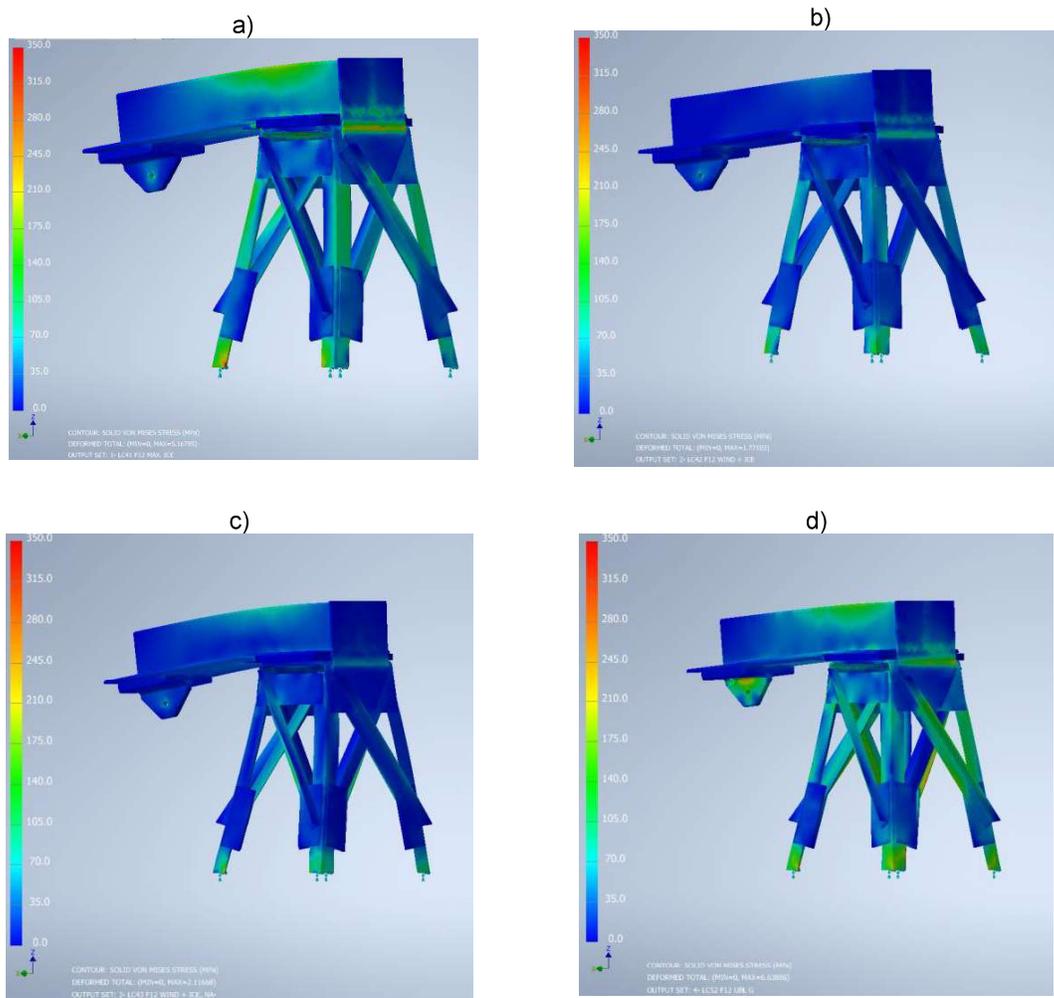
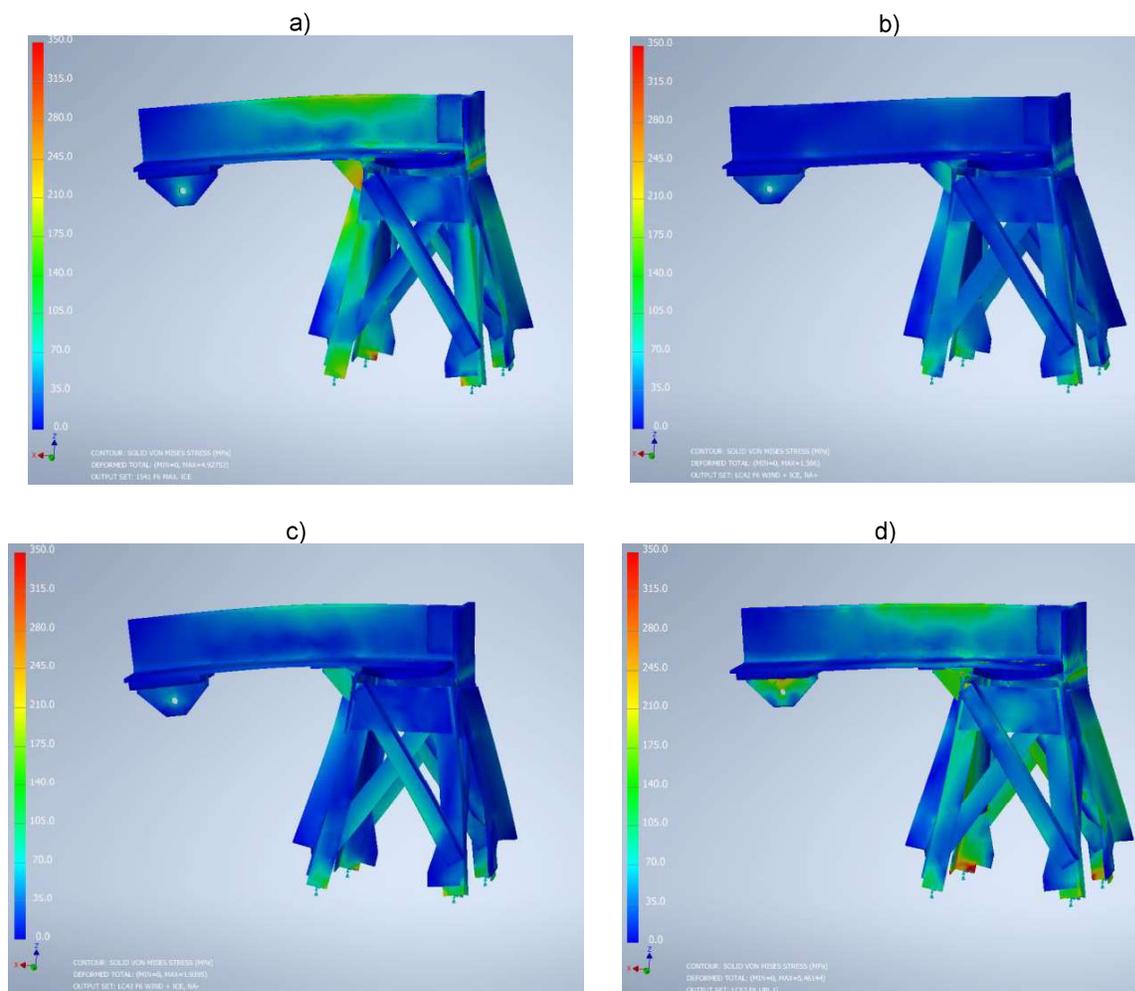
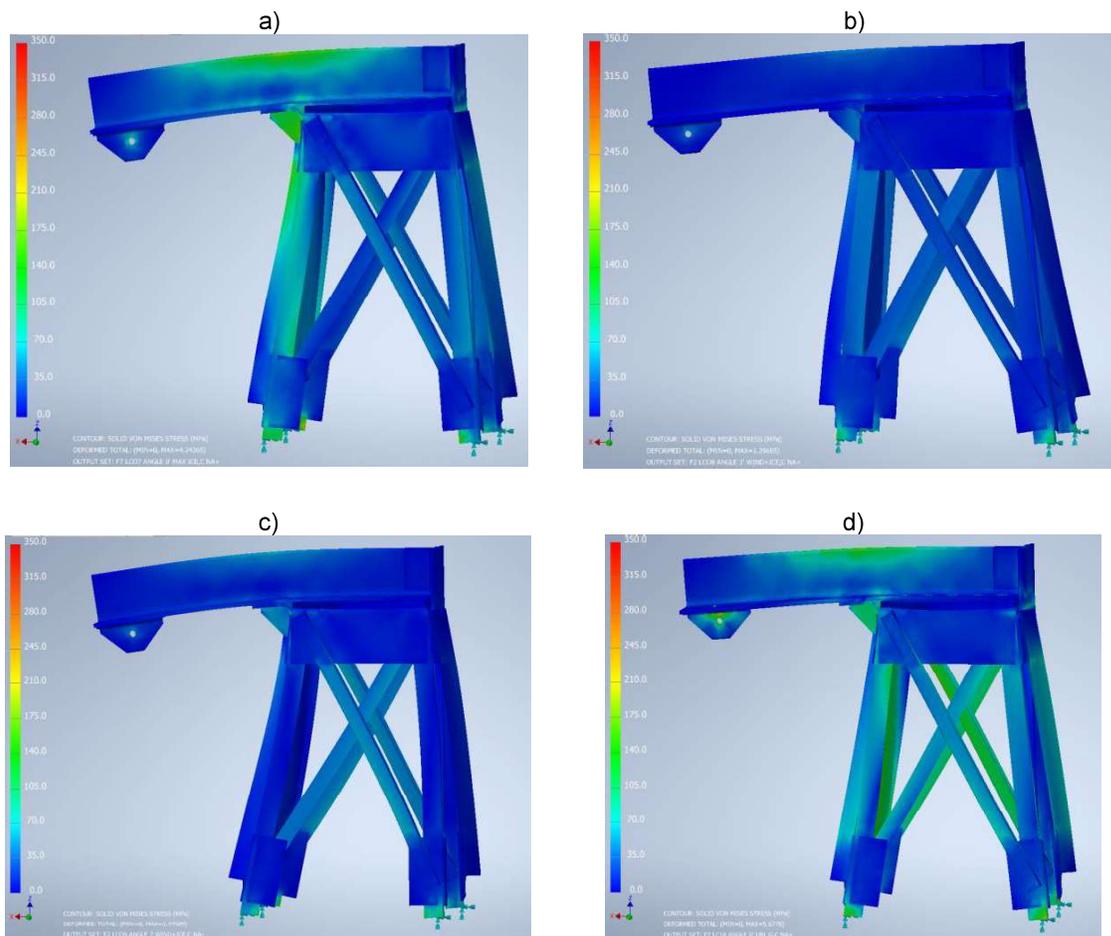
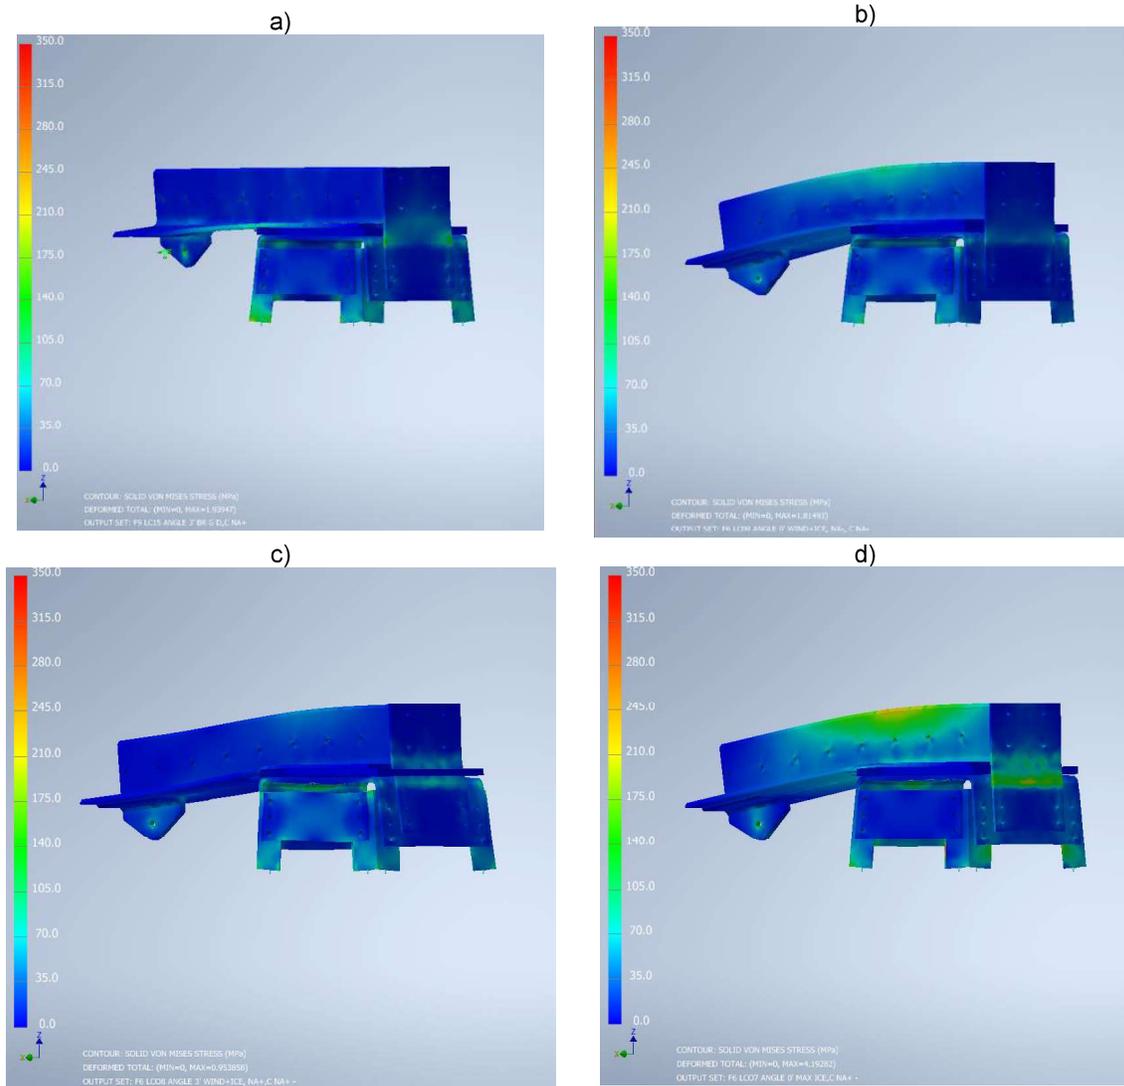
Finite element analysis was conducted for OPGW peak of each tower family (i.e., A2, A4, B1, and B2). Von mises stress distribution was checked for each of the 4 loading cases shown in Table 2. Stress values were compared to the yield stress of 350 WT steel ( $F_y=350$  MPa). Figures 8 to 11, show the Von Mises stresses distribution for towers A2, A4, B1, and B2 respectively, for the loading cases shown in Table 2. The deformed shape in the figures is magnified with a displacement factor of 10% for presentation purposes. As seen in the figures, the maximum stress for all load cases of the 4 tower groups was kept below 350 MPa, except for some areas, where sharp edges/change in geometry existed. These overstresses are only due to stress concentration and can be ignored.

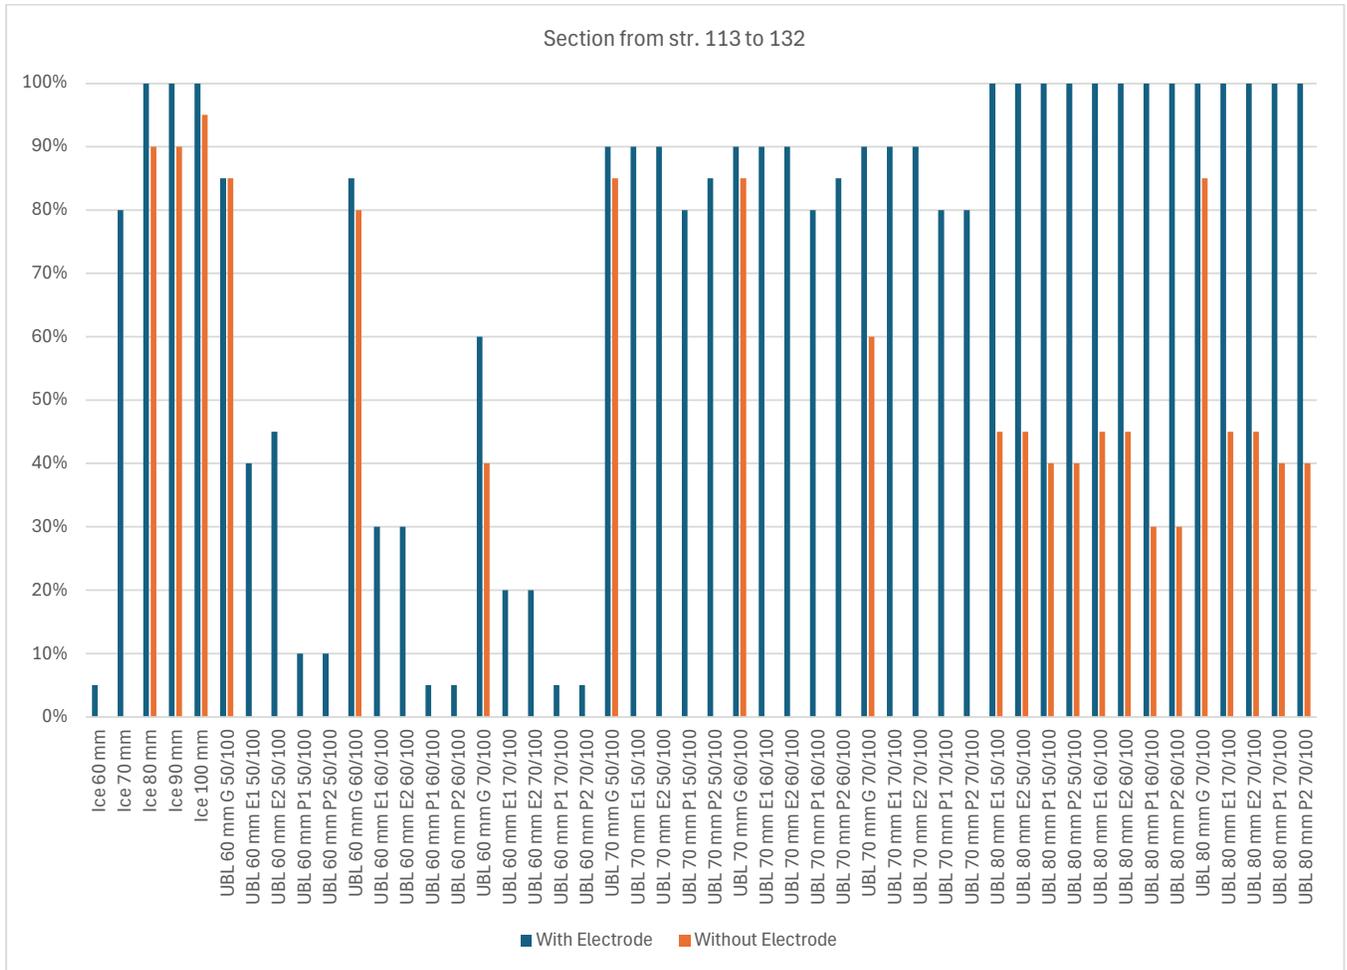
Figure 3 - Percentage of Structure Failures - Section 113 to 132

In the section from structure 113 to 132 (Figure 3) under balanced ice loading with the electrode attached to the structure, between 5% and 80% of the structures in the section will fail with 60 mm and 70 mm of radial ice respectively. Without the electrode attached to the structures, there are zero structure failures in this section for 60 mm and 70 mm of radial ice. This shows a clear benefit to removing the electrode in this section. Over 70 mm of balanced ice load, all structure will fail with the electrode attached to the structures and between 90% to 95% will fail without the electrode attached to the structures.

- on the OPGW (G) the percentage of structure failure for 70/100% unbalanced is 85% (note that for load cases 60/100% and 50/100%, the loads are so high that the structure analysis failed to converge and all structures are assumed to have failed),
- on EL1, EL2, P1, and P2 the percentage of structure failures range from 30% to 45%.

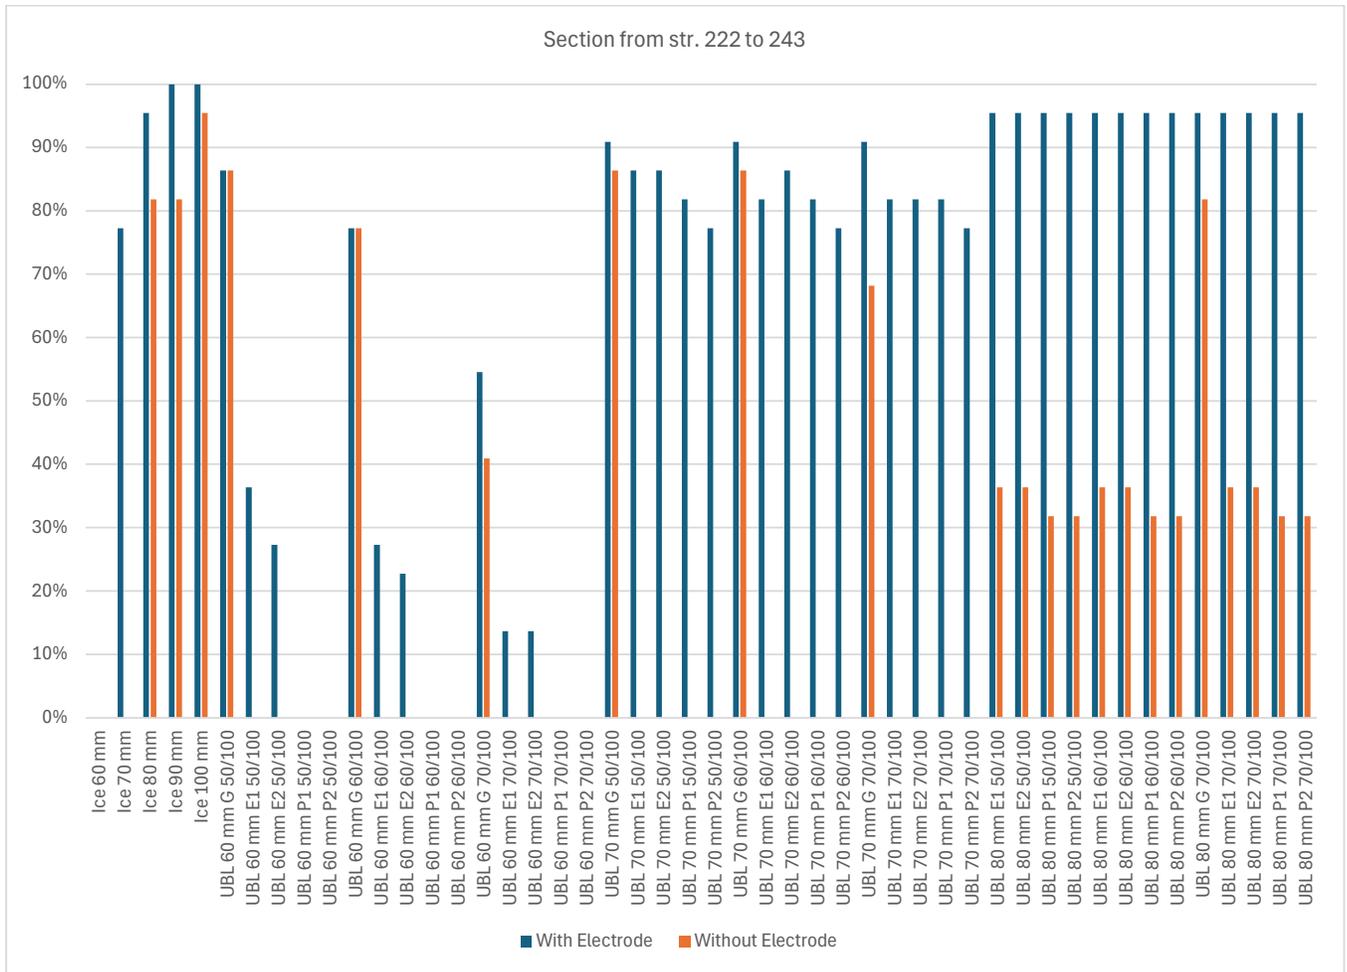
Figure 4- Percentage of Structure Failures - Structure 222 to 243

The results for the section from structure 222 to 243 (Figure 4) are similar to the section from 113 to 132, with slightly lower percentages of failures overall. Under balanced ice loading, between 0% and 77% of the structures with electrode in the section will fail with 60 mm and 70 mm of ice load, respectively. Without the electrode on the structure, there are zero structure failures in this section for 60 mm and 70 mm of ice load. This shows a clear benefit to removing the electrode in this section. Over 70 mm of balanced ice load, between 95% to 100% of structures will fail with the electrode and 82% to 95% will fail without the electrode.

- structures with the electrode:
  - 95% of structures failed for all load cases,
- structures without the electrode:
  - on the OPGW (g) the percentage of structure failure for 70/100% unbalanced is 82%,
  - on EL1, EL2, P1, and P2 the percentage of structure failures range from 32% to 36%.

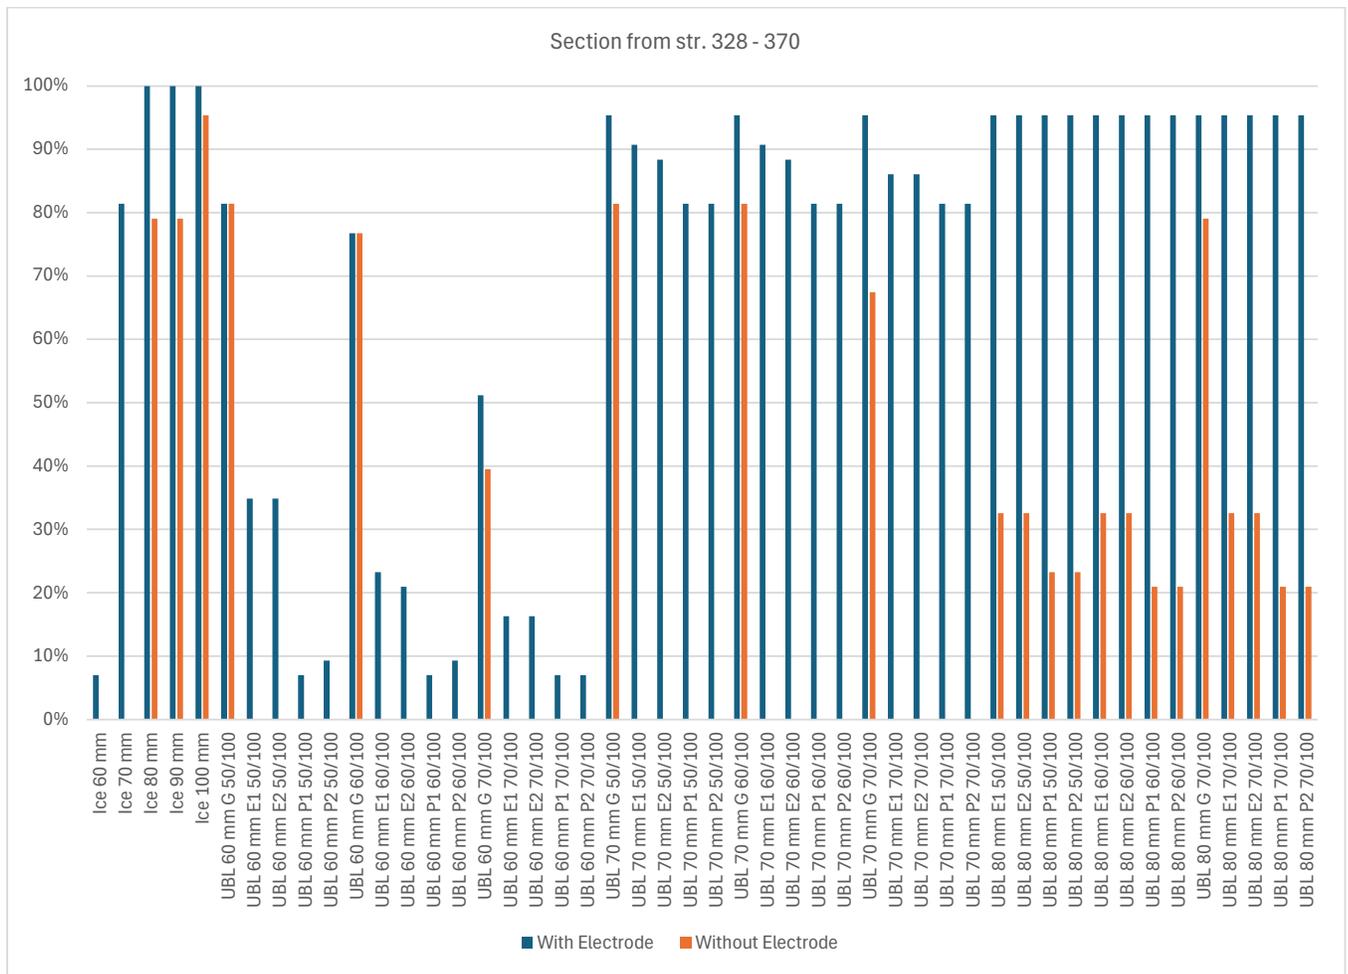
Figure 5 - Percentage of Structure Failures - Structures 328 to 370

The results for the section from structure 328 to 370 (Figure 5) are very similar to the section from 222 to 243. Under balanced ice loading for structures with the electrode, between 7% and 81% of the structures in the section will fail with 60 mm and 70 mm of ice load, respectively. Without the electrode attached to the structure, there are zero structure failures in this section for 60 mm and 70 mm of ice load. This shows a clear benefit to removing the electrode from the structures in this section. Over 70 mm of balanced ice load, 100% of structures will fail with the electrode and 79% to 95% will fail without the electrode.

- structures with the electrode:
  - 95% of structures failed for all load cases,
- structures without the electrode:
  - on the OPGW (g) the percentage of structure failure for 70/100% unbalanced is 79%,
  - on EL1, EL2, P1, and P2 the percentage of structure failures range from 21% to 33%.

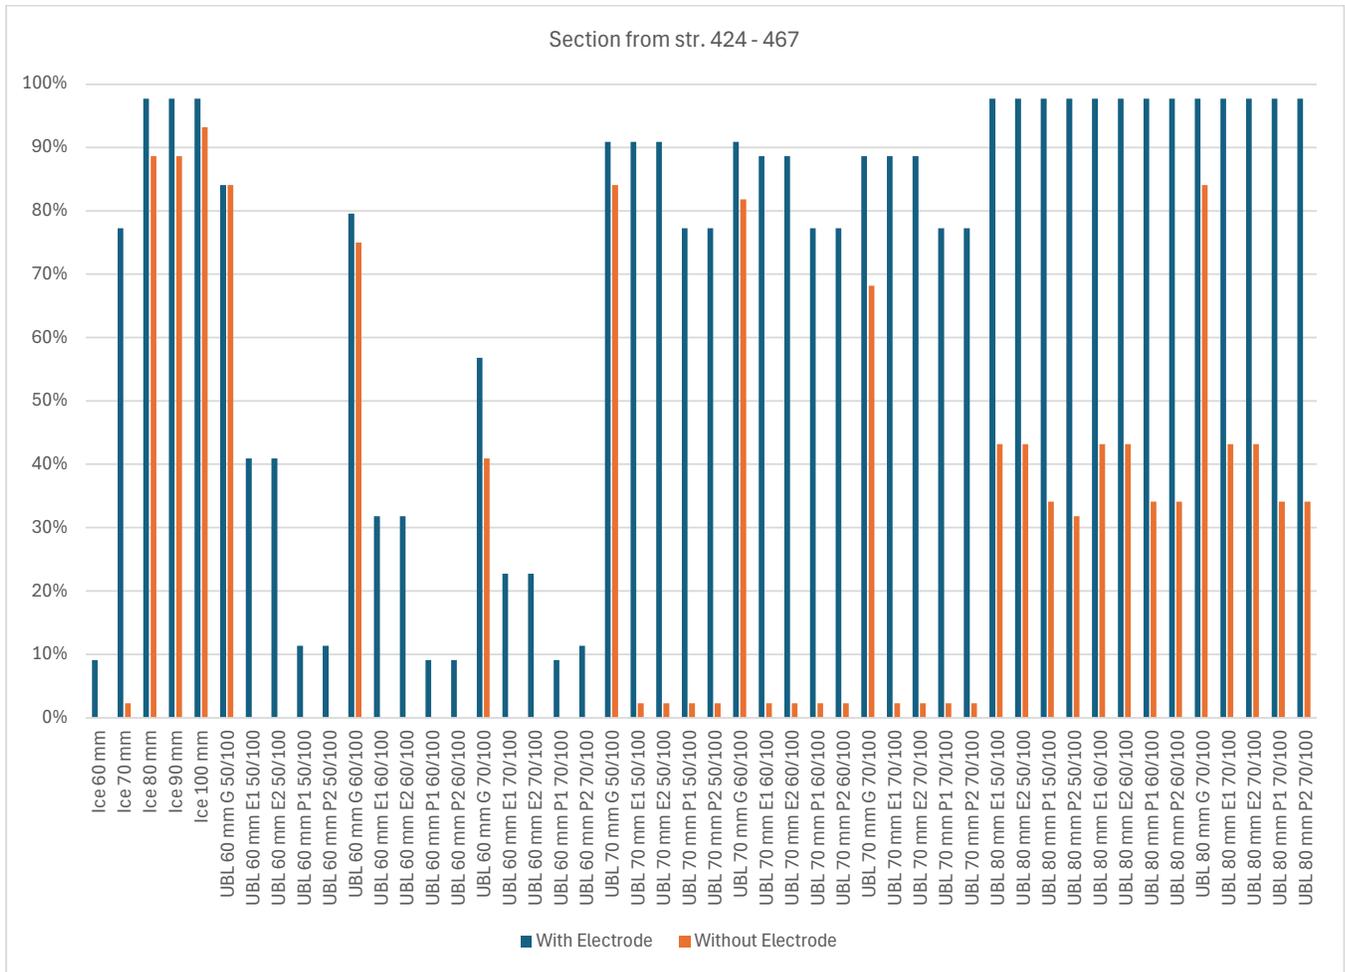
Figure 6 - Percentage of Structure Failures - Structures 424 to 467

The results for the section from structure 424 to 467 (Figure 6) are similar to the section from 113 to 132. Under unbalanced ice loading, between 9% and 77% of the structures with the electrode in the section will fail with 60 mm and

- structures with the electrode:
  - 98% of structures failed for all load cases,
- structures without the electrode:
  - on the OPGW (g) the percentage of structure failures for 70/100% unbalanced is 84%,
  - on EL1, EL2, P1, and P2 the percentage of structure failures range from 34% to 43%.

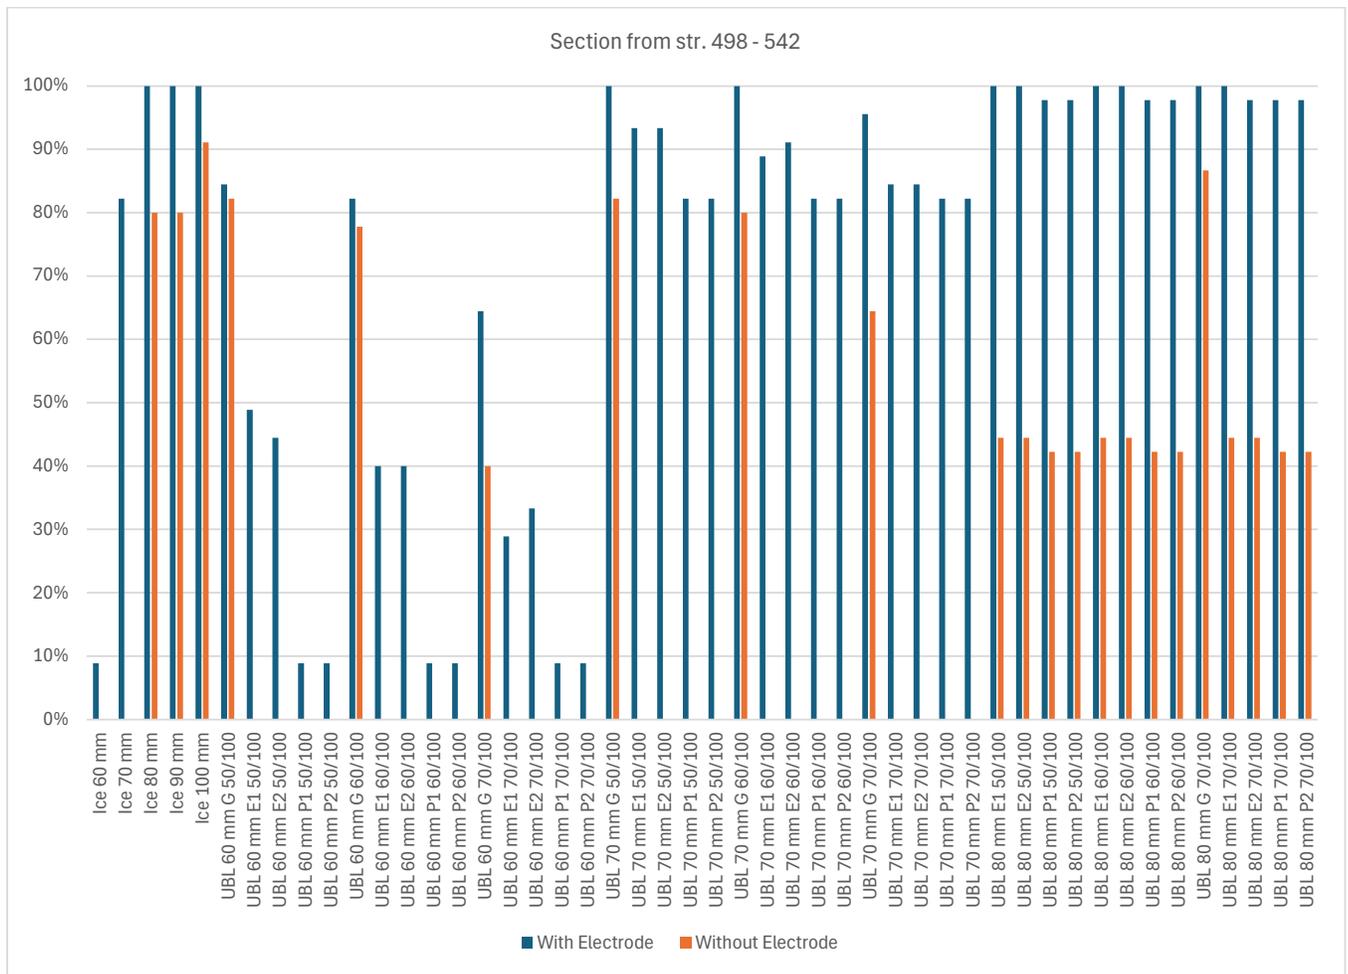
Figure 7- Percentage of Structure Failures - Structure 498 to 542

The results for the section from structure 498 to 542 (Figure 7) are similar to the section from 113 to 132. Under balanced ice loading, between 9% and 82% of the structures with the electrode in the section will fail with 60 mm and 70 mm of ice load, respectively. Without the electrode attached to the structures, there are no failures in this section for 60 mm and 70 mm of ice load. With over 70 mm of balanced ice load, 100% of structures will fail with the electrode and between 80% to 91% will fail without the electrode. This shows a clear benefit to removing the electrode from the structures in this section.

- structures with the electrode:
  - 98% to 100% of structures failed for all load cases,
- structures without the electrode:
  - on the OPGW (g) the percentage of structure failures for 70/100% unbalanced is 87%,
  - on EL1, EL2, P1, and P2 the percentage of structure failures range from 42% to 44%.

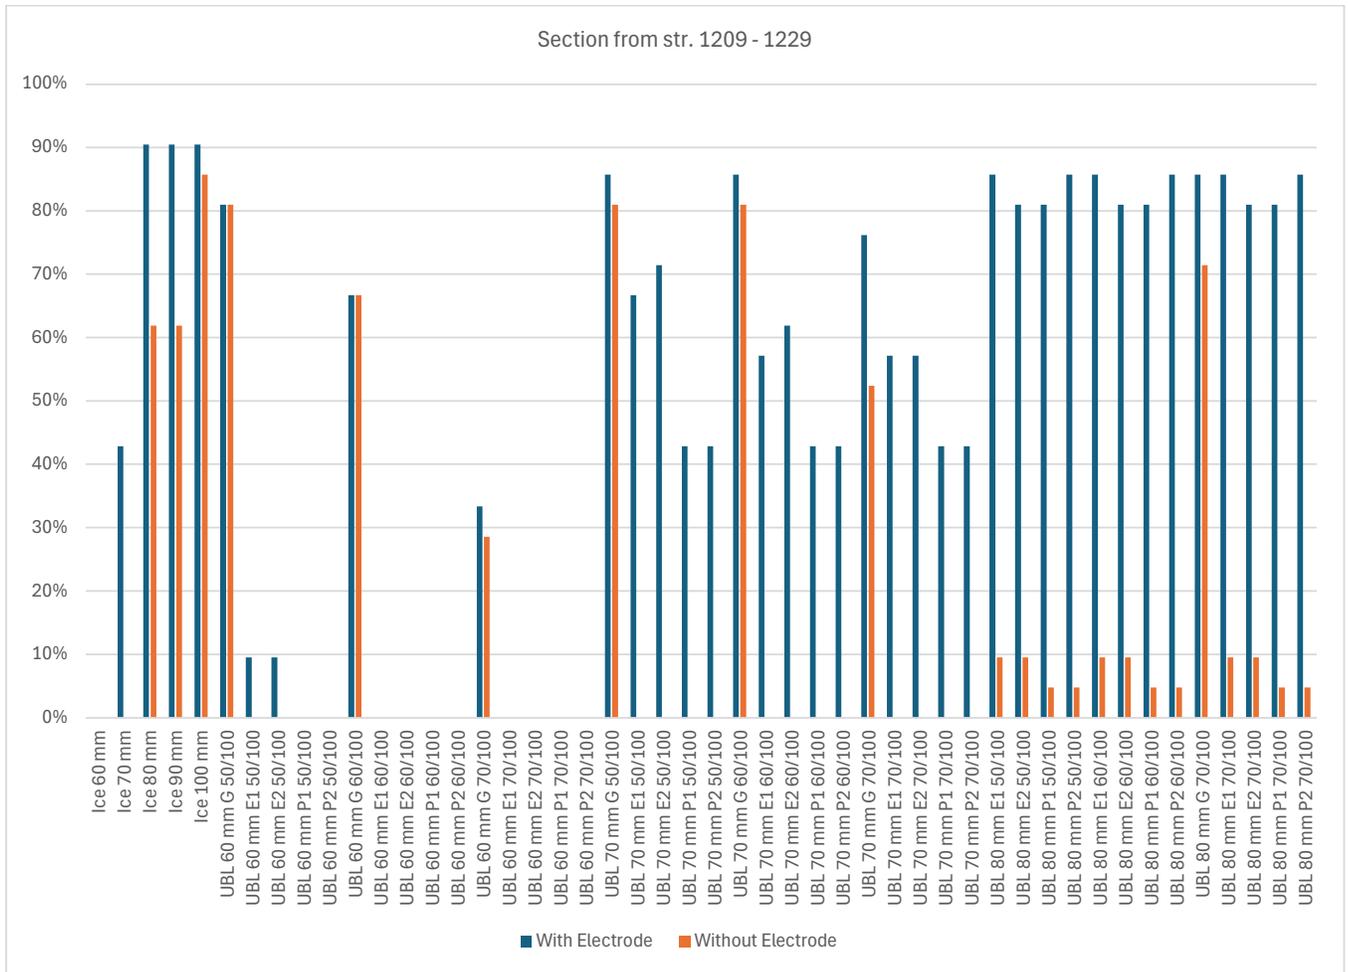
Figure 8 - Percentage of Structure Failures - Structures 1209 to 1229

The results for the section from structure 1209 to 1229 (Figure 8) have less failures than all other section. Under unbalanced ice loading, between 0% and 43% of the structures with the electrode in the section will fail with 60 mm and

- structures with the electrode:
  - 81% to 86% of structures failed for all load cases,
- structures without the electrode:
  - on the OPGW (G) the percentage of structure failure for 70/100% unbalanced is 71%,
  - on EL1, EL2, P1, and P2 the percentage of structure failures range from 5% to 10%.
