**Re: Quarterly Report on Asset Performance in Support of Resource Adequacy for the Twelve Months Ended December 31, 2025**

# Quarterly Report on Asset Performance in Support of Resource Adequacy

For the Twelve Months Ended December 31, 2025

# LIL Strengthening Overview

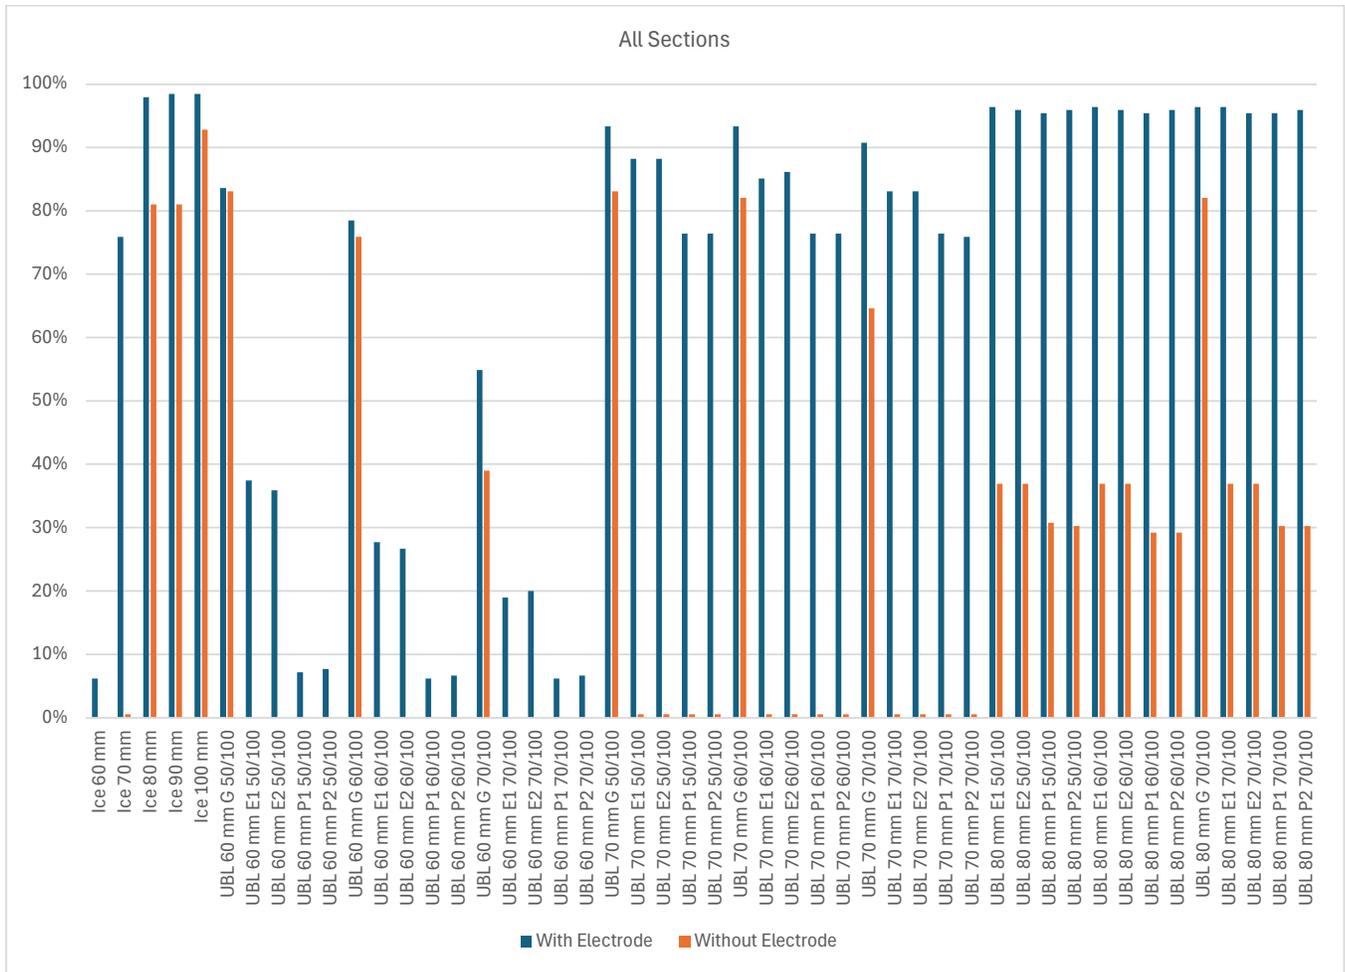
Figure 9 - Percentage of Structure Failures Summary of All Sections

Figure 9 shows the summary of all sections combined.
