Re: Holyrood Thermal Generating Station Unit 2 Stack Movement Assessment

Holyrood Thermal Generating Station Unit 2 Stack Movement Assessment

A Report to the Board of Commissioners of Public Utilities

Unit 2 Stack Condition Assessment Memo by Hatch - November 26, 2018

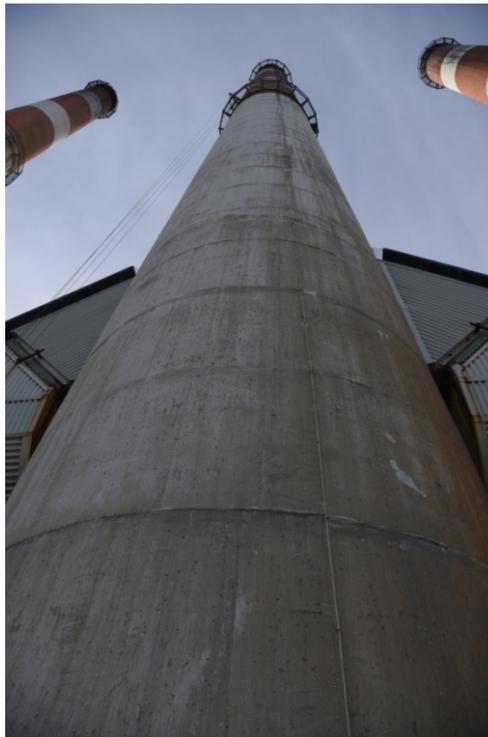
Figure 6: Holyrood Thermal Generating Station Unit 2 Stack

4 On the morning of November 15, 2018, personnel at Holyrood observed what was considered
5 to be abnormal swaying motion of the Unit 2 stack. The movement was described to be in
6 excess of that observed at the adjacent stacks for Units 1 and 3. An exact measurement of the
7 stack movement could not be obtained due to strong buffeting wind and the inability for the
8 survey equipment to lock on the moving structure. The movement was described by on-site
9 personnel as slow and somewhat elliptical, with the greatest deflection in the direction
10 perpendicular to the wind. Figure 5 indicates the direction of the wind and the motion on the

- 1 Unit 2 stack shown in Figure 6. On-site monitoring equipment recorded west-north-west winds
- 2 with gust speeds of 90 km/h to 95 km/h at the time of the observation. The maximum recorded
- 3 gust wind speed in the 24-hours leading up to the observation was 119 km/h.
