Re: Holyrood Thermal Generating Station Unit 2 Stack Movement Assessment

Holyrood Thermal Generating Station

Exhaust Stack No. 2

H358827-00000-240-230-0002

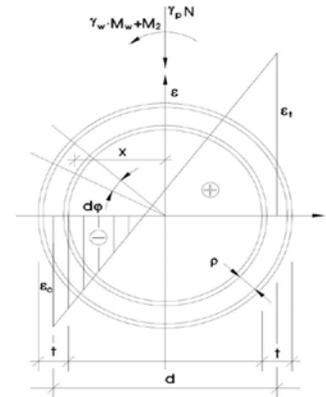
r	Radius of stack section	r =	3852.5	mm	
X	Location of neutral axis	X =	-1284.2		
fcu	Design strength of concrete	fcu =	15.6	MPa	Refer CL 5.5
ε _{ty}	Rebar strain at its yield stress	ε _{ty} =	0.00104		
S	Rebar spacing	S =	249.5	mm	
ρ	Ratio of reinforcement	ρ =	0.00437		
N	Section axial compression capacity	N =	-64039.5	kN	
		Utilization	15.9%		Comply
M	Section bending capacity	M =	171101.4	kN*m	
		Utilization	36.9%		Comply

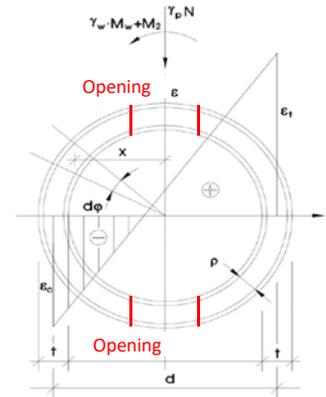
r	Radius of stack section	r =	3722	mm	
X	Location of neutral axis	X =	-1240.7		
fcu	Design strength of concrete	fcu =	15.6	MPa	Refer CL 5.5
ε _{ty}	Rebar strain at its yield stress	ε _{ty} =	0.00104		
S	Rebar spacing	S =	242.8	mm	
ρ	Ratio of reinforcement	ρ =	0.00363		
N	Section axial compression capacity	N =	-41381.8	kN	
		Utilization	22.5%		Comply
M	Section bending capacity	M =	125068.8	kN*m	
		Utilization	44.4%		Comply

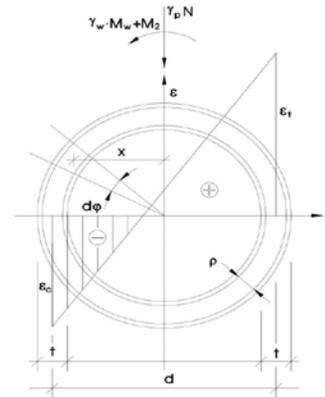
r	Radius of stack section	r=	3124	mm	
X	Location of neutral axis	X=	-1041.3		
fcu	Design strength of concrete	fcu=	13.7	MPa	Refer CL 5.5
ε _{ty}	Rebar strain at its yield stress	ε _{ty} =	0.00104		
S	Rebar spacing	S=	251.6	mm	
ρ	Ratio of reinforcement	ρ=	0.00449		
N	Section axial compression capacity	N=	-22815.7	kN	
		Utilization	14.7%		Comply
M	Section bending capacity	M=	49991.7	kN*m	
		Utilization	38.4%		Comply

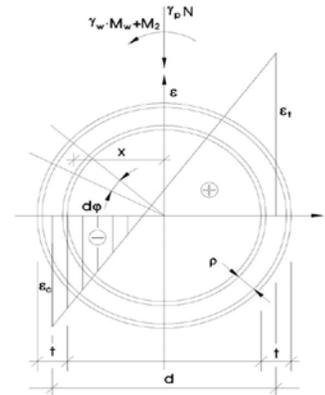
r	Radius of stack section	r=	3852.5	mm	
X	Location of neutral axis	X=	-1284.2		
fcu	Design strength of concrete	fcu=	15.6	MPa	Refer CL 5.5
ε _{ty}	Rebar strain at its yield stress	ε _{ty} =	0.00104		
S	Rebar spacing	S=	249.5	mm	
ρ	Ratio of reinforcement	ρ=	0.00437		
N	Section axial compression capacity	N=	-64039.5	kN	
		Utilization	15.9%		Comply
M	Section bending capacity	M=	171101.4	kN*m	
		Utilization	44.9%		Comply

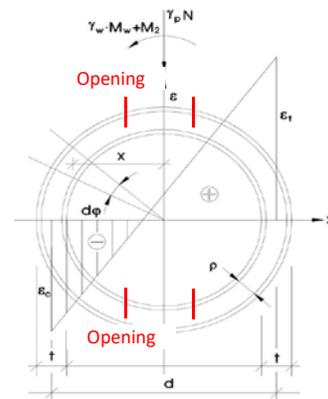
r	Radius of stack section	r=	3722	mm	
X	Location of neutral axis	X=	-1240.7		
fcu	Design strength of concrete	fcu=	15.6	MPa	Refer CL 5.5
ε _{ty}	Rebar strain at its yield stress	ε _{ty} =	0.00104		
S	Rebar spacing	S=	242.8	mm	
ρ	Ratio of reinforcement	ρ=	0.00363		
N	Section axial compression capacity	N=	-41381.8	kN	
		Utilization	22.5%		Comply
M	Section bending capacity	M=	125068.8	kN*m	
		Utilization	54%		Comply

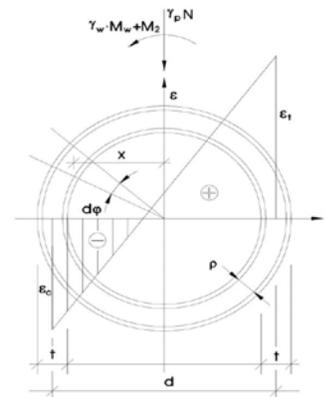
r	Radius of stack section	r=	3124	mm
X	Location of neutral axis	X=	-1041.3	
fcu	Design strength of concrete	fcu=	13.7	MPa Refer CL 5.5
ε _{ty}	Rebar strain at its yield stress	ε _{ty} =	0.00104	
S	Rebar spacing	S=	251.6	mm
ρ	Ratio of reinforcement	ρ=	0.00449	
N	Section axial compression capacity	N=	-22815.7	kN
		Utilization	14.7%	Comply
M	Section bending capacity	M=	49991.7	kN*m
		Utilization	46.7%	Comply

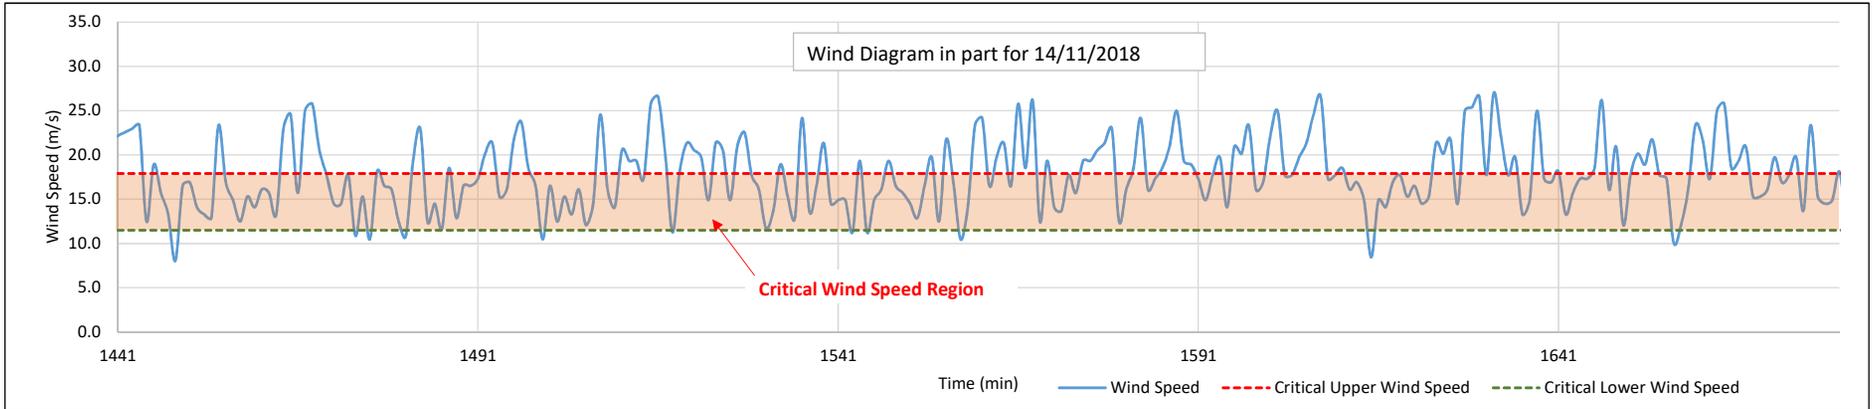
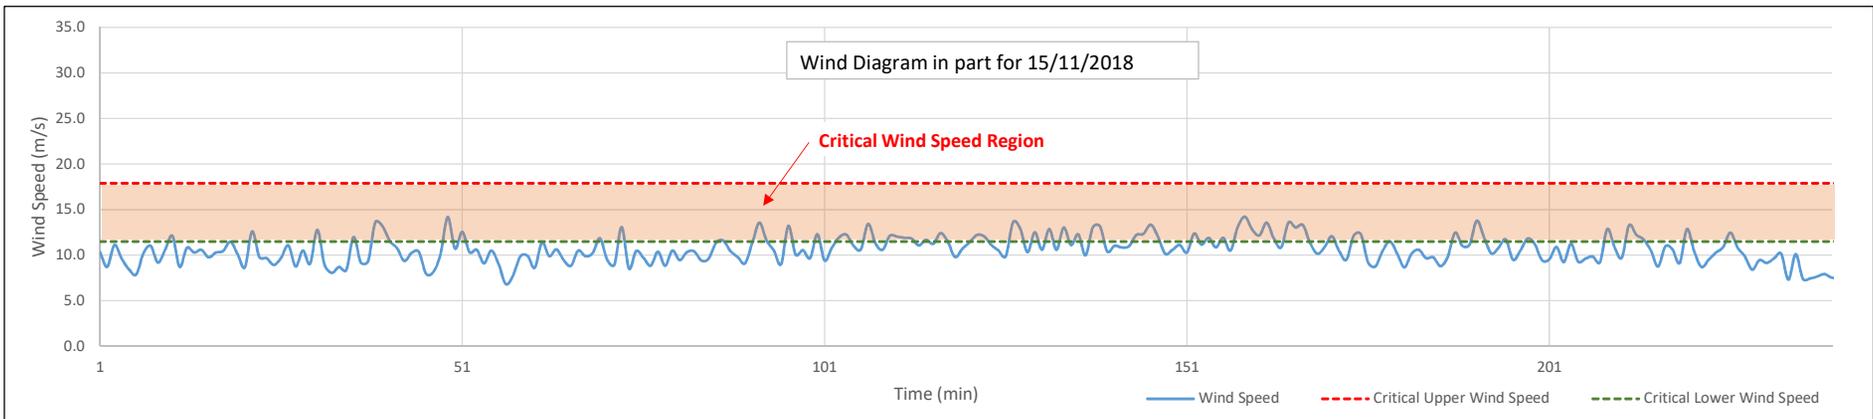
Critical Wind Speed for As-Design Stack

Note: With reference to CICIND Model Code for Concrete Chimneys – 2011, it deems to be reasonable to consider +/- 25% as a critical wind speed range for vortex shedding assessment.
