Re: Newfoundland & Labrador Hydro's 2003 Capital Budget Application

Enclosed please find fifteen (15) copies of Newfoundland and Labrador Hydro's responses to Requests for Information numbers PUB 1.0 to PUB 9.2.

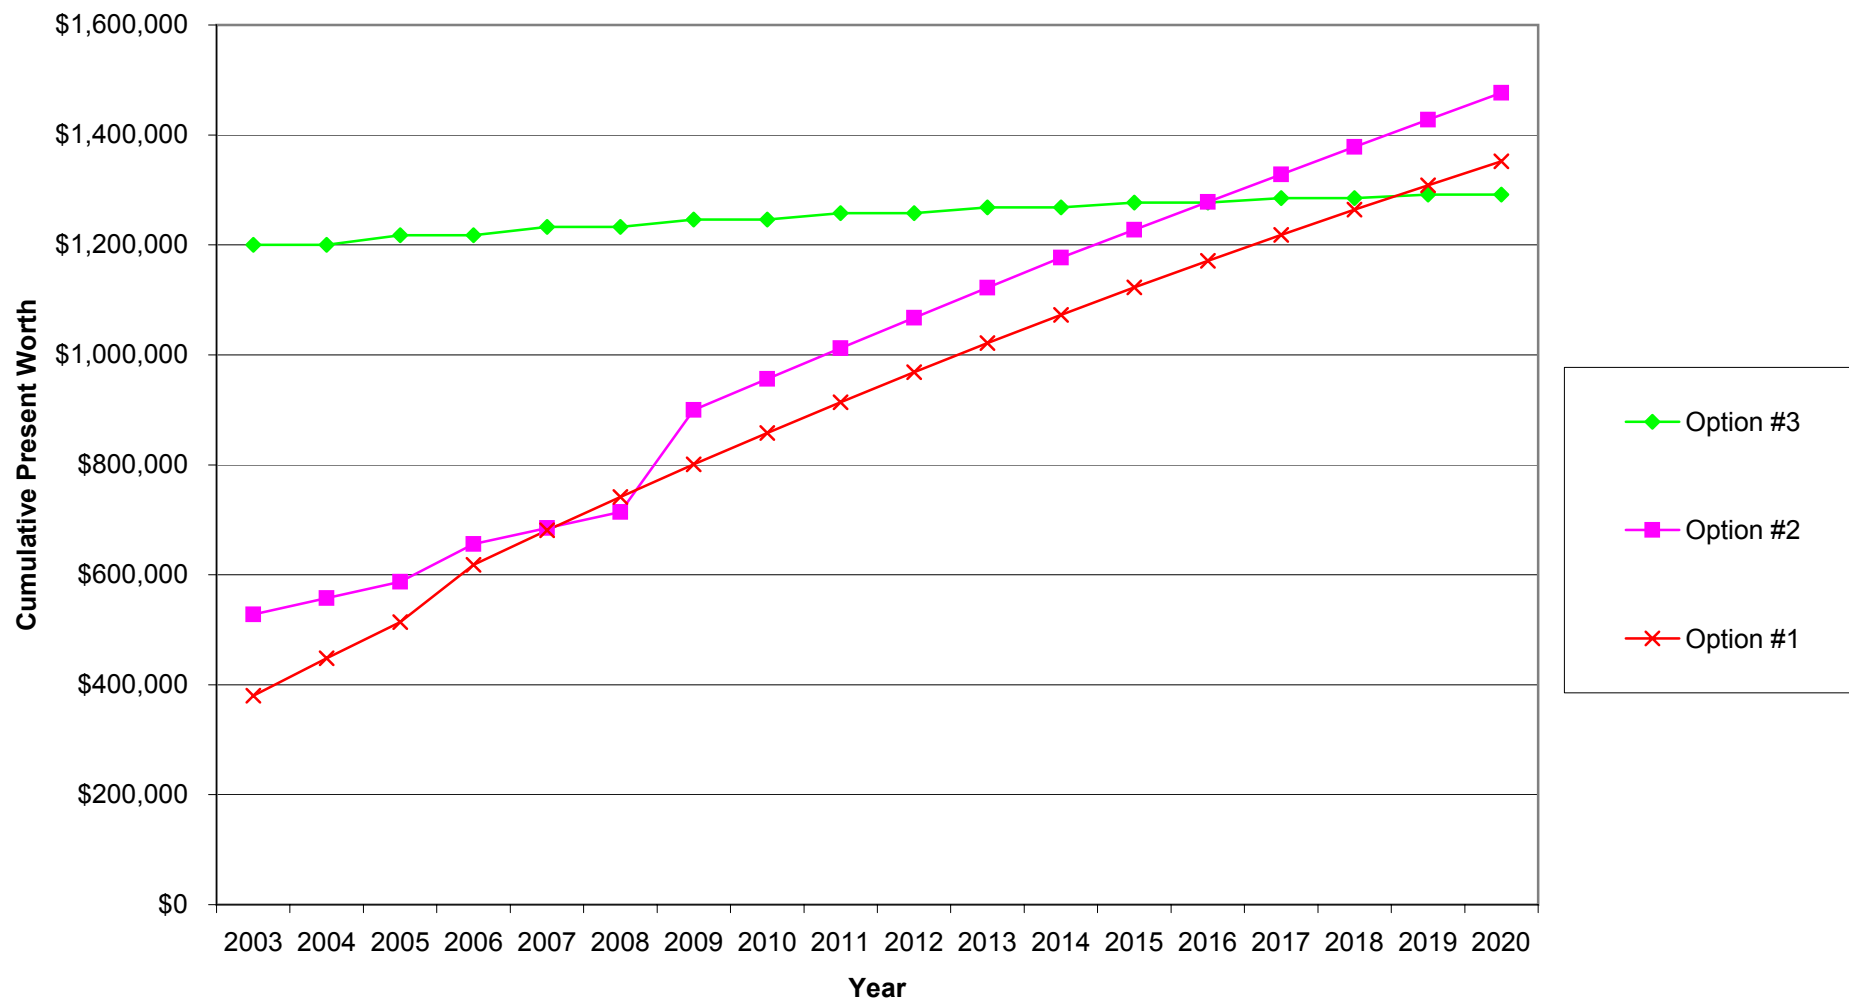
Cumulative Worth Comparision

The results of this calculation revealed that the replacement of the stack liner is the least cost option over the 18-year evaluation period. The results of this comparison are shown in Appendix A, Cumulative Present Worth Comparison.

A cumulative present worth comparison was conducted for the three options listed above. The cumulative present worth calculation assumed an 18-year horizon, discount rate of 8%, average inflation rate of 2%, and an increase in annual maintenance and repair costs of 3% due to larger areas requiring repairs.
